Level Crossing Safety Impact Assessment (LCSIA)

Lincoln Road level crossing, Addington, Christchurch

Prepared for Christchurch City Council

Prepared by Beca Limited

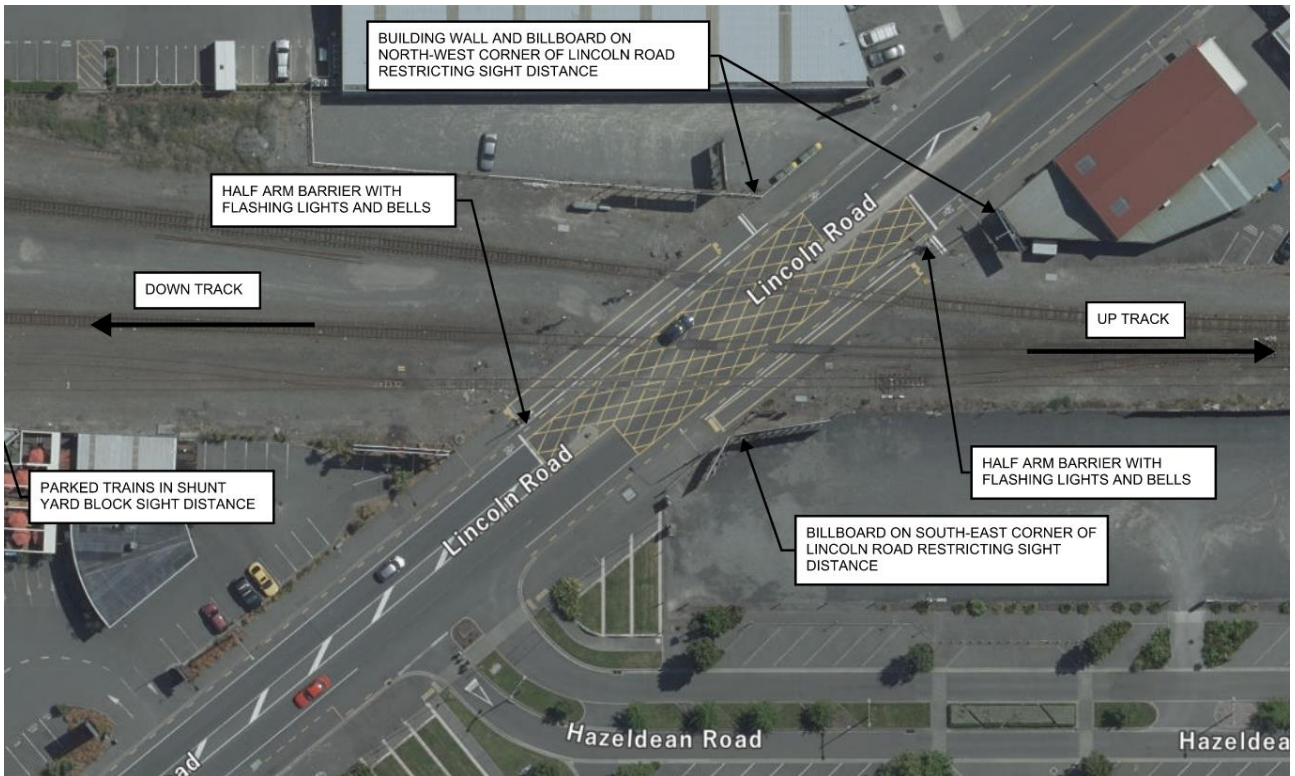
The vertical geometry is flat on the northbound approach. There is a slight rise in the road on the southbound approach. This seems to be impacting driver's ability to effectively judge whether there is enough space for them to clear the rail corridor before the vehicle queue. There is no risk of vehicles grounding out on either approach.

There are visibility restrictions caused by properties and billboards on both approaches. On the southbound approach visibility is restricted in the up track direction by billboards and fencing. The down track direction is partially obscured by stationary train carriages in the shunting yard.

Figure 3: Lincoln Road level crossing key crossing features and visibility restrictions

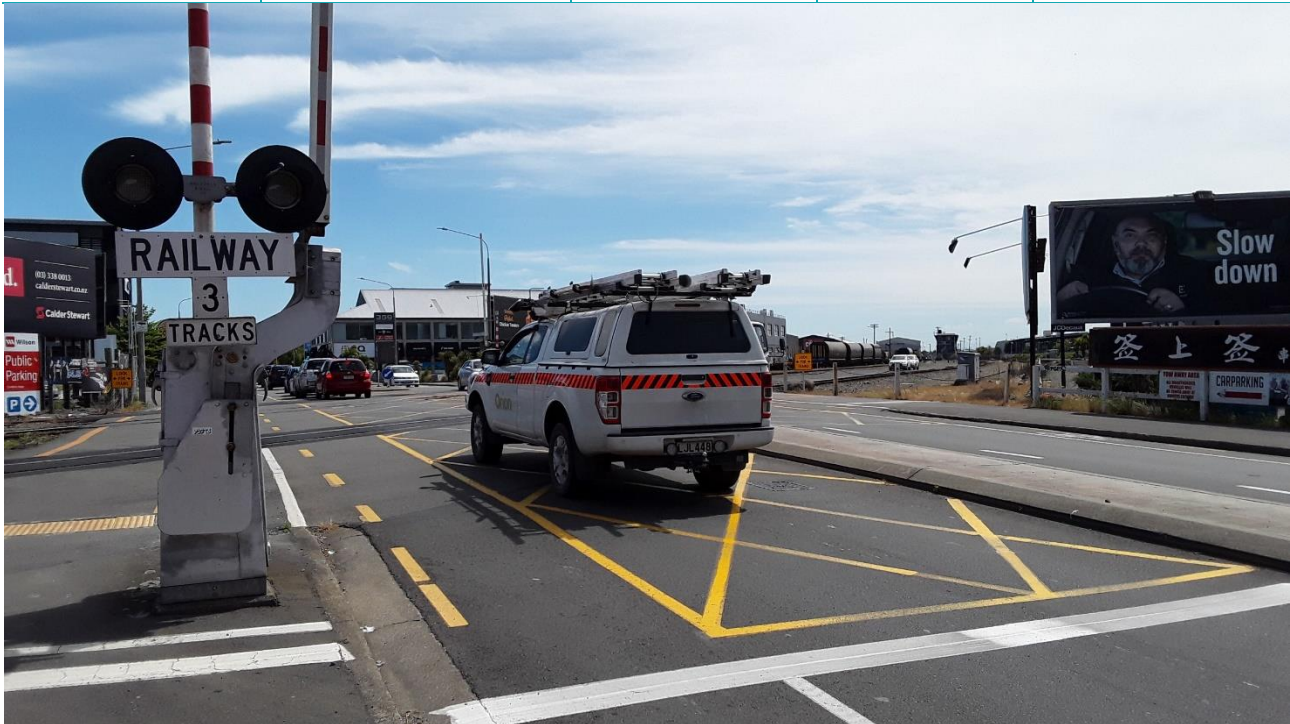
- The two signalised intersections create large queues that frequently stack the rail corridor. Drivers were observed to frequently enter the rail corridor without being able to clear the other side as shown in
- Emergency braking was also observed due to this issue however drivers normally ended up in the clear zone hatch area either within or directly under the half arm barrier. This can result in drivers driving onto the footpath to clear the rail corridor when a train is coming as shown
- Queueing also block the adjacent signalised intersections during busy peak hour times. This is a significant road safety issue for drivers and cyclists. Large queues also cause other safety issues related to reverse priority behaviour at commercial accessways. This behaviour has led several rear end and cycle crashes as evidenced in the CAS crash database.

Figure 4: Traffic queues stacked across the multiple tracks within the rail corridor at the Lincoln Road level crossing

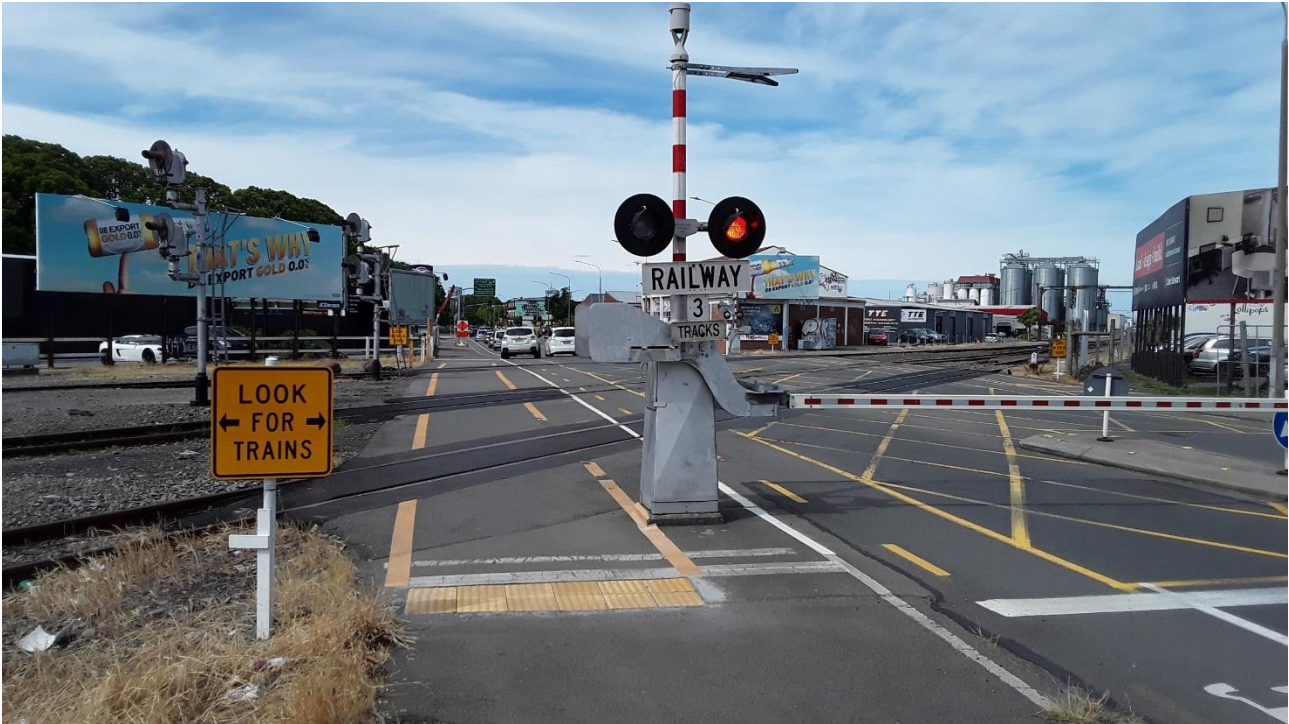
Figure 5: Vehicle observed driving onto the cycle lane and footpath to clear the rail corridor as a train travelling eastbound approaches the Lincoln Road level crossing

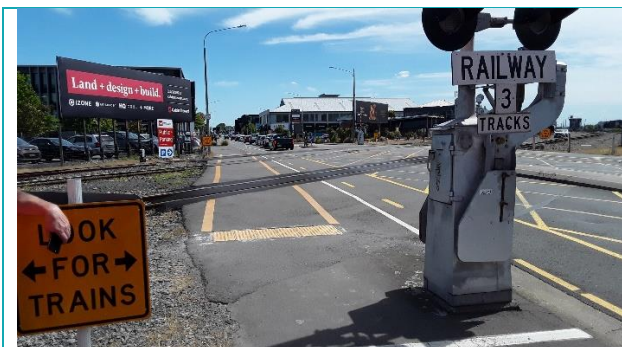
The tactiles are installed after the flashing lights and bells assembly due to the skew of the crossing as shown in Figure 6 . A 150mm white holding line has been painted the footpath to help warn pedestrians of the correct stopping point.

Figure 6: Tactile indicators installed behind the flashing lights and bells assembly on the eastern crossing

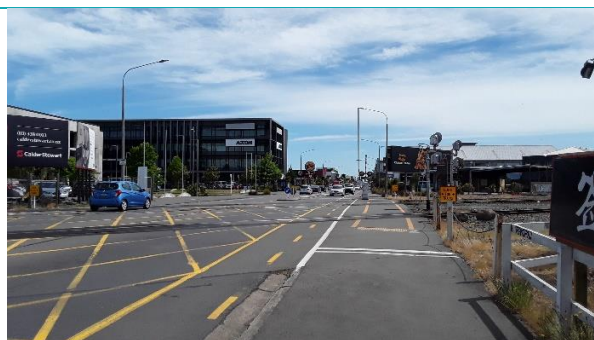
Figure 7: Western pedestrian crossing with passive warning control layout shown. There is no adjacent flashing lights and bells assembly on this approach

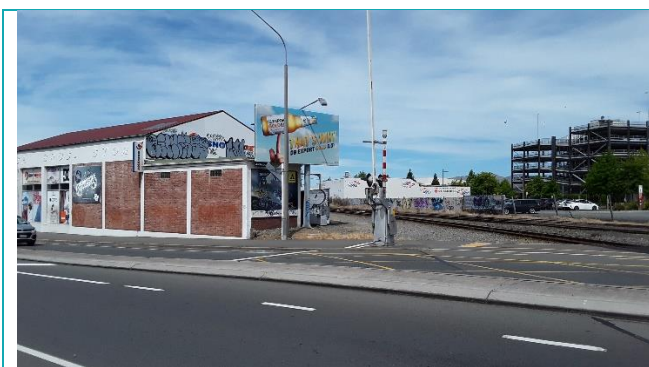
Figure 8: Pedestrian sight line from the western pedestrian crossing looking up track (east) severely restricted by property

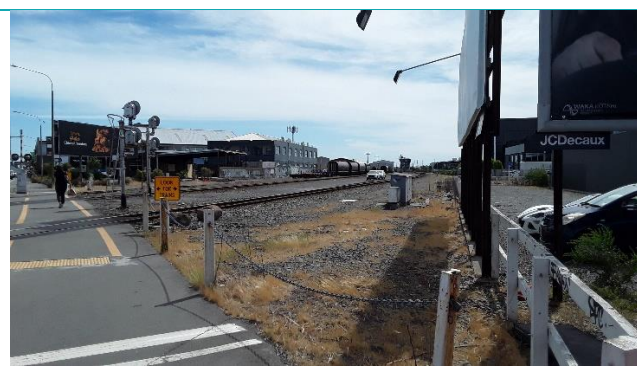
Figure 9: Pedestrian sight line from the western pedestrian crossing looking down track (west) is limited by the curve in the rail track

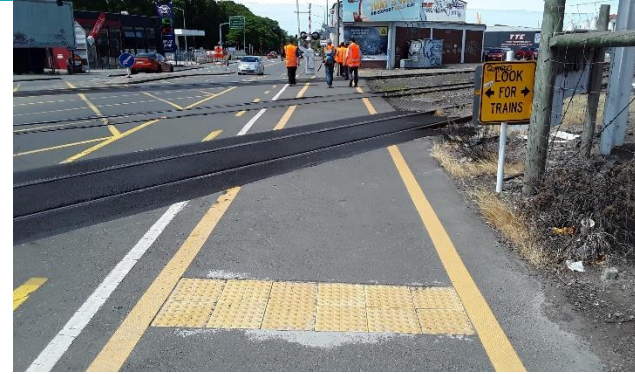
The crossing panels are constructed of asphalt. The eastbound line and the siding line have recently been replaced and are in good condition. The westbound line (middle track) has not been replaced and the asphalt surface is lifting creating a tripping hazard on the eastern pedestrian crossing.

There is some graffiti on signs as shown in Figure 10.

Figure 10: New asphalt panel on the siding line. Lifting of the asphalt surface is visible on the westbound lane (middle track). Note the graffiti on the look for trains signs.

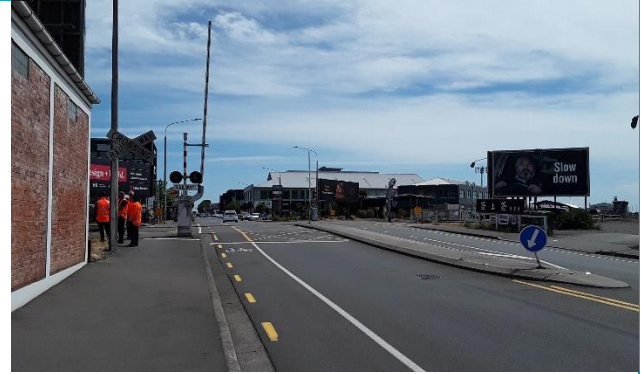
The road surface on approach to the crossing in good condition. The clear hatch cross zone is not faded and is easily recognisable but has not been repainted on the new asphalt surface.

Figure 11: Southbound approach surface in good condition

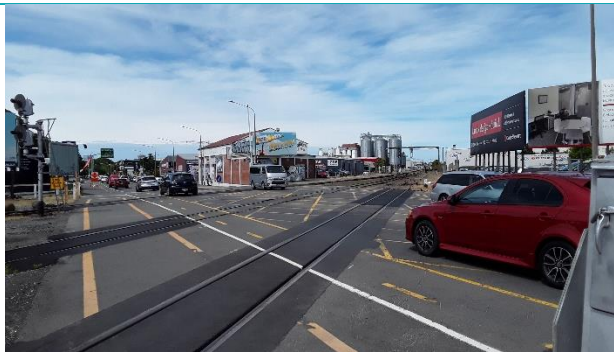
- **Extremely frequent queuing across the rail corridor** – adjacent signalised intersections cause large queues to develop which block multiple tracks across the rail corridor as shown in Figure 12

Figure 12: Queues forming at the Lincoln Road – Moorhouse Avenue signalised intersection stacking across multiple tracks at the Lincoln Road level crossing

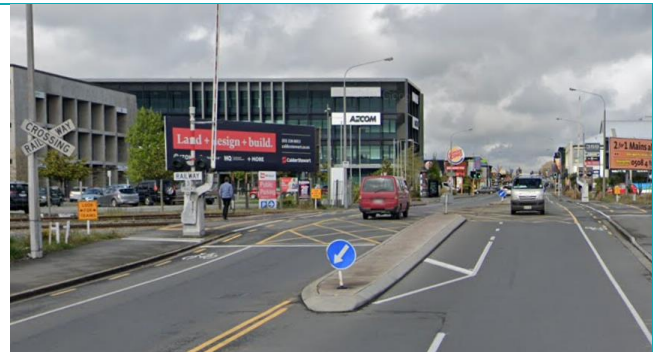
Figure 13: Vertical rise north of the rail corridor makes it difficult for drivers to judge whether there is enough space to clear the rail corridor when queues develop
