Invercargill City Council

Surrey Park Grandstand

Detailed Seismic Assessment Report

Date: 21/01/2019
Reference: 6-VI043.00
Status: Final

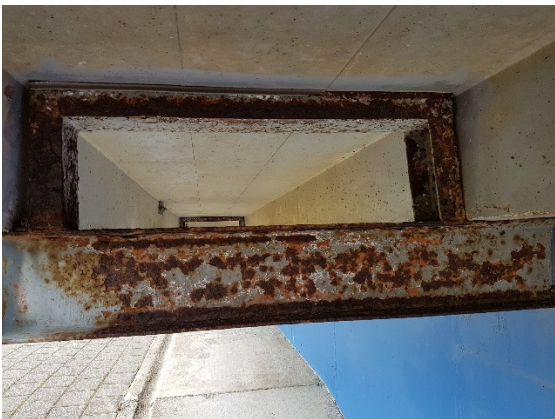
It is apparent that the building has substantial corrosion to structural steel members. Some of the secondary steel sections that support the bleacher seating were observed with corrosion (Photo 1). Cracking to the encasement of the steel portal frame were observed; presumably caused by corrosion development triggered by water ingress on the top of concrete encasement (Photo 2). The level of corrosion at this stage is not considered to be significant in terms of reducing the seismic capacity at this stage. However, the affected steel requires cleaning back and repainting to ensure that the level of corrosion does not cause further deterioration that may lead to an issue of structural stability. Where damaged the concrete encasement of the steel columns should be removed with the structural steel inspected prior to a repair solution being specified to remediate. During the inspection it was noted that patch-repair approach has been done in some locations, particularly to the base of the SHS posts supporting the grandstand roof, however, we are unaware of the process followed when this was completed. If corrosion has not been adequately treated, the underlying problem and corrosion will continue that could potentially create risks (durability and stability) to the structure.

Photo 1: Corroded Steel Section

Furthermore, cleaning and painting of all steelwork are recommended to manage future durability of the structure. The accurate extent of this work can be determined following the completion of the detailed investigations outlined below.

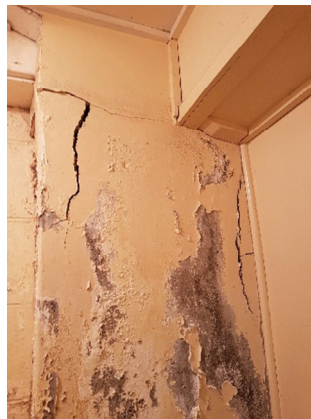
Photo 2: Cracking to Concrete Encasement

The Kensington Consulting has completed an initial structural assessment (ISA) in February 2013 and identified issues on the condition of the building concerning corrosion of the steelwork and cracking of concrete. Minor cracking of the concrete encasement around the main steel portal frames at the north wall was noted. They recommended that the observed cracks be monitored.

- Concrete block wall construction. Need to confirm or otherwise if the existing concrete block work is unreinforced;
- Corrosion. This will determine the extent of corrosion, corrosion-induced structural damage, and an evaluation of the building's residual life if required. This should include a factual report and recommendations outlining the repair options.
- Site-specific geotechnical investigation and interpretative report. This is necessary to confirm ground conditions and potential geotechnical hazards.

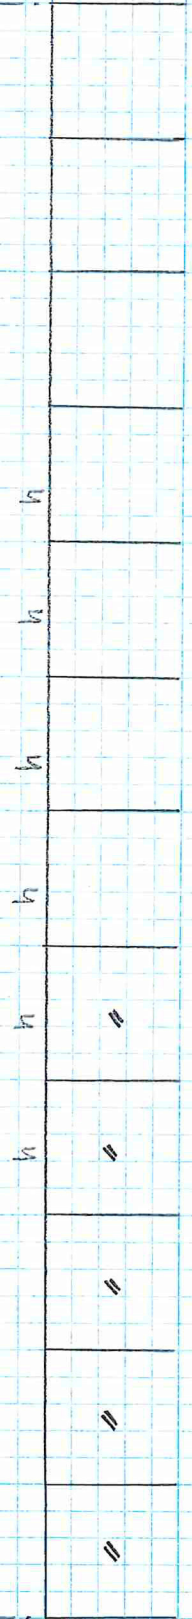
NORTH WALL ELEVATION
 GRID A

← 5 BAYS W/ 6" UNREINFORCED
 CONG. BLOCK WALL, AS PER
 SITE OBSERVATION. →

- _____ EXISTING MEMBS. TO REMAIN
- Ch) EXISTING MEMBS. TO BE REPLACED
- " EXISTING 6" CONG. BLOCK WALL TO BE REMOVED & REPLACE WITH REINF. CONG. BLOCK WALL
