# Arboricultural Assessment

**Site Address:** 42 Lakings Rd

**Affected Trees:** One *Quercus phellos* and one *Quercus palustris*

**Date of Report:** 5 August 2019

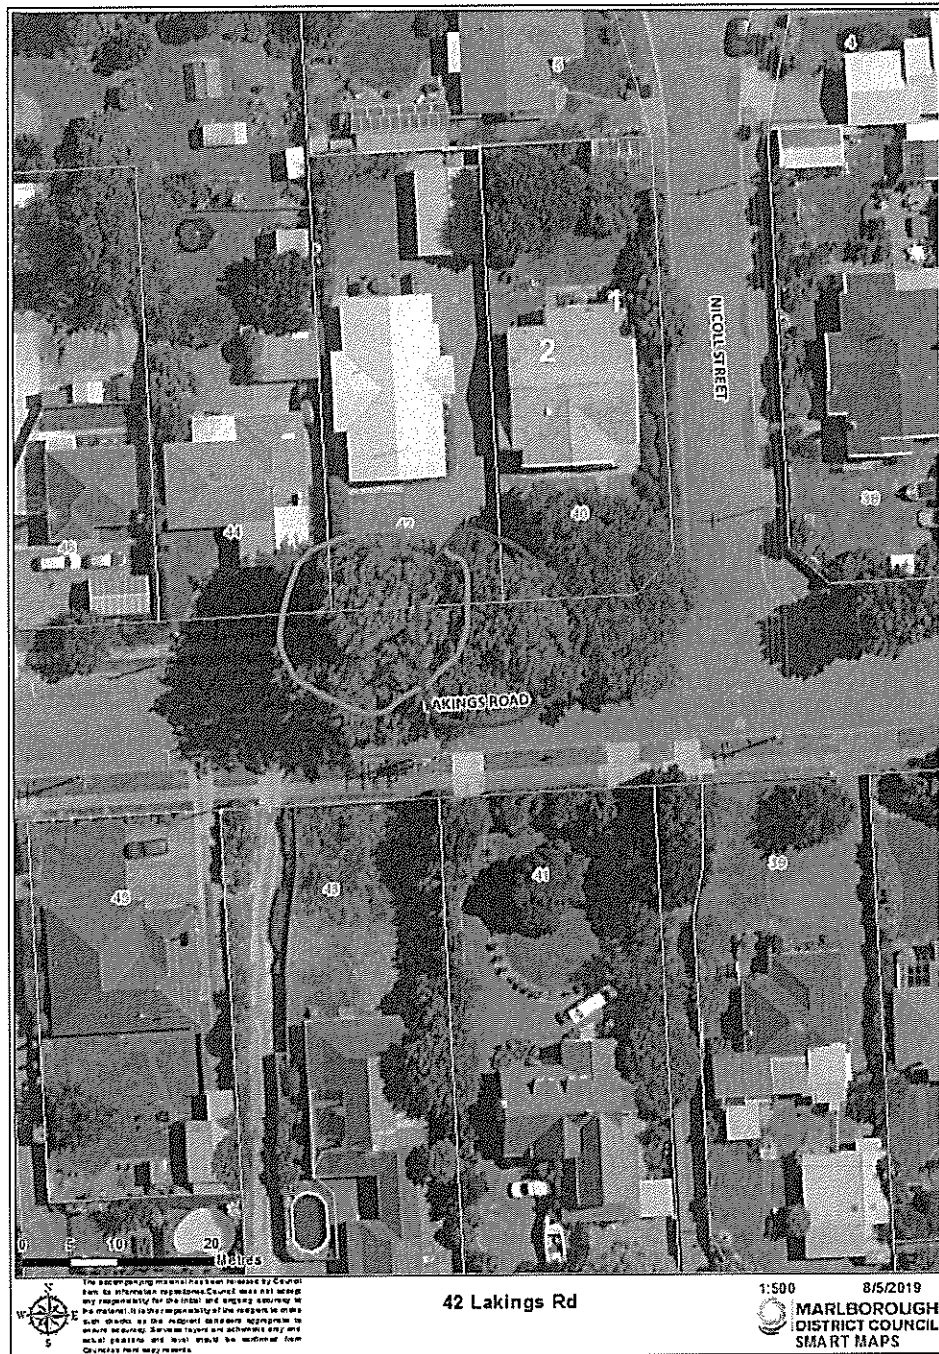
Fig 1. Light green T1, *Quercus phellos*, Dark green T2, *Quercus palustris*

That a 10% end-weight reduction be considered of scaffold branches where over extension (beyond the general canopy, Fig 1.) is likely to result in increased wind load, and also of large horizontally attached scaffolds as mitigation of SLD.
