Operational Review

Lake Hawea Vegetation Fire

Incident Number: F2642681

Date of Incident: 2nd November 2018

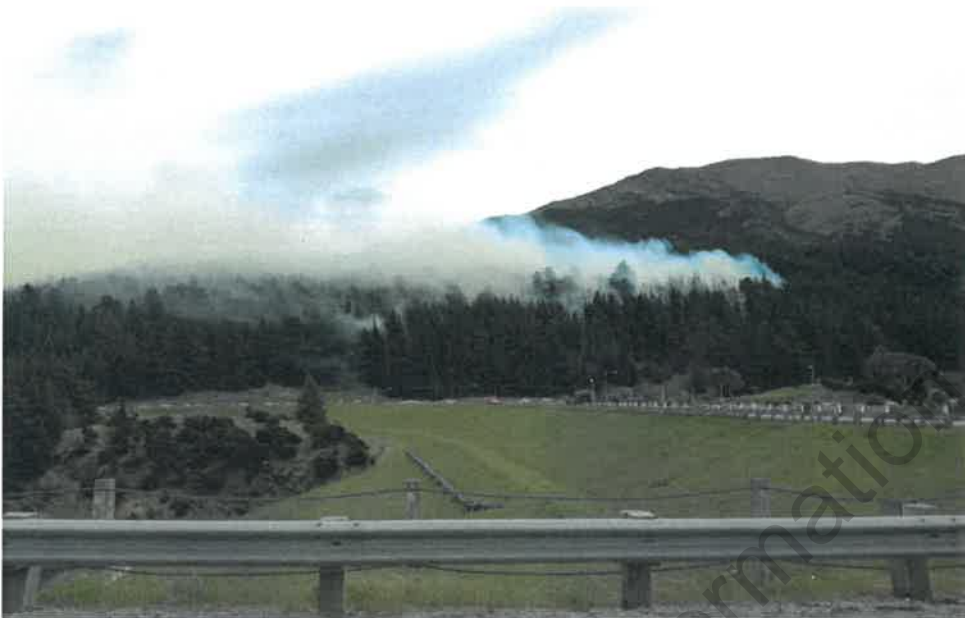
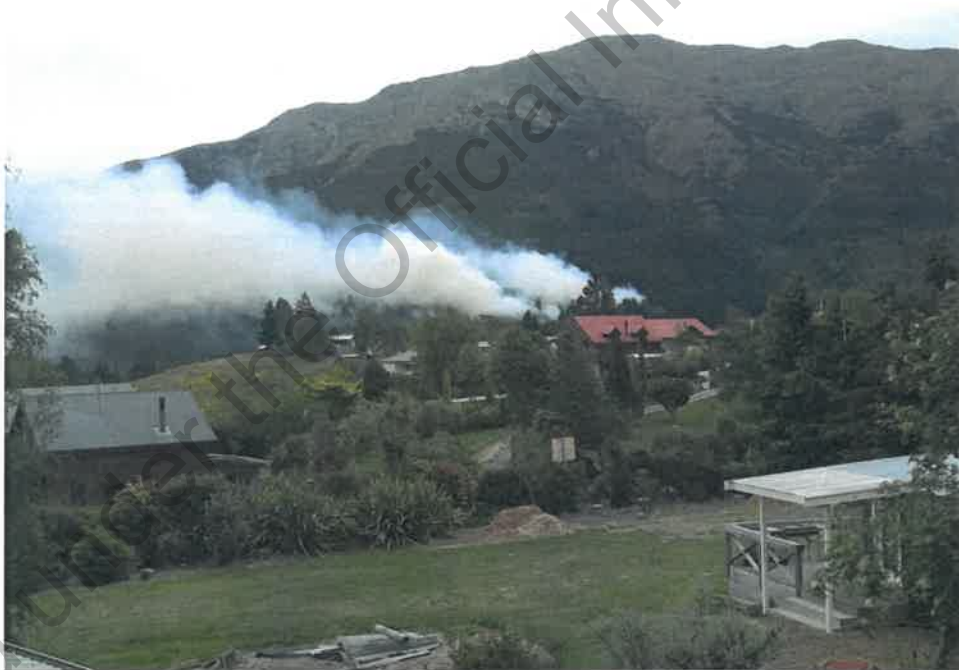
These photos taken from the Lake Hawea township showing wind direction and the fire in early stages
