ASSESSOR'S REPORT AS 012

For Multiple Unit Complex

WHRS Act (2006) CLAIM NUMBER 05533

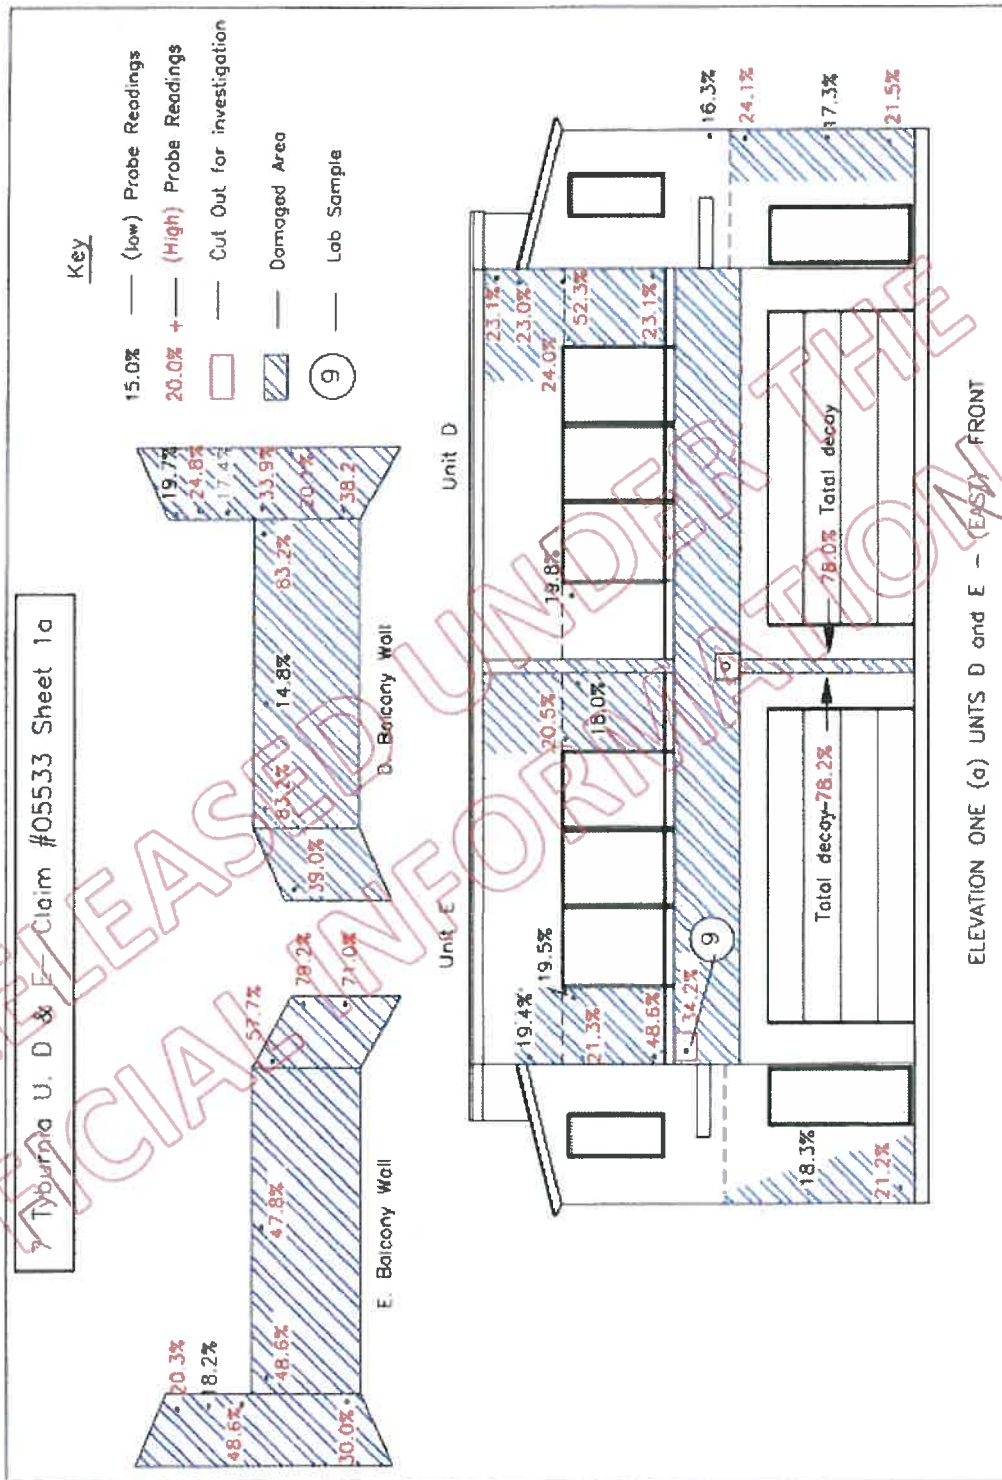
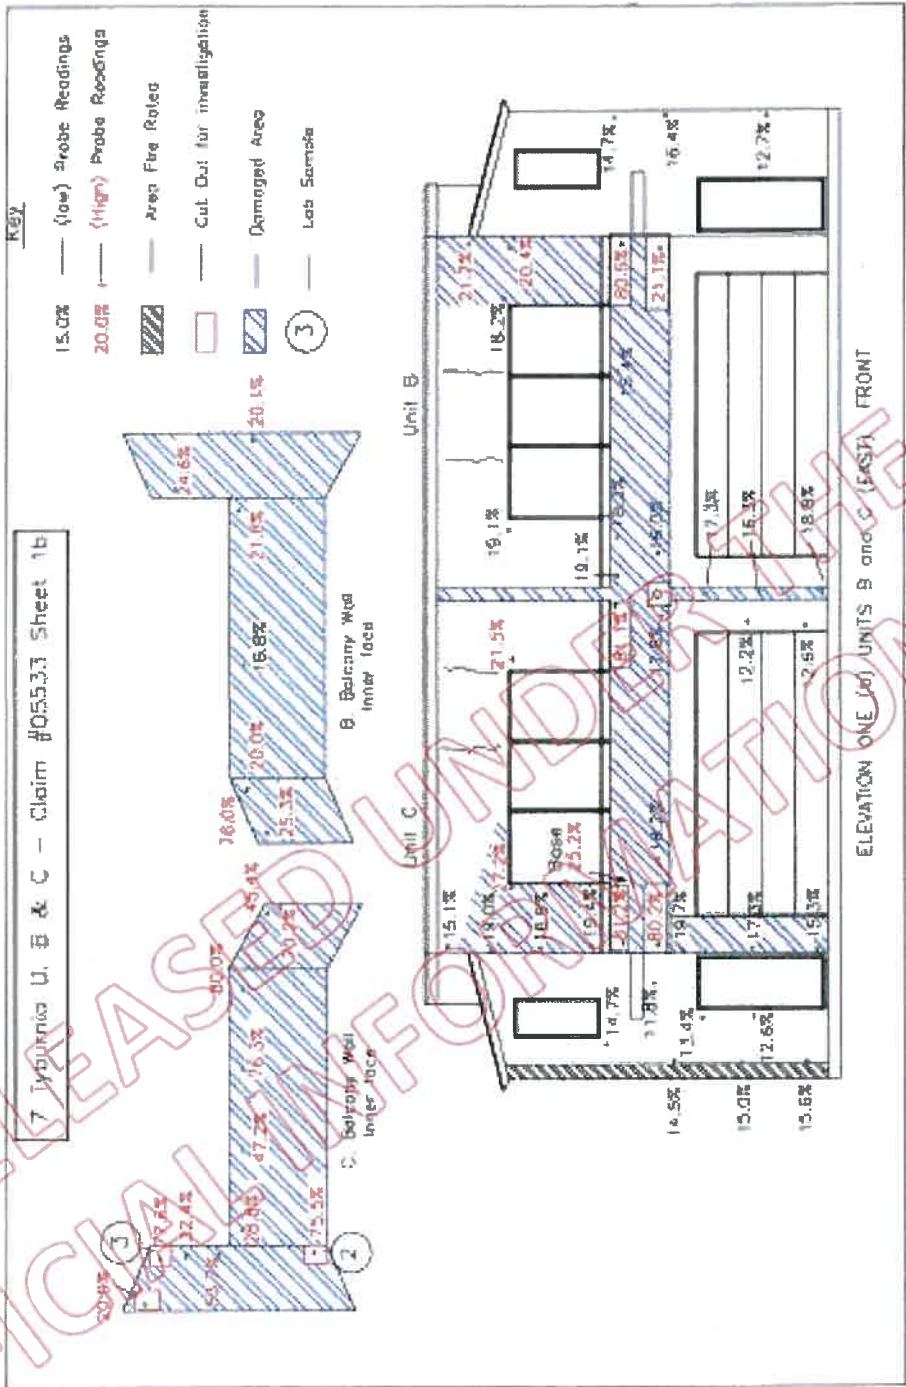
The CAD sketch drawings below show all invasive moisture readings taken externally on the eastern elevation; note all readings over 18% are shown marked in red, some probe readings were below the 18% threshold

Note: Hatched areas on the above sketch drawings are the areas which, in my view, have sustained damage to the framing and other building elements, due to water/moisture ingress.

During invasive testing it became evident that moisture is ingressing into the wall cavities, as moisture readings into the timber framing were registering in excess of 18% in resistance mode

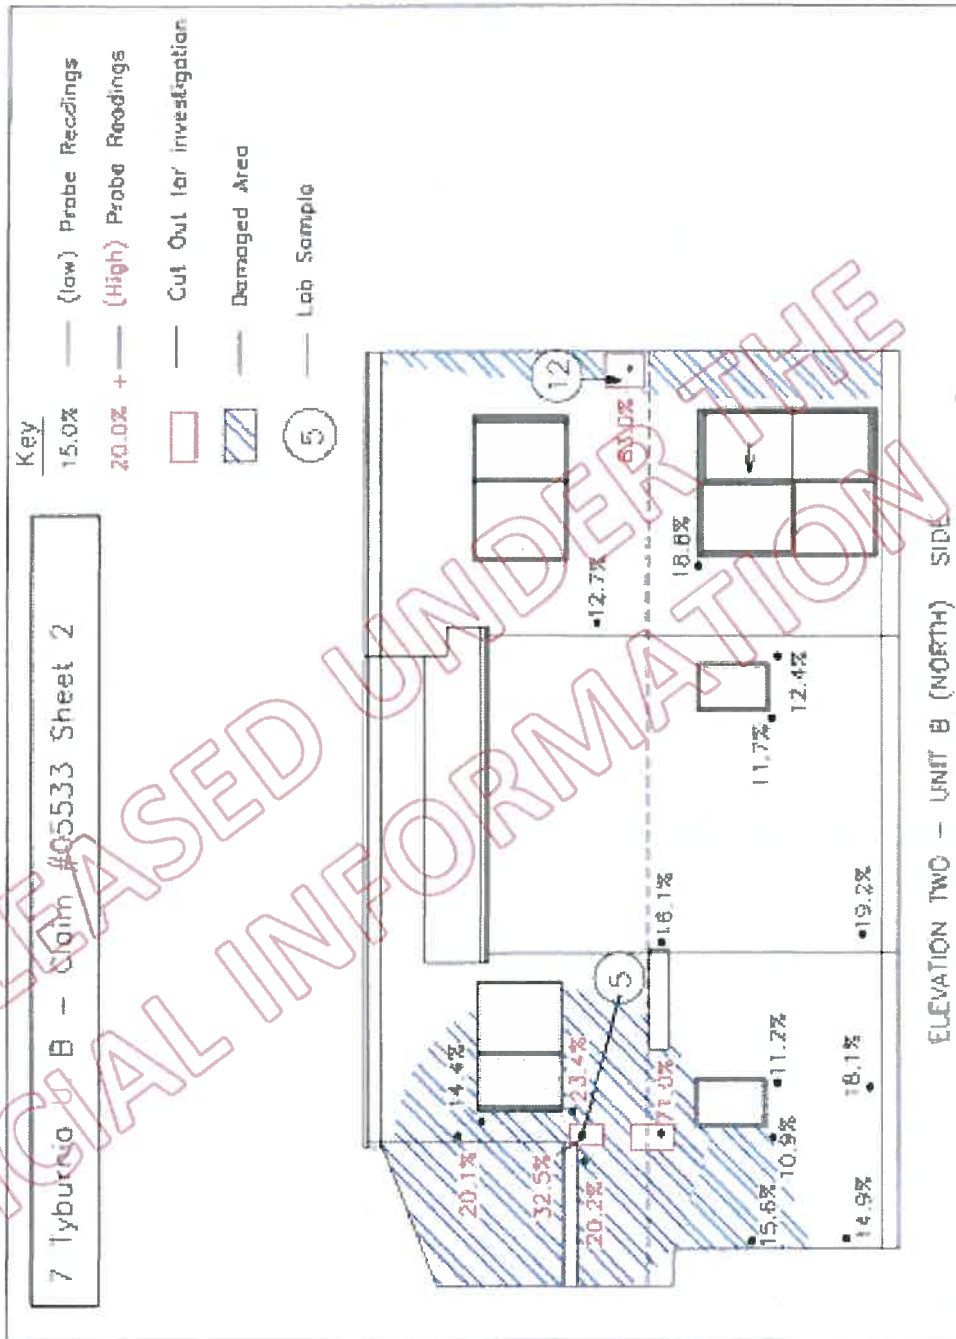
The CAD sketch drawing below shows all invasive moisture readings taken externally on the northern elevation; note all readings over 20% are shown marked in red, some probe readings were below the 20% threshold

Note: Hatched areas on the above sketch drawings are the areas which, in my view, have sustained damage to the framing and other building elements, due to water/moisture ingress.

During invasive testing it became evident that moisture is ingressing into the wall cavities, as moisture readings into the timber framing were registering in excess of 18% in resistance mode

Cut-out Location	Photo ref (if any)	Observations
Lab Samples	2b 68 to 2b 74	<p>The roof parapets have not been constructed in accordance the Building Consent documents and have failed. The cap flashing is flat and water is ponding around joins, there is no up-stand to the front parapet causing water ingress into the wall cavities. The parapet cap flashing junctions and joints have been badly constructed and merely surface sealed with unprotected sealant.</p>
Cut out No. 5		<p>The junctions where the balcony wall timber capping intersects with the eastern wall do not have saddle flashings installed, consequently gravitational water is able to ingress into the wall cavities below which is causing extensive damage to the wall framing below, the 450x100mm garage support beams and the balcony floor joists and substrate.</p>
Cut out No. 12		<p>The Harditex™ cladding as fixed appears not to be in compliance with the James Hardie Technical Information 1998 for the following reasons</p> <ul style="list-style-type: none"> ➤ The Sheet configuration is not in accordance with Section 3: Fig. 12, 13, and 14 page 10 ➤ The installation of the proprietary H mould, vertical and horizontal control joints have not been installed in accordance with Section 4 Fig. 23, to 26 and Fig. 31 to 34, pages 15 to 18; none of the corner mitre or horizontal butt joints has been adequately sealed or is watertight. ➤ The installation of the aluminium joinery is not in accordance with Section 3: Fig. 15 to 18, pages 11 and 12; or Section 6 Fig. 58 to 62 page 38; there was no evidence of jamb or sill flashings or proprietary seals correctly installed, some of the windows have failed. ➤ The ground clearance on this elevation is not in accordance with Section 5: Fig. 46, to 48 pages 26and 27, consequently damage has occurred to the lower framing. ➤ The Harditex™ clad balcony walls and wing walls on this elevation are not in accordance with Section 6: Fig. 68 page 39; the timber capping has failed. The method of fixing the metal handrails is also poor building practice and has failed. <p>The result of the above listed variations from the Harditex™ Technical Information and recommendations in my view is causing the premature breakdown of the cladding system and is allowing water ingress into the wall cavities causing damage.</p>

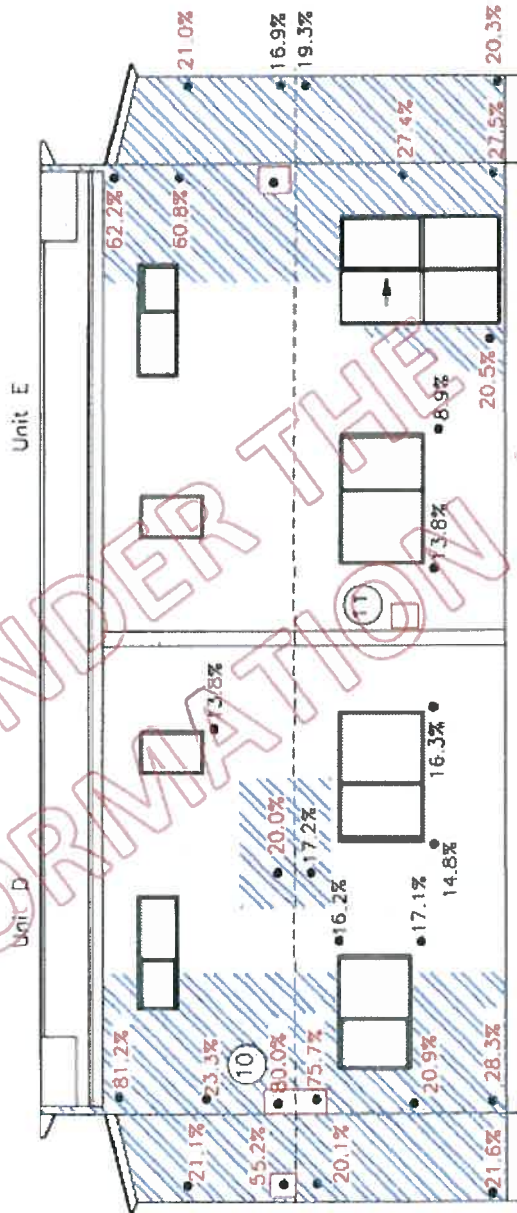
Note: Hatched areas on the above sketch drawings are the areas which, in my view, have sustained damage to the framing and other building elements, due to water/moisture ingress. During invasive testing it became evident that moisture is ingressing into the wall cavities, as moisture readings into the timber framing were registering in excess of 18% in resistance mode

<i>Cut-out Location</i>	<i>Photo ref (if any)</i>	<i>Observations</i>
Cut out Nos. 10 and 11	3b 75 to 3b 82 3c 83 to 3c 84 3d 85 to 3d 96 3e 97 to 3e 101	<p>The roof parapets have not been constructed in accordance the Building Consent documents and have failed. The parapet cap flashing junctions and joints have been badly constructed and merely surface sealed with unprotected sealant.</p> <p>The apron flashings at the western end of the parapets have been incorrectly installed, and kick-out or diverter flashings have not been fitted, consequently roof water is entering the wall cavities at the north west and south west corners at the roof-parapet junction causing fungal decay to the wall framing.</p> <p>The Harditex™ cladding as fixed appears not to be in compliance with the James Hardie Technical Information 1998 for the following reasons</p> <ul style="list-style-type: none"> ➤ The Sheet configuration is not in accordance with Section 3: Fig. 12, 13, and 14 page 10 ➤ The installation of the proprietary H mould, vertical and horizontal control joints have not been installed in accordance with Section 4 Fig. 23, to 26 and Fig. 31 to 34, pages 15 to 18; none of the corner mitre or horizontal butt joints has been adequately sealed or is watertight. <p>The installation of the aluminium joinery is not in accordance with Section 3: Fig. 15 to 18, pages 11 and 12; or Section 6 Fig. 58 to 62 page 38; there was no evidence of jamb or sill flashings or proprietary seals correctly installed, some of the windows have failed.</p> <ul style="list-style-type: none"> ➤ The ground clearance on this elevation is not in accordance with Section 5: Fig. 46, to 48 pages 26 and 27, consequently damage has occurred to the lower framing.. <p>The result of the above listed variations from the Harditex™ Technical Information and recommendations in my view is causing the premature breakdown of the cladding system and is allowing water ingress into the wall cavities causing damage.</p>
