<b>Photo Elevation &amp; Number</b>	<b>Page No,</b>	<b>Description</b>
<b>Elevation 1e</b>		
1e - 1	119	General view front
1e - 2	120	Cut out and high moisture reading at south east corner of balcony wall
1e - 3	120	High moisture reading at east balcony wall
1e - 4	121	High moisture reading at south east corner of balcony wall
1e - 5	121	High moisture reading at centre of eastern balcony wall
1e - 6	122	High moisture reading at wing wall junction
1e - 7	122	High moisture reading at base of wing wall
1e - 8	123	North wall / balcony junction – no saddle flashing
1e - 9	123	Open mitre at corner of timber balcony capping
1e - 10	124	Photograph showing incorrectly installed hand rail stanchion
1e - 11	124	Inter-storey H mould terminates at end of head flashing
1e - 12	125	Inter-storey H mould terminates mid sheet at wing wall
1e – 12/1	126	Photograph showing cladding hard down on balcony floor tiles
<b>Elevation 1d</b>

East (Front) Elevation 1 – Units E, D, B, C

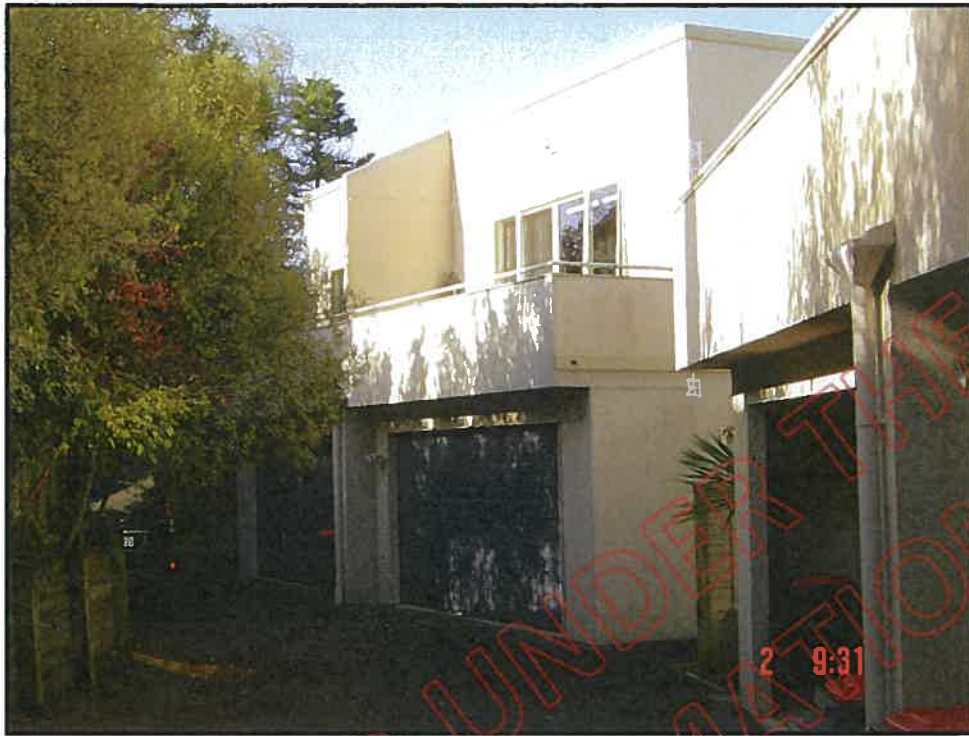
Unit d  
Photograph 1e 1

General view of front elevation

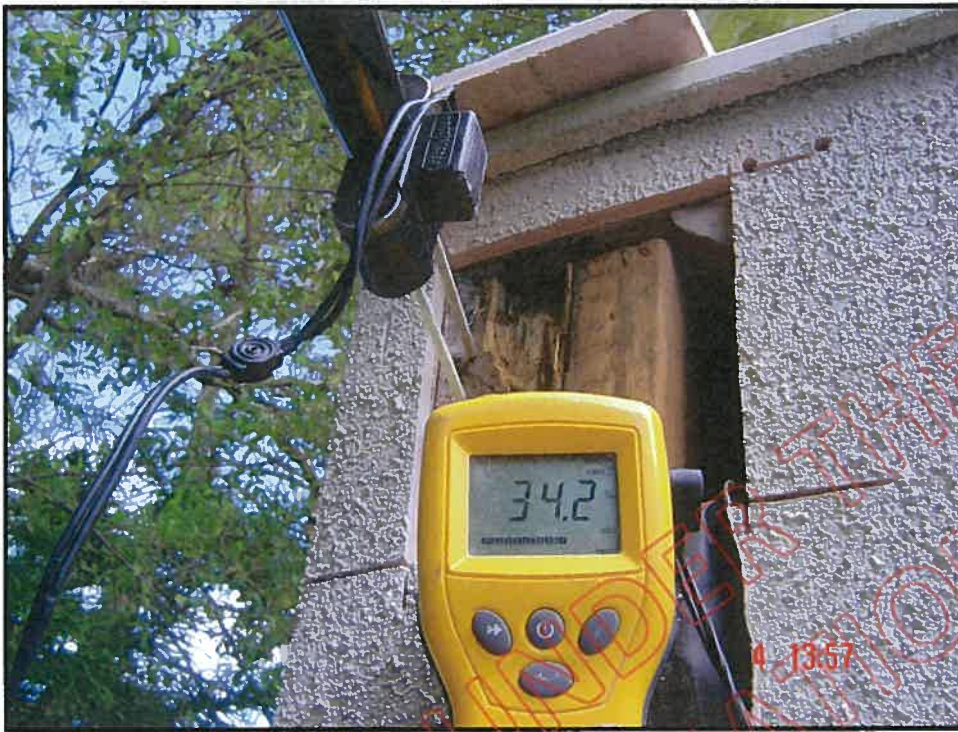
Photograph 1e 2

Cut out and probe reading at south east corner of balcony wall (Laboratory sample 9)

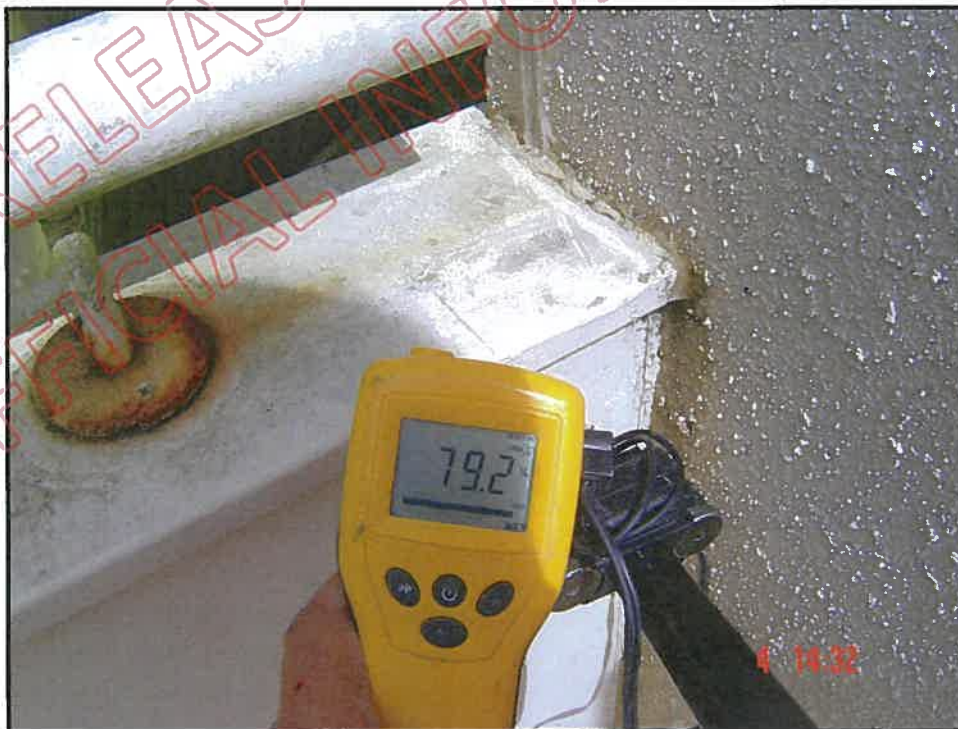
Photograph 1e 3

Very high probe moisture reading at east wall balcony wall junction (note: no saddle flashing at junction); note also corroded handrail stanchion incorrect application

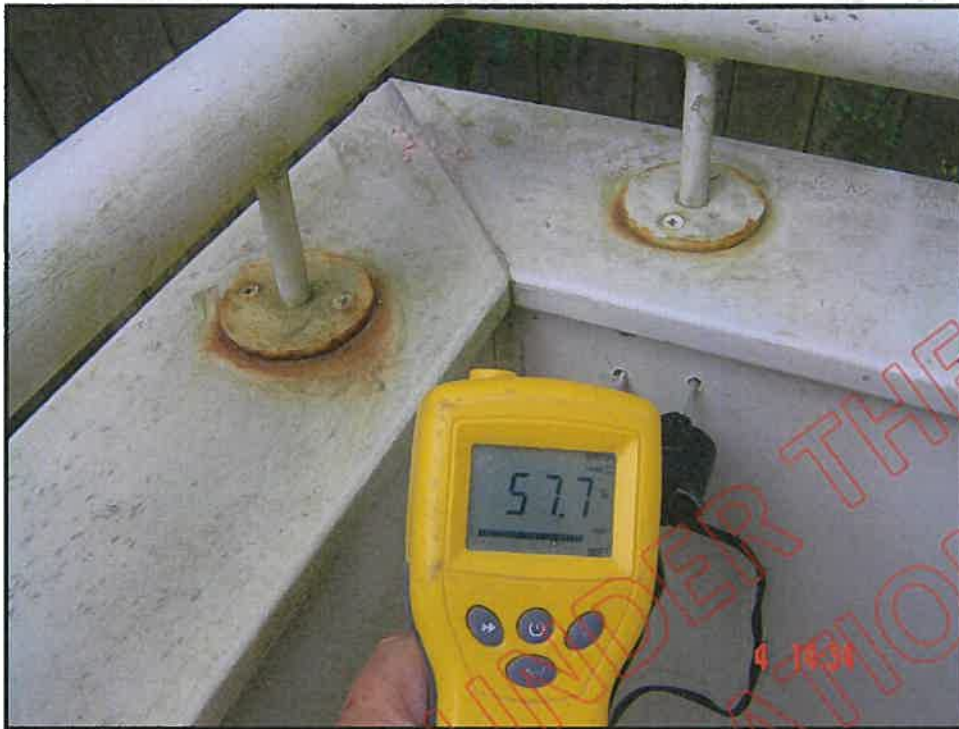
Photograph 1e 4

Very high probe moisture reading at south east corner of balcony wall

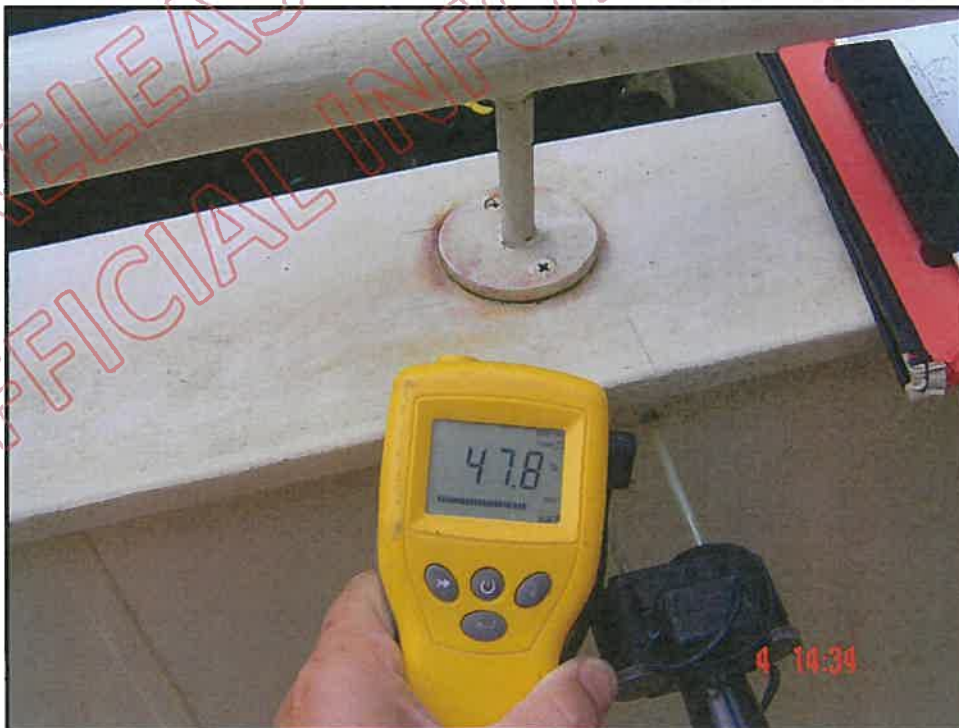
Photograph 1e 5

Very high probe moisture reading at centre of eastern balcony wall; note incorrect installation of hand rail stanchion

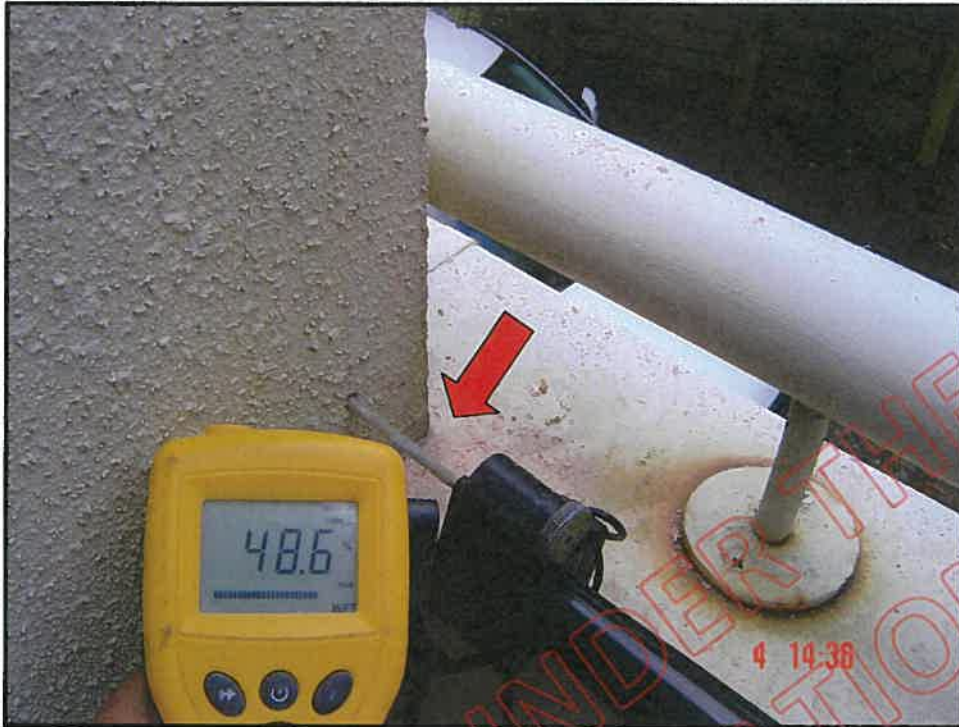
Photograph 1e 6

Very high probe moisture reading above balcony capping – wing wall junction; note no saddle flashing at this junction, note incorrect installation of hand rail stanchion

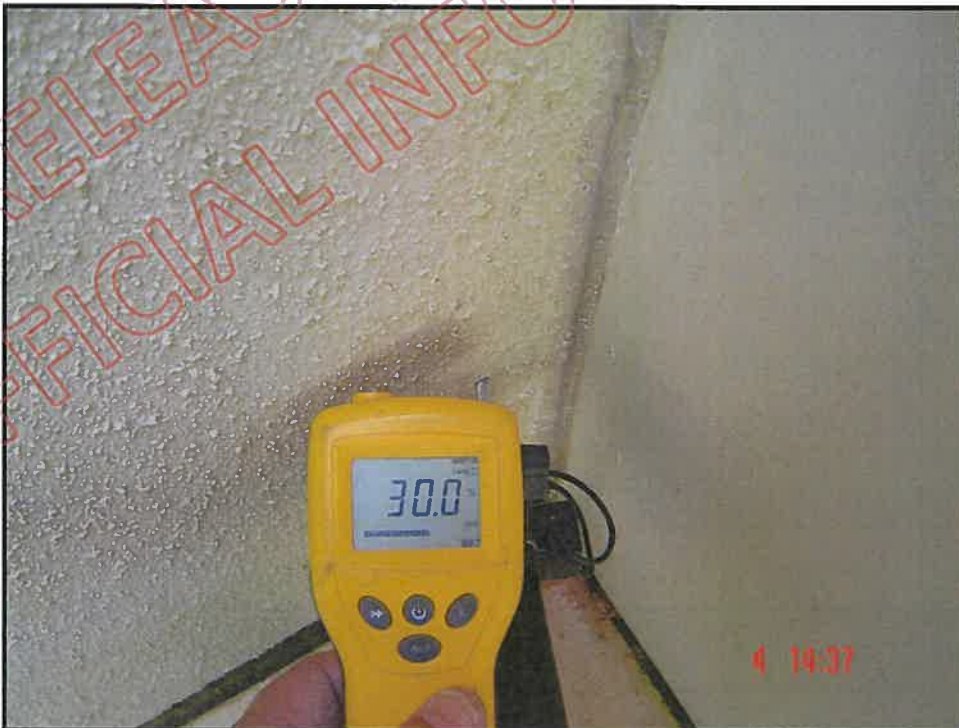
Photograph 1e 7

Very high probe moisture reading at base of wing wall; note cladding has insufficient clearance above tiled balcony floor

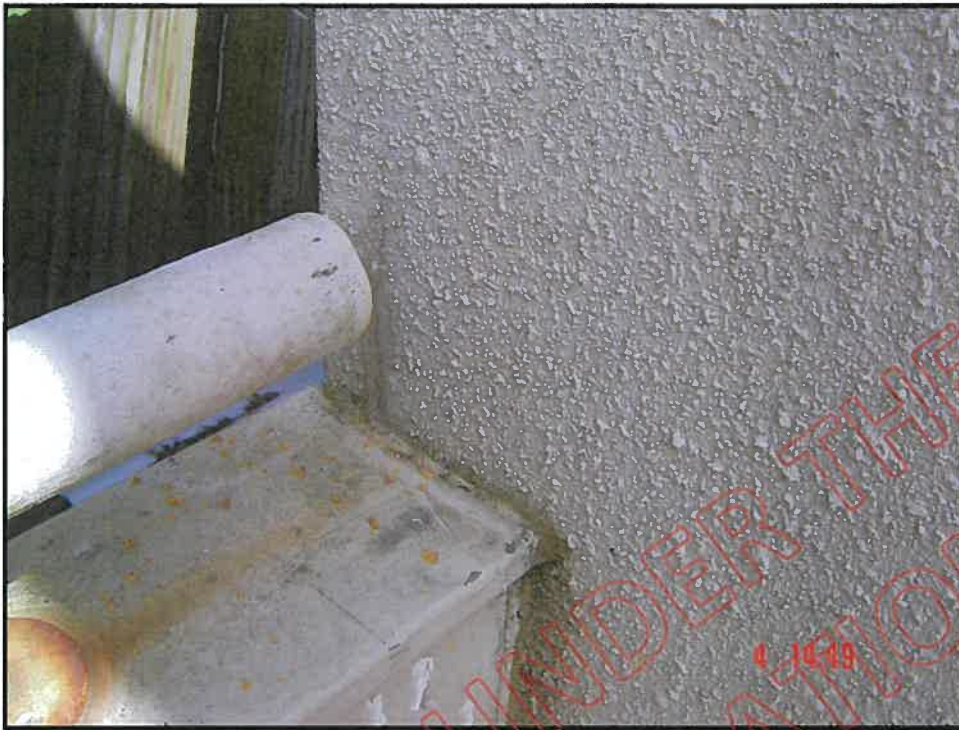
Photograph 1e 8

North wall – balcony wall junction (note: no saddle flashing at junction).

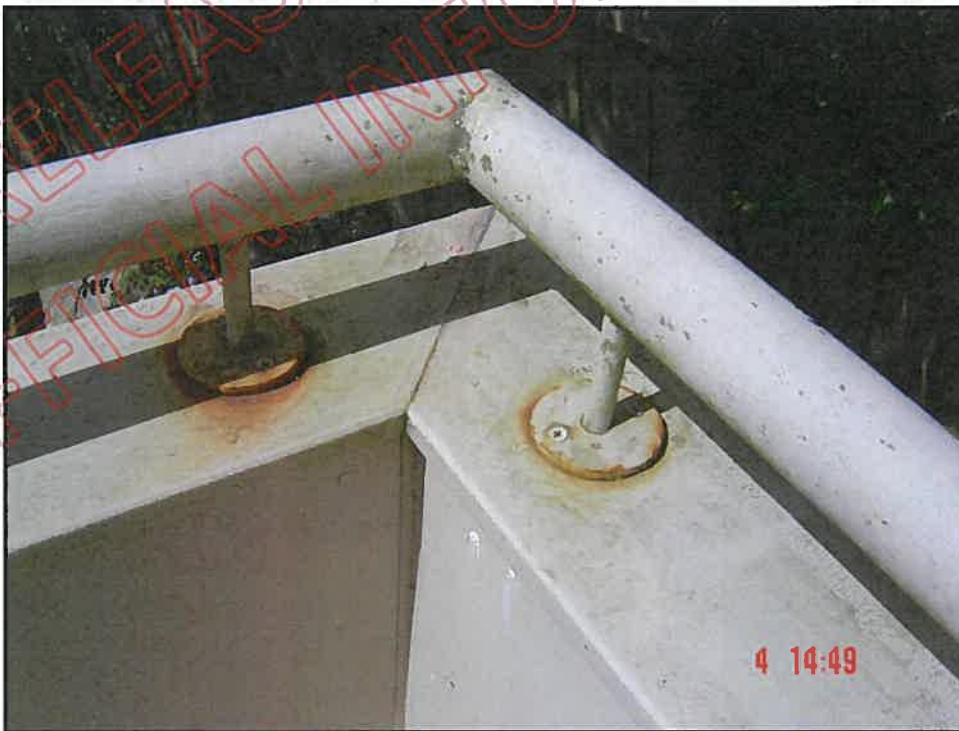
Photograph 1e 9

Top of balcony wall at south east corner; note corroded hand rail stanchions and open mitre to timber capping, mitre has no weather protection

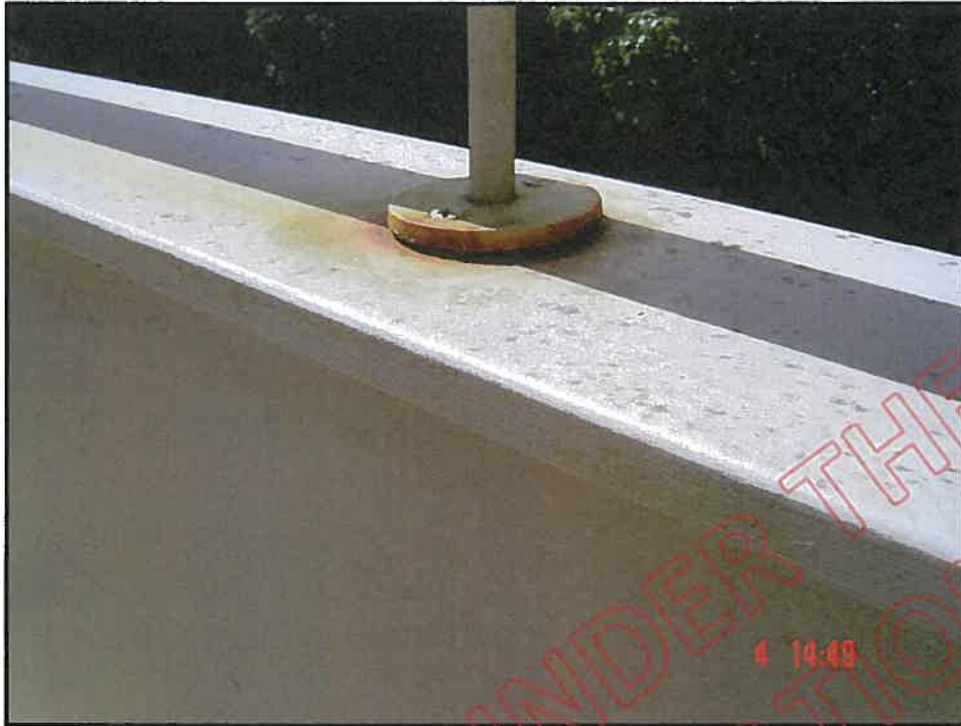
Photograph 1e 10

Eastern balcony wall showing incorrectly installed corroded hand rail stanchions

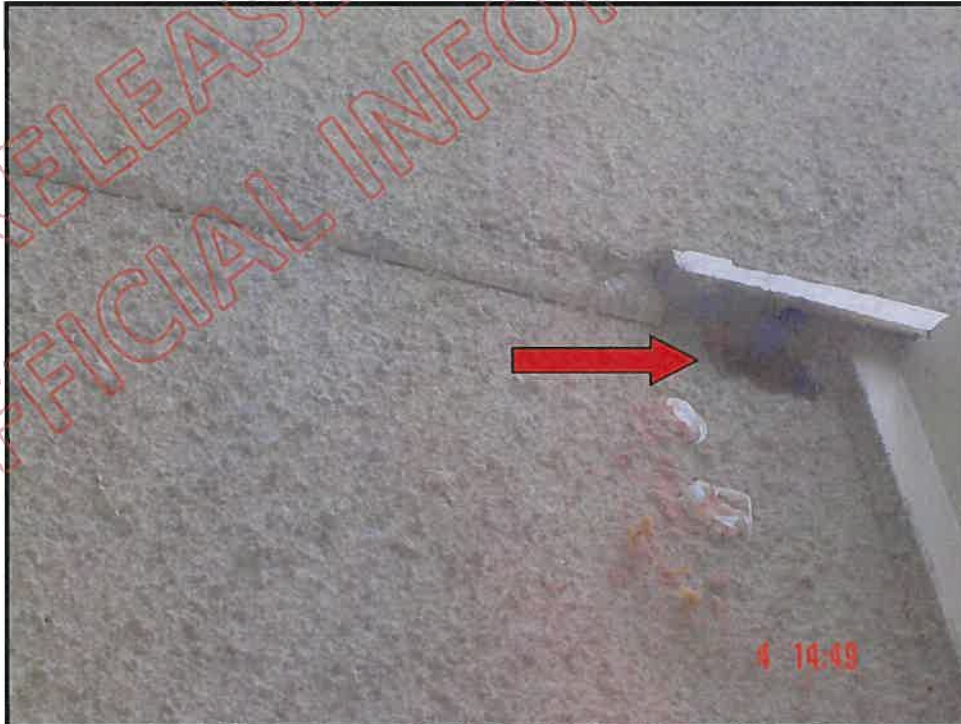
Photograph 1e 11

Incorrectly placed inter-storey joint butting into balcony door head flashing; note gap at join and hole with bare harditex under head flashing

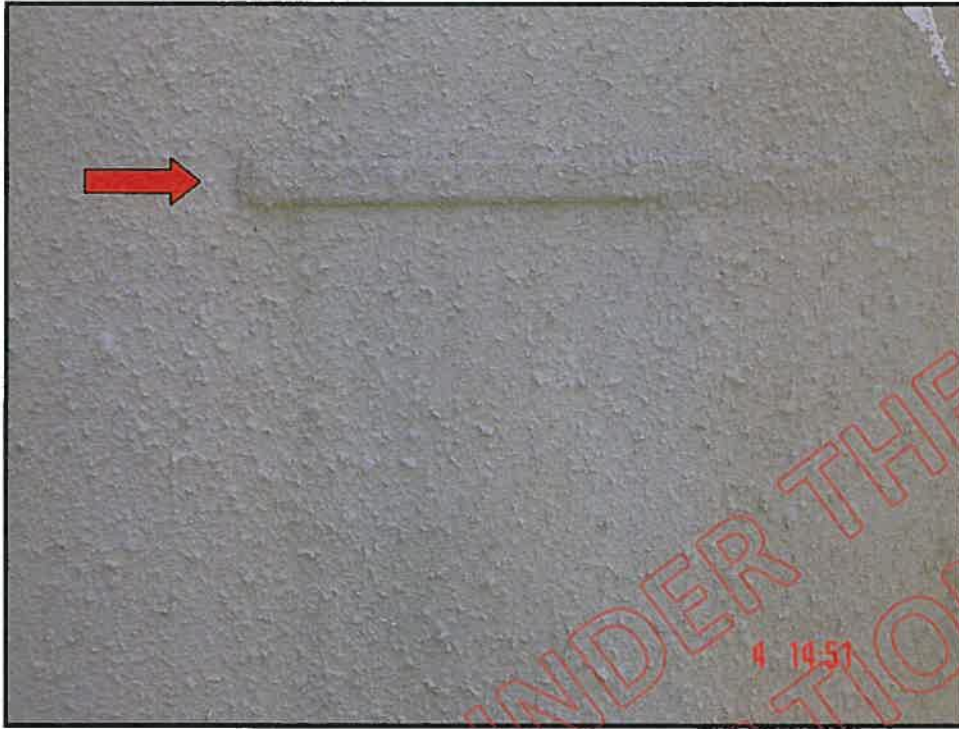
Photograph 1e 12

Inter- storey join finishes mid sheet at wing wall

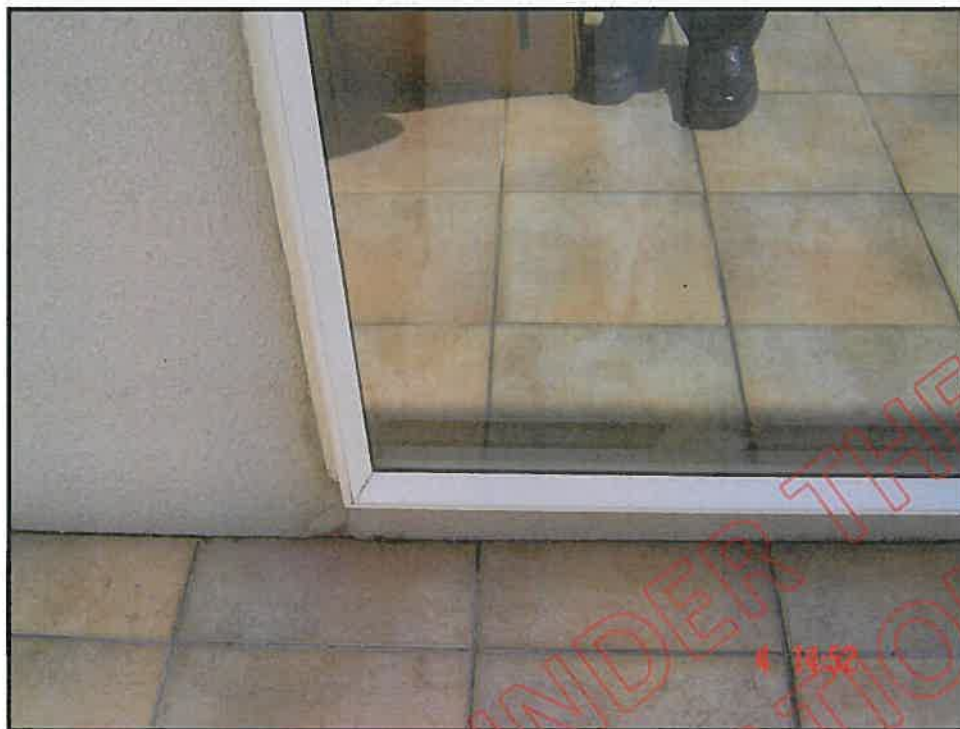
Photograph 1e 12/1

East wall shows cladding finishing hard down onto tiled balcony floor

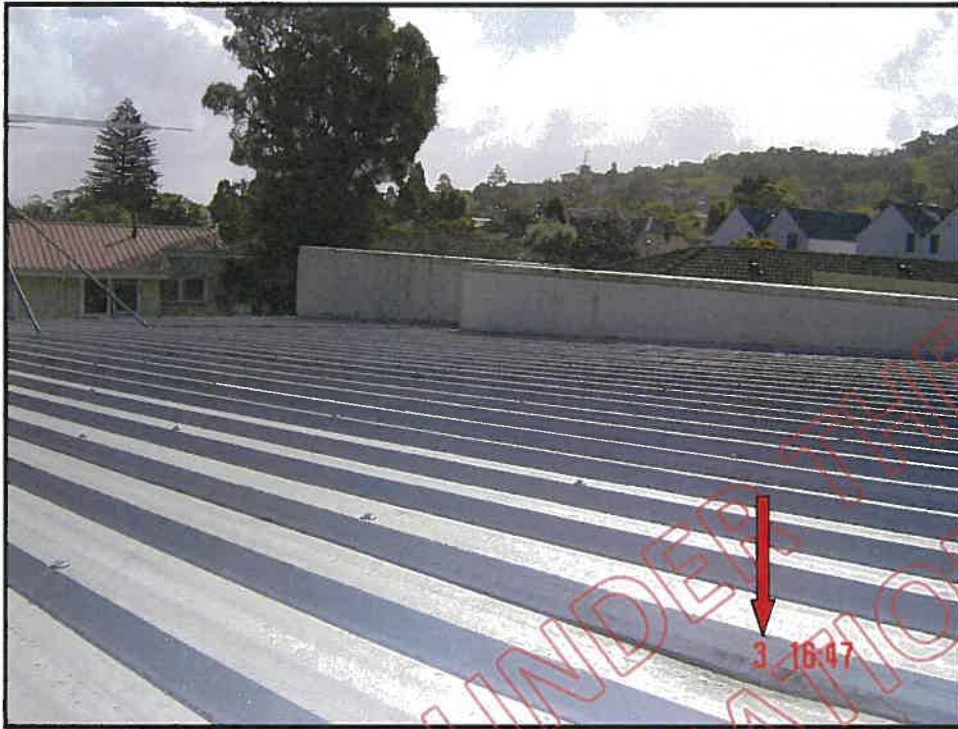
**Unit D**  
**Photograph 1d 13**

General view of roof units D and E showing damage to the profile due possibly to incorrect walking

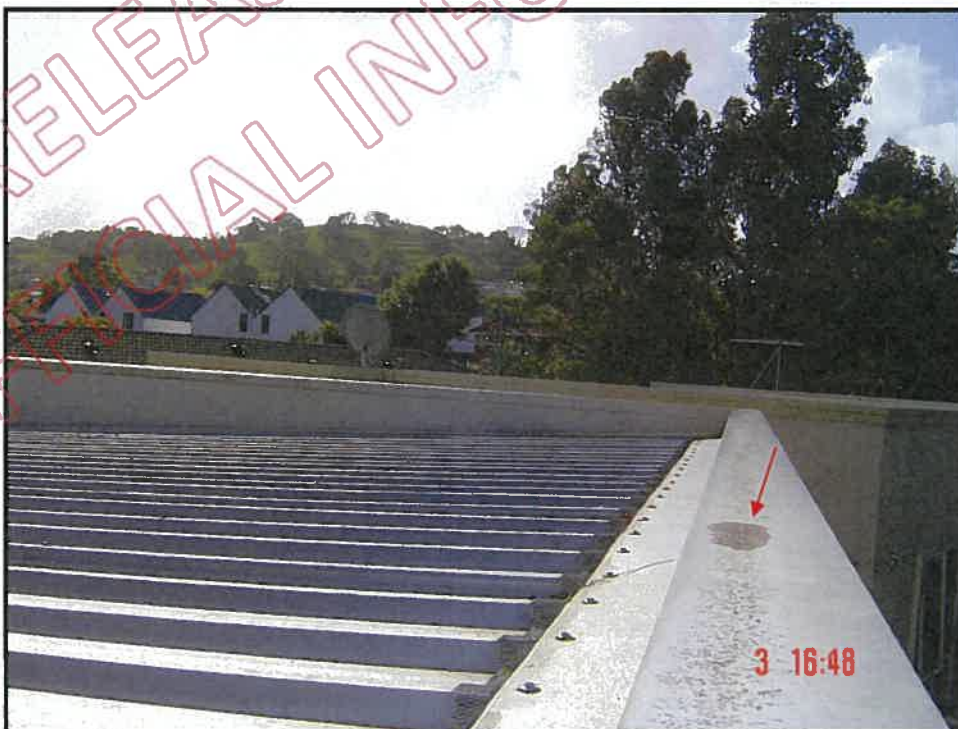
**Photograph 1d 14**

General view of roof unit D: note water ponding on flat cap flashing

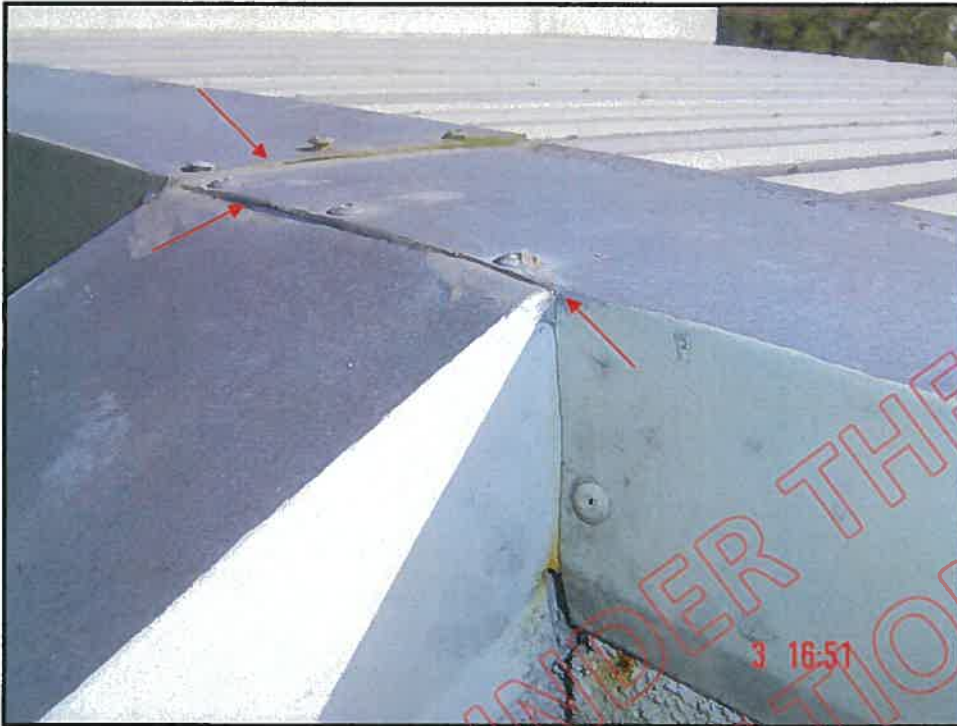
Photograph 1d 15

Badly designed cap flashing / wing wall flashing: note corrosion at and below vertical joint

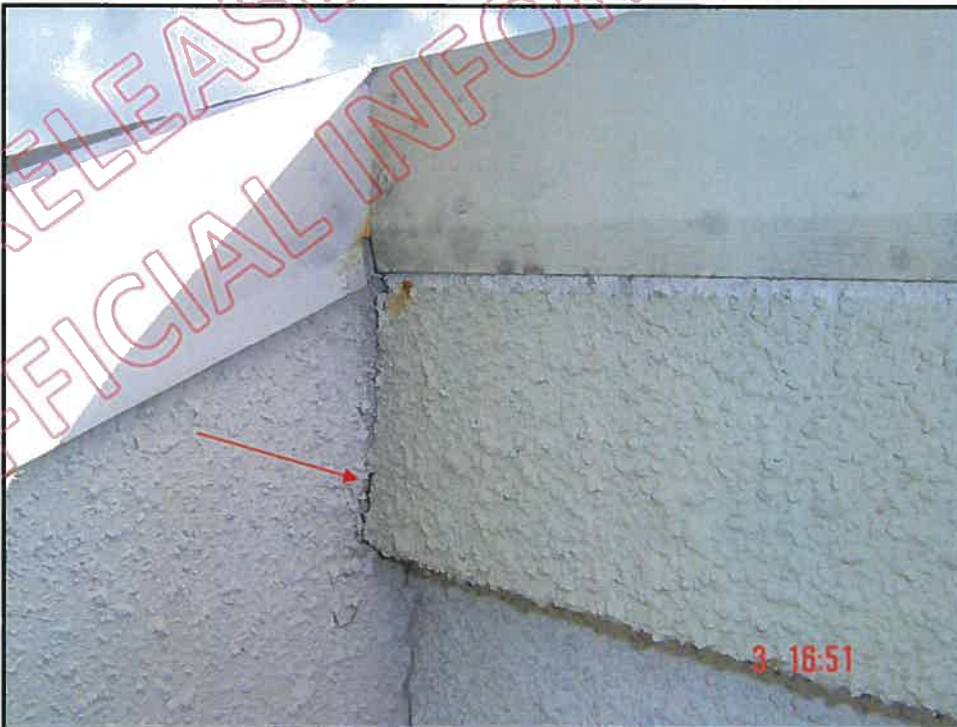
Photograph 1d 16

Open joint where timber fascia abuts wing wall cladding

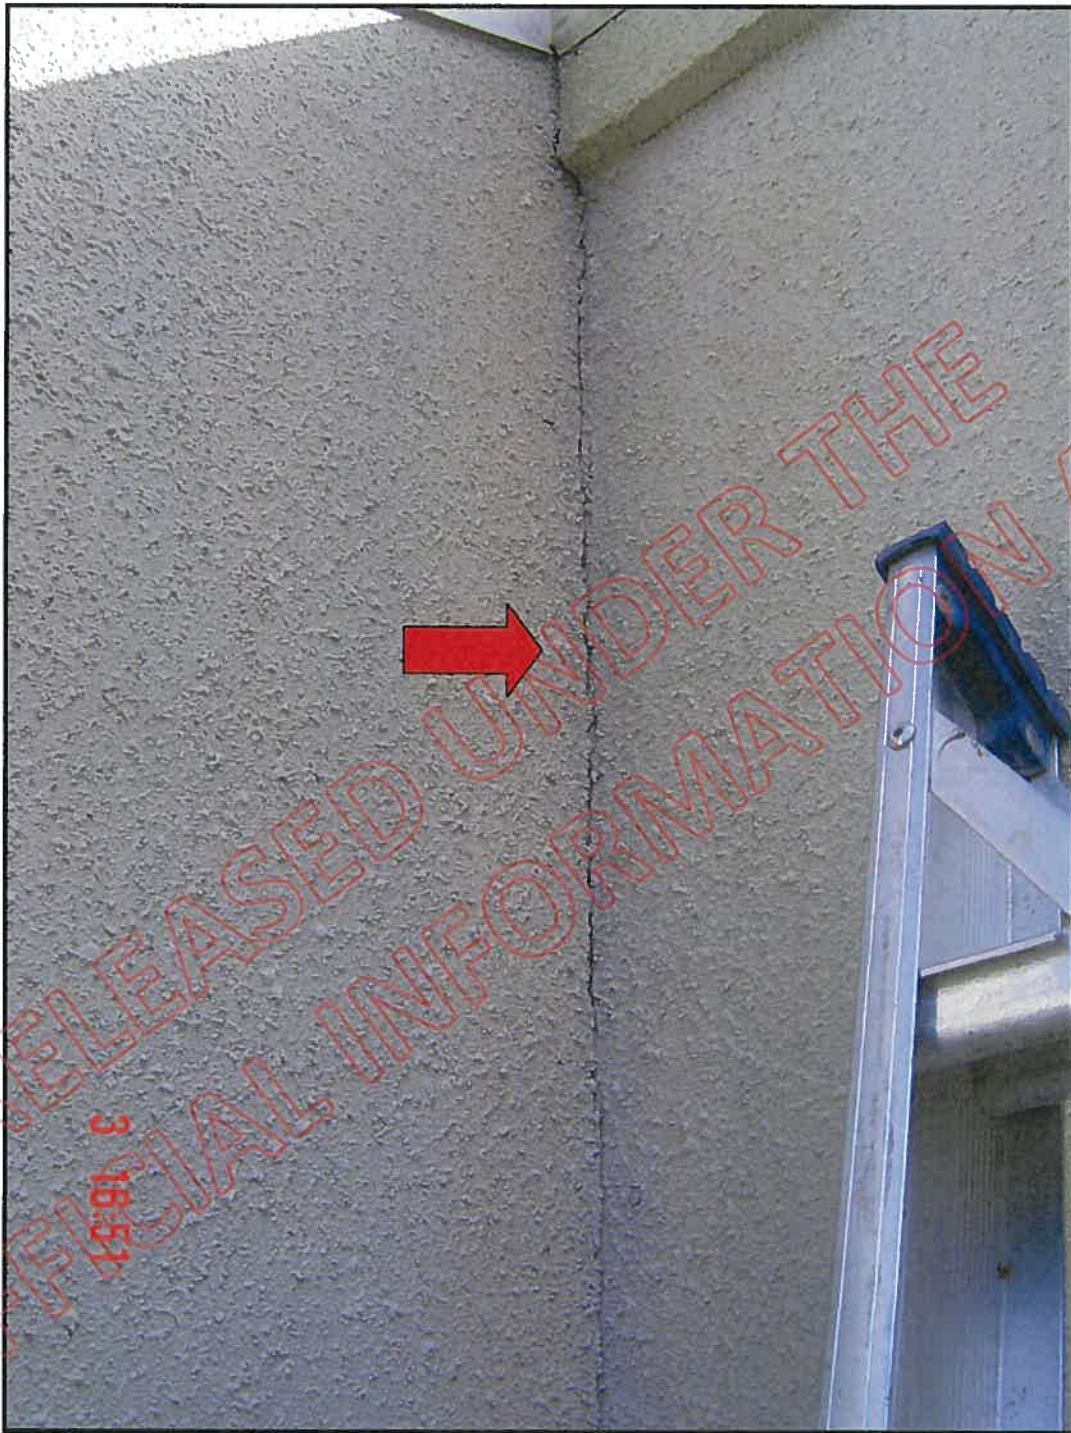
Photograph 1d 17

Vertical cracking at east wall / wing wall junction; allows moisture ingress

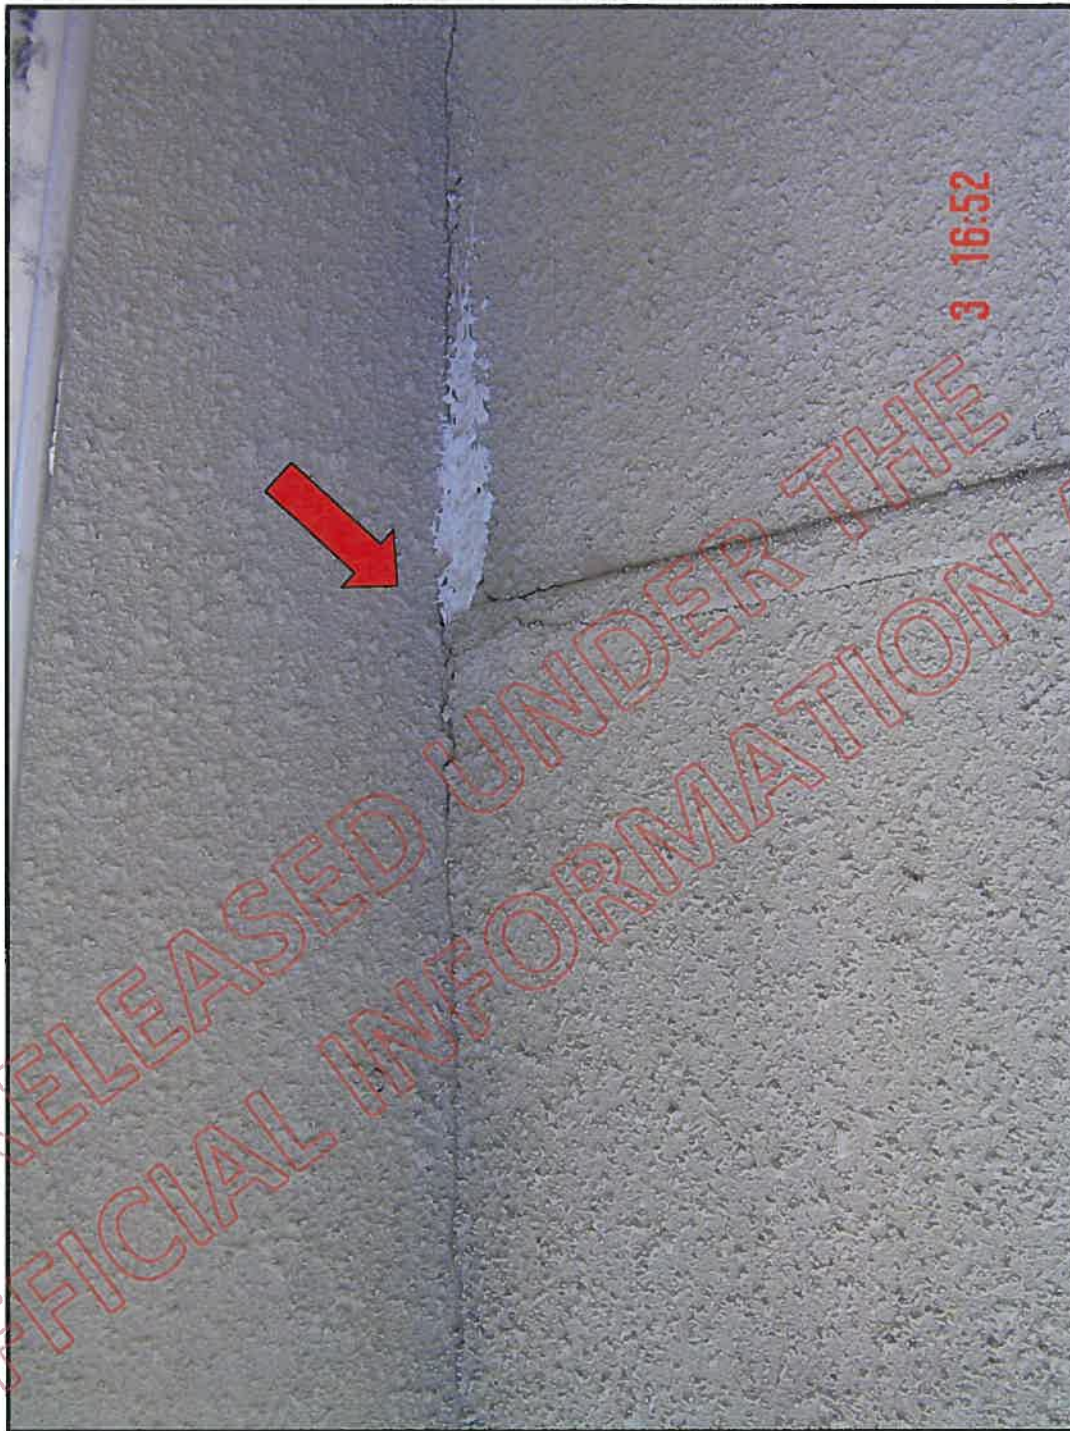
Photograph 1d 18

Vertical cracking at east wall / wing wall junction: note inter-storey joint terminates at wing wall face, allows moisture ingress

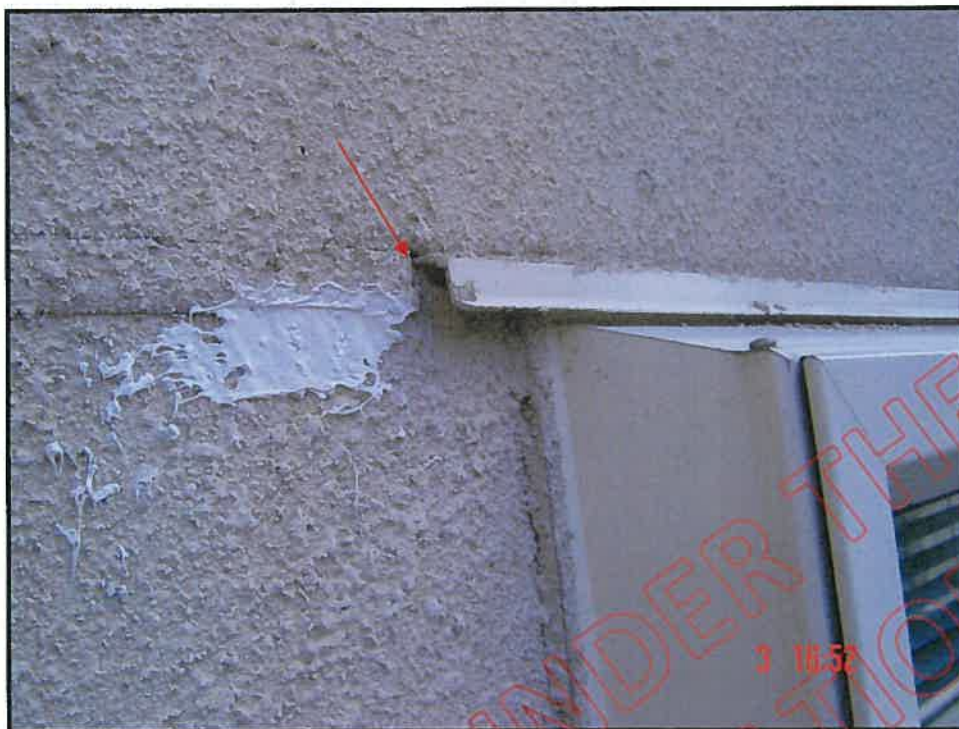
Photograph 1d 19

Inter-storey joint butts up to balcony door head flashing left hand side. Open joint is allowing moisture ingress

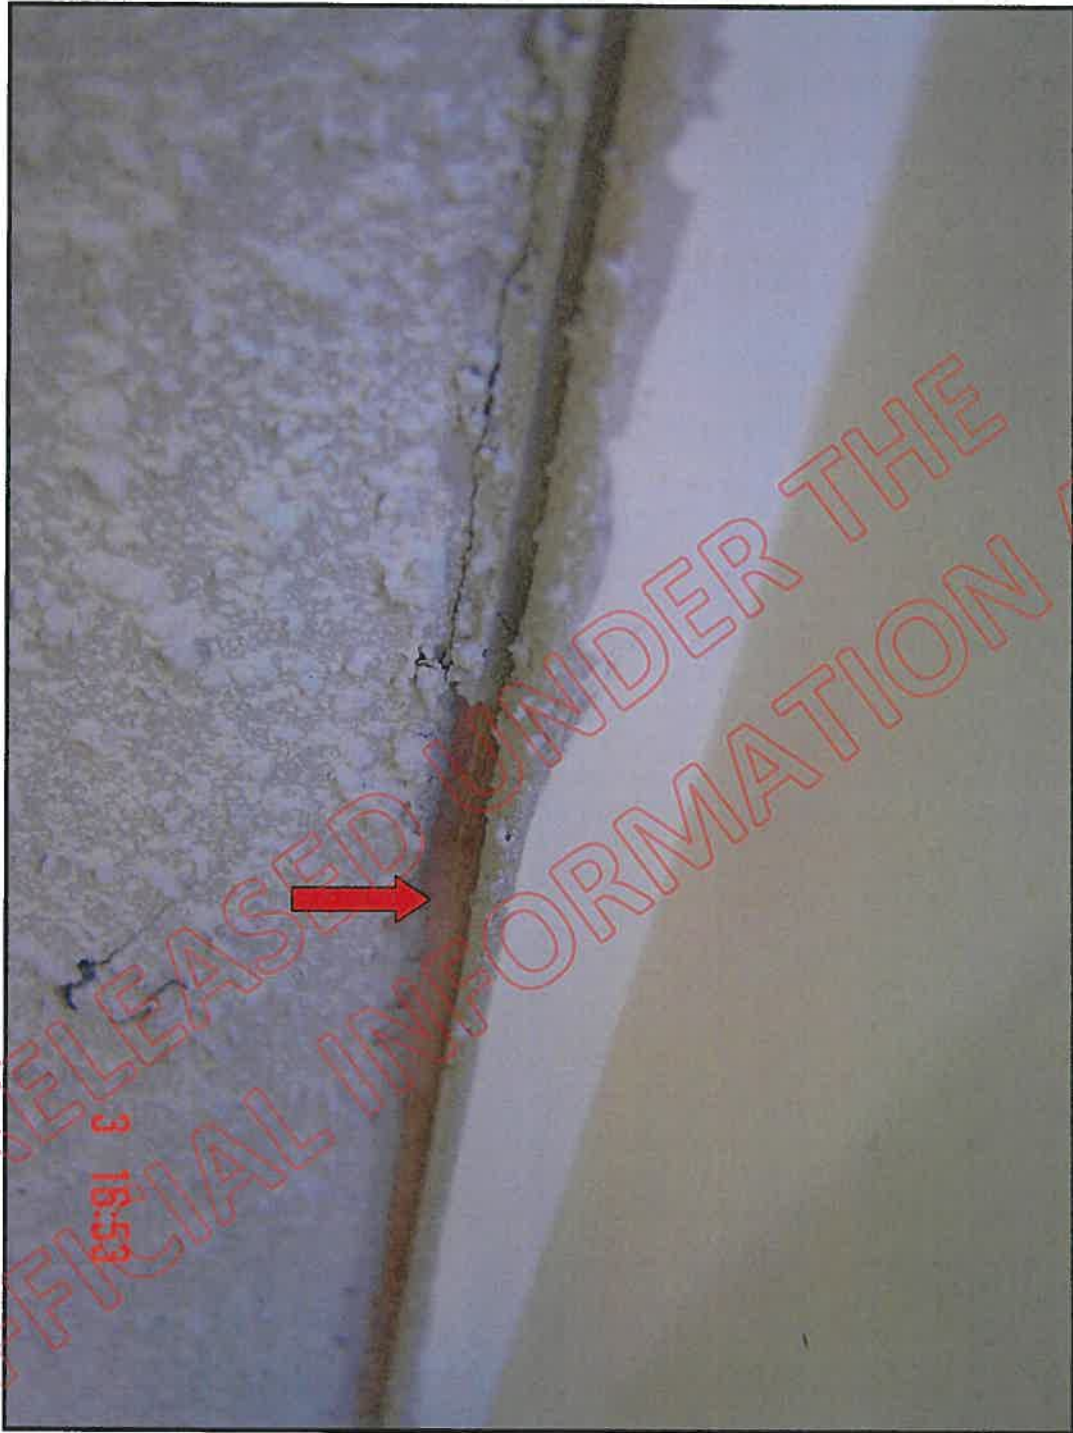
Photograph 1d 20

Total joint failure at balcony door jamb, left hand side; note no flashings, seals and raw Harditex

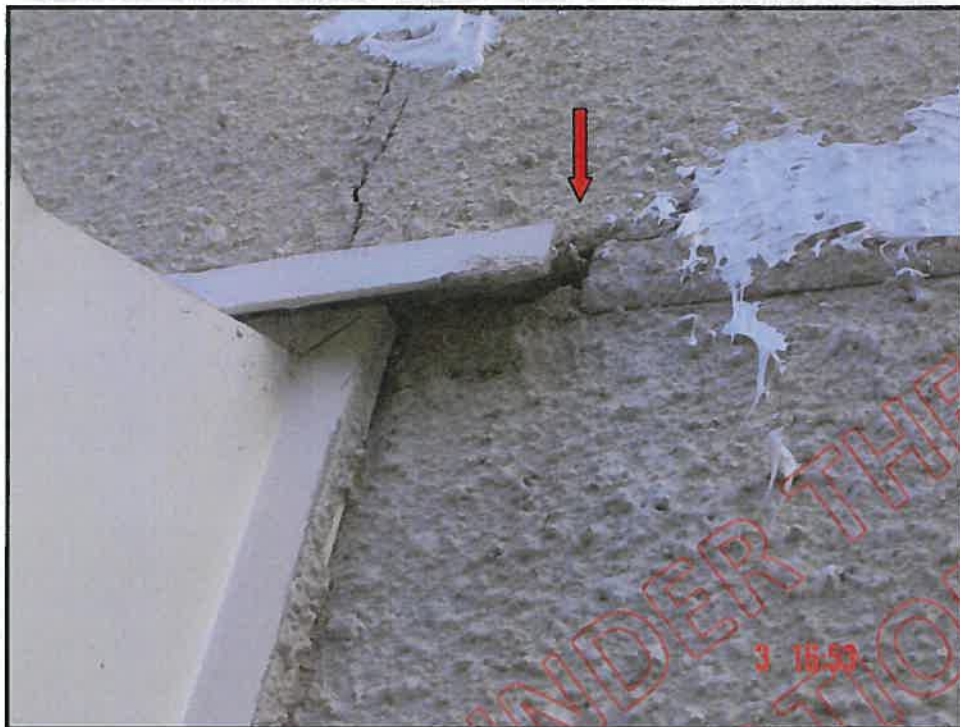
Photograph 1d 21

Inter-storey joint butts up to balcony door head flashing right hand side; Open joint is allowing moisture ingress

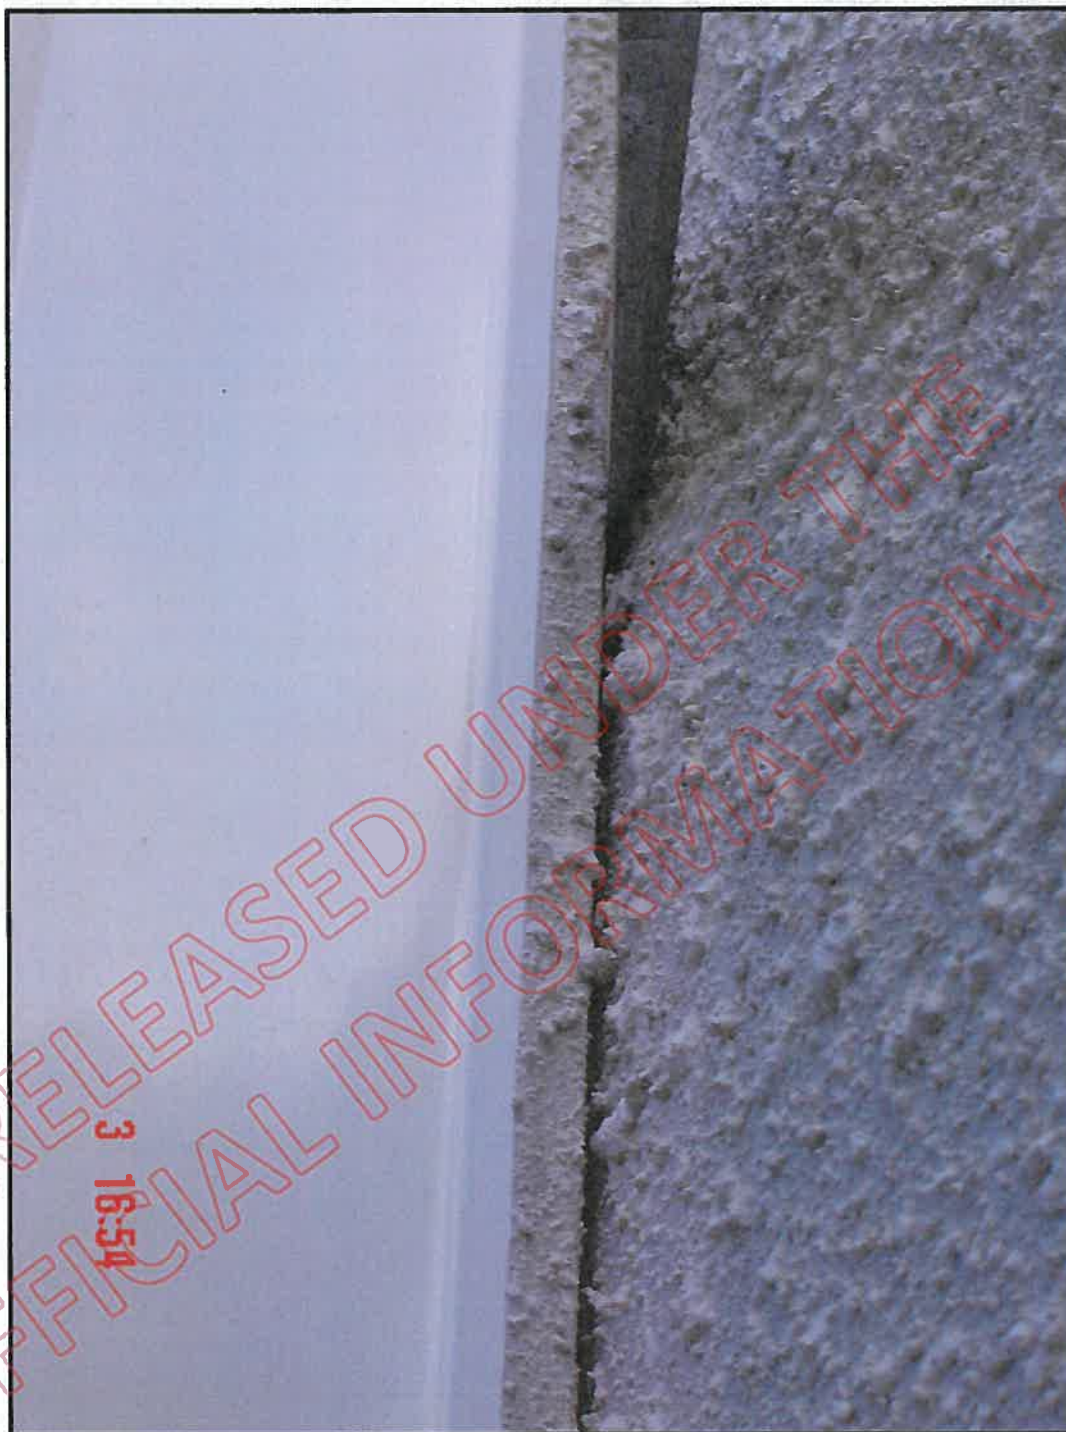
Photograph 1d 22

Joint failure at balcony door jamb, right hand side; note no flashings or seals

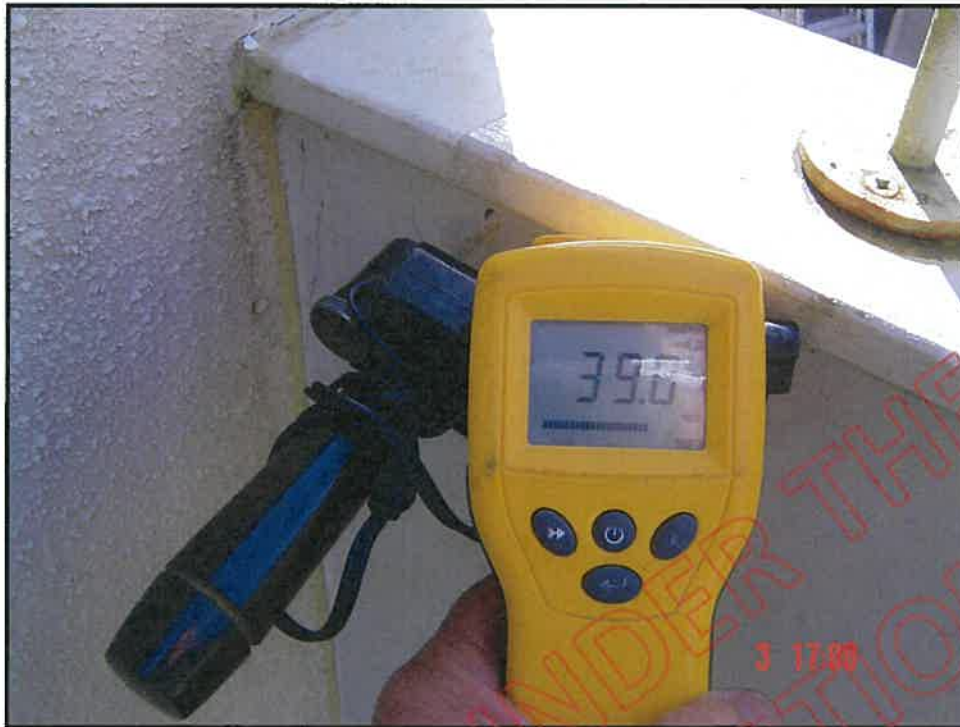
Photograph 1d 23

Very high probe moisture reading at east wall balcony wall junction (note: no saddle flashing at junction); note also corroded handrail stanchion incorrect application

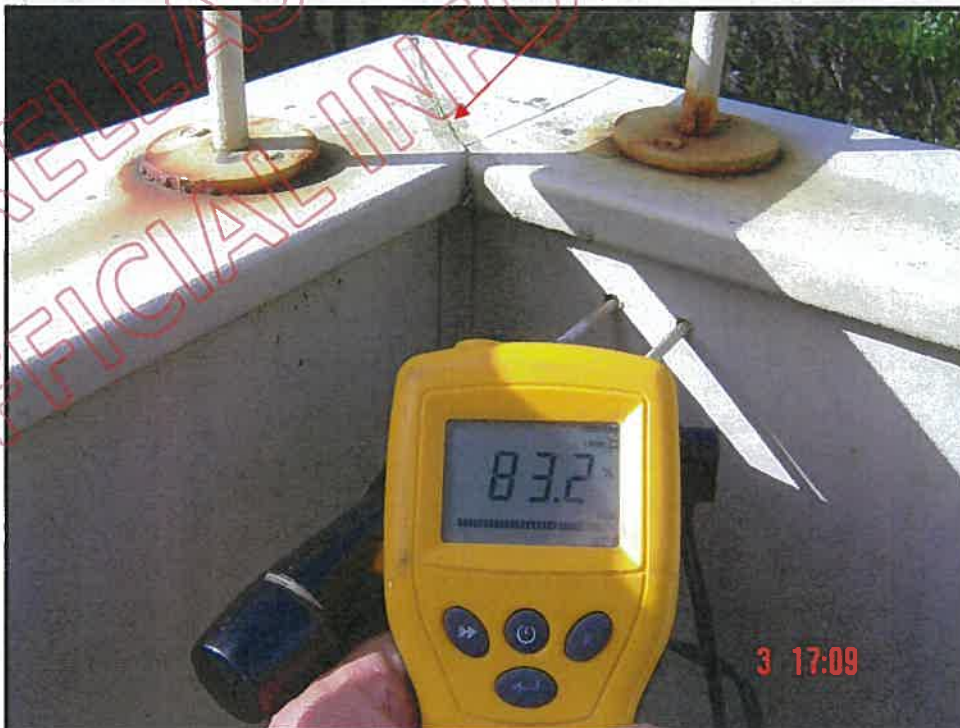
Photograph 1d 24

Very high probe moisture reading at north east corner balcony wall junction (note: open and unprotected mitre joint); note also corroded handrail stanchion and incorrect application

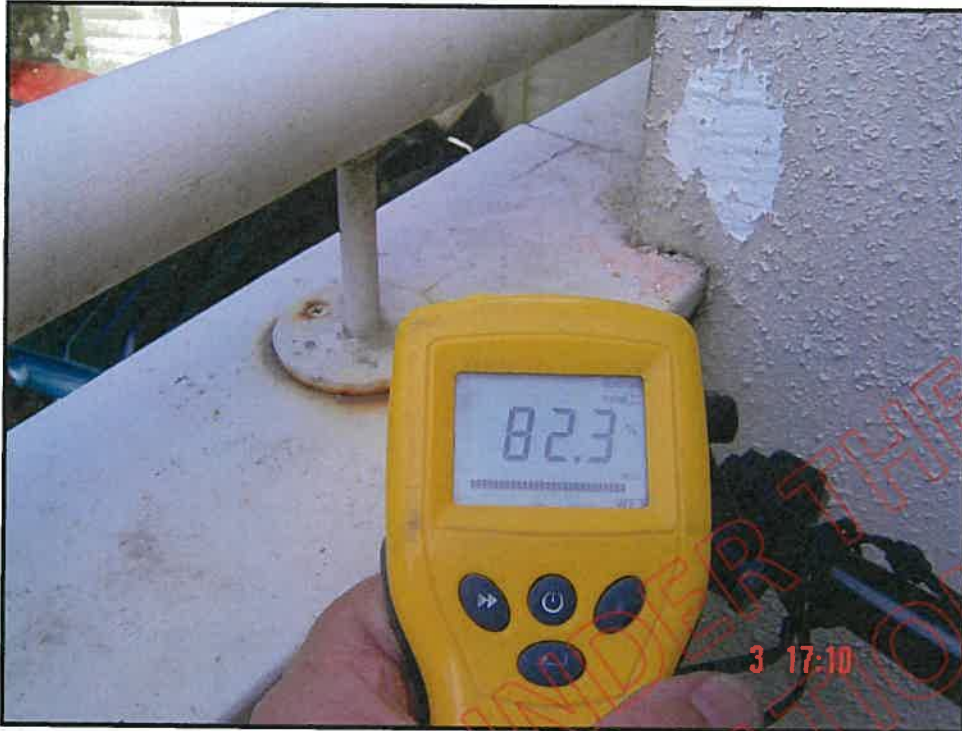
Photograph 1d 25

Very high probe moisture reading at wing wall balcony wall junction (note: no saddle flashing at junction); note also corroded handrail stanchion and incorrect application
