<b>Photo Elevation &amp; Number</b>	<b>Page No,</b>	<b>Description</b>
<b>Elevation 1e</b>		
1e - 1	119	General view front
1e - 2	120	Cut out and high moisture reading at south east corner of balcony wall
1e - 3	120	High moisture reading at east balcony wall
1e - 4	121	High moisture reading at south east corner of balcony wall
1e - 5	121	High moisture reading at centre of eastern balcony wall
1e - 6	122	High moisture reading at wing wall junction
1e - 7	122	High moisture reading at base of wing wall
1e - 8	123	North wall / balcony junction – no saddle flashing
1e - 9	123	Open mitre at corner of timber balcony capping
1e - 10	124	Photograph showing incorrectly installed hand rail stanchion
1e - 11	124	Inter-storey H mould terminates at end of head flashing
1e - 12	125	Inter-storey H mould terminates mid sheet at wing wall
1e – 12/1	126	Photograph showing cladding hard down on balcony floor tiles
<b>Elevation 1d</b>

East (Front) Elevation 1 – Units E, D, B, C

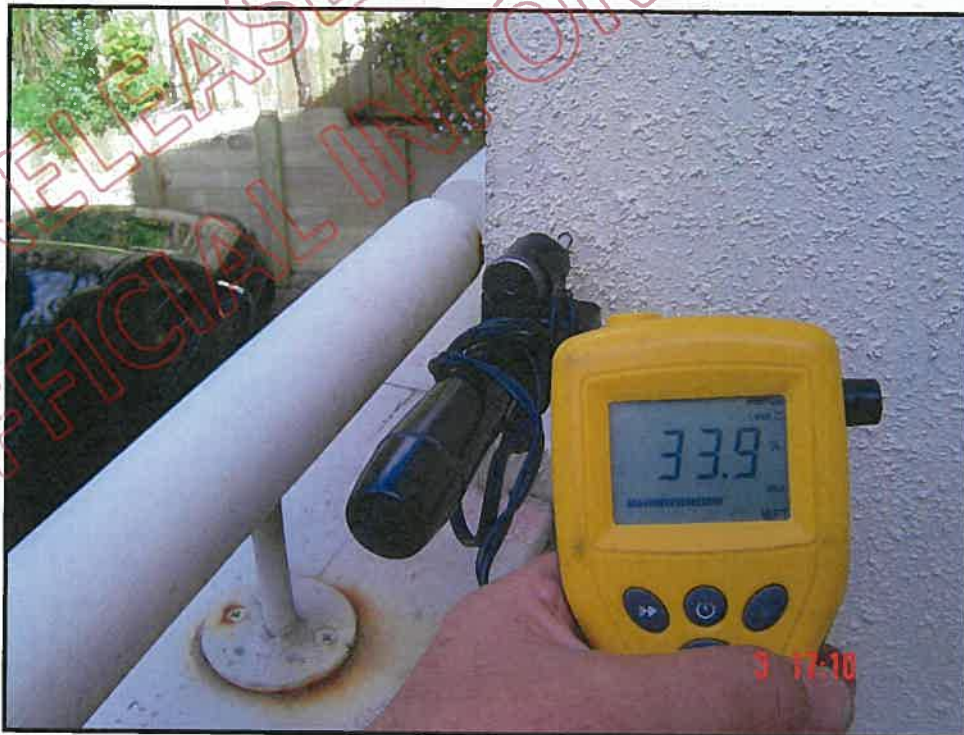
Photograph 1d 26

Very high probe moisture reading above wing wall balcony wall junction

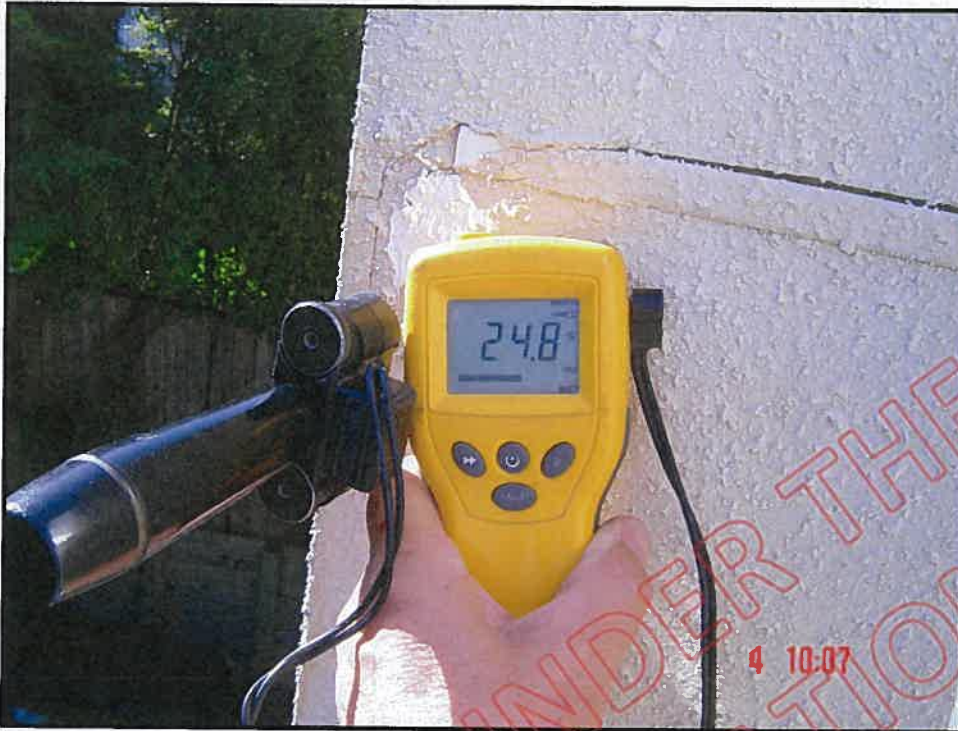
Photograph 1d 27

High probe moisture reading below inter-storey at front face of wing wall: note inter-storey joint terminates at mid sheet: end of mould is open allowing moisture ingress

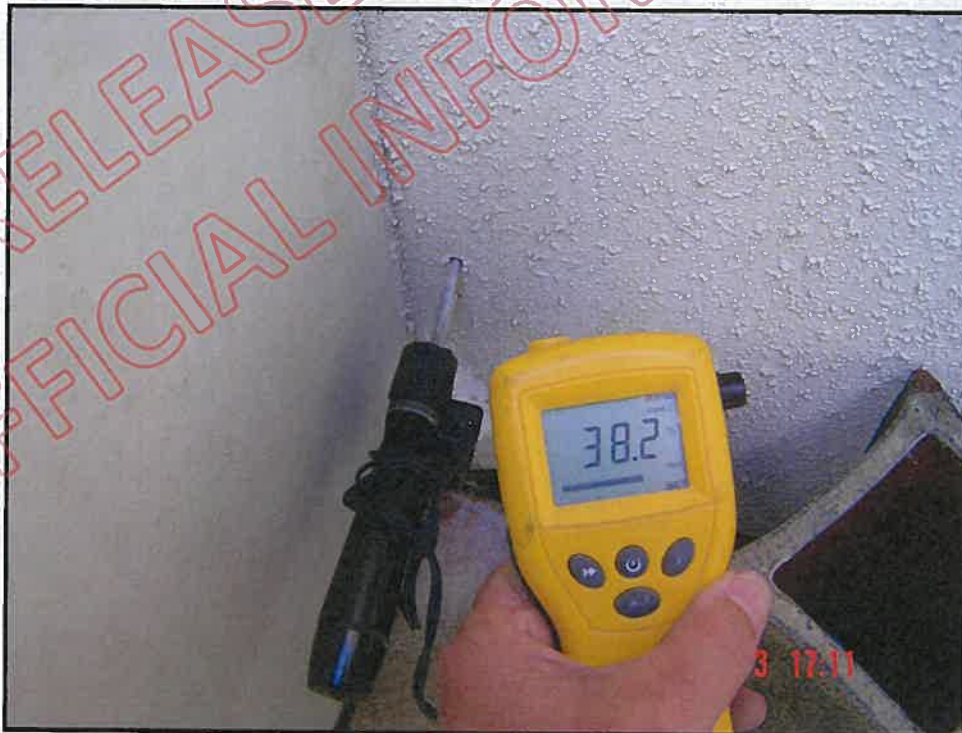
Photograph 1d 28

High probe moisture reading at base of wing wall/balcony junction

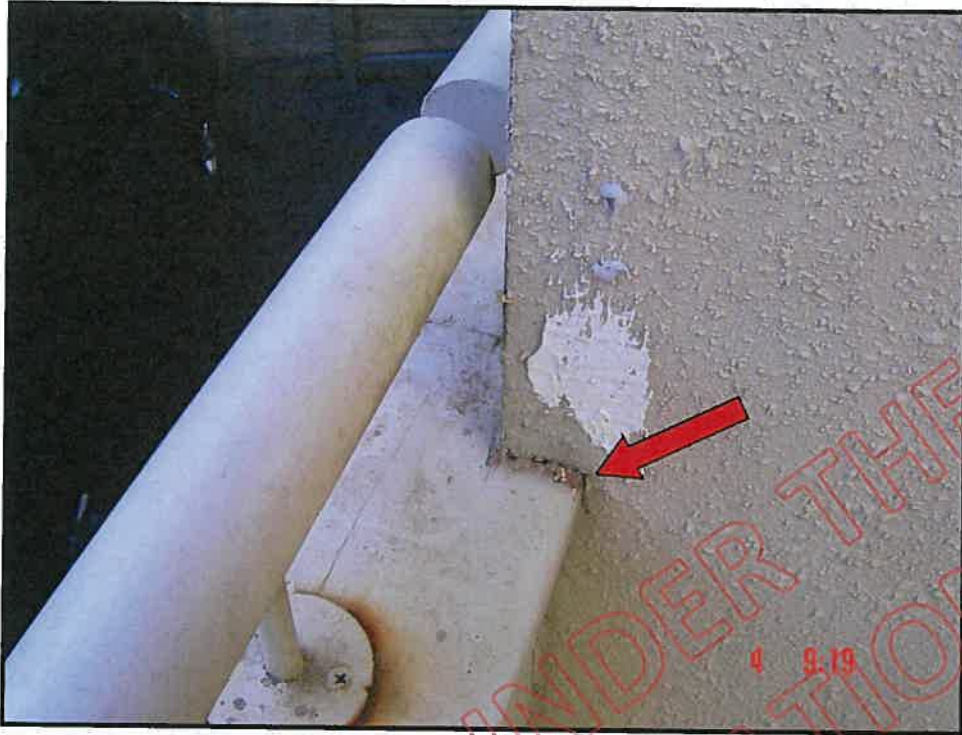
Photograph 1d 29

Close up of wing wall balcony wall cap junction showing point of water entry

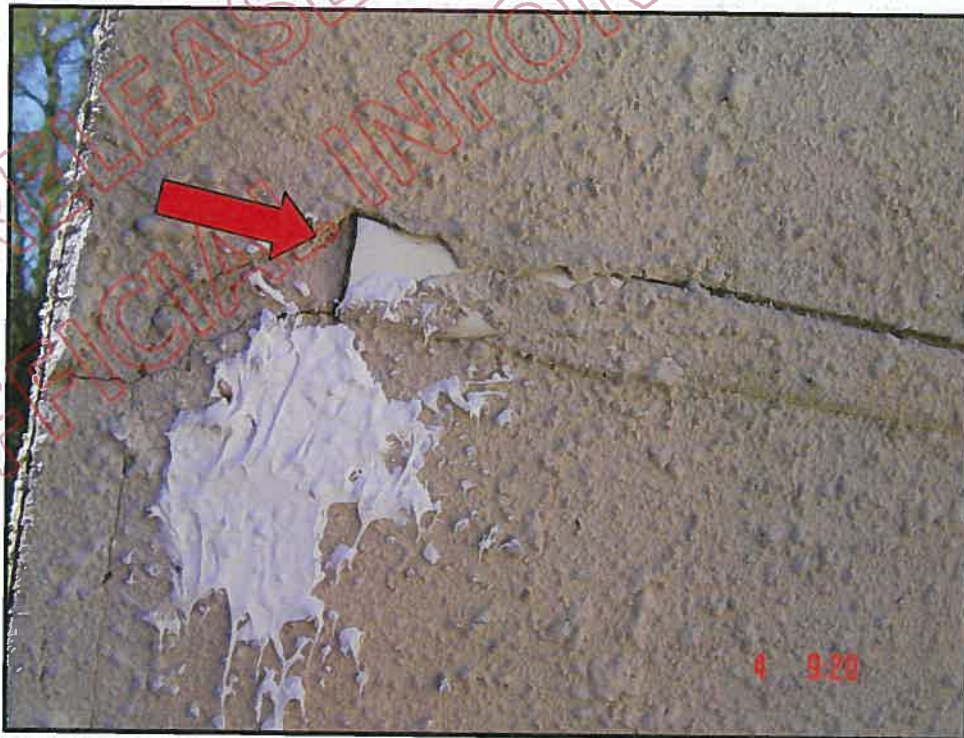
Photograph 1d 30

Close up of wing wall balcony showing inter-storey moulding open end, point of water entry; note joint failure below inter-storey; refer photograph (d27)

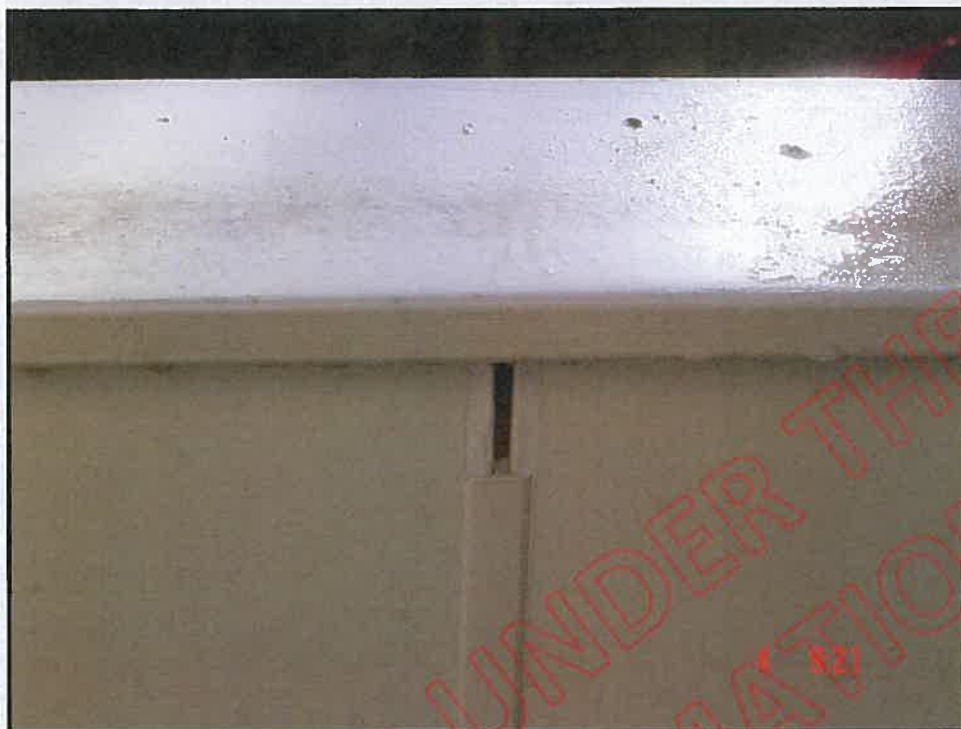
Photograph 1d 31

Photograph showing poorly fixed jointer, jointer has dropped and allowing moisture ingress

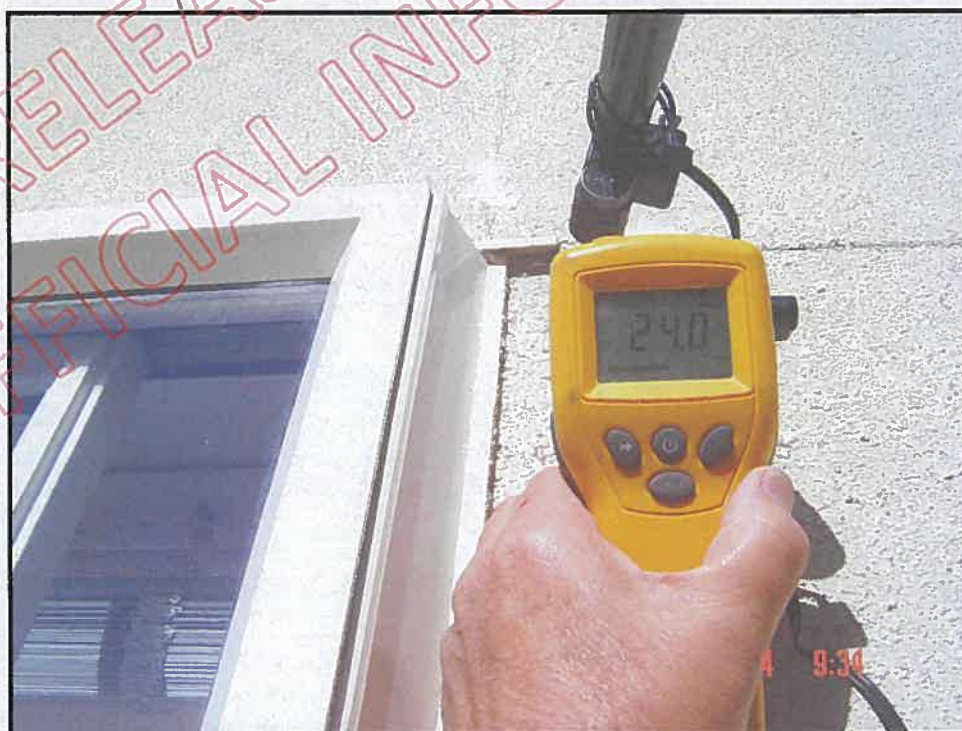
Photograph 1d 32

High probe moisture reading at right side of balcony sliding door head flashing; refer photograph 1d 21

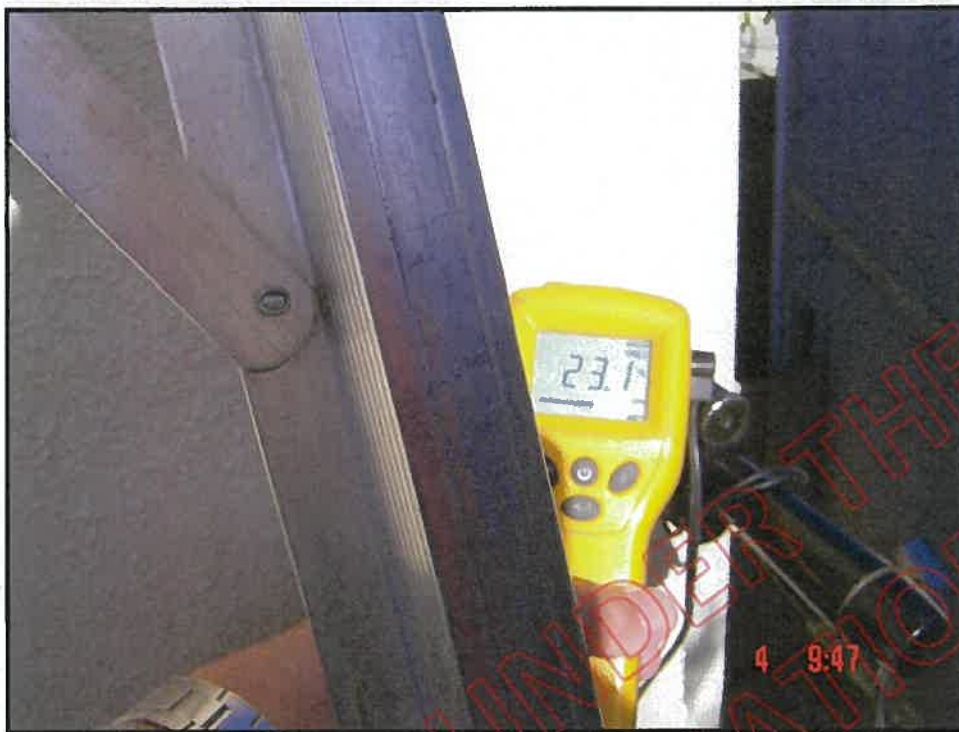
Photograph 1d 33

High probe moisture reading at north end of east wall 200mm below fascia

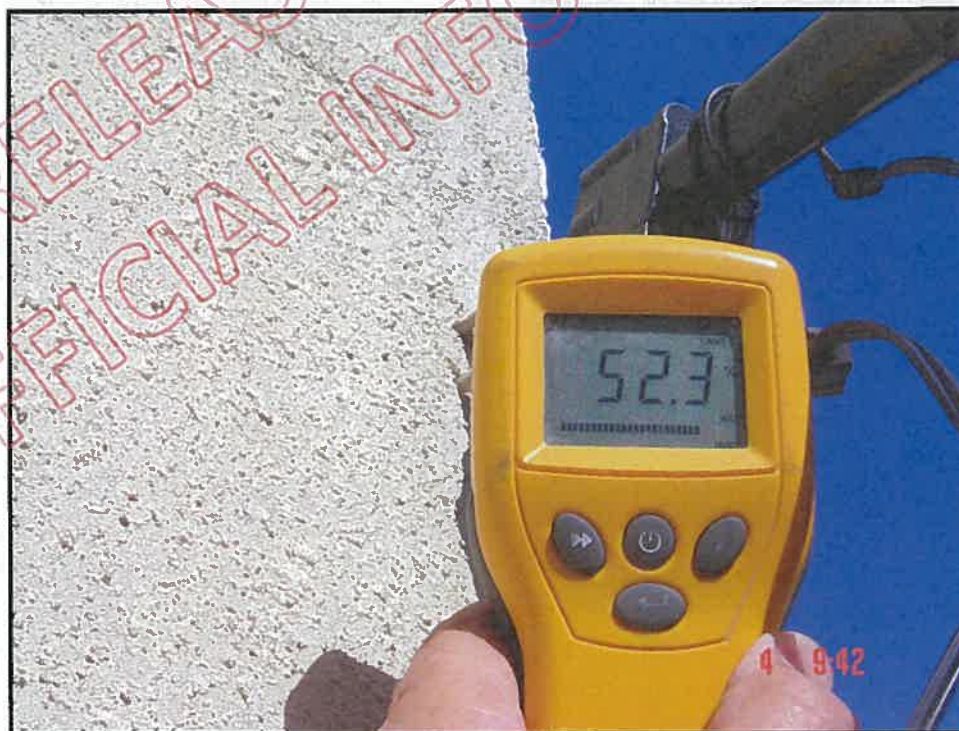
Photograph 1d 34

Very high probe moisture reading at north end of east wall 600mm below fascia

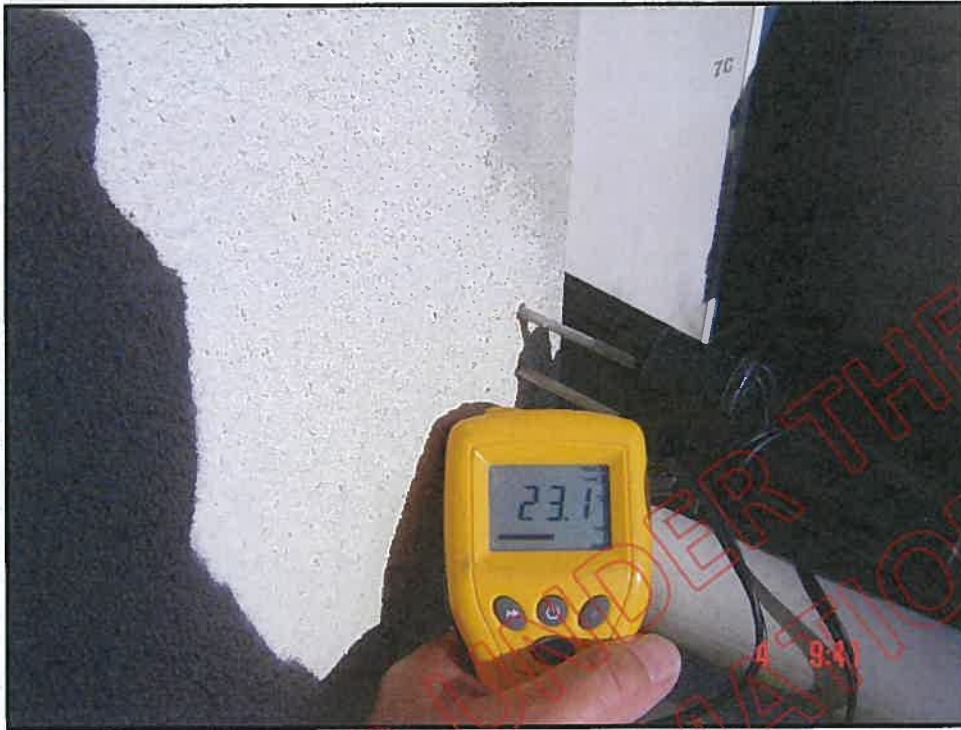
Photograph 1d 35

High probe moisture reading at north end of east wall above balcony wall hand rail

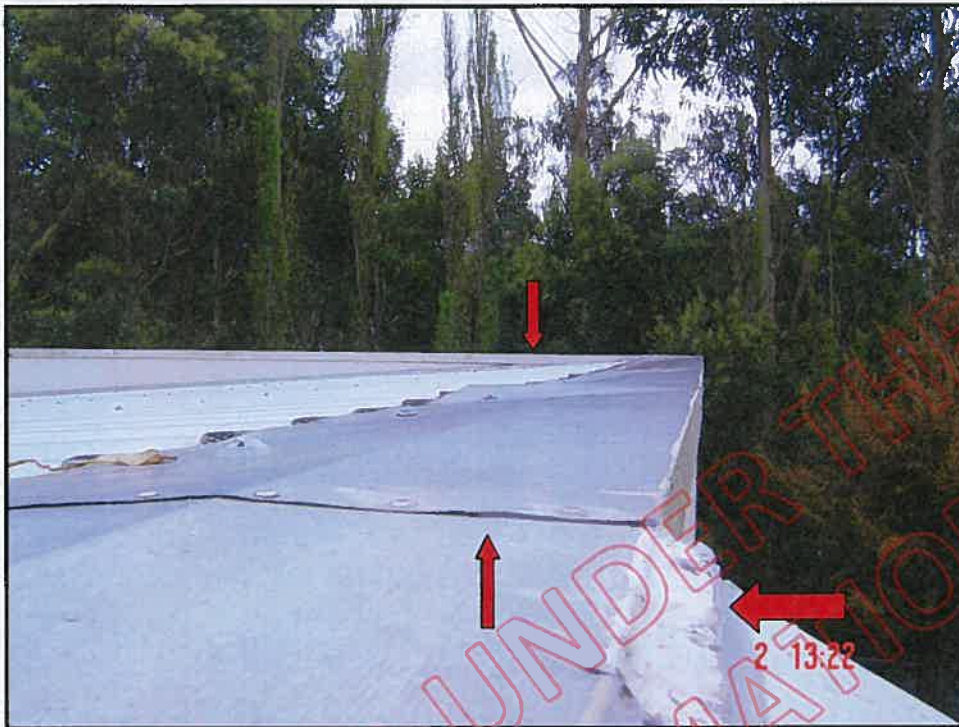
Photograph 1c 36

General view of unit B roof showing insufficient height to east and side parapet walls; note also poor cap joints

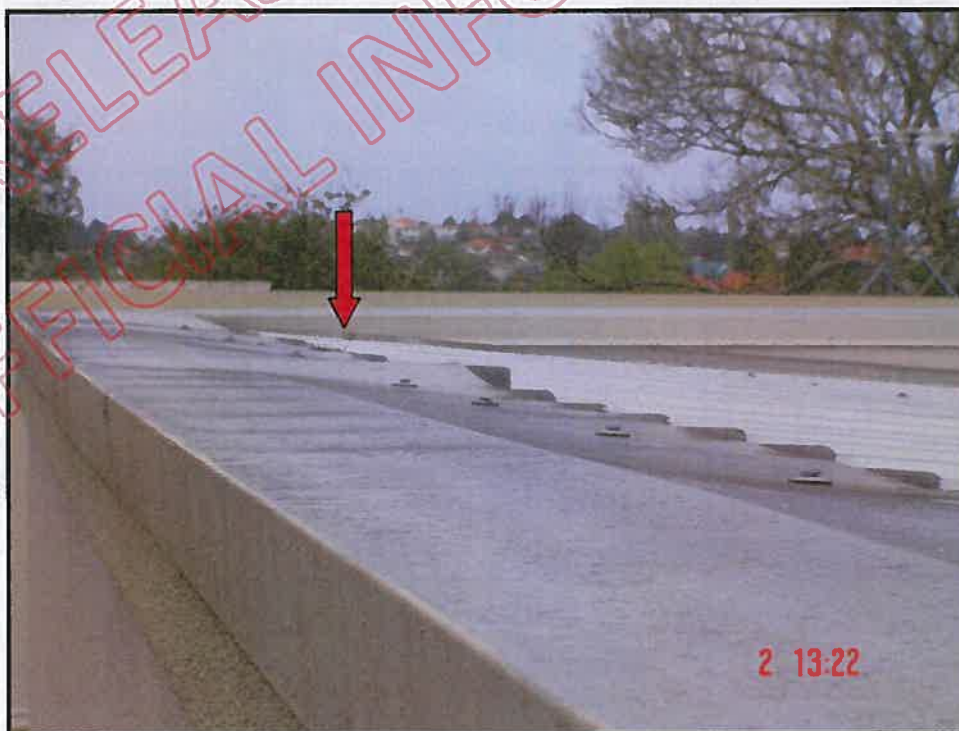
Photograph 1c 37

General view of unit C roof showing insufficient height to east and side parapet walls

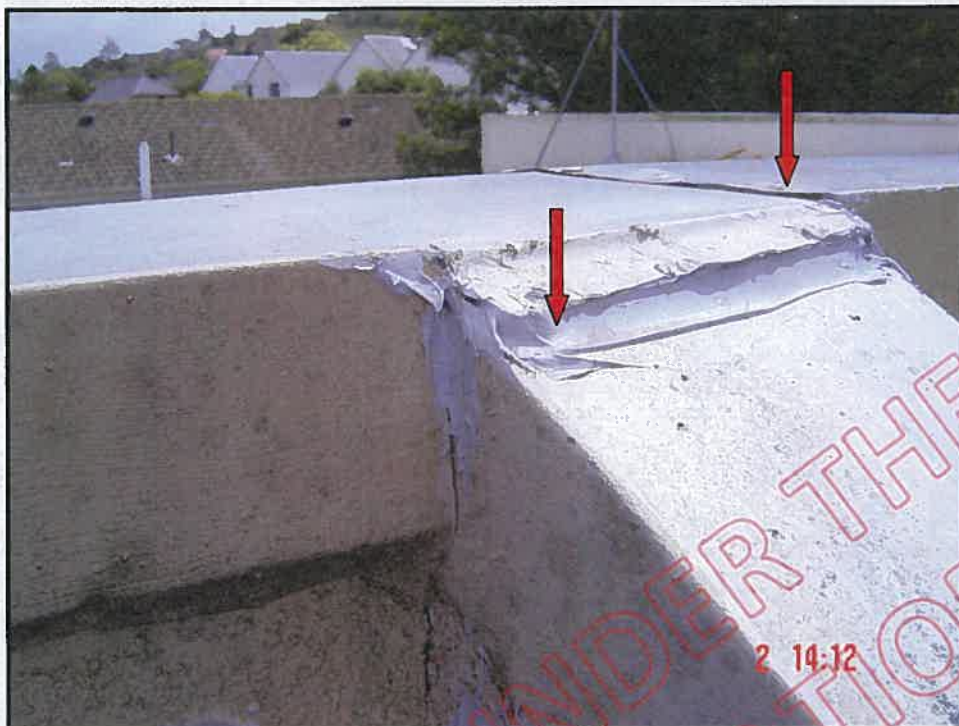
Photograph 1c 38

Badly designed cap flashing / wing wall flashing: note copious amount of exposed sealant applied in an attempt to achieve weathertightness, note also open lap joint

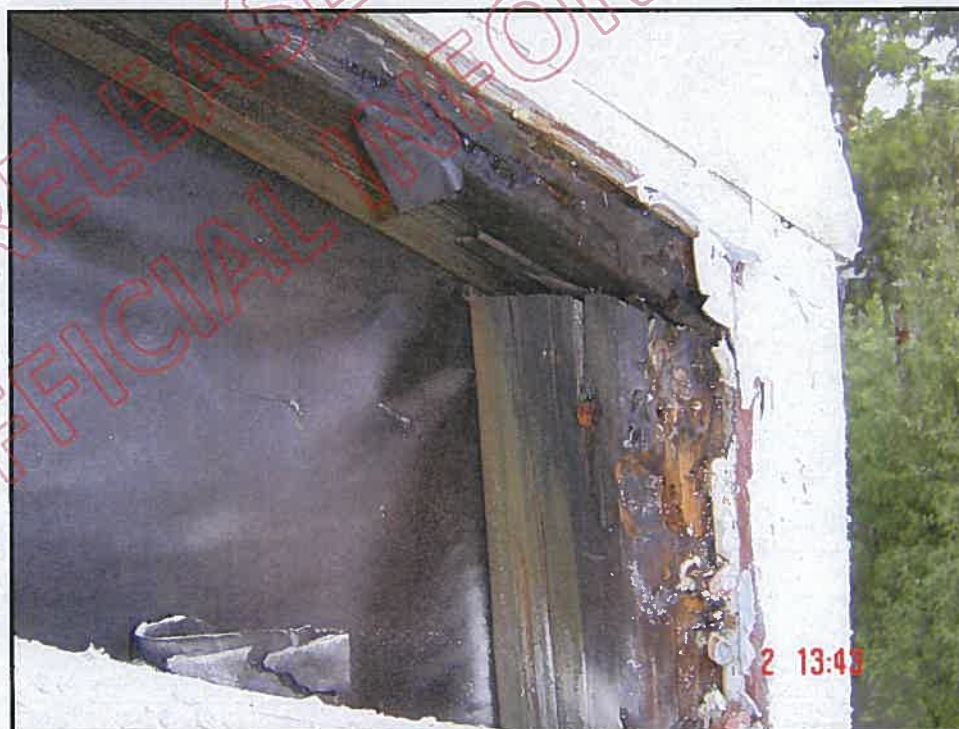
Photograph 1c 39

Cut out at top front corner of wing wall showing advanced decay; refer laboratory sample (3)

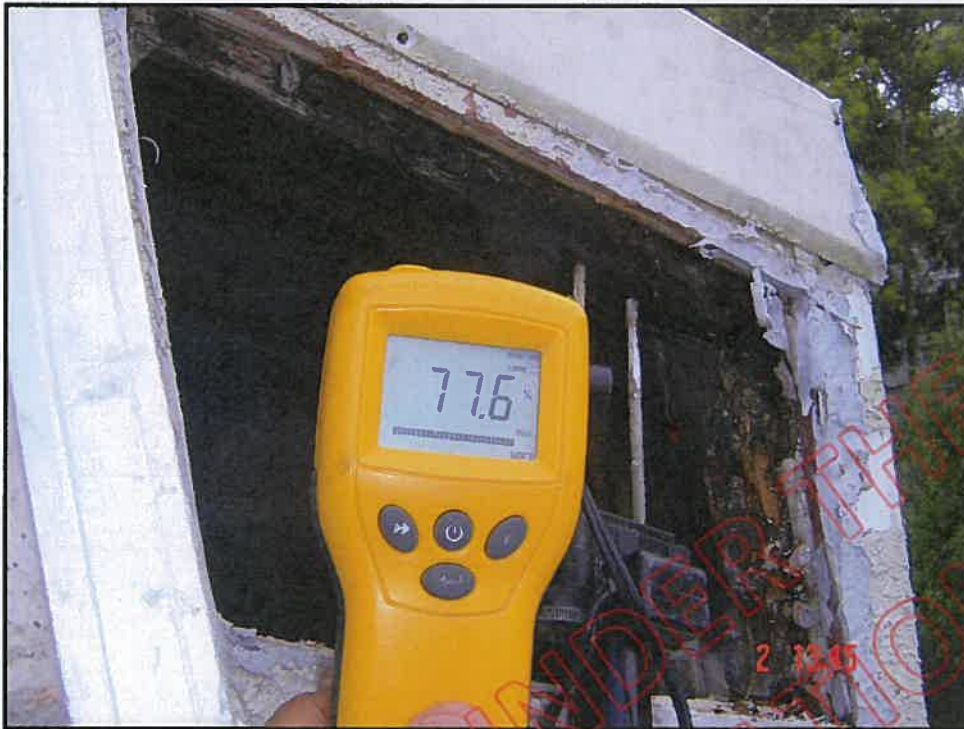
Photograph 1c 40

Cut out and very high probe moisture reading at top front corner of wing wall showing advanced decay; point of water entry is poorly designed and fitted wing wall cap flashing

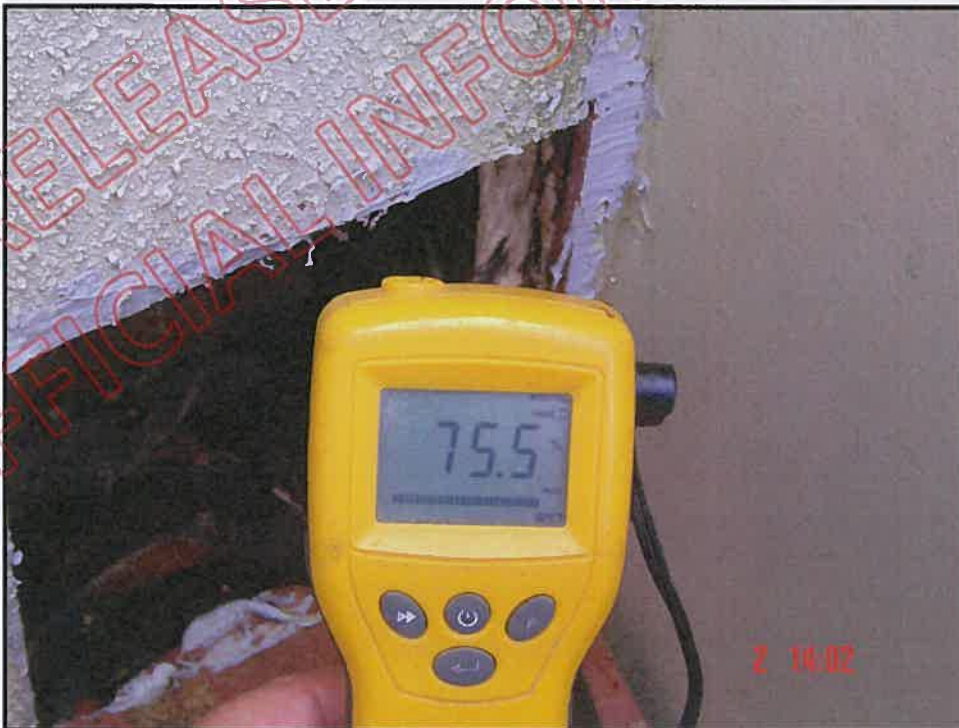
Photograph 1c 41

Cut out and very high probe moisture reading at the base of the front of the wing wall showing advanced decay; refer laboratory sample (2)

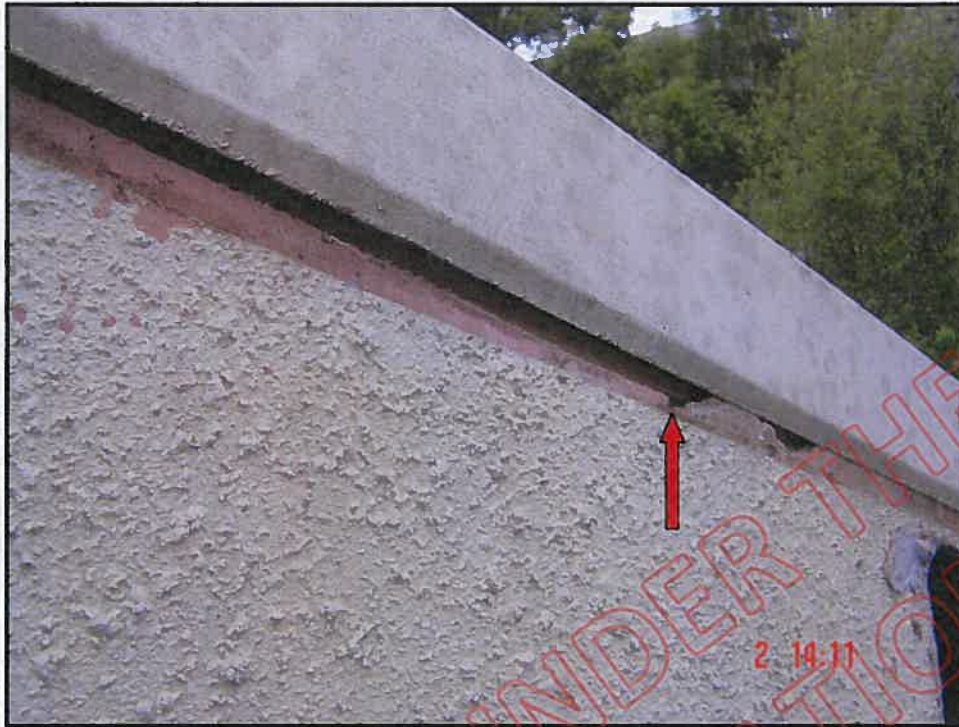
Photograph 1c 42

Wing wall cap flashing showing cap barely covering Harditex; note wall should be textured prior to fitting cap flashing, Harditex not sealed at sheet edges as required

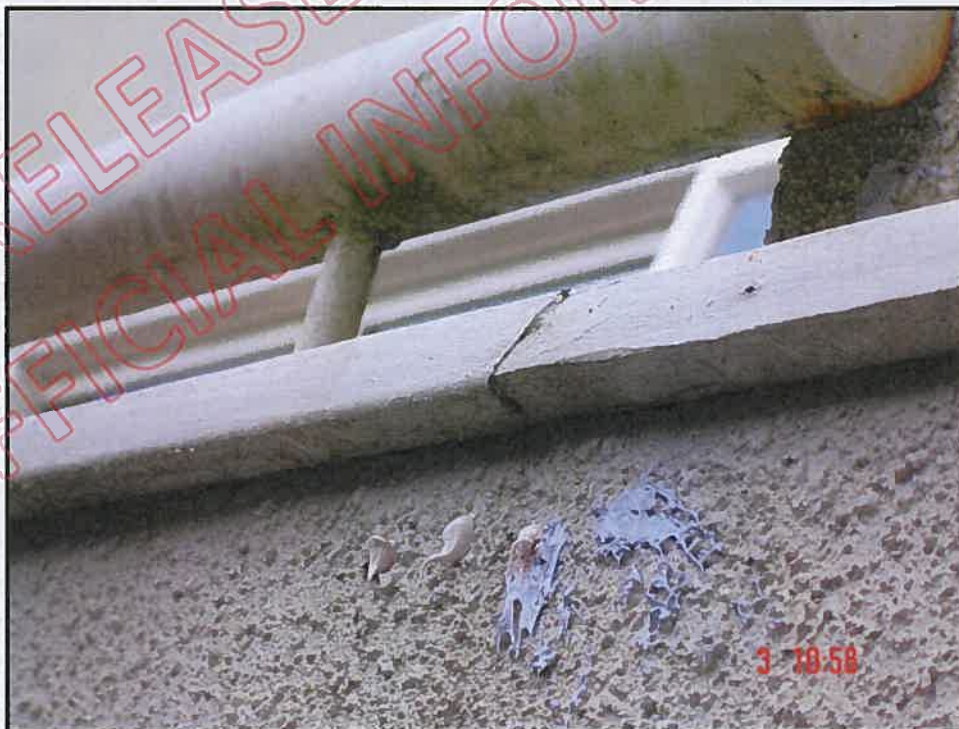
Photograph 1c 43

Open and unprotected spliced joint in timber capping

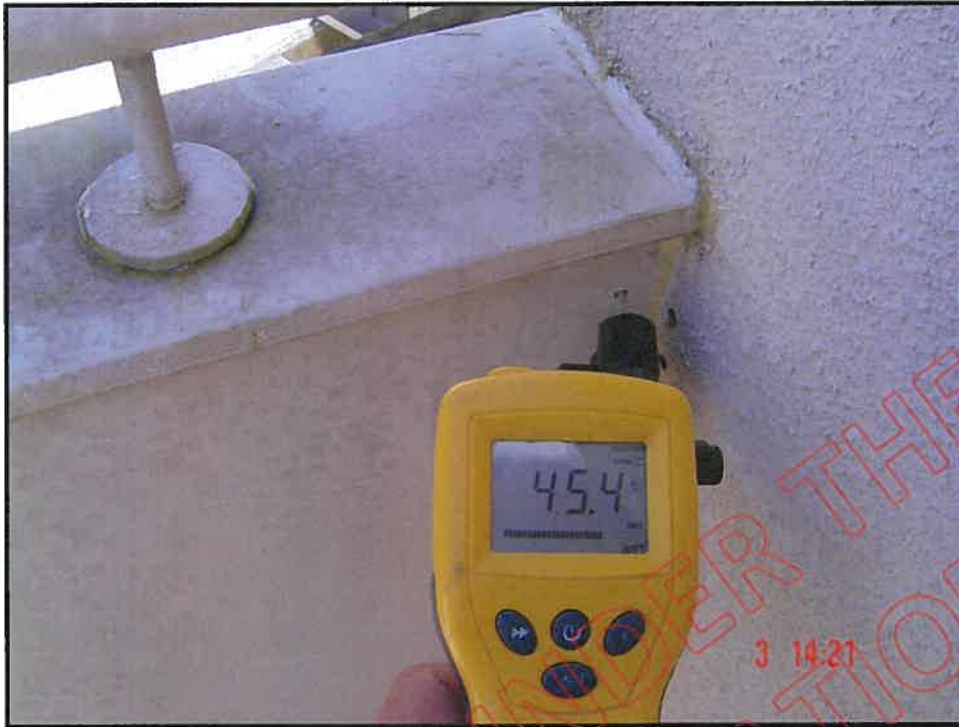
Photograph 1c 44

Very high probe moisture reading at east wall / wing wall junction: note no saddle flashing at balcony / wing wall junction

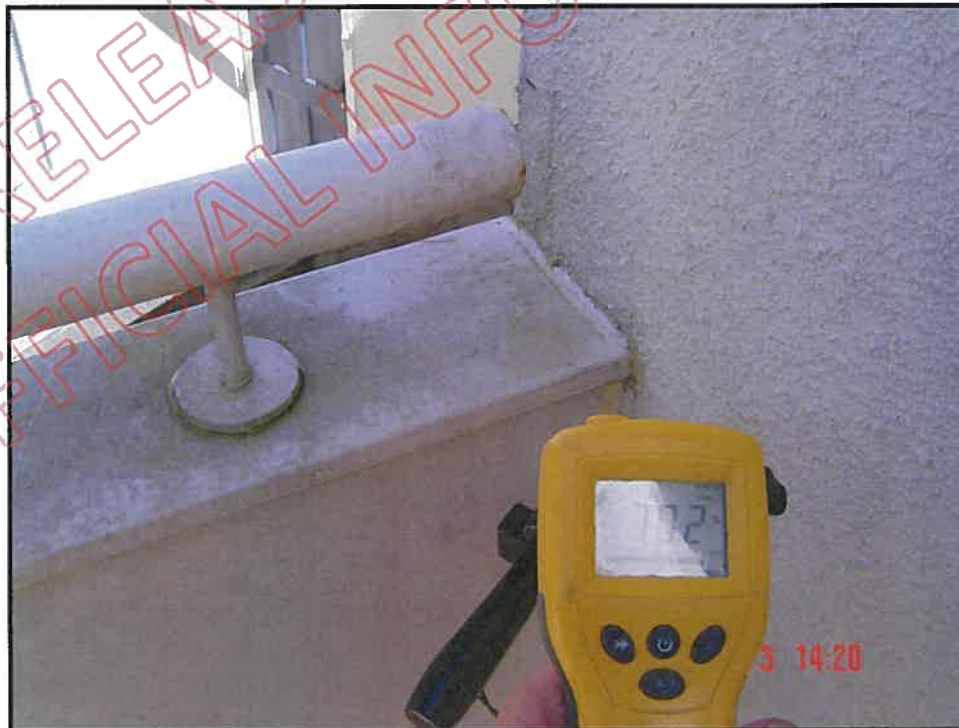
Photograph 1c 45

Very high probe moisture reading at balcony wall / wing wall junction: note no saddle flashing at balcony / wing wall junction

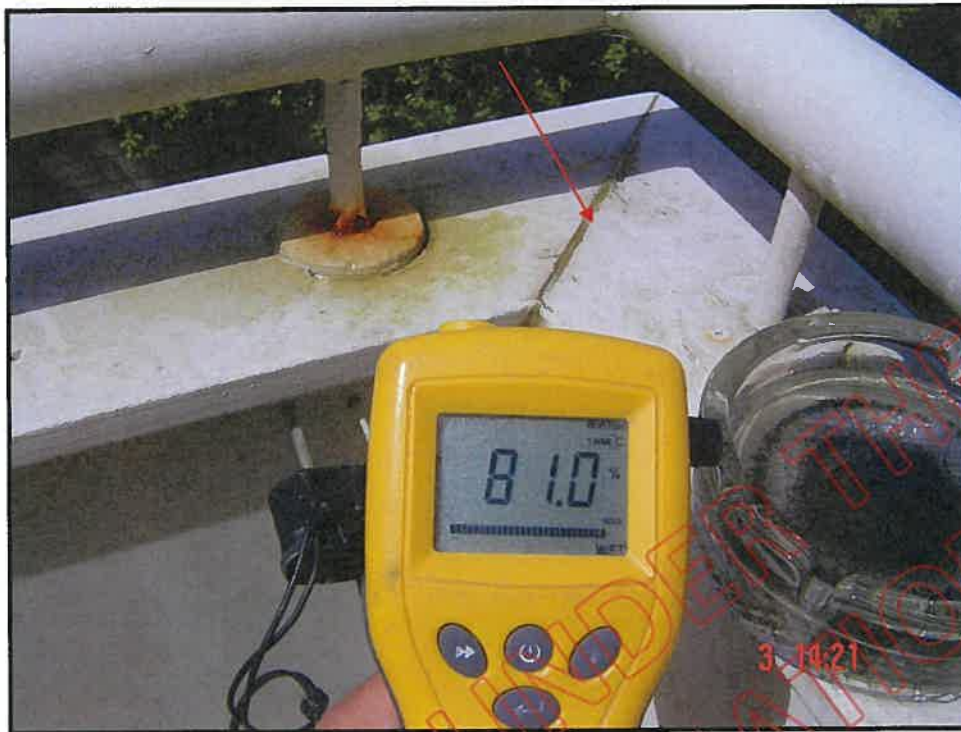
**Photograph 1c 46**

Very high probe moisture reading at south east corner balcony wall junction (note: open and unprotected mitre joint); note also corroded handrail stanchion and incorrect application

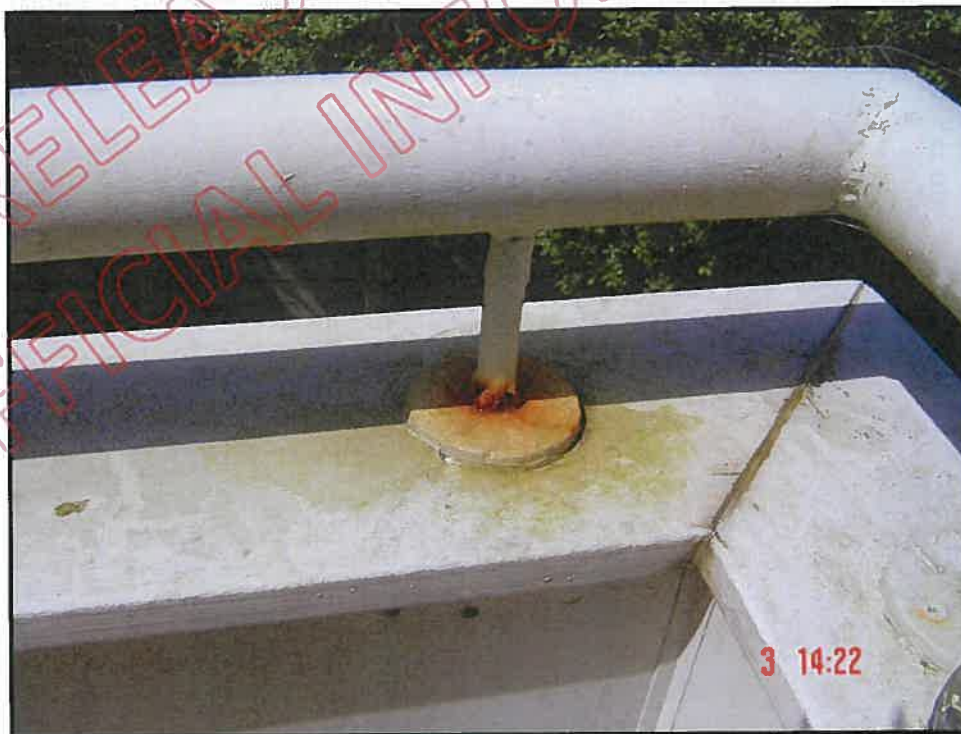
**Photograph 1c 47**

Close up of open and unprotected mitre joint at south east corner of balcony wall); note also corroded handrail stanchion and incorrect application

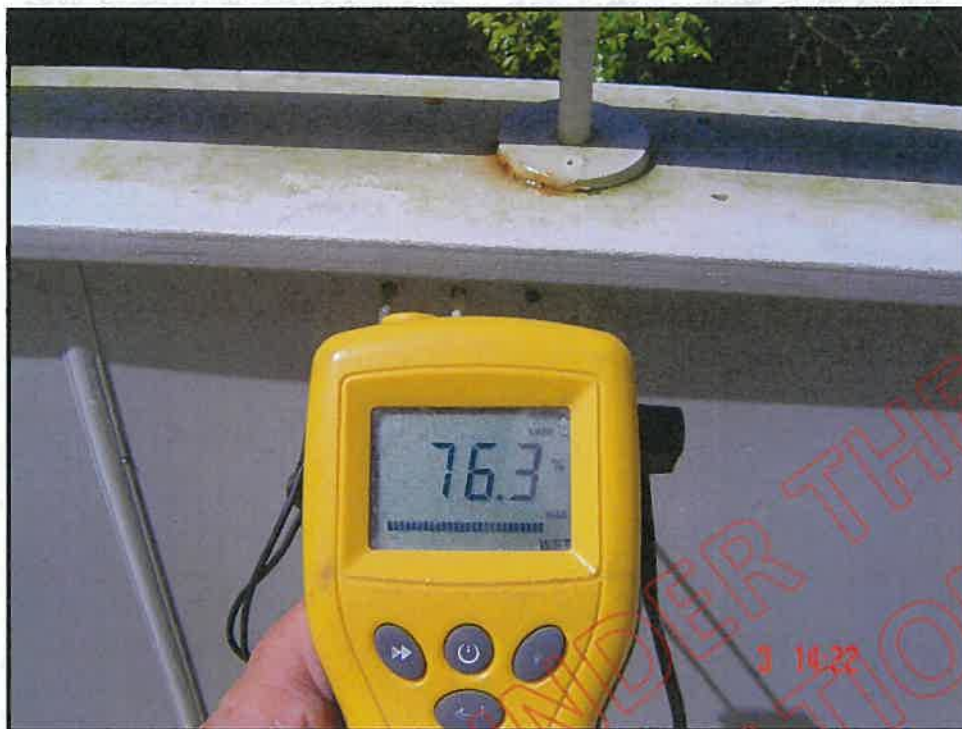
Photograph 1c 48

Very high probe moisture reading at centre of balcony wall

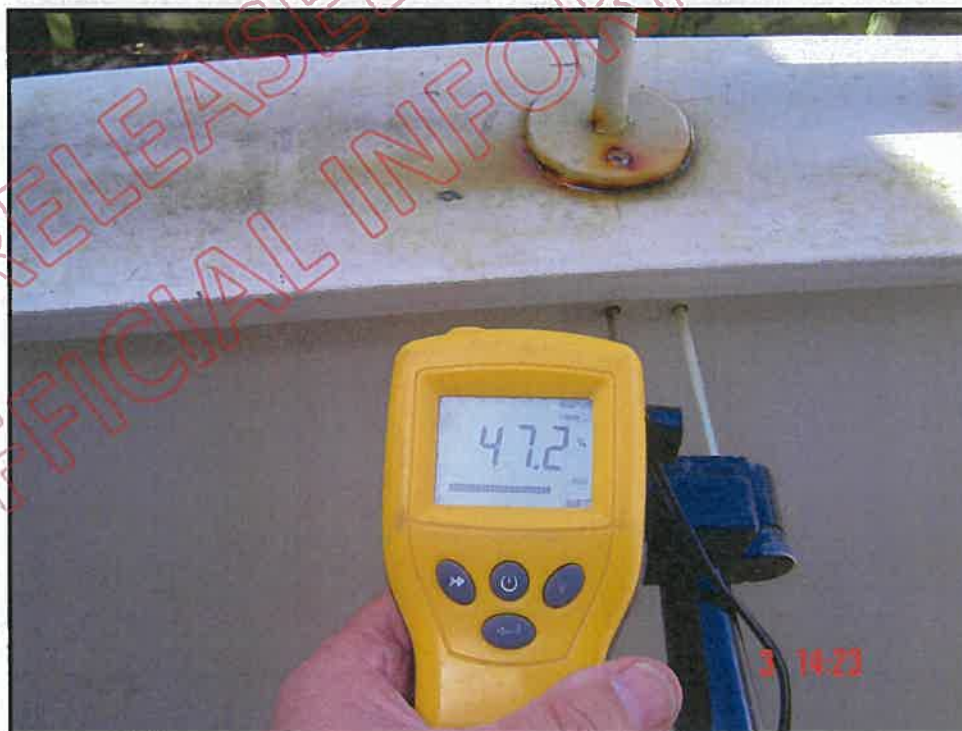
Photograph 1c 49

Very high probe moisture reading near to the centre of balcony wall

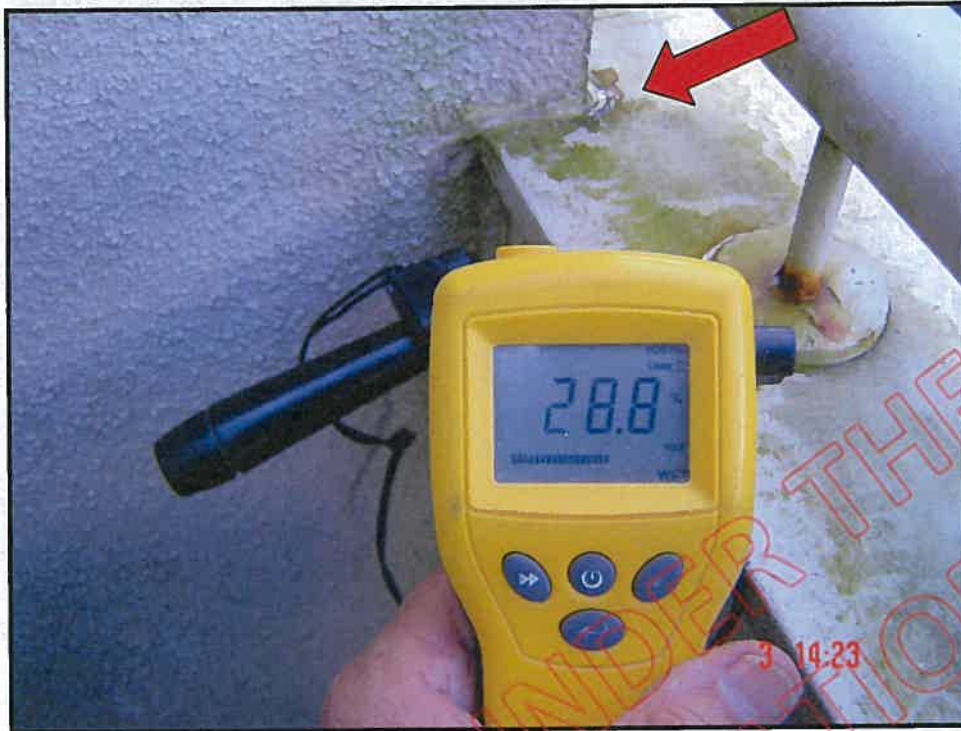
Photograph 1c 50

Very high probe moisture reading top of balcony wall adjacent to the wing wall; note no saddle flashing at balcony / wing wall junction

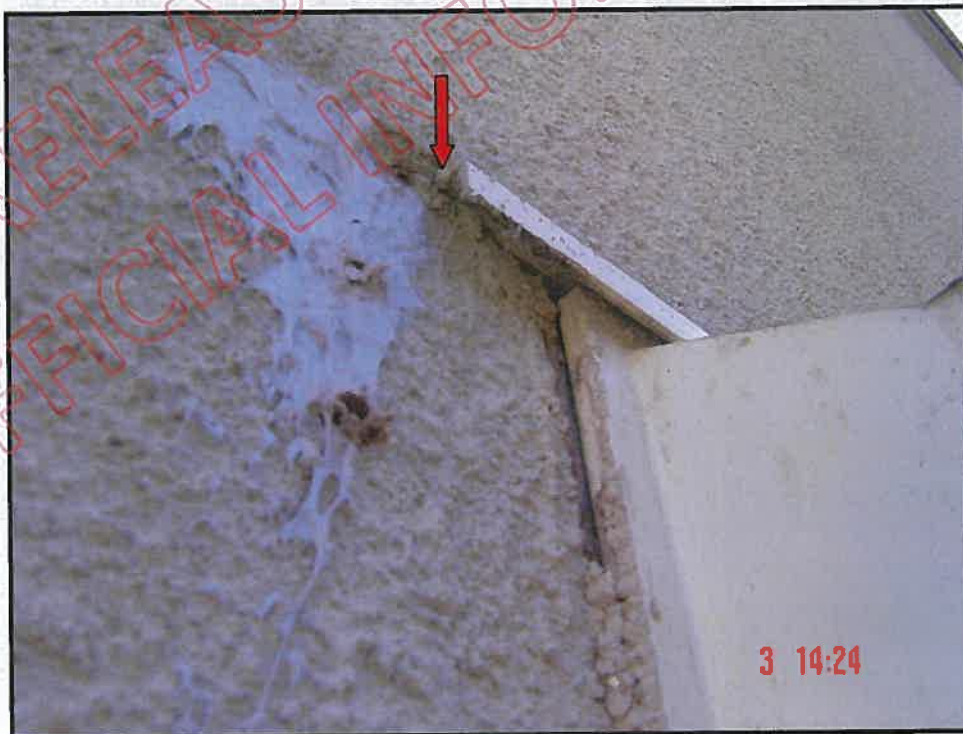
Photograph 1c 51

Inter-storey joint butts up to balcony door head flashing left hand side; Open joint is allowing moisture ingress

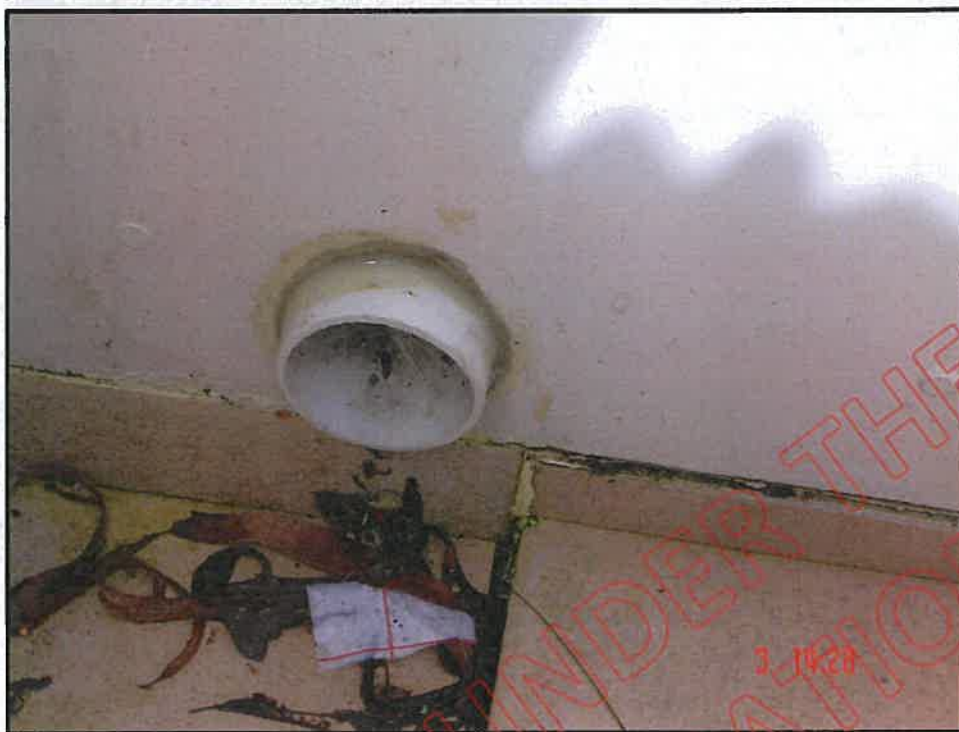
Photograph 1c 52

Inadequately designed and fitted balcony drainage overflow

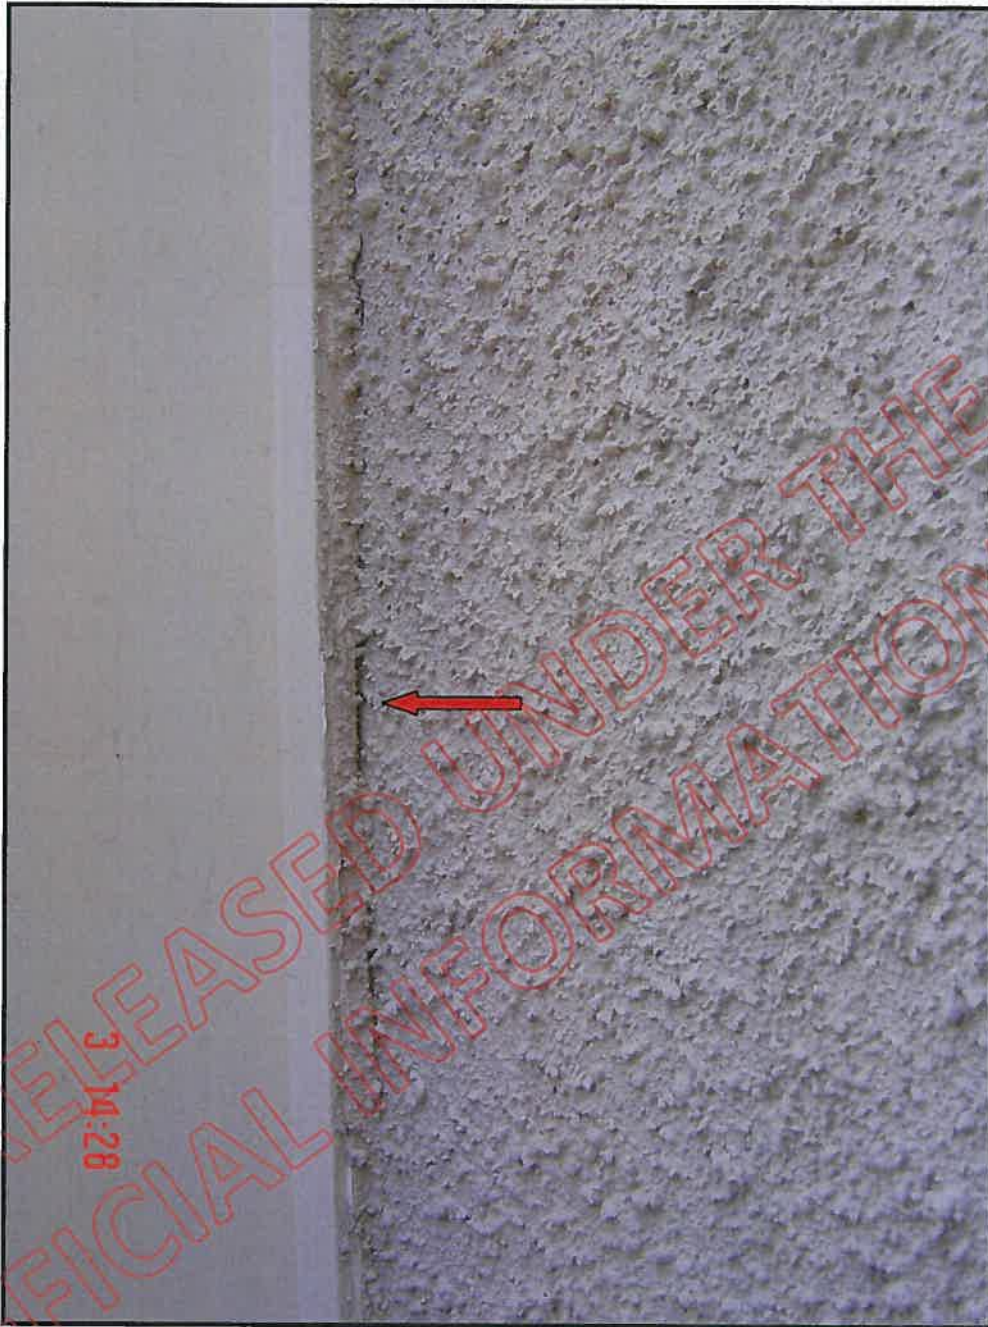
Photograph 1c 53

Failed jamb seal at right hand side of balcony door

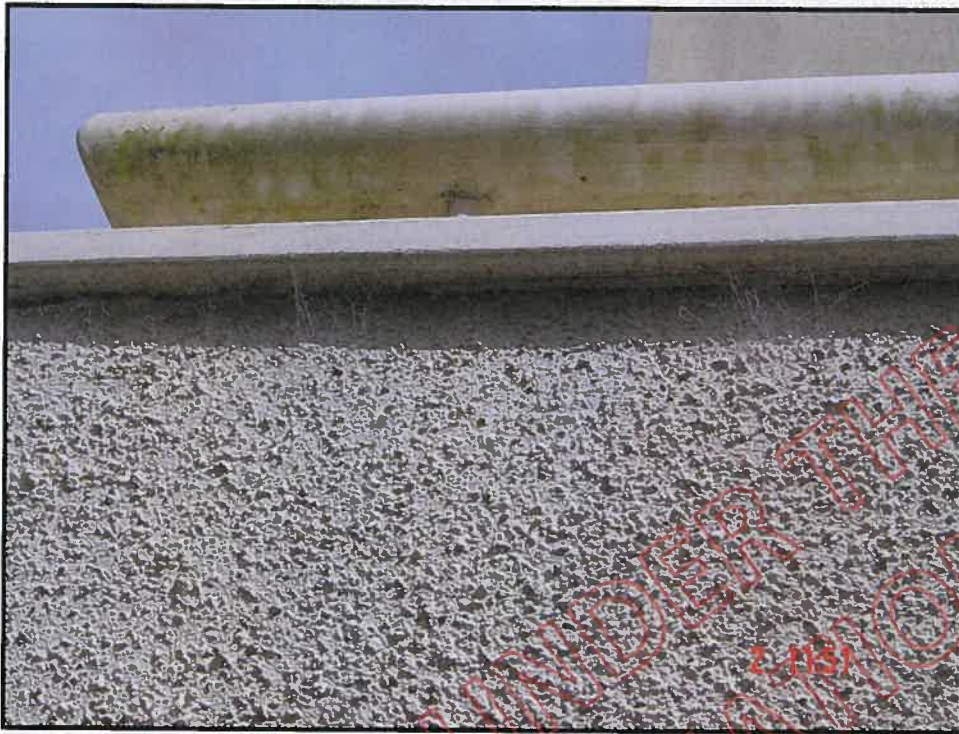
Photograph 1c 54

Looking up under timber balcony wall cap: note junction not sealed

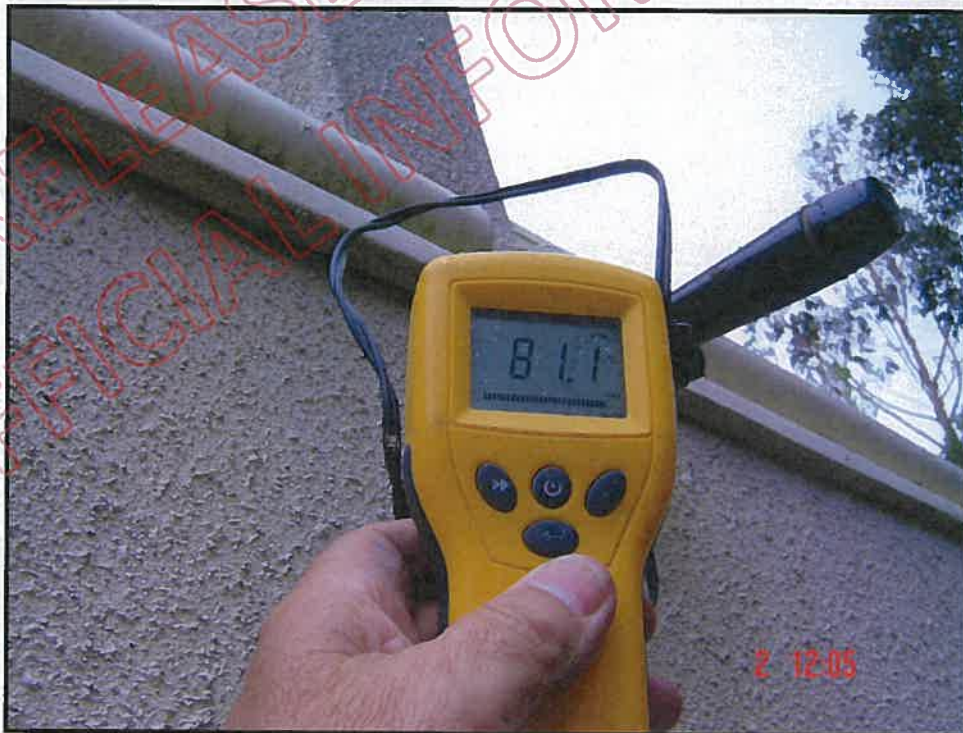
Photograph 1c 55

Very high probe moisture reading at eastern face of balcony wall at wing wall
