<b>Photo Elevation &amp; Number</b>	<b>Page No,</b>	<b>Description</b>
<b>Elevation 1e</b>		
1e - 1	119	General view front
1e - 2	120	Cut out and high moisture reading at south east corner of balcony wall
1e - 3	120	High moisture reading at east balcony wall
1e - 4	121	High moisture reading at south east corner of balcony wall
1e - 5	121	High moisture reading at centre of eastern balcony wall
1e - 6	122	High moisture reading at wing wall junction
1e - 7	122	High moisture reading at base of wing wall
1e - 8	123	North wall / balcony junction – no saddle flashing
1e - 9	123	Open mitre at corner of timber balcony capping
1e - 10	124	Photograph showing incorrectly installed hand rail stanchion
1e - 11	124	Inter-storey H mould terminates at end of head flashing
1e - 12	125	Inter-storey H mould terminates mid sheet at wing wall
1e – 12/1	126	Photograph showing cladding hard down on balcony floor tiles
<b>Elevation 1d</b>

East (Front) Elevation 1 – Units E, D, B, C

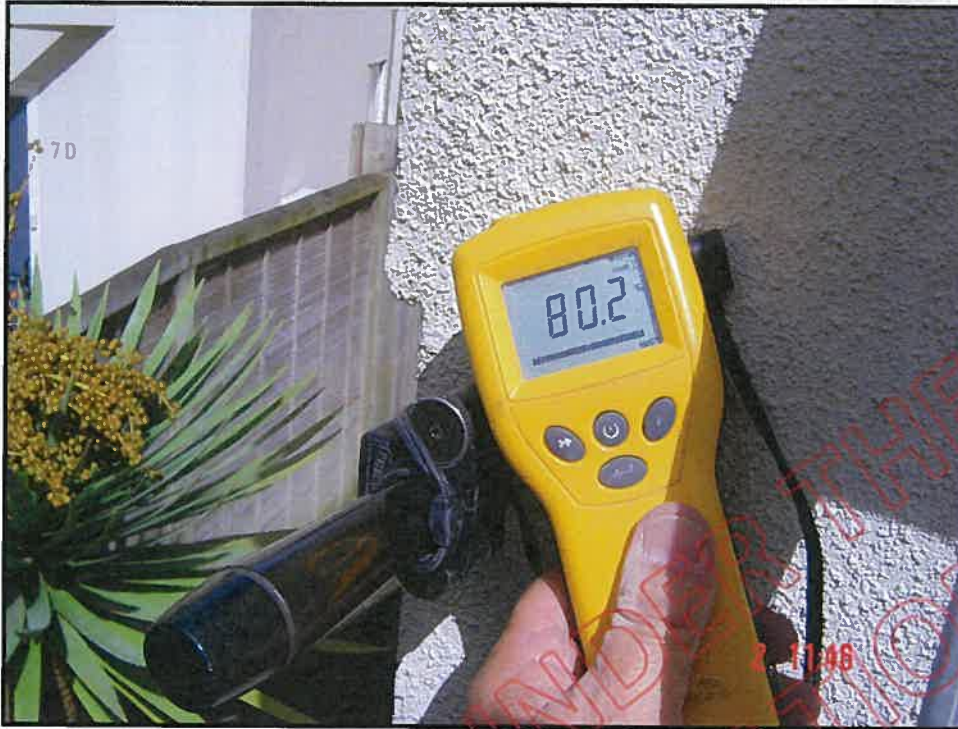
Photograph 1c 56

Very high probe moisture reading at north east corner balcony wall adjacent to garage door head, right hand side

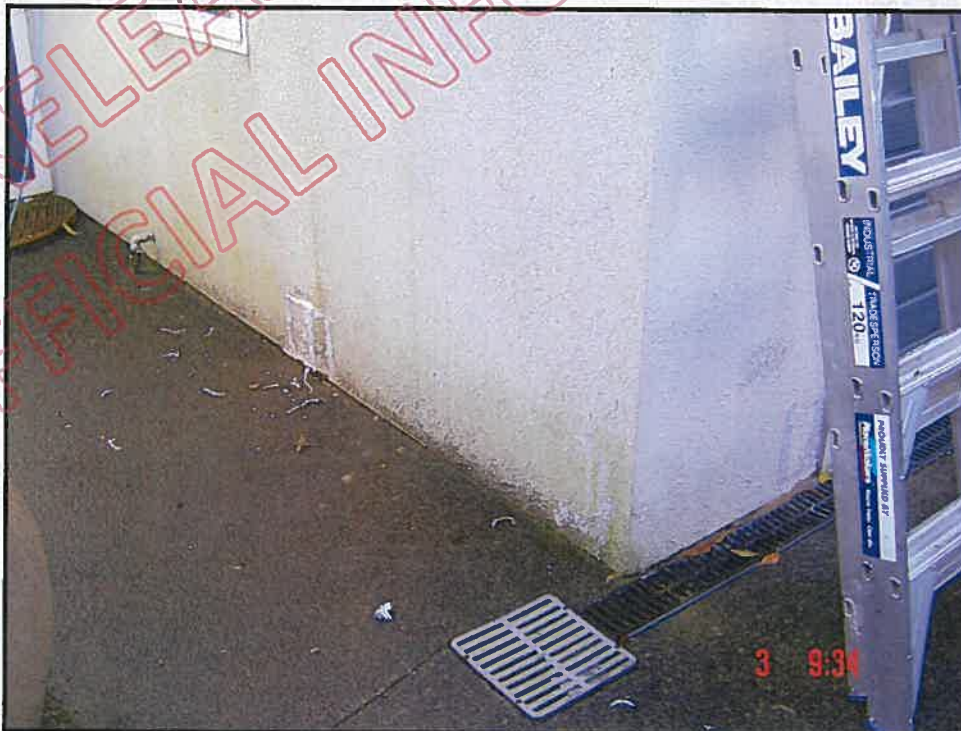
Photograph 1c 57

Photograph showing cladding extending to paving; should have minimum of 100mm clearance

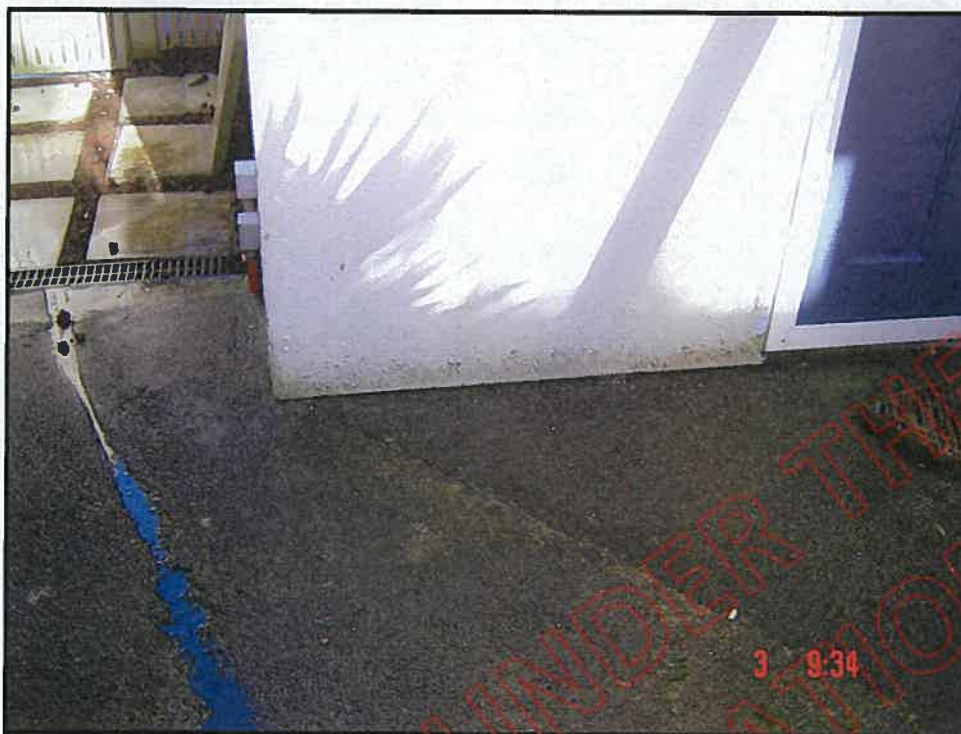
Photograph 1c 58

Photograph showing cladding extending to paving; should have minimum of 100mm clearance
