Unit B

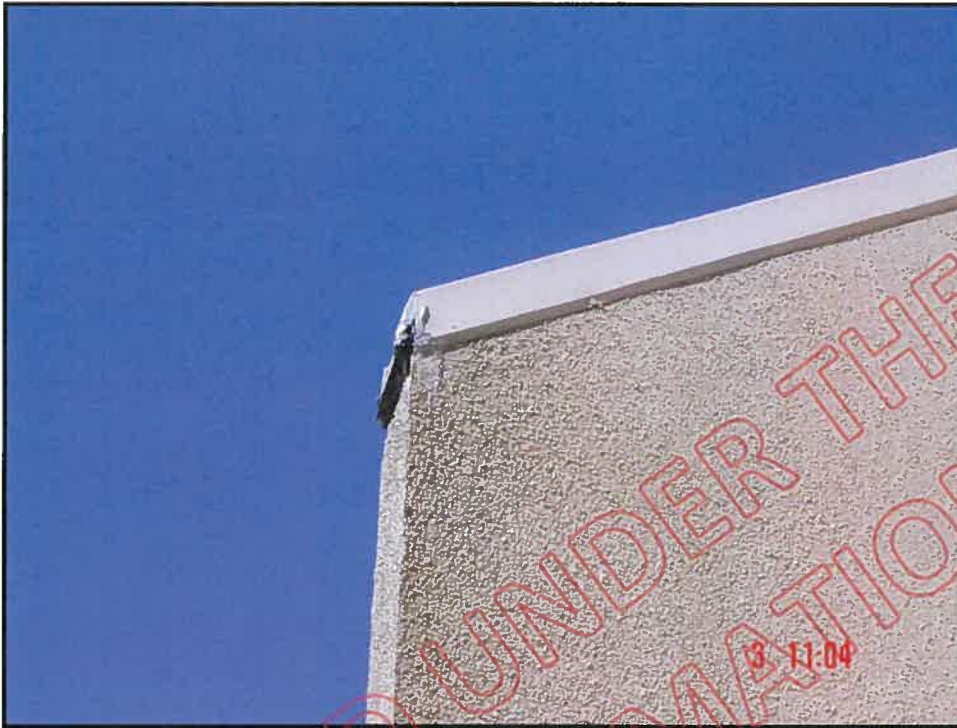
Photograph 1b 59

General view of inter-tenancy wing wall showing poorly designed and installed cap-flashing,

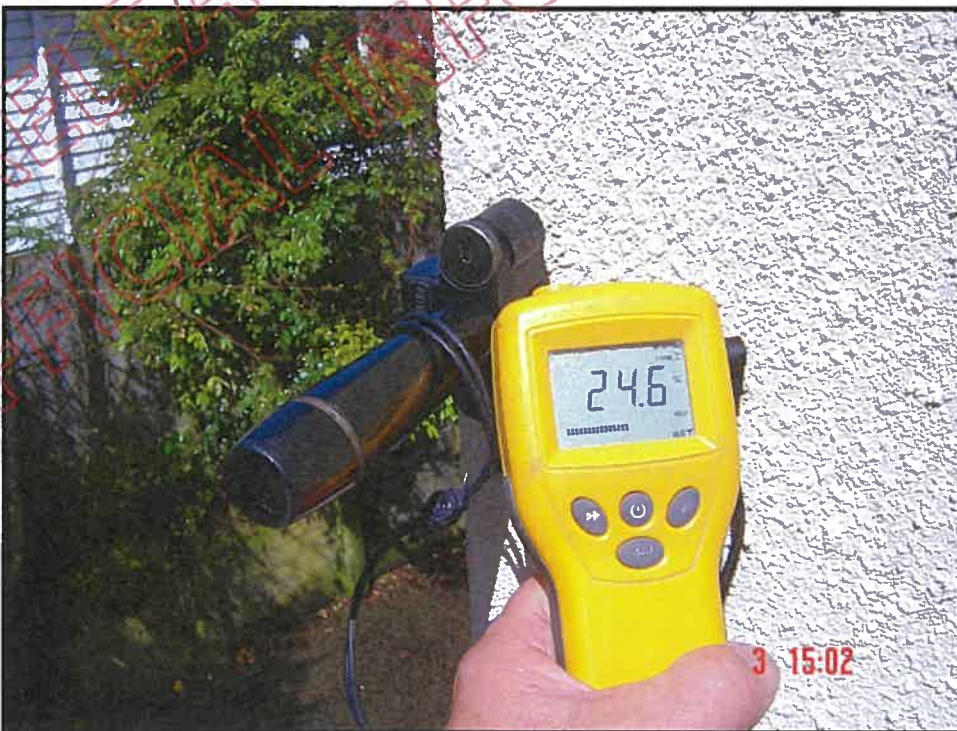
Photograph 1b 60

High probe moisture reading near top of wing wall at front

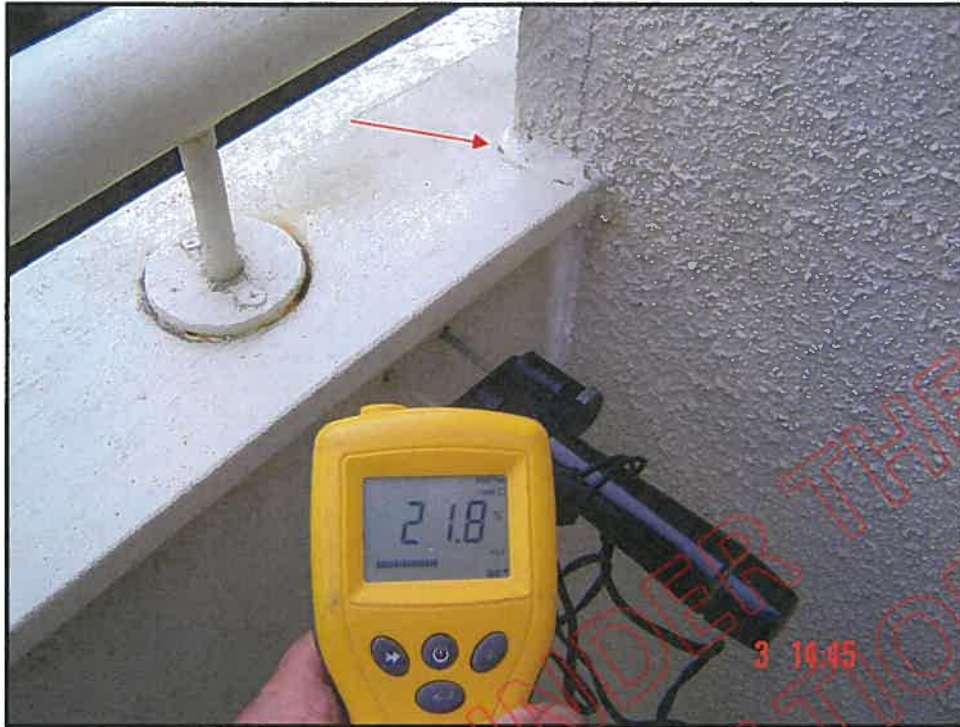
Photograph 1b 61

High probe moisture reading at top of balcony wall adjacent to the wing wall; note no saddle flashing at balcony / wing wall junction

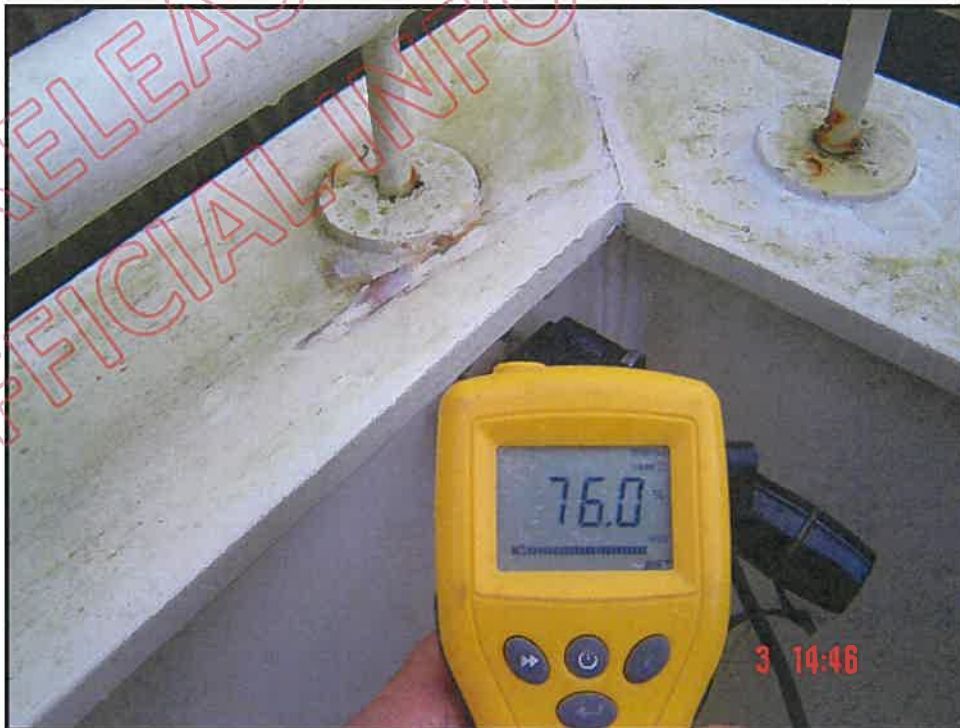
Photograph 1b 62

Very high probe moisture reading at top of north east corner of balcony wall

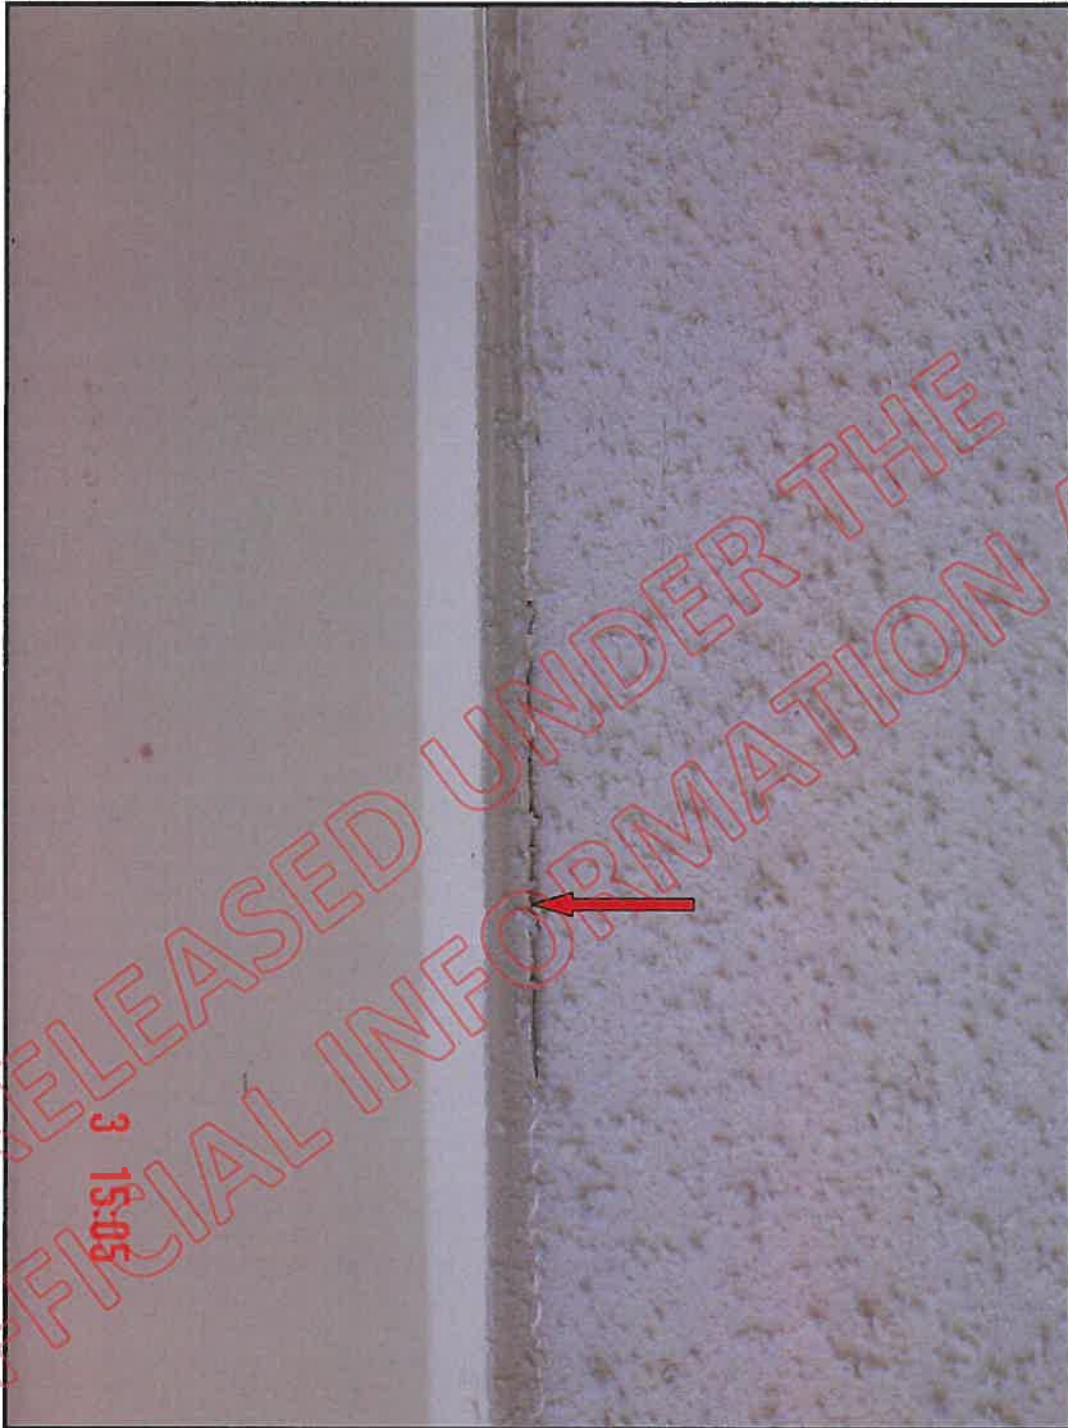
Photograph 1b 63

Failed jamb seal at right hand side of balcony door

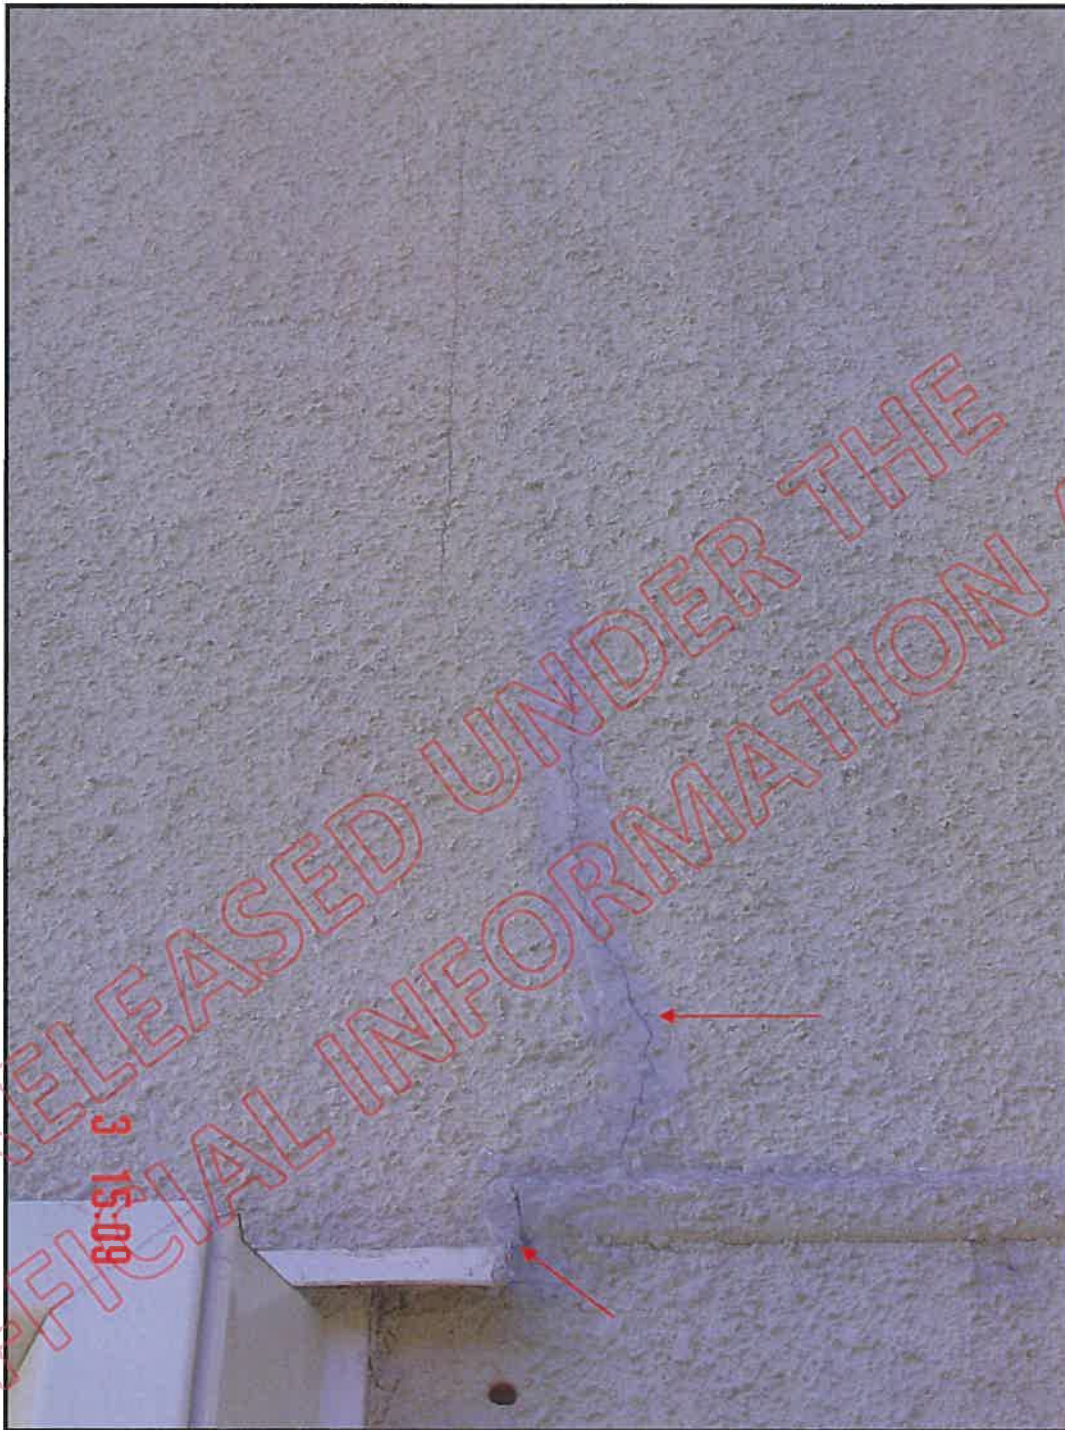
Photograph 1b 64

Inter-storey joint butts up to balcony door head flashing right hand side; Open joint is allowing moisture ingress: note cracking to cladding sheet above door head, recently sealed

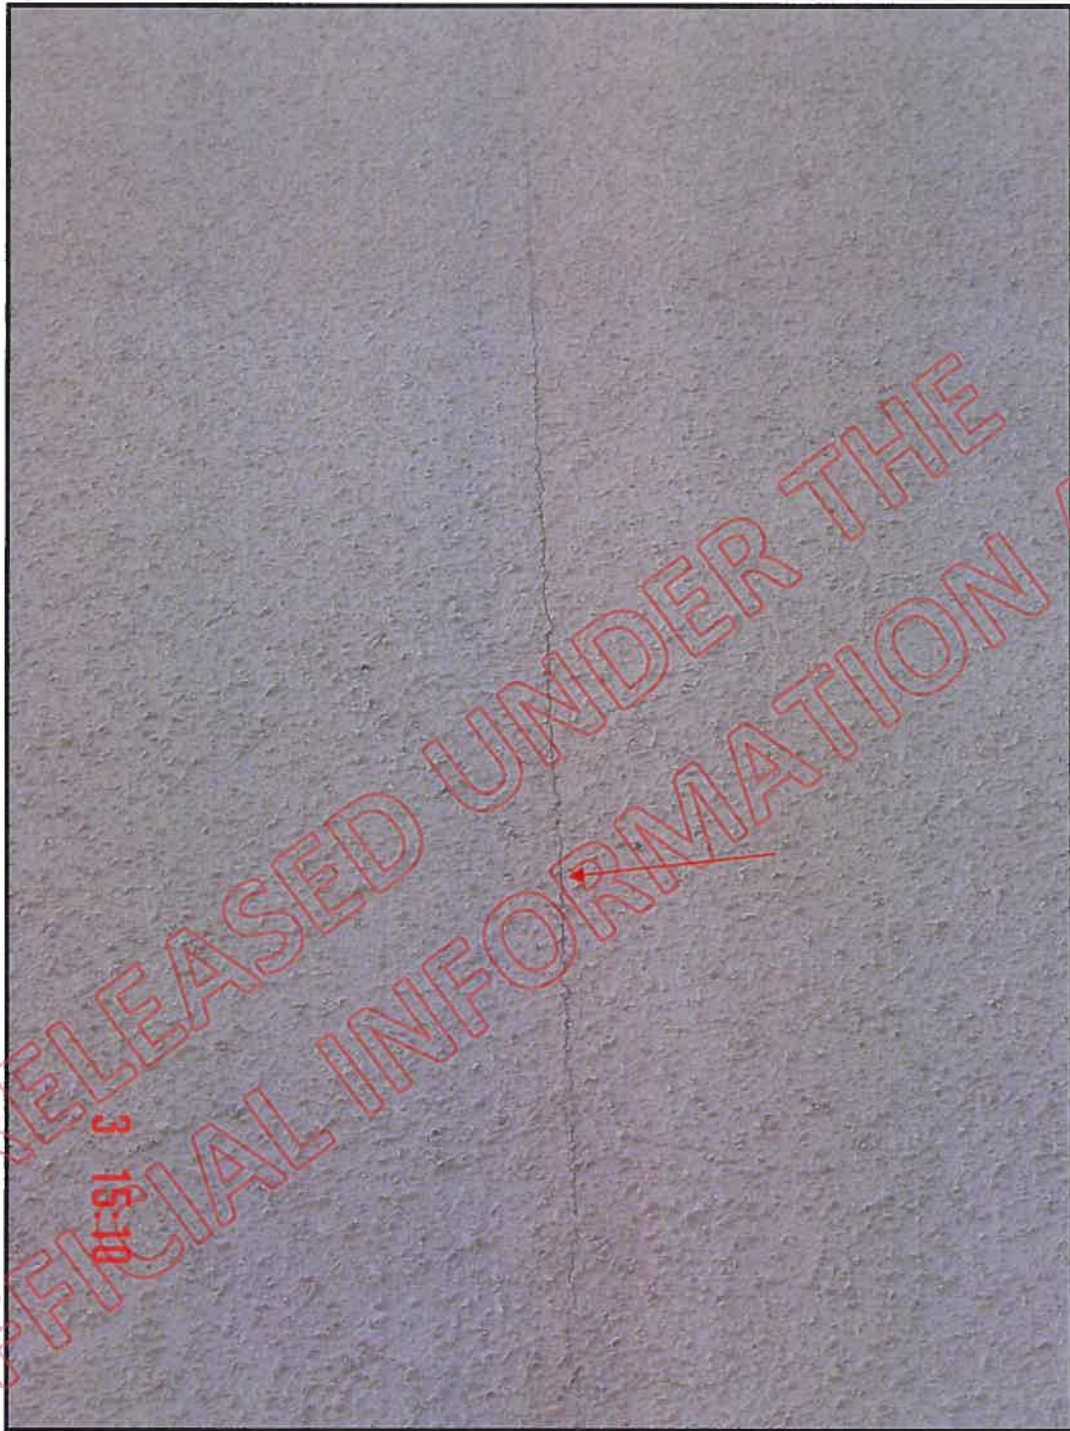
Photograph 1b 65

Cracking to cladding sheet above balcony doors

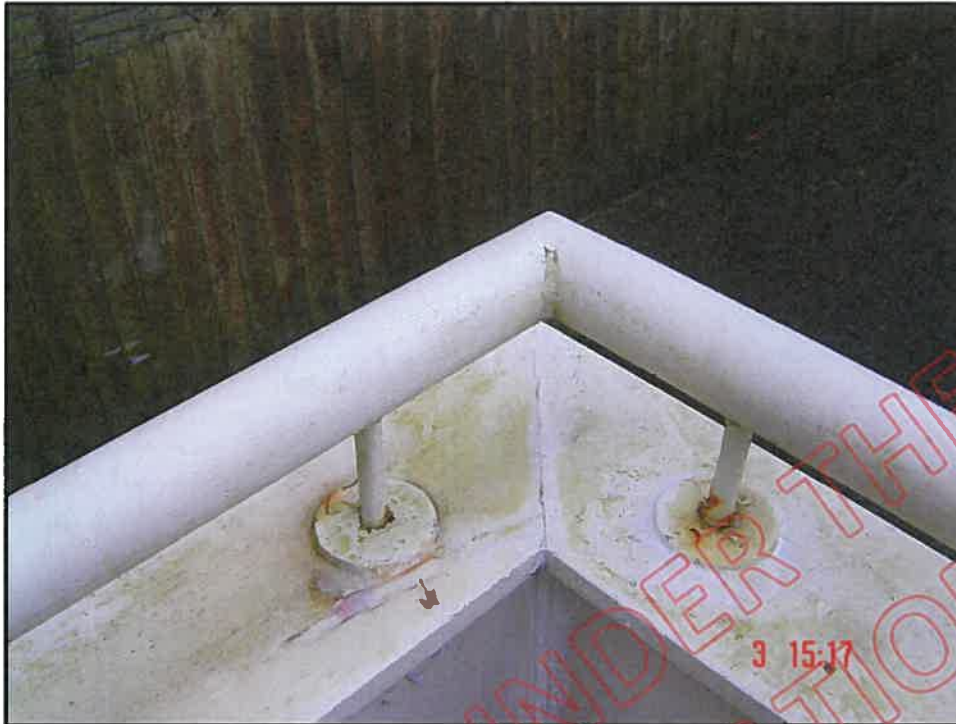
Photograph 1b 66

Open and unprotected timber capping mitre joint at north east corner; note also corroded and incorrect design and installation of hand rail stanchions

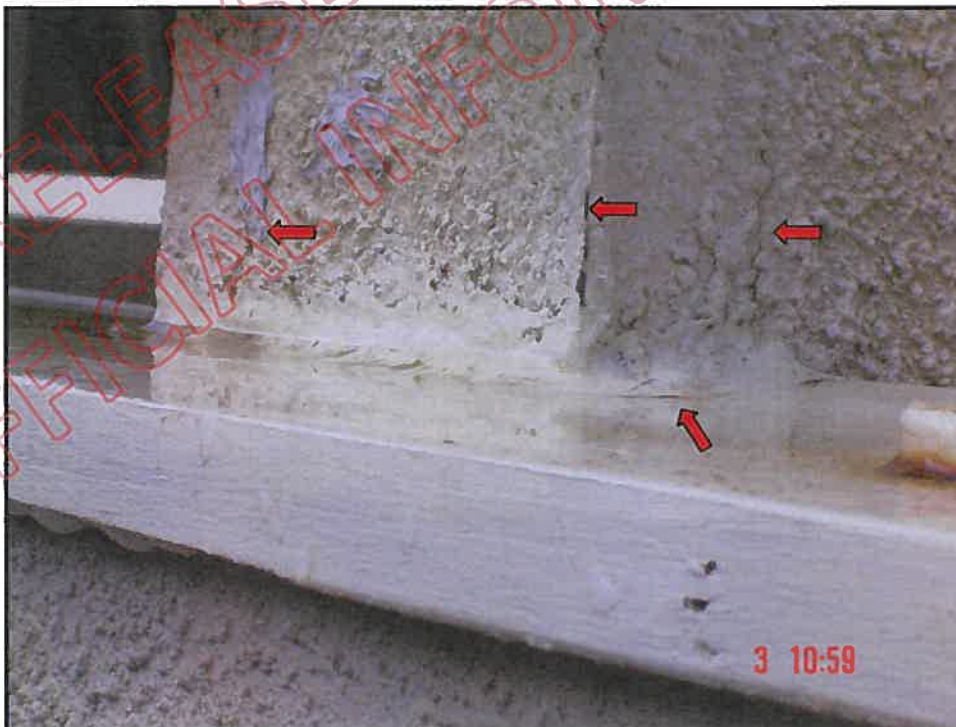
Photograph 1b 67

Balcony capping wing wall junction: note cracking at joins to wing wall cladding, no saddle flashing, exposed sealant failing. Point of entry for water ingress

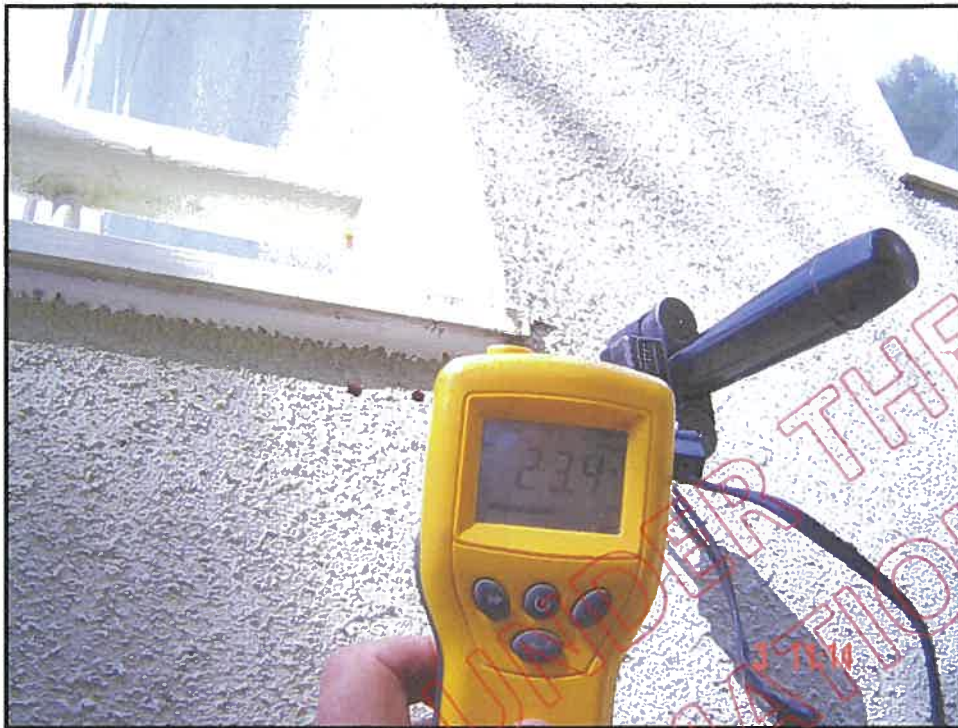
Unit B
Photograph 2b 68

High probe moisture reading at north wall / balcony junction; note no saddle flashing, point of entry for water ingress

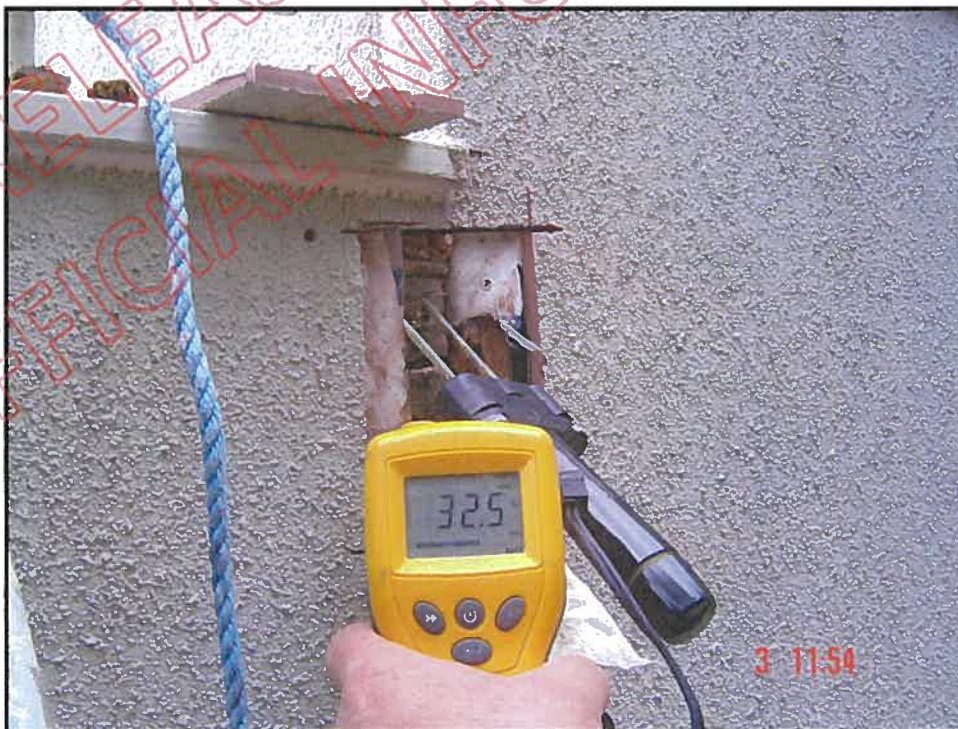
Photograph 2b 69

Cut out and high probe moisture reading at north wall / balcony wall junction; Laboratory sample 5.

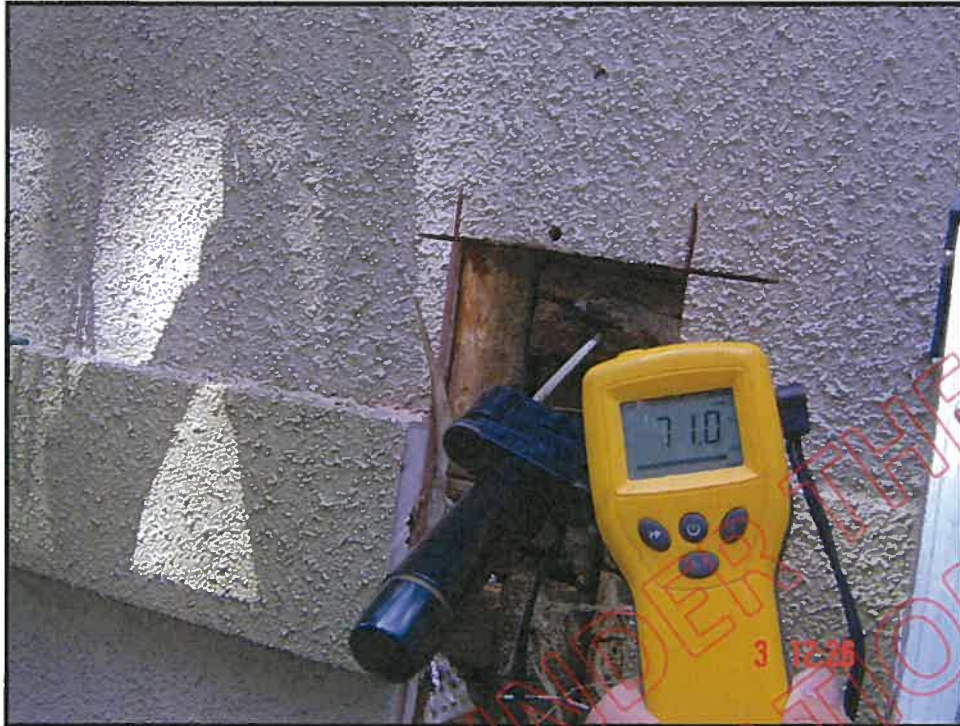
Photograph 2b 70

Cut out and high probe moisture reading at north wall inter-storey below balcony wall junction: note advanced decay to studs, plate and end of 450x100mm support beam, note also the incorrect installation of the polystyrene reveal

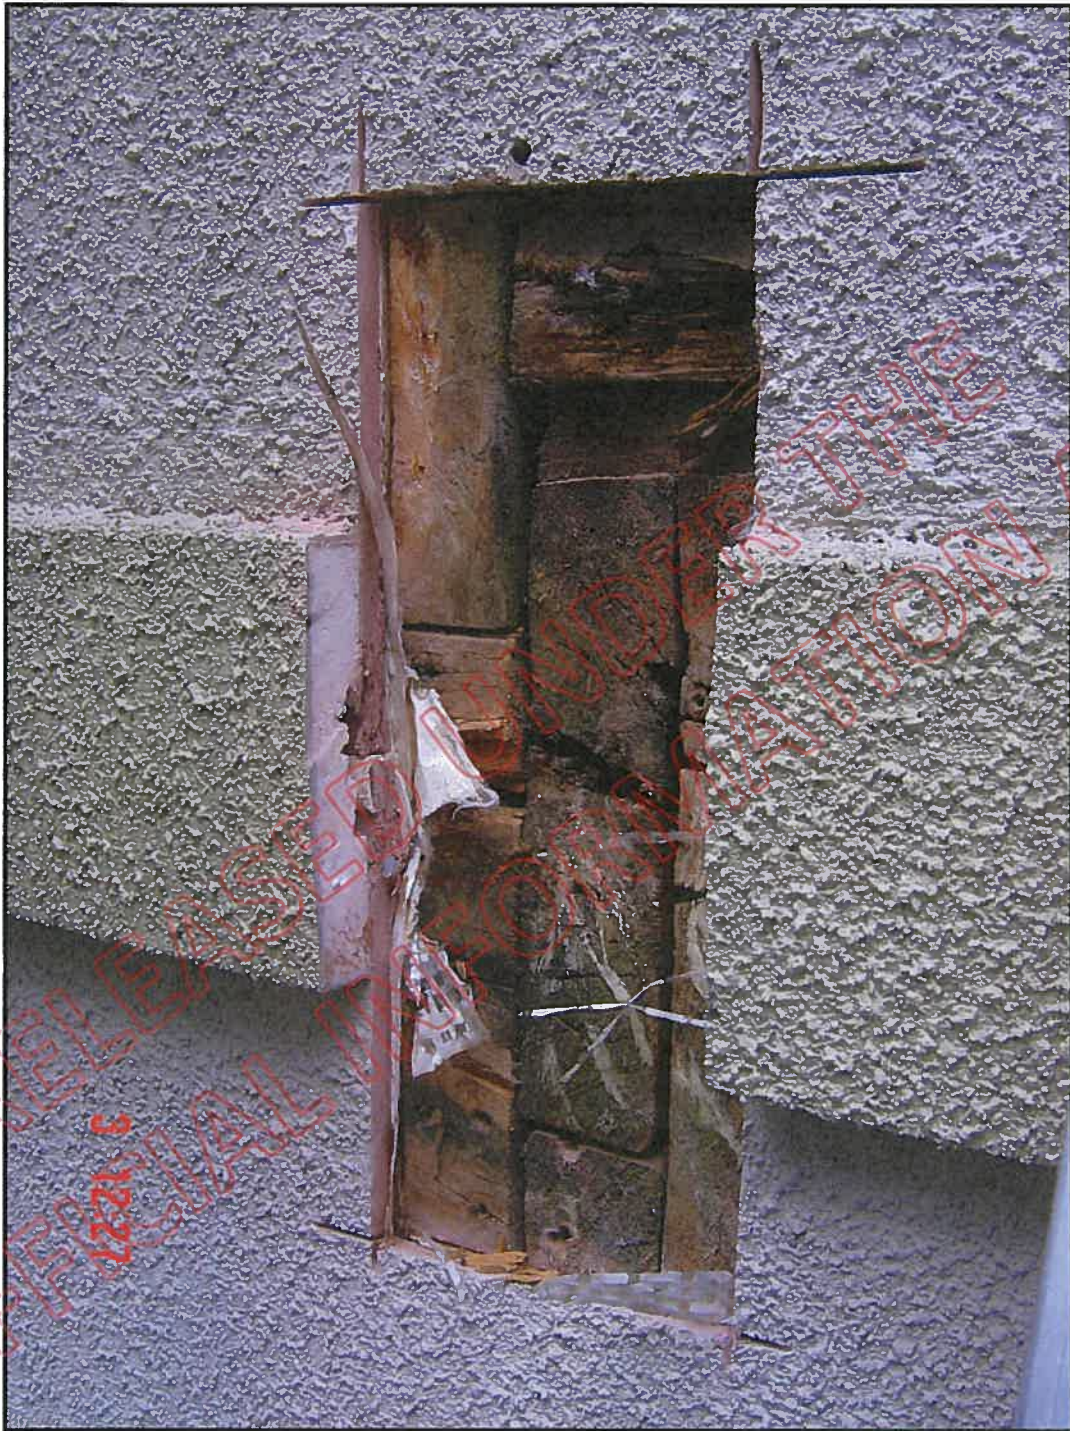
Photograph 2b 71

Cut out at north wall inter-storey below balcony wall junction: note advanced decay to studs, plate and end of 450x100mm support beam, note also the incorrect installation of the polystyrene reveal

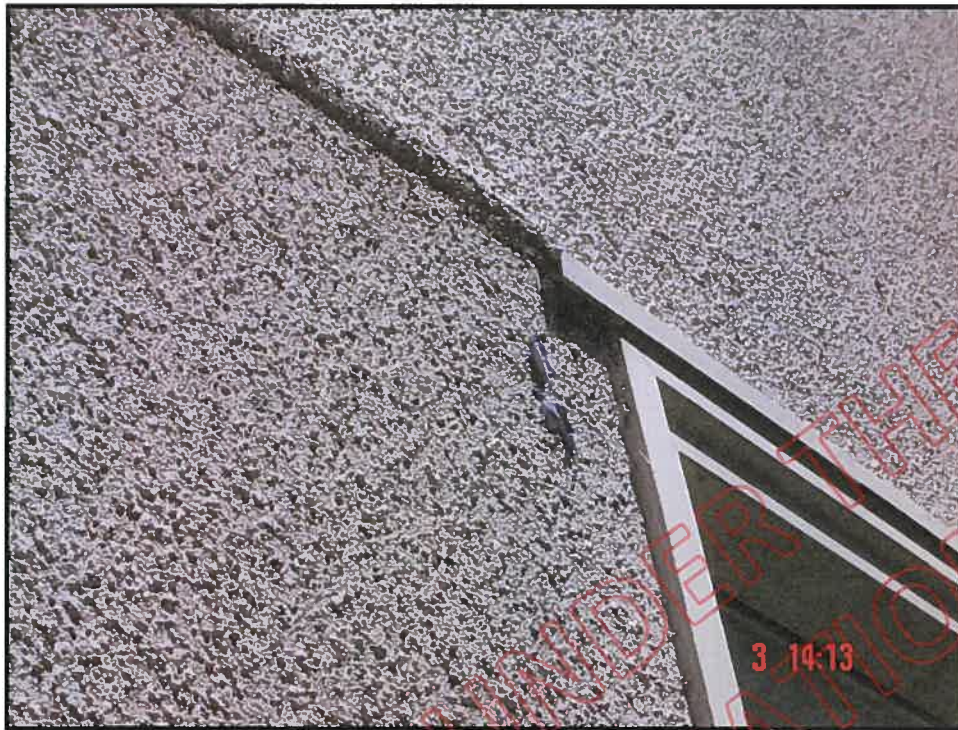
Photograph 2b 72

Photograph showing inter-storey H mould terminating at end of head flashing

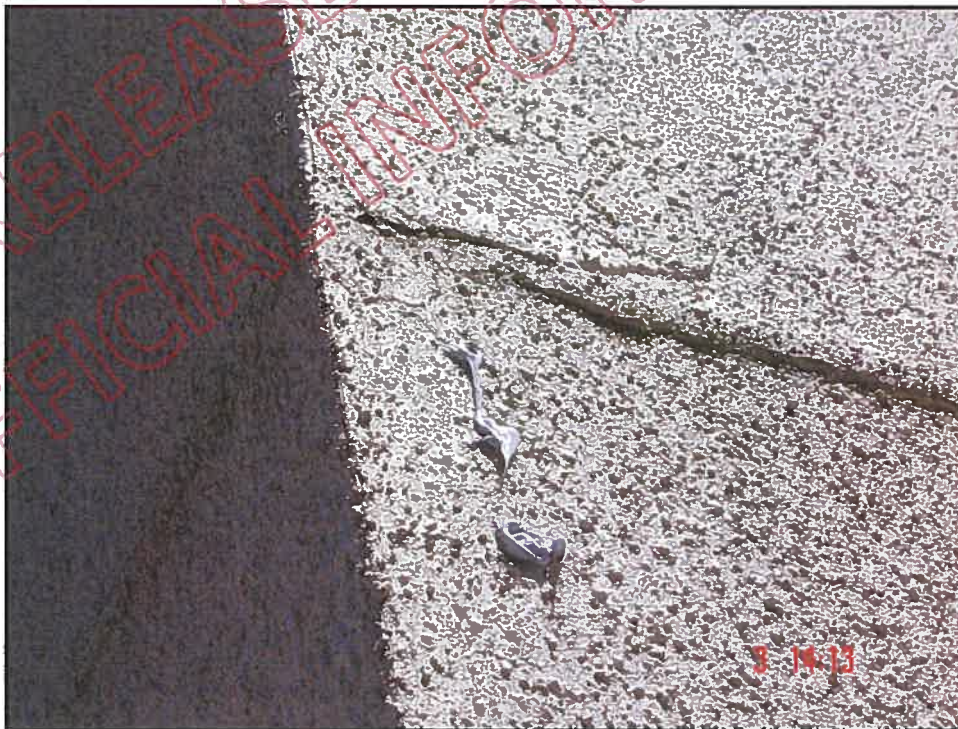
Photograph 2b 73

Photograph showing inter-storey H mould terminating at

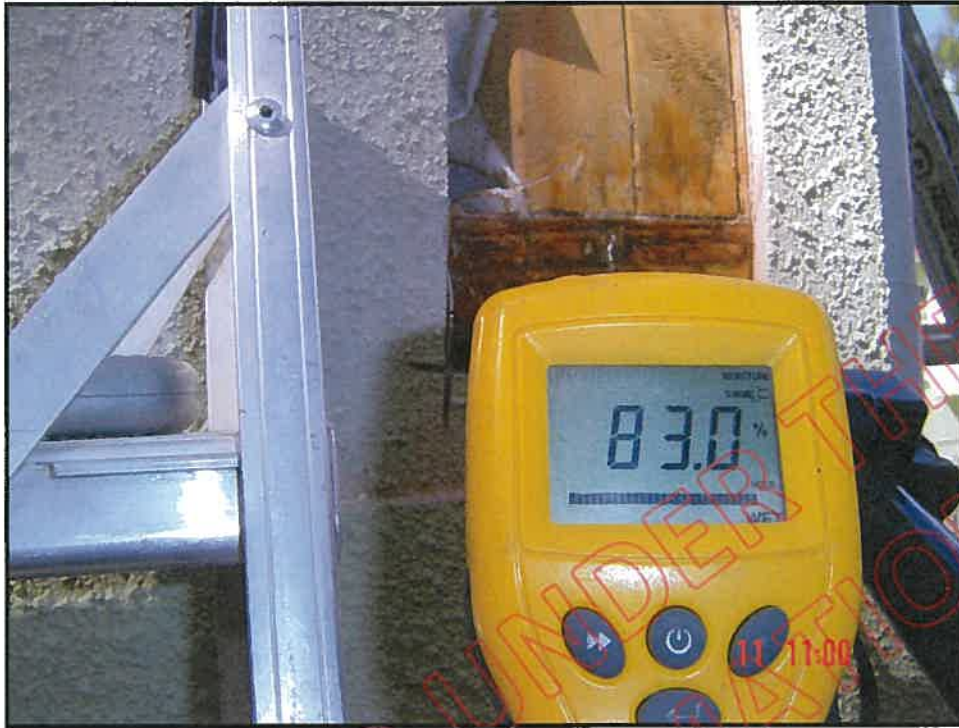
Photograph 2b 74

Cut out showing very high probe reading and decay at North West corner above inter-storey joint.

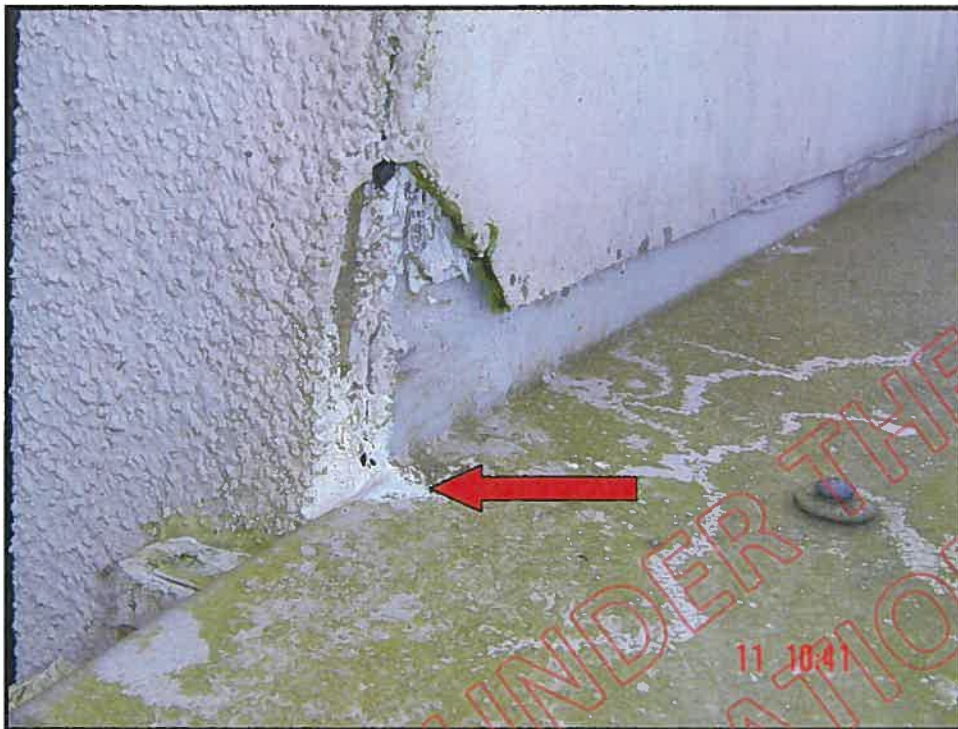
Photograph 3b 77

Poor detailing at end of apron flashing: point of water entry

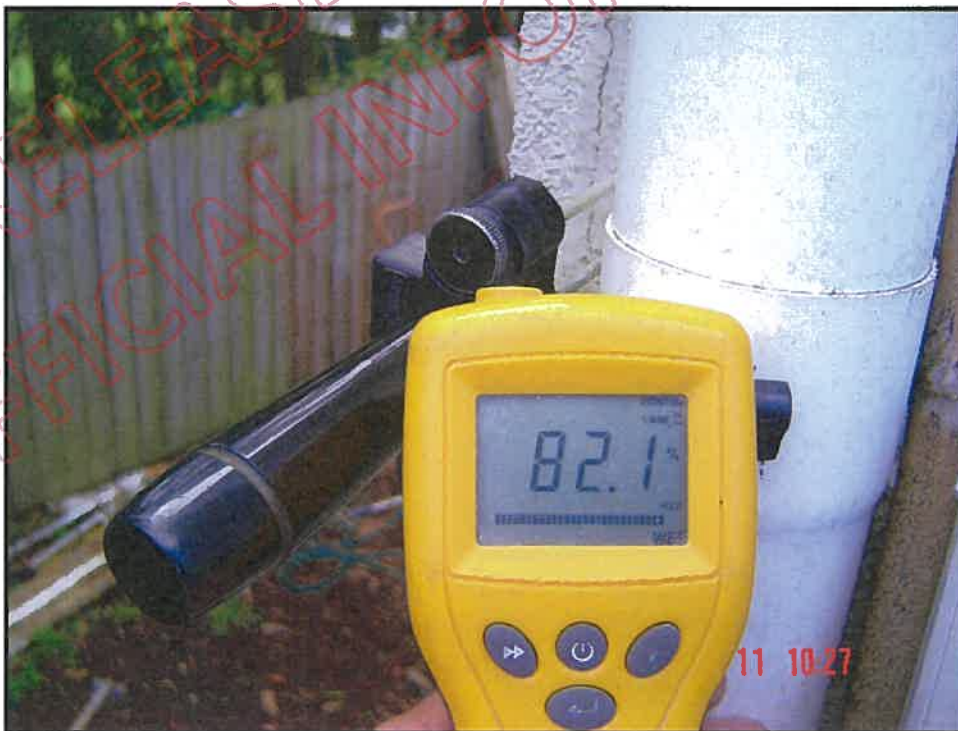
Photograph 3b 78

Very high probe reading at west wall below apron flashing junction

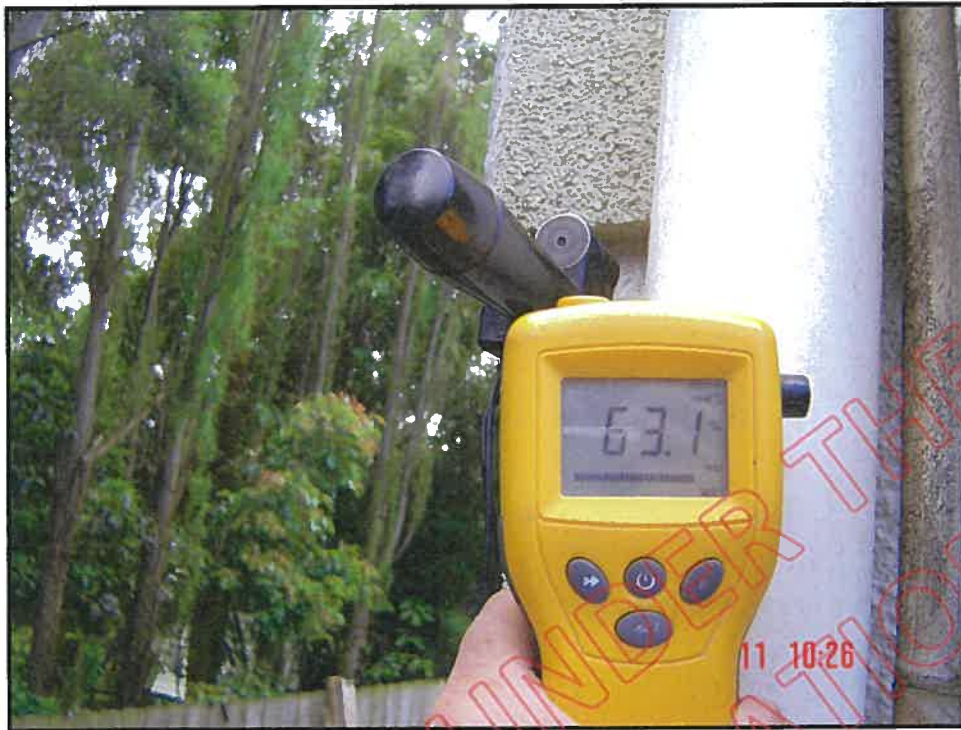
Photograph 3b 79

Very high probe reading at west wall below inter-storey

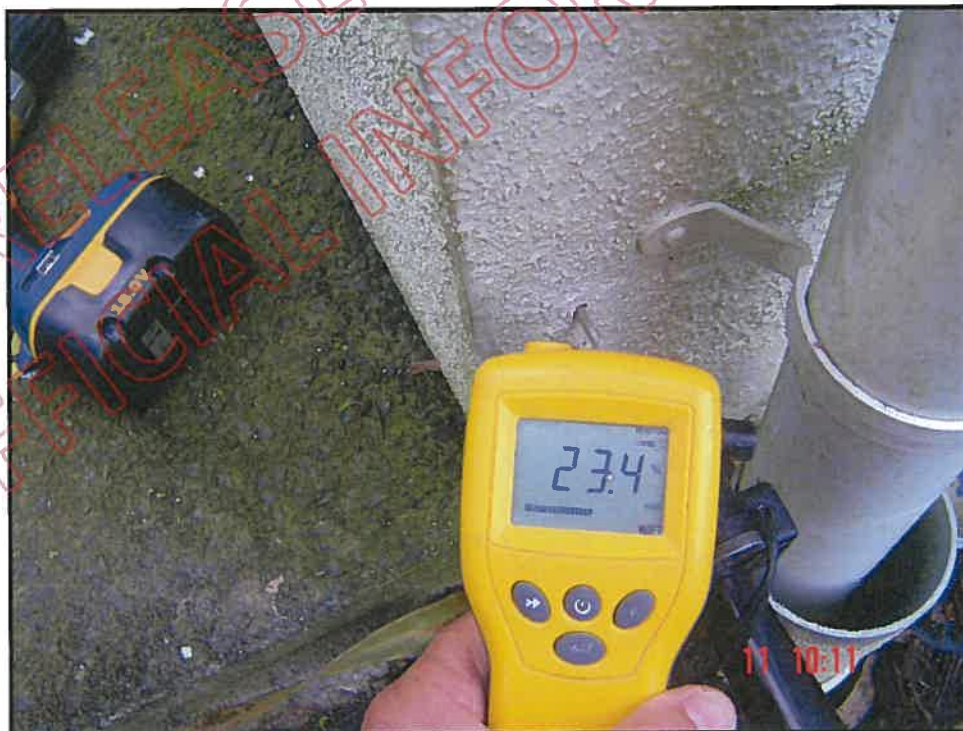
Photograph 3b 80

High probe reading at west wall 200mm above base

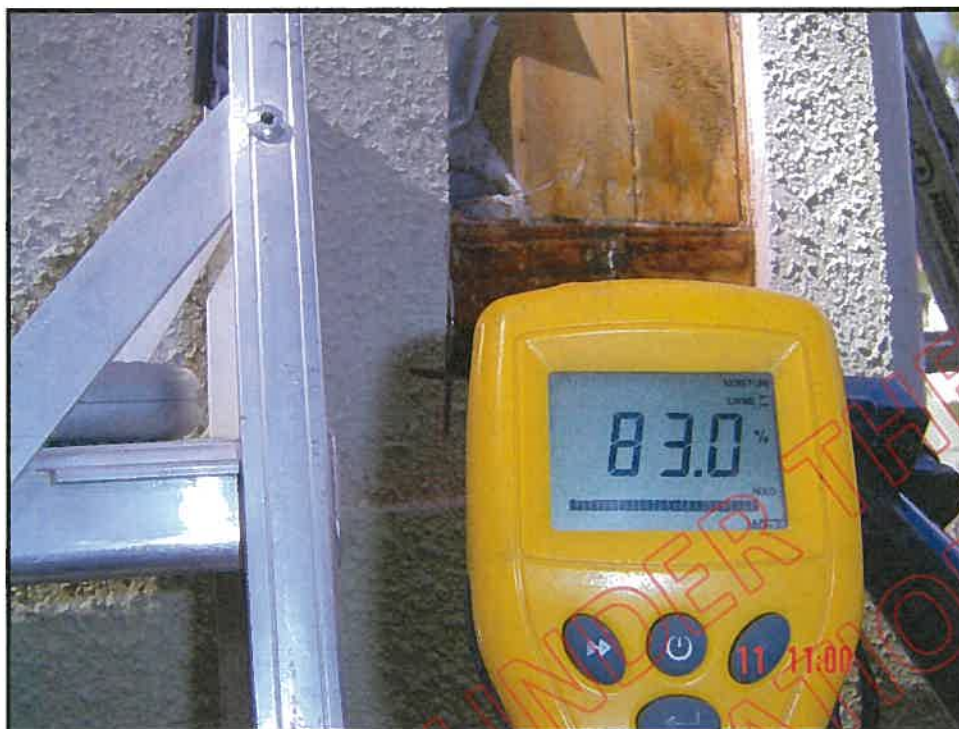
Photograph 3b 81

Very high probe moisture reading at cut out at North West corner in er-storey joint; (see cut out No. 12 elevation 2 north side)

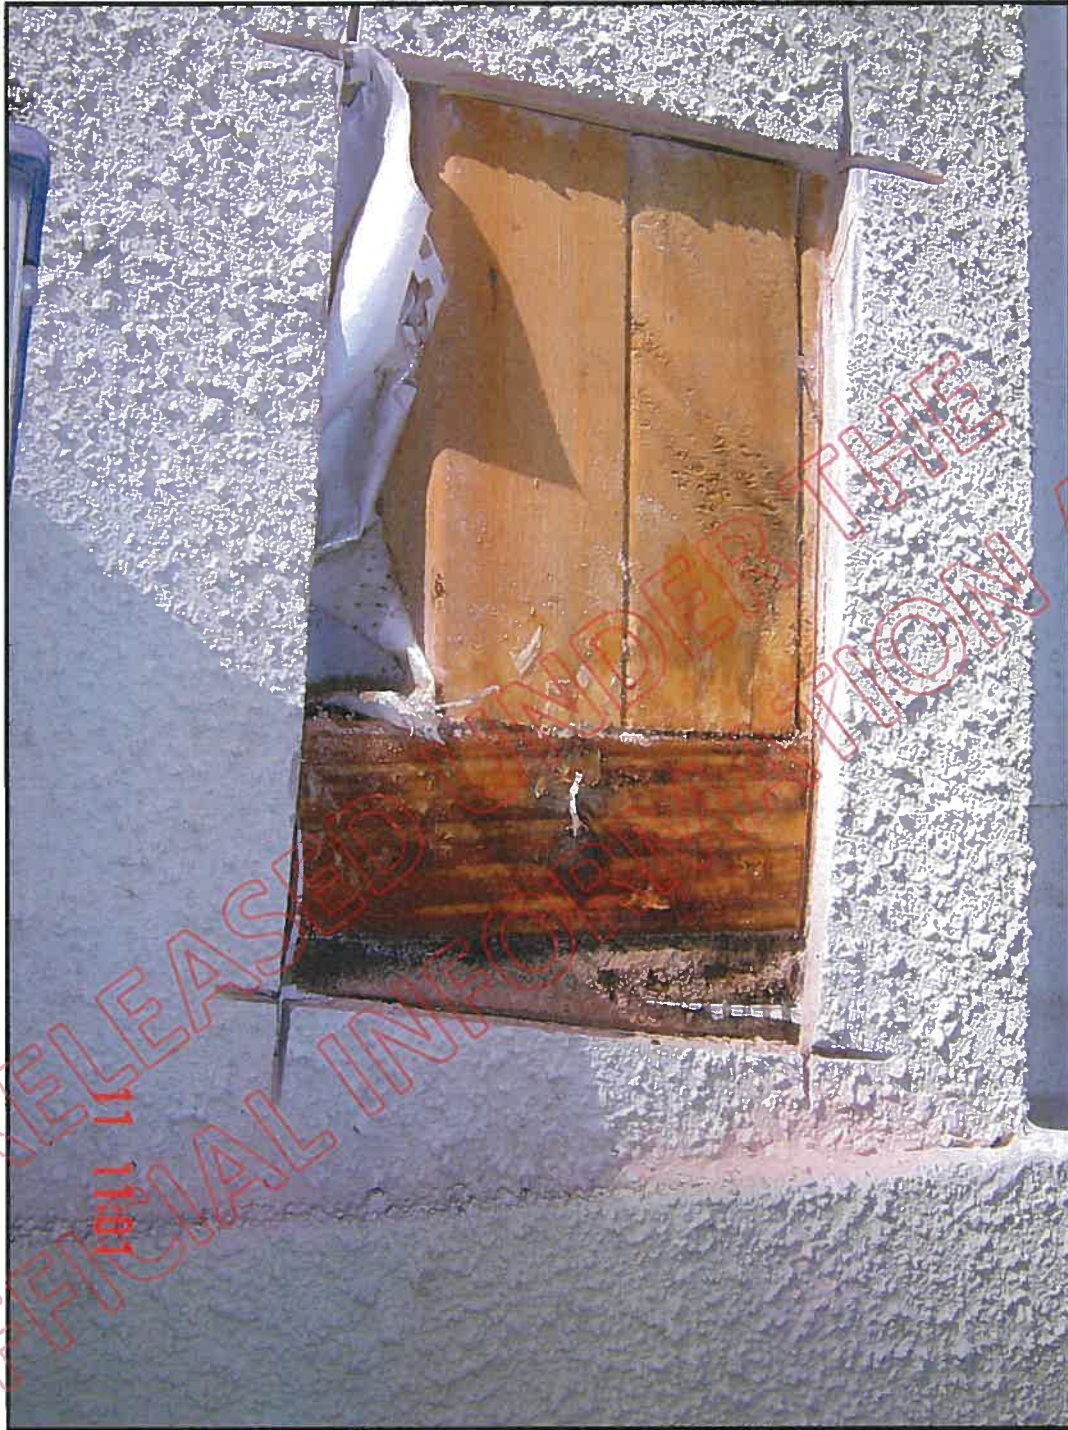
Photograph 3b 82

Cut out at North West corner inter-storey joint showing fungal decay

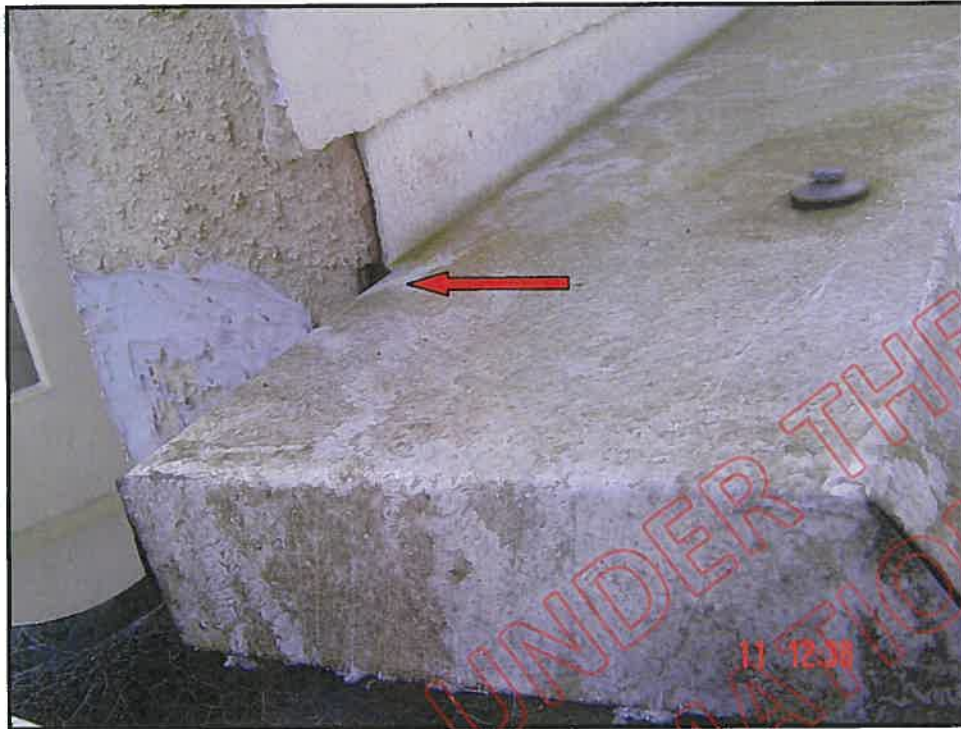
Unit D
Photograph 3d 85

Poor detailing at end of apron flashing: point of water entry

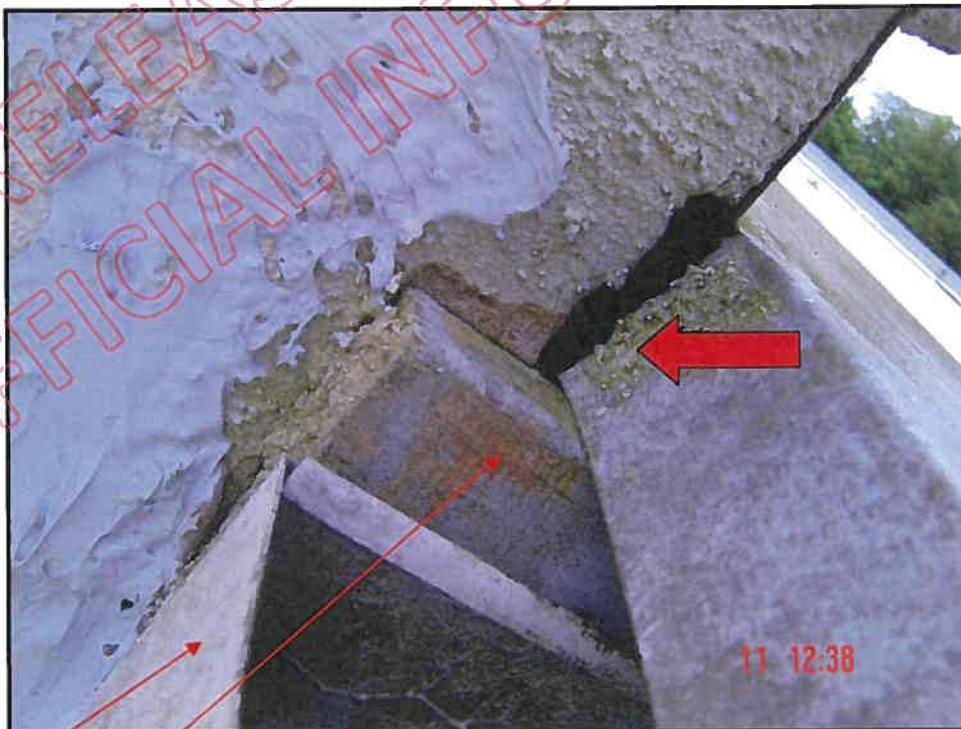
Photograph 3d 86

Spouting - Fascia

Close up of photograph 3d 85

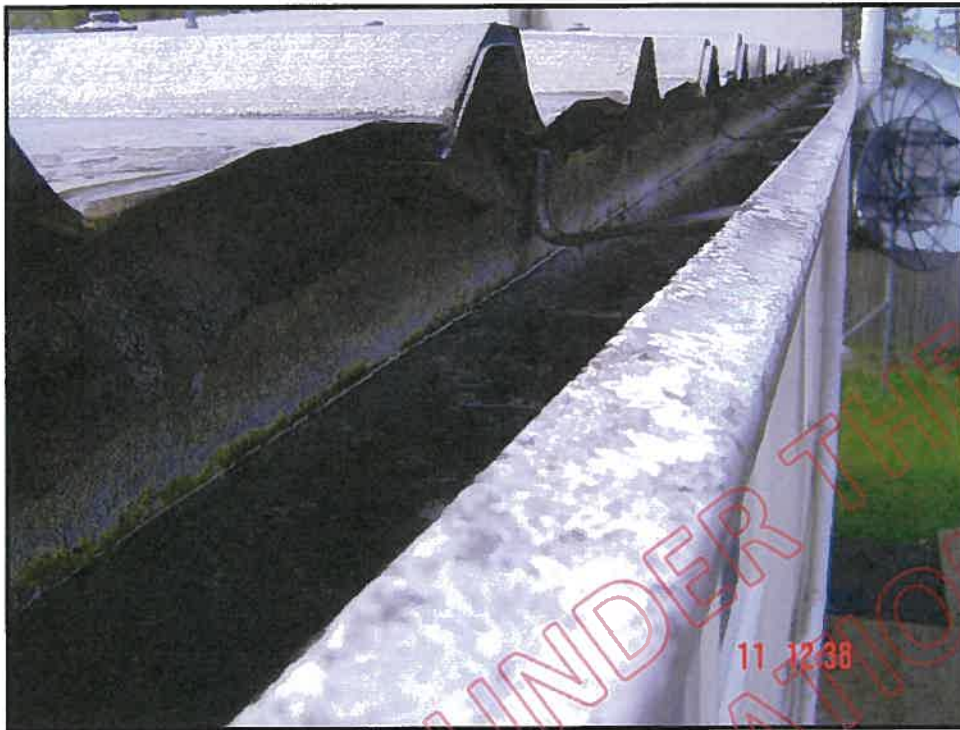
Photograph 3d 87

General view of spouting and roof end: note water ponding in spouting

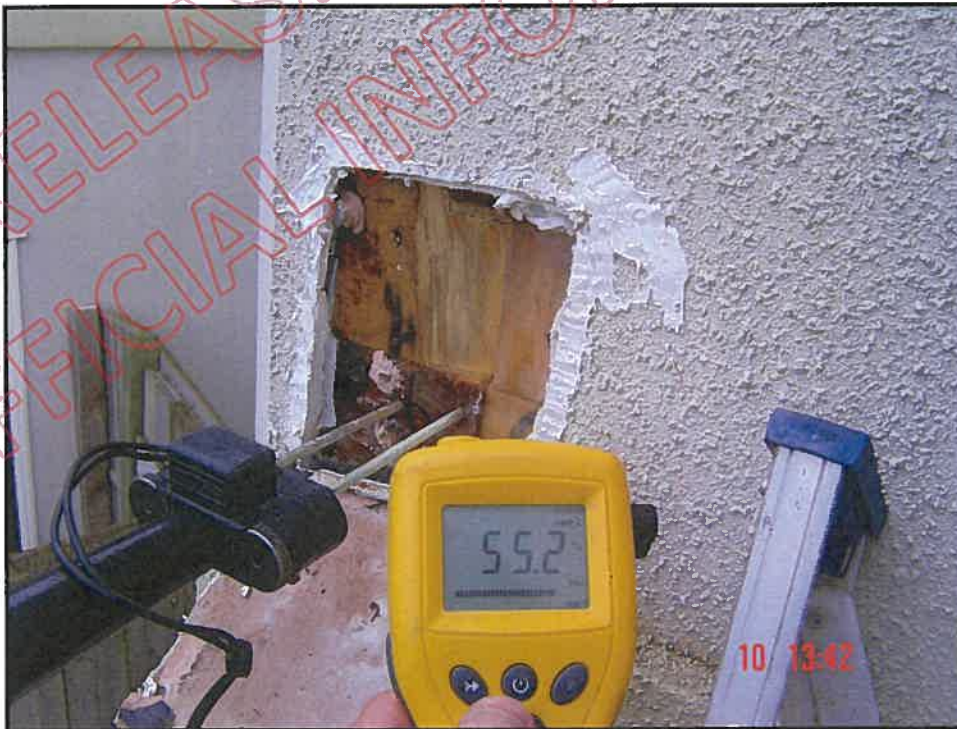
Photograph 3d 88

Cut out and high probe reading at northern corner of stair well
