Unit B

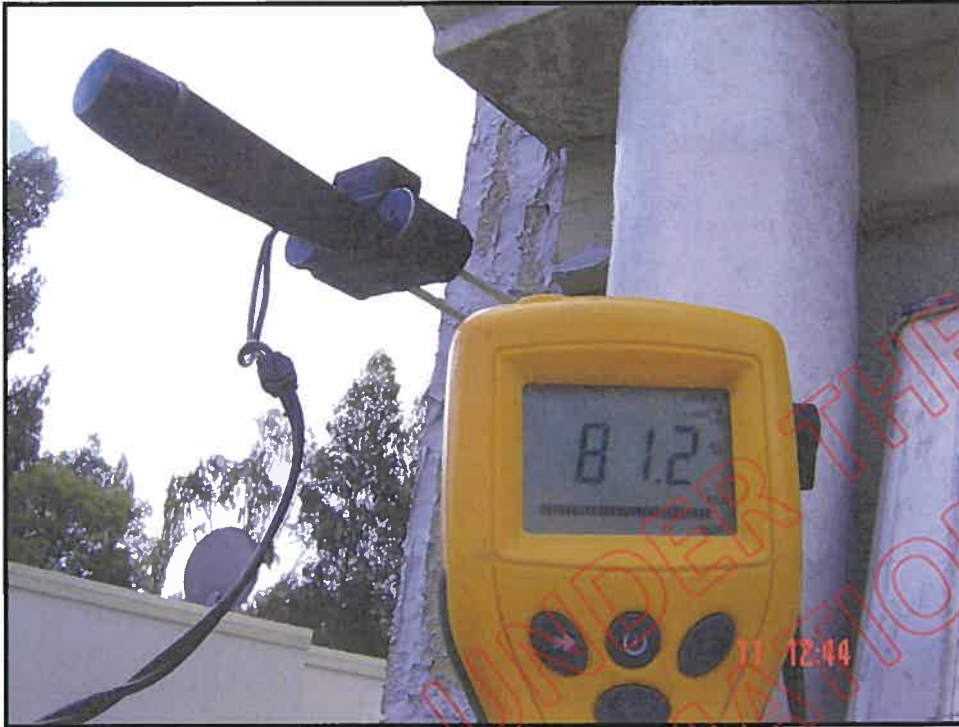
Photograph 3d 89

High probe reading at northern corner below fascia

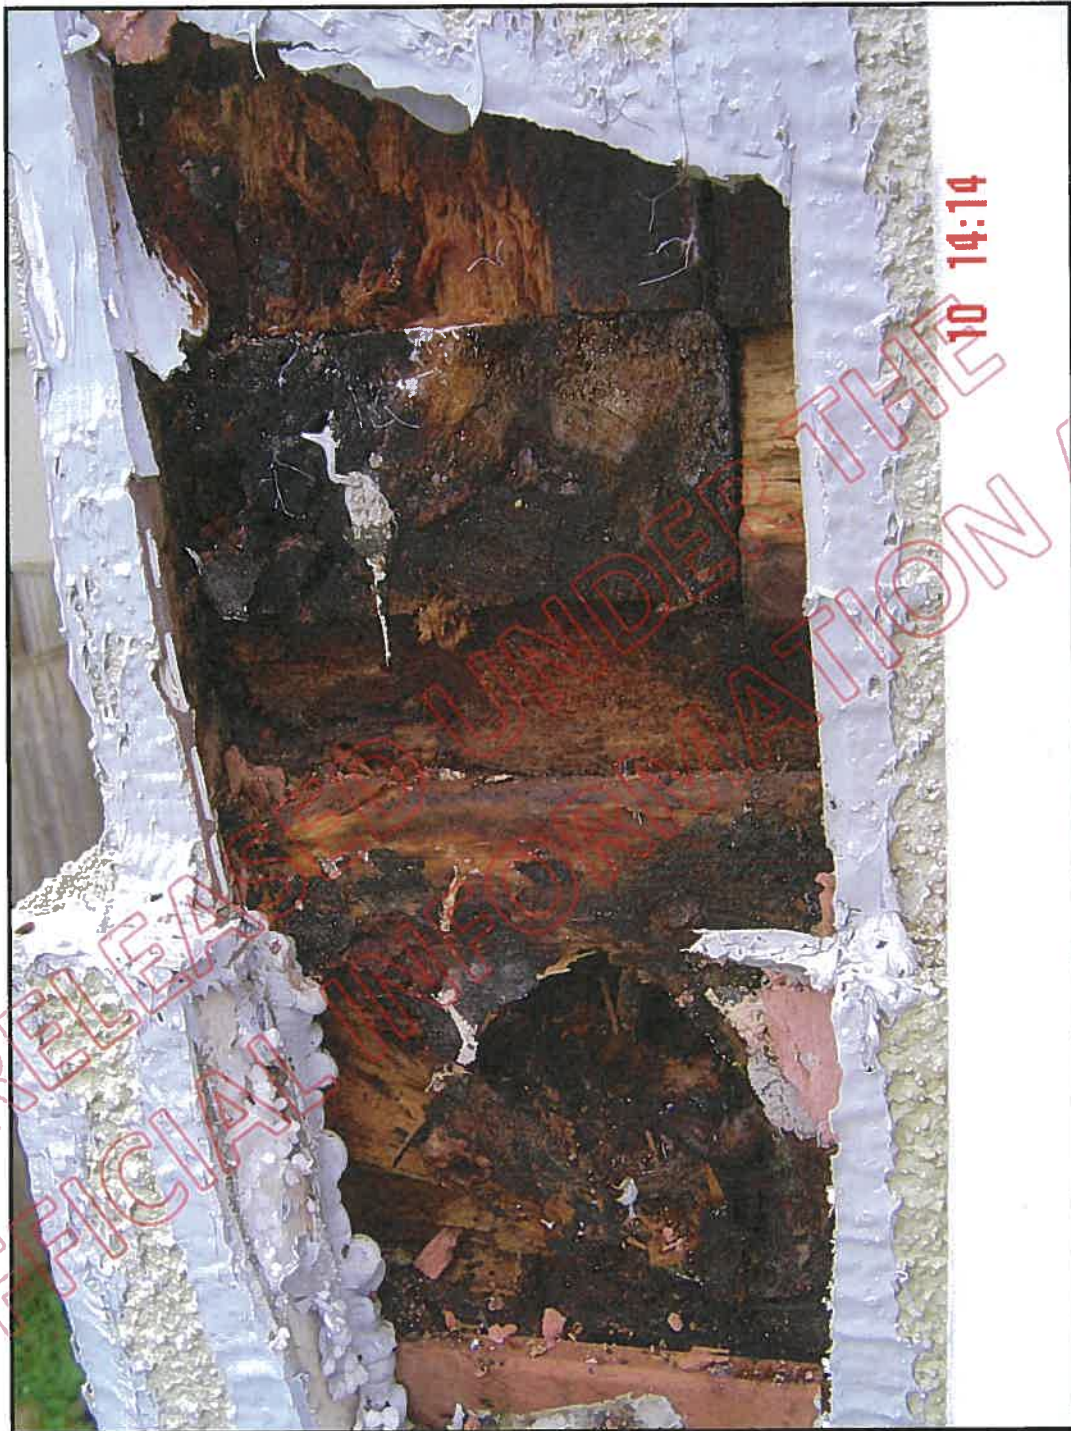
Photograph 3d 91

Cut out No. 10 as at photograph 3d 90 showing total decay of the framing, boundary joist, plates and flooring

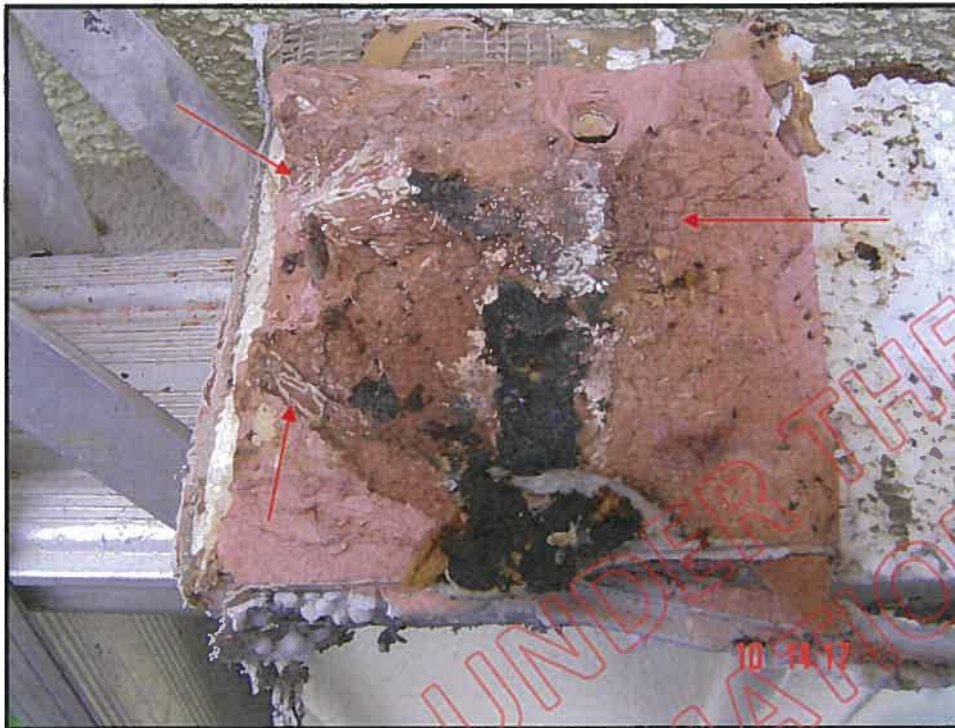
Photograph 3d 92

Back of Harditex™ showing decayed building paper and fungal hyphie infestation of the Harditex™

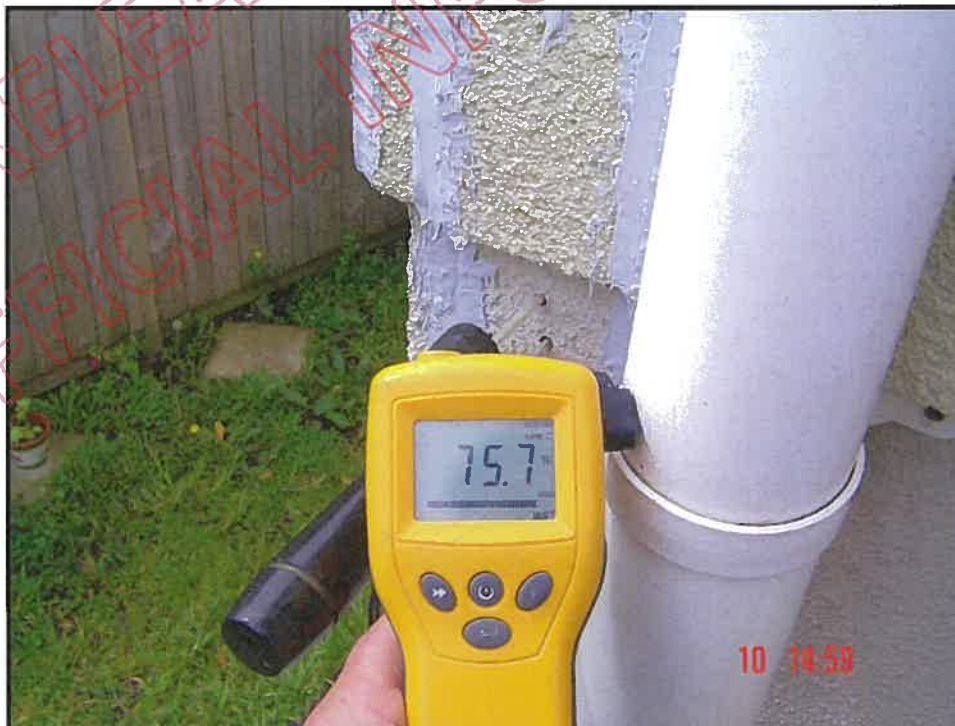
Photograph 3d 93

High probe reading below inter-storey junction

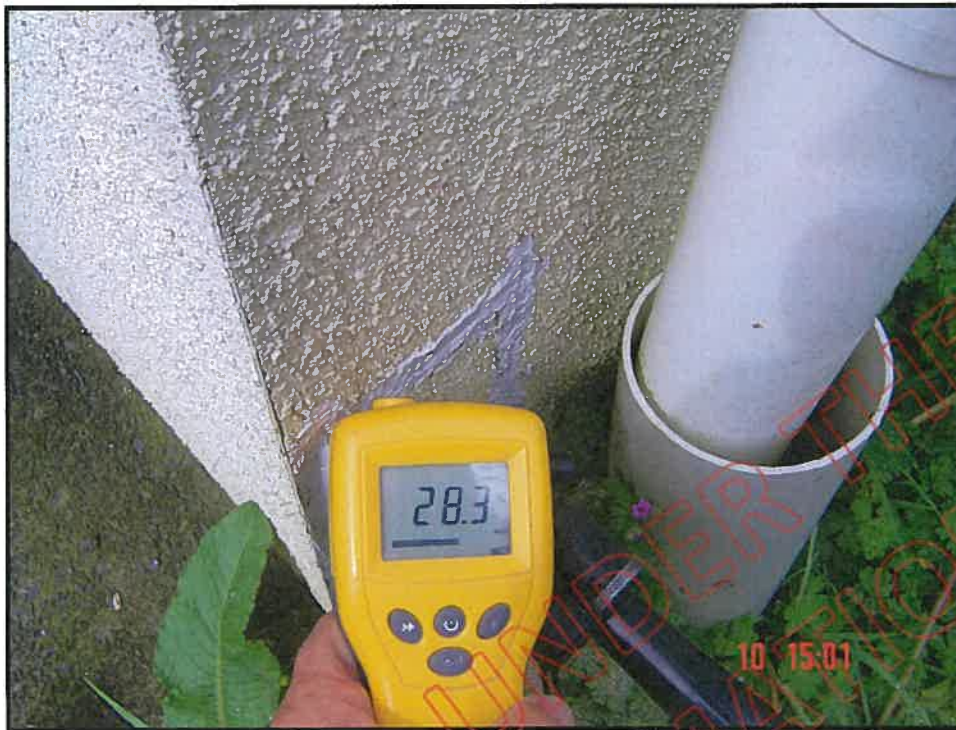
Photograph 3d 94

High probe reading at base

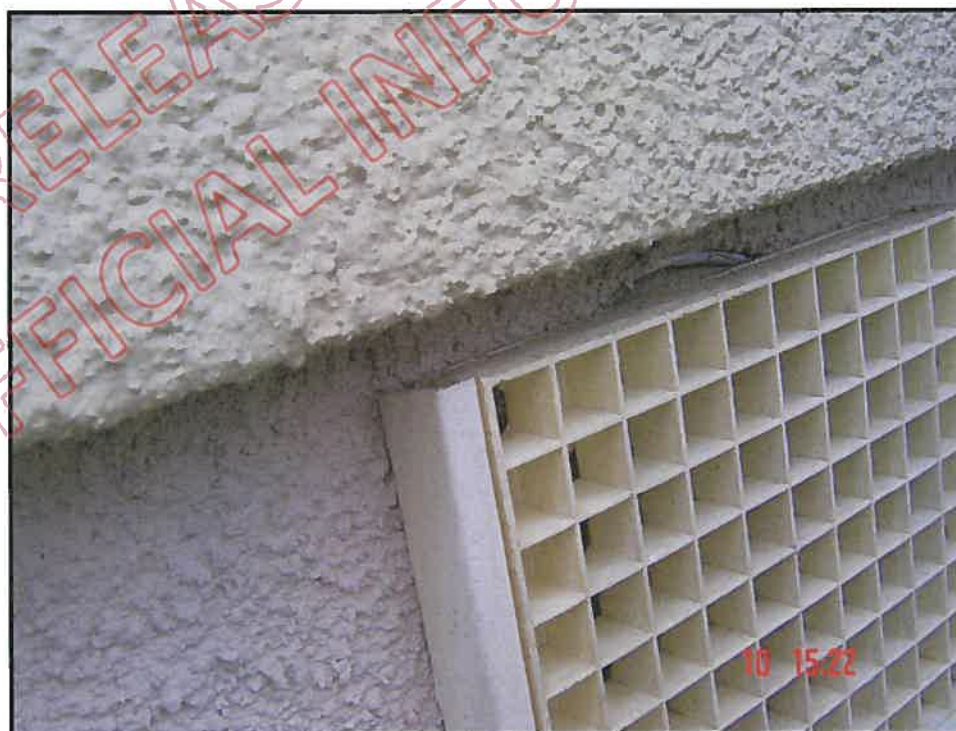
Photograph 3d 95

Unsealed extractor fan vent cover

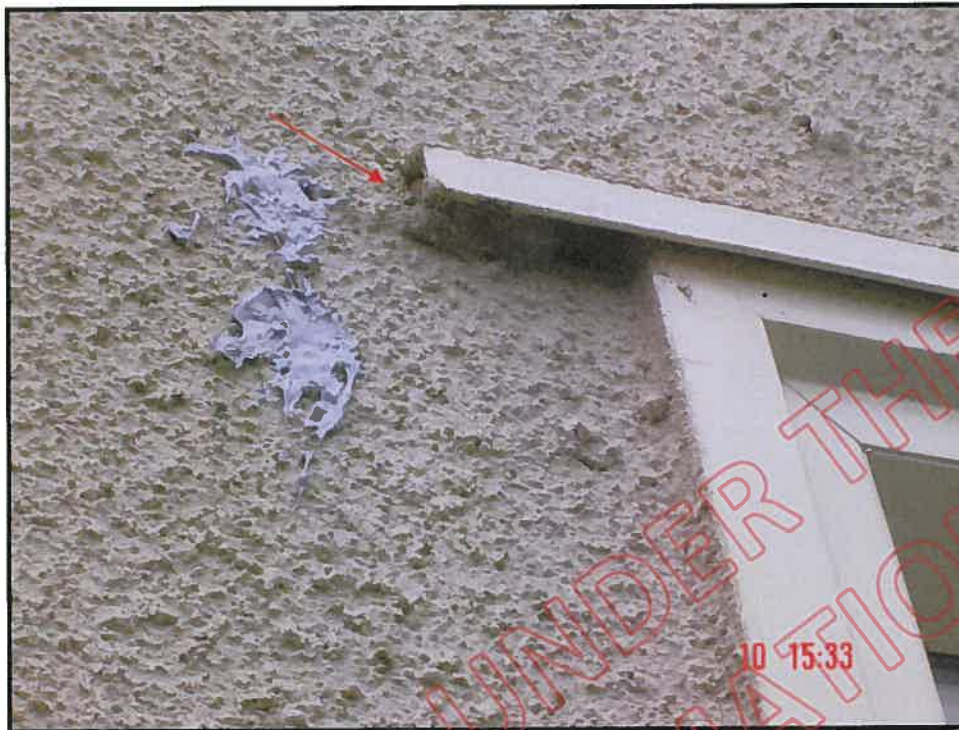
Photograph 3d 96

End of head flashing unsealed

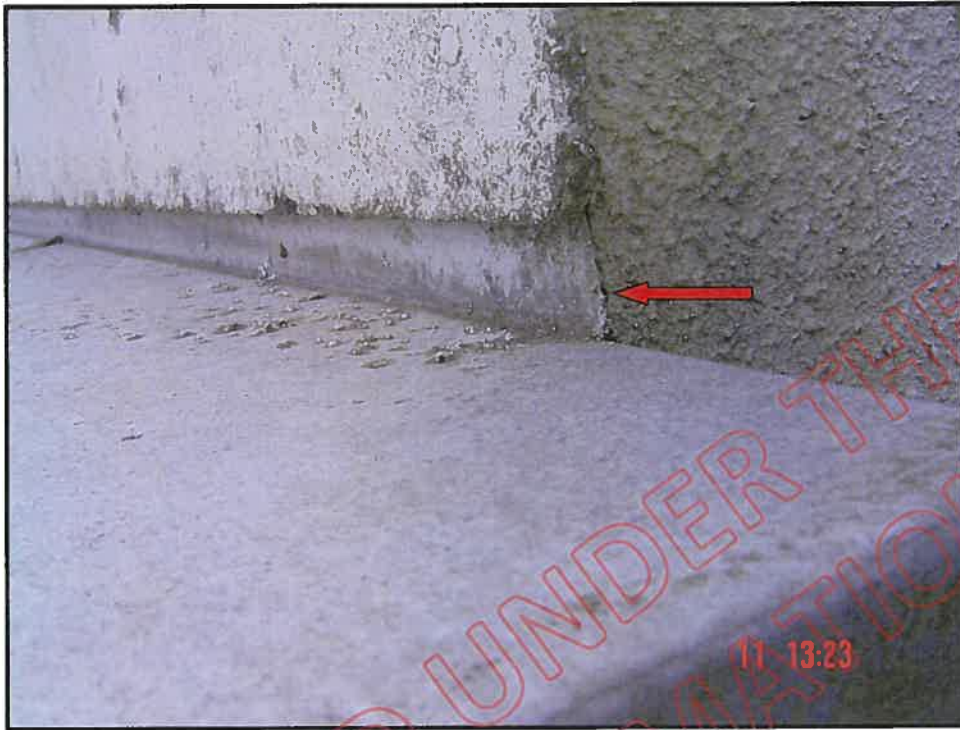
Photograph 3e 97

Poor detailing at end of apron flashing: point of entry

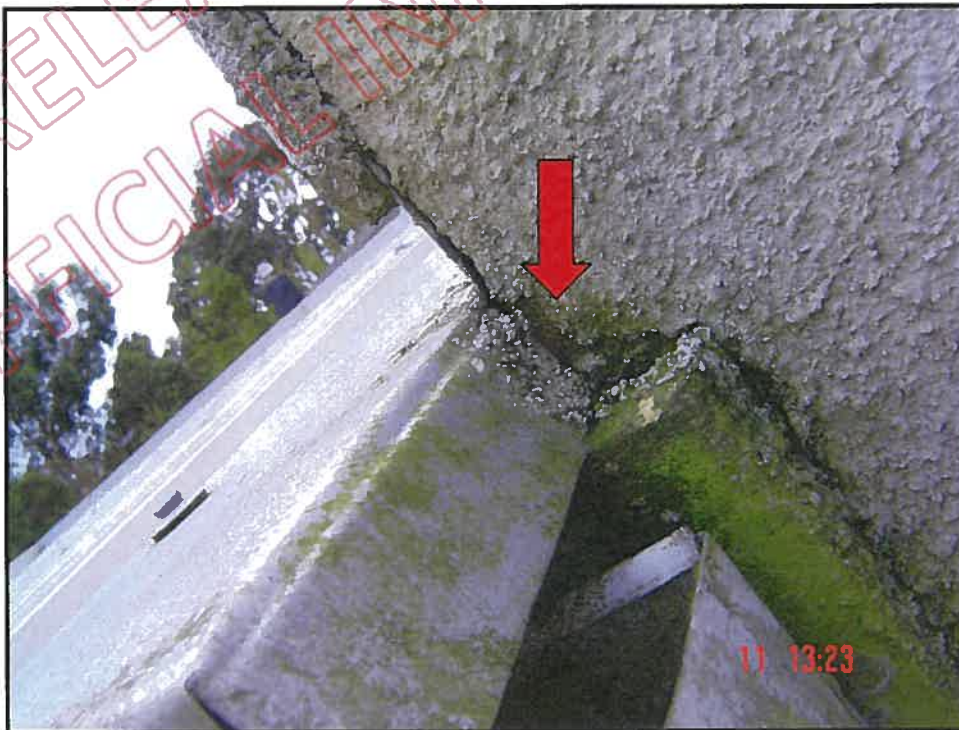
Photograph 3e 98

Close up of previous photograph showing water point of entry

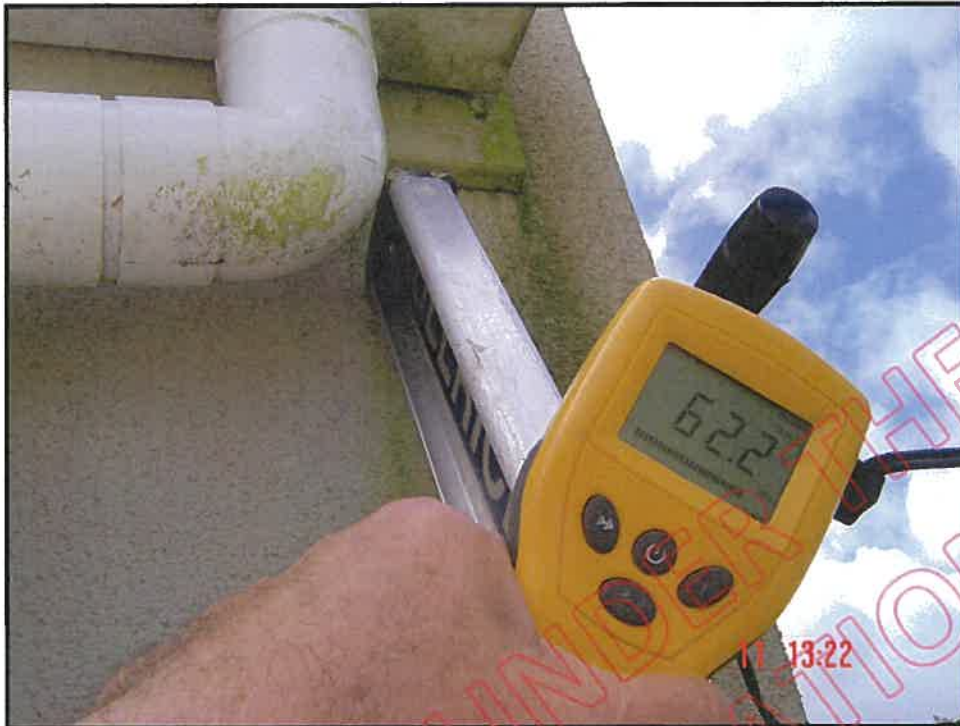
Photograph 3e 99

Very high probe moisture reading at south west corner below spouting

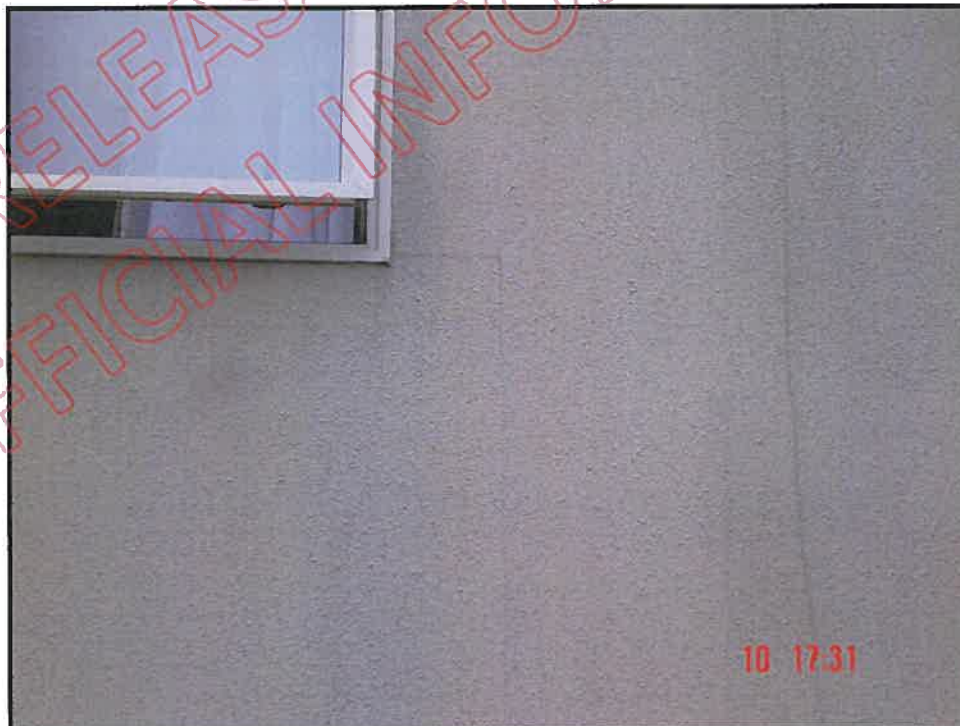
Photograph 3e 100

West wall showing incorrect sheet configuration and joint failure

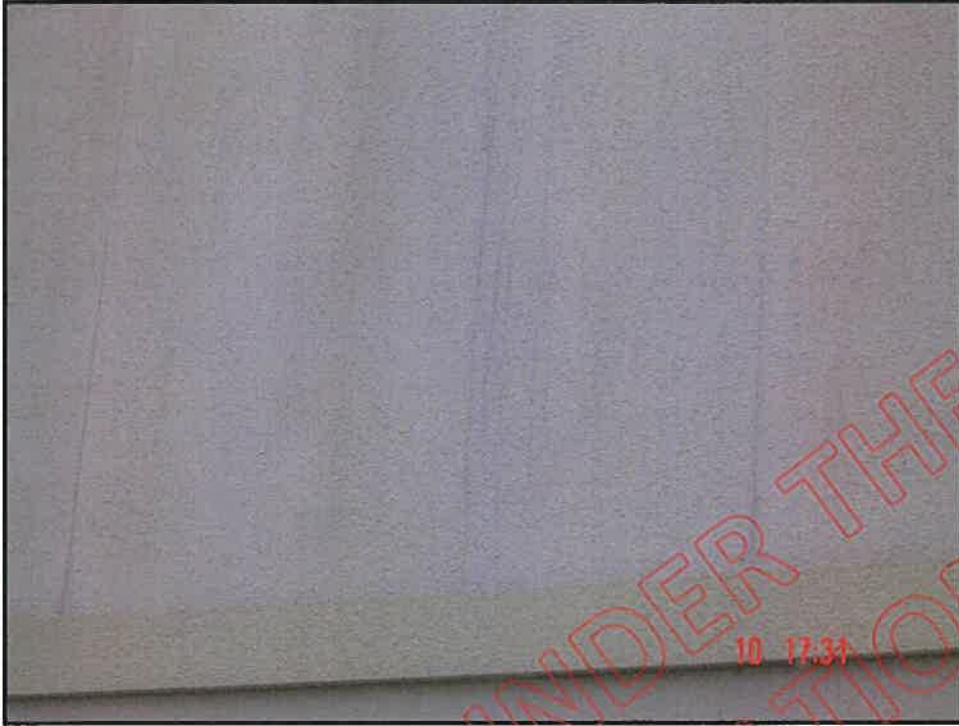
Photograph 3e 101

West wall showing joint failure

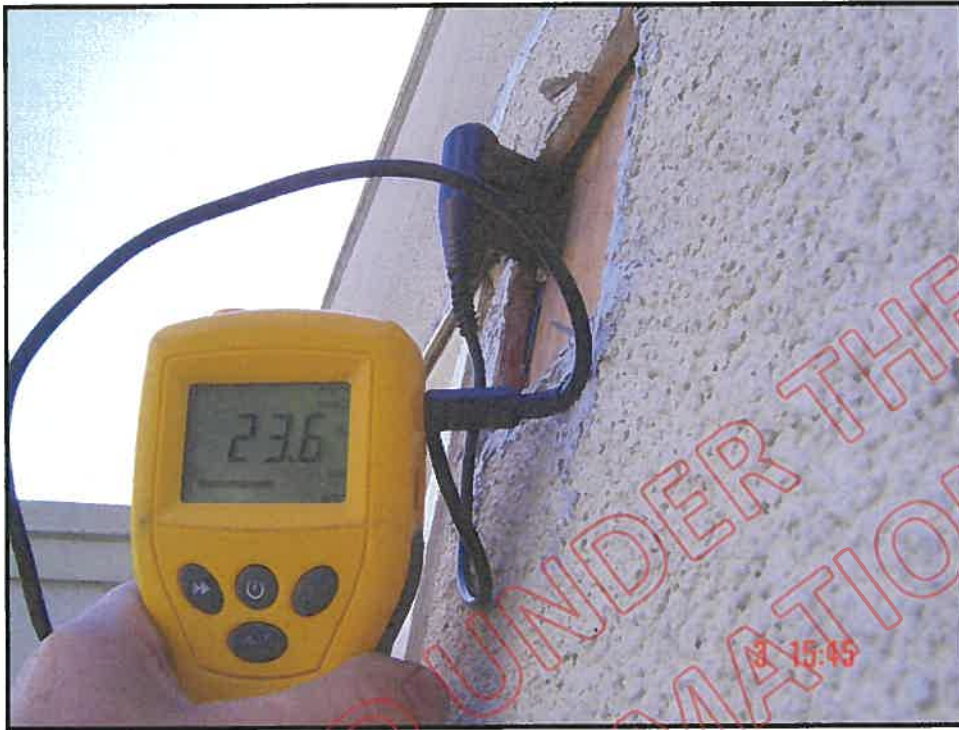
Unit C
Photograph 4c 102

Cut out and high probe reading at head of living room window

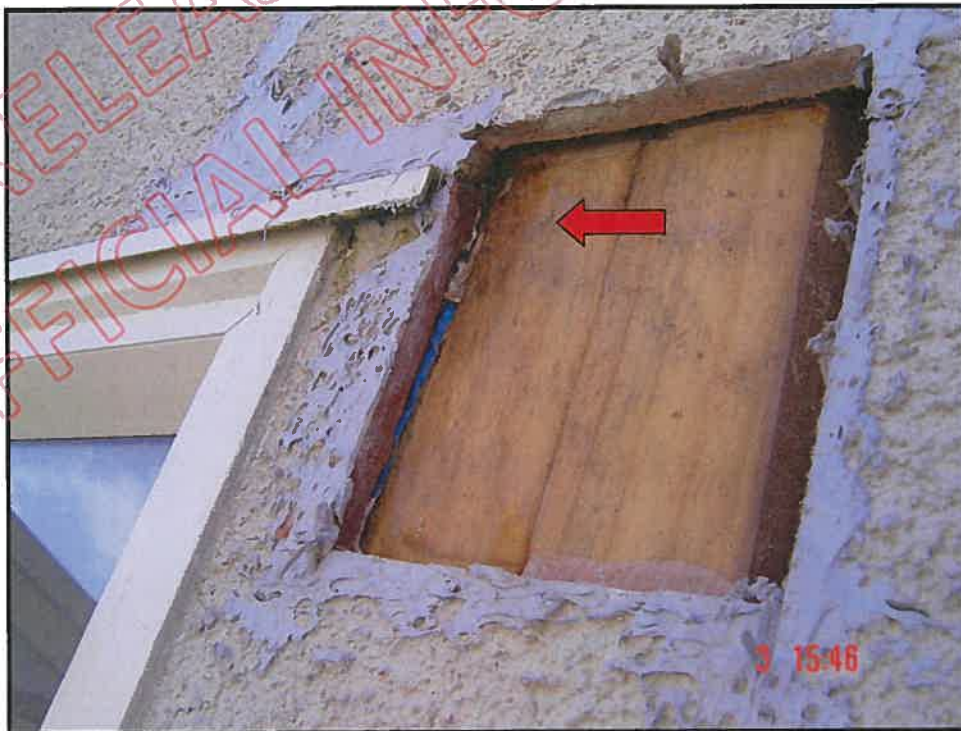
Photograph 4c 103

Cut out as above showing early fungal decay

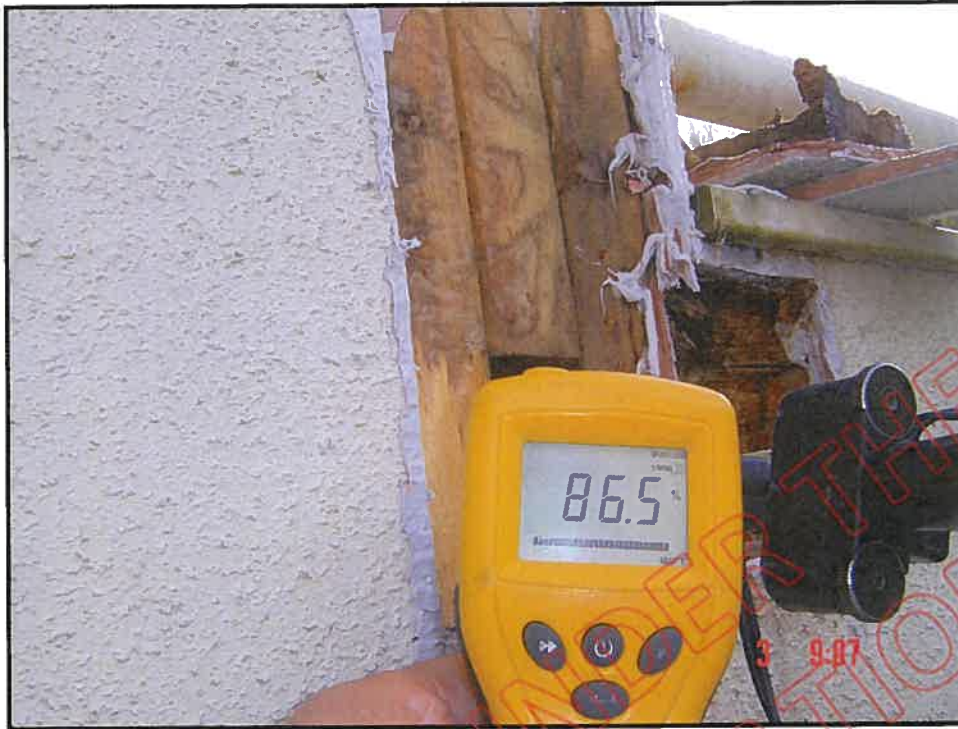
Photograph 4c 104

Cut out and high probe reading at south wall/balcony wall junction showing advanced fungal decay

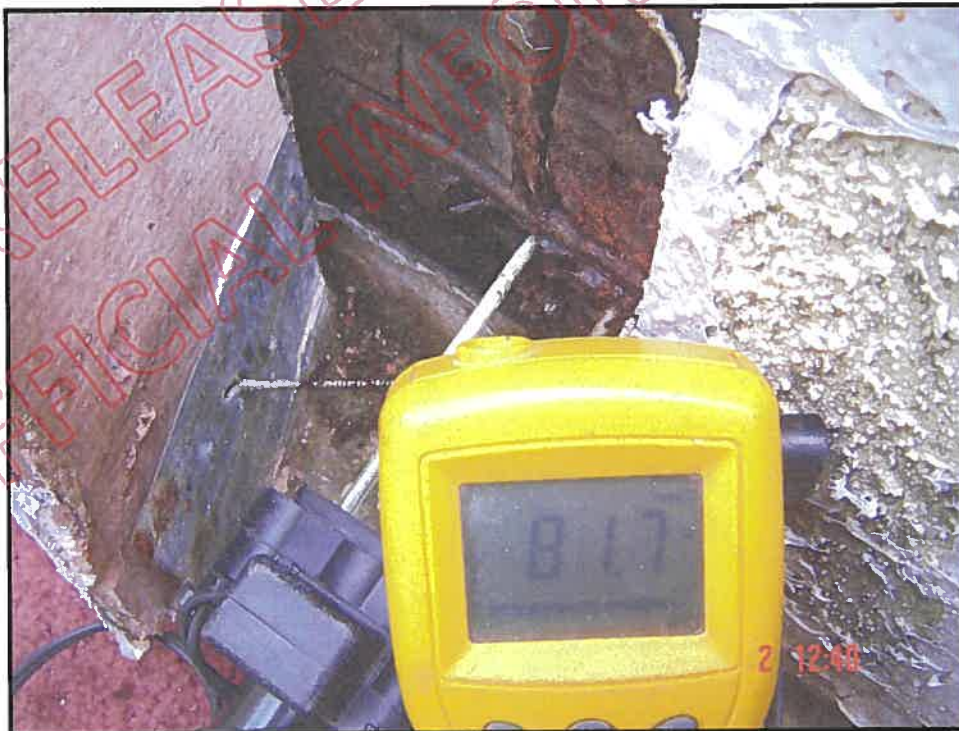
Photograph 4c 105

Cut out and high probe reading; south wall at base showing advanced fungal decay to frame and bottom plate

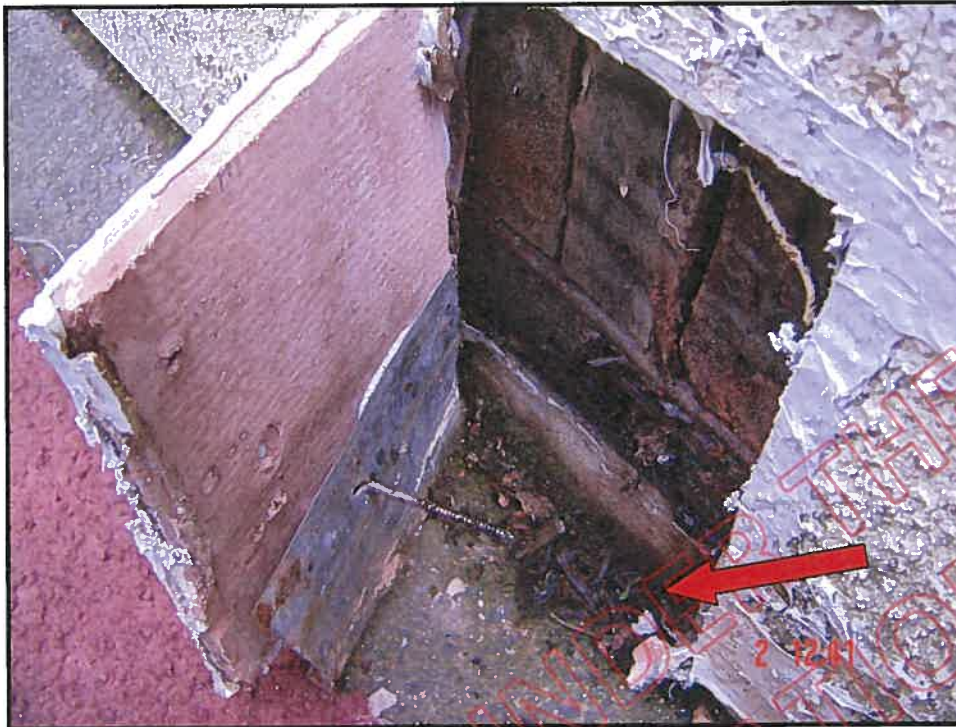
Photograph 4c 106

Close up of photograph 4c 104: note bottom plate is less than 50mm from surrounding ground level

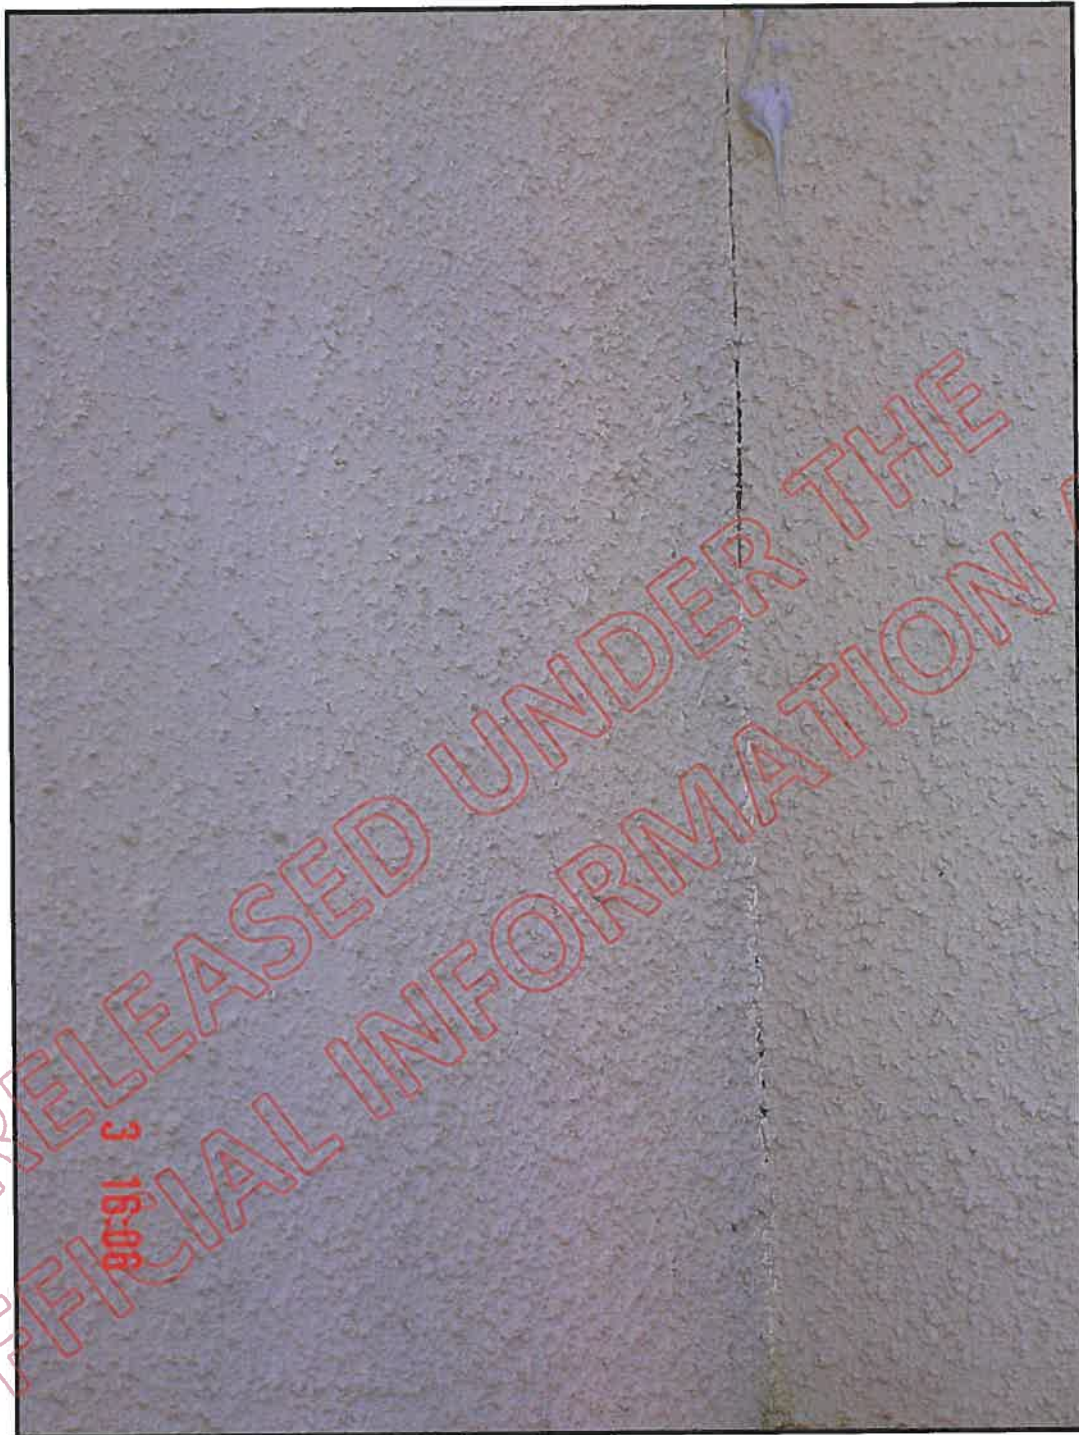
Photograph 4c 107

Photograph showing sheet joint failure at internal corner to left side of front door

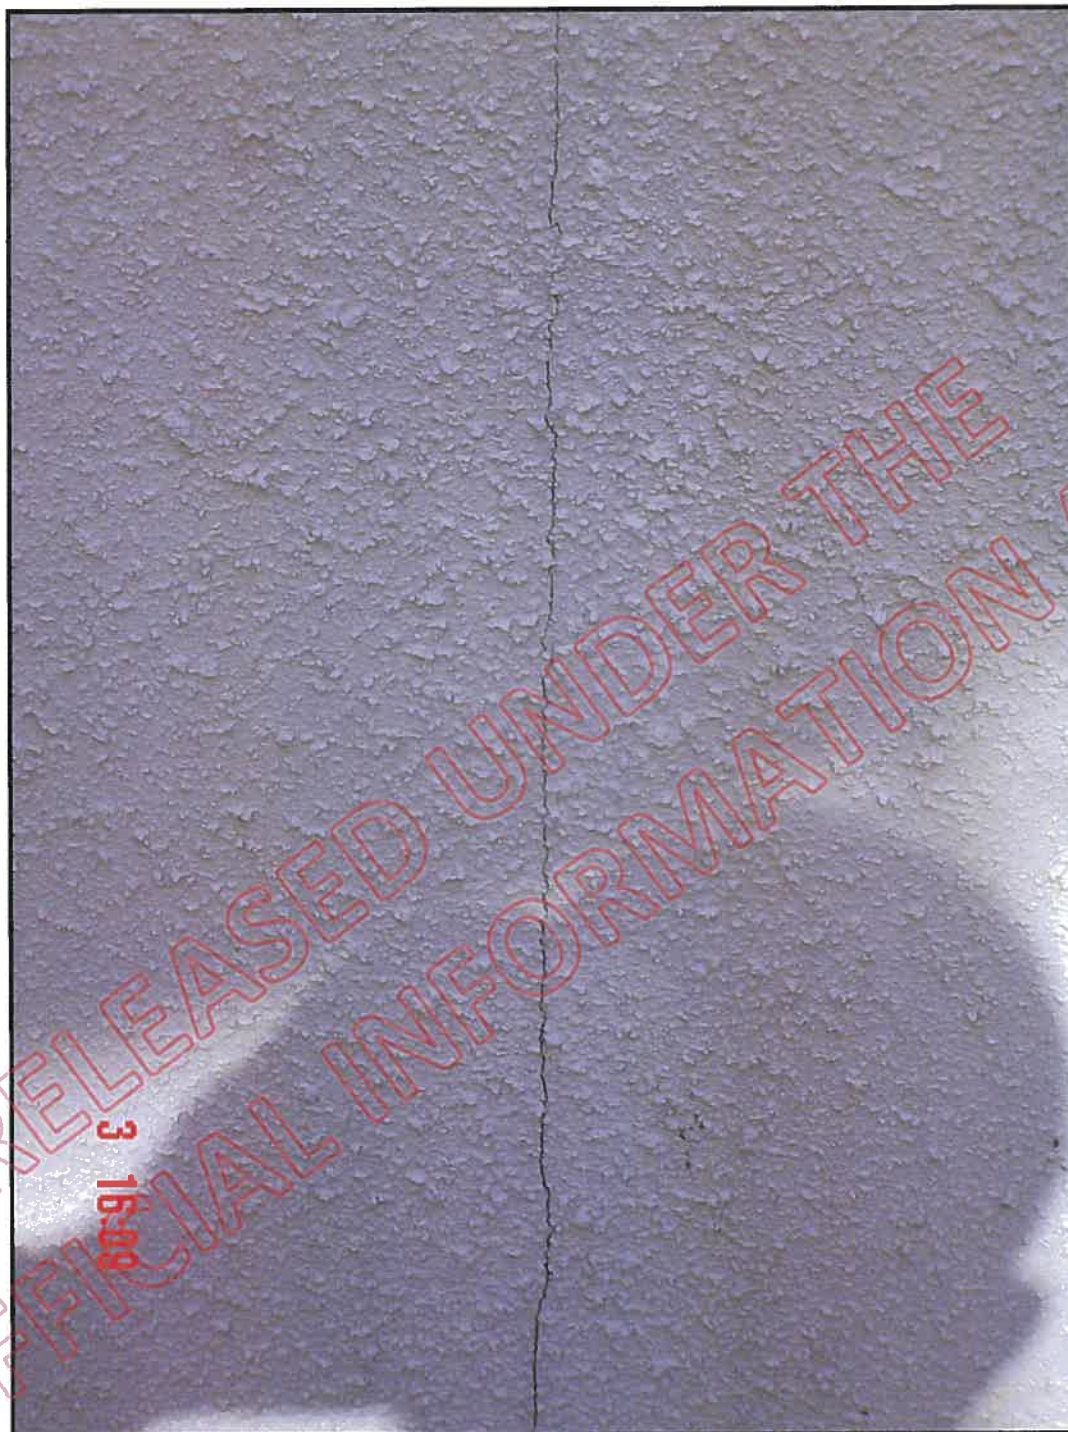
Photograph 4c 108

Photograph showing sheet joint failure at left side of garage window

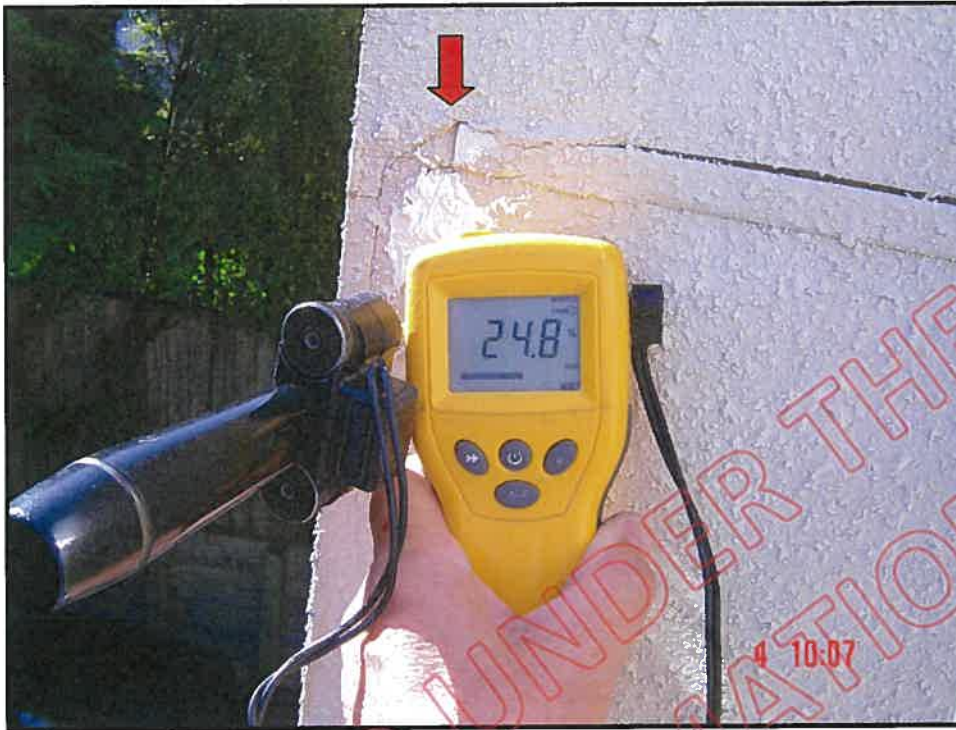
Photograph 5d 109

High probe reading below inter-storey joint at north-east corner; note open end of H mould

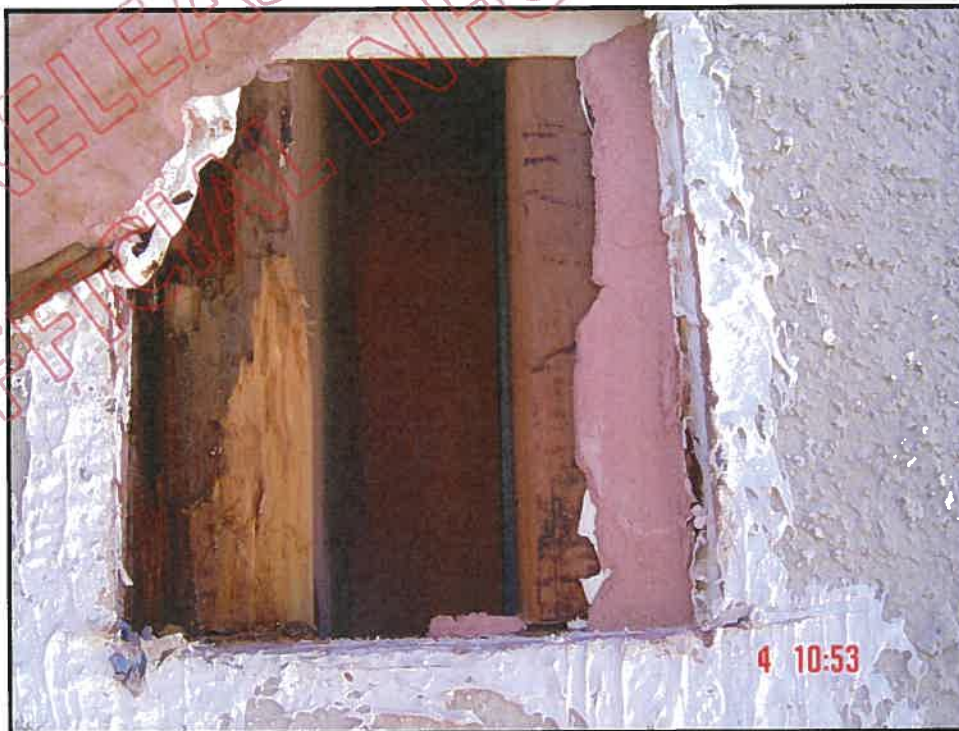
Photograph 5d 110

Cut out below inter-storey joint at north east corner

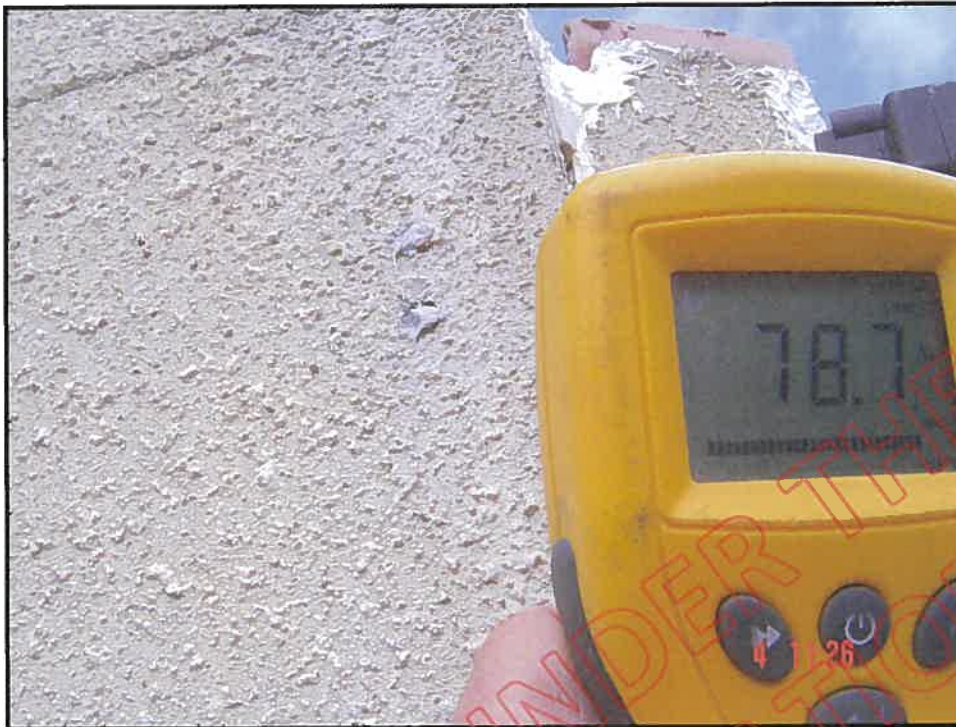
Photograph 5d 111

Cut out and very high probe reading adjacent to top left side of living room window, north east corner

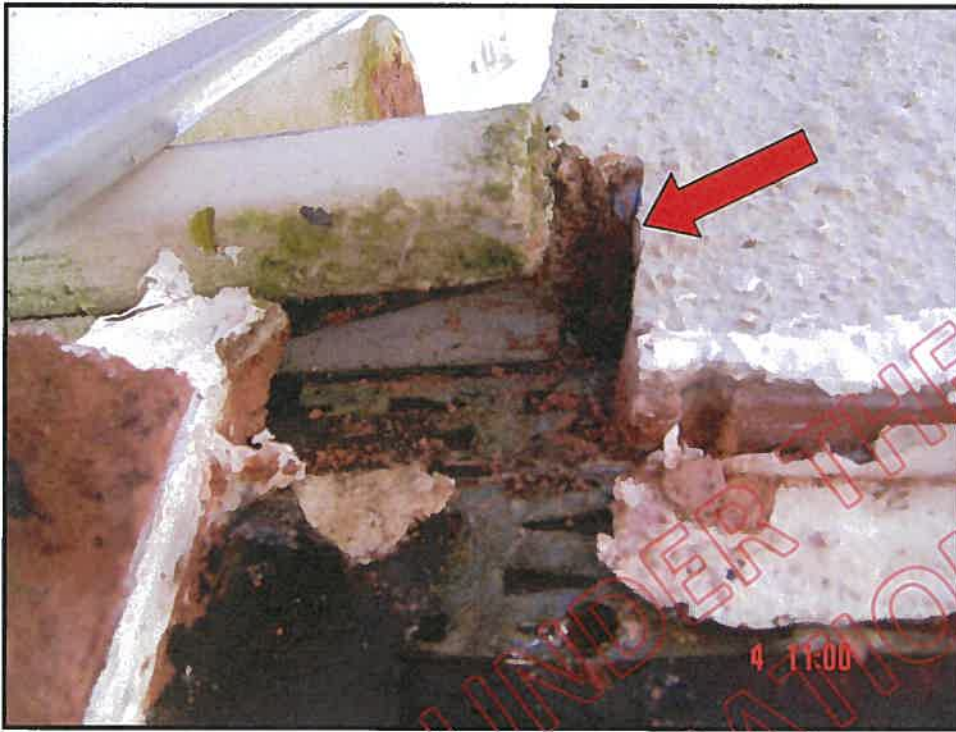
Photograph 5d 113

Close up of 5d 112 showing advanced decay and corrosion to nail plate; note no saddle flashing

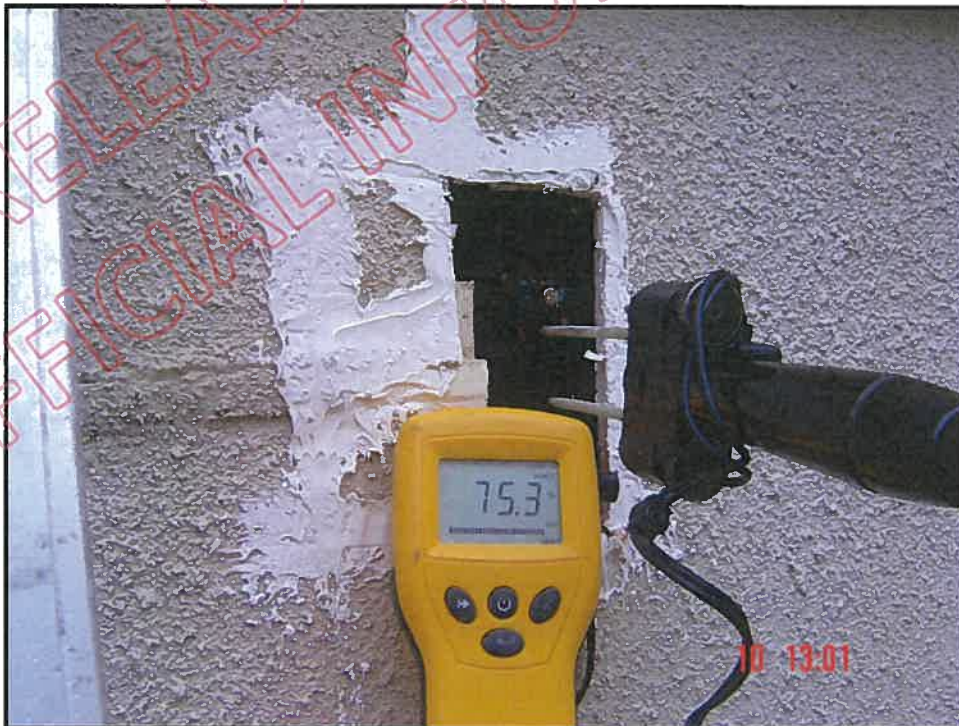
Photograph 5d 114

Cut out and very high probe reading at first floor inter-storey below living room window

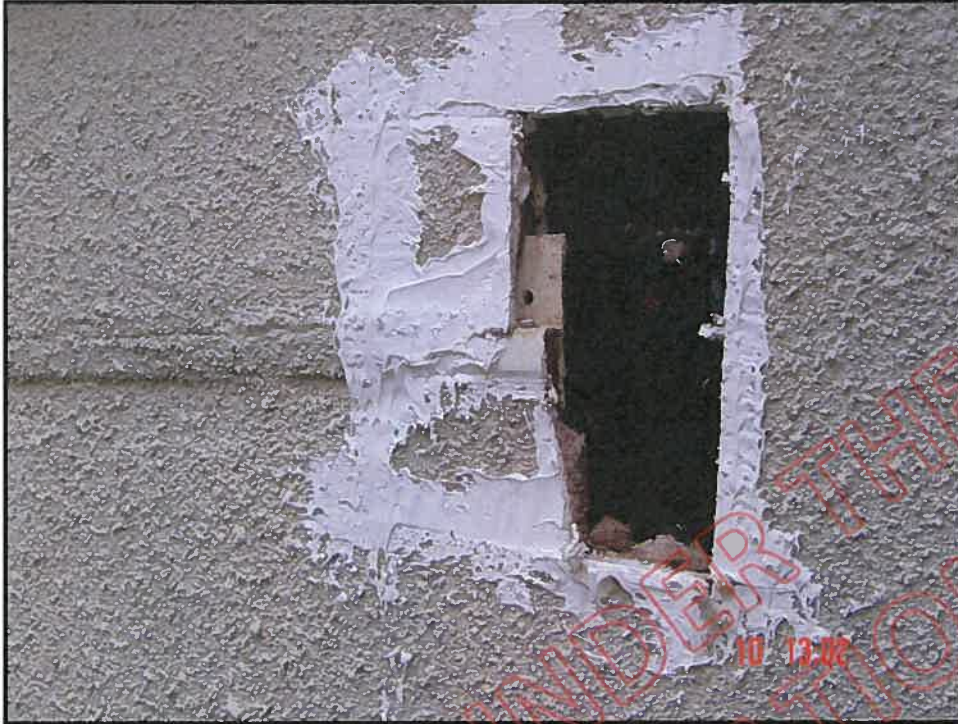
Photograph 5d 115

Cut out at first floor inter-storey below living room window showing advanced decay: note inter-storey H mould terminates at vertical-sheet join

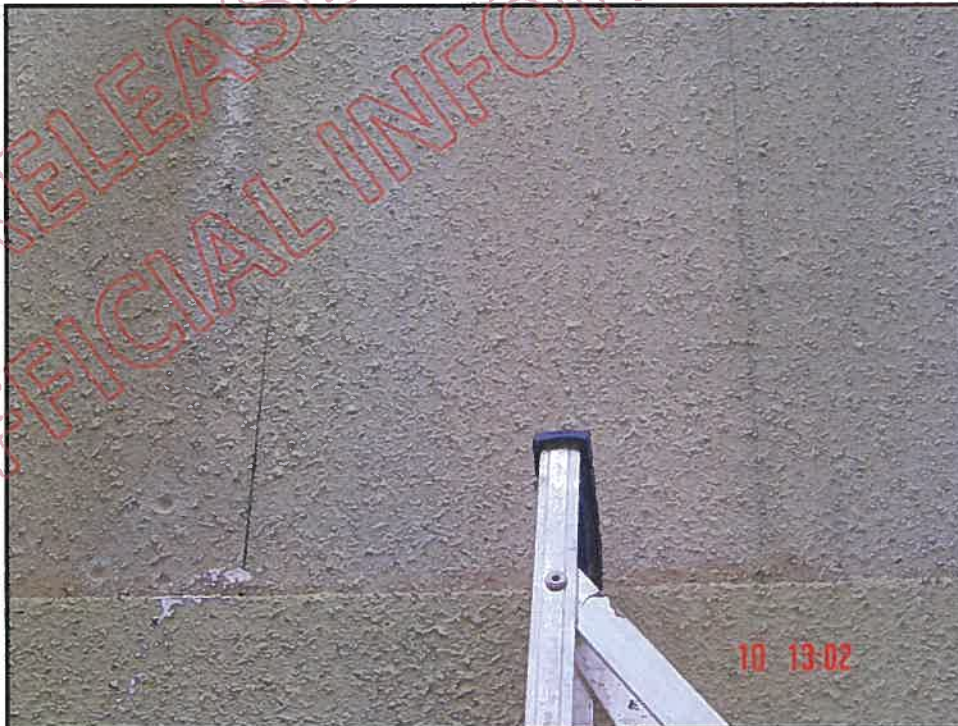
Photograph 5d 116

Photograph showing incorrect sheet configuration and joint failure above inter-storey

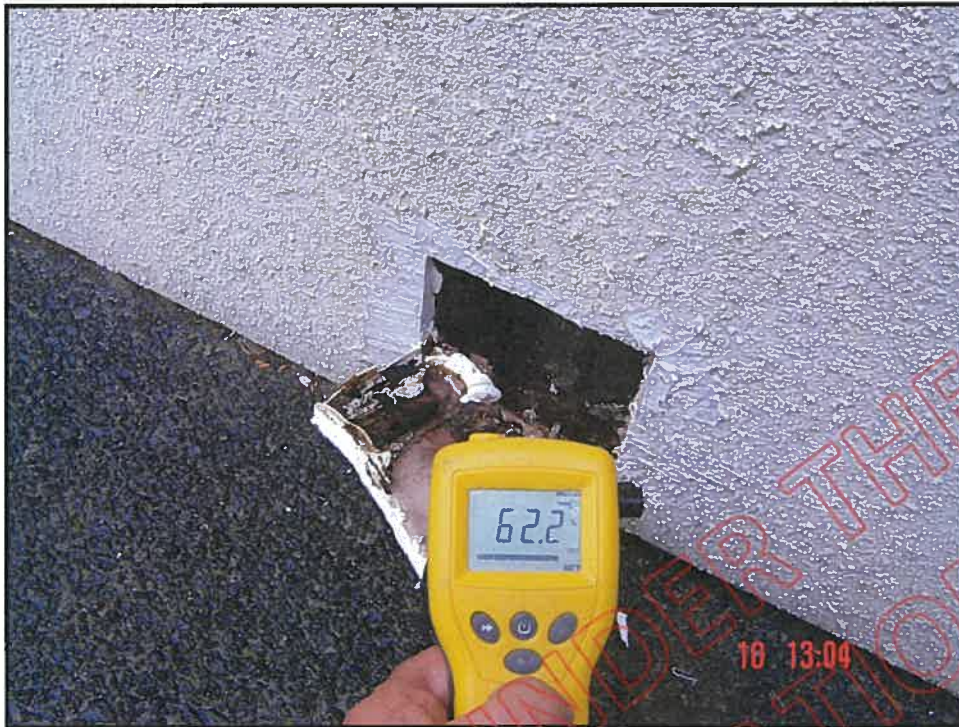
Photograph 5d 117

Cut out and very high probe reading at first floor at bottom plate below garage window: note cladding extends down to ground level

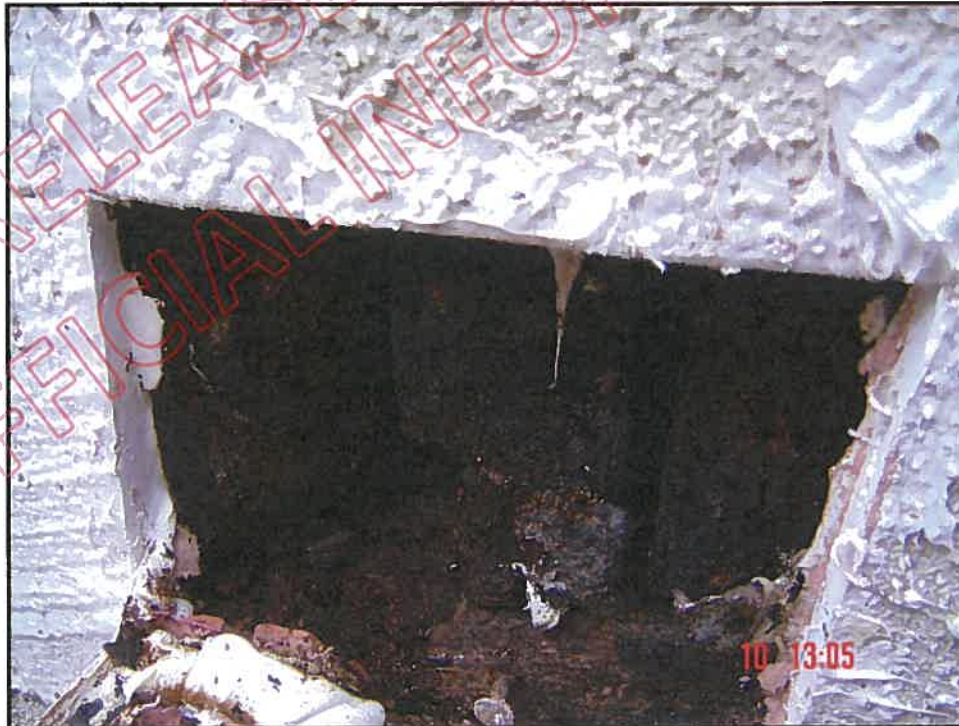
Photograph 5d 118

Close up of photograph 5d 116: showing total decay to bottom plate and frame
