Unit B

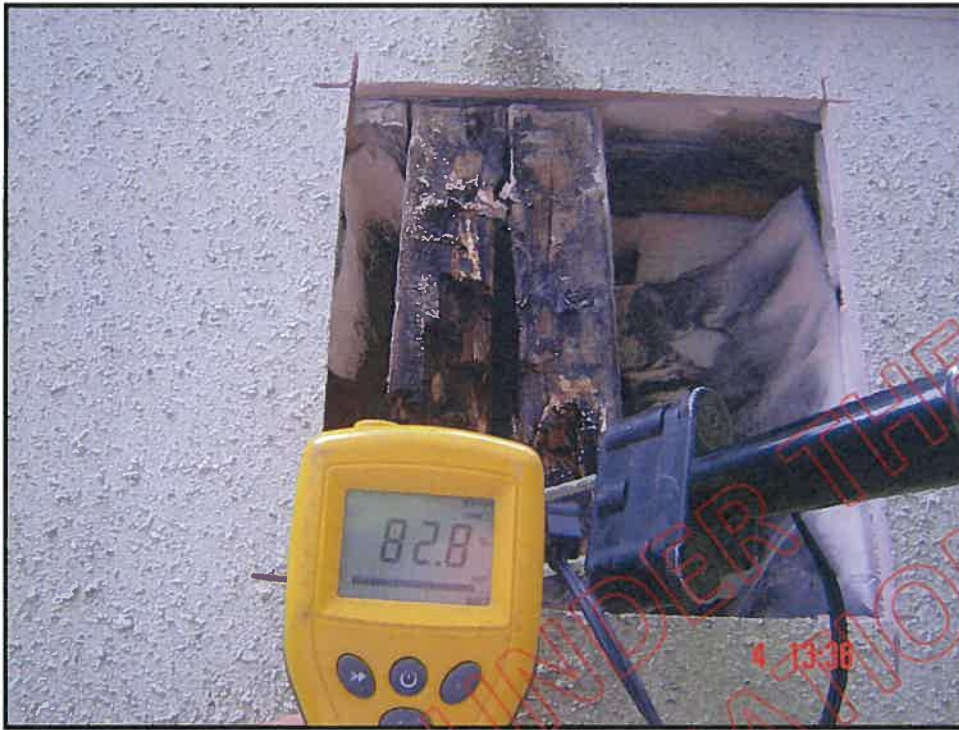
Photograph 6e 119

Cut out and high probe reading at south wall/balcony wall junction showing advanced fungal decay

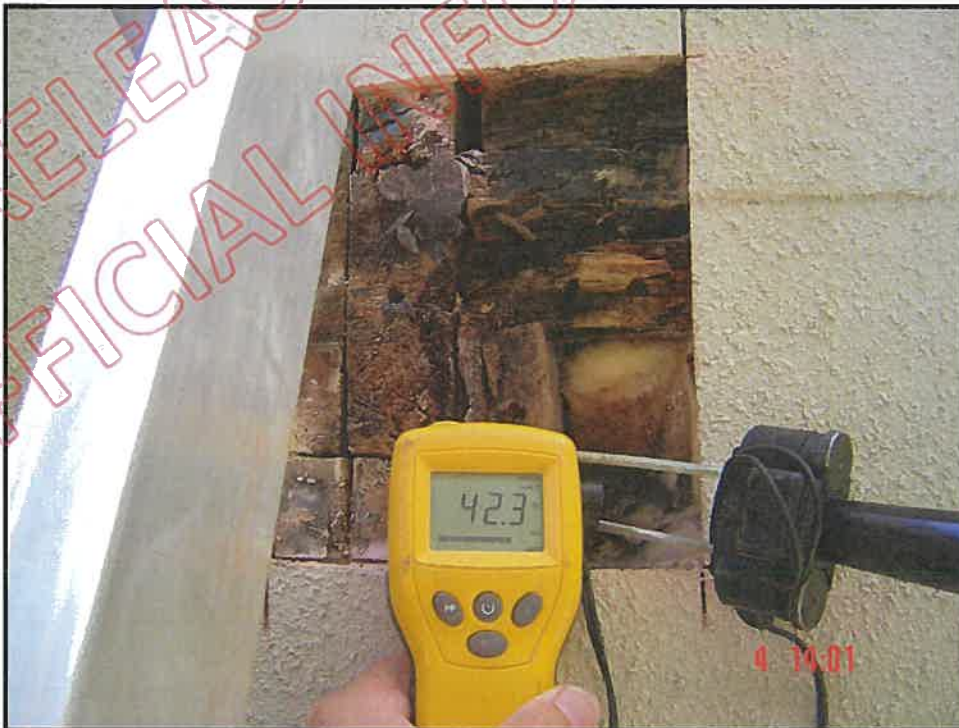
Photograph 6e 120

Cut out and high probe reading at south wall inter-storey below balcony junction, showing advanced fungal decay to frame garage beam and plates

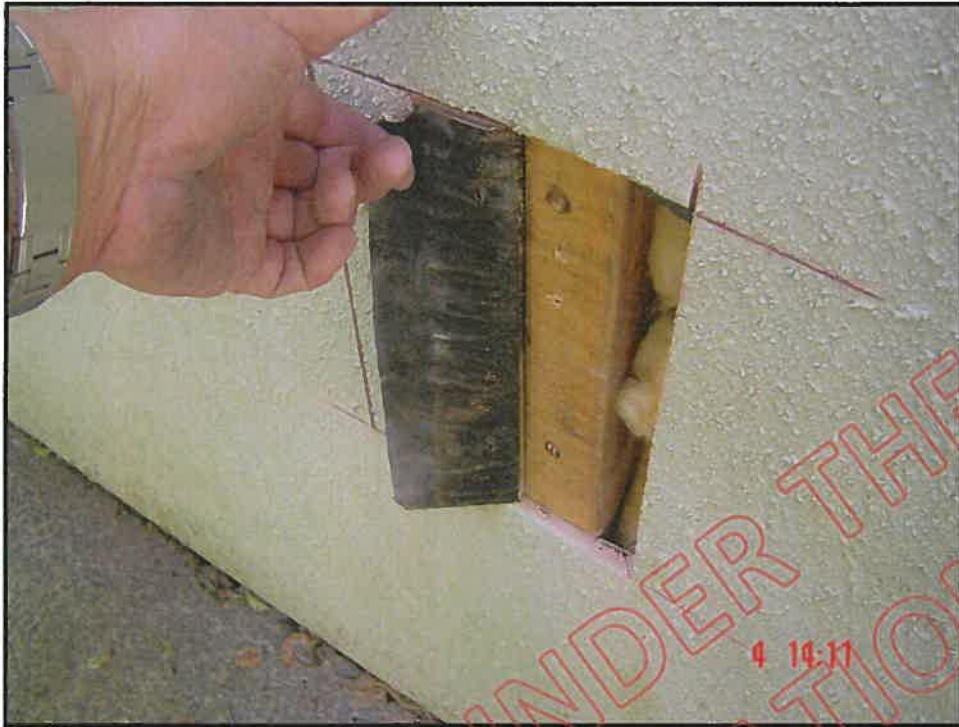
Photograph 6e 121

Cut out below garage window; south wall at base

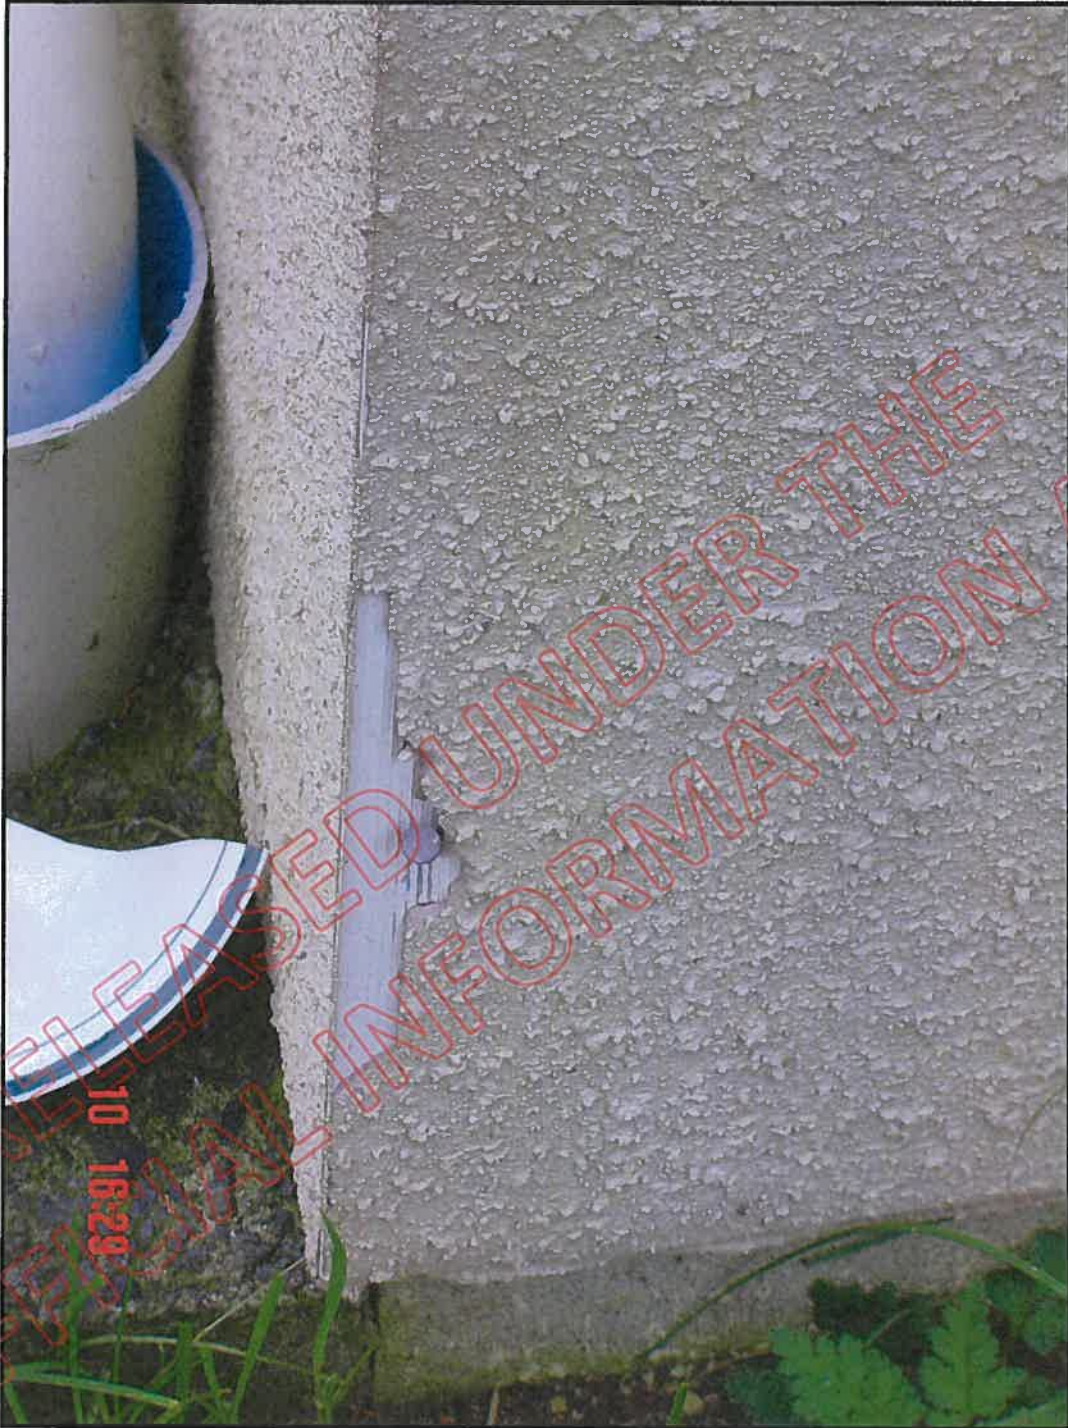
Photograph 6e 122

Joint failure at south east corner: note insufficient ground clearance

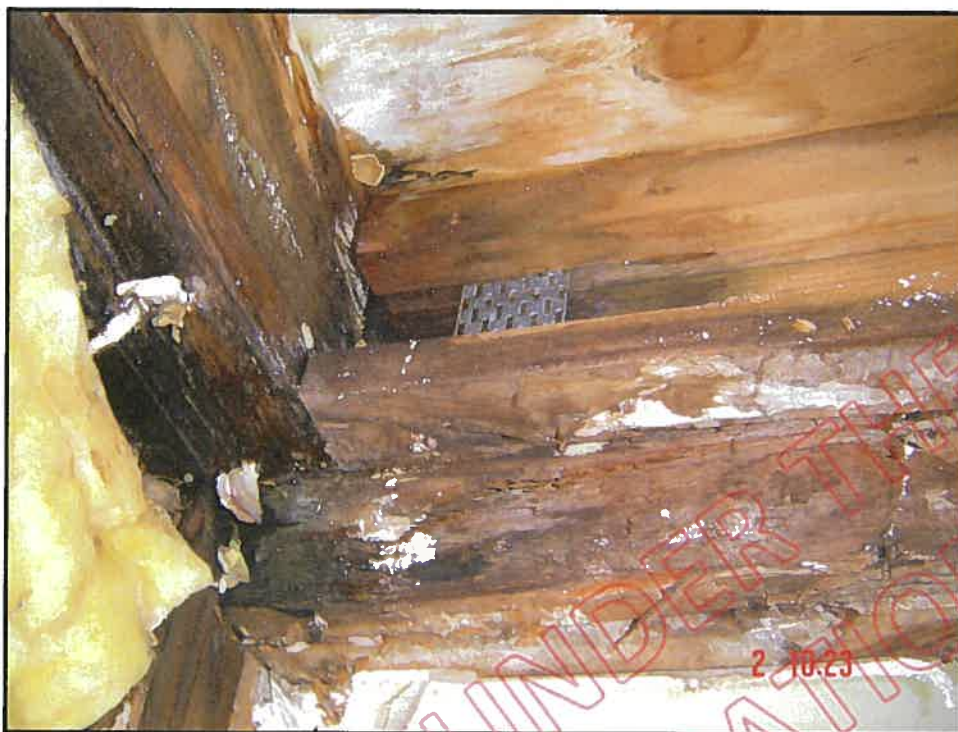
Photograph Internal- c 123

Photograph showing totally decayed 450x100mm beam

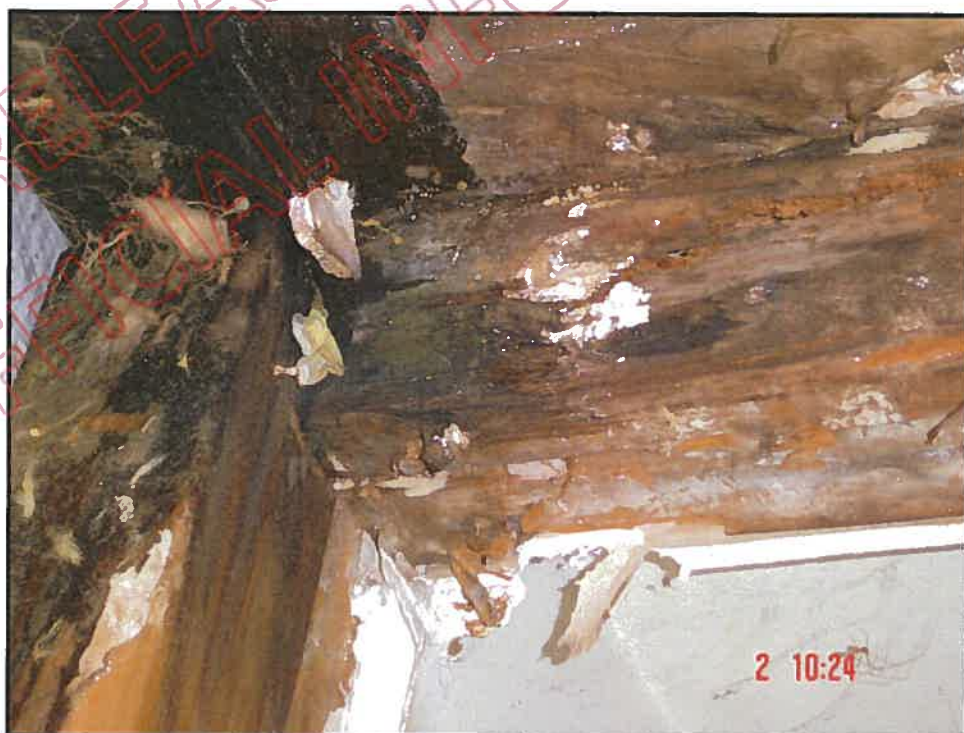
Photograph Internal-c 124

Close up of photograph- c 123

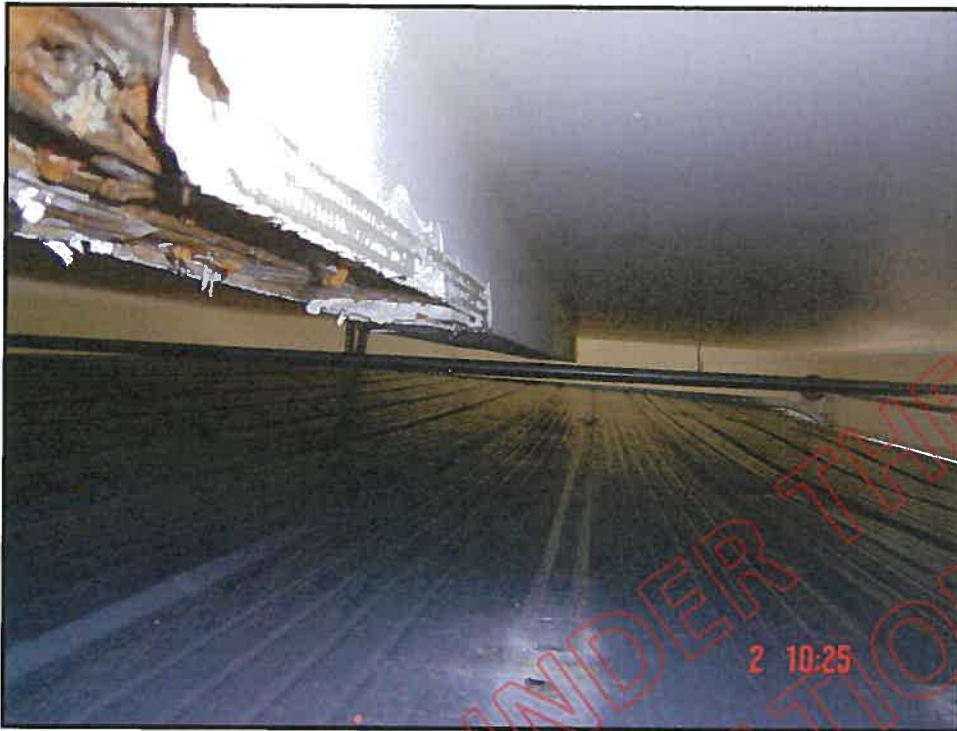
Photograph Internal- c 125

Photograph showing decay and slump in 450x100 garage beam

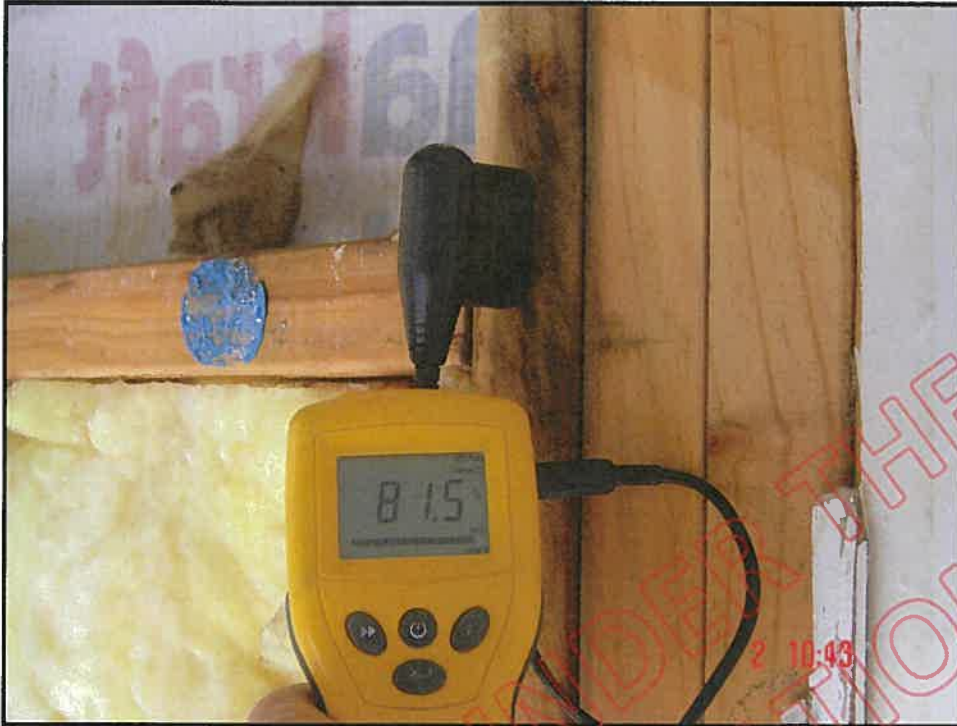
Photograph Internal- c 127

High moisture reading and decay in beam support framing

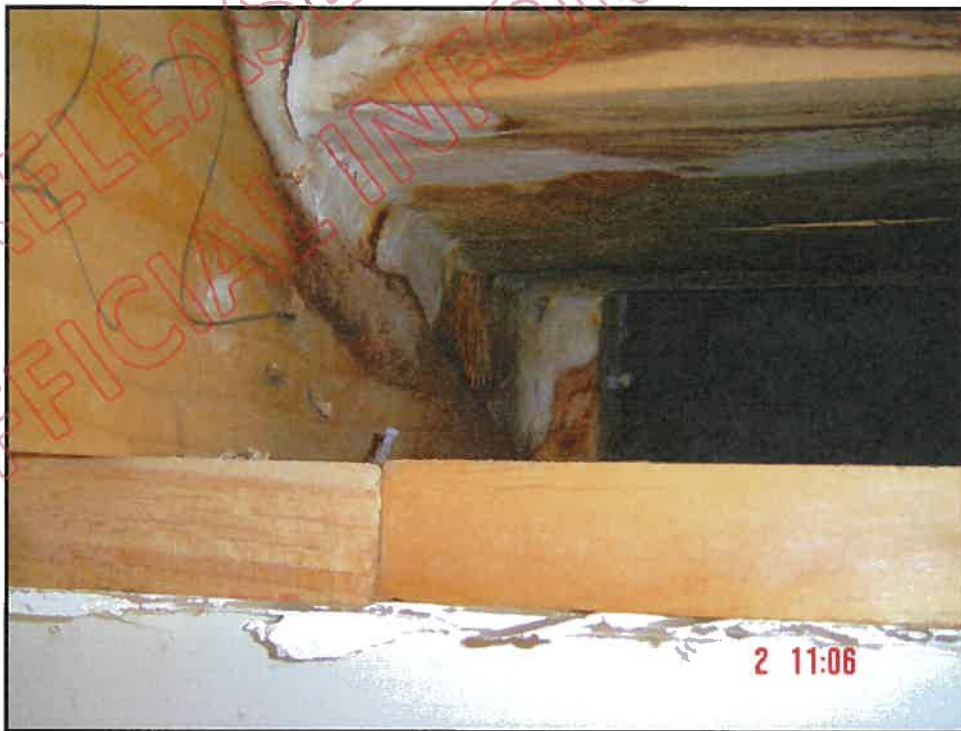
Photograph Internal- c 128

Heavy fungal decay in ceiling and floor joist supporting lounge floor and balcony

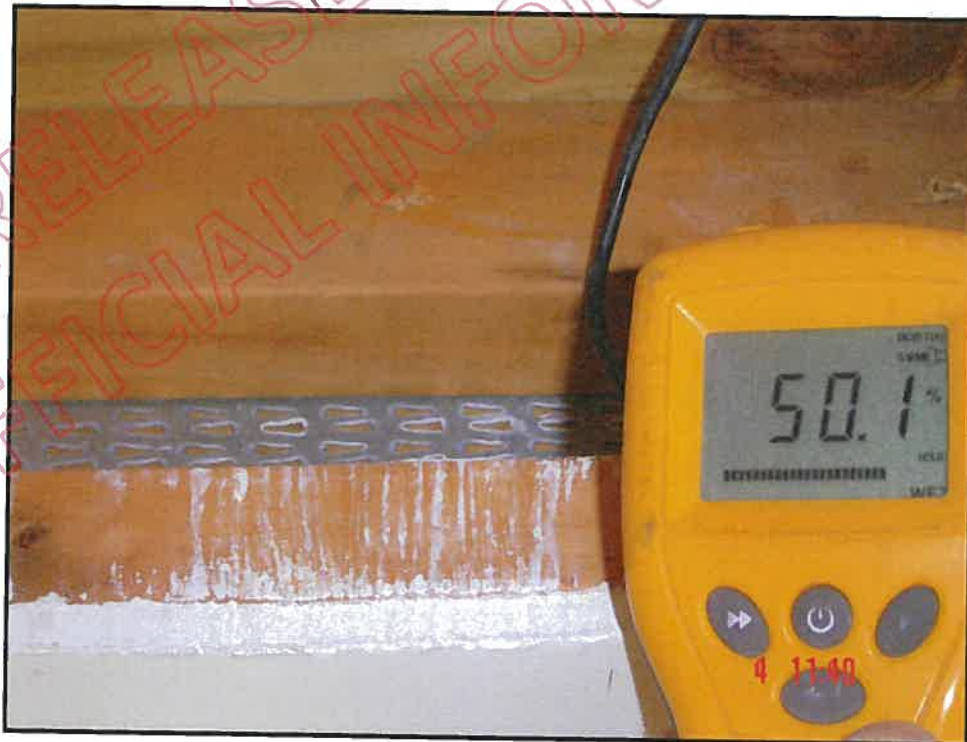
Photograph Internal- d 130

High probe moisture reading floor joist adjacent to garage beam

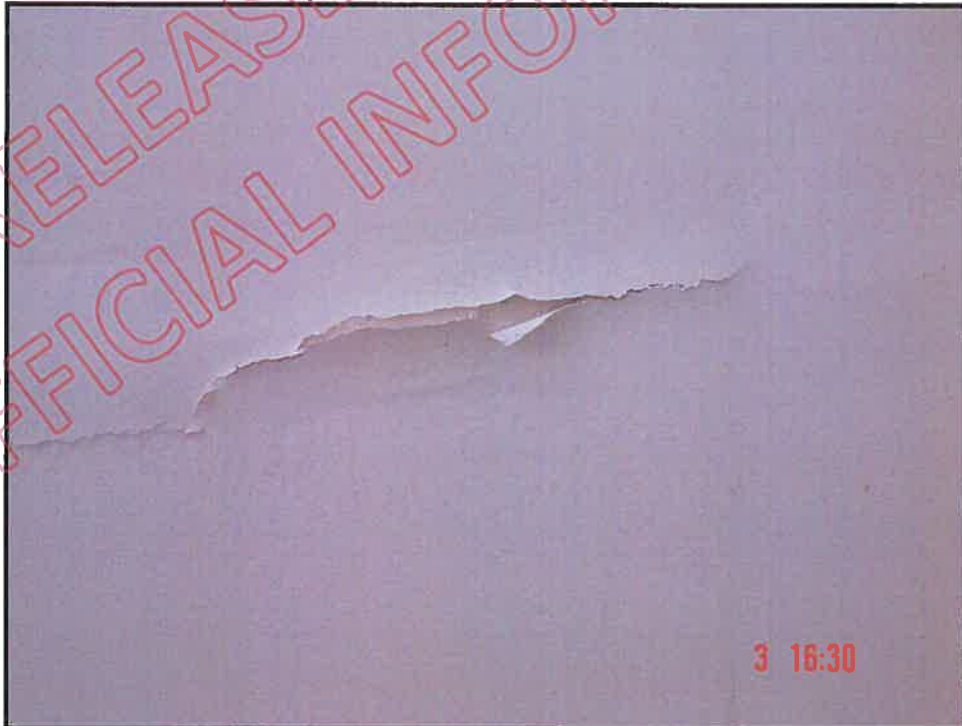
Photograph Internal- d 132

Damage to unit D lounge ceiling due to roof leak
