ASBESTOS MANAGEMENT PLAN & SITE MANAGEMENT SURVEYS

Site: South Canterbury DHB
Queen Street, Parkside, Timaru

Prepared for: South Canterbury District Health Board

Project Ref: C-00727

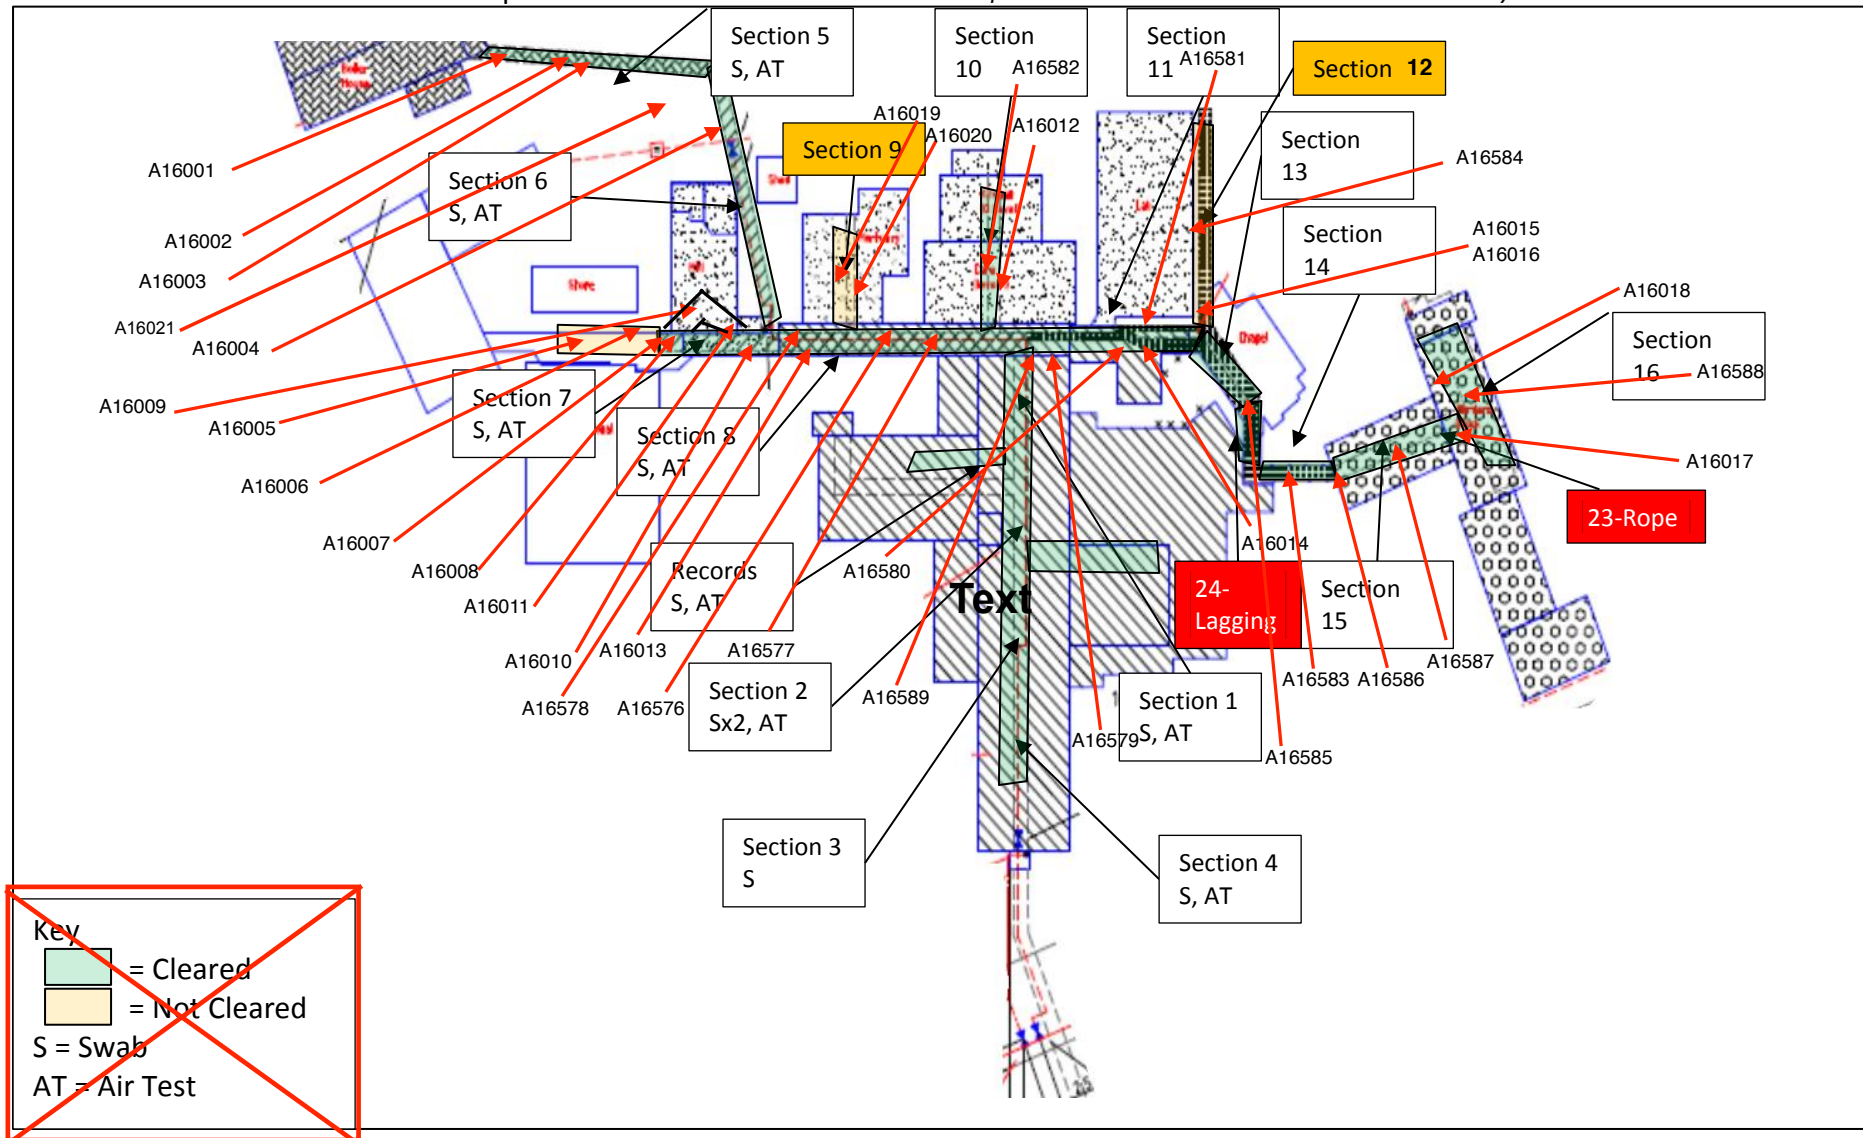
Figure 1 Site Map Detailing Asbestos Results

The numbers below detail where samples were collected from. Note: this map is not to scale and is used as an indication only.
