Body Corporate 134848, C/- 10 View Ridge Drive, Ranui, Auckland 0612.

Site Specific Asbestos Management Plan 1A and 1B Nile Road, Milford

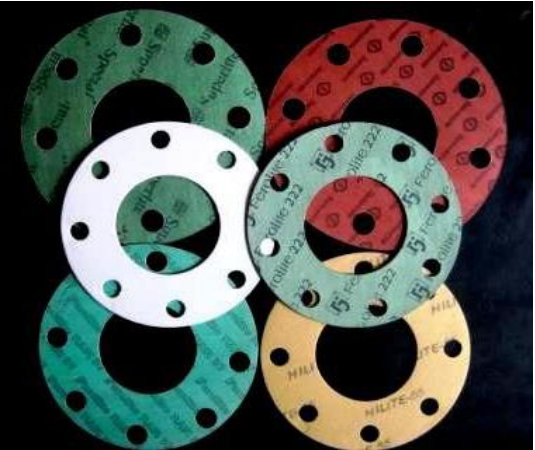
Item #	Level	Material Location	Material Description	Extent	Material Assessment				Accessibility	Labelling Status	Example photo
					Product	Extent of Damage	Treatment	Surface			
012	All	1A Nile Road - Pipework, equipment, machinery & tanks throughout the building	Gaskets	N/a	2	1	1	4	D	Not possible to label

Control Measures		All gaskets are to be presumed to contain asbestos and be left undisturbed unless it can be confirmed that they do not contain asbestos.									
Planned Removal / Remediation		To be tested or removed under appropriate control prior to any works that may cause disturbance.									
Reason for decision		Increased risk of exposure during removal. Low risk of exposure when the gaskets are fully intact and inserted between mating surfaces which restricts access to workers.									
Date of Re-Assessment		N/a	Remediation time scale		As required.

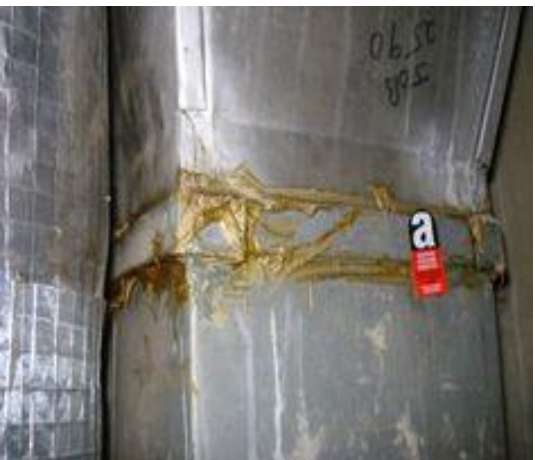
Item #	Level	Material Location	Material Description	Extent	Material Assessment				Accessibility	Labelling Status	Example photo
					Product	Extent of Damage	Treatment	Surface			
013	All	1A Nile Road - Throughout the building to ducting, equipment, machinery, building structure and windows - see executive summary	Mastics, Putty & Sealants	N/a	1	0	0	1	D	Not possible to label

Control Measures		All mastics, putties and sealants are to be presumed to contain asbestos and be left undisturbed unless it can be confirmed that they do not contain asbestos.									
Planned Removal / Remediation		To be tested or removed under appropriate control prior to any works that may cause disturbance.									
Reason for decision		Very low exposure risk in situ due to the material type (hardness or flexibility).									
Date of Re-Assessment		N/a	Remediation time scale		As required

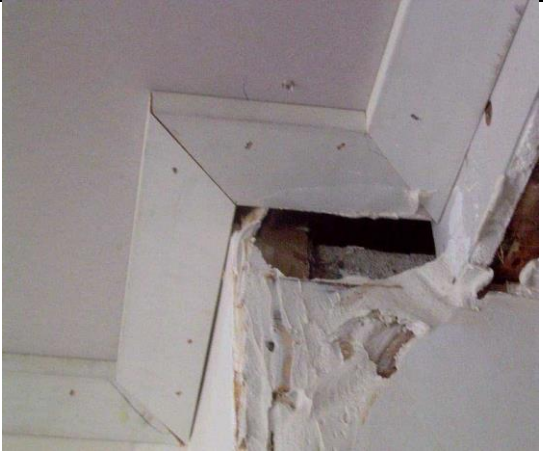
Item #	Level	Material Location	Material Description	Extent	Material Assessment				Accessibility	Labelling Status	Example photo
					Product	Extent of Damage	Treatment	Surface			
014	All	1A Nile Road - Throughout the building to walls and ceiling	Plaster finishes and GIB stopping compounds	N/a	1	0	1	2	D	Not possible to label

Control Measures		Presumed to contain asbestos unless proven otherwise - do not carry out any work that would cause disturbance to these materials without testing.									
Planned Removal / Remediation		To be tested or removed under appropriate control prior to any works that may cause disturbance.									
Reason for decision		Low risk of exposure to workers when material is in good condition as fibres are bound in hard plaster.									
Date of Re-Assessment		N/a	Remediation time scale		As required

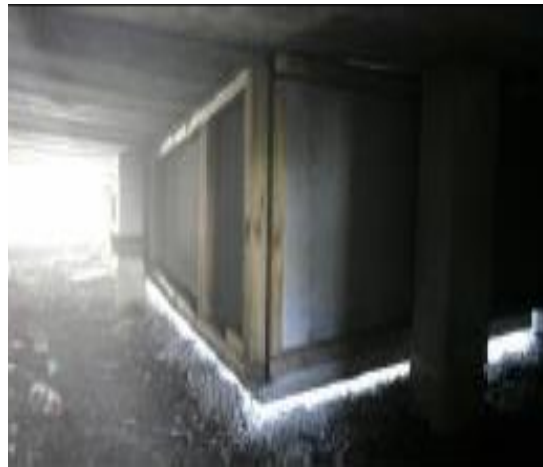
Item #	Level	Material Location	Material Description	Extent	Material Assessment				Accessibility	Labelling Status	Item actual photo
					Product	Extent of Damage	Treatment	Surface			
009	Ext.	1A & 1B Nile Road - Cladding and Debris Underneath Rear Walkway	Fibre Cement	8sqm	1	2	1	4	D	Not Labelled

Control Measures		Item Removed									
Planned Removal / Remediation		Item Removed									
Reason for decision		Item Removed									
Date of Re-Assessment		N/a	Remediation time scale		Removed – 4 th April 2018

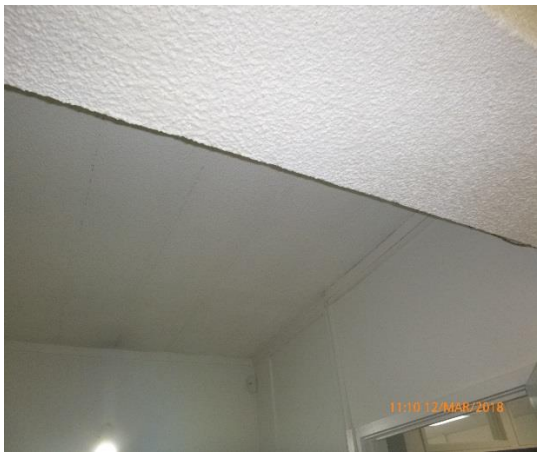
Item #	Level	Material Location	Material Description	Extent	Material Assessment				Accessibility	Labelling Status	Item actual photo
					Product	Extent of Damage	Treatment	Surface			
010	Grnd	1A Nile Road - Toilets and Kitchen – Covering to Ceilings	Textured Coating	20sqm	1	1	1	3	M	Not Labelled

Control Measures		Monitor the Materials Condition – do not disturb the material.									
Planned Removal / Remediation		Remove using a Class A Licensed Asbestos Removal Contractor Prior to Any Works that May Cause a Disturbance.									
Reason for decision		The material presents a low risk of worker exposure in its current condition but may release airborne fibres easily if disturbed during any planned works to the area.									
Date of Re-Assessment		23 rd March 2019	Remediation time scale		As required

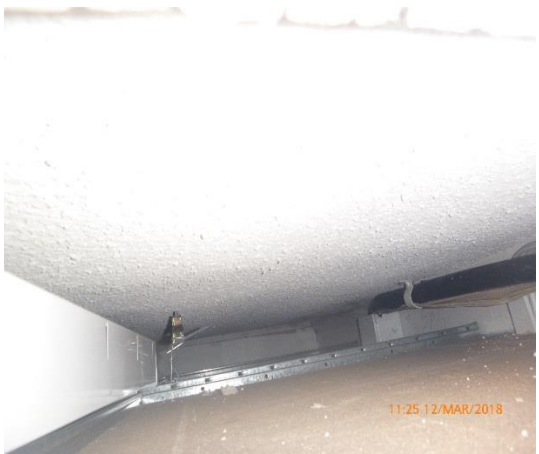
Item #	Level	Material Location	Material Description	Extent	Material Assessment				Accessibility	Labelling Status	Item Photo
					Product	Extent of Damage	Treatment	Surface			
011	Grnd	1A Nile Road - Throughout all Office and Other Room Ceilings in Ceiling Void	Textured Coating	160sq m	1	1	1	3	M	Not Labelled

Control Measures		Monitor the Materials Condition – do not disturb the material. Area only partially accessed therefore entry must be risk assessed to determine whether any additional control measures are required.									
Planned Removal / Remediation		Remove using a Class A Licensed Asbestos Removal Contractor Prior to Any Works that May Cause a Disturbance.									
Reason for decision		The material presents a low risk of worker exposure in its current condition but may release airborne fibres easily if disturbed during any planned works to the area.									
Date of Re-Assessment		23 rd March 2019	Remediation time scale		As required
