## 1 DOCUMENT CONTROL

**WORKSITE ASBESTOS REGISTER – Te Puna Building**

**WORKSITE ASBESTOS REGISTER – Te Puna Building - SPECIFIC AREAS OF SURVEY LIMITATIONS**

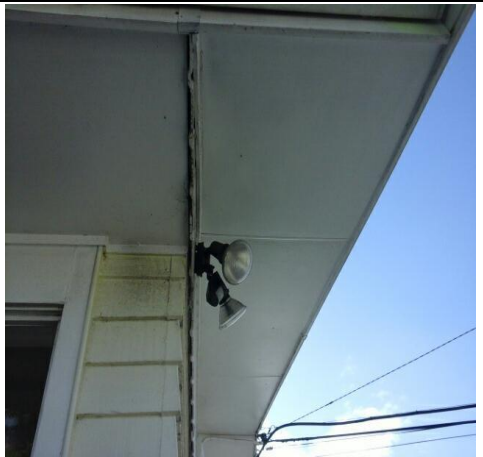
Item #	Level	Material Location	Material Description	Extent	Material Assessment				Accessibility	Labelling Status	Item photo
					Product	Extent of Damage	Treatment	Surface			
001	Ext.	Soffits	Fibre Cement	50 lin m	1	0	1	2	D	Not Labelled

<b>Control Measures</b>		This condition of this material will be monitored – do not disturb									
<b>Planned Removal / Remediation</b>		Removal to be carried out by an appropriately licensed removalist when necessary or prior to any works which could disturb the material.									
<b>Reason for decision</b>		Increased risk of exposure during removal. Material is low risk whilst in situ and in good condition.									
<b>Date of Re-Assessment</b>		19 <sup>th</sup> April 2019	<b>Remediation time scale</b>		As required.

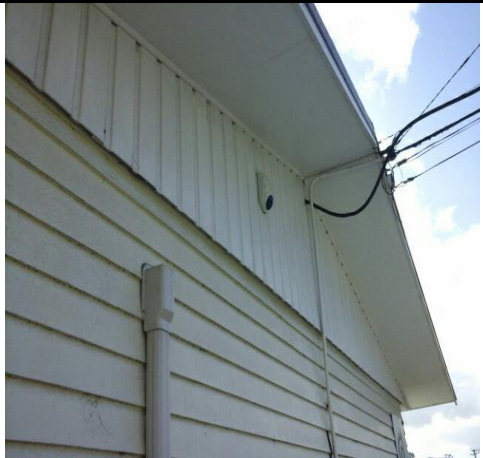
Item #	Level	Material Location	Material Description	Extent	Material Assessment				Accessibility	Labelling Status	Item example photo
					Product	Extent of Damage	Treatment	Surface			
002	Ext.	Profiled High Level Wall Cladding	Fibre Cement	5m2	1	0	1	2	D	Not Labelled

<b>Control Measures</b>		This condition of this material will be monitored – do not disturb									
<b>Planned Removal / Remediation</b>		Removal to be carried out by an appropriately licensed removalist when necessary or prior to any works which could disturb the material.									
<b>Reason for decision</b>		Increased risk of exposure during removal. Material is low risk whilst in situ and in good condition.									
<b>Date of Re-Assessment</b>		19 <sup>th</sup> April 2019	<b>Remediation time scale</b>		As required

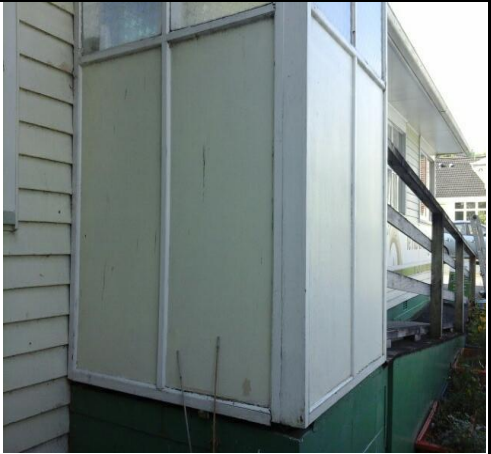
Item #	Level	Material Location	Material Description	Extent	Material Assessment					Accessibility	Labelling Status	Item photo
					Product	Extent of Damage	Treatment	Surface	Score			
003	Ext.	Flat Sheet Wall Cladding to Entrances	Fibre Cement	4m2	1	0	1	2	D	Not Labelled

<b>Control Measures</b>		This condition of this material will be monitored – do not disturb										
<b>Planned Removal / Remediation</b>		Removal to be carried out by an appropriately licensed removalist when necessary or prior to any works which could disturb the material.										
<b>Reason for decision</b>		Increased risk of exposure during removal. Material is low risk whilst in situ and in good condition.										
<b>Date of Re-Assessment</b>		19 <sup>th</sup> April 2019	<b>Remediation time scale</b>		As required

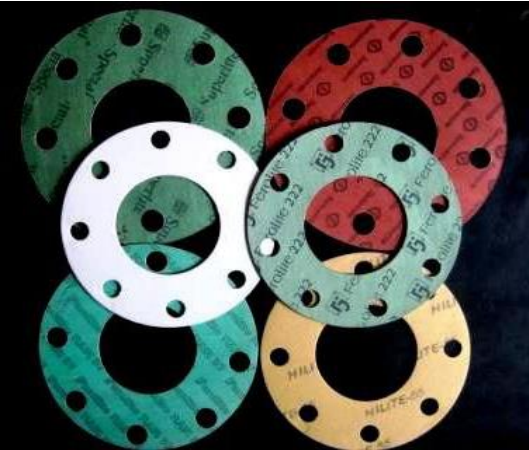
Item #	Level	Material Location	Material Description	Extent	Material Assessment				Accessibility	Labelling Status	Example photo
					Product	Extent of Damage	Treatment	Surface			
019	All	Pipework, equipment, machinery & tanks throughout the building	Gaskets	N/a	2	1	1	4	D	Not possible to label

<b>Control Measures</b>		All gaskets are to be presumed to contain asbestos and be left undisturbed unless it can be confirmed that they do not contain asbestos.									
<b>Planned Removal / Remediation</b>		To be tested or removed under appropriate control prior to any works that may cause disturbance.									
<b>Reason for decision</b>		Increased risk of exposure during removal. Low risk of exposure when the gaskets are fully intact and inserted between mating surfaces which restricts access to workers.									
<b>Date of Re-Assessment</b>		N/a	<b>Remediation time scale</b>		As required.

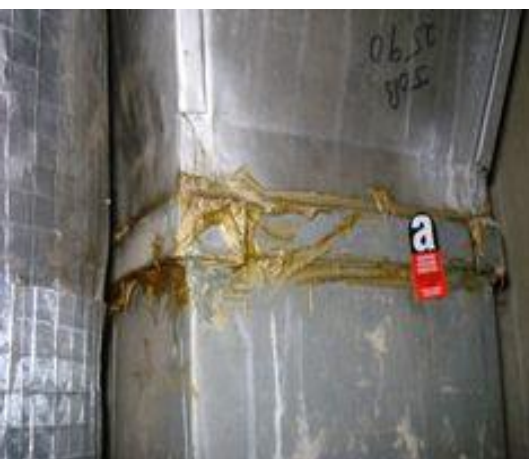
Item #	Level	Material Location	Material Description	Extent	Material Assessment				Accessibility	Labelling Status	Example photo
					Product	Extent of Damage	Treatment	Surface			
020	All	Throughout the building to ducting, equipment, machinery, building structure and windows - see executive summary	Mastics, Putty & Sealants	N/a	1	0	0	1	D	Not possible to label

<b>Control Measures</b>		All mastics, putties and sealants are to be presumed to contain asbestos and be left undisturbed unless it can be confirmed that they do not contain asbestos.									
<b>Planned Removal / Remediation</b>		To be tested or removed under appropriate control prior to any works that may cause disturbance.									
<b>Reason for decision</b>		Very low exposure risk in situ due to the material type (hardness or flexibility).									
<b>Date of Re-Assessment</b>		N/a	<b>Remediation time scale</b>		As required

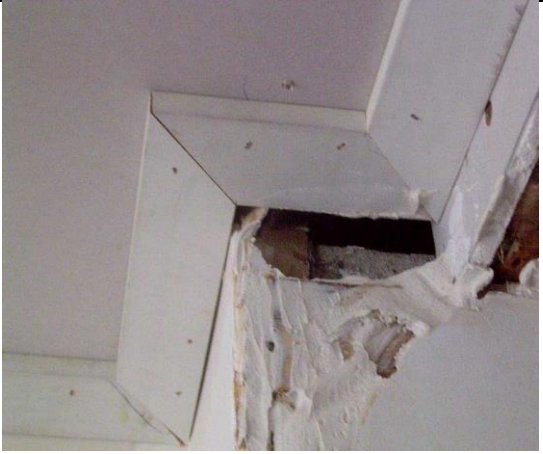
Item #	Level	Material Location	Material Description	Extent	Material Assessment				Accessibility	Labelling Status	Example photo
					Product	Extent of Damage	Treatment	Surface			
021	All	Throughout the building to walls and ceiling	Plaster finishes and GIB stopping compounds	N/a	1	0	1	2	D	Not possible to label

<b>Control Measures</b>		Presumed to contain asbestos unless proven otherwise - do not carry out any work that would cause disturbance to these materials without testing.									
<b>Planned Removal / Remediation</b>		To be tested or removed under appropriate control prior to any works that may cause disturbance.									
<b>Reason for decision</b>		Low risk of exposure to workers when material is in good condition as fibres are bound in hard plaster.									
<b>Date of Re-Assessment</b>		N/a	<b>Remediation time scale</b>		As required

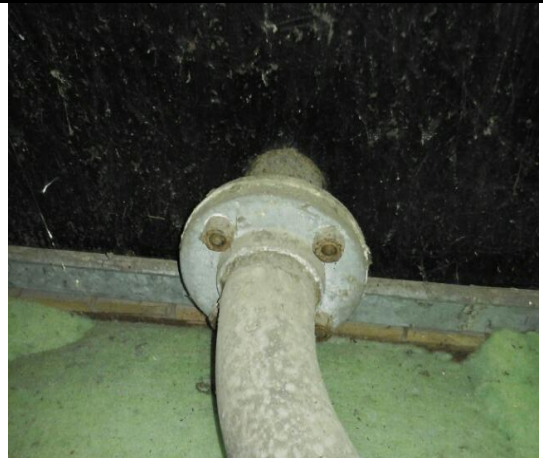
Item #	Level	Material Location	Material Description	Extent	Material Assessment				Accessibility	Labelling Status	Item actual photo
					Product	Extent of Damage	Treatment	Surface			
001	Roof Space	Above Community Health - Gaskets to Pipework Flanges	Gaskets	4no	2	1	1	4	D	Not Labelled

<b>Control Measures</b>		The material will be labelled and its condition will be monitored – do not disturb									
<b>Planned Removal / Remediation</b>		Removal to be carried out by an appropriately licensed removalist when necessary or prior to any works which could disturb the material.									
<b>Reason for decision</b>		Increased risk of exposure during removal. Material is low risk whilst in situ and well bonded within the mating surfaces of the flange.									
<b>Date of Re-Assessment</b>		19 <sup>th</sup> April 2019	<b>Remediation time scale</b>		As required

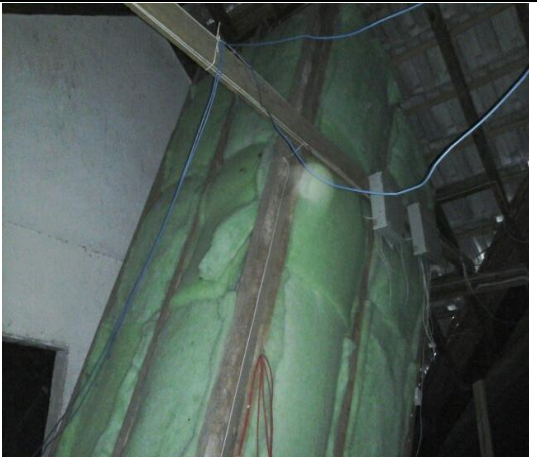
Item #	Level	Material Location	Material Description	Extent	Material Assessment				Accessibility	Labelling Status	Item actual photo
					Product	Extent of Damage	Treatment	Surface			
002	Roof Space	Above Community Health - Lining to Skylight	Fibre Cement	8m <sup>2</sup>	1	1	1	3	D	Not Labelled

<b>Control Measures</b>		The material will be labelled and its condition will be monitored – do not disturb									
<b>Planned Removal / Remediation</b>		Removal to be carried out by an appropriately licensed removalist when necessary or prior to any works which could disturb the material.									
<b>Reason for decision</b>		Increased risk of exposure during removal. Material is low risk whilst in situ and in good condition.									
<b>Date of Re-Assessment</b>		19 <sup>th</sup> April 2019	<b>Remediation time scale</b>		As required

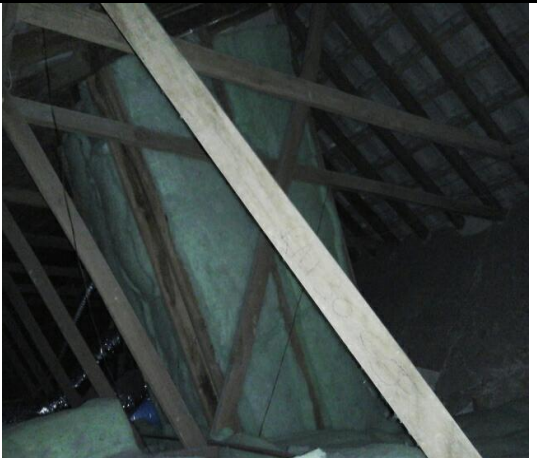
Item #	Level	Material Location	Material Description	Extent	Material Assessment				Accessibility	Labelling Status	Item Photo
					Product	Extent of Damage	Treatment	Surface			
011	Roof Space	Above Birthing Centre - Lining to Skylights	Fibre Cement	40m <sup>2</sup>	1	2	1	4	D	Not Labelled

<b>Control Measures</b>		The material will be labelled and its condition will be monitored – do not disturb									
<b>Planned Removal / Remediation</b>		Removal to be carried out by an appropriately licensed removalist when necessary or prior to any works which could disturb the material.									
<b>Reason for decision</b>		Increased risk of exposure during removal. Material is low risk whilst in situ and in a difficult to reach location.									
<b>Date of Re-Assessment</b>		19 <sup>th</sup> April 2019	<b>Remediation time scale</b>		As required

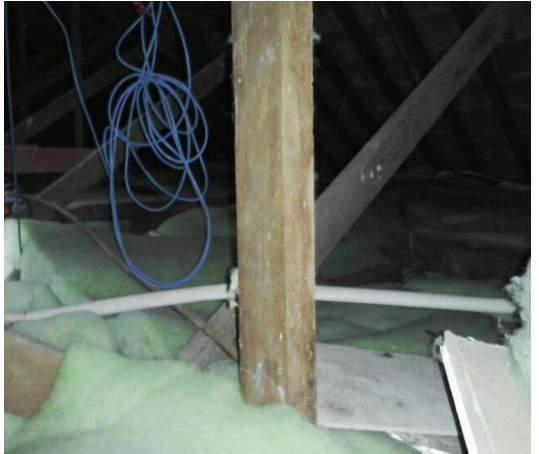
Item #	Level	Material Location	Material Description	Extent	Material Assessment				Accessibility	Labelling Status	Item Photo
					Product	Extent of Damage	Treatment	Surface			
012	Roof Space	Above Birthing Centre - Debris on Insulation	Fibre Cement	4no	1	2	1	4	D	Not Labelled

<b>Control Measures</b>		All debris will be removed. Access into the roof space will be controlled to ensure anyone entering the area is aware of the risk and able to avoid any disturbance of the material.									
<b>Planned Removal / Remediation</b>		Wrap, remove and dispose of as asbestos waste under semi-controlled conditions.									
<b>Reason for decision</b>		Low risk material in large pieces that can be wrapped and removed easily. Therefore, only a minor disturbance of the material with a low risk of worker exposure.									
<b>Date of Re-Assessment</b>		N/a	<b>Remediation time scale</b>		Within 3 months

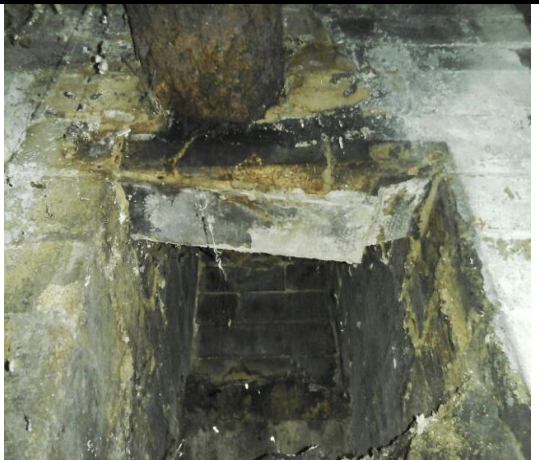
Item #	Level	Material Location	Material Description	Extent	Material Assessment				Accessibility	Labelling Status	Item Photo
					Product	Extent of Damage	Treatment	Surface			
004	Bsmt & Srv Tnls	Panel Above Small Wall Hatch	Fibre Cement	1no	1	2	1	4	D	Not Labelled

<b>Control Measures</b>		Access restricted into area due to items 006, 007 and 008 – do not enter this area unless planned by a competent person.									
<b>Planned Removal / Remediation</b>		Removal during friable remediation works throughout the basement and service tunnels.									
<b>Reason for decision</b>		The item cannot be accessed whilst the area is restricted. The risk of any future exposure to workers will be eliminated if removed during friable remediation works in the area.									
<b>Date of Re-Assessment</b>		N/a	<b>Remediation time scale</b>		As required

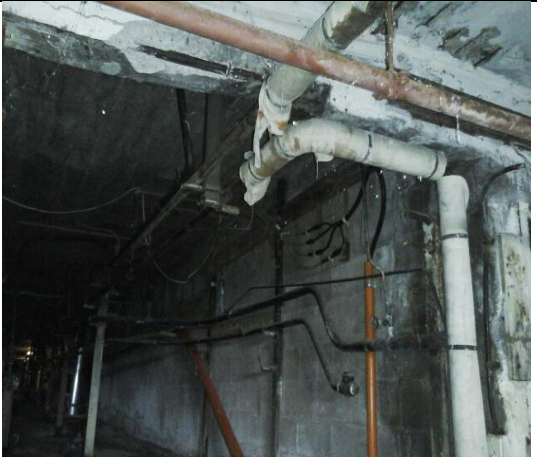
Item #	Level	Material Location	Material Description	Extent	Material Assessment				Accessibility	Labelling Status	Item Photo
					Product	Extent of Damage	Treatment	Surface			
005	Bsmt & Srvc Tunls	Gaskets to Pipework Flanges	Gaskets	N/a	2	1	1	4	D	Not possible to label

<b>Control Measures</b>		Access restricted into area due to items 006, 007 and 008 – do not enter this area unless planned by a competent person.									
<b>Planned Removal / Remediation</b>		Removal by Class A Licensed Asbestos Removal Contractor when necessary or prior to any works which could disturb the material.									
<b>Reason for decision</b>		Increased risk of exposure during removal. Material is low risk whilst in situ and well bonded within the mating surfaces of the flange.									
<b>Date of Re-Assessment</b>		N/a	<b>Remediation time scale</b>		As required

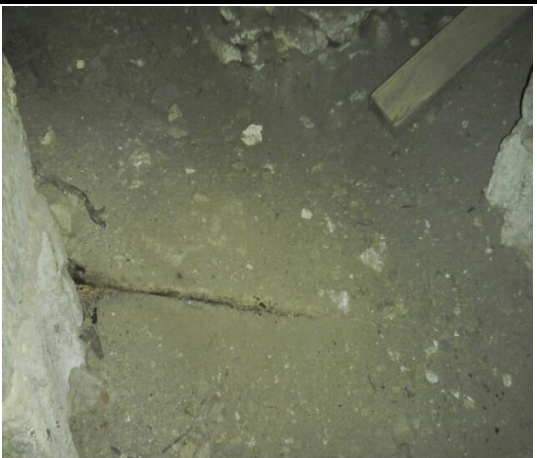
Item #	Level	Material Location	Material Description	Extent	Material Assessment				Accessibility	Labelling Status	Item Photo
					Product	Extent of Damage	Treatment	Surface			
006	Bsmt & Srvc Tunls	Debris to Exposed Ground Floors	Thermal Insulation	N/a	3	3	3	9	E	Not possible to label

<b>Control Measures</b>		Access is restricted – do not enter this area unless planned by a competent person.									
<b>Planned Removal / Remediation</b>		Removal by Class A Licensed Asbestos Removal Contractor prior to any major works that affect the area.									
<b>Reason for decision</b>		High risk of exposure to anyone entering the area. A lot of the buildings services run through this area and must be accessed for decommissioning, maintenance and upgrade during works to the building.									
<b>Date of Re-Assessment</b>		N/a	<b>Remediation time scale</b>		As required

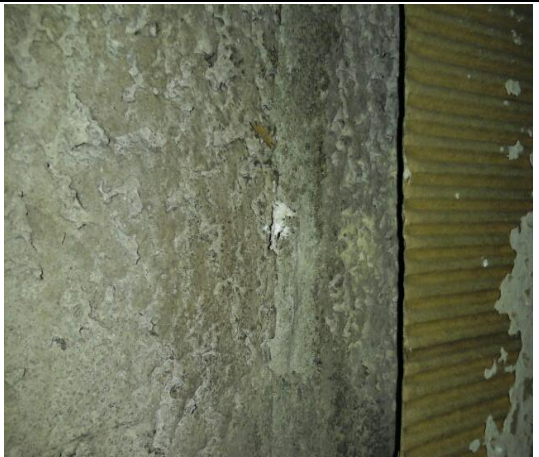
Item #	Level	Material Location	Material Description	Extent	Material Assessment				Accessibility	Labelling Status	Item Photo
					Product	Extent of Damage	Treatment	Surface			
007	Bsmt & Srvc Tunls	Debris to Block Walls	Thermal Insulation	N/a	3	3	3	9	E	Not possible to label

<b>Control Measures</b>		Access is restricted – do not enter this area unless planned by a competent person.									
<b>Planned Removal / Remediation</b>		Removal by Class A Licensed Asbestos Removal Contractor prior to any major works that affect the area.									
<b>Reason for decision</b>		High risk of exposure to anyone entering the area. A lot of the buildings services run through this area and must be accessed for decommissioning, maintenance and upgrade during works to the building.									
<b>Date of Re-Assessment</b>		N/a	N/a	As required

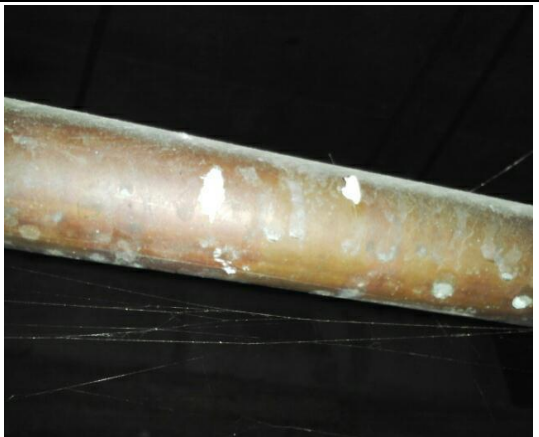
Item #	Level	Material Location	Material Description	Extent	Material Assessment				Accessibility	Labelling Status	Item Photo
					Product	Extent of Damage	Treatment	Surface			
008	Bsmt & Srvc Tunls	Debris and Residues to Pipework	Thermal Insulation	N/a	3	3	3	9	E	Not possible to label

<b>Control Measures</b>		Access is restricted – do not enter this area unless planned by a competent person.									
<b>Planned Removal / Remediation</b>		Removal by Class A Licensed Asbestos Removal Contractor prior to any major works that affect the area.									
<b>Reason for decision</b>		High risk of exposure to anyone entering the area. A lot of the buildings services run through this area and must be accessed for decommissioning, maintenance and upgrade during works to the building.									
<b>Date of Re-Assessment</b>		N/a	N/a	As required

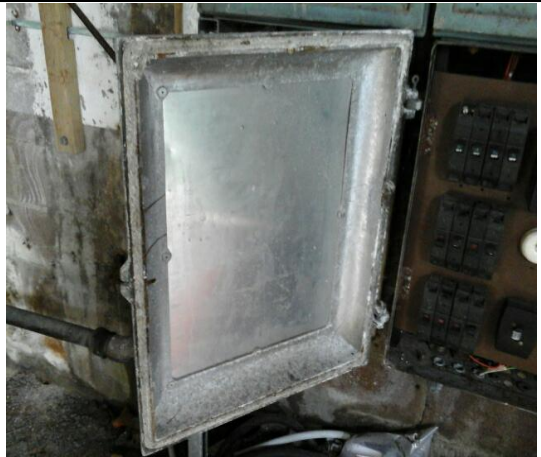
Item #	Level	Material Location	Material Description	Extent	Material Assessment				Accessibility	Labelling Status	Item Photo
					Product	Extent of Damage	Treatment	Surface			
009	Bsmt & Srvc Tunnls	Rope Lining to DB Hatch	Woven Product	1.5lin m	2	2	2	6	E	Not Labelled

<b>Control Measures</b>		Access restricted into area due to items 006, 007 and 008 – do not enter this area unless planned by a competent person.									
<b>Planned Removal / Remediation</b>		Removal by Class A Licensed Asbestos Removal Contractor during friable remediation works throughout the basement and service tunnels.									
<b>Reason for decision</b>		The item cannot be accessed whilst the area is restricted. The risk of any future exposure to workers will be eliminated if removed during friable remediation works in the area.									
<b>Date of Re-Assessment</b>		N/a	<b>Remediation time scale</b>		As required

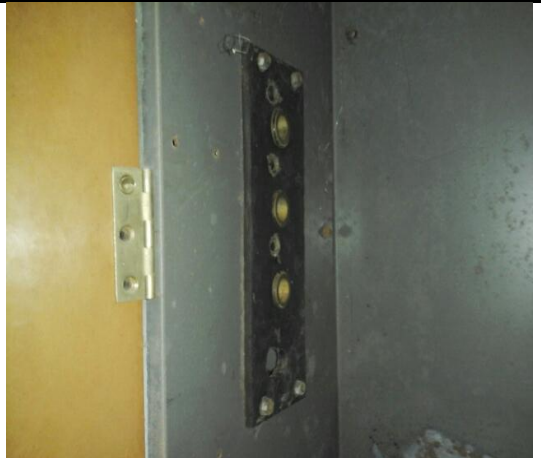
Item #	Level	Material Location	Material Description	Extent	Material Assessment				Accessibility	Labelling Status	Item Photo
					Product	Extent of Damage	Treatment	Surface			
010	Bsmt & Srvc Tunnls	Panels Within and Behind DB Units	Composite	3no	1	1	0	2	D	Not Labelled

<b>Control Measures</b>		Access restricted into area due to items 006, 007 and 008 – do not enter this area unless planned by a competent person.									
<b>Planned Removal / Remediation</b>		Removal during friable remediation works throughout the basement and service tunnels.									
<b>Reason for decision</b>		The item cannot be accessed whilst the area is restricted. The risk of any future exposure to workers will be eliminated if removed during friable remediation works in the area.									
<b>Date of Re-Assessment</b>		N/a	<b>Remediation time scale</b>		As required

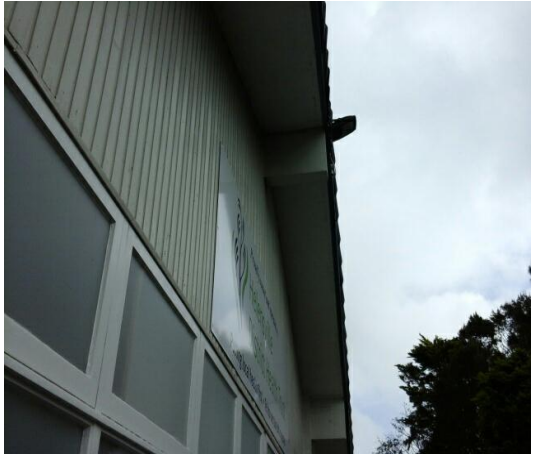
Item #	Level	Material Location	Material Description	Extent	Material Assessment				Accessibility	Labelling Status	Example Photo
					Product	Extent of Damage	Treatment	Surface Score			
013	Ext.	Soffits	Fibre Cement	200lin m	1	0	0	1	D	Not Labelled

<b>Control Measures</b>		This condition of this material will be monitored – do not disturb									
<b>Planned Removal / Remediation</b>		Removal to be carried out by an appropriately licensed removalist when necessary or prior to any works which could disturb the material.									
<b>Reason for decision</b>		Increased risk of exposure during removal. Material is low risk whilst in situ and in good condition.									
<b>Date of Re-Assessment</b>		19 <sup>th</sup> April 2019	<b>Remediation time scale</b>		As required.

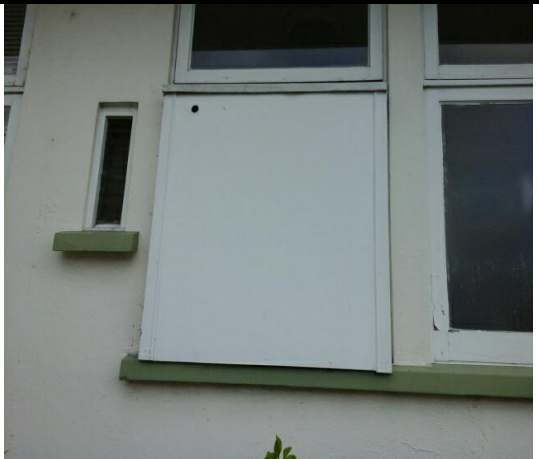
Item #	Level	Material Location	Material Description	Extent	Material Assessment				Accessibility	Labelling Status	Item Photo
					Product	Extent of Damage	Treatment	Surface Score			
017	Ext.	Panel to Wall of Community Health	Fibre Cement	1m <sup>2</sup>	1	1	1	3	D	Not Labelled

<b>Control Measures</b>		This condition of this material will be monitored – do not disturb									
<b>Planned Removal / Remediation</b>		Removal to be carried out by an appropriately licensed removalist when necessary or prior to any works which could disturb the material.									
<b>Reason for decision</b>		Increased risk of exposure during removal. Material is low risk whilst in situ and in good condition.									
<b>Date of Re-Assessment</b>		19 <sup>th</sup> April 2019	<b>Remediation time scale</b>		As required.

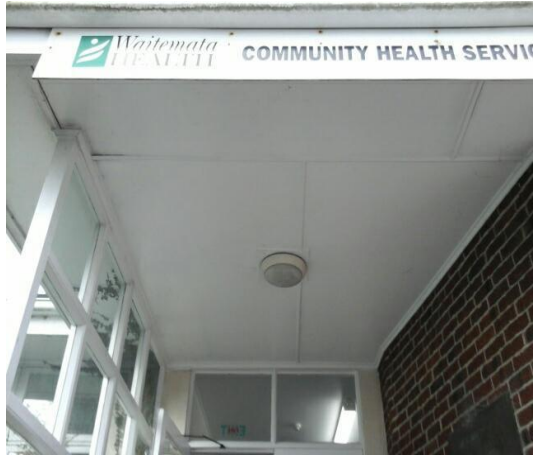
Item #	Level	Material Location	Material Description	Extent	Material Assessment					Accessibility	Labelling Status	Item Photo
					Product	Extent of Damage	Treatment	Surface	Score			
018	Ext.	Canopy to Community Health	Fibre Cement	6m <sup>2</sup>	1	0	1	2	D	Not Labelled

<b>Control Measures</b>		This condition of this material will be monitored – do not disturb										
<b>Planned Removal / Remediation</b>		Removal to be carried out by an appropriately licensed removalist when necessary or prior to any works which could disturb the material.										
<b>Reason for decision</b>		Increased risk of exposure during removal. Material is low risk whilst in situ and in good condition.										
<b>Date of Re-Assessment</b>		19 <sup>th</sup> April 2019	<b>Remediation time scale</b>		As required.

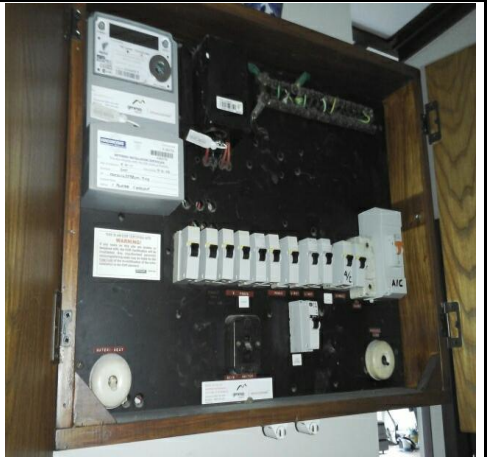
Item #	Level	Material Location	Material Description	Extent	Material Assessment				Accessibility	Labelling Status	Item photo
					Product	Extent of Damage	Treatment	Surface Score			
001	Grnd	Electrical Backboard	Composite	0.5m <sup>2</sup>	1	1	0	2	D	Not labelled

<b>Control Measures</b>		The item will be labelled and its condition monitored – do not disturb.									
<b>Planned Removal / Remediation</b>		Removal to be carried out when necessary or prior to any works which could disturb the material.									
<b>Reason for decision</b>		Increased risk of exposure during removal. Material is low risk whilst in situ and in good condition.									
<b>Date of Re-Assessment</b>		19 <sup>th</sup> April 2019	<b>Remediation time scale</b>		As required

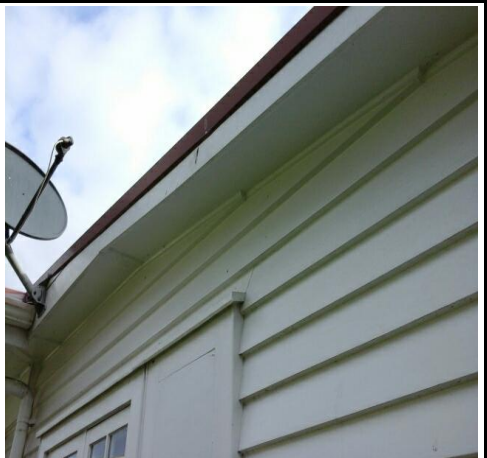
Item #	Level	Material Location	Material Description	Extent	Material Assessment				Accessibility	Labelling Status	Item example photo
					Product	Extent of Damage	Treatment	Surface Score			
002	Ext.	Soffits to Extension	Fibre Cement	3lin m	1	0	1	2	D	Not labelled

<b>Control Measures</b>		This condition of this material will be monitored – do not disturb.									
<b>Planned Removal / Remediation</b>		Removal to be carried out by an appropriately licensed removalist when necessary or prior to any works which could disturb the material.									
<b>Reason for decision</b>		Increased risk of exposure during removal. Material is low risk whilst in situ and in good condition.									
<b>Date of Re-Assessment</b>		19 <sup>th</sup> April 2019	<b>Remediation time scale</b>		As required

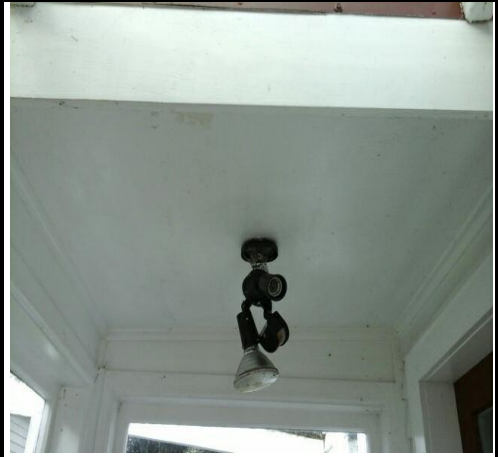
Item #	Level	Material Location	Material Description	Extent	Material Assessment					Accessibility	Labelling Status	Item photo
					Product	Extent of Damage	Treatment	Surface	Score			
003	Ext.	Canopy to Extension	Fibre Cement	1m <sup>2</sup>	1	0	1	2	D	Not labelled

<b>Control Measures</b>		This condition of this material will be monitored – do not disturb.										
<b>Planned Removal / Remediation</b>		Removal to be carried out by an appropriately licensed removalist when necessary or prior to any works which could disturb the material.										
<b>Reason for decision</b>		Increased risk of exposure during removal. Material is low risk whilst in situ and in good condition.										
<b>Date of Re-Assessment</b>		19 <sup>th</sup> April 2019	<b>Remediation time scale</b>		As required
