## Asbestos Management Survey Report

Whanganui Hospital,  
(Te Awhina)

### **Whanganui Hospital**

### **Te Awhina**

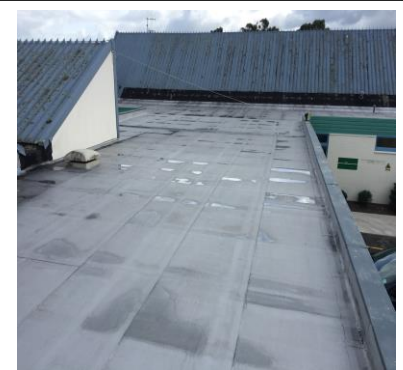
Photograph No.	001
Location/Area	External: Roof Top
Suspected Material Identified	Waterproofing (Silver)
Condition of Material Identified	Good
<b>Categories: (Assessment type).</b> 1: ACM common characteristics or 2: Presumed ACM or 3: Sample collected for analysis	2: Presumed ACM
Sample No.	Sample not taken
Laboratory Analysis Findings	Analysis not conducted
Quantity of Material Identified	705.0m2

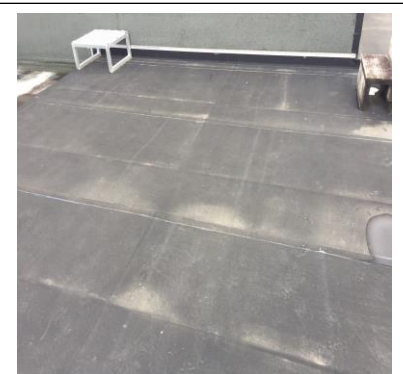
**ID: CARD NO:002**

Photograph No.	002
Location/Area	External: Roof Top
Suspected Material Identified	Waterproofing (Black)
Condition of Material Identified	Good
<b>Categories: (Assessment type).</b> 1: ACM common characteristics or 2: Presumed ACM or 3: Sample collected for analysis	2: Presumed ACM
Sample No.	Sample not taken
Laboratory Analysis Findings	Analysis not conducted
Quantity of Material Identified	216.0m2

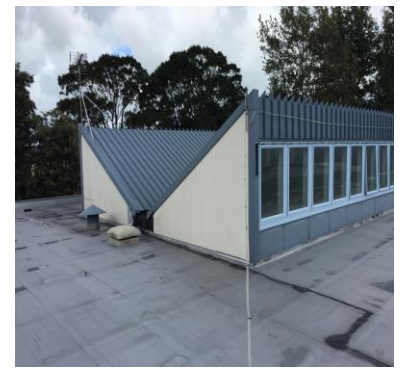
**ID: CARD NO:003**

Photograph No.	003
Location/Area	Roof Top: Saw tooth (East)
Suspected Material Identified	ACM Board
Condition of Material Identified	Good
<b>Categories: (Assessment type).</b> 1: ACM common characteristics or 2: Presumed ACM or 3: Sample collected for analysis	2: Presumed ACM
Sample No.	Sample not taken
Laboratory Analysis Findings	Analysis not conducted
Quantity of Material Identified	13.2m2

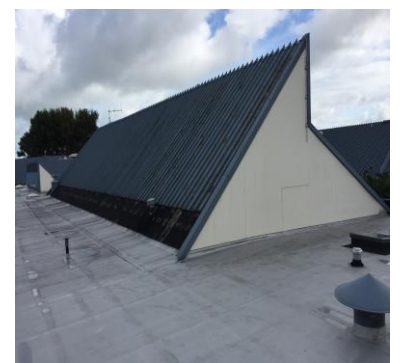
**ID: CARD NO:004**

Photograph No.	004
Location/Area	Roof Top: Saw tooth (Middle)
Suspected Material Identified	ACM Board
Condition of Material Identified	Good
<b>Categories: (Assessment type).</b> 1: ACM common characteristics or 2: Presumed ACM or 3: Sample collected for analysis	2: Presumed ACM
Sample No.	Sample not taken
Laboratory Analysis Findings	Analysis not conducted
Quantity of Material Identified	50.4m2

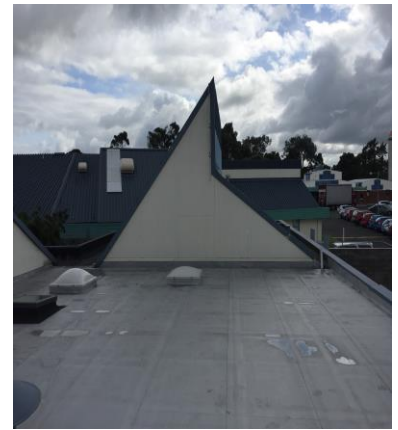
Photograph No.	005
Location/Area	Roof Top: Saw tooth (North)
Suspected Material Identified	ACM Board
Condition of Material Identified	Good
<b>Categories: (Assessment type).</b> 1: ACM common characteristics or 2: Presumed ACM or 3: Sample collected for analysis	2: Presumed ACM
Sample No.	Sample not taken
Laboratory Analysis Findings	Analysis not conducted
Quantity of Material Identified	36.5m2

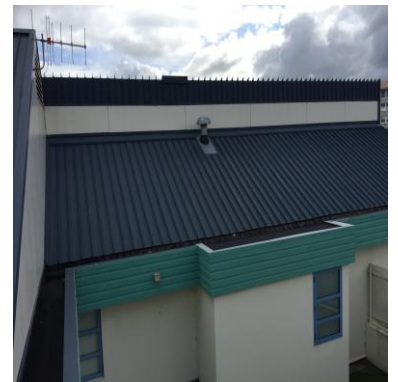
Photograph No.	006
Location/Area	Roof Top: Saw tooth (North/West)
Suspected Material Identified	ACM Board
Condition of Material Identified	Good
<b>Categories: (Assessment type).</b> 1: ACM common characteristics or 2: Presumed ACM or 3: Sample collected for analysis	2: Presumed ACM
Sample No.	Sample not taken
Laboratory Analysis Findings	Analysis not conducted
Quantity of Material Identified	108.0m2

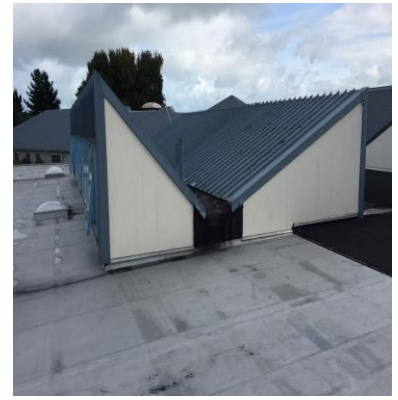
Photograph No.	007
Location/Area	Roof Top: Saw tooth (South)
Suspected Material Identified	ACM Board
Condition of Material Identified	Good
<b>Categories: (Assessment type).</b> 1: ACM common characteristics or 2: Presumed ACM or 3: Sample collected for analysis	2: Presumed ACM
Sample No.	Sample not taken
Laboratory Analysis Findings	Analysis not conducted
Quantity of Material Identified	29.6m2

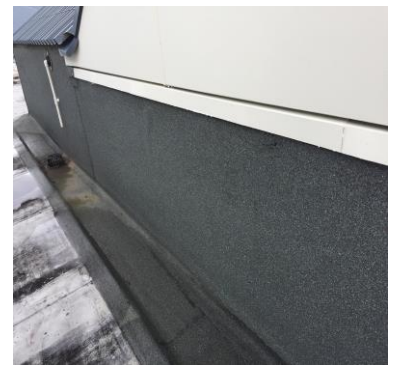
Photograph No.	008
Location/Area	External: Roof Top
Suspected Material Identified	Waterproofing (textured)
Condition of Material Identified	Good
<b>Categories: (Assessment type).</b> 1: ACM common characteristics or 2: Presumed ACM or 3: Sample collected for analysis	2: Presumed ACM
Sample No.	Sample not taken
Laboratory Analysis Findings	Analysis not conducted
Quantity of Material Identified	14.4m2

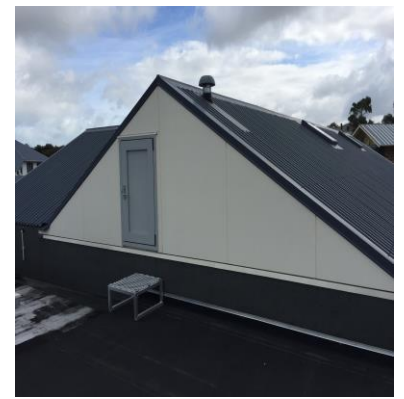
Photograph No.	009
Location/Area	Roof Top: Saw tooth (South/West)
Suspected Material Identified	ACM Board
Condition of Material Identified	Good
<b>Categories: (Assessment type).</b> 1: ACM common characteristics or 2: Presumed ACM or 3: Sample collected for analysis	2: Presumed ACM
Sample No.	Sample not taken
Laboratory Analysis Findings	Analysis not conducted
Quantity of Material Identified	15.0m2

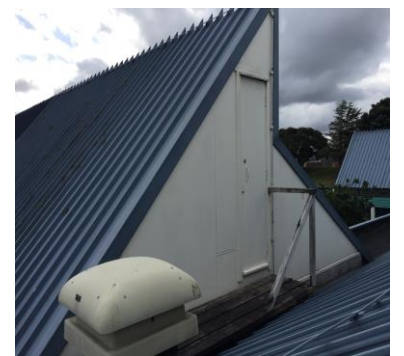
Photograph No.	010
Location/Area	Roof Top: Saw tooth (West)
Suspected Material Identified	ACM Board
Condition of Material Identified	Good
<b>Categories: (Assessment type).</b> 1: ACM common characteristics or 2: Presumed ACM or 3: Sample collected for analysis	2: Presumed ACM
Sample No.	Sample not taken
Laboratory Analysis Findings	Analysis not conducted
Quantity of Material Identified	26.64m2

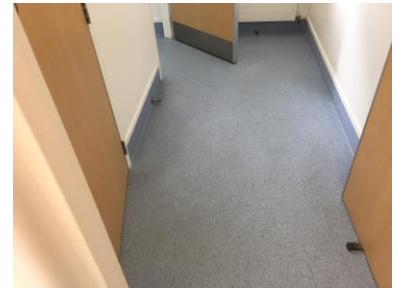
Photograph No.	011
Location/Area	Internal: Public toilet (Entry)
Suspected Material Identified	Vinyl Flooring (Blue)
Condition of Material Identified	Good
<b>Categories: (Assessment type).</b> 1: ACM common characteristics or 2: Presumed ACM or 3: Sample collected for analysis	2: Presumed
Sample No.	Sample not taken
Laboratory Analysis Findings	Analysis not conducted
Quantity of Material Identified	4.4m2

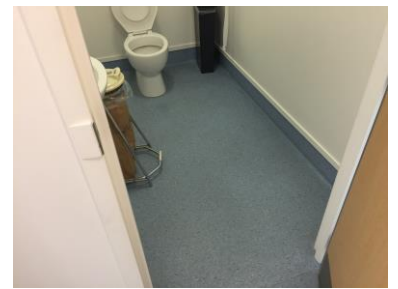
Photograph No.	012
Location/Area	Internal: Public toilet 1
Suspected Material Identified	Vinyl Flooring (Blue)
Condition of Material Identified	Good
<b>Categories: (Assessment type).</b> 1: ACM common characteristics or 2: Presumed ACM or 3: Sample collected for analysis	2: Presumed
Sample No.	Sample not taken
Laboratory Analysis Findings	Analysis not conducted
Quantity of Material Identified	7.3m2

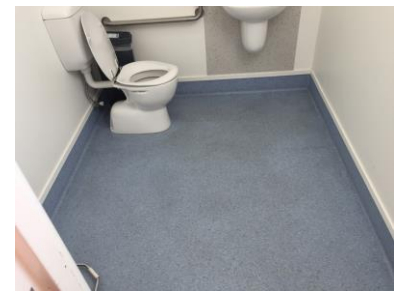
Photograph No.	013
Location/Area	Internal: Public toilet Accessible
Suspected Material Identified	Vinyl Flooring (Blue)
Condition of Material Identified	Good
<b>Categories: (Assessment type).</b> 1: ACM common characteristics or 2: Presumed ACM or 3: Sample collected for analysis	2: Presumed
Sample No.	Sample not taken
Laboratory Analysis Findings	Analysis not conducted
Quantity of Material Identified	7.3m2

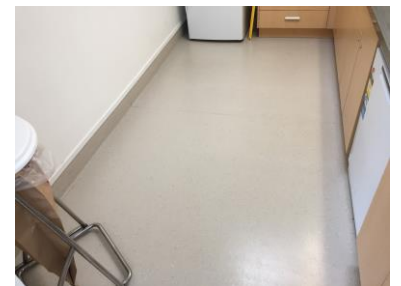
Photograph No.	014
Location/Area	Client kitchen
Suspected Material Identified	Vinyl Flooring (Cream)
Condition of Material Identified	Good
<b>Categories: (Assessment type).</b> 1: ACM common characteristics or 2: Presumed ACM or 3: Sample collected for analysis	2: Presumed
Sample No.	Sample not taken
Laboratory Analysis Findings	Analysis not conducted
Quantity of Material Identified	6.3m2

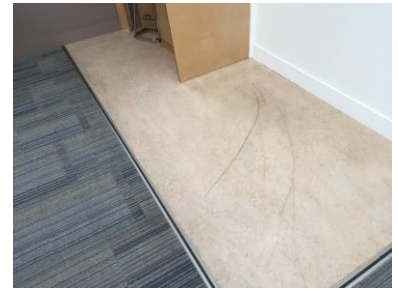
Photograph No.	015
Location/Area	Whanau Room
Suspected Material Identified	Vinyl Flooring (Cream)
Condition of Material Identified	Good
<b>Categories: (Assessment type).</b> 1: ACM common characteristics or 2: Presumed ACM or 3: Sample collected for analysis	2: Presumed
Sample No.	Sample not taken
Laboratory Analysis Findings	Analysis not conducted
Quantity of Material Identified	5.6m2

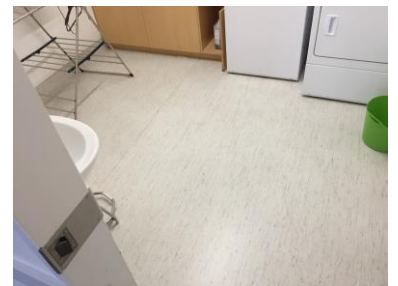
Photograph No.	016
Location/Area	Laundry
Suspected Material Identified	Vinyl Flooring (Cream)
Condition of Material Identified	Good
<b>Categories: (Assessment type).</b> 1: ACM common characteristics or 2: Presumed ACM or 3: Sample collected for analysis	2: Presumed
Sample No.	Sample not taken
Laboratory Analysis Findings	Analysis not conducted
Quantity of Material Identified	8.9m2

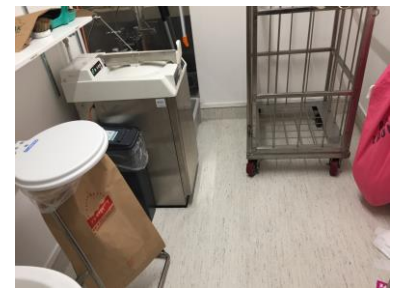
Photograph No.	017
Location/Area	Sluice Room
Suspected Material Identified	Vinyl Flooring (Cream)
Condition of Material Identified	Good
<b>Categories: (Assessment type).</b> 1: ACM common characteristics or 2: Presumed ACM or 3: Sample collected for analysis	2: Presumed
Sample No.	Sample not taken
Laboratory Analysis Findings	Analysis not conducted
Quantity of Material Identified	5.6m2

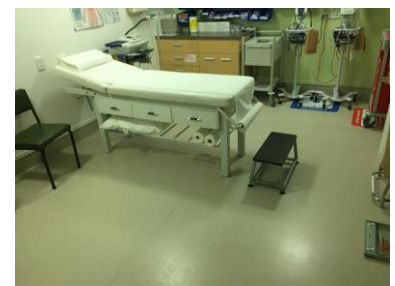
Photograph No.	018
Location/Area	Clinic Room 1
Suspected Material Identified	Vinyl Flooring (Green)
Condition of Material Identified	Good
<b>Categories: (Assessment type).</b> 1: ACM common characteristics or 2: Presumed ACM or 3: Sample collected for analysis	2: Presumed
Sample No.	Sample not taken
Laboratory Analysis Findings	Analysis not conducted
Quantity of Material Identified	16.5m2

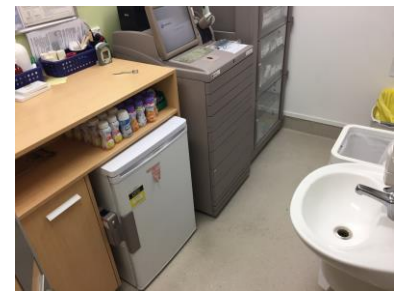
Photograph No.	019
Location/Area	BYXIS Room
Suspected Material Identified	Vinyl Flooring (Cream)
Condition of Material Identified	Good
<b>Categories: (Assessment type).</b> 1: ACM common characteristics or 2: Presumed ACM or 3: Sample collected for analysis	2: Presumed
Sample No.	Sample not taken
Laboratory Analysis Findings	Analysis not conducted
Quantity of Material Identified	5.7m2

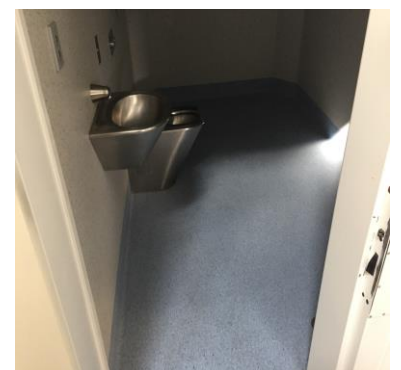
Photograph No.	020
Location/Area	Seclusion Room 1
Suspected Material Identified	Vinyl Floor/Walls (Blue/Stone)
Condition of Material Identified	Good
<b>Categories: (Assessment type).</b> 1: ACM common characteristics or 2: Presumed ACM or 3: Sample collected for analysis	2: Presumed
Sample No.	Sample not taken
Laboratory Analysis Findings	Analysis not conducted
Quantity of Material Identified	6.6m2 / 31.2m2

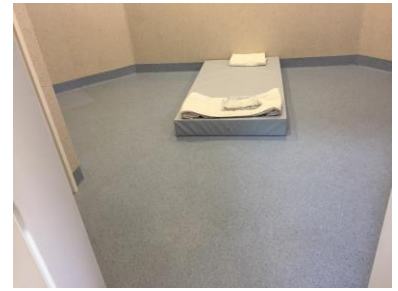
Photograph No.	021
Location/Area	Seclusion Room 2
Suspected Material Identified	Vinyl Floor/Walls (Blue/Stone)
Condition of Material Identified	Good
<b>Categories: (Assessment type).</b> 1: ACM common characteristics or 2: Presumed ACM or 3: Sample collected for analysis	2: Presumed
Sample No.	Sample not taken
Laboratory Analysis Findings	Analysis not conducted
Quantity of Material Identified	20.6m2 / 41.4m2

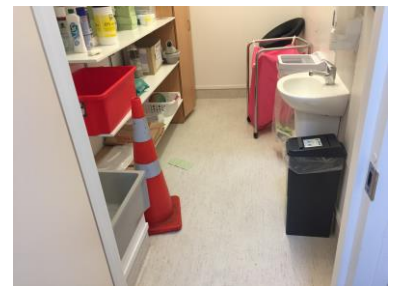
Photograph No.	022
Location/Area	Seclusion Room Storage
Suspected Material Identified	Vinyl Flooring (Blue)
Condition of Material Identified	Good
<b>Categories: (Assessment type).</b> 1: ACM common characteristics or 2: Presumed ACM or 3: Sample collected for analysis	2: Presumed
Sample No.	Sample not taken
Laboratory Analysis Findings	Analysis not conducted
Quantity of Material Identified	6.6m2

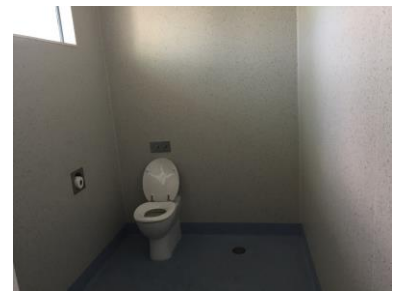
Photograph No.	023
Location/Area	Tui Wing: Bathroom
Suspected Material Identified	Vinyl Floor/Walls (Blue/Stone)
Condition of Material Identified	Good
<b>Categories: (Assessment type).</b> 1: ACM common characteristics or 2: Presumed ACM or 3: Sample collected for analysis	2: Presumed
Sample No.	Sample not taken
Laboratory Analysis Findings	Analysis not conducted
Quantity of Material Identified	4.9m <sup>2</sup> / 18.9m <sup>2</sup>

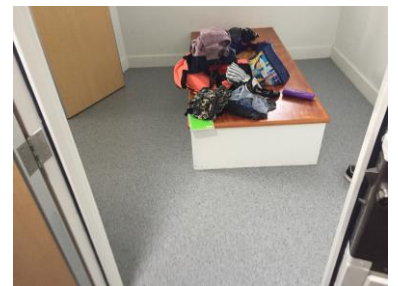
Photograph No.	024
Location/Area	Tui Wing: Room 1
Suspected Material Identified	Vinyl Walls (Grey)
Condition of Material Identified	Good
<b>Categories: (Assessment type).</b> 1: ACM common characteristics or 2: Presumed ACM or 3: Sample collected for analysis	2: Presumed
Sample No.	Sample not taken
Laboratory Analysis Findings	Analysis not conducted
Quantity of Material Identified	8.0m <sup>2</sup>

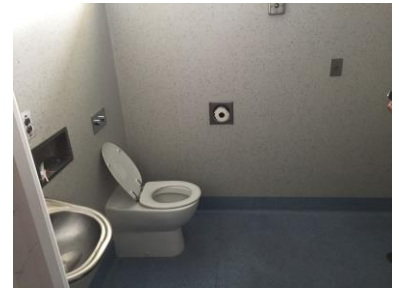
Photograph No.	025
Location/Area	Tui Wing: Room 1 Bathroom
Suspected Material Identified	Vinyl Floor/Walls (Blue/Stone)
Condition of Material Identified	Good
<b>Categories: (Assessment type).</b> 1: ACM common characteristics or 2: Presumed ACM or 3: Sample collected for analysis	2: Presumed
Sample No.	Sample not taken
Laboratory Analysis Findings	Analysis not conducted
Quantity of Material Identified	6.2m2 / 24.0m2

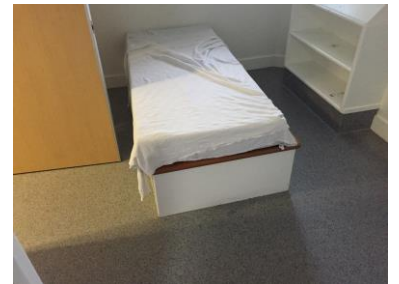
Photograph No.	026
Location/Area	Tui Wing: Room 2
Suspected Material Identified	Vinyl Flooring (Grey)
Condition of Material Identified	Good
<b>Categories: (Assessment type).</b> 1: ACM common characteristics or 2: Presumed ACM or 3: Sample collected for analysis	2: Presumed
Sample No.	Sample not taken
Laboratory Analysis Findings	Analysis not conducted
Quantity of Material Identified	8.3m2

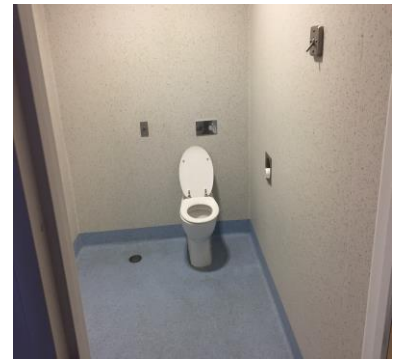
Photograph No.	027
Location/Area	Tui Wing: Room 2 Bathroom
Suspected Material Identified	Vinyl Floor/Walls (Blue/Stone)
Condition of Material Identified	Good
<b>Categories: (Assessment type).</b> 1: ACM common characteristics or 2: Presumed ACM or 3: Sample collected for analysis	2: Presumed
Sample No.	Sample not taken
Laboratory Analysis Findings	Analysis not conducted
Quantity of Material Identified	4.2m2 / 20.5m2

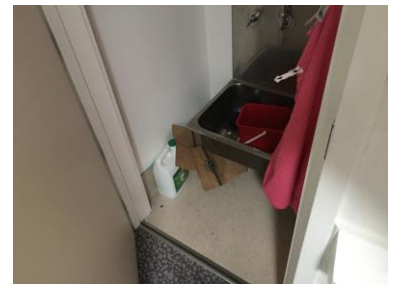
Photograph No.	028
Location/Area	Tui Wing: Cleaners Cupboard
Suspected Material Identified	Vinyl Flooring (Cream)
Condition of Material Identified	Good
<b>Categories: (Assessment type).</b> 1: ACM common characteristics or 2: Presumed ACM or 3: Sample collected for analysis	2: Presumed
Sample No.	Sample not taken
Laboratory Analysis Findings	Analysis not conducted
Quantity of Material Identified	1.0m2

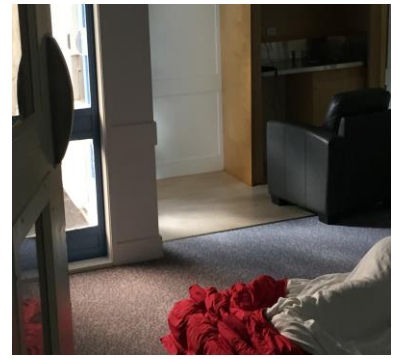
Photograph No.	029
Location/Area	Tui Wing: Room 3
Suspected Material Identified	Vinyl Flooring (Cream)
Condition of Material Identified	Good
<b>Categories: (Assessment type).</b> 1: ACM common characteristics or 2: Presumed ACM or 3: Sample collected for analysis	2: Presumed
Sample No.	Sample not taken
Laboratory Analysis Findings	Analysis not conducted
Quantity of Material Identified	4.3m2

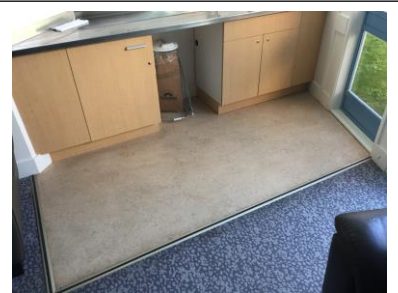
Photograph No.	030
Location/Area	Tui Wing: Quiet Lounge
Suspected Material Identified	Vinyl Flooring (Cream)
Condition of Material Identified	Good
<b>Categories: (Assessment type).</b> 1: ACM common characteristics or 2: Presumed ACM or 3: Sample collected for analysis	2: Presumed
Sample No.	Sample not taken
Laboratory Analysis Findings	Analysis not conducted
Quantity of Material Identified	2.9m2

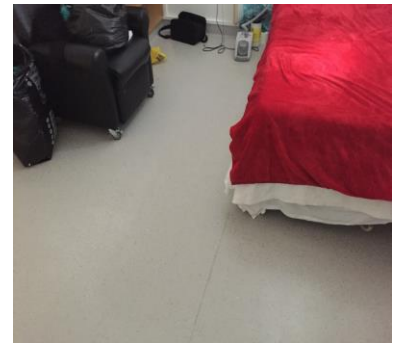
Photograph No.	031
Location/Area	Kea Wing: Room 1
Suspected Material Identified	Vinyl Flooring (Grey)
Condition of Material Identified	Good
<b>Categories: (Assessment type).</b> 1: ACM common characteristics or 2: Presumed ACM or 3: Sample collected for analysis	2: Presumed
Sample No.	Sample not taken
Laboratory Analysis Findings	Analysis not conducted
Quantity of Material Identified	10.2m2

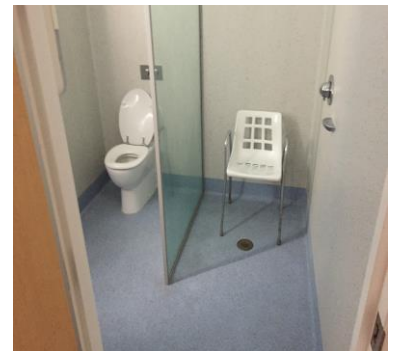
Photograph No.	032
Location/Area	Kea Wing: Room 1 Bathroom
Suspected Material Identified	Vinyl Floor/Walls (Blue/Stone)
Condition of Material Identified	Good
<b>Categories: (Assessment type).</b> 1: ACM common characteristics or 2: Presumed ACM or 3: Sample collected for analysis	2: Presumed
Sample No.	Sample not taken
Laboratory Analysis Findings	Analysis not conducted
Quantity of Material Identified	4.4m2 / 21.6m2

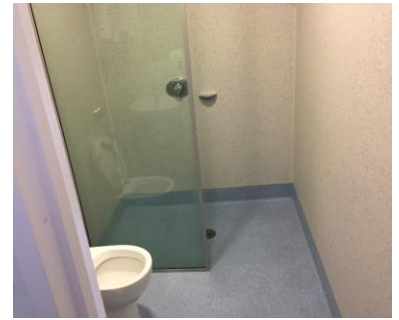
Photograph No.	033
Location/Area	Kea Wing: Room 2 Bathroom
Suspected Material Identified	Vinyl Floor/Walls (Blue/Stone)
Condition of Material Identified	Good
<b>Categories: (Assessment type).</b> 1: ACM common characteristics or 2: Presumed ACM or 3: Sample collected for analysis	2: Presumed
Sample No.	Sample not taken
Laboratory Analysis Findings	Analysis not conducted
Quantity of Material Identified	3.3m <sup>2</sup> / 17.2m <sup>2</sup>

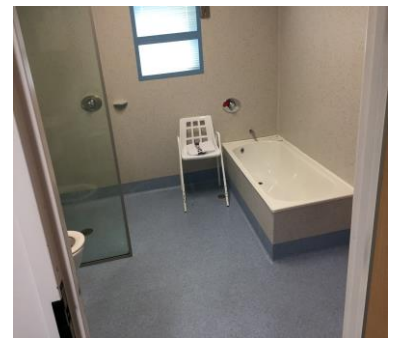
Photograph No.	034
Location/Area	Kea Wing: Public Bathroom
Suspected Material Identified	Vinyl Floor/Walls (Blue/Stone)
Condition of Material Identified	Good
<b>Categories: (Assessment type).</b> 1: ACM common characteristics or 2: Presumed ACM or 3: Sample collected for analysis	2: Presumed
Sample No.	Sample not taken
Laboratory Analysis Findings	Analysis not conducted
Quantity of Material Identified	6.0m <sup>2</sup> / 24.3m <sup>2</sup>

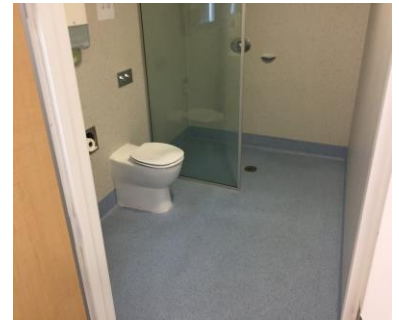
Photograph No.	035
Location/Area	Kea Wing: Room 7 Bathroom
Suspected Material Identified	Vinyl Floor/Walls (Blue/Stone)
Condition of Material Identified	Good
<b>Categories: (Assessment type).</b> 1: ACM common characteristics or 2: Presumed ACM or 3: Sample collected for analysis	2: Presumed
Sample No.	Sample not taken
Laboratory Analysis Findings	Analysis not conducted
Quantity of Material Identified	5.1m <sup>2</sup> / 24.0m <sup>2</sup>

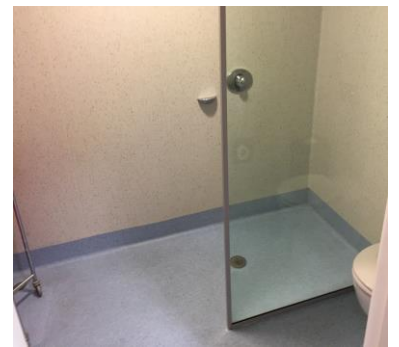
Photograph No.	036
Location/Area	Kea Wing: Public Bathroom 2
Suspected Material Identified	Vinyl Floor/Walls (Blue/Stone)
Condition of Material Identified	Good
<b>Categories: (Assessment type).</b> 1: ACM common characteristics or 2: Presumed ACM or 3: Sample collected for analysis	2: Presumed
Sample No.	Sample not taken
Laboratory Analysis Findings	Analysis not conducted
Quantity of Material Identified	5.3m <sup>2</sup> / 23.2m <sup>2</sup>

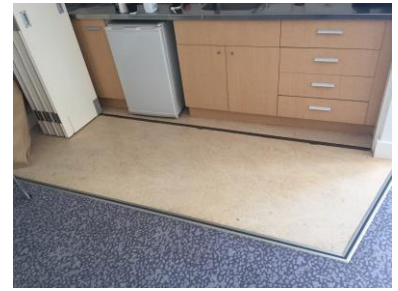
Photograph No.	037
Location/Area	Kereru Wing: Kitchen
Suspected Material Identified	Vinyl Flooring (Cream)
Condition of Material Identified	Good
<b>Categories: (Assessment type).</b> 1: ACM common characteristics or 2: Presumed ACM or 3: Sample collected for analysis	2: Presumed
Sample No.	Sample not taken
Laboratory Analysis Findings	Analysis not conducted
Quantity of Material Identified	4.0m2

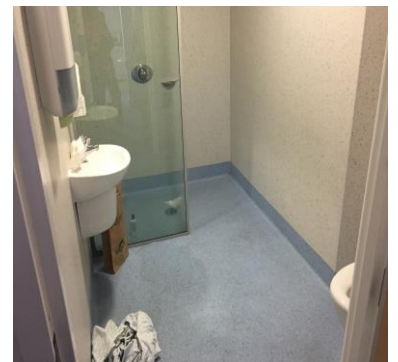
Photograph No.	038
Location/Area	Kereru Wing: Bathroom
Suspected Material Identified	Vinyl Floor/Walls (Blue/Stone)
Condition of Material Identified	Good
<b>Categories: (Assessment type).</b> 1: ACM common characteristics or 2: Presumed ACM or 3: Sample collected for analysis	2: Presumed
Sample No.	Sample not taken
Laboratory Analysis Findings	Analysis not conducted
Quantity of Material Identified	4.8m2 / 20.7m2

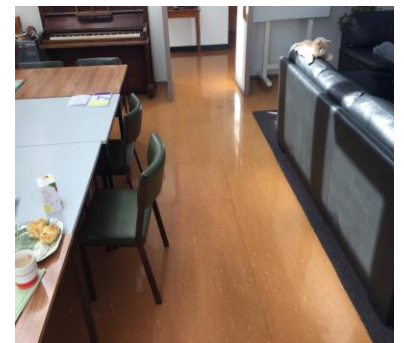
Photograph No.	039
Location/Area	Day Room Lounge
Suspected Material Identified	Vinyl Flooring (Orange)
Condition of Material Identified	Good
<b>Categories: (Assessment type).</b> 1: ACM common characteristics or 2: Presumed ACM or 3: Sample collected for analysis	2: Presumed
Sample No.	Sample not taken
Laboratory Analysis Findings	Analysis not conducted
Quantity of Material Identified	130.0m2

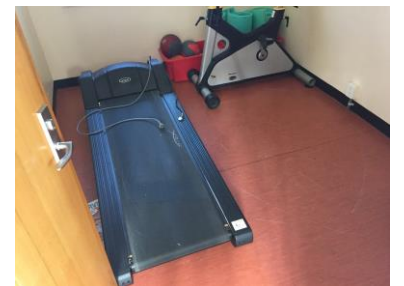
Photograph No.	040
Location/Area	Exercise Room
Suspected Material Identified	Vinyl Flooring (Red)
Condition of Material Identified	Good
<b>Categories: (Assessment type).</b> 1: ACM common characteristics or 2: Presumed ACM or 3: Sample collected for analysis	2: Presumed
Sample No.	Sample not taken
Laboratory Analysis Findings	Analysis not conducted
Quantity of Material Identified	8.1m2

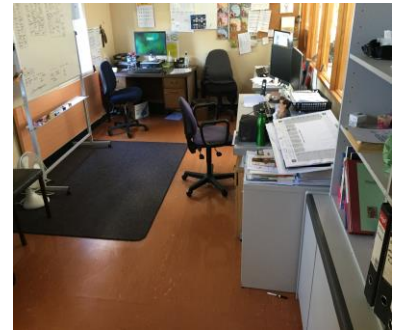
Photograph No.	041
Location/Area	Day Room Office
Suspected Material Identified	Vinyl Flooring (Orange)
Condition of Material Identified	Good
<b>Categories: (Assessment type).</b> 1: ACM common characteristics or 2: Presumed ACM or 3: Sample collected for analysis	2: Presumed
Sample No.	Sample not taken
Laboratory Analysis Findings	Analysis not conducted
Quantity of Material Identified	26.1m2

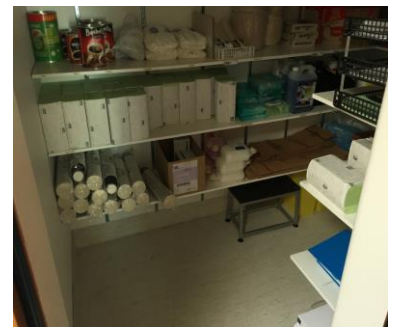
Photograph No.	042
Location/Area	Store Room 1
Suspected Material Identified	Vinyl Flooring (Grey)
Condition of Material Identified	Good
<b>Categories: (Assessment type).</b> 1: ACM common characteristics or 2: Presumed ACM or 3: Sample collected for analysis	2: Presumed
Sample No.	Sample not taken
Laboratory Analysis Findings	Analysis not conducted
Quantity of Material Identified	4.4m2

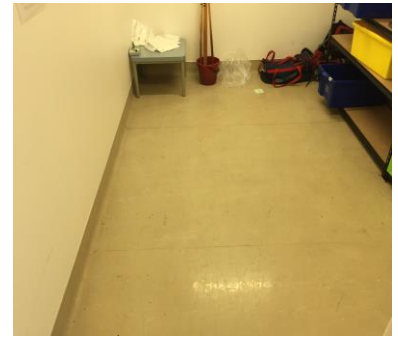
Photograph No.	043
Location/Area	Store Room 2
Suspected Material Identified	Vinyl Flooring (Cream)
Condition of Material Identified	Good
<b>Categories: (Assessment type).</b> 1: ACM common characteristics or 2: Presumed ACM or 3: Sample collected for analysis	2: Presumed
Sample No.	Sample not taken
Laboratory Analysis Findings	Analysis not conducted
Quantity of Material Identified	8.2m2

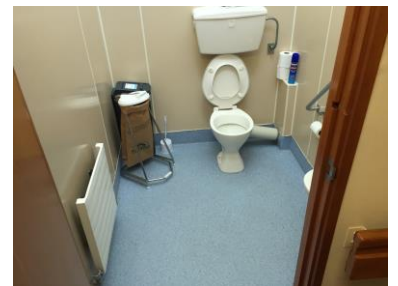
Photograph No.	044
Location/Area	Staff Area: Toilet
Suspected Material Identified	Vinyl Flooring (Blue)
Condition of Material Identified	Good
<b>Categories: (Assessment type).</b> 1: ACM common characteristics or 2: Presumed ACM or 3: Sample collected for analysis	2: Presumed
Sample No.	Sample not taken
Laboratory Analysis Findings	Analysis not conducted
Quantity of Material Identified	2.3m2

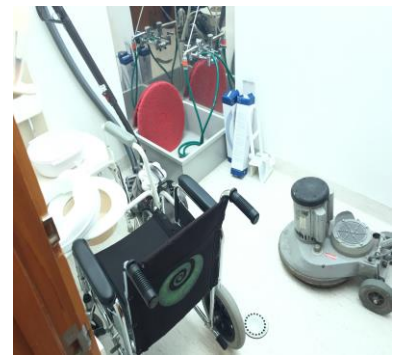
Photograph No.	045
Location/Area	Staff Area: Bathroom
Suspected Material Identified	Vinyl Flooring (Light Blue)
Condition of Material Identified	Good
<b>Categories: (Assessment type).</b> 1: ACM common characteristics or 2: Presumed ACM or 3: Sample collected for analysis	2: Presumed
Sample No.	Sample not taken
Laboratory Analysis Findings	Analysis not conducted
Quantity of Material Identified	4.5m2

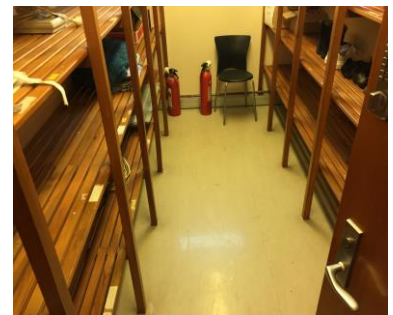
Photograph No.	046
Location/Area	Staff Area: Linen Room
Suspected Material Identified	Vinyl Flooring (Green)
Condition of Material Identified	Good
<b>Categories: (Assessment type).</b> 1: ACM common characteristics or 2: Presumed ACM or 3: Sample collected for analysis	2: Presumed
Sample No.	Sample not taken
Laboratory Analysis Findings	Analysis not conducted
Quantity of Material Identified	8.0m2

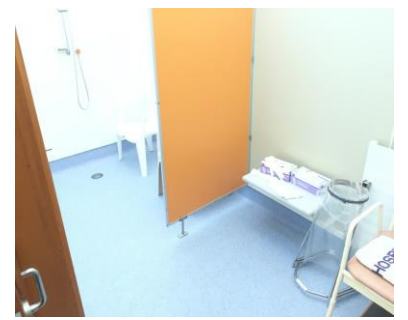
Photograph No.	047
Location/Area	Staff Area: W/C Shower
Suspected Material Identified	Vinyl Flooring (Light Blue)
Condition of Material Identified	Good
<b>Categories: (Assessment type).</b> 1: ACM common characteristics or 2: Presumed ACM or 3: Sample collected for analysis	2: Presumed
Sample No.	Sample not taken
Laboratory Analysis Findings	Analysis not conducted
Quantity of Material Identified	7.2m2
