## Asbestos Management Survey Report

**WHANGANUI HOSPITAL  
TE WHARE KAKARIKI**

**ASBESTOS MANAGEMENT SURVEY**

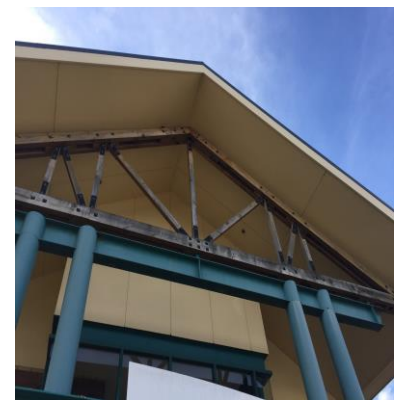
Photograph No.	001
Location/Area	Main Entry (canopy)
Suspected Material Identified	ACM Board
Condition of Material Identified	Good
<b>Categories: (Assessment type).</b> 1: ACM common characteristics or 2: Presumed ACM or 3: Sample collected for analysis	Presumed ACM
Sample No.	N/A
Laboratory Analysis Findings	N/A
Quantity of Material Identified	60 m <sup>2</sup>

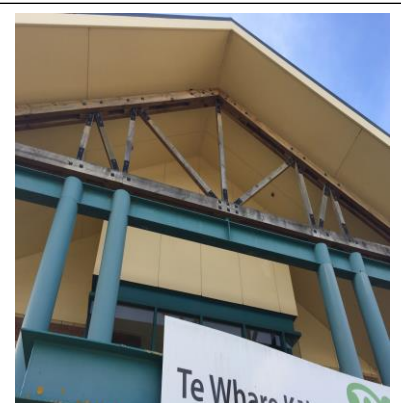
**ID: CARD NO:002**

Photograph No.	002
Location/Area	Main Entry (walls)
Suspected Material Identified	ACM Board
Condition of Material Identified	Good
<b>Categories: (Assessment type).</b> 1: ACM common characteristics or 2: or 3: Sample collected for analysis	Presumed ACM
Sample No.	N/A
Laboratory Analysis Findings	N/A
Quantity of Material Identified	26 m <sup>2</sup>

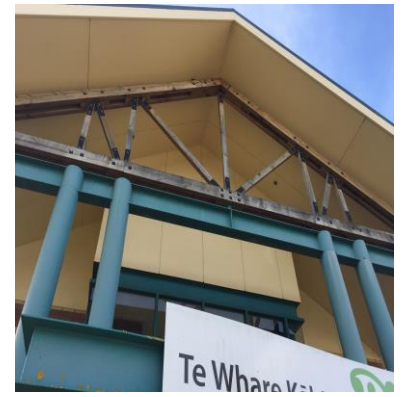
**ID: CARD NO:003**

Photograph No.	003
Location/Area	Soffit Lining (all areas)
Suspected Material Identified	ACM Board
Condition of Material Identified	Good
<b>Categories: (Assessment type).</b> 1: ACM common characteristics or 2: or 3: Sample collected for analysis	Presumed ACM
Sample No.	N/A
Laboratory Analysis Findings	N/A
Quantity of Material Identified	165.9 m <sup>2</sup>

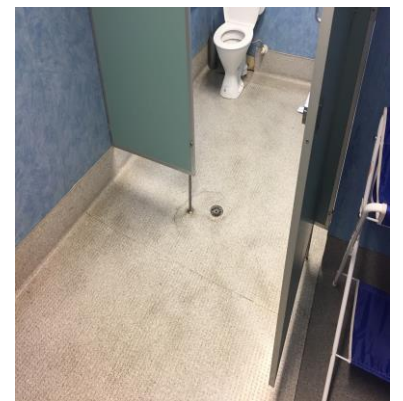
Photograph No.	004
Location/Area	Reception Area Unisex Toilet
Suspected Material Identified	Vinyl Floor
Condition of Material Identified	Good
<b>Categories: (Assessment type).</b> 1: ACM common characteristics or 2: or 3: Sample collected for analysis	Presumed ACM
Sample No.	N/A
Laboratory Analysis Findings	N/A
Quantity of Material Identified	9.5m <sup>2</sup>

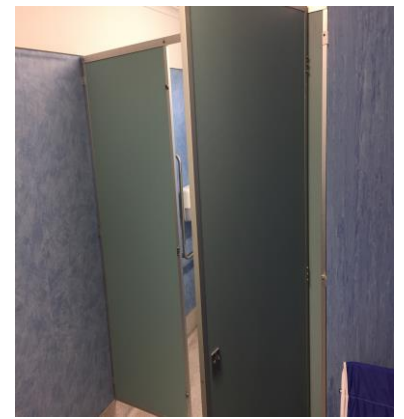
Photograph No.	005
Location/Area	Reception Area Unisex Toilet
Suspected Material Identified	Vinyl Walls
Condition of Material Identified	Good
<b>Categories: (Assessment type).</b> 1: ACM common characteristics or 2: or 3: Sample collected for analysis	Presumed ACM
Sample No.	N/A
Laboratory Analysis Findings	N/A
Quantity of Material Identified	25 m <sup>2</sup>

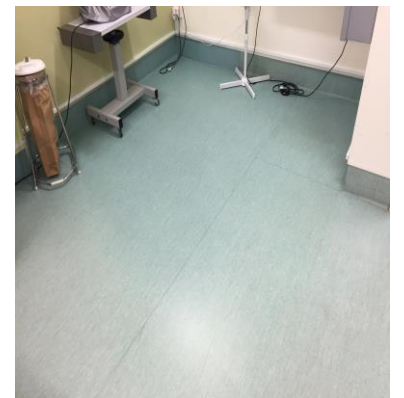
Photograph No.	006
Location/Area	Clinic Rm 1
Suspected Material Identified	Vinyl Floor
Condition of Material Identified	Good
<b>Categories: (Assessment type).</b> 1: ACM common characteristics or 2: or 3: Sample collected for analysis	Presumed ACM
Sample No.	N/A
Laboratory Analysis Findings	N/A
Quantity of Material Identified	20.3m <sup>2</sup>

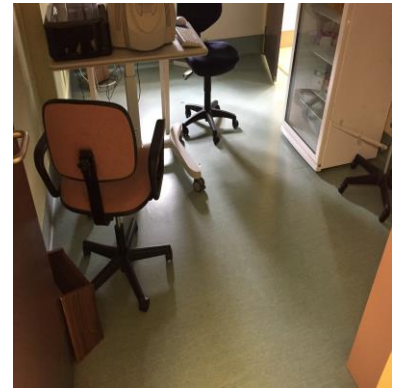
Photograph No.	007
Location/Area	Eye Exam Room
Suspected Material Identified	Vinyl Floor
Condition of Material Identified	Good
<b>Categories: (Assessment type).</b> 1: ACM common characteristics or 2: or 3: Sample collected for analysis	Presumed ACM
Sample No.	N/A
Laboratory Analysis Findings	N/A
Quantity of Material Identified	11 m <sup>2</sup>

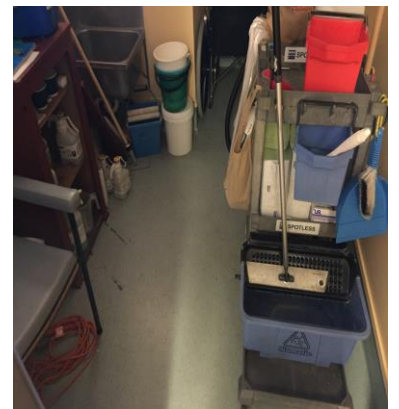
Photograph No.	008
Location/Area	Cleaners Cupboard
Suspected Material Identified	Vinyl Floor
Condition of Material Identified	Good
<b>Categories: (Assessment type).</b> 1: ACM common characteristics or 2: or 3: Sample collected for analysis	Presumed ACM
Sample No.	N/A
Laboratory Analysis Findings	N/A
Quantity of Material Identified	7m <sup>2</sup>

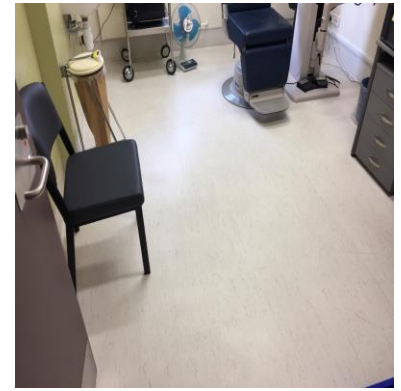
Photograph No.	009
Location/Area	Consulting Room 2
Suspected Material Identified	Vinyl Floor
Condition of Material Identified	Good
<b>Categories: (Assessment type).</b> 1: ACM common characteristics or 2: or 3: Sample collected for analysis	Presumed ACM
Sample No.	N/A
Laboratory Analysis Findings	N/A
Quantity of Material Identified	10.9 m <sup>2</sup>

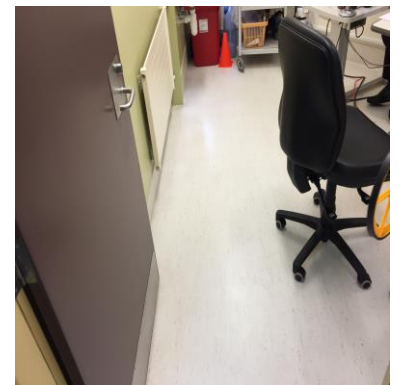
Photograph No.	010
Location/Area	Consulting Room 5
Suspected Material Identified	Vinyl Floor
Condition of Material Identified	Good
<b>Categories: (Assessment type).</b> 1: ACM common characteristics or 2: or 3: Sample collected for analysis	Presumed ACM
Sample No.	N/A
Laboratory Analysis Findings	N/A
Quantity of Material Identified	12m <sup>2</sup>

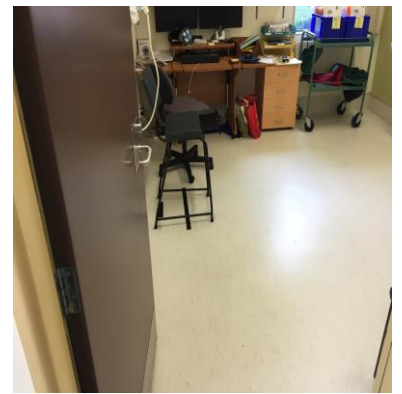
Photograph No.	011
Location/Area	Consulting Room 4
Suspected Material Identified	Vinyl Floor
Condition of Material Identified	Good
<b>Categories: (Assessment type).</b> 1: ACM common characteristics or 2: Presumed ACM or 3: Sample collected for analysis	Presumed ACM
Sample No.	N/A
Laboratory Analysis Findings	N/A
Quantity of Material Identified	14m <sup>2</sup>

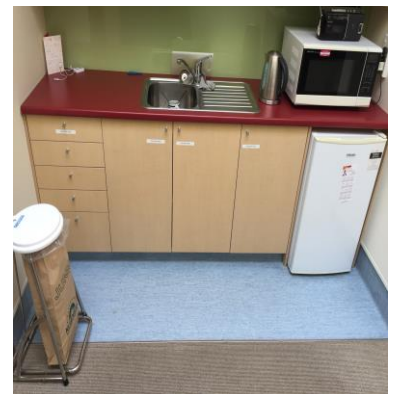
Photograph No.	012
Location/Area	Kitchen
Suspected Material Identified	Vinyl Floor
Condition of Material Identified	Good
<b>Categories: (Assessment type).</b> 1: ACM common characteristics or 2: Presumed ACM or 3: Sample collected for analysis	Presumed ACM
Sample No.	N/A
Laboratory Analysis Findings	N/A
Quantity of Material Identified	1.7 m <sup>2</sup>

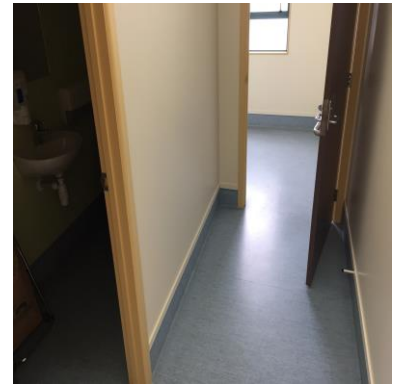
Photograph No.	013
Location/Area	Staff Toilets
Suspected Material Identified	Vinyl Floor
Condition of Material Identified	Good
<b>Categories: (Assessment type).</b> 1: ACM common characteristics or 2: Presumed ACM or 3: Sample collected for analysis	Presumed ACM
Sample No.	N/A
Laboratory Analysis Findings	N/A
Quantity of Material Identified	10.5m <sup>2</sup>

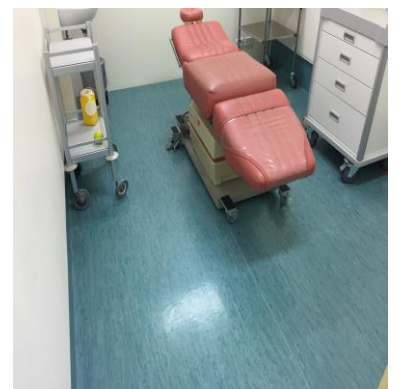
Photograph No.	014
Location/Area	Injection Room
Suspected Material Identified	Vinyl Floor
Condition of Material Identified	Good
<b>Categories: (Assessment type).</b> 1: ACM common characteristics or 2: Presumed ACM or 3: Sample collected for analysis	Presumed ACM
Sample No.	N/A
Laboratory Analysis Findings	N/A
Quantity of Material Identified	9.8m <sup>2</sup>

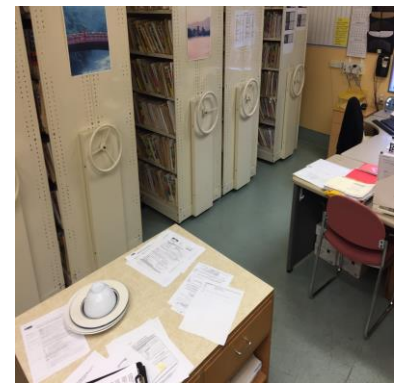
Photograph No.	015
Location/Area	Files Room
Suspected Material Identified	Vinyl Floor
Condition of Material Identified	Good
<b>Categories: (Assessment type).</b> 1: ACM common characteristics or 2: Presumed ACM or 3: Sample collected for analysis	Presumed ACM
Sample No.	N/A
Laboratory Analysis Findings	N/A
Quantity of Material Identified	69m <sup>2</sup>

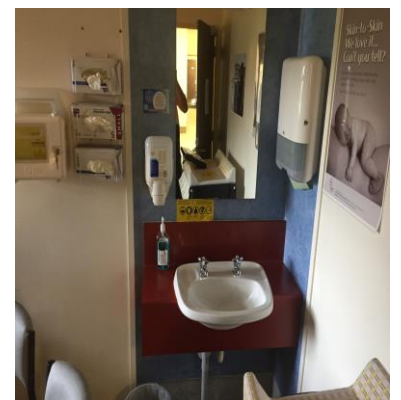
Photograph No.	016
Location/Area	Clinic Room 4
Suspected Material Identified	Vinyl Floor/Walls
Condition of Material Identified	Good
<b>Categories: (Assessment type).</b> 1: ACM common characteristics or 2: Presumed ACM or 3: Sample collected for analysis	Presumed ACM
Sample No.	N/A
Laboratory Analysis Findings	N/A
Quantity of Material Identified	24m <sup>2</sup>

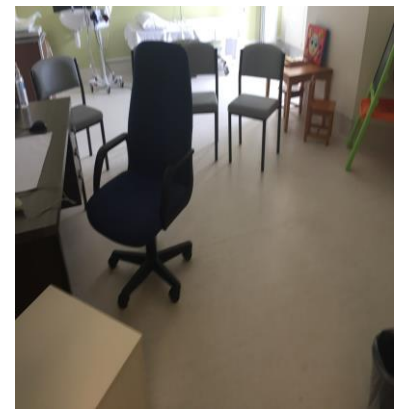
Photograph No.	017
Location/Area	Women & children Ward Consulting Room 3
Suspected Material Identified	Vinyl Floor
Condition of Material Identified	Good
<b>Categories: (Assessment type).</b> 1: ACM common characteristics or 2: Presumed ACM or 3: Sample collected for analysis	Presumed ACM
Sample No.	N/A
Laboratory Analysis Findings	N/A
Quantity of Material Identified	12.8m <sup>2</sup>

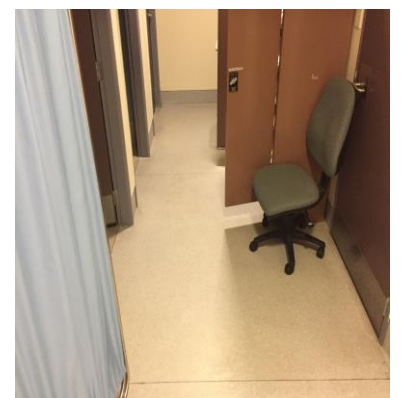
Photograph No.	018
Location/Area	Women & children Ward Consulting Room 1
Suspected Material Identified	Vinyl Floor
Condition of Material Identified	Good
<b>Categories: (Assessment type).</b> 1: ACM common characteristics or 2: Presumed ACM or 3: Sample collected for analysis	Presumed ACM
Sample No.	N/A
Laboratory Analysis Findings	N/A
Quantity of Material Identified	30m <sup>2</sup>

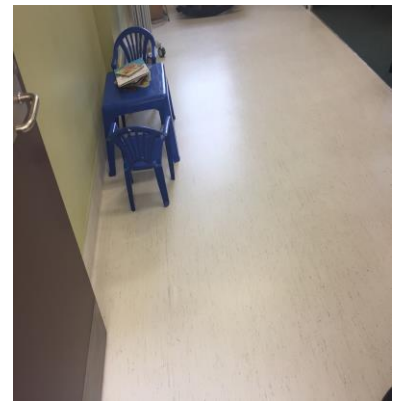
Photograph No.	019
Location/Area	Women & children Ward Bathroom Entry
Suspected Material Identified	Vinyl Floor
Condition of Material Identified	Good
<b>Categories: (Assessment type).</b> 1: ACM common characteristics or 2: Presumed ACM or 3: Sample collected for analysis	Presumed ACM
Sample No.	N/A
Laboratory Analysis Findings	N/A
Quantity of Material Identified	10m <sup>2</sup>

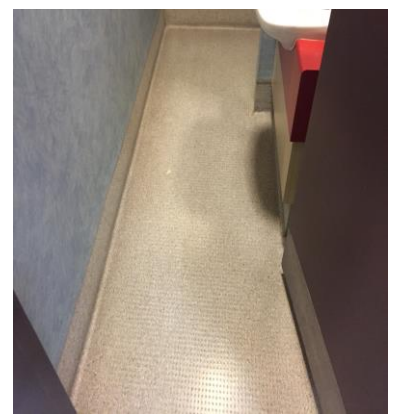
Photograph No.	020
Location/Area	Women & children Ward Bathroom
Suspected Material Identified	Vinyl Floor
Condition of Material Identified	Good
<b>Categories: (Assessment type).</b> 1: ACM common characteristics or 2: Presumed ACM or 3: Sample collected for analysis	Presumed ACM
Sample No.	N/A
Laboratory Analysis Findings	N/A
Quantity of Material Identified	8.7m <sup>2</sup>

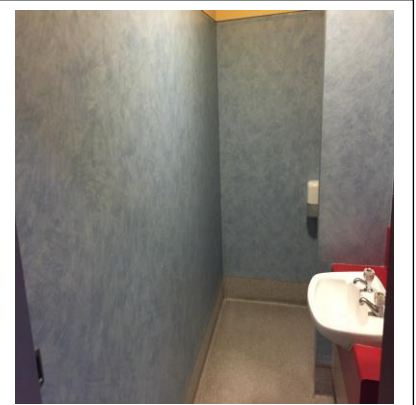
Photograph No.	021
Location/Area	Women & children Ward Bathroom
Suspected Material Identified	Vinyl Walls
Condition of Material Identified	Good
<b>Categories: (Assessment type).</b> 1: ACM common characteristics or 2: Presumed ACM or 3: Sample collected for analysis	Presumed ACM
Sample No.	N/A
Laboratory Analysis Findings	N/A
Quantity of Material Identified	29m <sup>2</sup>

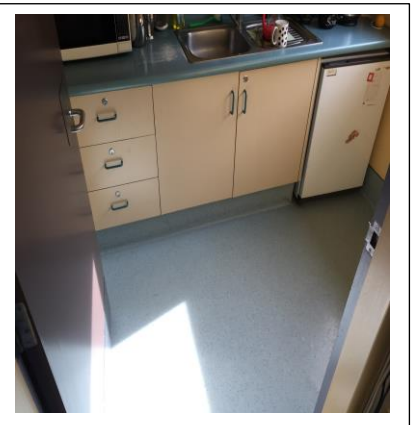
Photograph No.	022
Location/Area	Women & children Ward Child Therapy-Kitchen
Suspected Material Identified	Vinyl Floor
Condition of Material Identified	Good
<b>Categories: (Assessment type).</b> 1: ACM common characteristics or 2: Presumed ACM or 3: Sample collected for analysis	Presumed ACM
Sample No.	N/A
Laboratory Analysis Findings	N/A
Quantity of Material Identified	2.4m <sup>2</sup>

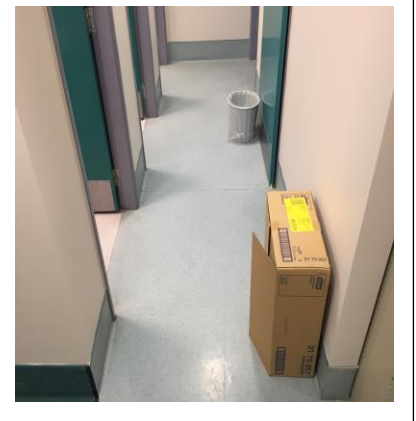
Photograph No.	023
Location/Area	Women & children Ward Ladies Toilet (entry)
Suspected Material Identified	Vinyl Floor
Condition of Material Identified	Good
<b>Categories: (Assessment type).</b> 1: ACM common characteristics or 2: Presumed ACM or 3: Sample collected for analysis	Presumed ACM
Sample No.	N/A
Laboratory Analysis Findings	N/A
Quantity of Material Identified	13m <sup>2</sup>

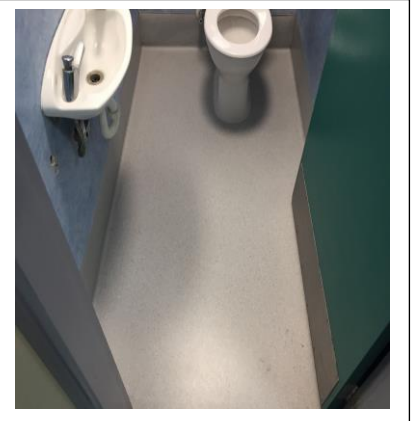
Photograph No.	024
Location/Area	Women & children Ward Ladies Toilet
Suspected Material Identified	Vinyl Floor
Condition of Material Identified	Good
<b>Categories: (Assessment type).</b> 1: ACM common characteristics or 2: Presumed ACM or 3: Sample collected for analysis	Presumed ACM
Sample No.	N/A
Laboratory Analysis Findings	N/A
Quantity of Material Identified	5.4m <sup>2</sup>

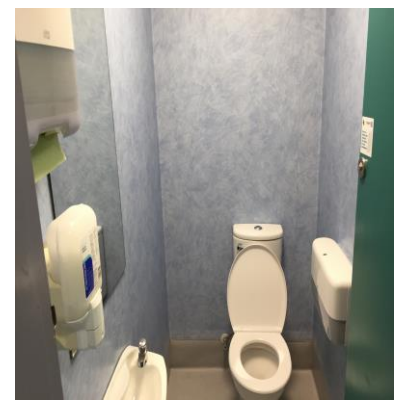
Photograph No.	025
Location/Area	Women & children Ward Ladies Toilet
Suspected Material Identified	Vinyl Walls
Condition of Material Identified	Good
<b>Categories: (Assessment type).</b> 1: ACM common characteristics or 2: Presumed ACM or 3: Sample collected for analysis	Presumed ACM
Sample No.	N/A
Laboratory Analysis Findings	N/A
Quantity of Material Identified	28m <sup>2</sup>

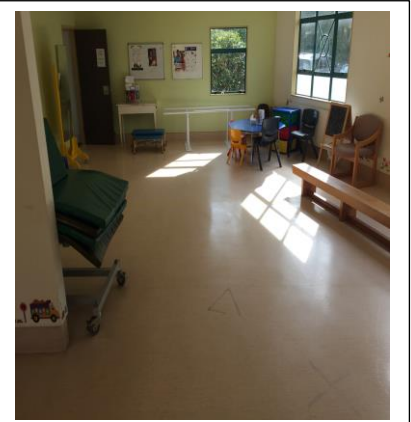
Photograph No.	026
Location/Area	Women & children Ward Development Gym
Suspected Material Identified	Vinyl Floor
Condition of Material Identified	Good
<b>Categories: (Assessment type).</b> 1: ACM common characteristics or 2: Presumed ACM or 3: Sample collected for analysis	Presumed ACM
Sample No.	N/A
Laboratory Analysis Findings	N/A
Quantity of Material Identified	70m <sup>2</sup>

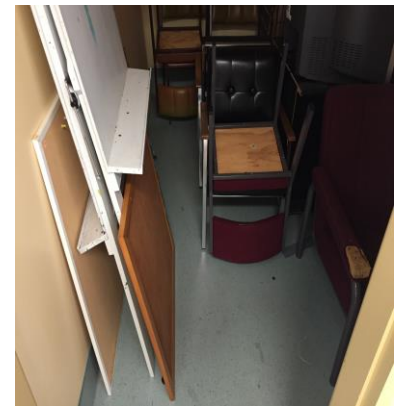
Photograph No.	027
Location/Area	Women & children Ward Meeting Room (store rm)
Suspected Material Identified	Vinyl Floor
Condition of Material Identified	Good
<b>Categories: (Assessment type).</b> 1: ACM common characteristics or 2: Presumed ACM or 3: Sample collected for analysis	Presumed ACM
Sample No.	N/A
Laboratory Analysis Findings	N/A
Quantity of Material Identified	5m <sup>2</sup>

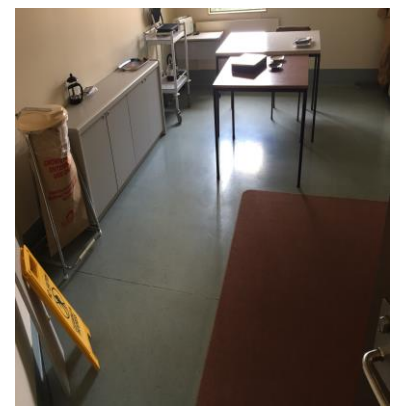
Photograph No.	028
Location/Area	Women & children Ward Kitchen
Suspected Material Identified	Vinyl Floor
Condition of Material Identified	Good
<b>Categories: (Assessment type).</b> 1: ACM common characteristics or 2: Presumed ACM or 3: Sample collected for analysis	Presumed ACM
Sample No.	N/A
Laboratory Analysis Findings	N/A
Quantity of Material Identified	24m <sup>2</sup>

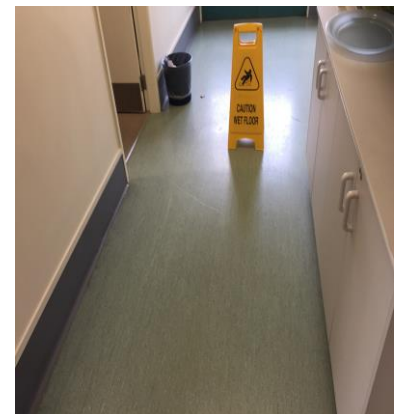
Photograph No.	029
Location/Area	Women & children Ward Foyer/Kitchen
Suspected Material Identified	Vinyl Floor
Condition of Material Identified	Good
<b>Categories: (Assessment type).</b> 1: ACM common characteristics or 2: Presumed ACM or 3: Sample collected for analysis	Presumed ACM
Sample No.	N/A
Laboratory Analysis Findings	N/A
Quantity of Material Identified	5.6m <sup>2</sup>

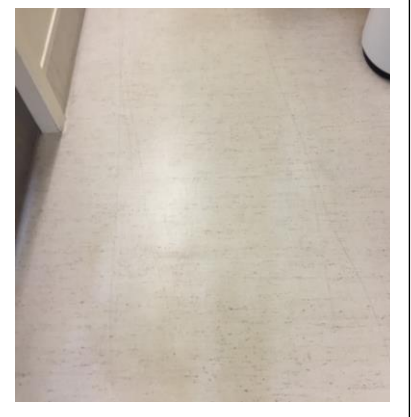
Photograph No.	030
Location/Area	Women & children Ward Foyer Rear Entry
Suspected Material Identified	Vinyl Floor
Condition of Material Identified	Good
<b>Categories: (Assessment type).</b> 1: ACM common characteristics or 2: Presumed ACM or 3: Sample collected for analysis	Presumed ACM
Sample No.	N/A
Laboratory Analysis Findings	N/A
Quantity of Material Identified	8.9m <sup>2</sup>

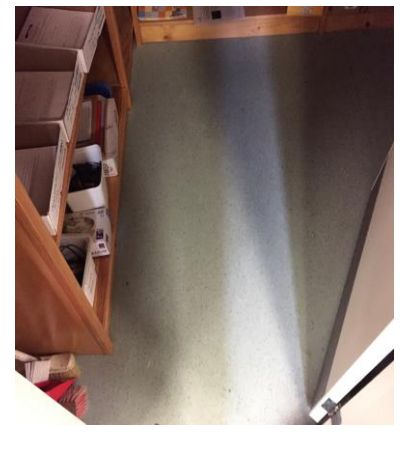
Photograph No.	031
Location/Area	Women & children Ward Resource Room 1
Suspected Material Identified	Vinyl Floor
Condition of Material Identified	Good
<b>Categories: (Assessment type).</b> 1: ACM common characteristics or 2: Presumed ACM or 3: Sample collected for analysis	Presumed ACM
Sample No.	N/A
Laboratory Analysis Findings	N/A
Quantity of Material Identified	6m <sup>2</sup>

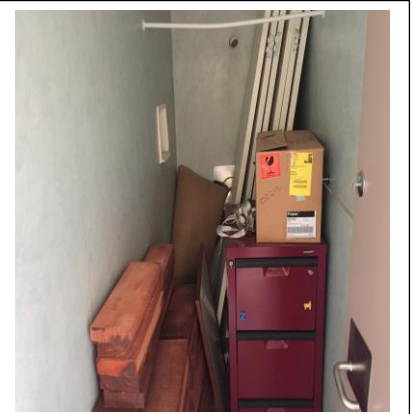
Photograph No.	032
Location/Area	Women & children Ward (b)
Suspected Material Identified	Vinyl Floor/Walls
Condition of Material Identified	Good
<b>Categories: (Assessment type).</b> 1: ACM common characteristics or 2: Presumed ACM or 3: Sample collected for analysis	Presumed ACM
Sample No.	N/A
Laboratory Analysis Findings	N/A
Quantity of Material Identified	3.1m <sup>2</sup> / 13.3m <sup>2</sup>

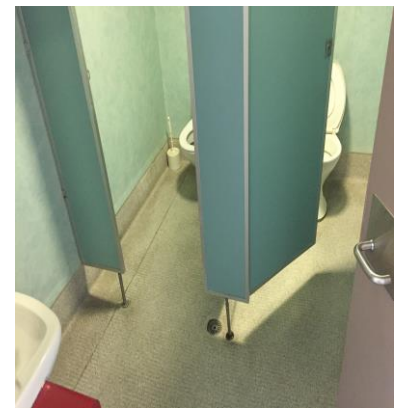
Photograph No.	033
Location/Area	Women & children Ward (b) Male Toilet
Suspected Material Identified	Vinyl Floor/Walls
Condition of Material Identified	Good
<b>Categories: (Assessment type).</b> 1: ACM common characteristics or 2: Presumed ACM or 3: Sample collected for analysis	Presumed ACM
Sample No.	N/A
Laboratory Analysis Findings	N/A
Quantity of Material Identified	6.3m <sup>2</sup> / 24m <sup>2</sup>

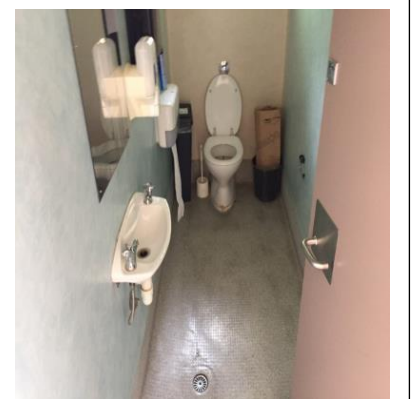
Photograph No.	034
Location/Area	Women & children Ward (b) Toilet
Suspected Material Identified	Vinyl Floor/Walls
Condition of Material Identified	Good
<b>Categories: (Assessment type).</b> 1: ACM common characteristics or 2: Presumed ACM or 3: Sample collected for analysis	Presumed ACM
Sample No.	N/A
Laboratory Analysis Findings	N/A
Quantity of Material Identified	3m <sup>2</sup> / 15.4m <sup>2</sup>

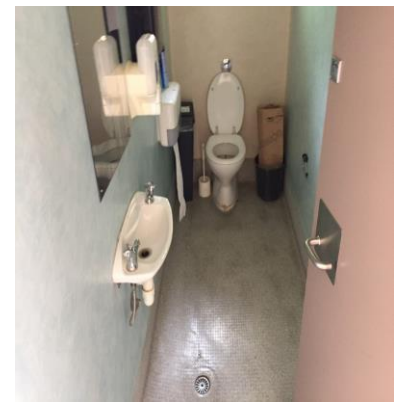
Photograph No.	035
Location/Area	Women & children Ward (b) Toilet
Suspected Material Identified	Vinyl Floor/Wall
Condition of Material Identified	Good
<b>Categories: (Assessment type).</b> 1: ACM common characteristics or 2: Presumed ACM or 3: Sample collected for analysis	Presumed ACM
Sample No.	N/A
Laboratory Analysis Findings	N/A
Quantity of Material Identified	3m <sup>2</sup> / 15.4m <sup>2</sup>

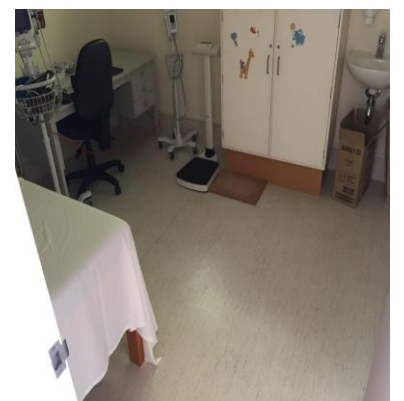
Photograph No.	036
Location/Area	Women & children Ward (a) Clinic room
Suspected Material Identified	Vinyl Floor
Condition of Material Identified	Good
<b>Categories: (Assessment type).</b> 1: ACM common characteristics or 2: Presumed ACM or 3: Sample collected for analysis	Presumed ACM
Sample No.	N/A
Laboratory Analysis Findings	N/A
Quantity of Material Identified	11.7m <sup>2</sup>

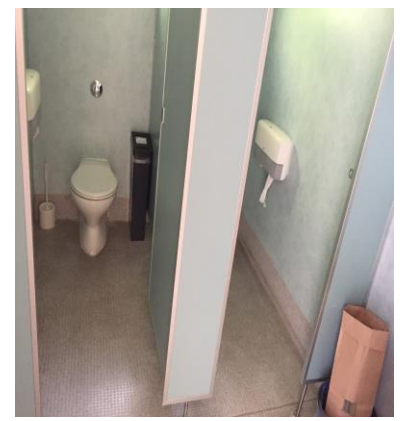
Photograph No.	037
Location/Area	Women & children Ward (a) Female Staff Toilet
Suspected Material Identified	Vinyl Floor/Walls
Condition of Material Identified	Good
<b>Categories: (Assessment type).</b> 1: ACM common characteristics or 2: Presumed ACM or 3: Sample collected for analysis	Presumed ACM
Sample No.	N/A
Laboratory Analysis Findings	N/A
Quantity of Material Identified	7.3m <sup>2</sup> / 23.3m <sup>2</sup>

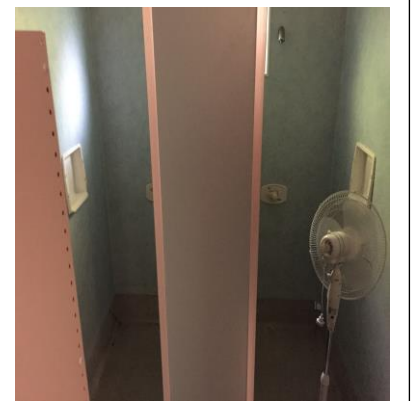
Photograph No.	038
Location/Area	Women & children Ward (a) Female Staff Shower
Suspected Material Identified	Vinyl Floor/Walls
Condition of Material Identified	Good
<b>Categories: (Assessment type).</b> 1: ACM common characteristics or 2: Presumed ACM or 3: Sample collected for analysis	Presumed ACM
Sample No.	N/A
Laboratory Analysis Findings	N/A
Quantity of Material Identified	7.3m <sup>2</sup> / 23.3m <sup>2</sup>

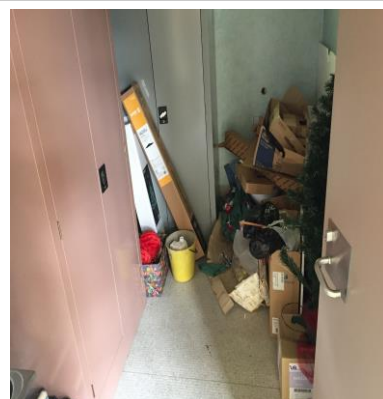
Photograph No.	039
Location/Area	Women & children Ward (a) Cleaners Room
Suspected Material Identified	Vinyl Floor/Walls
Condition of Material Identified	Good
<b>Categories: (Assessment type).</b> 1: ACM common characteristics or 2: Presumed ACM or 3: Sample collected for analysis	Presumed ACM
Sample No.	N/A
Laboratory Analysis Findings	N/A
Quantity of Material Identified	4.4m <sup>2</sup> / 19.9m <sup>2</sup>

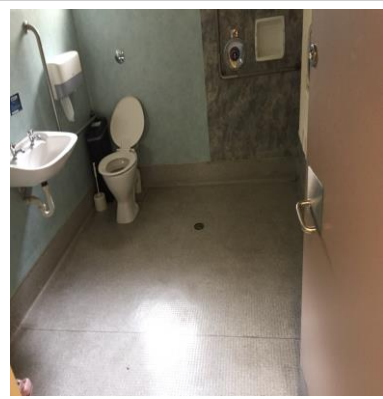
Photograph No.	040
Location/Area	Women & children Ward (a) Public Toilet
Suspected Material Identified	Vinyl Floor/wall
Condition of Material Identified	Good
<b>Categories: (Assessment type).</b> 1: ACM common characteristics or 2: Presumed ACM or 3: Sample collected for analysis	Presumed ACM
Sample No.	N/A
Laboratory Analysis Findings	N/A
Quantity of Material Identified	9m <sup>2</sup> / 21m <sup>2</sup>

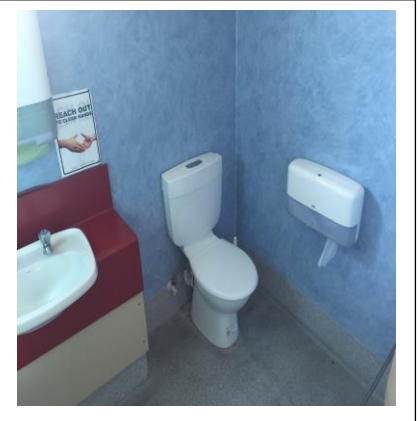
Photograph No.	041
Location/Area	Women & children Ward Upstairs Male Toilet
Suspected Material Identified	Vinyl Floor/Wall
Condition of Material Identified	Good
<b>Categories: (Assessment type).</b> 1: ACM common characteristics or 2: Presumed ACM or 3: Sample collected for analysis	Presumed ACM
Sample No.	N/A
Laboratory Analysis Findings	N/A
Quantity of Material Identified	4m <sup>2</sup> / 11m <sup>2</sup>

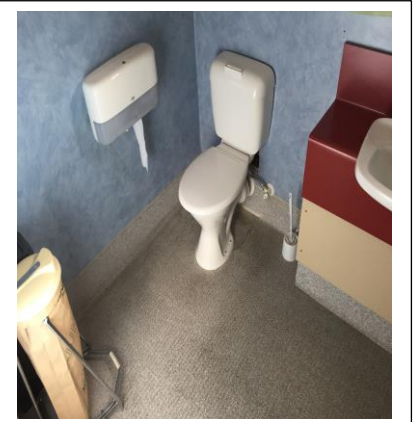
Photograph No.	042
Location/Area	Women & children Ward Upstairs Female Toilet
Suspected Material Identified	Vinyl Floor/Wall
Condition of Material Identified	Good
<b>Categories: (Assessment type).</b> 1: ACM common characteristics or 2: Presumed ACM or 3: Sample collected for analysis	Presumed ACM
Sample No.	N/A
Laboratory Analysis Findings	N/A
Quantity of Material Identified	4m <sup>2</sup> / 11m <sup>2</sup>
