## Asbestos Management Survey Report

Whanganui Hospital,  
Whakatau Mate House.

**Whakatau Mate House**

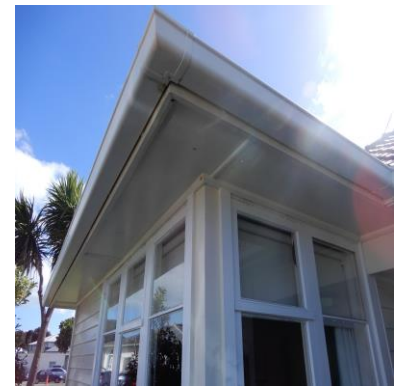
**ID: CARD NO:001**

Photograph No.	1
Location/Area	External: Soffit Lining
Suspected Material Identified	ACM board
Condition of Material Identified	Good
<b>Categories: (Assessment type).</b> 1: ACM common characteristics or 2: Presumed ACM or 3: Sample collected for analysis	2: Presumed ACM
Sample No.	Sample Not Taken
Laboratory Analysis Findings	Analysis Not Conducted
Quantity of Material Identified	12.0m2

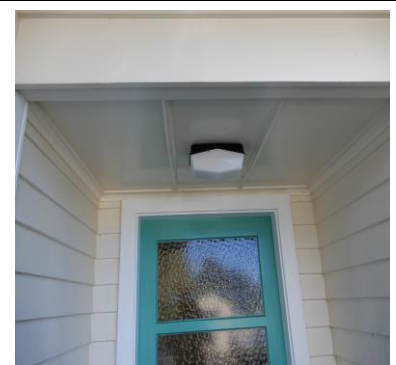
**ID: CARD NO:002**

Photograph No.	2
Location/Area	External: Front door Entry
Suspected Material Identified	ACM board
Condition of Material Identified	Good
<b>Categories: (Assessment type).</b> 1: ACM common characteristics or 2: Presumed ACM or 3: Sample collected for analysis	2: Presumed ACM
Sample No.	Sample Not Taken
Laboratory Analysis Findings	Analysis Not Conducted
Quantity of Material Identified	1.5m2

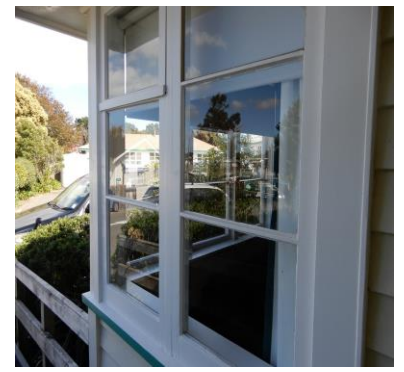
**ID: CARD NO:003**

Photograph No.	3
Location/Area	External: Window Frame
Suspected Material Identified	Compound Putty
Condition of Material Identified	Good
<b>Categories: (Assessment type).</b> 1: ACM common characteristics or 2: Presumed ACM or 3: Sample collected for analysis	2: Presumed ACM
Sample No.	Sample Not Taken
Laboratory Analysis Findings	Analysis Not Conducted
Quantity of Material Identified	56.0L/M

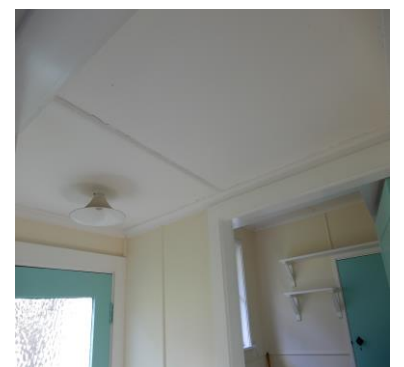
**ID: CARD NO:004**

Photograph No.	4
Location/Area	Internal: Rear Entry
Suspected Material Identified	ACM board
Condition of Material Identified	Good
<b>Categories: (Assessment type).</b> 1: ACM common characteristics or 2: Presumed ACM or 3: Sample collected for analysis	2: Presumed ACM
Sample No.	Sample Not Taken
Laboratory Analysis Findings	Analysis Not Conducted
Quantity of Material Identified	1.5m2

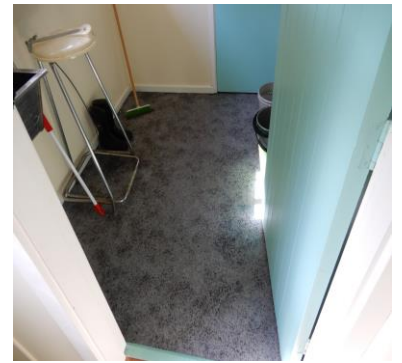
**ID: CARD NO:005**

Photograph No.	5
Location/Area	Internal: Laundry
Suspected Material Identified	Vinyl Flooring
Condition of Material Identified	Good
<b>Categories: (Assessment type).</b> 1: ACM common characteristics or 2: Presumed ACM or 3: Sample collected for analysis	2: Presumed ACM
Sample No.	Sample Not Taken
Laboratory Analysis Findings	Analysis Not Conducted
Quantity of Material Identified	3.0m2

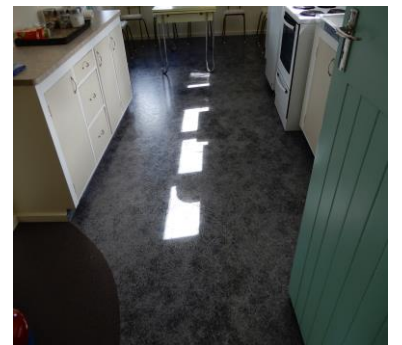
**ID: CARD NO:006**

Photograph No.	6
Location/Area	Internal: Kitchen
Suspected Material Identified	Vinyl Flooring
Condition of Material Identified	Good
<b>Categories: (Assessment type).</b> 1: ACM common characteristics or 2: Presumed ACM or 3: Sample collected for analysis	2: Presumed ACM
Sample No.	Sample Not Taken
Laboratory Analysis Findings	Analysis Not Conducted
Quantity of Material Identified	15.0m2

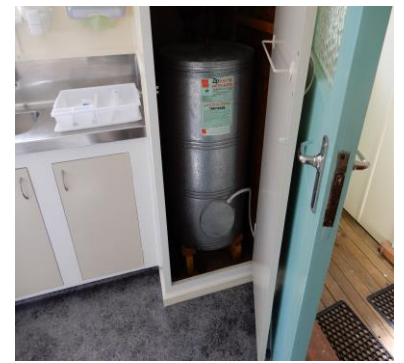
**ID: CARD NO:007**

Photograph No.	7
Location/Area	Internal: Kitchen (H.W.C.)
Suspected Material Identified	ACM Board
Condition of Material Identified	Good
<b>Categories: (Assessment type).</b> 1: ACM common characteristics or 2: Presumed ACM or 3: Sample collected for analysis	2: Presumed ACM
Sample No.	Sample Not Taken
Laboratory Analysis Findings	Analysis Not Conducted
Quantity of Material Identified	2.0m2

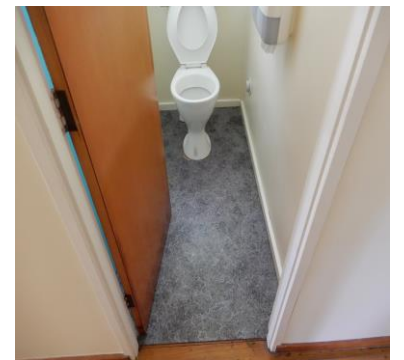
**ID: CARD NO:008**

Photograph No.	8
Location/Area	Internal: Toilet
Suspected Material Identified	Vinyl Flooring
Condition of Material Identified	Good
<b>Categories: (Assessment type).</b> 1: ACM common characteristics or 2: Presumed ACM or 3: Sample collected for analysis	2: Presumed ACM
Sample No.	Sample Not Taken
Laboratory Analysis Findings	Analysis Not Conducted
Quantity of Material Identified	2.0m2

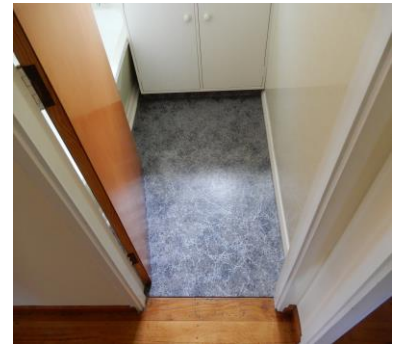
**ID: CARD NO:009**

Photograph No.	9
Location/Area	Internal: Bathroom
Suspected Material Identified	Vinyl Flooring
Condition of Material Identified	Good
<b>Categories: (Assessment type).</b> 1: ACM common characteristics or 2: Presumed ACM or 3: Sample collected for analysis	2: Presumed ACM
Sample No.	Sample Not Taken
Laboratory Analysis Findings	Analysis Not Conducted
Quantity of Material Identified	1.3m2
