Asbestos Management Survey Report

WHANGANUI HOSPITAL KITCHEN SURVEY

KITCHEN-EXTERIOR & INTERNAL

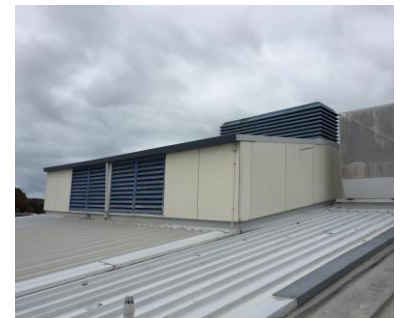
Photograph No.	1
Location/Area	Exterior: Rooftop-Vent Walls
Suspected Material Identified	ACM Board
Condition of Material Identified	Good
Categories: (Assessment type). 1: ACM common characteristics or 2: Presumed ACM or 3: Sample collected for analysis	2: Presumed ACM
Sample No.	Sample Not Taken
Laboratory Analysis Findings	Analysis Not Required
Quantity of Material Identified	44.34m2

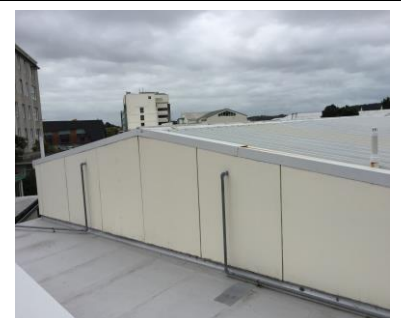
ID: CARD NO:002

Photograph No.	2
Location/Area	Exterior: Rooftop Walls
Suspected Material Identified	ACM Board
Condition of Material Identified	Good
Categories: (Assessment type). 1: ACM common characteristics or 2: Presumed ACM or 3: Sample collected for analysis	2: Presumed ACM
Sample No.	Sample Not Taken
Laboratory Analysis Findings	Analysis Not Required
Quantity of Material Identified	70.1m2

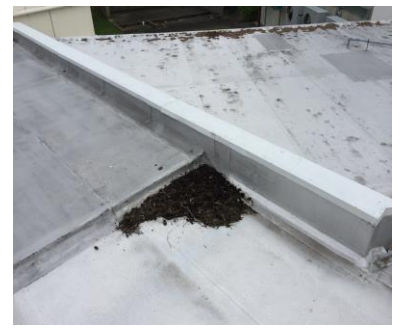
ID: CARD NO:003

Photograph No.	3
Location/Area	Exterior: Rooftop-Floor
Suspected Material Identified	Waterproofing (Silver)
Condition of Material Identified	Good
Categories: (Assessment type). 1: ACM common characteristics or 2: Presumed ACM or 3: Sample collected for analysis	2: Presumed ACM
Sample No.	Sample Not Taken
Laboratory Analysis Findings	Analysis Not Required
Quantity of Material Identified	257.0m2

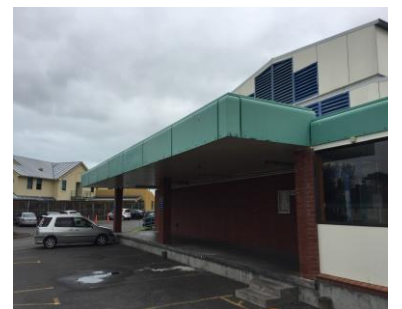
ID: CARD NO:004

Photograph No.	4
Location/Area	Exterior: Delivery Bay (Upper Wall)
Suspected Material Identified	ACM Board
Condition of Material Identified	Good
Categories: (Assessment type). 1: ACM common characteristics or 2: Presumed ACM or 3: Sample collected for analysis	2: Presumed ACM
Sample No.	Sample Not Taken
Laboratory Analysis Findings	Analysis Not Required
Quantity of Material Identified	23.2m2

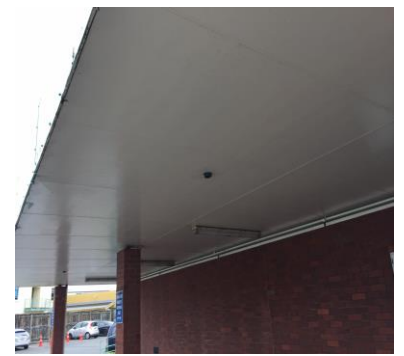
ID: CARD NO:005

Photograph No.	5
Location/Area	Exterior: Delivery Bay (Canopy)
Suspected Material Identified	ACM Board
Condition of Material Identified	Good
Categories: (Assessment type). 1: ACM common characteristics or 2: Presumed ACM or 3: Sample collected for analysis	2: Presumed ACM
Sample No.	Sample Not Taken
Laboratory Analysis Findings	Analysis Not Required
Quantity of Material Identified	75.0m2

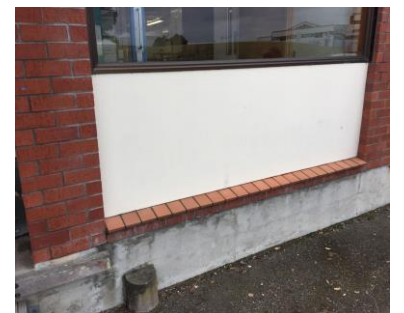
ID: CARD NO:006

Photograph No.	6
Location/Area	Exterior: Window Panels
Suspected Material Identified	ACM Board
Condition of Material Identified	Good
Categories: (Assessment type). 1: ACM common characteristics or 2: Presumed ACM or 3: Sample collected for analysis	2: Presumed ACM
Sample No.	Sample Not Taken
Laboratory Analysis Findings	Analysis Not Required
Quantity of Material Identified	4.3m2

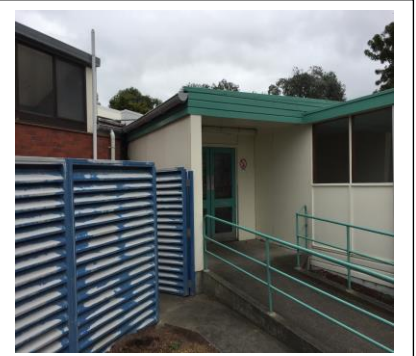
ID: CARD NO:007

Photograph No.	7
Location/Area	Exterior: Entry (Walls)
Suspected Material Identified	ACM Board
Condition of Material Identified	Good
Categories: (Assessment type). 1: ACM common characteristics or 2: Presumed ACM or 3: Sample collected for analysis	2: Presumed ACM
Sample No.	Sample Not Taken
Laboratory Analysis Findings	Analysis Not Required
Quantity of Material Identified	20.7m2

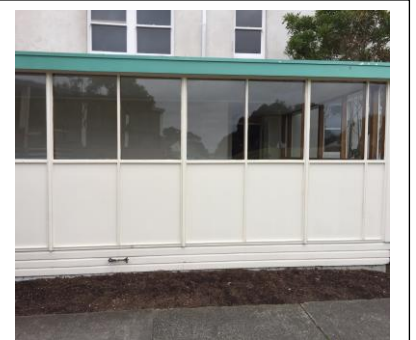
ID: CARD NO:008

Photograph No.	8
Location/Area	Exterior: Entry (Window Panels)
Suspected Material Identified	ACM Board
Condition of Material Identified	Good
Categories: (Assessment type). 1: ACM common characteristics or 2: Presumed ACM or 3: Sample collected for analysis	2: Presumed ACM
Sample No.	Sample Not Taken
Laboratory Analysis Findings	Analysis Not Required
Quantity of Material Identified	14.0m2

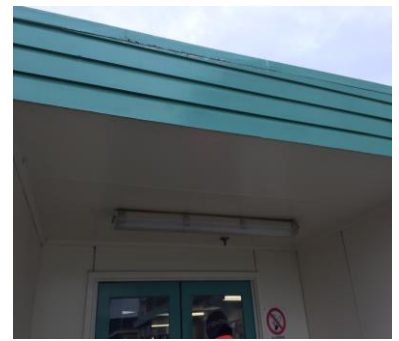
ID: CARD NO:009

Photograph No.	9
Location/Area	Exterior: Entry (Ceiling)
Suspected Material Identified	ACM Board
Condition of Material Identified	Good
Categories: (Assessment type). 1: ACM common characteristics or 2: Presumed ACM or 3: Sample collected for analysis	2: Presumed ACM
Sample No.	Sample Not Taken
Laboratory Analysis Findings	Analysis Not Required
Quantity of Material Identified	4.3m2

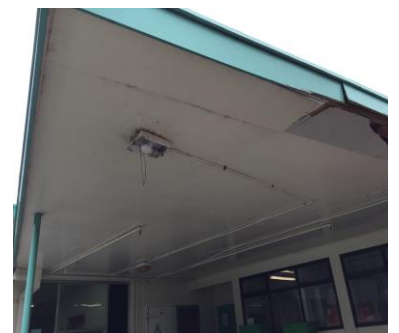
ID: CARD NO:010

Photograph No.	10
Location/Area	Exterior: West Delivery Bay (Canopy)
Suspected Material Identified	ACM Board
Condition of Material Identified	Good
Categories: (Assessment type). 1: ACM common characteristics or 2: Presumed ACM or 3: Sample collected for analysis	2: Presumed ACM
Sample No.	Sample Not Taken
Laboratory Analysis Findings	Analysis Not Required
Quantity of Material Identified	42.0m2

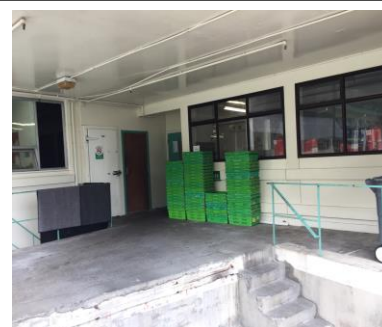
ID: CARD NO:011

Photograph No.	11
Location/Area	Exterior: West Delivery Bay (Walls)
Suspected Material Identified	ACM Board
Condition of Material Identified	Good
Categories: (Assessment type). 1: ACM common characteristics or 2: Presumed ACM or 3: Sample collected for analysis	2: Presumed ACM
Sample No.	Sample Not Taken
Laboratory Analysis Findings	Analysis Not Required
Quantity of Material Identified	17.0m2

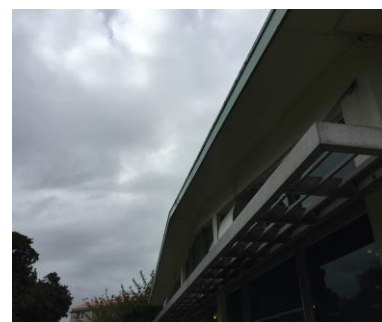
ID: CARD NO:012

Photograph No.	12
Location/Area	Exterior: Soffit Lining
Suspected Material Identified	ACM Board
Condition of Material Identified	Good
Categories: (Assessment type). 1: ACM common characteristics or 2: Presumed ACM or 3: Sample collected for analysis	2: Presumed ACM
Sample No.	Sample Not Taken
Laboratory Analysis Findings	Analysis Not Required
Quantity of Material Identified	82.0m2

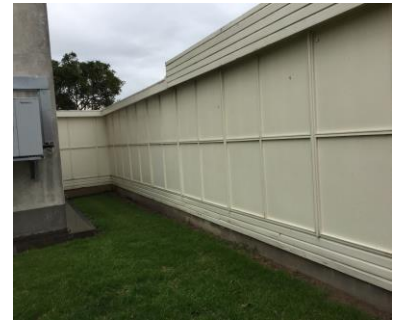
ID: CARD NO:013

Photograph No.	13
Location/Area	Exterior: North Side (Walls)
Suspected Material Identified	ACM Board
Condition of Material Identified	Good
Categories: (Assessment type). 1: ACM common characteristics or 2: Presumed ACM or 3: Sample collected for analysis	2: Presumed ACM
Sample No.	Sample Not Taken
Laboratory Analysis Findings	Analysis Not Required
Quantity of Material Identified	42.0m2

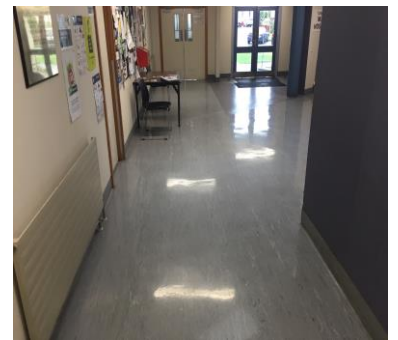
ID: CARD NO:014

Photograph No.	14
Location/Area	Main Foyer: Floor
Suspected Material Identified	Vinyl Floor (Blue/Grey)
Condition of Material Identified	Good
Categories: (Assessment type). 1: ACM common characteristics or 2: Presumed ACM or 3: Sample collected for analysis	2: Presumed ACM
Sample No.	Sample Not Taken
Laboratory Analysis Findings	Analysis Not Required
Quantity of Material Identified	76.5m2

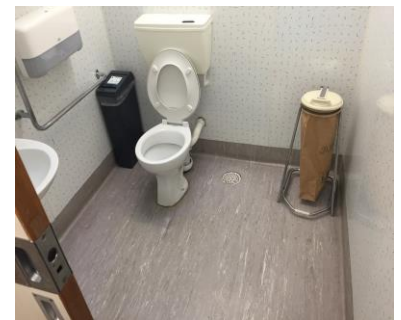
ID: CARD NO:015

Photograph No.	15
Location/Area	W/C Toilet: Floor
Suspected Material Identified	Vinyl Floor (Marble Brown)
Condition of Material Identified	Good
Categories: (Assessment type). 1: ACM common characteristics or 2: Presumed ACM or 3: Sample collected for analysis	2: Presumed ACM
Sample No.	Sample Not Taken
Laboratory Analysis Findings	Analysis Not Required
Quantity of Material Identified	2.5m2

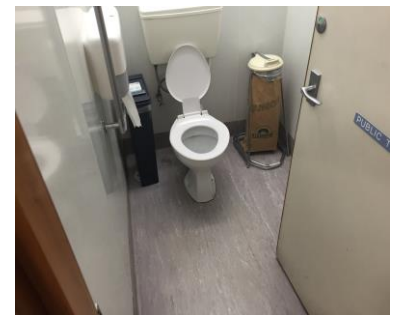
ID: CARD NO:016

Photograph No.	16
Location/Area	Public Toilet: (Floor)
Suspected Material Identified	Vinyl Floor (Marble Brown)
Condition of Material Identified	Good
Categories: (Assessment type). 1: ACM common characteristics or 2: Presumed ACM or 3: Sample collected for analysis	2: Presumed ACM
Sample No.	Sample Not Taken
Laboratory Analysis Findings	Analysis Not Required
Quantity of Material Identified	1.9m2

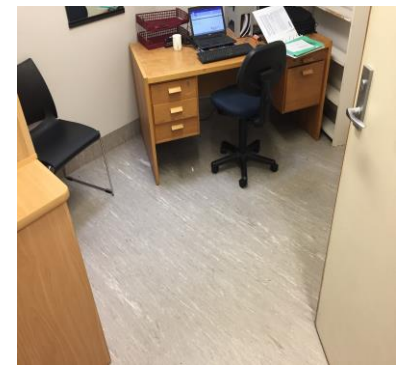
ID: CARD NO:017

Photograph No.	17
Location/Area	Spotless Office 1: Floor
Suspected Material Identified	Vinyl Floor (Marble Brown)
Condition of Material Identified	Good
Categories: (Assessment type). 1: ACM common characteristics or 2: Presumed ACM or 3: Sample collected for analysis	2: Presumed ACM
Sample No.	Sample Not Taken
Laboratory Analysis Findings	Analysis Not Required
Quantity of Material Identified	6.5m2

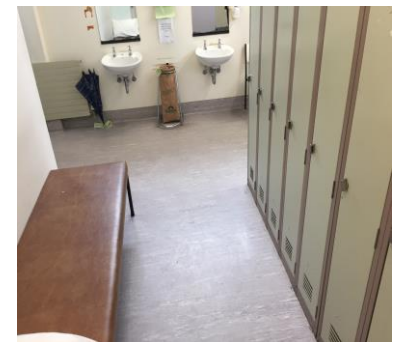
ID: CARD NO:018

Photograph No.	18
Location/Area	Female Staff Locker: Floor
Suspected Material Identified	Vinyl Floor (Marble Brown)
Condition of Material Identified	Good
Categories: (Assessment type). 1: ACM common characteristics or 2: Presumed ACM or 3: Sample collected for analysis	2: Presumed ACM
Sample No.	Sample Not Taken
Laboratory Analysis Findings	Analysis Not Required
Quantity of Material Identified	43.0m2

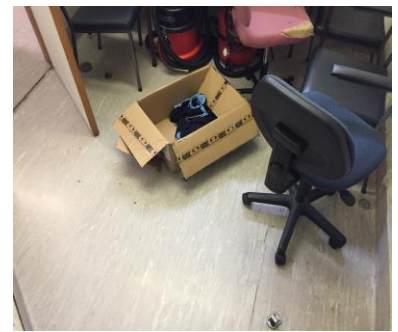
Photograph No.	19
Location/Area	Store Room: Floor
Suspected Material Identified	Vinyl Floor (Marble Brown)
Condition of Material Identified	Good
Categories: (Assessment type). 1: ACM common characteristics or 2: Presumed ACM or 3: Sample collected for analysis	2: Presumed ACM
Sample No.	Sample Not Taken
Laboratory Analysis Findings	Analysis Not Required
Quantity of Material Identified	7.0m2

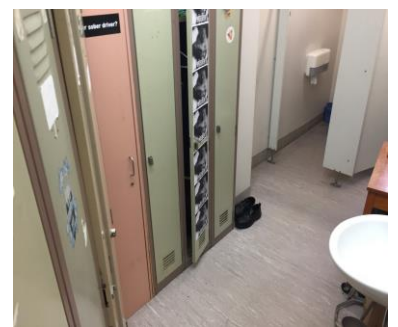
Photograph No.	20
Location/Area	Male Locker Room: Floor
Suspected Material Identified	Vinyl Floor (Marble Brown)
Condition of Material Identified	Good
Categories: (Assessment type). 1: ACM common characteristics or 2: Presumed ACM or 3: Sample collected for analysis	2: Presumed ACM
Sample No.	Sample Not Taken
Laboratory Analysis Findings	Analysis Not Required
Quantity of Material Identified	12.7m2

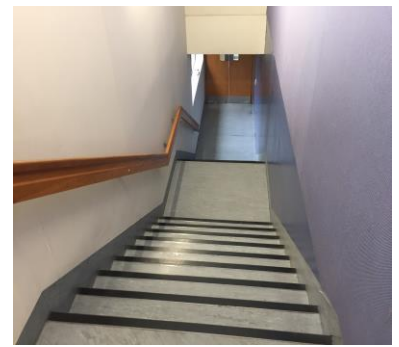
Photograph No.	21
Location/Area	Main Hospital Stairway: Floor
Suspected Material Identified	Vinyl Floor (Blue)
Condition of Material Identified	Good
Categories: (Assessment type). 1: ACM common characteristics or 2: Presumed ACM or 3: Sample collected for analysis	2: Presumed ACM
Sample No.	Sample Not Taken
Laboratory Analysis Findings	Analysis Not Required
Quantity of Material Identified	10.8m2

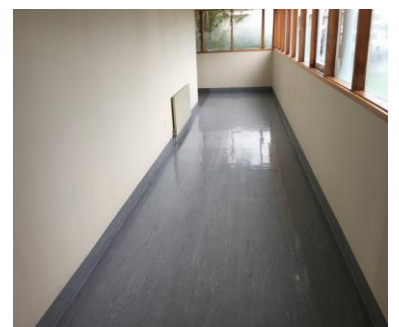
Photograph No.	
Location/Area	Lambie Access: Floor
Suspected Material Identified	Vinyl Floor (Blue)
Condition of Material Identified	Good
Categories: (Assessment type). 1: ACM common characteristics or 2: Presumed ACM or 3: Sample collected for analysis	2: Presumed ACM
Sample No.	Sample Not Taken
Laboratory Analysis Findings	Analysis Not Required
Quantity of Material Identified	24.0m2

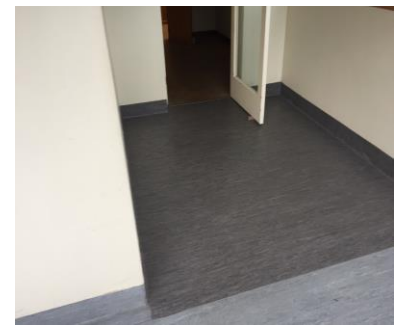
Photograph No.	23
Location/Area	Lambie Access: Floor
Suspected Material Identified	Vinyl Floor (Grey)
Condition of Material Identified	Good
Categories: (Assessment type). 1: ACM common characteristics or 2: Presumed ACM or 3: Sample collected for analysis	2: Presumed ACM
Sample No.	Sample Not Taken
Laboratory Analysis Findings	Analysis Not Required
Quantity of Material Identified	5.9m2

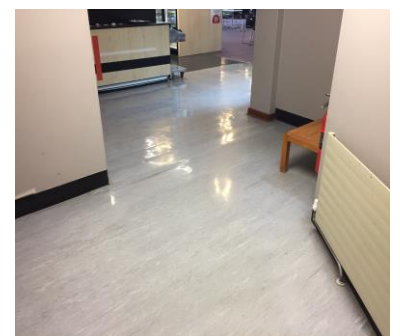
Photograph No.	24
Location/Area	Cafeteria: Floor
Suspected Material Identified	Vinyl Floor (Blue)
Condition of Material Identified	Good
Categories: (Assessment type). 1: ACM common characteristics or 2: Presumed ACM or 3: Sample collected for analysis	2: Presumed ACM
Sample No.	Sample Not Taken
Laboratory Analysis Findings	Analysis Not Required
Quantity of Material Identified	64.0m2

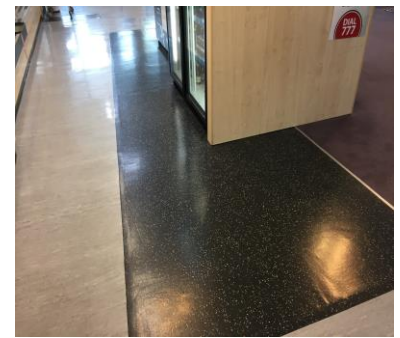
Photograph No.	25
Location/Area	Cafeteria: Floor
Suspected Material Identified	Vinyl Floor (Black)
Condition of Material Identified	Good
Categories: (Assessment type). 1: ACM common characteristics or 2: Presumed ACM or 3: Sample collected for analysis	2: Presumed ACM
Sample No.	Sample Not Taken
Laboratory Analysis Findings	Analysis Not Required
Quantity of Material Identified	15.0m2

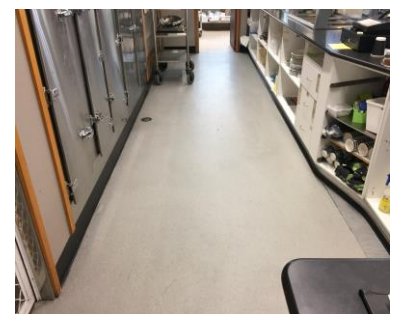
Photograph No.	26
Location/Area	Cafeteria: Floor
Suspected Material Identified	Vinyl Floor (Grey Stone)
Condition of Material Identified	Good
Categories: (Assessment type). 1: ACM common characteristics or 2: Presumed ACM or 3: Sample collected for analysis	2: Presumed ACM
Sample No.	Sample Not Taken
Laboratory Analysis Findings	Analysis Not Required
Quantity of Material Identified	16.0m2

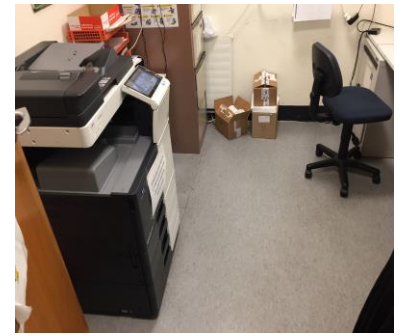
Photograph No.	27
Location/Area	Kitchen Office: Floor
Suspected Material Identified	Vinyl Floor (Blue)
Condition of Material Identified	Good
Categories: (Assessment type). 1: ACM common characteristics or 2: Presumed ACM or 3: Sample collected for analysis	2: Presumed ACM
Sample No.	Sample Not Taken
Laboratory Analysis Findings	Analysis Not Required
Quantity of Material Identified	9.0m2

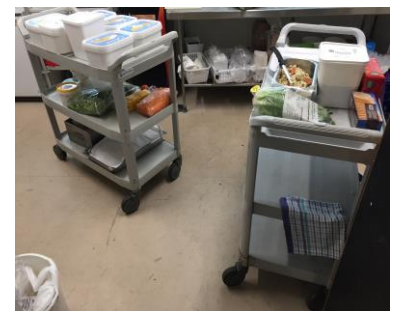
Photograph No.	28
Location/Area	Sandwich Room: Floor
Suspected Material Identified	Vinyl Floor (Cream)
Condition of Material Identified	Good
Categories: (Assessment type). 1: ACM common characteristics or 2: Presumed ACM or 3: Sample collected for analysis	2: Presumed ACM
Sample No.	Sample Not Taken
Laboratory Analysis Findings	Analysis Not Required
Quantity of Material Identified	15.0m2

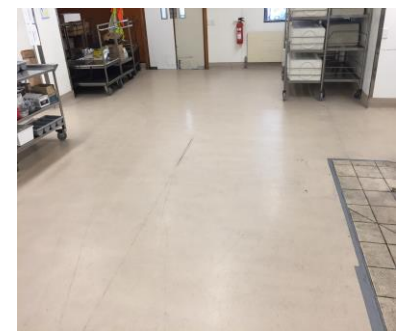
Photograph No.	29
Location/Area	Kitchen: Floor
Suspected Material Identified	Vinyl Floor (Cream)
Condition of Material Identified	Good
Categories: (Assessment type). 1: ACM common characteristics or 2: Presumed ACM or 3: Sample collected for analysis	2: Presumed ACM
Sample No.	Sample Not Taken
Laboratory Analysis Findings	Analysis Not Required
Quantity of Material Identified	152.0m2

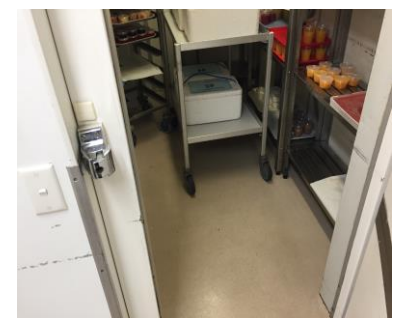
Photograph No.	30
Location/Area	Kitchen: Chiller (x4)
Suspected Material Identified	Vinyl Floor (Cream)
Condition of Material Identified	Good
Categories: (Assessment type). 1: ACM common characteristics or 2: Presumed ACM or 3: Sample collected for analysis	2: Presumed ACM
Sample No.	Sample Not Taken
Laboratory Analysis Findings	Analysis Not Required
Quantity of Material Identified	26.0

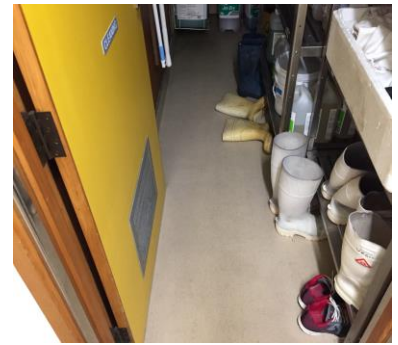
Photograph No.	31
Location/Area	Kitchen: Cleaners Room
Suspected Material Identified	Vinyl Floor (Cream)
Condition of Material Identified	Good
Categories: (Assessment type). 1: ACM common characteristics or 2: Presumed ACM or 3: Sample collected for analysis	2: Presumed ACM
Sample No.	Sample Not Taken
Laboratory Analysis Findings	Analysis Not Required
Quantity of Material Identified	4.5m2

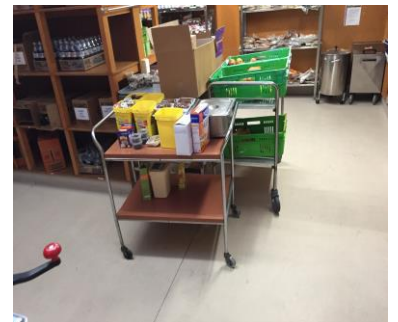
Photograph No.	32
Location/Area	Kitchen: Food Storage
Suspected Material Identified	Vinyl Floor (Cream)
Condition of Material Identified	Good
Categories: (Assessment type). 1: ACM common characteristics or 2: Presumed ACM or 3: Sample collected for analysis	2: Presumed ACM
Sample No.	Sample Not Taken
Laboratory Analysis Findings	Analysis Not Required
Quantity of Material Identified	25.0m2

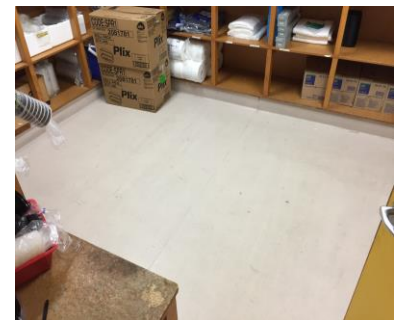
Photograph No.	33
Location/Area	Kitchen: Equipment Room
Suspected Material Identified	Vinyl Floor (Cream)
Condition of Material Identified	Good
Categories: (Assessment type). 1: ACM common characteristics or 2: Presumed ACM or 3: Sample collected for analysis	2: Presumed ACM
Sample No.	Sample Not Taken
Laboratory Analysis Findings	Analysis Not Required
Quantity of Material Identified	9.2m2

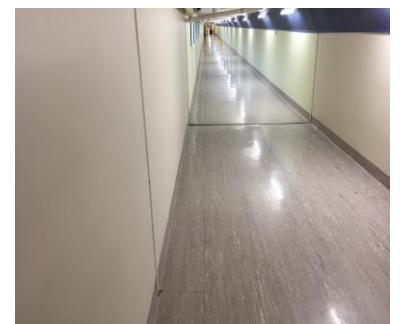
Photograph No.	34
Location/Area	Main Hospital Tunnel: Floor
Suspected Material Identified	Vinyl Floor (Marble Grey)
Condition of Material Identified	Good
Categories: (Assessment type). 1: ACM common characteristics or 2: Presumed ACM or 3: Sample collected for analysis	2: Presumed ACM
Sample No.	Sample Not Taken
Laboratory Analysis Findings	Analysis Not Required
Quantity of Material Identified	194.1m2

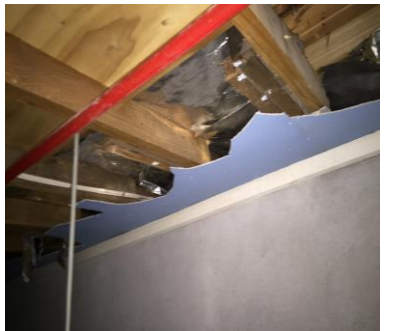
Photograph No.	36

Location/Area	Ceiling Void: Ceiling	
Suspected Material Identified	ACM Board	
Condition of Material Identified	Damaged	
Categories: (Assessment type). 1: ACM common characteristics or 2: Presumed ACM or 3: Sample collected for analysis	2: Presumed ACM	
Sample No.	Sample Not Taken	
Laboratory Analysis Findings	Analysis Not Required	
Quantity of Material Identified	30.0m2

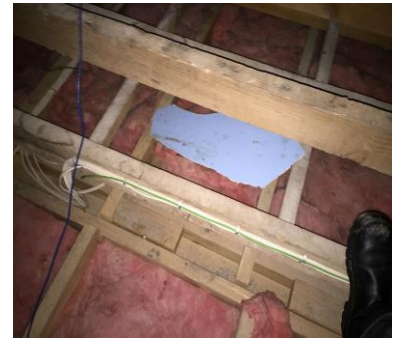
Photograph No.	37
Location/Area	Ceiling Void: Floor
Suspected Material Identified	ACM Board
Condition of Material Identified	Damaged
Categories: (Assessment type). 1: ACM common characteristics or 2: Presumed ACM or 3: Sample collected for analysis	2: Presumed ACM
Sample No.	Sample Not Taken
Laboratory Analysis Findings	Analysis Not Required
Quantity of Material Identified	12.0m2
