## Asbestos Management Survey Report

### LAMBIE BUILDING MANAGEMENT SURVEY

### **WHANGANUI HOSPITAL**

### **LAMBIE BUILDING-EXTERIOR & INTERNAL**

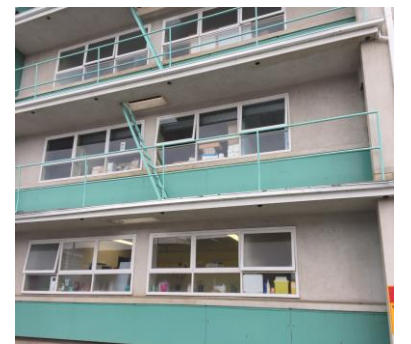
Floor.	Exterior
Location/Area	Exterior: Window Panels
Suspected Material Identified	ACM Board
Condition of Material Identified	Stable
<b>Categories: (Assessment type).</b> 1: ACM common characteristics or 2: Presumed ACM or 3: Sample collected for analysis	1: ACM common characteristics
Sample No.	Sample Not Taken
Laboratory Analysis Findings	Analysis Not Conducted
Quantity of Material Identified	39.6m2

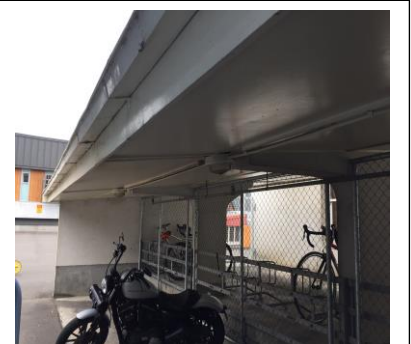
**ID: CARD NO:002**

Floor.	Exterior
Location/Area	Exterior: Bike Shed (Ceiling/Walls)
Suspected Material Identified	ACM Board
Condition of Material Identified	Stable
<b>Categories: (Assessment type).</b> 1: ACM common characteristics or 2: Presumed ACM or 3: Sample collected for analysis	2: Presumed ACM
Sample No.	Sample Not Taken
Laboratory Analysis Findings	Analysis Not Conducted
Quantity of Material Identified	40.0m2

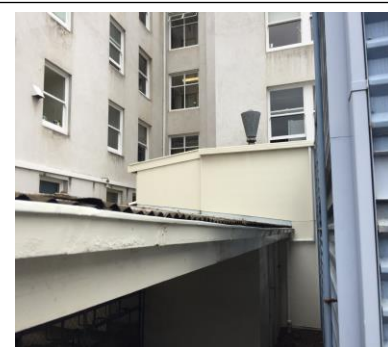
**ID: CARD NO:003**

Floor.	Exterior
Location/Area	Exterior: Wall Lining
Suspected Material Identified	ACM Board
Condition of Material Identified	Stable
<b>Categories: (Assessment type).</b> 1: ACM common characteristics or 2: Presumed ACM or 3: Sample collected for analysis	2: Presumed ACM
Sample No.	Sample Not Taken
Laboratory Analysis Findings	Analysis Not Conducted
Quantity of Material Identified	37.0m2

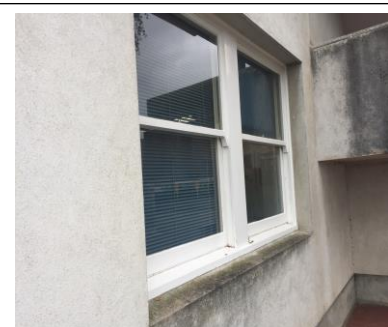
**ID: CARD NO:004**

Floor.	Exterior
Location/Area	Exterior: Windows
Suspected Material Identified	Putty Compound
Condition of Material Identified	Stable
<b>Categories: (Assessment type).</b> 1: ACM common characteristics or 2: Presumed ACM or 3: Sample collected for analysis	2: Presumed ACM
Sample No.	Sample Not Taken
Laboratory Analysis Findings	Analysis Not Conducted
Quantity of Material Identified	1896.0L/M

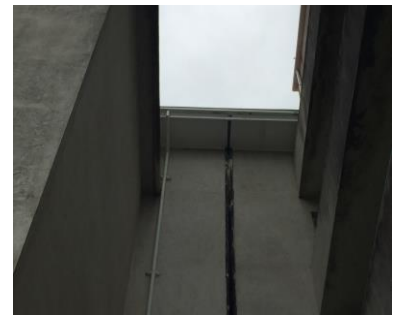
Floor.	Exterior
Location/Area	Exterior: Soffit Lining
Suspected Material Identified	ACM Board
Condition of Material Identified	Stable
<b>Categories: (Assessment type).</b> 1: ACM common characteristics or 2: Presumed ACM or 3: Sample collected for analysis	2: Presumed ACM
Sample No.	Sample Not Taken
Laboratory Analysis Findings	Analysis Not Conducted
Quantity of Material Identified	2.5m2

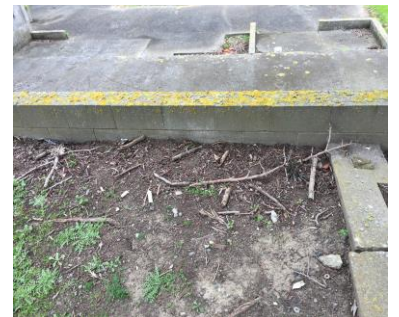
Floor.	Exterior
Location/Area	Exterior: Concrete Pad
Suspected Material Identified	ACM Board (Debris)
Condition of Material Identified	Stable
<b>Categories: (Assessment type).</b> 1: ACM common characteristics or 2: Presumed ACM or 3: Sample collected for analysis	2: Presumed ACM
Sample No.	Sample Not Taken
Laboratory Analysis Findings	Analysis Not Conducted
Quantity of Material Identified	6.0m2

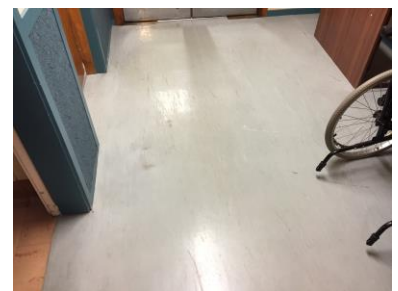
Floor.	Ground Floor
Location/Area	CART: Entry
Suspected Material Identified	Vinyl Floor
Condition of Material Identified	Stable
<b>Categories: (Assessment type).</b> 1: ACM common characteristics or 2: Presumed ACM or 3: Sample collected for analysis	2: Presumed ACM
Sample No.	Sample Not Taken
Laboratory Analysis Findings	Analysis Not Conducted
Quantity of Material Identified	7.4m2

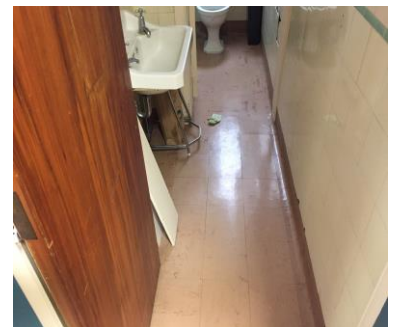
Floor.	Ground Floor
Location/Area	CART: Toilet
Suspected Material Identified	Vinyl Floor
Condition of Material Identified	Stable
<b>Categories: (Assessment type).</b> 1: ACM common characteristics or 2: Presumed ACM or 3: Sample collected for analysis	2: Presumed ACM
Sample No.	Sample Not Taken
Laboratory Analysis Findings	Analysis Not Conducted
Quantity of Material Identified	3.9m2

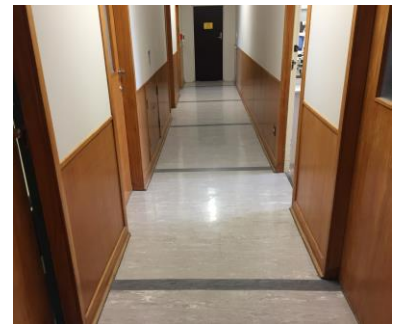
Floor.	Ground Floor
Location/Area	Reception: Corridor
Suspected Material Identified	Vinyl Floor
Condition of Material Identified	Stable
<b>Categories: (Assessment type).</b> 1: ACM common characteristics or 2: Presumed ACM or 3: Sample collected for analysis	2: Presumed ACM
Sample No.	Sample Not Taken
Laboratory Analysis Findings	Analysis Not Conducted
Quantity of Material Identified	15.0m2

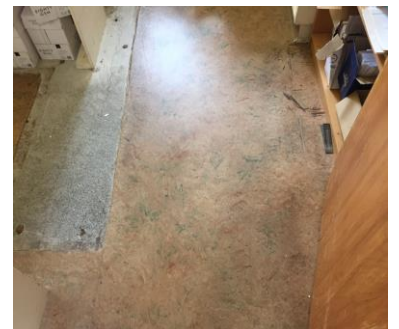
Floor.	Ground Floor
Location/Area	Referral Hub: Files
Suspected Material Identified	Vinyl Floor
Condition of Material Identified	Stable
<b>Categories: (Assessment type).</b> 1: ACM common characteristics or 2: Presumed ACM or 3: Sample collected for analysis	2: Presumed ACM
Sample No.	Sample Not Taken
Laboratory Analysis Findings	Analysis Not Conducted
Quantity of Material Identified	6.3m2

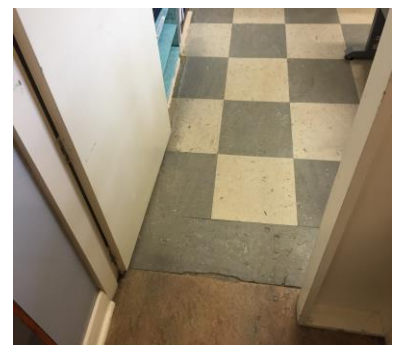
Floor.	Ground Floor
Location/Area	Referral Hub: Office
Suspected Material Identified	Vinyl Floor
Condition of Material Identified	Stable
<b>Categories: (Assessment type).</b> 1: ACM common characteristics or 2: Presumed ACM or 3: Sample collected for analysis	2: Presumed ACM
Sample No.	Sample Not Taken
Laboratory Analysis Findings	Analysis Not Conducted
Quantity of Material Identified	17.0m2

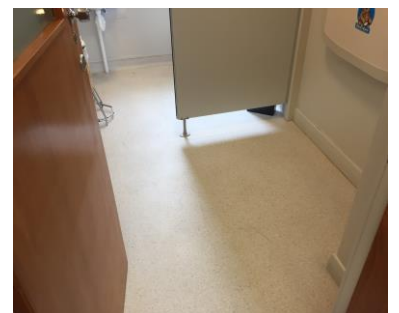
Floor.	Ground Floor
Location/Area	Reception: Accessible Toilet
Suspected Material Identified	Vinyl Floor
Condition of Material Identified	Stable
<b>Categories: (Assessment type).</b> 1: ACM common characteristics or 2: Presumed ACM or 3: Sample collected for analysis	2: Presumed ACM
Sample No.	Sample Not Taken
Laboratory Analysis Findings	Analysis Not Conducted
Quantity of Material Identified	6.3m2

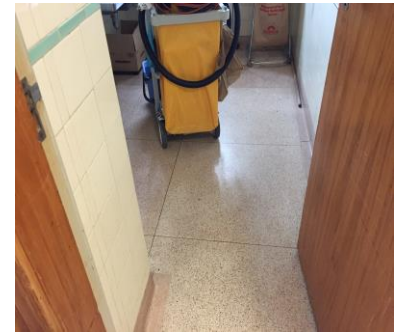
Floor.	Ground Floor
Location/Area	Cleaners Room: Floor
Suspected Material Identified	Vinyl Floor
Condition of Material Identified	Stable
<b>Categories: (Assessment type).</b> 1: ACM common characteristics or 2: Presumed ACM or 3: Sample collected for analysis	2: Presumed ACM
Sample No.	Sample Not Taken
Laboratory Analysis Findings	Analysis Not Conducted
Quantity of Material Identified	6.6m2

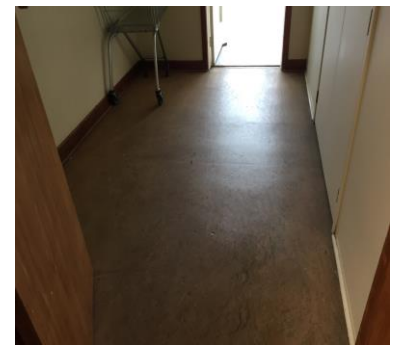
Floor.	Ground Floor
Location/Area	Kitchen: Corridor
Suspected Material Identified	Vinyl Floor
Condition of Material Identified	Stable
<b>Categories: (Assessment type).</b> 1: ACM common characteristics or 2: Presumed ACM or 3: Sample collected for analysis	2: Presumed ACM
Sample No.	Sample Not Taken
Laboratory Analysis Findings	Analysis Not Conducted
Quantity of Material Identified	7.2m2

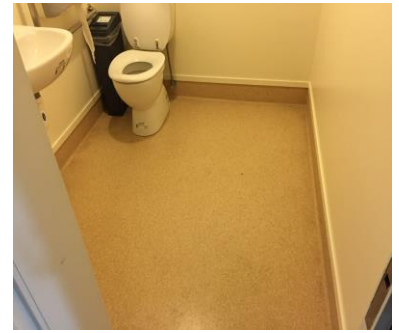
Floor.	Ground Floor
Location/Area	Wheelchair Toilet
Suspected Material Identified	Vinyl Floor
Condition of Material Identified	Stable
<b>Categories: (Assessment type).</b> 1: ACM common characteristics or 2: Presumed ACM or 3: Sample collected for analysis	2: Presumed ACM
Sample No.	Sample Not Taken
Laboratory Analysis Findings	Analysis Not Conducted
Quantity of Material Identified	2.8m2

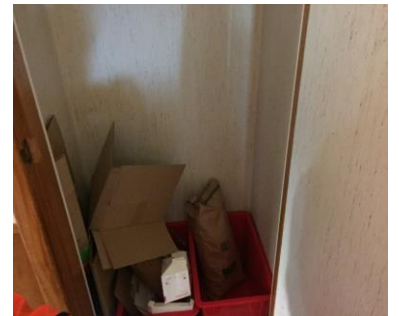
Floor.	Ground Floor
Location/Area	Rubbish Cupboard
Suspected Material Identified	Vinyl Floor
Condition of Material Identified	Stable
<b>Categories: (Assessment type).</b> 1: ACM common characteristics or 2: Presumed ACM or 3: Sample collected for analysis	2: Presumed ACM
Sample No.	Sample Not Taken
Laboratory Analysis Findings	Analysis Not Conducted
Quantity of Material Identified	5.0m2

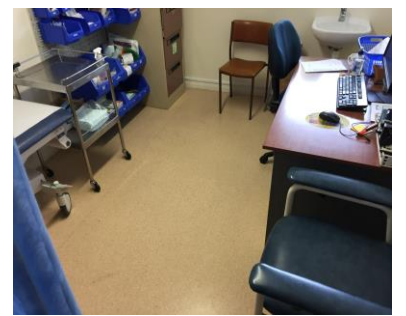
Floor.	Ground Floor
Location/Area	Clinic Room 2
Suspected Material Identified	Vinyl Floor
Condition of Material Identified	Stable
<b>Categories: (Assessment type).</b> 1: ACM common characteristics or 2: Presumed ACM or 3: Sample collected for analysis	2: Presumed ACM
Sample No.	Sample Not Taken
Laboratory Analysis Findings	Analysis Not Conducted
Quantity of Material Identified	11.5m2

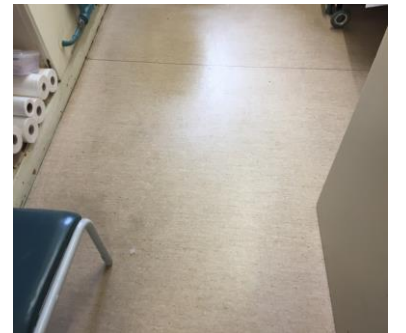
Floor.	Ground Floor
Location/Area	Clinic Room 1
Suspected Material Identified	Vinyl Floor
Condition of Material Identified	Stable
<b>Categories: (Assessment type).</b> 1: ACM common characteristics or 2: Presumed ACM or 3: Sample collected for analysis	2: Presumed ACM
Sample No.	Sample Not Taken
Laboratory Analysis Findings	Analysis Not Conducted
Quantity of Material Identified	11.5m2

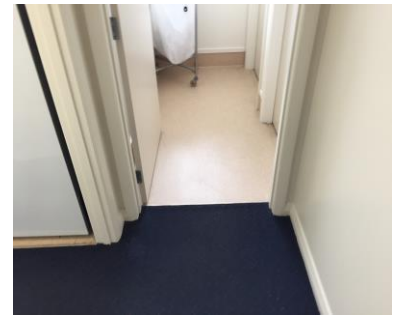
Floor.	Ground Floor
Location/Area	Kitchen Toilet
Suspected Material Identified	Vinyl Floor
Condition of Material Identified	Stable
<b>Categories: (Assessment type).</b> 1: ACM common characteristics or 2: Presumed ACM or 3: Sample collected for analysis	2: Presumed ACM
Sample No.	Sample Not Taken
Laboratory Analysis Findings	Analysis Not Conducted
Quantity of Material Identified	4.5m2

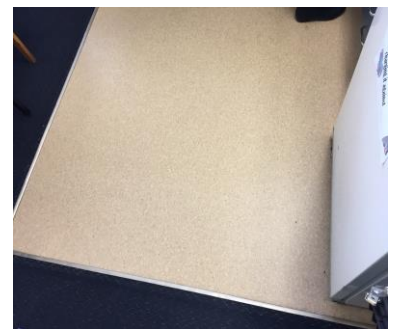
Floor.	Ground Floor
Location/Area	Kitchen Floor
Suspected Material Identified	Vinyl Floor
Condition of Material Identified	Stable
<b>Categories: (Assessment type).</b> 1: ACM common characteristics or 2: Presumed ACM or 3: Sample collected for analysis	2: Presumed ACM
Sample No.	Sample Not Taken
Laboratory Analysis Findings	Analysis Not Conducted
Quantity of Material Identified	4.3m2

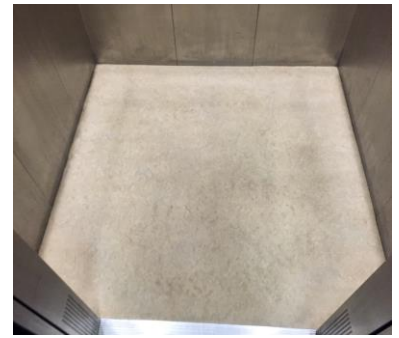
Floor.	Elevator
Location/Area	Elevator Floor
Suspected Material Identified	Vinyl Floor
Condition of Material Identified	Stable
<b>Categories: (Assessment type).</b> 1: ACM common characteristics or 2: Presumed ACM or 3: Sample collected for analysis	2: Presumed ACM
Sample No.	Sample Not Taken
Laboratory Analysis Findings	Analysis Not Conducted
Quantity of Material Identified	1.8m2

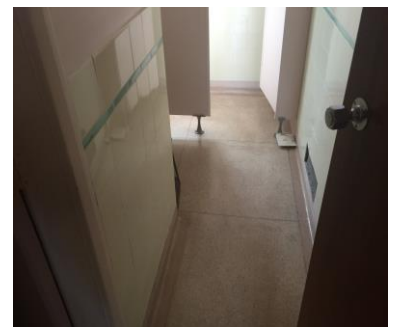
Floor.	First Floor
Location/Area	Lavatory
Suspected Material Identified	Vinyl Floor
Condition of Material Identified	Stable
<b>Categories: (Assessment type).</b> 1: ACM common characteristics or 2: Presumed ACM or 3: Sample collected for analysis	2: Presumed ACM
Sample No.	Sample Not Taken
Laboratory Analysis Findings	Analysis Not Conducted
Quantity of Material Identified	6.5m2

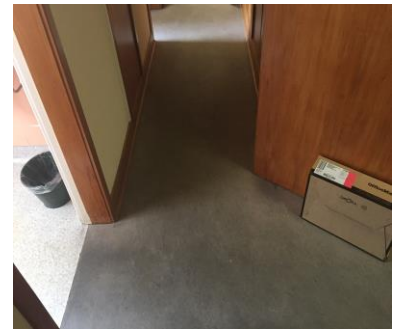
Floor.	First Floor
Location/Area	SI: Corridor
Suspected Material Identified	Vinyl Floor
Condition of Material Identified	Stable
<b>Categories: (Assessment type).</b> 1: ACM common characteristics or 2: Presumed ACM or 3: Sample collected for analysis	2: Presumed ACM
Sample No.	Sample Not Taken
Laboratory Analysis Findings	Analysis Not Conducted
Quantity of Material Identified	7.4m2

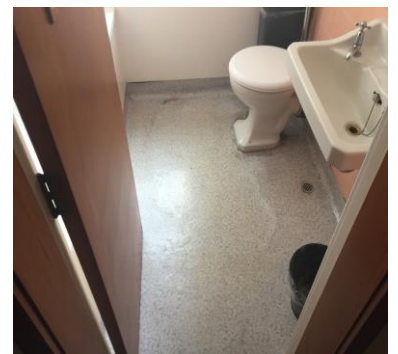
Floor.	First Floor
Location/Area	SI: Wharepaku
Suspected Material Identified	Vinyl Floor
Condition of Material Identified	Stable
<b>Categories: (Assessment type).</b> 1: ACM common characteristics or 2: Presumed ACM or 3: Sample collected for analysis	2: Presumed ACM
Sample No.	Sample Not Taken
Laboratory Analysis Findings	Analysis Not Conducted
Quantity of Material Identified	4.5m2

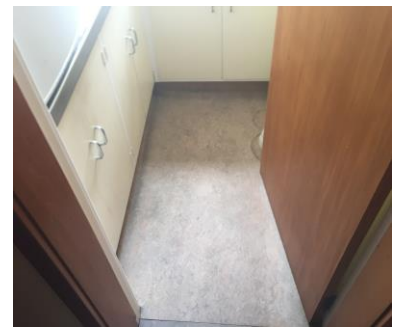
Floor.	First Floor
Location/Area	SI: Kitchen
Suspected Material Identified	Vinyl Floor
Condition of Material Identified	Stable
<b>Categories: (Assessment type).</b> 1: ACM common characteristics or 2: Presumed ACM or 3: Sample collected for analysis	2: Presumed ACM
Sample No.	Sample Not Taken
Laboratory Analysis Findings	Analysis Not Conducted
Quantity of Material Identified	.800m2

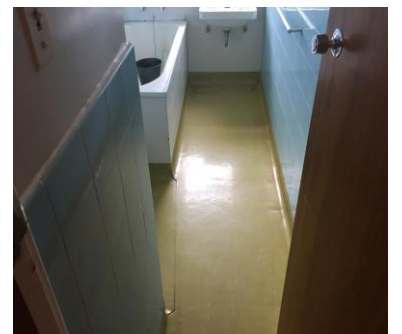
Floor.	First Floor
Location/Area	Te Hau Ranga Ora: Toilet
Suspected Material Identified	Vinyl Floor
Condition of Material Identified	Stable
<b>Categories: (Assessment type).</b> 1: ACM common characteristics or 2: Presumed ACM or 3: Sample collected for analysis	2: Presumed ACM
Sample No.	Sample Not Taken
Laboratory Analysis Findings	Analysis Not Conducted
Quantity of Material Identified	4.0m2

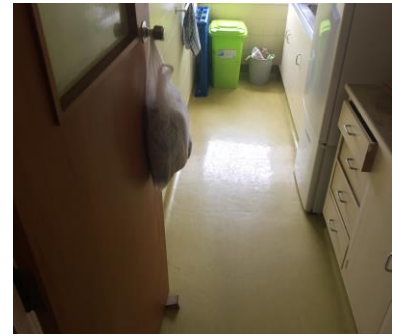
Floor.	First Floor
Location/Area	Te Hau Ranga Ora: Kitchen
Suspected Material Identified	Vinyl Floor
Condition of Material Identified	Stable
<b>Categories: (Assessment type).</b> 1: ACM common characteristics or 2: Presumed ACM or 3: Sample collected for analysis	2: Presumed ACM
Sample No.	Sample Not Taken
Laboratory Analysis Findings	Analysis Not Conducted
Quantity of Material Identified	Kitchen

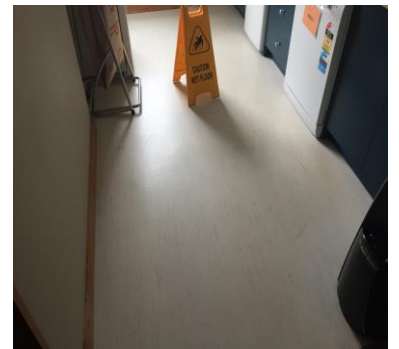
Floor.	First Floor
Location/Area	ICT Dept: Kitchen
Suspected Material Identified	Vinyl Floor
Condition of Material Identified	Stable
<b>Categories: (Assessment type).</b> 1: ACM common characteristics or 2: Presumed ACM or 3: Sample collected for analysis	2: Presumed ACM
Sample No.	Sample Not Taken
Laboratory Analysis Findings	Analysis Not Conducted
Quantity of Material Identified	5.2m2

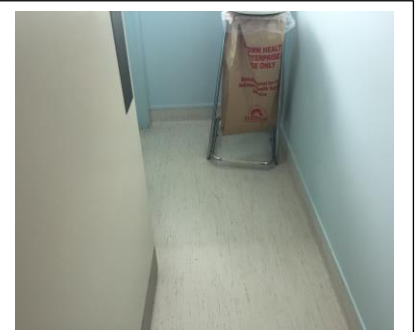
Floor.	First Floor
Location/Area	ICT Dept: Toilet
Suspected Material Identified	Vinyl Floor
Condition of Material Identified	Stable
<b>Categories: (Assessment type).</b> 1: ACM common characteristics or 2: Presumed ACM or 3: Sample collected for analysis	2: Presumed ACM
Sample No.	Sample Not Taken
Laboratory Analysis Findings	Analysis Not Conducted
Quantity of Material Identified	4.8m2

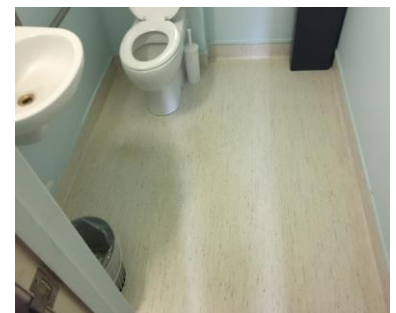
Floor.	First Floor
Location/Area	ICT Dept: Accessible Toilet
Suspected Material Identified	Vinyl Floor
Condition of Material Identified	Stable
<b>Categories: (Assessment type).</b> 1: ACM common characteristics or 2: Presumed ACM or 3: Sample collected for analysis	2: Presumed ACM
Sample No.	Sample Not Taken
Laboratory Analysis Findings	Analysis Not Conducted
Quantity of Material Identified	2.6m2

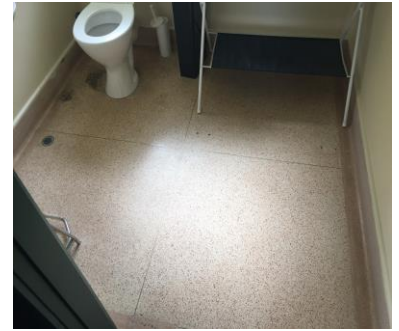
Floor.	Second Floor
Location/Area	Public Health: Unisex Toilet
Suspected Material Identified	Vinyl Floor
Condition of Material Identified	Stable
<b>Categories: (Assessment type).</b> 1: ACM common characteristics or 2: Presumed ACM or 3: Sample collected for analysis	2: Presumed ACM
Sample No.	Sample Not Taken
Laboratory Analysis Findings	Analysis Not Conducted
Quantity of Material Identified	3.2m2

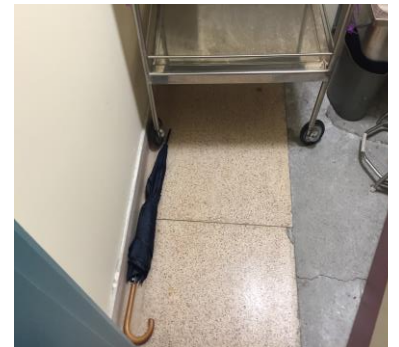
Floor.	Second Floor
Location/Area	Public Health: Cleaners Cupboard
Suspected Material Identified	Vinyl Floor
Condition of Material Identified	Stable
<b>Categories: (Assessment type).</b> 1: ACM common characteristics or 2: Presumed ACM or 3: Sample collected for analysis	2: Presumed ACM
Sample No.	Sample Not Taken
Laboratory Analysis Findings	Analysis Not Conducted
Quantity of Material Identified	1.0m2

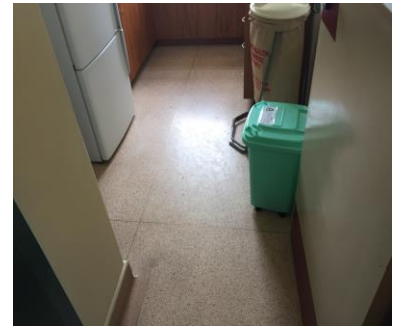
Floor.	Second Floor
Location/Area	Public Health: Kitchen
Suspected Material Identified	Vinyl Floor
Condition of Material Identified	Stable
<b>Categories: (Assessment type).</b> 1: ACM common characteristics or 2: Presumed ACM or 3: Sample collected for analysis	2: Presumed ACM
Sample No.	Sample Not Taken
Laboratory Analysis Findings	Analysis Not Conducted
Quantity of Material Identified	5.6m2

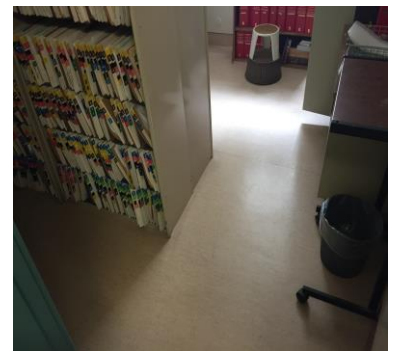
Floor.	Second Floor
Location/Area	Public Health: Files Room
Suspected Material Identified	Vinyl Floor
Condition of Material Identified	Stable
<b>Categories: (Assessment type).</b> 1: ACM common characteristics or 2: Presumed ACM or 3: Sample collected for analysis	2: Presumed ACM
Sample No.	Sample Not Taken
Laboratory Analysis Findings	Analysis Not Conducted
Quantity of Material Identified	11.8m2

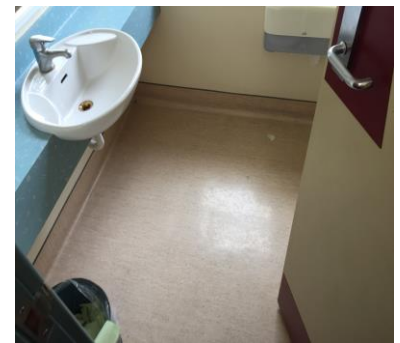
Floor.	Second Floor
Location/Area	Public Health: Female Toilet
Suspected Material Identified	Vinyl Floor
Condition of Material Identified	Stable
<b>Categories: (Assessment type).</b> 1: ACM common characteristics or 2: Presumed ACM or 3: Sample collected for analysis	2: Presumed ACM
Sample No.	Sample Not Taken
Laboratory Analysis Findings	Analysis Not Conducted
Quantity of Material Identified	3.0m2

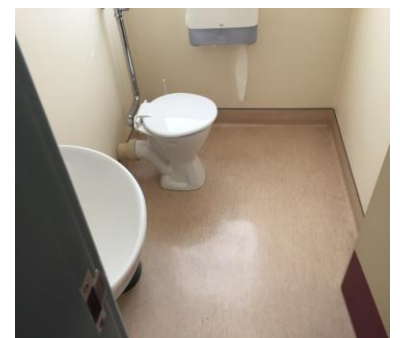
Floor.	Second Floor
Location/Area	Public Health: Male Toilet
Suspected Material Identified	Vinyl Floor
Condition of Material Identified	Stable
<b>Categories: (Assessment type).</b> 1: ACM common characteristics or 2: Presumed ACM or 3: Sample collected for analysis	2: Presumed ACM
Sample No.	Sample Not Taken
Laboratory Analysis Findings	Analysis Not Conducted
Quantity of Material Identified	3.3m2

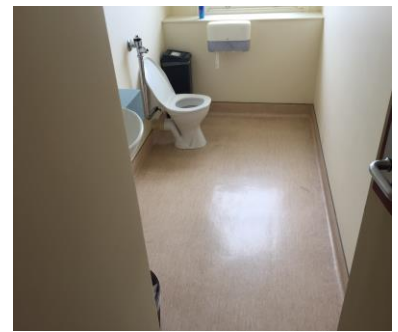
Floor.	Second Floor
Location/Area	Public health: Unisex Toilet
Suspected Material Identified	Vinyl Floor
Condition of Material Identified	Stable
<b>Categories: (Assessment type).</b> 1: ACM common characteristics or 2: Presumed ACM or 3: Sample collected for analysis	2: Presumed ACM
Sample No.	Sample Not Taken
Laboratory Analysis Findings	Analysis Not Conducted
Quantity of Material Identified	4.6m2

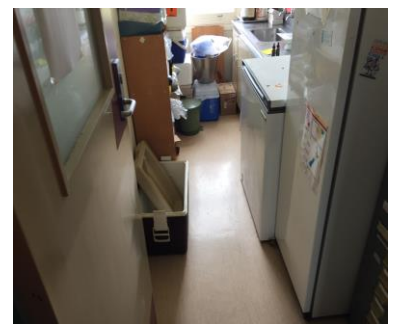
Floor.	Second Floor
Location/Area	Public Health: Kitchen
Suspected Material Identified	Vinyl Floor
Condition of Material Identified	Stable
<b>Categories: (Assessment type).</b> 1: ACM common characteristics or 2: Presumed ACM or 3: Sample collected for analysis	2: Presumed ACM
Sample No.	Sample Not Taken
Laboratory Analysis Findings	Analysis Not Conducted
Quantity of Material Identified	5.8m2

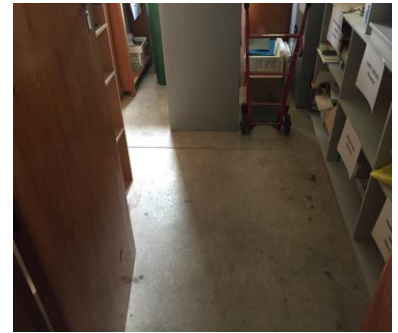
Floor.	Second Floor
Location/Area	Public Health: Room 218
Suspected Material Identified	Vinyl Floor
Condition of Material Identified	Stable
<b>Categories: (Assessment type).</b> 1: ACM common characteristics or 2: Presumed ACM or 3: Sample collected for analysis	2: Presumed ACM
Sample No.	Sample Not Taken
Laboratory Analysis Findings	Analysis Not Conducted
Quantity of Material Identified	7.0m2

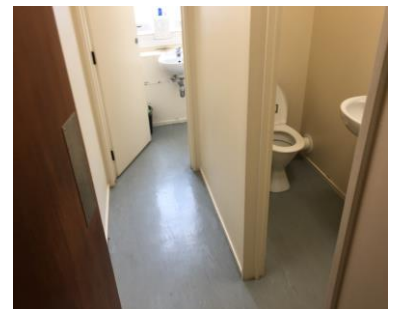
Floor.	Third Floor
Location/Area	Toilet: Floor
Suspected Material Identified	Vinyl Flooring
Condition of Material Identified	Stable
<b>Categories: (Assessment type).</b> 1: ACM common characteristics or 2: Presumed ACM or 3: Sample collected for analysis	2: Presumed ACM
Sample No.	Sample Not Taken
Laboratory Analysis Findings	Analysis Not Conducted
Quantity of Material Identified	8.0m2

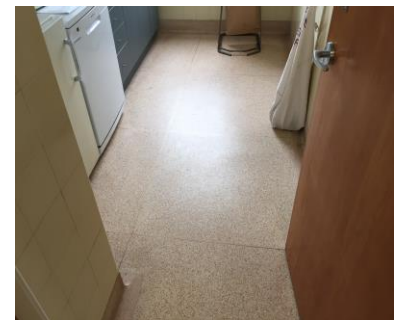
Floor.	Third Floor
Location/Area	Kitchen: Floor
Suspected Material Identified	Vinyl Flooring
Condition of Material Identified	Stable
<b>Categories: (Assessment type).</b> 1: ACM common characteristics or 2: Presumed ACM or 3: Sample collected for analysis	2: Presumed ACM
Sample No.	Sample Not Taken
Laboratory Analysis Findings	Analysis Not Conducted
Quantity of Material Identified	4.8m2

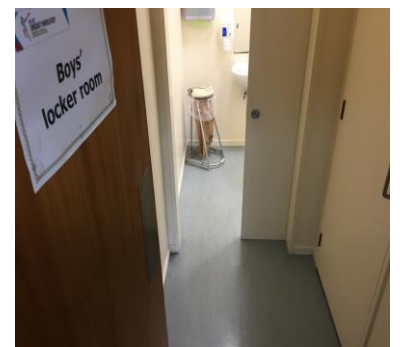
Floor.	Third Floor
Location/Area	Boys Locker Room: Floor
Suspected Material Identified	Vinyl Flooring
Condition of Material Identified	Stable
<b>Categories: (Assessment type).</b> 1: ACM common characteristics or 2: Presumed ACM or 3: Sample collected for analysis	2: Presumed ACM
Sample No.	Sample Not Taken
Laboratory Analysis Findings	Analysis Not Conducted
Quantity of Material Identified	5.0m2

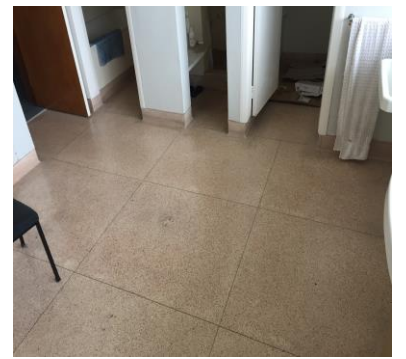
Floor.	Third Floor
Location/Area	Locker Room: Floor
Suspected Material Identified	Vinyl Flooring
Condition of Material Identified	Stable
<b>Categories: (Assessment type).</b> 1: ACM common characteristics or 2: Presumed ACM or 3: Sample collected for analysis	2: Presumed ACM
Sample No.	Sample Not Taken
Laboratory Analysis Findings	Analysis Not Conducted
Quantity of Material Identified	14.0m2

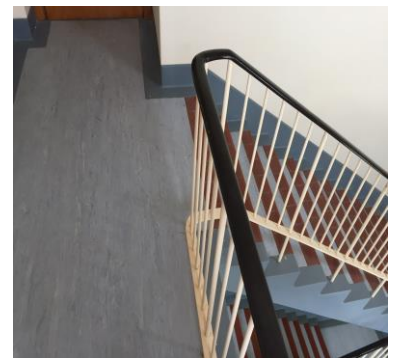
Floor.	Stairway
Location/Area	Stairway: Floor
Suspected Material Identified	Vinyl Flooring
Condition of Material Identified	Stable
<b>Categories: (Assessment type).</b> 1: ACM common characteristics or 2: Presumed ACM or 3: Sample collected for analysis	2: Presumed ACM
Sample No.	Sample Not Taken
Laboratory Analysis Findings	Analysis Not Conducted
Quantity of Material Identified	78.5m2

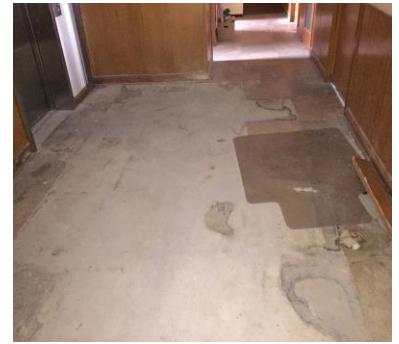
Floor.	Fourth Floor
Location/Area	Elevator Foyer: Floor
Suspected Material Identified	Vinyl Flooring
Condition of Material Identified	Stable
<b>Categories: (Assessment type).</b> 1: ACM common characteristics or 2: Presumed ACM or 3: Sample collected for analysis	2: Presumed ACM
Sample No.	Sample Not Taken
Laboratory Analysis Findings	Analysis Not Conducted
Quantity of Material Identified	12.6m2

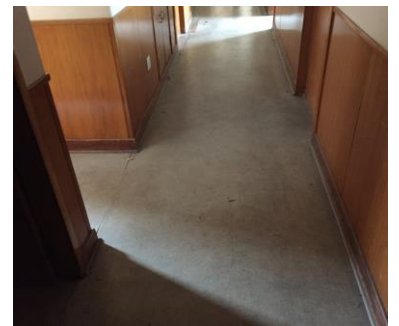
Floor.	Fourth Floor
Location/Area	Corridor: Floor
Suspected Material Identified	Vinyl Flooring
Condition of Material Identified	Stable
<b>Categories: (Assessment type).</b> 1: ACM common characteristics or 2: Presumed ACM or 3: Sample collected for analysis	2: Presumed ACM
Sample No.	Sample Not Taken
Laboratory Analysis Findings	Analysis Not Conducted
Quantity of Material Identified	17.0m2

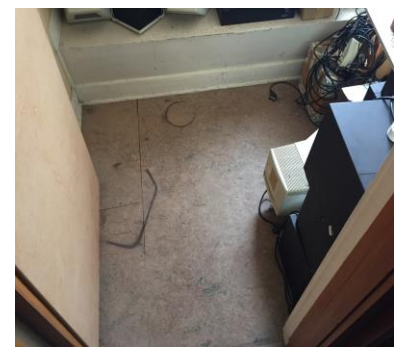
Floor.	Fourth Floor
Location/Area	Equipment Room: Floor
Suspected Material Identified	Vinyl Flooring
Condition of Material Identified	Stable
<b>Categories: (Assessment type).</b> 1: ACM common characteristics or 2: Presumed ACM or 3: Sample collected for analysis	2: Presumed ACM
Sample No.	Sample Not Taken
Laboratory Analysis Findings	Analysis Not Conducted
Quantity of Material Identified	4.0m2

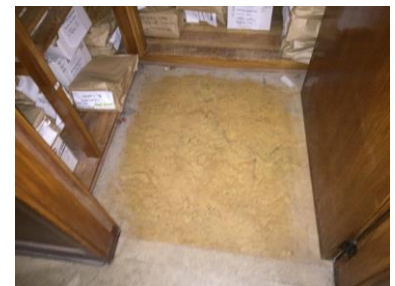
Floor.	Fourth Floor
Location/Area	Store Cupboard: Floor
Suspected Material Identified	Vinyl Flooring
Condition of Material Identified	Stable
<b>Categories: (Assessment type).</b> 1: ACM common characteristics or 2: Presumed ACM or 3: Sample collected for analysis	2: Presumed ACM
Sample No.	Sample Not Taken
Laboratory Analysis Findings	Analysis Not Conducted
Quantity of Material Identified	3.5m2

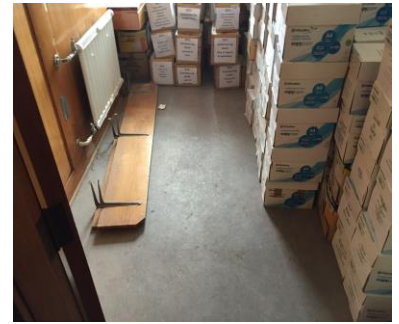
Floor.	Fourth Floor
Location/Area	Storage Room: Floor
Suspected Material Identified	Vinyl Flooring
Condition of Material Identified	Stable
<b>Categories: (Assessment type).</b> 1: ACM common characteristics or 2: Presumed ACM or 3: Sample collected for analysis	2: Presumed ACM
Sample No.	Sample Not Taken
Laboratory Analysis Findings	Analysis Not Conducted
Quantity of Material Identified	9.5m2
