Asbestos Management Survey Report

***WHANGANUI HOSPITAL
W.D.H.B OFFICES - 4th FLOOR
ASBESTOS MANAGEMENT SURVEY***

WHANGANUI HOSPITAL – W.D.H.B OFFICES 4th FLOOR

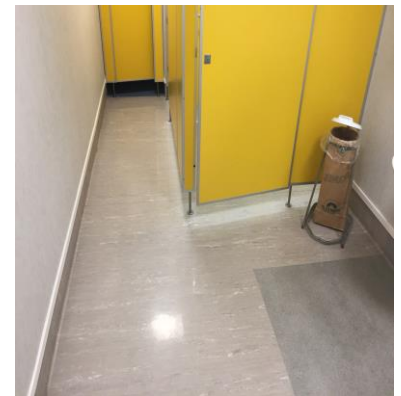
ID: CARD NO:001

Photograph No.	001
Location/Area	Women Toilet 1
Suspected Material Identified	Vinyl Floor
Condition of Material Identified	Good
Categories: (Assessment type). 1: ACM common characteristics or 2: Presumed ACM or 3: Sample collected for analysis	Presumed ACM
Sample No.	N/A
Laboratory Analysis Findings	N/A
Quantity of Material Identified	15M ²

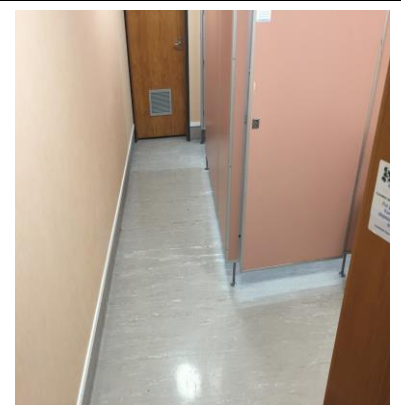
ID: CARD NO:002

Photograph No.	002
Location/Area	Male Toilet 1
Suspected Material Identified	Vinyl Floor
Condition of Material Identified	Good
Categories: (Assessment type). 1: ACM common characteristics or 2: Presumed ACM or 3: Sample collected for analysis	Presumed ACM
Sample No.	N/A
Laboratory Analysis Findings	N/A
Quantity of Material Identified	15M ²

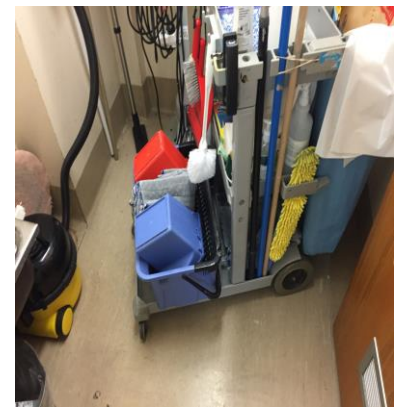
ID: CARD NO:003

Photograph No.	003
Location/Area	Cleaner Room
Suspected Material Identified	Vinyl Floor
Condition of Material Identified	Good
Categories: (Assessment type). 1: ACM common characteristics or 2: Presumed ACM or 3: Sample collected for analysis	Presumed ACM
Sample No.	N/A
Laboratory Analysis Findings	N/A
Quantity of Material Identified	4m ²

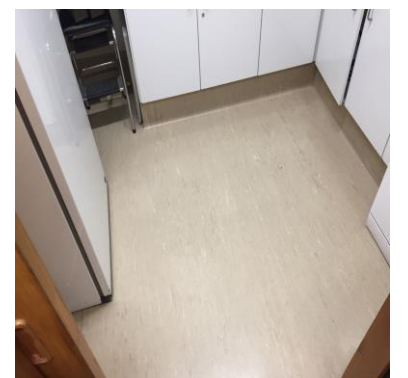
ID: CARD NO:004

Photograph No.	004
Location/Area	Copier Room
Suspected Material Identified	Vinyl Floor
Condition of Material Identified	Good
Categories: (Assessment type). 1: ACM common characteristics or 2: Presumed ACM or 3: Sample collected for analysis	Presumed ACM
Sample No.	N/A
Laboratory Analysis Findings	N/A
Quantity of Material Identified	22m ²

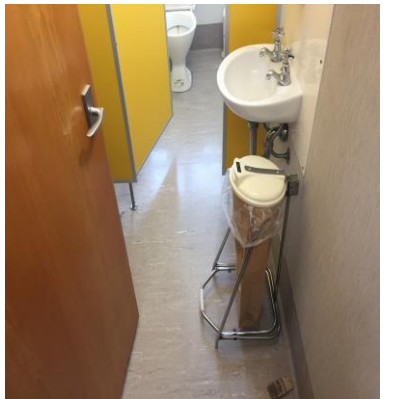
Photograph No.	006

Location/Area	Male Toilet 2	
Suspected Material Identified	Vinyl Floor	
Condition of Material Identified	Good	
Categories: (Assessment type). 1: ACM common characteristics or 2: Presumed ACM or 3: Sample collected for analysis	Presumed ACM	
Sample No.	N/A	
Laboratory Analysis Findings	N/A	
Quantity of Material Identified	2.5m ²

006	006	Male Toilet 2	2	2.5m ²	Vinyl Floor	Suspect ACM	1	0	0	0	0	0	0	0	0	0	0	Very low risk	Complete a Risk Assessment.
007	007	Women Toilet 2	2	2.5m ²	Vinyl Floor	Suspect ACM	1	0	0	0	0	0	0	0	0	0	0	Very low risk	Complete a Risk Assessment.
008	008	Safe	2	9.5m ²	Vinyl Floor	Suspect ACM	1	0	0	0	0	0	0	0	0	0	0	Very low risk	Complete a Risk Assessment.
009																			
010

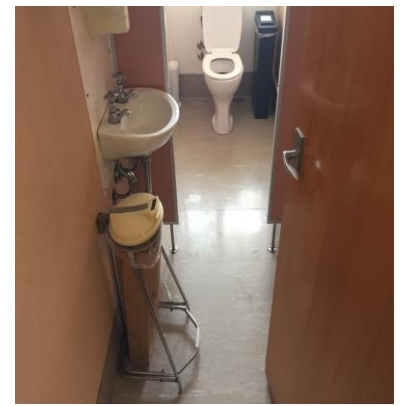
ID: CARD NO:007

Photograph No.	007
Location/Area	Women Toilet 2
Suspected Material Identified	Vinyl Floor
Condition of Material Identified	Good
Categories: (Assessment type). 1: ACM common characteristics or 2: Presumed ACM or 3: Sample collected for analysis	Presumed ACM
Sample No.	N/A
Laboratory Analysis Findings	N/A
Quantity of Material Identified	2.5m ²
