Asbestos Management Survey Report

***WHANGANUI HOSPITAL
PLANT ROOM & ROOF TOP - 5th FLOOR
ASBESTOS MANAGEMENT SURVEY***

WHANGANUI HOSPITAL –PLANT ROOM & ROOF TOP 5th FLOOR

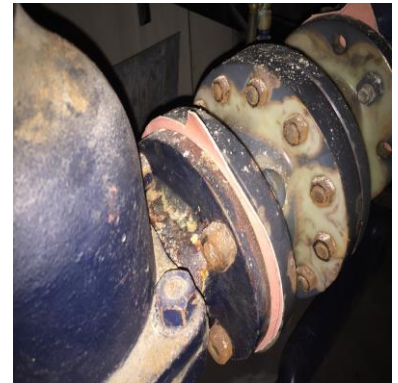
ID: CARD NO:001

Photograph No.	001
Location/Area	Plant Room
Suspected Material Identified	Gaskets
Condition of Material Identified	Good
Categories: (Assessment type). 1: ACM common characteristics or 2: Presumed ACM or 3: Sample collected for analysis	Presumed ACM
Sample No.	N/A
Laboratory Analysis Findings	N/A
Quantity of Material Identified	120 l/m

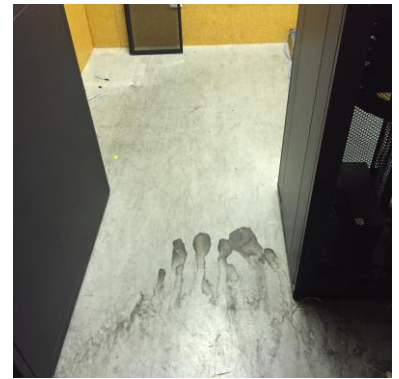
ID: CARD NO:003

Photograph No.	003
Location/Area	C.P.U Room
Suspected Material Identified	Vinyl Floor
Condition of Material Identified	Good
Categories: (Assessment type). 1: ACM common characteristics or 2: Presumed ACM or 3: Sample collected for analysis	Presumed ACM
Sample No.	N/A
Laboratory Analysis Findings	N/A
Quantity of Material Identified	9.5m ²

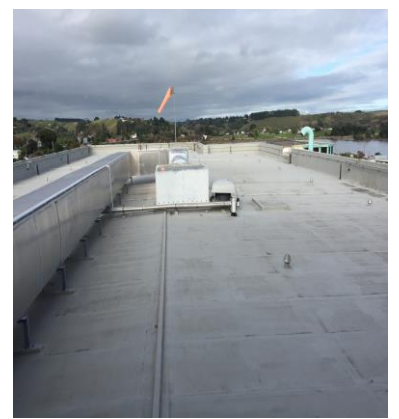
ID: CARD NO:004

Photograph No.	004
Location/Area	Lower Roof Top
Suspected Material Identified	Waterproofing
Condition of Material Identified	Good
Categories: (Assessment type). 1: ACM common characteristics or 2: Presumed ACM or 3: Sample collected for analysis	Presumed ACM
Sample No.	N/A
Laboratory Analysis Findings	N/A
Quantity of Material Identified	950m ²

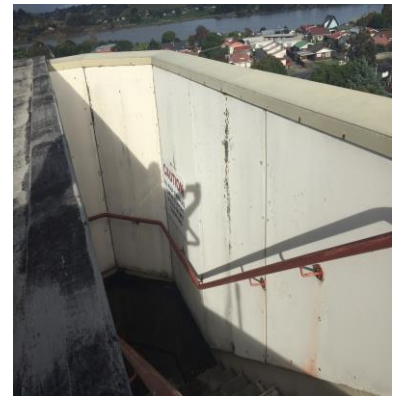
ID: CARD NO:005

Photograph No.	005
Location/Area	Lower Roof Top Stair Access
Suspected Material Identified	ACM Board (walls)
Condition of Material Identified	Good
Categories: (Assessment type). 1: ACM common characteristics or 2: Presumed ACM or 3: Sample collected for analysis	Presumed ACM
Sample No.	N/A
Laboratory Analysis Findings	N/A
Quantity of Material Identified	22m ²

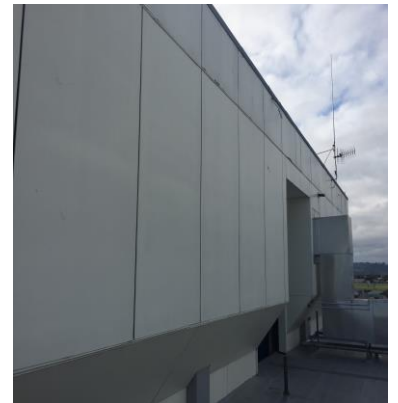
ID: CARD NO:006

Photograph No.	006
Location/Area	Upper Roof Top
Suspected Material Identified	Exterior Cladding
Condition of Material Identified	Good
Categories: (Assessment type). 1: ACM common characteristics or 2: Presumed ACM or 3: Sample collected for analysis	Presumed ACM
Sample No.	N/A
Laboratory Analysis Findings	N/A
Quantity of Material Identified	560.6m ²

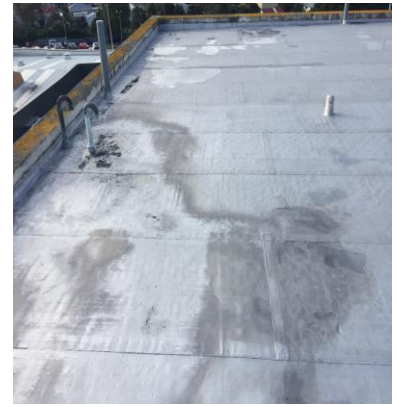
ID: CARD NO:007

Photograph No.	007
Location/Area	Upper Roof Top
Suspected Material Identified	Waterproofing (textured)
Condition of Material Identified	Good
Categories: (Assessment type). 1: ACM common characteristics or 2: Presumed ACM or 3: Sample collected for analysis	Presumed ACM
Sample No.	N/A
Laboratory Analysis Findings	N/A
Quantity of Material Identified	378m ²

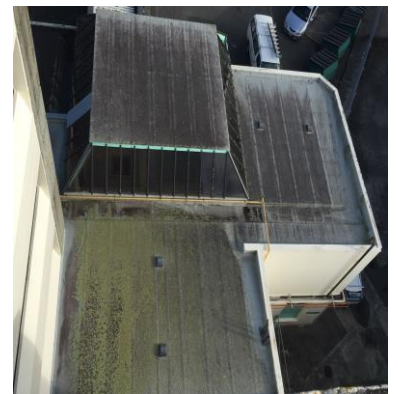
ID: CARD NO:008

Photograph No.	008
Location/Area	Upper Roof Top
Suspected Material Identified	Waterproofing
Condition of Material Identified	Good
Categories: (Assessment type). 1: ACM common characteristics or 2: Presumed ACM or 3: Sample collected for analysis	Presumed ACM
Sample No.	N/A
Laboratory Analysis Findings	N/A
Quantity of Material Identified	95m ²

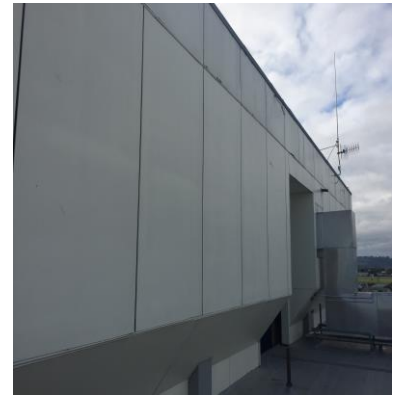
ID: CARD NO:009

Photograph No.	009
Location/Area	2 nd Floor Upper Roof Top
Suspected Material Identified	Waterproofing
Condition of Material Identified	Good
Categories: (Assessment type). 1: ACM common characteristics or 2: Presumed ACM or 3: Sample collected for analysis	Presumed ACM
Sample No.	N/A
Laboratory Analysis Findings	N/A
Quantity of Material Identified	305m ²
