## Asbestos Management Survey Report

### WHANGANUI HOSPITAL SUPPORT SERVICES

### **WHANGANUI HOSPITAL-SUPPORT SERVICES**

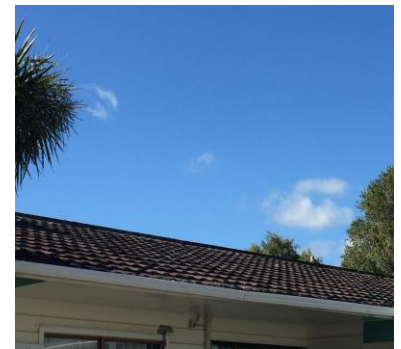
**ID: CARD NO:001**

Photograph No.	1
Location/Area	Exterior: Roof
Suspected Material Identified	Decramastic Tiles
Condition of Material Identified	Good
<b>Categories: (Assessment type).</b> 1: ACM common characteristics or 2: Presumed ACM or 3: Sample collected for analysis	1: ACM common characteristics
Sample No.	Sample Not Taken
Laboratory Analysis Findings	Analysis Not Conduct
Quantity of Material Identified	300.0m2

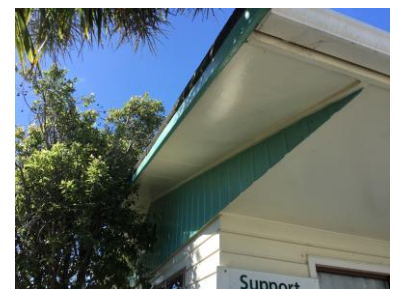
**ID: CARD NO:002**

Photograph No.	2
Location/Area	Exterior: Soffits
Suspected Material Identified	ACM Board
Condition of Material Identified	Good
<b>Categories: (Assessment type).</b> 1: ACM common characteristics or 2: Presumed ACM or 3: Sample collected for analysis	2: Presumed ACM
Sample No.	Sample Not Taken
Laboratory Analysis Findings	Analysis Not Conduct
Quantity of Material Identified	100.0m2

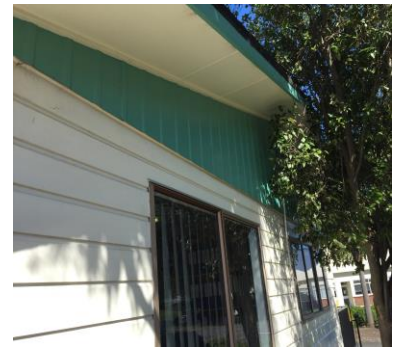
**ID: CARD NO:003**

Photograph No.	3
Location/Area	Exterior: Gable Ends
Suspected Material Identified	ACM Board
Condition of Material Identified	Good
<b>Categories: (Assessment type).</b> 1: ACM common characteristics or 2: Presumed ACM or 3: Sample collected for analysis	2: Presumed ACM
Sample No.	Sample Not Taken
Laboratory Analysis Findings	Analysis Not Conduct
Quantity of Material Identified	15.0m2

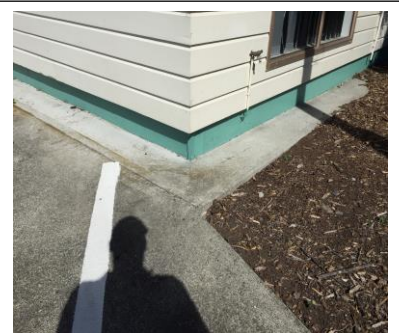
**ID: CARD NO:004**

Photograph No.	4
Location/Area	Exterior: Lower Skirting
Suspected Material Identified	ACM Board
Condition of Material Identified	Good
<b>Categories: (Assessment type).</b> 1: ACM common characteristics or 2: Presumed ACM or 3: Sample collected for analysis	2: Presumed ACM
Sample No.	Sample Not Taken
Laboratory Analysis Findings	Analysis Not Conduct
Quantity of Material Identified	36.0m2

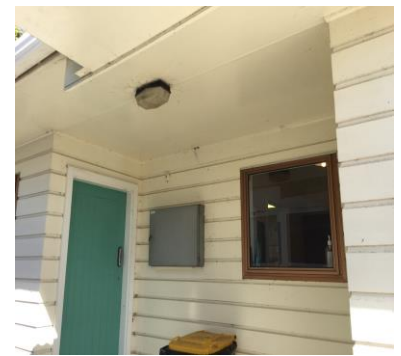
**ID: CARD NO:005**

Photograph No.	5
Location/Area	Exterior: Rear Entry
Suspected Material Identified	ACM Board
Condition of Material Identified	Good
<b>Categories: (Assessment type).</b> 1: ACM common characteristics or 2: Presumed ACM or 3: Sample collected for analysis	2: Presumed ACM
Sample No.	Sample Not Taken
Laboratory Analysis Findings	Analysis Not Conduct
Quantity of Material Identified	4.5m2

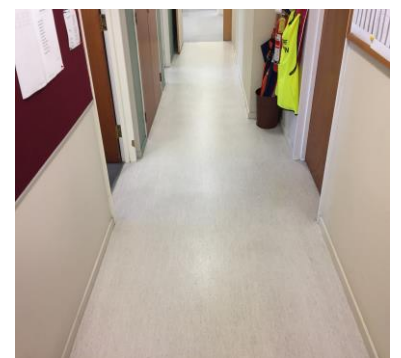
**ID: CARD NO:006**

Photograph No.	6
Location/Area	Internal: Hallway
Suspected Material Identified	Vinyl Flooring
Condition of Material Identified	Good
<b>Categories: (Assessment type).</b> 1: ACM common characteristics or 2: Presumed ACM or 3: Sample collected for analysis	2: Presumed ACM
Sample No.	Sample Not Taken
Laboratory Analysis Findings	Analysis Not Conduct
Quantity of Material Identified	10.8m2

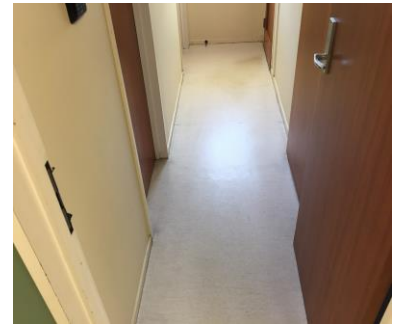
**ID: CARD NO:007**

Photograph No.	7
Location/Area	Internal: Bathroom Entry
Suspected Material Identified	Vinyl Flooring
Condition of Material Identified	Good
<b>Categories: (Assessment type).</b> 1: ACM common characteristics or 2: Presumed ACM or 3: Sample collected for analysis	2: Presumed ACM
Sample No.	Sample Not Taken
Laboratory Analysis Findings	Analysis Not Conduct
Quantity of Material Identified	4.0m2

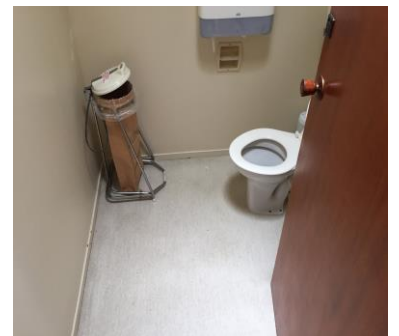
**ID: CARD NO:008**

Photograph No.	8
Location/Area	Internal: Gents Toilet
Suspected Material Identified	Vinyl Flooring
Condition of Material Identified	Good
<b>Categories: (Assessment type).</b> 1: ACM common characteristics or 2: Presumed ACM or 3: Sample collected for analysis	2: Presumed ACM
Sample No.	Sample Not Taken
Laboratory Analysis Findings	Analysis Not Conduct
Quantity of Material Identified	4.0m2

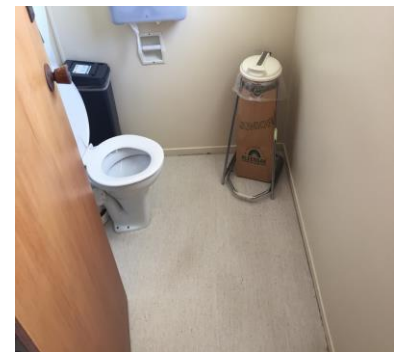
**ID: CARD NO:009**

Photograph No.	9
Location/Area	Internal: Ladies Toilet
Suspected Material Identified	Vinyl Flooring
Condition of Material Identified	Good
<b>Categories: (Assessment type).</b> 1: ACM common characteristics or 2: Presumed ACM or 3: Sample collected for analysis	2: Presumed ACM
Sample No.	Sample Not Taken
Laboratory Analysis Findings	Analysis Not Conduct
Quantity of Material Identified	4.0m2

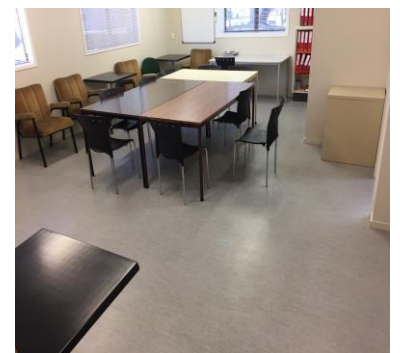
**ID: CARD NO:010**

Photograph No.	10
Location/Area	Internal: Smoko Room
Suspected Material Identified	Vinyl Flooring
Condition of Material Identified	Good
<b>Categories: (Assessment type).</b> 1: ACM common characteristics or 2: Presumed ACM or 3: Sample collected for analysis	2: Presumed ACM
Sample No.	Sample Not Taken
Laboratory Analysis Findings	Analysis Not Conduct
Quantity of Material Identified	35.0m2
