Asbestos Management Survey Report

Whanganui Hospital,
Unit 11.

UNIT 11

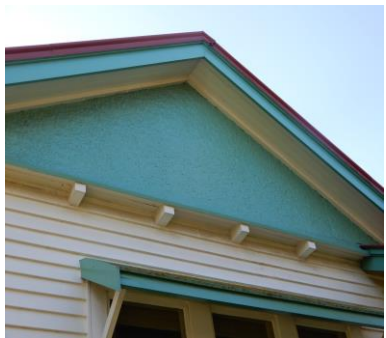
Photograph No.	1

Location/Area	External: Gable End	
Suspected Material Identified	Textured Cladding	
Condition of Material Identified	Good	
Categories: (Assessment type). 1: ACM common characteristics or 2: Presumed ACM or 3: Sample collected for analysis	2: Presumed ACM	
Sample No.	Sample Not Taken	
Laboratory Analysis Findings	Analysis Not Conducted	
Quantity of Material Identified	20.0m2

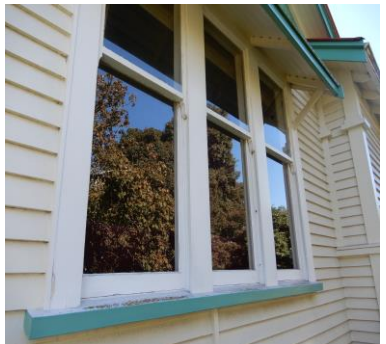
Photograph No.	2

Location/Area	External: Window Frame	
Suspected Material Identified	Compound Putty	
Condition of Material Identified	Good	
Categories: (Assessment type). 1: ACM common characteristics or 2: Presumed ACM or 3: Sample collected for analysis	2: Presumed ACM	
Sample No.	Sample Not Taken	
Laboratory Analysis Findings	Analysis Not Conducted	
Quantity of Material Identified	200.0L/M

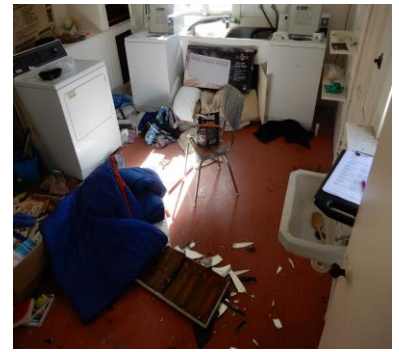
Photograph No.	3
Location/Area	Internal: Laundry
Suspected Material Identified	Vinyl Flooring
Condition of Material Identified	Good
Categories: (Assessment type). 1: ACM common characteristics or 2: Presumed ACM or 3: Sample collected for analysis	2: Presumed ACM
Sample No.	Sample Not Taken
Laboratory Analysis Findings	Analysis Not Conducted
Quantity of Material Identified	12.0m2

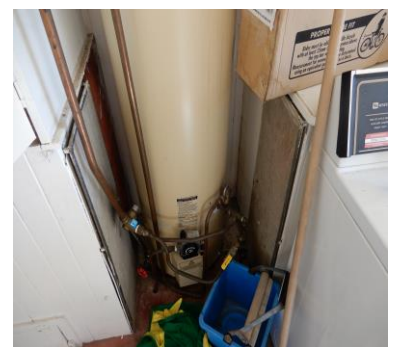
Photograph No.	
Location/Area	Internal: Laundry (H.W.C.)
Suspected Material Identified	ACM Board
Condition of Material Identified	Good
Categories: (Assessment type). 1: ACM common characteristics or 2: Presumed ACM or 3: Sample collected for analysis	2: Presumed ACM
Sample No.	Sample Not Taken
Laboratory Analysis Findings	Analysis Not Conducted
Quantity of Material Identified	1.8m2

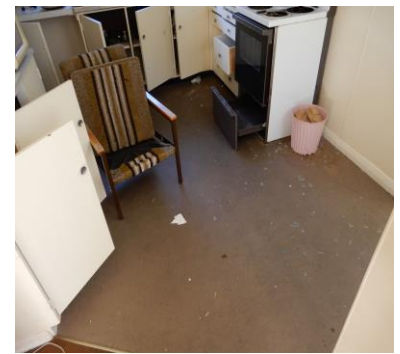
Photograph No.	5
Location/Area	Internal: Kitchen
Suspected Material Identified	Vinyl Flooring
Condition of Material Identified	Good
Categories: (Assessment type). 1: ACM common characteristics or 2: Presumed ACM or 3: Sample collected for analysis	2: Presumed ACM
Sample No.	Sample Not Taken
Laboratory Analysis Findings	Analysis Not Conducted
Quantity of Material Identified	9.0m2

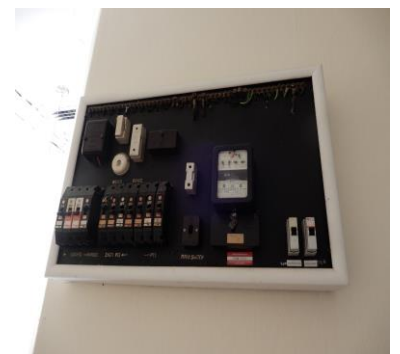
Photograph No.	
Location/Area	Hallway: Fuse Board
Suspected Material Identified	Compressed Board
Condition of Material Identified	Good
Categories: (Assessment type). 1: ACM common characteristics or 2: Presumed ACM or 3: Sample collected for analysis	2: Presumed ACM
Sample No.	Sample Not Taken
Laboratory Analysis Findings	Analysis Not Conducted
Quantity of Material Identified	.800m2

006	6	Internal: Hallway	2	.800m2	Fuse Board	Compressed Board	1	0	0	1	0	0	0	0	0	0	0	Very low risk	Complete a Risk Assessment.
007	7	Internal: Lounge	2	1.2m2	Heater Backing board	Compressed Board	1	0	0	1	0	0	0	0	0	0	0	Very low risk	Complete a Risk Assessment.
008	8	Internal: Toilet	2	2.1m2	Vinyl Flooring (Speckled)	Vinyl or backing resin	1	0	0	1	0	0	0	0	0	0	0	Very low risk	Complete a Risk Assessment.
009	9	Internal: Bathroom	2	2.0m2	Vinyl Flooring (Blue)	Vinyl or backing resin	1	0	0	1	0	0	0	0	0	0	0	Very low risk	Complete a Risk Assessment.
010	10	Internal: Bedroom 6	2	25.0m2	Ceiling Panels	Compressed Board	1	0	0	1	0	0	0	0	0	0	0	Very low risk	Complete a Risk Assessment.

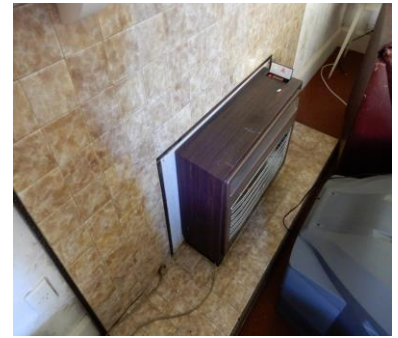
Photograph No.	7
Location/Area	Lounge: Heater (Backing Board)
Suspected Material Identified	Compressed Board
Condition of Material Identified	Good
Categories: (Assessment type). 1: ACM common characteristics or 2: Presumed ACM or 3: Sample collected for analysis	2: Presumed ACM
Sample No.	Sample Not Taken
Laboratory Analysis Findings	Analysis Not Conducted
Quantity of Material Identified	1.2m2

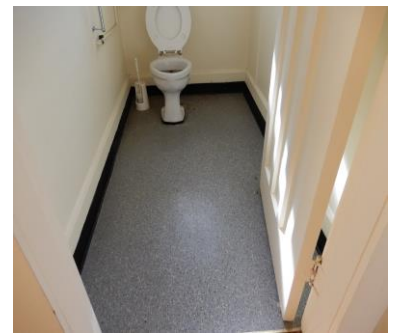
Photograph No.	8
Location/Area	Internal: Toilet
Suspected Material Identified	Vinyl Flooring
Condition of Material Identified	Good
Categories: (Assessment type). 1: ACM common characteristics or 2: Presumed ACM or 3: Sample collected for analysis	2: Presumed ACM
Sample No.	Sample Not Taken
Laboratory Analysis Findings	Analysis Not Conducted
Quantity of Material Identified	2.1m2

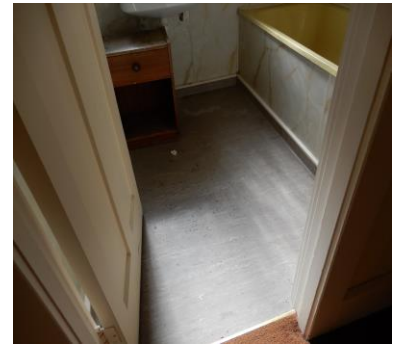
Photograph No.	9
Location/Area	Internal: Bathroom
Suspected Material Identified	Vinyl Flooring
Condition of Material Identified	Good
Categories: (Assessment type). 1: ACM common characteristics or 2: Presumed ACM or 3: Sample collected for analysis	2: Presumed ACM
Sample No.	Sample Not Taken
Laboratory Analysis Findings	Analysis Not Conducted
Quantity of Material Identified	2.0m2

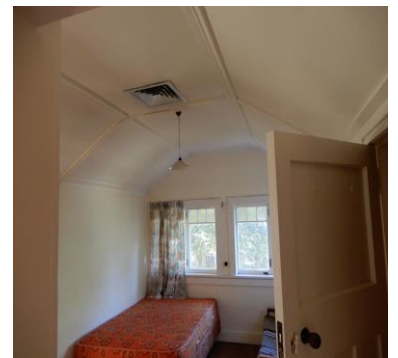
Photograph No.	10
Location/Area	Internal: Bedroom 6 (Ceiling)
Suspected Material Identified	ACM Board
Condition of Material Identified	Good
Categories: (Assessment type). 1: ACM common characteristics or 2: Presumed ACM or 3: Sample collected for analysis	2: Presumed ACM
Sample No.	Sample Not Taken
Laboratory Analysis Findings	Analysis Not Conducted
Quantity of Material Identified	25.0m2

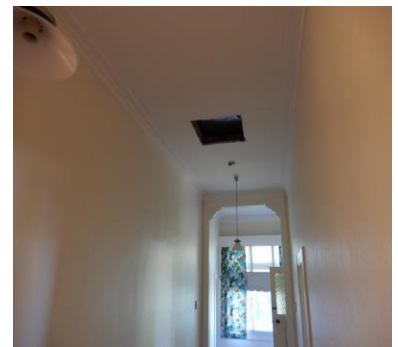
Photograph No.	11
Location/Area	Internal: Hallway (Ceiling)
Suspected Material Identified	Lath & Plaster
Condition of Material Identified	Good
Categories: (Assessment type). 1: ACM common characteristics or 2: Presumed ACM or 3: Sample collected for analysis	2: Presumed ACM
Sample No.	Sample Not Taken
Laboratory Analysis Findings	Analysis Not Conducted
Quantity of Material Identified	30.0m2

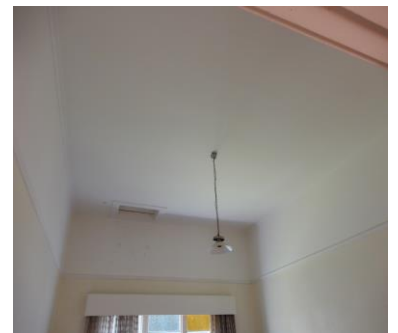
Photograph No.	12
Location/Area	Internal: Dining Room (Ceiling)
Suspected Material Identified	Lath & Plaster
Condition of Material Identified	Good
Categories: (Assessment type). 1: ACM common characteristics or 2: Presumed ACM or 3: Sample collected for analysis	2: Presumed ACM
Sample No.	Sample Not Taken
Laboratory Analysis Findings	Analysis Not Conducted
Quantity of Material Identified	31.0m2

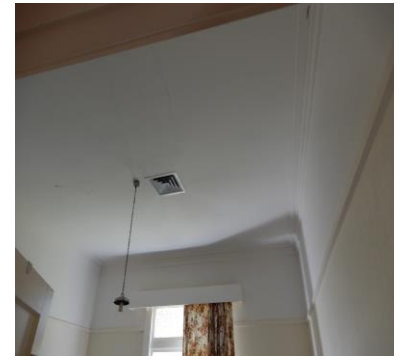
Photograph No.	13
Location/Area	Internal: Bedroom (Ceiling)
Suspected Material Identified	Lath & Plaster
Condition of Material Identified	Good
Categories: (Assessment type). 1: ACM common characteristics or 2: Presumed ACM or 3: Sample collected for analysis	2: Presumed ACM
Sample No.	Sample Not Taken
Laboratory Analysis Findings	Analysis Not Conducted
Quantity of Material Identified	31.0m2

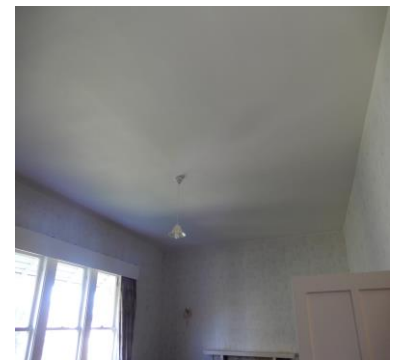
Photograph No.	14
Location/Area	Internal: Lounge (Ceiling)
Suspected Material Identified	Lath & Plaster
Condition of Material Identified	Good
Categories: (Assessment type). 1: ACM common characteristics or 2: Presumed ACM or 3: Sample collected for analysis	2: Presumed ACM
Sample No.	Sample Not Taken
Laboratory Analysis Findings	Analysis Not Conducted
Quantity of Material Identified	37.5m2

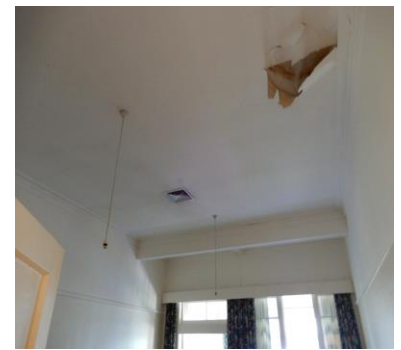
Photograph No.	15
Location/Area	Internal: Bedroom 4 (Ceiling)
Suspected Material Identified	Lath & Plaster
Condition of Material Identified	Good
Categories: (Assessment type). 1: ACM common characteristics or 2: Presumed ACM or 3: Sample collected for analysis	2: Presumed ACM
Sample No.	Sample Not Taken
Laboratory Analysis Findings	Analysis Not Conducted
Quantity of Material Identified	44.0m2

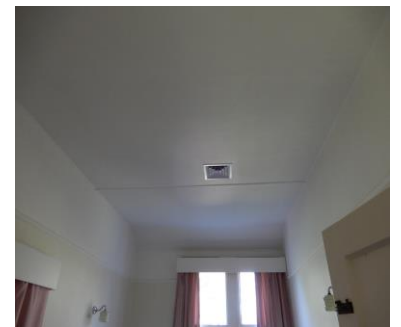
Photograph No.	
Location/Area	Internal: Bedroom 2 (Ceiling)
Suspected Material Identified	Lath & Plaster
Condition of Material Identified	Good
Categories: (Assessment type). 1: ACM common characteristics or 2: Presumed ACM or 3: Sample collected for analysis	2: Presumed ACM
Sample No.	Sample Not Taken
Laboratory Analysis Findings	Analysis Not Conducted
Quantity of Material Identified	28.0m2

016	16	Internal: Bedroom 2	2	28.0m2	Ceiling Material	Lath & Plaster	1	0	0	1	0	0	0	0	0	0	0	Very low risk	Complete a Risk Assessment.
017	17	Exterior: Rear Shed	1	30.0m2	Wall Lining	Compressed Board	1	0	0	1	0	0	0	0	0	0	0	Very low risk	Complete a Risk Assessment.
018	18	Internal: Rear Shed	2	7.0m2	Vinyl Flooring	Vinyl or Backing resin	1	0	0	1	0	0	0	0	0	0	0	Very low risk	Complete a Risk Assessment.
019	19	Internal: Rear Shed	2	.150m2	Fuse Board	Compressed Board	1	0	0	1	0	0	0	0	0	0	0	Very low risk	Complete a Risk Assessment.
020	20

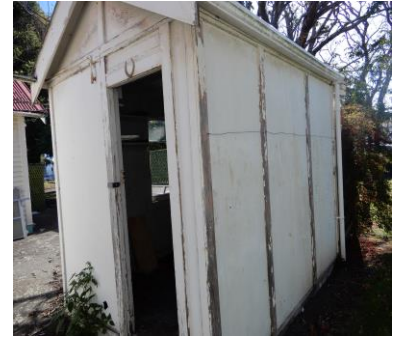
Photograph No.	17
Location/Area	Rear Shed: Exterior Walls
Suspected Material Identified	ACM Board
Condition of Material Identified	Damaged
Categories: (Assessment type). 1: ACM common characteristics or 2: Presumed ACM or 3: Sample collected for analysis	1: ACM common characteristics
Sample No.	Sample Not Taken
Laboratory Analysis Findings	Analysis Not Conducted
Quantity of Material Identified	30.0m2

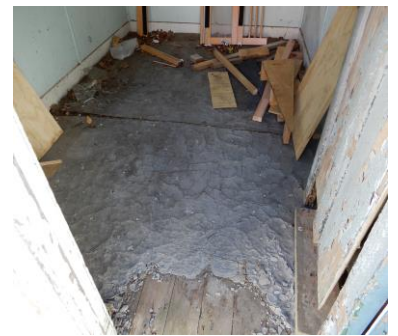
Photograph No.	18
Location/Area	Rear Shed: Floor
Suspected Material Identified	Vinyl Flooring
Condition of Material Identified	Damaged
Categories: (Assessment type). 1: ACM common characteristics or 2: Presumed ACM or 3: Sample collected for analysis	2: Presumed ACM
Sample No.	Sample Not Taken
Laboratory Analysis Findings	Analysis Not Conducted
Quantity of Material Identified	7.0m2

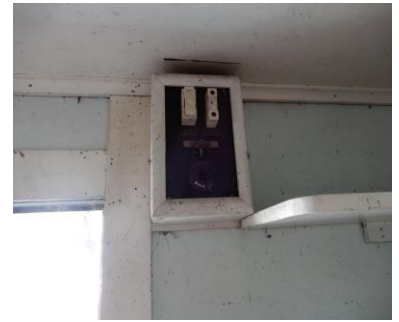
Photograph No.	19
Location/Area	Rear Shed: Fuse Board
Suspected Material Identified	ACM Board
Condition of Material Identified	Good
Categories: (Assessment type). 1: ACM common characteristics or 2: Presumed ACM or 3: Sample collected for analysis	2: Presumed ACM
Sample No.	Sample Not Taken
Laboratory Analysis Findings	Analysis Not Conducted
Quantity of Material Identified	.150m2
