Asbestos Management Survey Report

***WHANGANUI HOSPITAL
C.P.U BLOCK
ASBESTOS MANAGEMENT SURVEY***

WHANGANUI HOSPITAL – C.P.U BLOCK

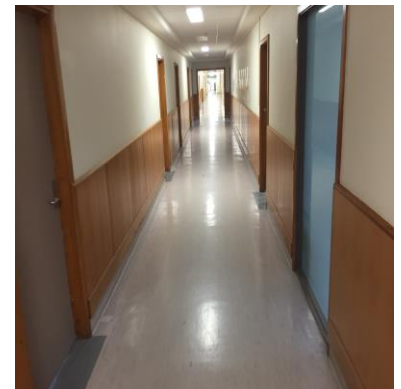
ID: CARD NO:001

Photograph No.	001
Location/Area	Ground Floor-Corridor
Suspected Material Identified	Vinyl Floor
Condition of Material Identified	Good
Categories: (Assessment type). 1: ACM common characteristics or 2: Presumed ACM or 3: Sample collected for analysis	Presumed ACM
Sample No.	N/A
Laboratory Analysis Findings	N/A
Quantity of Material Identified	60m ²

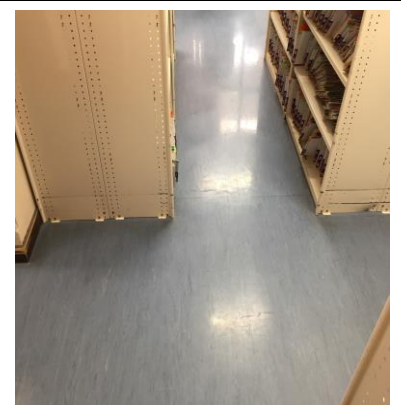
ID: CARD NO:002

Photograph No.	002
Location/Area	Ground Floor-File Room
Suspected Material Identified	Vinyl Floor (blue)
Condition of Material Identified	Good
Categories: (Assessment type). 1: ACM common characteristics or 2: Presumed ACM or 3: Sample collected for analysis	Presumed ACM
Sample No.	N/A
Laboratory Analysis Findings	N/A
Quantity of Material Identified	97m ²

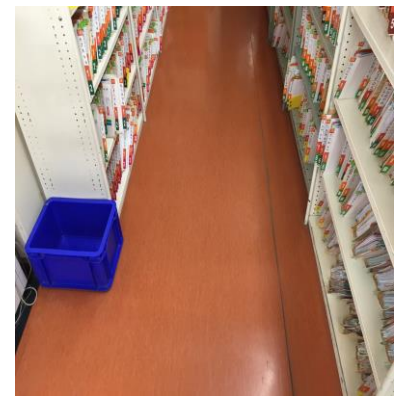
ID: CARD NO:003

Photograph No.	003
Location/Area	Ground Floor-File Room
Suspected Material Identified	Vinyl Floor (orange)
Condition of Material Identified	Good
Categories: (Assessment type). 1: ACM common characteristics or 2: Presumed ACM or 3: Sample collected for analysis	Presumed ACM
Sample No.	N/A
Laboratory Analysis Findings	N/A
Quantity of Material Identified	96m ²

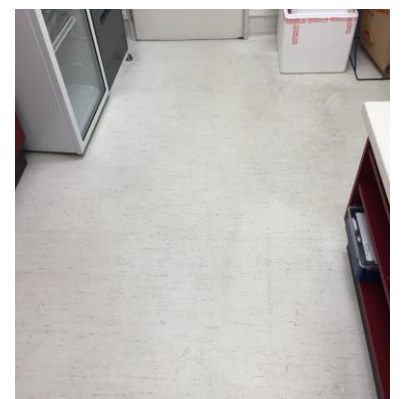
ID: CARD NO:004

Photograph No.	004
Location/Area	Ground Floor-Corridor
Suspected Material Identified	Vinyl Floor
Condition of Material Identified	Good
Categories: (Assessment type). 1: ACM common characteristics or 2: Presumed ACM or 3: Sample collected for analysis	Presumed ACM
Sample No.	N/A
Laboratory Analysis Findings	N/A
Quantity of Material Identified	2m ²

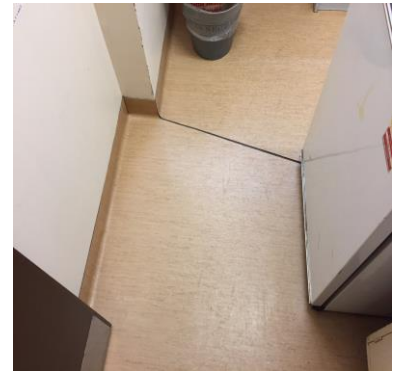
ID: CARD NO:005

Photograph No.	005
Location/Area	Ground Floor-Kitchen
Suspected Material Identified	Vinyl Floor
Condition of Material Identified	Good
Categories: (Assessment type). 1: ACM common characteristics or 2: Presumed ACM or 3: Sample collected for analysis	Presumed ACM
Sample No.	N/A
Laboratory Analysis Findings	N/A
Quantity of Material Identified	3.5m ²

ID Card No	Photo No	Location/Area Description	Sample Ref Category No	Quantity	Product Description	Asbestos Type	Product Type	Condition	Surface Treatment	Asbestos Type	Material Risk Score	Normal Occupant Activity	Likelihood of Disturbance	Human Exposure Potential	Maintenance Activity	Priority Risk Score	Overall Risk Score	Action	
001	001	Ground Floor-Corridor	2	60m ²	Vinyl Floor.	Suspect ACM	1	0	0	0	0	0	0	0	0	0	0	Very low risk	Complete a Risk Assessment.
002	002	Ground Floor-File Room	2	97m ²	Vinyl Floor. (blue)	Suspect ACM	1	0	0	0	0	0	0	0	0	0	0	Very low risk	Complete a Risk Assessment.
003	003	Ground Floor-File Room	2	96m ²	Vinyl Floor. (orange)	Suspect ACM	1	0	0	0	0	0	0	0	0	0	0	Very low risk	Complete a Risk Assessment.
004	004	Ground Floor-Corridor	2	2m ²	Vinyl Floor.	Suspect ACM	1	0	0	0	0	0	0	0	0	0	0	Very low risk	Complete a Risk Assessment.
005	005	Ground Floor-Kitchen	2	3.5m ²	Vinyl Floor.	Suspect ACM	1	0	0	0	0	0	0	0	0	0	0	Very low risk	Complete a Risk Assessment.

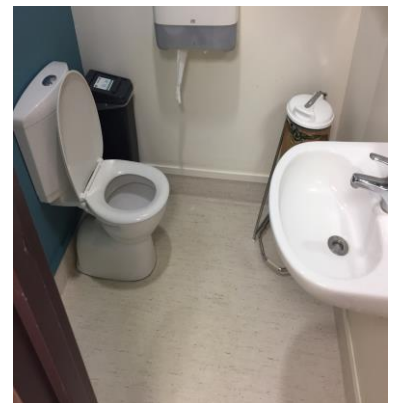
ID: CARD NO:006

Photograph No.	006
Location/Area	Ground Floor-Toilet
Suspected Material Identified	Vinyl Floor
Condition of Material Identified	Good
Categories: (Assessment type). 1: ACM common characteristics or 2: Presumed ACM or 3: Sample collected for analysis	Presumed ACM
Sample No.	N/A
Laboratory Analysis Findings	N/A
Quantity of Material Identified	2m ²

006	006	Ground Floor-Toilet	2	2m ²	Vinyl Floor.	Suspect ACM	1	0	0	0	0	0	0	0	0	0	0	Very low risk	Complete a Risk Assessment.
007	007	1 st Floor-Corridor	2	119m ²	Vinyl Floor.	Suspect ACM	1	0	0	0	0	0	0	0	0	0	0	Very low risk	Complete a Risk Assessment.
008	008	1 st Floor-Pharmacy Foyer	2	15m ²	Vinyl Floor.	Suspect ACM	1	0	0	0	0	0	0	0	0	0	0	Very low risk	Complete a Risk Assessment.
009	009	1 st Floor-Pharmacy Rm	2	10.6m ²	Vinyl Floor.	Suspect ACM	1	0	0	0	0	0	0	0	0	0	0	Very low risk	Complete a Risk Assessment.
010	010	1 st Floor-Pharmacy Office	2	130m ²	Vinyl Floor.	Suspect ACM	1	0	0	0	0	0	0	0	0	0	0	Very low risk	Complete a Risk Assessment.

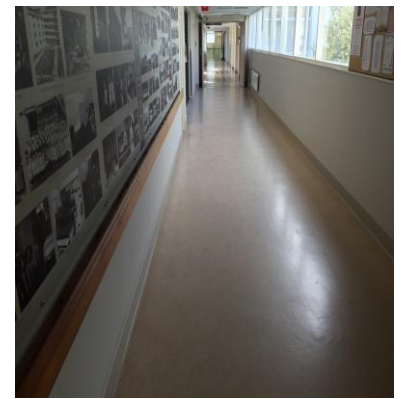
ID: CARD NO:007

Photograph No.	007
Location/Area	1 st Floor-Corridor
Suspected Material Identified	Vinyl Floor
Condition of Material Identified	Good
Categories: (Assessment type). 1: ACM common characteristics or 2: Presumed ACM or 3: Sample collected for analysis	Presumed ACM
Sample No.	N/A
Laboratory Analysis Findings	N/A
Quantity of Material Identified	119m ²

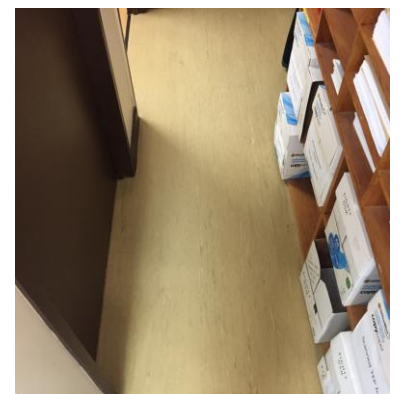
ID: CARD NO:008

Photograph No.	008
Location/Area	1 st Floor-Pharmacy Foyer
Suspected Material Identified	Vinyl Floor
Condition of Material Identified	Good
Categories: (Assessment type). 1: ACM common characteristics or 2: Presumed ACM or 3: Sample collected for analysis	Presumed ACM
Sample No.	N/A
Laboratory Analysis Findings	N/A
Quantity of Material Identified	15m ²

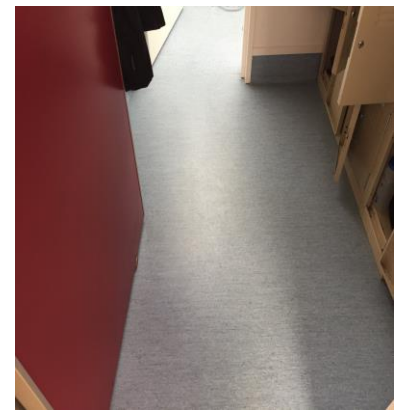
ID: CARD NO:009

Photograph No.	009
Location/Area	1 st Floor-Pharmacy Room
Suspected Material Identified	Vinyl Floor
Condition of Material Identified	Good
Categories: (Assessment type). 1: ACM common characteristics or 2: Presumed ACM or 3: Sample collected for analysis	Presumed ACM
Sample No.	N/A
Laboratory Analysis Findings	N/A
Quantity of Material Identified	10.6m ²

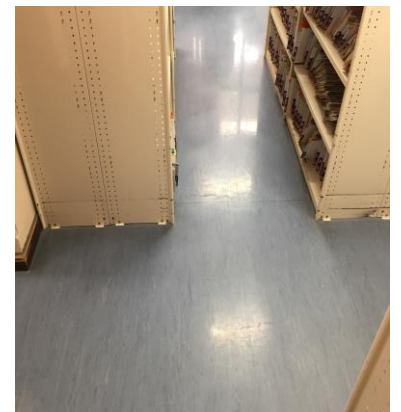
ID: CARD NO:010

Photograph No.	010
Location/Area	1 st Floor-Pharmacy Office
Suspected Material Identified	Vinyl Floor
Condition of Material Identified	Good
Categories: (Assessment type). 1: ACM common characteristics or 2: Presumed ACM or 3: Sample collected for analysis	Presumed ACM
Sample No.	N/A
Laboratory Analysis Findings	N/A
Quantity of Material Identified	130m ²

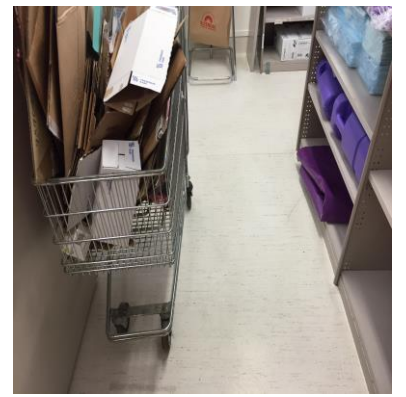
ID: CARD NO:011

Photograph No.	011
Location/Area	1 st Floor-Pharmacy Bulk Rm
Suspected Material Identified	Vinyl Floor
Condition of Material Identified	Good
Categories: (Assessment type). 1: ACM common characteristics or 2: Presumed ACM or 3: Sample collected for analysis	Presumed ACM
Sample No.	N/A
Laboratory Analysis Findings	N/A
Quantity of Material Identified	4.5m ²

011	011	1 st Floor-Pharmacy Bulk Room	2	14.5m ²	Vinyl Floor.	Suspect ACM	1	0	0	0	0	0	0	0	0	0	0	Very low risk	Complete a Risk Assessment.
012	012	1 st Floor-Pharmacy Toilet	2	6m ²	Vinyl Floor.	Suspect ACM	1	0	0	0	0	0	0	0	0	0	0	Very low risk	Complete a Risk Assessment.
013	013	External	2	57m ²	Wall Cladding	Suspect ACM	1	0	0	0	0	0	0	0	0	0	0	Very low risk	Complete a Risk Assessment.
014	014	External	2	36m ²	Soffit Lining	Suspect ACM	1	0	0	0	0	0	0	0	0	0	0	Very low risk	Complete a Risk Assessment.
015

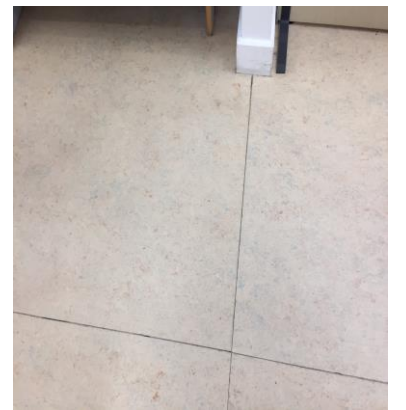
ID: CARD NO:012

Photograph No.	012
Location/Area	1 st Floor-Pharmacy Toilet
Suspected Material Identified	Vinyl Floor
Condition of Material Identified	Good
Categories: (Assessment type). 1: ACM common characteristics or 2: Presumed ACM or 3: Sample collected for analysis	Presumed ACM
Sample No.	N/A
Laboratory Analysis Findings	N/A
Quantity of Material Identified	6m ²

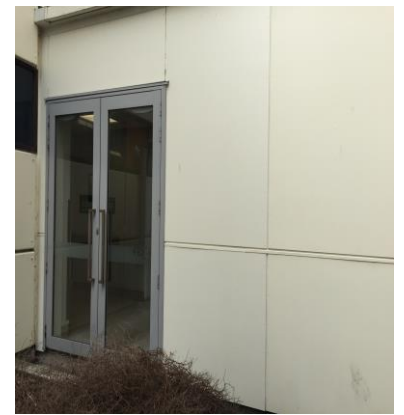
ID: CARD NO:013

Photograph No.	013
Location/Area	External-Wall Cladding
Suspected Material Identified	ACM Board
Condition of Material Identified	Good
Categories: (Assessment type). 1: ACM common characteristics or 2: Presumed ACM or 3: Sample collected for analysis	Presumed ACM
Sample No.	N/A
Laboratory Analysis Findings	N/A
Quantity of Material Identified	57m ²

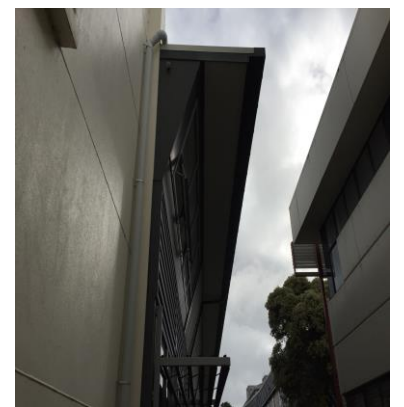
ID: CARD NO:014

Photograph No.	014
Location/Area	External-Soffit Lining
Suspected Material Identified	ACM Board
Condition of Material Identified	Good
Categories: (Assessment type). 1: ACM common characteristics or 2: Presumed ACM or 3: Sample collected for analysis	Presumed ACM
Sample No.	N/A
Laboratory Analysis Findings	N/A
Quantity of Material Identified	36m ²
