## **Asbestos Management Survey Report**

***CHILDRENS WARD  
WHANGANUI HOSPITAL  
ASBESTOS MANAGEMENT SURVEY***

### **WHANGANUI HOSPITAL – CHILDRENS WARDS**

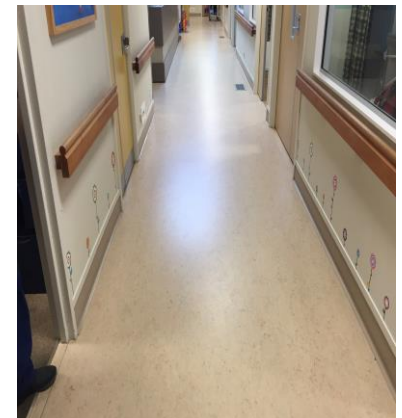
**ID: CARD NO:001**

Photograph No.	001
Location/Area	Corridors
Suspected Material Identified	Vinyl Floor
Condition of Material Identified	Good
<b>Categories: (Assessment type).</b> 1: ACM common characteristics or 2: Presumed ACM or 3: Sample collected for analysis	Presumed ACM
Sample No.	N/A
Laboratory Analysis Findings	N/A
Quantity of Material Identified	69m <sup>2</sup>

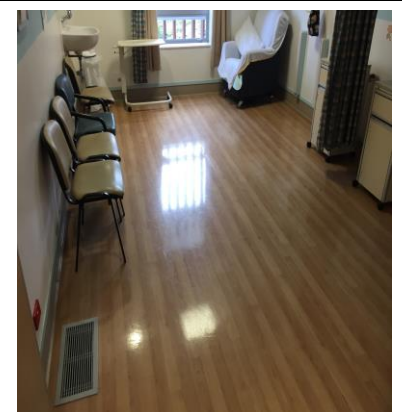
**ID: CARD NO:002**

Photograph No.	002
Location/Area	Room 7
Suspected Material Identified	Vinyl Floor/Walls
Condition of Material Identified	Good
<b>Categories: (Assessment type).</b> 1: ACM common characteristics or 2: Presumed ACM or 3: Sample collected for analysis	Presumed ACM
Sample No.	N/A
Laboratory Analysis Findings	N/A
Quantity of Material Identified	21m <sup>2</sup> /18.5m <sup>2</sup>

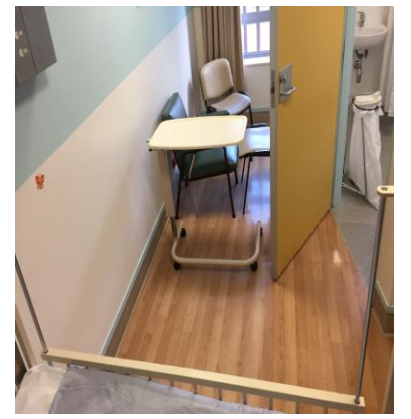
**ID: CARD NO:003**

Photograph No.	003
Location/Area	Room 6
Suspected Material Identified	Vinyl Floor/Walls
Condition of Material Identified	Good
<b>Categories: (Assessment type).</b> 1: ACM common characteristics or 2: Presumed ACM or 3: Sample collected for analysis	Presumed ACM
Sample No.	N/A
Laboratory Analysis Findings	N/A
Quantity of Material Identified	14m <sup>2</sup> /15m <sup>2</sup>

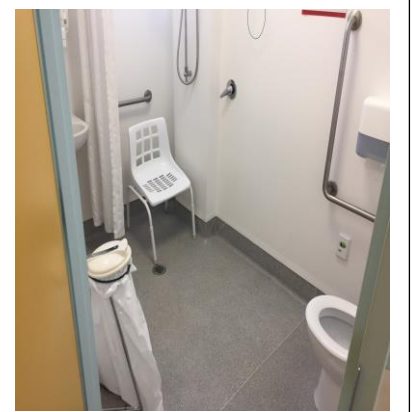
**ID: CARD NO:004**

Photograph No.	004
Location/Area	Room 6 Toilet/Shower
Suspected Material Identified	Vinyl Floor/Walls
Condition of Material Identified	Good
<b>Categories: (Assessment type).</b> 1: ACM common characteristics or 2: Presumed ACM or 3: Sample collected for analysis	Presumed ACM
Sample No.	N/A
Laboratory Analysis Findings	N/A
Quantity of Material Identified	4m <sup>2</sup> /17.5m <sup>2</sup>

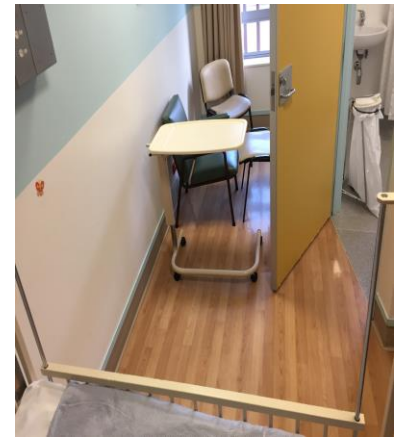
**ID: CARD NO:005**

Photograph No.	005
Location/Area	Room 5
Suspected Material Identified	Vinyl Floor/Walls
Condition of Material Identified	Good
<b>Categories: (Assessment type).</b> 1: ACM common characteristics or 2: Presumed ACM or 3: Sample collected for analysis	Presumed ACM
Sample No.	N/A
Laboratory Analysis Findings	N/A
Quantity of Material Identified	14m <sup>2</sup> /15m <sup>2</sup>

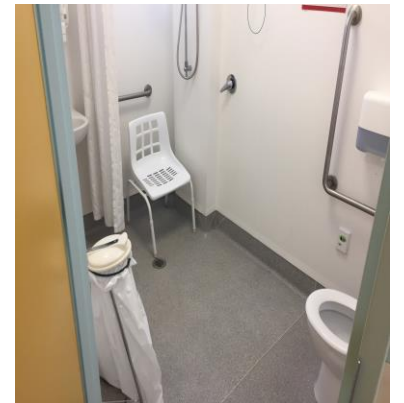
**ID: CARD NO:006**

Photograph No.	006
Location/Area	Room 5 Toilet/Shower
Suspected Material Identified	Vinyl Floor/Walls
Condition of Material Identified	Good
<b>Categories: (Assessment type).</b> 1: ACM common characteristics or 2: Presumed ACM or 3: Sample collected for analysis	Presumed ACM
Sample No.	N/A
Laboratory Analysis Findings	N/A
Quantity of Material Identified	4m <sup>2</sup> /17.5m <sup>2</sup>

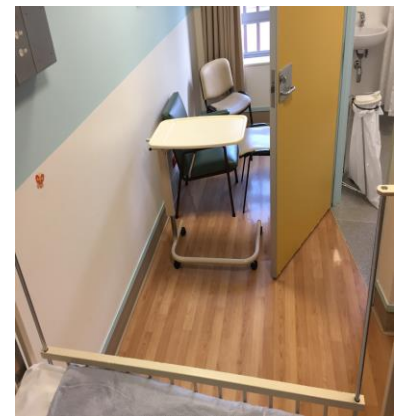
**ID: CARD NO:007**

Photograph No.	007
Location/Area	Room 4
Suspected Material Identified	Vinyl Floor/Walls
Condition of Material Identified	Good
<b>Categories: (Assessment type).</b> 1: ACM common characteristics or 2: Presumed ACM or 3: Sample collected for analysis	Presumed ACM
Sample No.	N/A
Laboratory Analysis Findings	N/A
Quantity of Material Identified	14m <sup>2</sup> /15m <sup>2</sup>

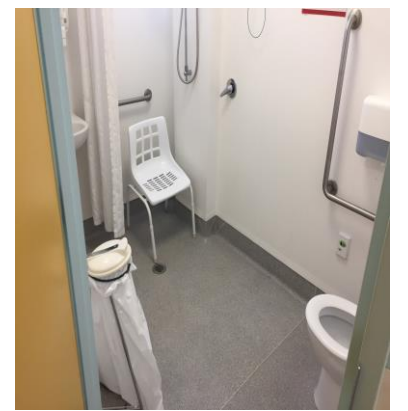
**ID: CARD NO:008**

Photograph No.	008
Location/Area	Room 4 Toilet/Shower
Suspected Material Identified	Vinyl Floor/Walls
Condition of Material Identified	Good
<b>Categories: (Assessment type).</b> 1: ACM common characteristics or 2: Presumed ACM or 3: Sample collected for analysis	Presumed ACM
Sample No.	N/A
Laboratory Analysis Findings	N/A
Quantity of Material Identified	4m <sup>2</sup> /17.5m <sup>2</sup>

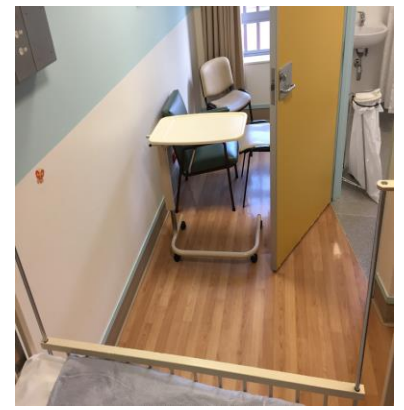
**ID: CARD NO:009**

Photograph No.	009
Location/Area	Room 3
Suspected Material Identified	Vinyl Floor/Walls
Condition of Material Identified	Good
<b>Categories: (Assessment type).</b> 1: ACM common characteristics or 2: Presumed ACM or 3: Sample collected for analysis	Presumed ACM
Sample No.	N/A
Laboratory Analysis Findings	N/A
Quantity of Material Identified	14m <sup>2</sup> /15m <sup>2</sup>

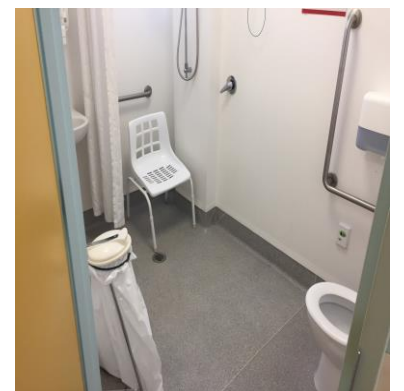
**ID: CARD NO:010**

Photograph No.	010
Location/Area	Room 3 Toilet/Shower
Suspected Material Identified	Vinyl Floor/Walls
Condition of Material Identified	Good
<b>Categories: (Assessment type).</b> 1: ACM common characteristics or 2: Presumed ACM or 3: Sample collected for analysis	Presumed ACM
Sample No.	N/A
Laboratory Analysis Findings	N/A
Quantity of Material Identified	4m <sup>2</sup> /17.5m <sup>2</sup>

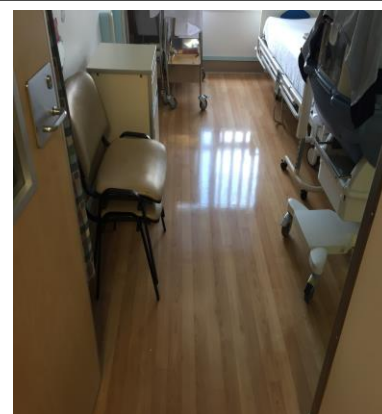
**ID: CARD NO:011**

Photograph No.	011
Location/Area	Room 2
Suspected Material Identified	Vinyl Floor/Walls
Condition of Material Identified	Good
<b>Categories: (Assessment type).</b> 1: ACM common characteristics or 2: Presumed ACM or 3: Sample collected for analysis	Presumed ACM
Sample No.	N/A
Laboratory Analysis Findings	N/A
Quantity of Material Identified	21m <sup>2</sup> /18.5m <sup>2</sup>

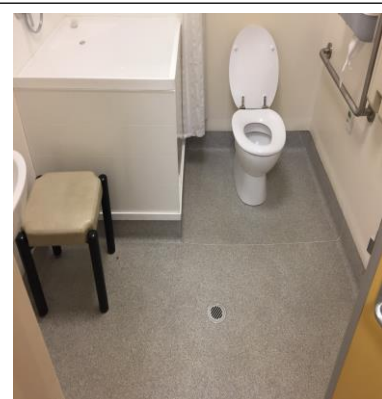
**ID: CARD NO:012**

Photograph No.	012
Location/Area	Unisex Toilet/Shower
Suspected Material Identified	Vinyl Floor/Walls
Condition of Material Identified	Good
<b>Categories: (Assessment type).</b> 1: ACM common characteristics or 2: Presumed ACM or 3: Sample collected for analysis	Presumed ACM
Sample No.	N/A
Laboratory Analysis Findings	N/A
Quantity of Material Identified	4.8m <sup>2</sup> /25m <sup>2</sup>

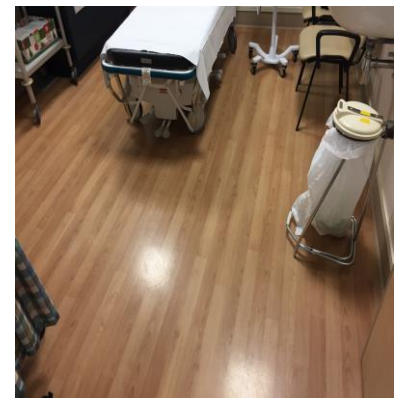
**ID: CARD NO:013**

Photograph No.	013
Location/Area	Room 1
Suspected Material Identified	Vinyl Floor/Walls
Condition of Material Identified	Good
<b>Categories: (Assessment type).</b> 1: ACM common characteristics or 2: Presumed ACM or 3: Sample collected for analysis	Presumed ACM
Sample No.	N/A
Laboratory Analysis Findings	N/A
Quantity of Material Identified	11.5m <sup>2</sup> /14m <sup>2</sup>

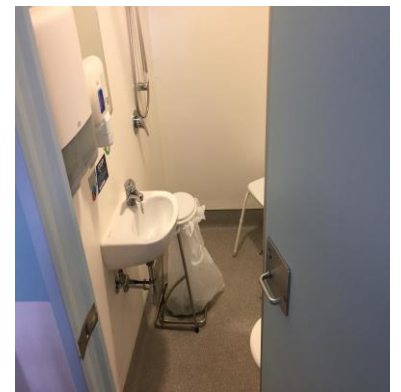
**ID: CARD NO:014**

Photograph No.	014
Location/Area	Room 1 Toilet/Shower
Suspected Material Identified	Vinyl Floor/Walls
Condition of Material Identified	Good
<b>Categories: (Assessment type).</b> 1: ACM common characteristics or 2: Presumed ACM or 3: Sample collected for analysis	Presumed ACM
Sample No.	N/A
Laboratory Analysis Findings	N/A
Quantity of Material Identified	3m <sup>2</sup> /15.4m <sup>2</sup>

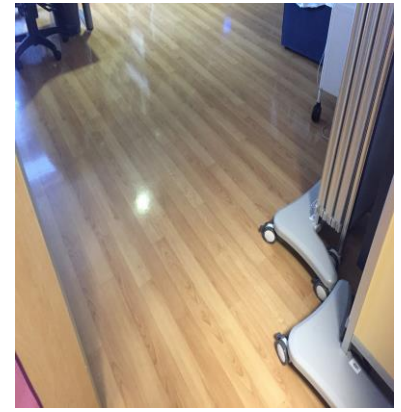
**ID: CARD NO:015**

Photograph No.	015
Location/Area	Special Care Baby Unit
Suspected Material Identified	Vinyl Floor
Condition of Material Identified	Good
<b>Categories: (Assessment type).</b> 1: ACM common characteristics or 2: Presumed ACM or 3: Sample collected for analysis	Presumed ACM
Sample No.	N/A
Laboratory Analysis Findings	N/A
Quantity of Material Identified	43.5m <sup>2</sup>

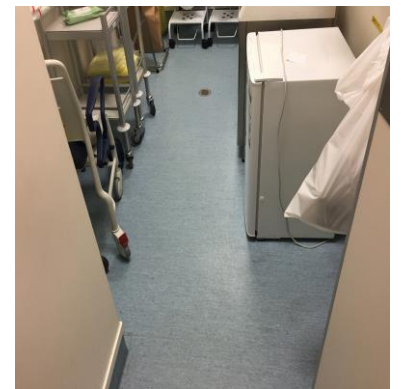
**ID: CARD NO:016**

Photograph No.	016
Location/Area	Utility Room
Suspected Material Identified	Vinyl Floor
Condition of Material Identified	Good
<b>Categories: (Assessment type).</b> 1: ACM common characteristics or 2: Presumed ACM or 3: Sample collected for analysis	Presumed ACM
Sample No.	N/A
Laboratory Analysis Findings	N/A
Quantity of Material Identified	9m <sup>2</sup>

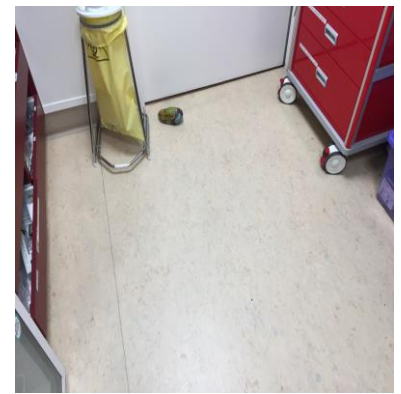
**ID: CARD NO:017**

Photograph No.	017
Location/Area	Store Room
Suspected Material Identified	Vinyl Floor
Condition of Material Identified	Good
<b>Categories: (Assessment type).</b> 1: ACM common characteristics or 2: Presumed ACM or 3: Sample collected for analysis	Presumed ACM
Sample No.	N/A
Laboratory Analysis Findings	N/A
Quantity of Material Identified	2.4m <sup>2</sup>

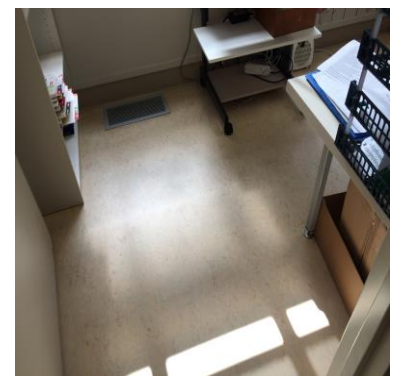
**ID: CARD NO:018**

Photograph No.	018
Location/Area	Treatment Room
Suspected Material Identified	Vinyl Floor/Walls
Condition of Material Identified	Good
<b>Categories: (Assessment type).</b> 1: ACM common characteristics or 2: Presumed ACM or 3: Sample collected for analysis	Presumed ACM
Sample No.	N/A
Laboratory Analysis Findings	N/A
Quantity of Material Identified	21m <sup>2</sup> /2m <sup>2</sup>

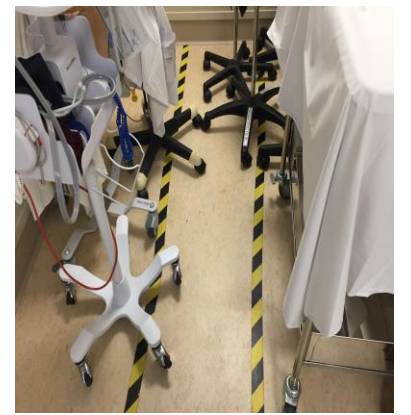
**ID: CARD NO:019**

Photograph No.	019
Location/Area	Monitor Room
Suspected Material Identified	Vinyl Floor
Condition of Material Identified	Good
<b>Categories: (Assessment type).</b> 1: ACM common characteristics or 2: Presumed ACM or 3: Sample collected for analysis	Presumed ACM
Sample No.	N/A
Laboratory Analysis Findings	N/A
Quantity of Material Identified	4.2m <sup>2</sup>

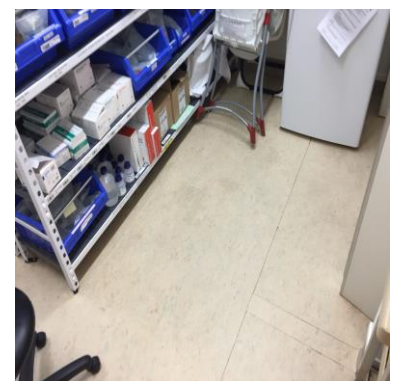
**ID: CARD NO:020**

Photograph No.	020
Location/Area	Drug Room
Suspected Material Identified	Vinyl Floor
Condition of Material Identified	Good
<b>Categories: (Assessment type).</b> 1: ACM common characteristics or 2: Presumed ACM or 3: Sample collected for analysis	Presumed ACM
Sample No.	N/A
Laboratory Analysis Findings	N/A
Quantity of Material Identified	8.9m <sup>2</sup>

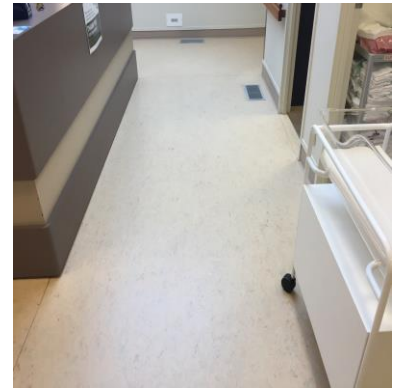
**ID: CARD NO:021**

Photograph No.	021
Location/Area	Nurses Station
Suspected Material Identified	Vinyl Floor
Condition of Material Identified	Good
<b>Categories: (Assessment type).</b> 1: ACM common characteristics or 2: Presumed ACM or 3: Sample collected for analysis	Presumed ACM
Sample No.	N/A
Laboratory Analysis Findings	N/A
Quantity of Material Identified	10m <sup>2</sup>

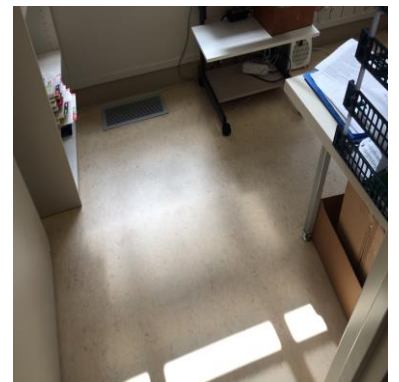
**ID: CARD NO:022**

Photograph No.	022
Location/Area	Office
Suspected Material Identified	Vinyl Floor
Condition of Material Identified	Good
<b>Categories: (Assessment type).</b> 1: ACM common characteristics or 2: Presumed ACM or 3: Sample collected for analysis	Presumed ACM
Sample No.	N/A
Laboratory Analysis Findings	N/A
Quantity of Material Identified	8.4m <sup>2</sup>

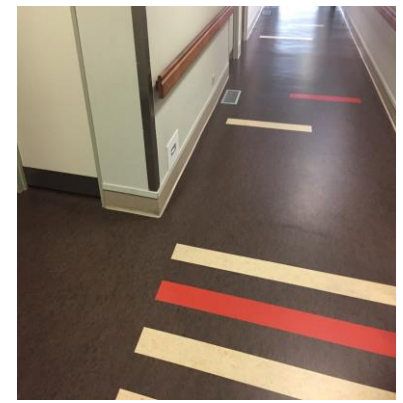
**ID: CARD NO:023**

Photograph No.	023
Location/Area	Maternity/Critical Corridor
Suspected Material Identified	Vinyl Floor
Condition of Material Identified	Good
<b>Categories: (Assessment type).</b> 1: ACM common characteristics or 2: Presumed ACM or 3: Sample collected for analysis	Presumed ACM
Sample No.	N/A
Laboratory Analysis Findings	N/A
Quantity of Material Identified	175m <sup>2</sup>

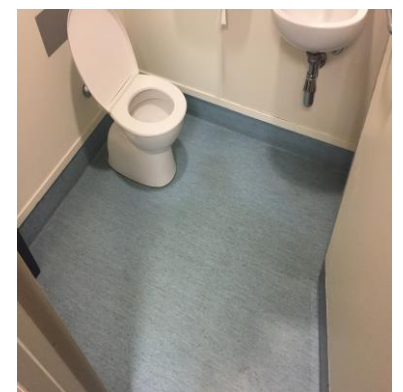
**ID: CARD NO:024**

Photograph No.	024
Location/Area	Unisex Toilet
Suspected Material Identified	Vinyl Floor
Condition of Material Identified	Good
<b>Categories: (Assessment type).</b> 1: ACM common characteristics or 2: Presumed ACM or 3: Sample collected for analysis	Presumed ACM
Sample No.	N/A
Laboratory Analysis Findings	N/A
Quantity of Material Identified	3.8m <sup>2</sup>

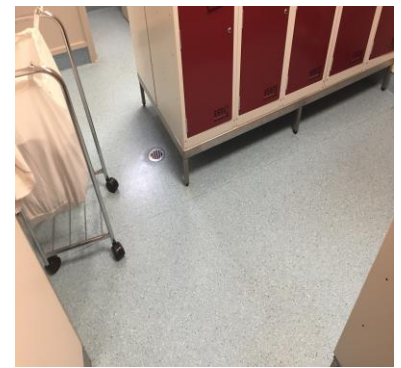
**ID: CARD NO:025**

Photograph No.	025
Location/Area	Change room
Suspected Material Identified	Vinyl Floor
Condition of Material Identified	Good
<b>Categories: (Assessment type).</b> 1: ACM common characteristics or 2: Presumed ACM or 3: Sample collected for analysis	Presumed ACM
Sample No.	N/A
Laboratory Analysis Findings	N/A
Quantity of Material Identified	13.5m <sup>2</sup>

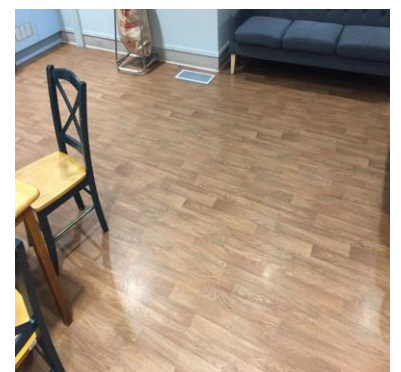
**ID: CARD NO:026**

Photograph No.	026
Location/Area	Family Lounge
Suspected Material Identified	Vinyl Floor
Condition of Material Identified	Good
<b>Categories: (Assessment type).</b> 1: ACM common characteristics or 2: Presumed ACM or 3: Sample collected for analysis	Presumed ACM
Sample No.	N/A
Laboratory Analysis Findings	N/A
Quantity of Material Identified	39m <sup>2</sup>

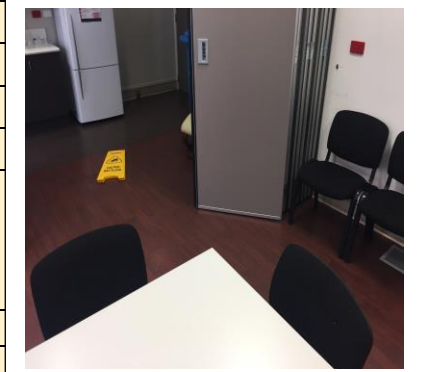
**ID: CARD NO:027**

Photograph No.	027
Location/Area	Meeting Room
Suspected Material Identified	Vinyl Floor
Condition of Material Identified	Good
<b>Categories: (Assessment type).</b> 1: ACM common characteristics or 2: Presumed ACM or 3: Sample collected for analysis	Presumed ACM
Sample No.	N/A
Laboratory Analysis Findings	N/A
Quantity of Material Identified	42m <sup>2</sup>

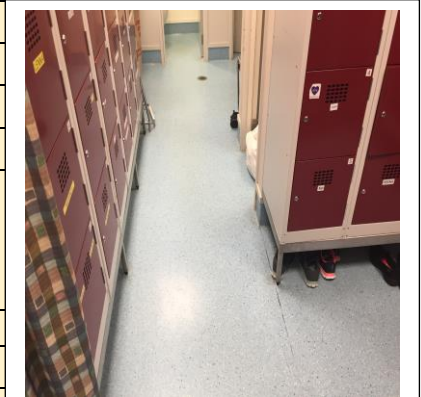
**ID: CARD NO:028**

Photograph No.	028
Location/Area	Women Change Room
Suspected Material Identified	Vinyl Floor
Condition of Material Identified	Good
<b>Categories: (Assessment type).</b> 1: ACM common characteristics or 2: Presumed ACM or 3: Sample collected for analysis	Presumed ACM
Sample No.	N/A
Laboratory Analysis Findings	N/A
Quantity of Material Identified	18m <sup>2</sup>
