Asbestos Management Survey Report

WHANGANUI HOSPITAL LOADING BAY & STORE ROOM ASBESTOS MANAGEMENT SURVEY

ASBESTOS MANAGEMENT SURVEY

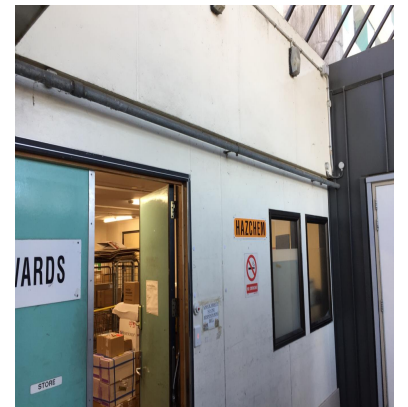
ID: CARD NO:001

Photograph No.	001
Location/Area	Loading Bay
Suspected Material Identified	Wall Cladding
Condition of Material Identified	Good
Categories: (Assessment type). 1: ACM common characteristics or 2: Presumed ACM or 3: Sample collected for analysis	Presumed ACM
Sample No.	N/A
Laboratory Analysis Findings	N/A
Quantity of Material Identified	46m ²

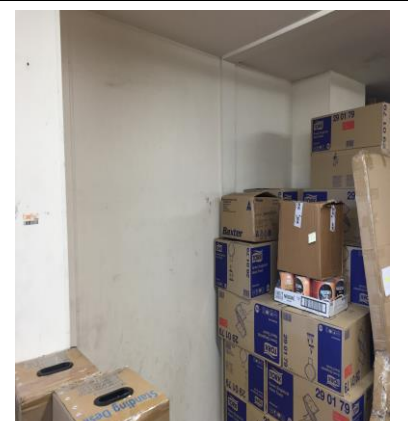
ID: CARD NO:002

Photograph No.	002
Location/Area	Store Room (inwards)
Suspected Material Identified	Walls
Condition of Material Identified	Good
Categories: (Assessment type). 1: ACM common characteristics or 2: Presumed ACM or 3: Sample collected for analysis	Presumed ACM
Sample No.	N/A
Laboratory Analysis Findings	N/A
Quantity of Material Identified	57m ²

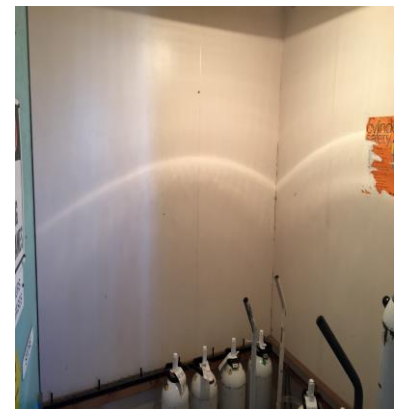
ID: CARD NO:003

Photograph No.	003
Location/Area	Store Room (oxygen)
Suspected Material Identified	Walls
Condition of Material Identified	Good
Categories: (Assessment type). 1: ACM common characteristics or 2: Presumed ACM or 3: Sample collected for analysis	Presumed ACM
Sample No.	N/A
Laboratory Analysis Findings	N/A
Quantity of Material Identified	13m ²

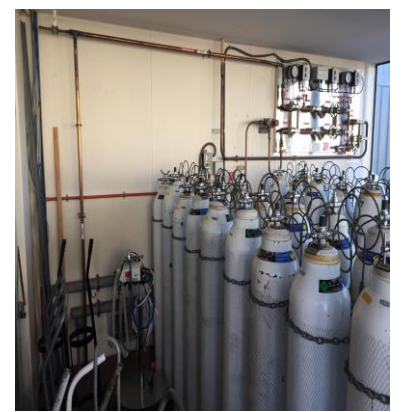
ID: CARD NO:004

Photograph No.	004
Location/Area	Store Room (gas)
Suspected Material Identified	Walls
Condition of Material Identified	Good
Categories: (Assessment type). 1: ACM common characteristics or 2: Presumed ACM or 3: Sample collected for analysis	Presumed ACM
Sample No.	N/A
Laboratory Analysis Findings	N/A
Quantity of Material Identified	41m ²

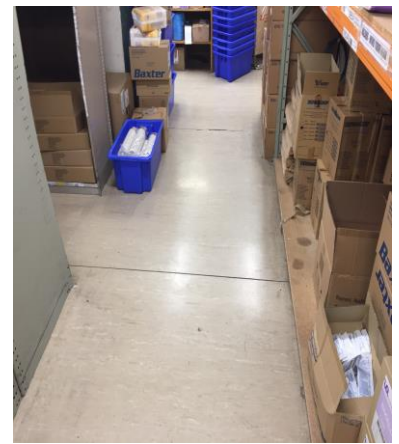
ID: CARD NO:005

Photograph No.	005
Location/Area	Store Room (supplies)
Suspected Material Identified	Vinyl Floor
Condition of Material Identified	Good
Categories: (Assessment type). 1: ACM common characteristics or 2: Presumed ACM or 3: Sample collected for analysis	Presumed ACM
Sample No.	N/A
Laboratory Analysis Findings	N/A
Quantity of Material Identified	144m ²

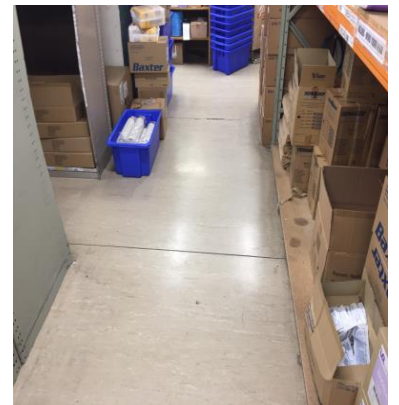
ID: CARD NO:006

Photograph No.	006
Location/Area	Store Room (reception)
Suspected Material Identified	Vinyl Floor
Condition of Material Identified	Good
Categories: (Assessment type). 1: ACM common characteristics or 2: Presumed ACM or 3: Sample collected for analysis	Presumed ACM
Sample No.	N/A
Laboratory Analysis Findings	N/A
Quantity of Material Identified	3.5m ²

006	006	Store Room (reception)	2	3.5m ²	Vinyl Floor	Suspect ACM	1	0	0	0	0	0	0	0	0	0	0	Very low risk	Complete a Risk Assessment.
007
