## **Asbestos Management Survey Report**

***WHANGANUI HOSPITAL  
W & A BUILDING  
ASBESTOS MANAGEMENT SURVEY***

### **W & A BUILDING – WHANGANUI HOSPITAL**

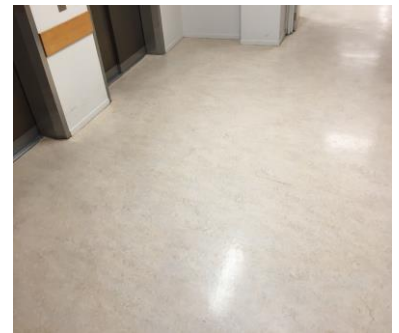
**ID: CARD NO:001**

Photograph No.	001
Location/Area	Ground Floor-Elevator Lobby
Suspected Material Identified	Vinyl Floor
Condition of Material Identified	Good
<b>Categories: (Assessment type).</b> 1: ACM common characteristics or 2: Presumed ACM or 3: Sample collected for analysis	Presumed ACM
Sample No.	N/A
Laboratory Analysis Findings	N/A
Quantity of Material Identified	16m <sup>2</sup>

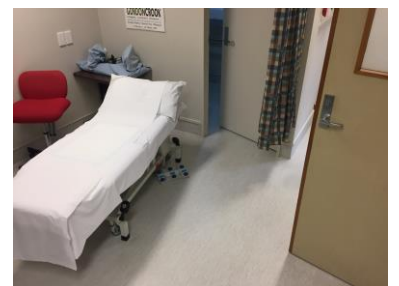
**ID: CARD NO:002**

Photograph No.	002
Location/Area	Ground Floor-C1 Room
Suspected Material Identified	Vinyl Floor
Condition of Material Identified	Good
<b>Categories: (Assessment type).</b> 1: ACM common characteristics or 2: Presumed ACM or 3: Sample collected for analysis	Presumed ACM
Sample No.	N/A
Laboratory Analysis Findings	N/A
Quantity of Material Identified	18m <sup>2</sup>

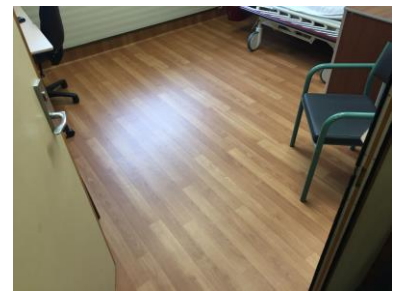
**ID: CARD NO:003**

Photograph No.	003
Location/Area	Ground Floor-C4 Room
Suspected Material Identified	Vinyl Floor
Condition of Material Identified	Good
<b>Categories: (Assessment type).</b> 1: ACM common characteristics or 2: Presumed ACM or 3: Sample collected for analysis	Presumed ACM
Sample No.	N/A
Laboratory Analysis Findings	N/A
Quantity of Material Identified	14m <sup>2</sup>

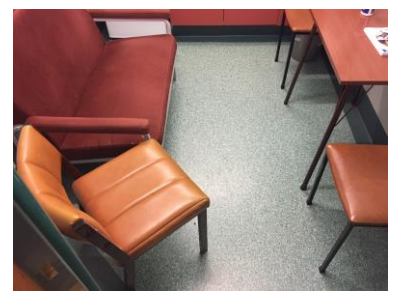
**ID: CARD NO:004**

Photograph No.	004
Location/Area	Ground Floor-Kitchen
Suspected Material Identified	Vinyl Floor
Condition of Material Identified	Good
<b>Categories: (Assessment type).</b> 1: ACM common characteristics or 2: Presumed ACM or 3: Sample collected for analysis	Presumed ACM
Sample No.	N/A
Laboratory Analysis Findings	N/A
Quantity of Material Identified	7m <sup>2</sup>

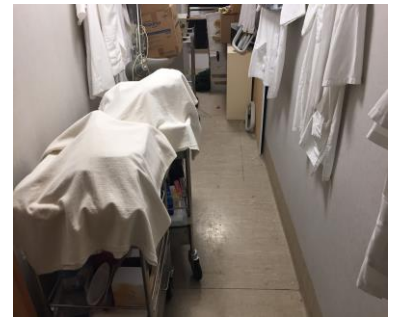
**ID: CARD NO:005**

Photograph No.	005
Location/Area	Ground Floor-Elevator Lobby (Change Room)
Suspected Material Identified	Vinyl Floor
Condition of Material Identified	Good
<b>Categories: (Assessment type).</b> 1: ACM common characteristics or 2: Presumed ACM or 3: Sample collected for analysis	Presumed ACM
Sample No.	N/A
Laboratory Analysis Findings	N/A
Quantity of Material Identified	8.3m <sup>2</sup>

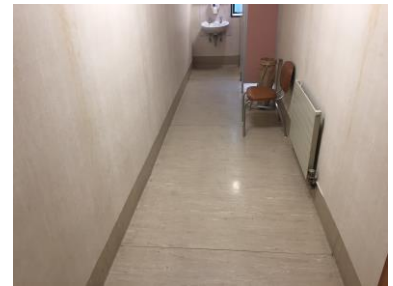
**ID: CARD NO:006**

Photograph No.	006
Location/Area	Ground Floor-Elevator Lobby (Women Toilet)
Suspected Material Identified	Vinyl Floor
Condition of Material Identified	Good
<b>Categories: (Assessment type).</b> 1: ACM common characteristics or 2: Presumed ACM or 3: Sample collected for analysis	Presumed ACM
Sample No.	N/A
Laboratory Analysis Findings	N/A
Quantity of Material Identified	8.3m <sup>2</sup>

006	006	Ground Floor-Women Toilet (elevator lobby)	2	8.3m <sup>2</sup>	Vinyl Floor	Suspect ACM	1	0	0	0	0	0	0	0	0	0	0	Very low risk	Complete a Risk Assessment.
007	007	Ground Floor-Unisex Toilet	2	14m <sup>2</sup>	Vinyl Floor	Suspect ACM	1	0	0	0	0	0	0	0	0	0	0	Very low risk	Complete a Risk Assessment.
008	008	Ground Floor-Cleaners Room	2	4m <sup>2</sup>	Vinyl Floor	Suspect ACM	1	0	0	0	0	0	0	0	0	0	0	Very low risk	Complete a Risk Assessment.
009	009	Ground Floor-Male Toilet	2	15m <sup>2</sup>	Vinyl Floor	Suspect ACM	1	0	0	0	0	0	0	0	0	0	0	Very low risk	Complete a Risk Assessment.
010	010	Ground Floor-Reception Lobby	2	25m <sup>2</sup>	Vinyl Floor	Suspect ACM	1	0	0	0	0	0	0	0	0	0	0	Very low risk	Complete a Risk Assessment.

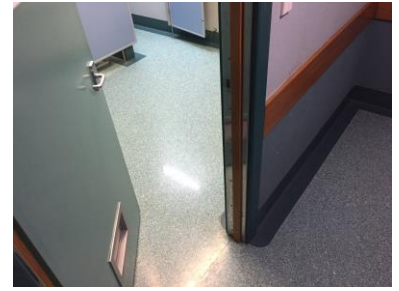
**ID: CARD NO:007**

Photograph No.	007
Location/Area	Ground Floor-Unisex Toilet
Suspected Material Identified	Vinyl Floor
Condition of Material Identified	Good
<b>Categories: (Assessment type).</b> 1: ACM common characteristics or 2: Presumed ACM or 3: Sample collected for analysis	Presumed ACM
Sample No.	N/A
Laboratory Analysis Findings	N/A
Quantity of Material Identified	14m <sup>2</sup>

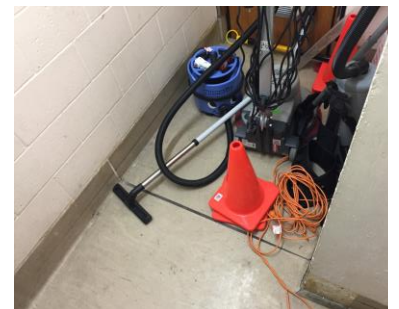
**ID: CARD NO:008**

Photograph No.	008
Location/Area	Ground Floor-Cleaners Room
Suspected Material Identified	Vinyl Floor
Condition of Material Identified	Good
<b>Categories: (Assessment type).</b> 1: ACM common characteristics or 2: Presumed ACM or 3: Sample collected for analysis	Presumed ACM
Sample No.	N/A
Laboratory Analysis Findings	N/A
Quantity of Material Identified	4m <sup>2</sup>

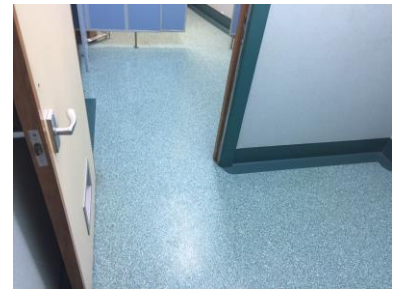
**ID: CARD NO:009**

Photograph No.	009
Location/Area	Ground Floor-Male Toilet
Suspected Material Identified	Vinyl Floor
Condition of Material Identified	Good
<b>Categories: (Assessment type).</b> 1: ACM common characteristics or 2: Presumed ACM or 3: Sample collected for analysis	Presumed ACM
Sample No.	N/A
Laboratory Analysis Findings	N/A
Quantity of Material Identified	15m <sup>2</sup>

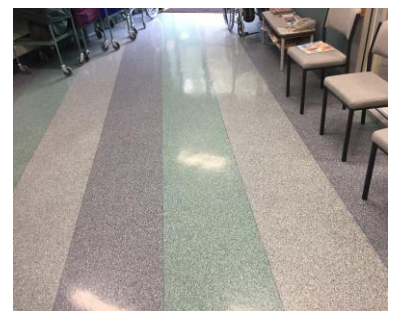
**ID: CARD NO:010**

Photograph No.	010
Location/Area	Ground Floor-Reception Lobby
Suspected Material Identified	Vinyl Floor
Condition of Material Identified	Good
<b>Categories: (Assessment type).</b> 1: ACM common characteristics or 2: Presumed ACM or 3: Sample collected for analysis	Presumed ACM
Sample No.	N/A
Laboratory Analysis Findings	N/A
Quantity of Material Identified	25m <sup>2</sup>

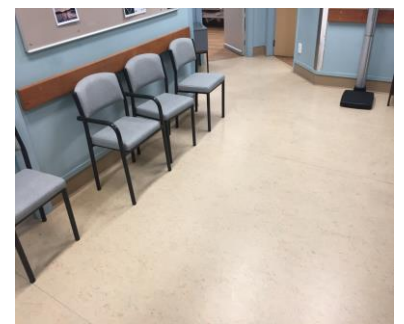
**ID: CARD NO:011**

Photograph No.	011
Location/Area	Ground Floor-Pre-admission
Suspected Material Identified	Vinyl Floor
Condition of Material Identified	Good
<b>Categories: (Assessment type).</b> 1: ACM common characteristics or 2: Presumed ACM or 3: Sample collected for analysis	Presumed ACM
Sample No.	N/A
Laboratory Analysis Findings	N/A
Quantity of Material Identified	15.1m <sup>2</sup>

011	011	Ground Floor-Pre-admission	2	15.1m <sup>2</sup>	Vinyl Floor	Suspect ACM	1	0	0	0	0	0	0	0	0	0	0	Very low risk	Complete a Risk Assessment.
012	012	Ground Floor-Pre-admission (B1)	2	12m <sup>2</sup>	Vinyl Floor	Suspect ACM	1	0	0	0	0	0	0	0	0	0	0	Very low risk	Complete a Risk Assessment.
013	013	Ground Floor-Pre-admission (B2)	2	12m <sup>2</sup>	Vinyl Floor	Suspect ACM	1	0	0	0	0	0	0	0	0	0	0	Very low risk	Complete a Risk Assessment.
014	014	Ground Floor-Pre-admission (B3)	2	12m <sup>2</sup>	Vinyl Floor	Suspect ACM	1	0	0	0	0	0	0	0	0	0	0	Very low risk	Complete a Risk Assessment.
015	015	Ground Floor-Reception Desk	2	16.5m <sup>2</sup>	Vinyl Cladding	Suspect ACM	1	0	0	0	0	0	0	0	0	0	0	Very low risk	Complete a Risk Assessment.
016	016	Ground Floor-Surgical Outpatients	2	30m <sup>2</sup>	Vinyl Floor	Suspect ACM	1	0	0	0	0	0	0	0	0	0	0	Very low risk	Complete a Risk Assessment.
017	017	Ground Floor-Surgical Outpatients (B7)	2	16.5m <sup>2</sup>	Vinyl Floor	Suspect ACM	1	0	0	0	0	0	0	0	0	0	0	Very low risk	Complete a Risk Assessment.

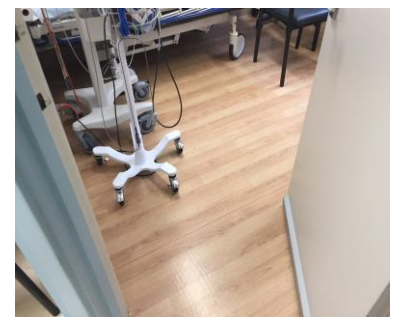
**ID: CARD NO:012**

Photograph No.	012
Location/Area	Ground Floor-Pre-admission (B1)
Suspected Material Identified	Vinyl Floor
Condition of Material Identified	Good
<b>Categories: (Assessment type).</b> 1: ACM common characteristics or 2: Presumed ACM or 3: Sample collected for analysis	Presumed ACM
Sample No.	N/A
Laboratory Analysis Findings	N/A
Quantity of Material Identified	12m <sup>2</sup>

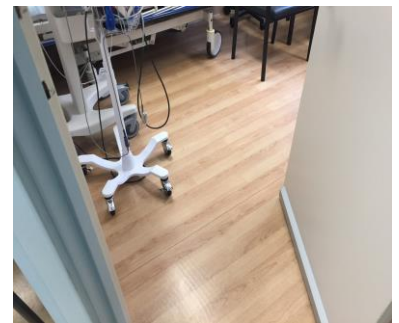
**ID: CARD NO:013**

Photograph No.	013
Location/Area	Ground Floor-Pre-admission (B2)
Suspected Material Identified	Vinyl Floor
Condition of Material Identified	Good
<b>Categories: (Assessment type).</b> 1: ACM common characteristics or 2: Presumed ACM or 3: Sample collected for analysis	Presumed ACM
Sample No.	N/A
Laboratory Analysis Findings	N/A
Quantity of Material Identified	12m <sup>2</sup>

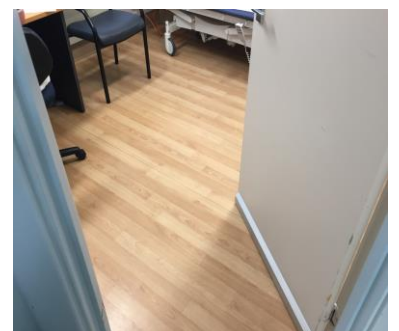
**ID: CARD NO:014**

Photograph No.	014
Location/Area	Ground Floor-Pre-admission (B3)
Suspected Material Identified	Vinyl Floor
Condition of Material Identified	Good
<b>Categories: (Assessment type).</b> 1: ACM common characteristics or 2: Presumed ACM or 3: Sample collected for analysis	Presumed ACM
Sample No.	N/A
Laboratory Analysis Findings	N/A
Quantity of Material Identified	12m <sup>2</sup>

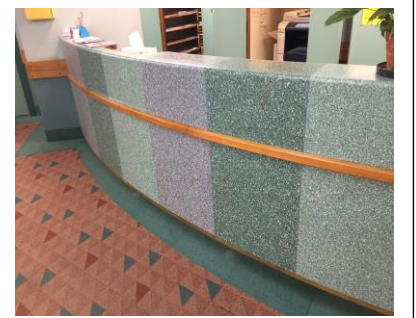
**ID: CARD NO:015**

Photograph No.	015
Location/Area	Ground Floor-Reception Desk
Suspected Material Identified	Vinyl Cladding
Condition of Material Identified	Good
<b>Categories: (Assessment type).</b> 1: ACM common characteristics or 2: Presumed ACM or 3: Sample collected for analysis	Presumed ACM
Sample No.	N/A
Laboratory Analysis Findings	N/A
Quantity of Material Identified	16.5m <sup>2</sup>

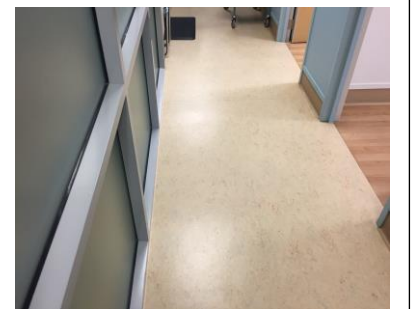
**ID: CARD NO:016**

Photograph No.	016
Location/Area	Ground Floor-Surgical Outpatients
Suspected Material Identified	Vinyl Floor
Condition of Material Identified	Good
<b>Categories: (Assessment type).</b> 1: ACM common characteristics or 2: Presumed ACM or 3: Sample collected for analysis	Presumed ACM
Sample No.	N/A
Laboratory Analysis Findings	N/A
Quantity of Material Identified	30m <sup>2</sup>

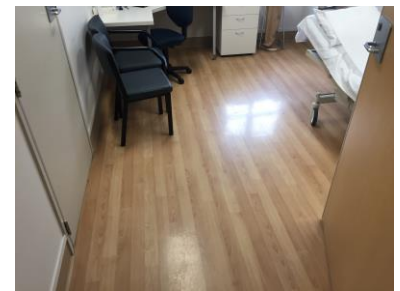
**ID: CARD NO:017**

Photograph No.	017
Location/Area	Ground Floor-Surgical Outpatients (B7)
Suspected Material Identified	Vinyl Floor
Condition of Material Identified	Good
<b>Categories: (Assessment type).</b> 1: ACM common characteristics or 2: Presumed ACM or 3: Sample collected for analysis	Presumed ACM
Sample No.	N/A
Laboratory Analysis Findings	N/A
Quantity of Material Identified	16.5m <sup>2</sup>

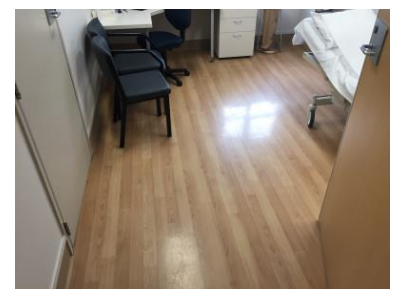
**ID: CARD NO:018**

Photograph No.	018
Location/Area	Ground Floor-Surgical Outpatients (B8)
Suspected Material Identified	Vinyl Floor
Condition of Material Identified	Good
<b>Categories: (Assessment type).</b> 1: ACM common characteristics or 2: Presumed ACM or 3: Sample collected for analysis	Presumed ACM
Sample No.	N/A
Laboratory Analysis Findings	N/A
Quantity of Material Identified	16.5m <sup>2</sup>

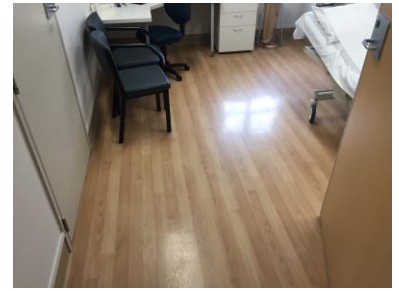
**ID: CARD NO:019**

Photograph No.	019
Location/Area	Ground Floor-Surgical Outpatients (B6)
Suspected Material Identified	Vinyl Floor
Condition of Material Identified	Good
<b>Categories: (Assessment type).</b> 1: ACM common characteristics or 2: Presumed ACM or 3: Sample collected for analysis	Presumed ACM
Sample No.	N/A
Laboratory Analysis Findings	N/A
Quantity of Material Identified	16.5m <sup>2</sup>

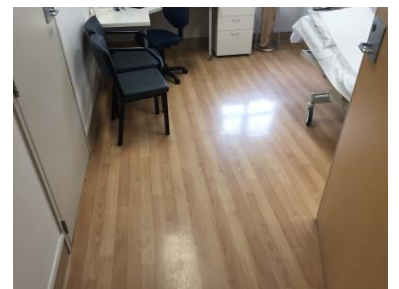
**ID: CARD NO:020**

Photograph No.	020
Location/Area	Ground Floor-Surgical Outpatients (B5)
Suspected Material Identified	Vinyl Floor
Condition of Material Identified	Good
<b>Categories: (Assessment type).</b> 1: ACM common characteristics or 2: Presumed ACM or 3: Sample collected for analysis	Presumed ACM
Sample No.	N/A
Laboratory Analysis Findings	N/A
Quantity of Material Identified	16.5m <sup>2</sup>

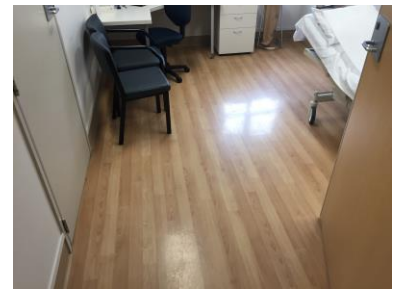
**ID: CARD NO:021**

Photograph No.	021
Location/Area	Ground Floor-Surgical Outpatients (B4)
Suspected Material Identified	Vinyl Floor
Condition of Material Identified	Good
<b>Categories: (Assessment type).</b> 1: ACM common characteristics or 2: Presumed ACM or 3: Sample collected for analysis	Presumed ACM
Sample No.	N/A
Laboratory Analysis Findings	N/A
Quantity of Material Identified	16.5m <sup>2</sup>

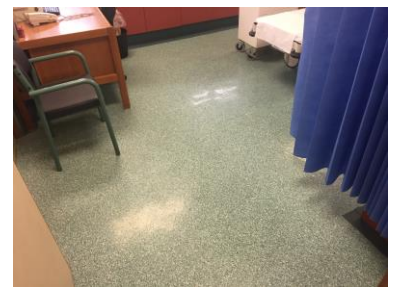
**ID: CARD NO:022**

Photograph No.	022
Location/Area	Ground Floor-Surgical Outpatients (B9)
Suspected Material Identified	Vinyl Floor
Condition of Material Identified	Good
<b>Categories: (Assessment type).</b> 1: ACM common characteristics or 2: Presumed ACM or 3: Sample collected for analysis	Presumed ACM
Sample No.	N/A
Laboratory Analysis Findings	N/A
Quantity of Material Identified	23m <sup>2</sup>

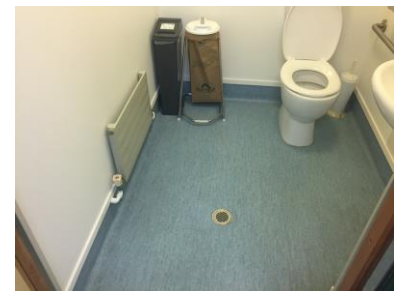
**ID: CARD NO:023**

Photograph No.	023
Location/Area	Ground Floor-Staff Toilet
Suspected Material Identified	Vinyl Floor
Condition of Material Identified	Good
<b>Categories: (Assessment type).</b> 1: ACM common characteristics or 2: Presumed ACM or 3: Sample collected for analysis	Presumed ACM
Sample No.	N/A
Laboratory Analysis Findings	N/A
Quantity of Material Identified	4m <sup>2</sup>

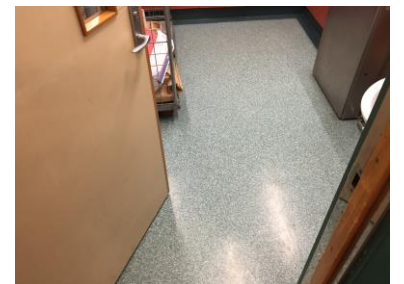
**ID: CARD NO:024**

Photograph No.	024
Location/Area	Ground Floor-Utility Room
Suspected Material Identified	Vinyl Floor
Condition of Material Identified	Good
<b>Categories: (Assessment type).</b> 1: ACM common characteristics or 2: Presumed ACM or 3: Sample collected for analysis	Presumed ACM
Sample No.	N/A
Laboratory Analysis Findings	N/A
Quantity of Material Identified	9m <sup>2</sup>

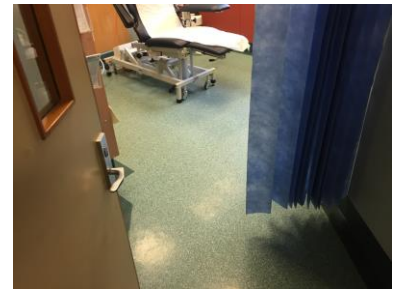
**ID: CARD NO:025**

Photograph No.	025
Location/Area	Ground Floor-Plaster (B10)
Suspected Material Identified	Vinyl Floor
Condition of Material Identified	Good
<b>Categories: (Assessment type).</b> 1: ACM common characteristics or 2: Presumed ACM or 3: Sample collected for analysis	Presumed ACM
Sample No.	N/A
Laboratory Analysis Findings	N/A
Quantity of Material Identified	24m <sup>2</sup>
