Asbestos Management Survey Report

***WHANGANUI HOSPITAL
MEDICAL WARD 3rd FLOOR
ASBESTOS MANAGEMENT SURVEY***

WHANGANUI HOSPITAL – MEDICAL WARD 3rd FLOOR

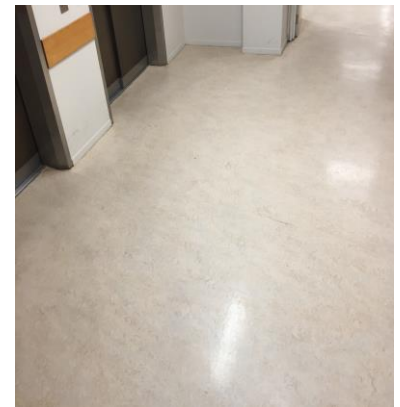
Photograph No.	001
Location/Area	Elevator Lobby
Suspected Material Identified	Vinyl Floor
Condition of Material Identified	Good
Categories: (Assessment type). 1: ACM common characteristics or 2: Presumed ACM or 3: Sample collected for analysis	Presumed ACM
Sample No.	N/A
Laboratory Analysis Findings	N/A
Quantity of Material Identified	16M ²

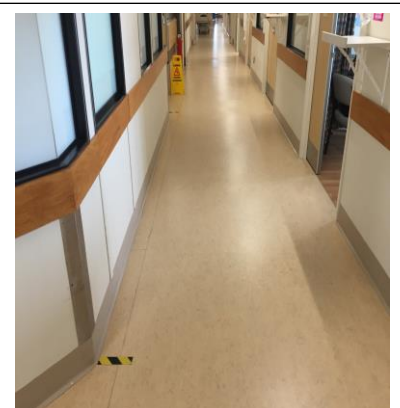
ID: CARD NO:002

Photograph No.	002
Location/Area	Main Corridor Area
Suspected Material Identified	Vinyl Floor
Condition of Material Identified	Good
Categories: (Assessment type). 1: ACM common characteristics or 2: Presumed ACM or 3: Sample collected for analysis	Presumed ACM
Sample No.	N/A
Laboratory Analysis Findings	N/A
Quantity of Material Identified	194m ²

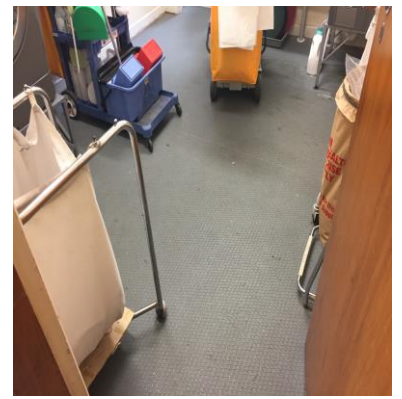
ID: CARD NO:003

Photograph No.	003
Location/Area	Cleaner Room N ^o 10
Suspected Material Identified	Vinyl Floor
Condition of Material Identified	Good
Categories: (Assessment type). 1: ACM common characteristics or 2: Presumed ACM or 3: Sample collected for analysis	Presumed ACM
Sample No.	N/A
Laboratory Analysis Findings	N/A
Quantity of Material Identified	4m ²

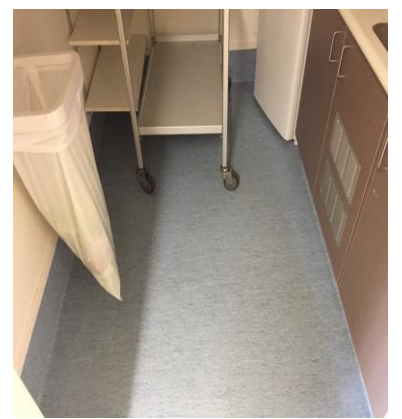
ID: CARD NO:004

Photograph No.	004
Location/Area	Beverage Bay
Suspected Material Identified	Vinyl Floor
Condition of Material Identified	Good
Categories: (Assessment type). 1: ACM common characteristics or 2: Presumed ACM or 3: Sample collected for analysis	Presumed ACM
Sample No.	N/A
Laboratory Analysis Findings	N/A
Quantity of Material Identified	4m ²

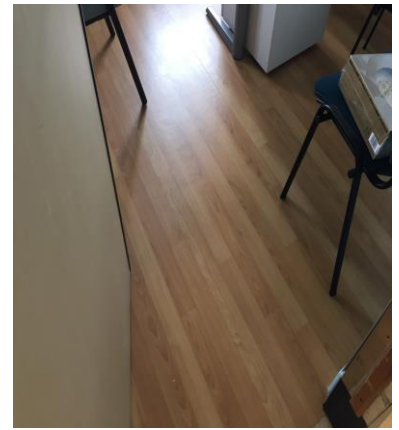
ID: CARD NO:005

Photograph No.	005
Location/Area	Family Room
Suspected Material Identified	Vinyl Floor
Condition of Material Identified	Good
Categories: (Assessment type). 1: ACM common characteristics or 2: Presumed ACM or 3: Sample collected for analysis	Presumed ACM
Sample No.	N/A
Laboratory Analysis Findings	N/A
Quantity of Material Identified	13m ²

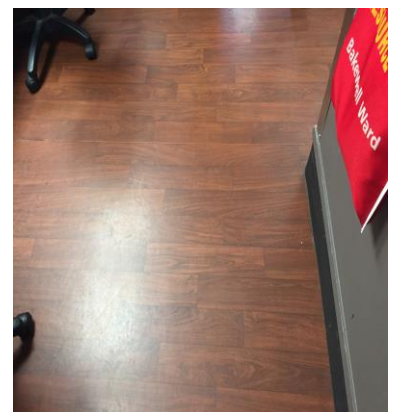
ID: CARD NO:006

Photograph No.	006
Location/Area	Clinical Nurse Manager
Suspected Material Identified	Vinyl Floor
Condition of Material Identified	Good
Categories: (Assessment type). 1: ACM common characteristics or 2: Presumed ACM or 3: Sample collected for analysis	Presumed ACM
Sample No.	N/A
Laboratory Analysis Findings	N/A
Quantity of Material Identified	7m ²

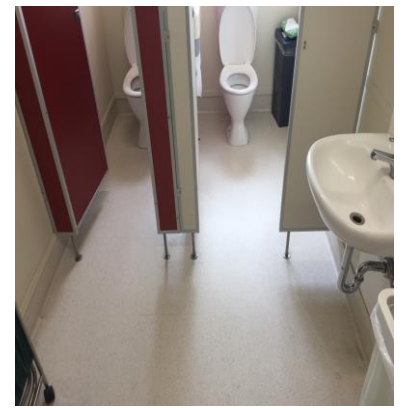
Photograph No.	007
Location/Area	Staff Toilet
Suspected Material Identified	Vinyl Floor
Condition of Material Identified	Good
Categories: (Assessment type). 1: ACM common characteristics or 2: Presumed ACM or 3: Sample collected for analysis	Presumed ACM
Sample No.	N/A
Laboratory Analysis Findings	N/A
Quantity of Material Identified	8m ²

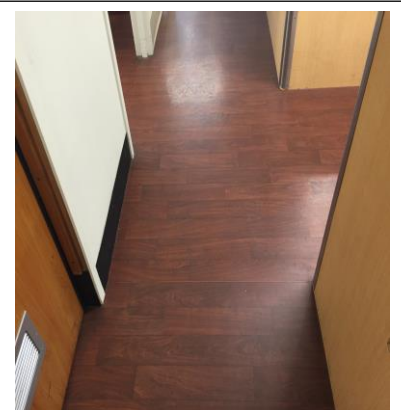
Photograph No.	008
Location/Area	Staff Station (a)
Suspected Material Identified	Vinyl Floor
Condition of Material Identified	Good
Categories: (Assessment type). 1: ACM common characteristics or 2: Presumed ACM or 3: Sample collected for analysis	Presumed ACM
Sample No.	N/A
Laboratory Analysis Findings	N/A
Quantity of Material Identified	39m ²

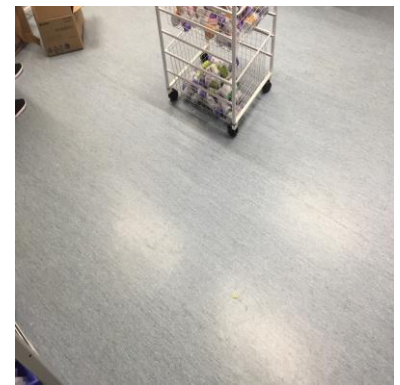
Photograph No.	009
Location/Area	Preparation Room
Suspected Material Identified	Vinyl Floor
Condition of Material Identified	Good
Categories: (Assessment type). 1: ACM common characteristics or 2: Presumed ACM or 3: Sample collected for analysis	Presumed ACM
Sample No.	N/A
Laboratory Analysis Findings	N/A
Quantity of Material Identified	16m ²

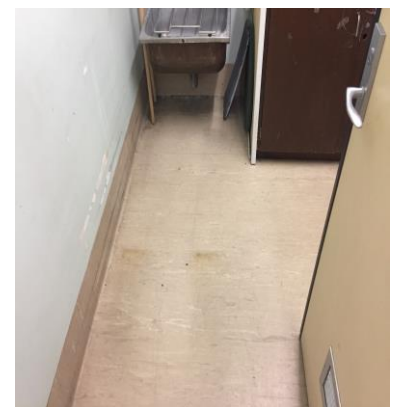
Photograph No.	010
Location/Area	Sluice Room
Suspected Material Identified	Vinyl Floor
Condition of Material Identified	Good
Categories: (Assessment type). 1: ACM common characteristics or 2: Presumed ACM or 3: Sample collected for analysis	Presumed ACM
Sample No.	N/A
Laboratory Analysis Findings	N/A
Quantity of Material Identified	15m ²

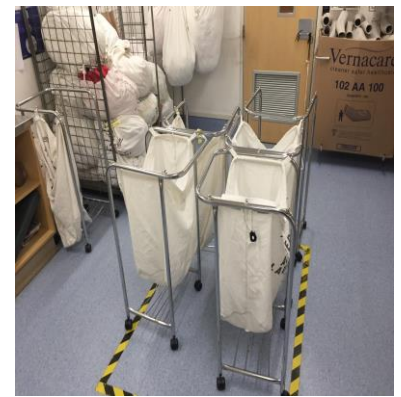
Photograph No.	011
Location/Area	Linen Room
Suspected Material Identified	Vinyl Floor
Condition of Material Identified	Good
Categories: (Assessment type). 1: ACM common characteristics or 2: Presumed ACM or 3: Sample collected for analysis	Presumed ACM
Sample No.	N/A
Laboratory Analysis Findings	N/A
Quantity of Material Identified	8m ²

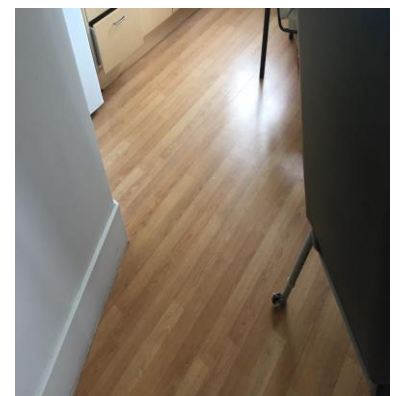
Photograph No.	012
Location/Area	Staff Station (b)
Suspected Material Identified	Vinyl Floor
Condition of Material Identified	Good
Categories: (Assessment type). 1: ACM common characteristics or 2: Presumed ACM or 3: Sample collected for analysis	Presumed ACM
Sample No.	N/A
Laboratory Analysis Findings	N/A
Quantity of Material Identified	31.5m ²

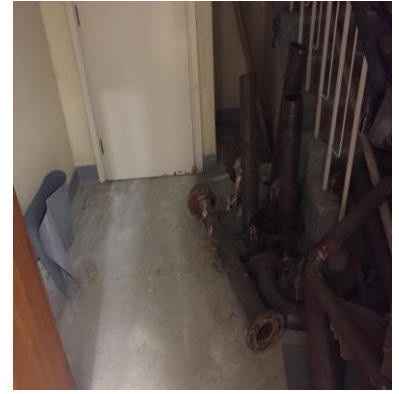
Photograph No.	013
Location/Area	Store Room N° 50
Suspected Material Identified	Vinyl Floor
Condition of Material Identified	Good
Categories: (Assessment type). 1: ACM common characteristics or 2: Presumed ACM or 3: Sample collected for analysis	Presumed ACM
Sample No.	N/A
Laboratory Analysis Findings	N/A
Quantity of Material Identified	7.5m ²

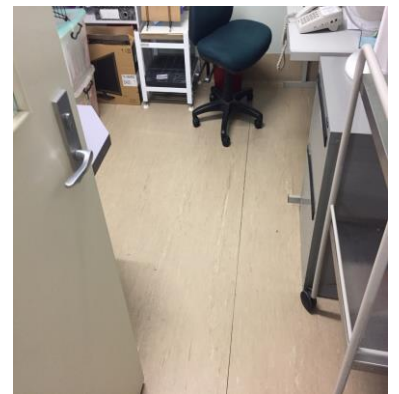
Photograph No.	014
Location/Area	Clinical Nurse Co-ordinator
Suspected Material Identified	Vinyl Floor
Condition of Material Identified	Good
Categories: (Assessment type). 1: ACM common characteristics or 2: Presumed ACM or 3: Sample collected for analysis	Presumed ACM
Sample No.	N/A
Laboratory Analysis Findings	N/A
Quantity of Material Identified	10.5m ²

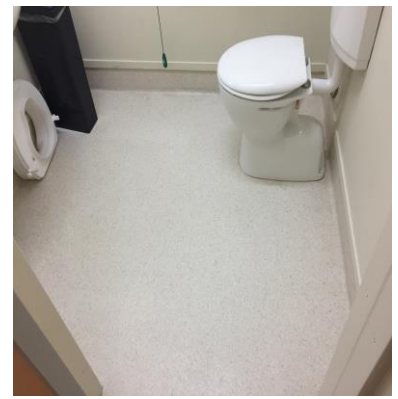
Photograph No.	015
Location/Area	W/C Toilet 2
Suspected Material Identified	Vinyl Floor
Condition of Material Identified	Good
Categories: (Assessment type). 1: ACM common characteristics or 2: Presumed ACM or 3: Sample collected for analysis	Presumed ACM
Sample No.	N/A
Laboratory Analysis Findings	N/A
Quantity of Material Identified	3.5m ²

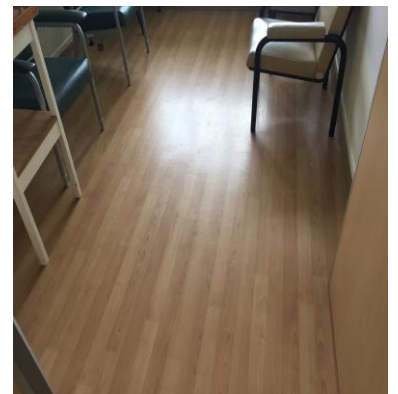
Photograph No.	016
Location/Area	Family Lounge
Suspected Material Identified	Vinyl Floor
Condition of Material Identified	Good
Categories: (Assessment type). 1: ACM common characteristics or 2: Presumed ACM or 3: Sample collected for analysis	Presumed ACM
Sample No.	N/A
Laboratory Analysis Findings	N/A
Quantity of Material Identified	8.5m ²

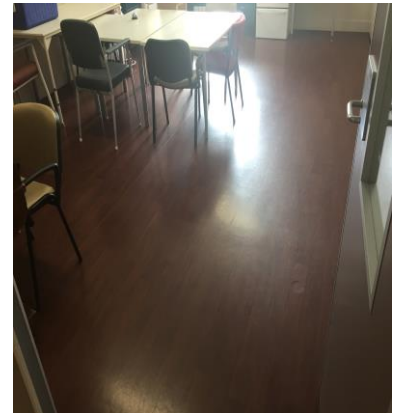
Photograph No.	017
Location/Area	Staff Kitchen
Suspected Material Identified	Vinyl Floor
Condition of Material Identified	Good
Categories: (Assessment type). 1: ACM common characteristics or 2: Presumed ACM or 3: Sample collected for analysis	Presumed ACM
Sample No.	N/A
Laboratory Analysis Findings	N/A
Quantity of Material Identified	24m ²

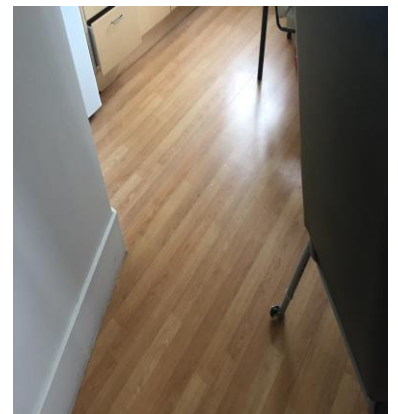
Photograph No.	018
Location/Area	Room 6
Suspected Material Identified	Vinyl Floor
Condition of Material Identified	Good
Categories: (Assessment type). 1: ACM common characteristics or 2: Presumed ACM or 3: Sample collected for analysis	Presumed ACM
Sample No.	N/A
Laboratory Analysis Findings	N/A
Quantity of Material Identified	45m ²

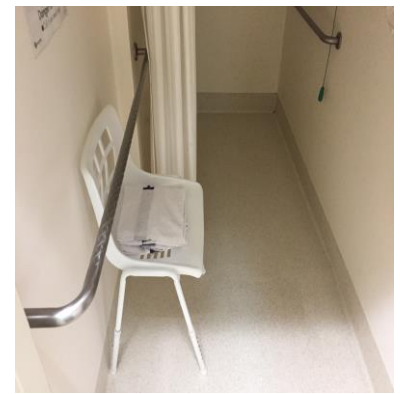
Photograph No.	019
Location/Area	Shower Room 3
Suspected Material Identified	Vinyl Floor/Walls
Condition of Material Identified	Good
Categories: (Assessment type). 1: ACM common characteristics or 2: Presumed ACM or 3: Sample collected for analysis	Presumed ACM
Sample No.	N/A
Laboratory Analysis Findings	N/A
Quantity of Material Identified	3m ² /14.8m ²

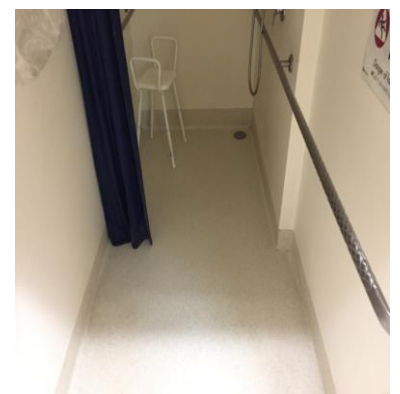
Photograph No.	02
Location/Area	Shower Room 4
Suspected Material Identified	Vinyl Floor/Walls
Condition of Material Identified	Good
Categories: (Assessment type). 1: ACM common characteristics or 2: Presumed ACM or 3: Sample collected for analysis	Presumed ACM
Sample No.	N/A
Laboratory Analysis Findings	N/A
Quantity of Material Identified	3m ² /14.8m ²

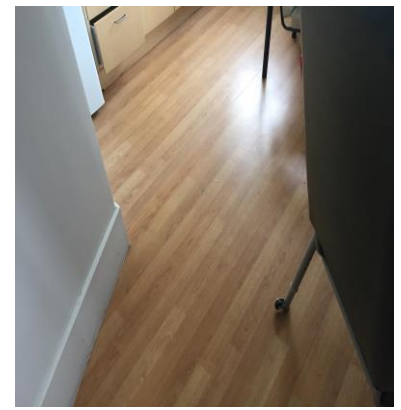
Photograph No.	021
Location/Area	Room 5
Suspected Material Identified	Vinyl Floor
Condition of Material Identified	Good
Categories: (Assessment type). 1: ACM common characteristics or 2: Presumed ACM or 3: Sample collected for analysis	Presumed ACM
Sample No.	N/A
Laboratory Analysis Findings	N/A
Quantity of Material Identified	45m ²

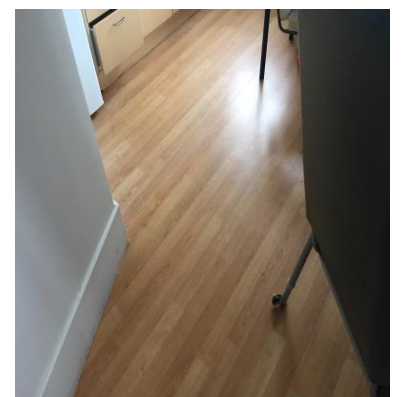
Photograph No.	02
Location/Area	Room 4
Suspected Material Identified	Vinyl Floor
Condition of Material Identified	Good
Categories: (Assessment type). 1: ACM common characteristics or 2: Presumed ACM or 3: Sample collected for analysis	Presumed ACM
Sample No.	N/A
Laboratory Analysis Findings	N/A
Quantity of Material Identified	45m ²

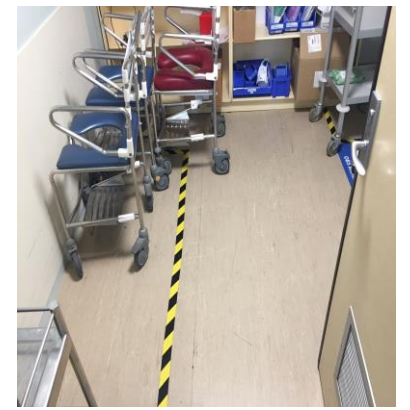
Photograph No.	023
Location/Area	Equipment Room
Suspected Material Identified	Vinyl Floor
Condition of Material Identified	Good
Categories: (Assessment type). 1: ACM common characteristics or 2: Presumed ACM or 3: Sample collected for analysis	Presumed ACM
Sample No.	N/A
Laboratory Analysis Findings	N/A
Quantity of Material Identified	9m ²

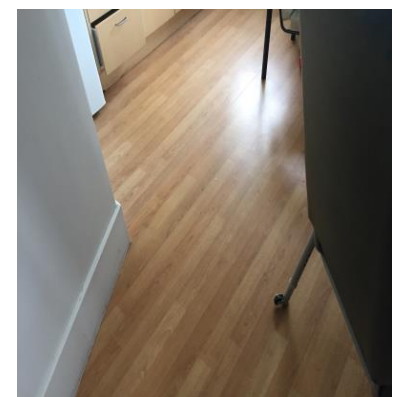
Photograph No.	024
Location/Area	Room 3
Suspected Material Identified	Vinyl Floor
Condition of Material Identified	Good
Categories: (Assessment type). 1: ACM common characteristics or 2: Presumed ACM or 3: Sample collected for analysis	Presumed ACM
Sample No.	N/A
Laboratory Analysis Findings	N/A
Quantity of Material Identified	45m ²

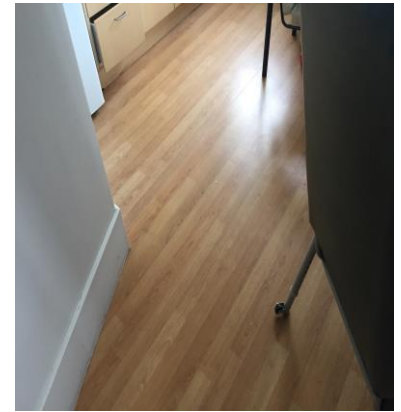
Photograph No.	025
Location/Area	Room 2
Suspected Material Identified	Vinyl Floor
Condition of Material Identified	Good
Categories: (Assessment type). 1: ACM common characteristics or 2: Presumed ACM or 3: Sample collected for analysis	Presumed ACM
Sample No.	N/A
Laboratory Analysis Findings	N/A
Quantity of Material Identified	45m ²

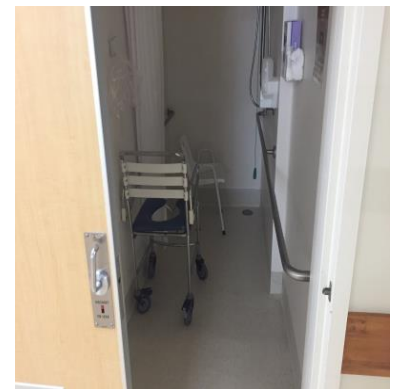
Photograph No.	026
Location/Area	Shower Room 2
Suspected Material Identified	Vinyl Floor/Walls
Condition of Material Identified	Good
Categories: (Assessment type). 1: ACM common characteristics or 2: Presumed ACM or 3: Sample collected for analysis	Presumed ACM
Sample No.	N/A
Laboratory Analysis Findings	N/A
Quantity of Material Identified	3m ² /14.8m ²

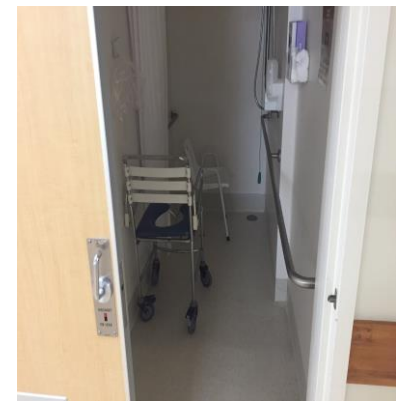
Photograph No.	027
Location/Area	Shower Room 1
Suspected Material Identified	Vinyl Floor/Walls
Condition of Material Identified	Good
Categories: (Assessment type). 1: ACM common characteristics or 2: Presumed ACM or 3: Sample collected for analysis	Presumed ACM
Sample No.	N/A
Laboratory Analysis Findings	N/A
Quantity of Material Identified	3m ² /14.8m ²

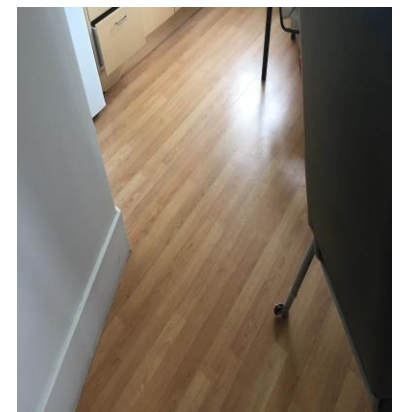
Photograph No.	028
Location/Area	Room 1
Suspected Material Identified	Vinyl Floor
Condition of Material Identified	Good
Categories: (Assessment type). 1: ACM common characteristics or 2: Presumed ACM or 3: Sample collected for analysis	Presumed ACM
Sample No.	N/A
Laboratory Analysis Findings	N/A
Quantity of Material Identified	45m ²

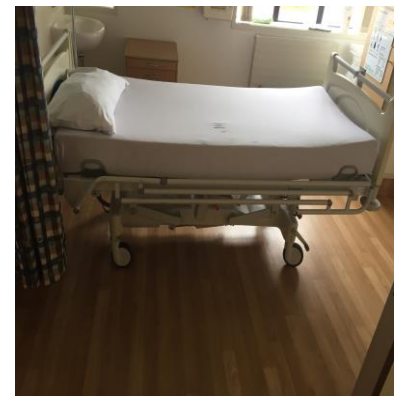
Photograph No.	029
Location/Area	Room 15
Suspected Material Identified	Vinyl Floor/Walls
Condition of Material Identified	Good
Categories: (Assessment type). 1: ACM common characteristics or 2: Presumed ACM or 3: Sample collected for analysis	Presumed ACM
Sample No.	N/A
Laboratory Analysis Findings	N/A
Quantity of Material Identified	15m ² /19m ²

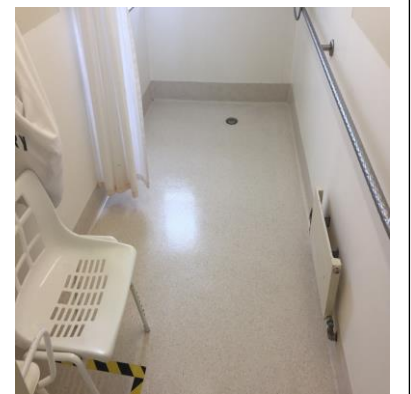
Photograph No.	030
Location/Area	Room 15 Bathroom
Suspected Material Identified	Vinyl Floor/Walls
Condition of Material Identified	Good
Categories: (Assessment type). 1: ACM common characteristics or 2: Presumed ACM or 3: Sample collected for analysis	Presumed ACM
Sample No.	N/A
Laboratory Analysis Findings	N/A
Quantity of Material Identified	6.5m ² /15m ²

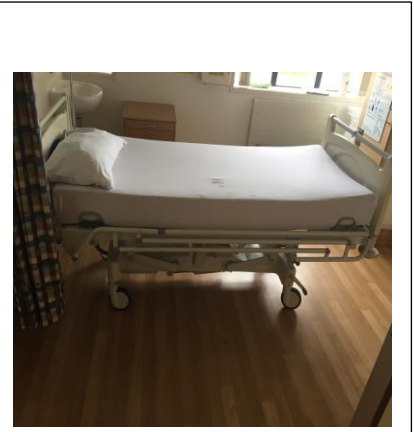
Photograph No.	031
Location/Area	Room 14
Suspected Material Identified	Vinyl Floor
Condition of Material Identified	Good
Categories: (Assessment type). 1: ACM common characteristics or 2: Presumed ACM or 3: Sample collected for analysis	Presumed ACM
Sample No.	N/A
Laboratory Analysis Findings	N/A
Quantity of Material Identified	15m ² /19m ²

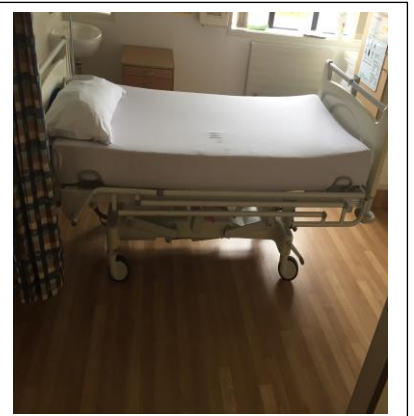
Photograph No.	032
Location/Area	Room 12
Suspected Material Identified	Vinyl Floor
Condition of Material Identified	Good
Categories: (Assessment type). 1: ACM common characteristics or 2: Presumed ACM or 3: Sample collected for analysis	Presumed ACM
Sample No.	N/A
Laboratory Analysis Findings	N/A
Quantity of Material Identified	15m ² /19m ²

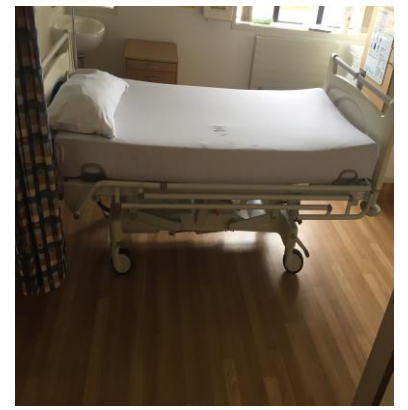
Photograph No.	033
Location/Area	Room 11
Suspected Material Identified	Vinyl Floor
Condition of Material Identified	Good
Categories: (Assessment type). 1: ACM common characteristics or 2: Presumed ACM or 3: Sample collected for analysis	Presumed ACM
Sample No.	N/A
Laboratory Analysis Findings	N/A
Quantity of Material Identified	15m ² /19m ²

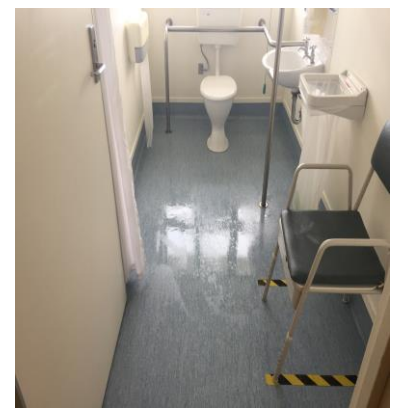
Photograph No.	034
Location/Area	Shower 5
Suspected Material Identified	Vinyl Floor/Walls
Condition of Material Identified	Good
Categories: (Assessment type). 1: ACM common characteristics or 2: Presumed ACM or 3: Sample collected for analysis	Presumed ACM
Sample No.	N/A
Laboratory Analysis Findings	N/A
Quantity of Material Identified	13m ² /14.8m ²

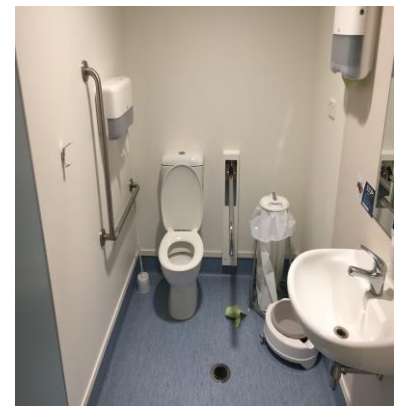
Photograph No.	035
Location/Area	W/C Toilet 1
Suspected Material Identified	Vinyl Floor
Condition of Material Identified	Good
Categories: (Assessment type). 1: ACM common characteristics or 2: Presumed ACM or 3: Sample collected for analysis	Presumed ACM
Sample No.	N/A
Laboratory Analysis Findings	N/A
Quantity of Material Identified	7m ²

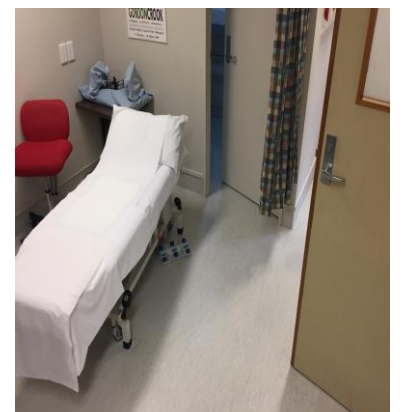
Photograph No.	036
Location/Area	Room 10
Suspected Material Identified	Vinyl Floor
Condition of Material Identified	Good
Categories: (Assessment type). 1: ACM common characteristics or 2: Presumed ACM or 3: Sample collected for analysis	Presumed ACM
Sample No.	N/A
Laboratory Analysis Findings	N/A
Quantity of Material Identified	15m ²

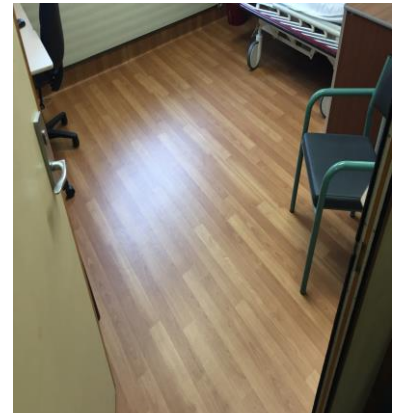
Photograph No.	037
Location/Area	Room 9
Suspected Material Identified	Vinyl Floor/Walls
Condition of Material Identified	Good
Categories: (Assessment type). 1: ACM common characteristics or 2: Presumed ACM or 3: Sample collected for analysis	Presumed ACM
Sample No.	N/A
Laboratory Analysis Findings	N/A
Quantity of Material Identified	13m ² /14.8m ²

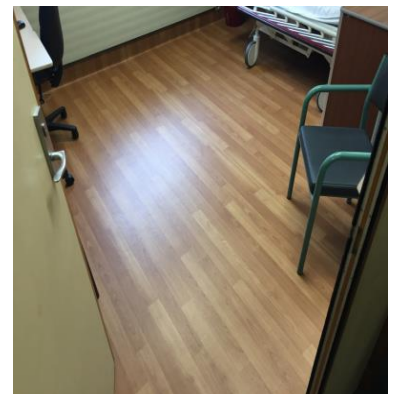
Photograph No.	038
Location/Area	Room 9
Suspected Material Identified	Vinyl Floor/Walls
Condition of Material Identified	Good
Categories: (Assessment type). 1: ACM common characteristics or 2: Presumed ACM or 3: Sample collected for analysis	Presumed ACM
Sample No.	N/A
Laboratory Analysis Findings	N/A
Quantity of Material Identified	13m ² /14.8m ²

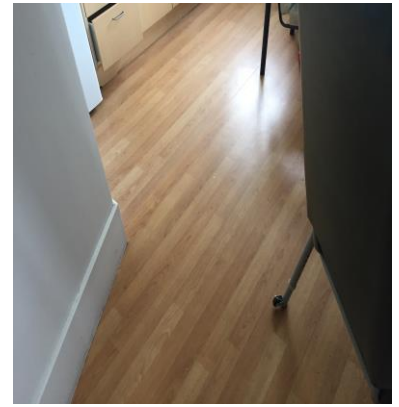
Photograph No.	039
Location/Area	Room 7
Suspected Material Identified	Vinyl Floor
Condition of Material Identified	Good
Categories: (Assessment type). 1: ACM common characteristics or 2: Presumed ACM or 3: Sample collected for analysis	Presumed ACM
Sample No.	N/A
Laboratory Analysis Findings	N/A
Quantity of Material Identified	45m ²
