Asbestos Management Survey Report

***WHANGANUI HOSPITAL
CRITICAL CARE
ASBESTOS MANAGEMENT SURVEY***

WHANGANUI HOSPITAL – CRITICAL CARE

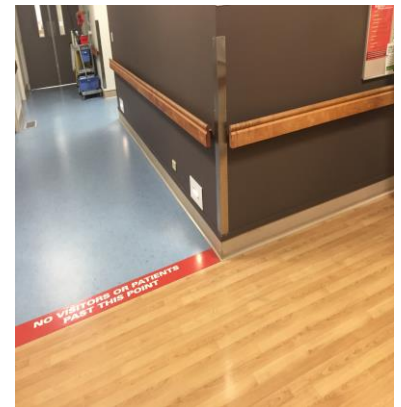
ID: CARD NO:001

Photograph No.	001
Location/Area	Corridors
Suspected Material Identified	Vinyl Floor
Condition of Material Identified	Good
Categories: (Assessment type). 1: ACM common characteristics or 2: Presumed ACM or 3: Sample collected for analysis	Presumed ACM
Sample No.	N/A
Laboratory Analysis Findings	N/A
Quantity of Material Identified	96.8m ²

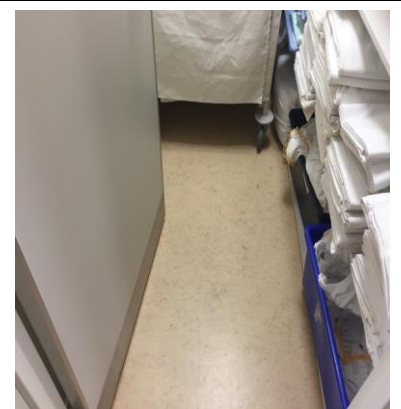
ID: CARD NO:002

Photograph No.	002
Location/Area	Linen Room
Suspected Material Identified	Vinyl Floor
Condition of Material Identified	Good
Categories: (Assessment type). 1: ACM common characteristics or 2: Presumed ACM or 3: Sample collected for analysis	Presumed ACM
Sample No.	N/A
Laboratory Analysis Findings	N/A
Quantity of Material Identified	3m ²

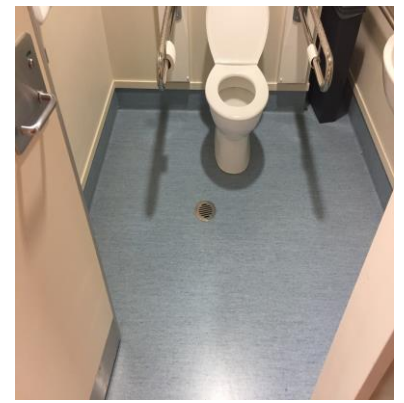
ID: CARD NO:003

Photograph No.	003
Location/Area	Unisex Toilet
Suspected Material Identified	Vinyl Floor
Condition of Material Identified	Good
Categories: (Assessment type). 1: ACM common characteristics or 2: Presumed ACM or 3: Sample collected for analysis	Presumed ACM
Sample No.	N/A
Laboratory Analysis Findings	N/A
Quantity of Material Identified	4m ²

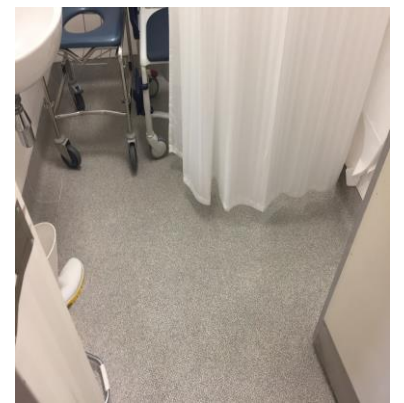
ID: CARD NO:004

Photograph No.	004
Location/Area	Shower Room
Suspected Material Identified	Vinyl Floor/Walls
Condition of Material Identified	Good
Categories: (Assessment type). 1: ACM common characteristics or 2: Presumed ACM or 3: Sample collected for analysis	Presumed ACM
Sample No.	N/A
Laboratory Analysis Findings	N/A
Quantity of Material Identified	4m ² /17.6m ²

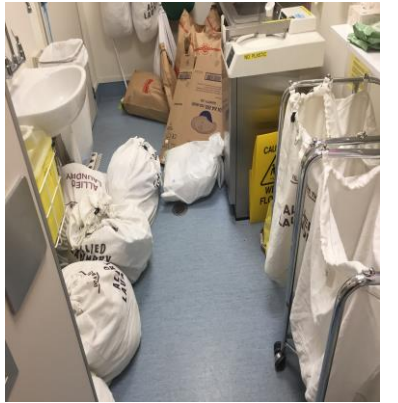
Photograph No.	006

Location/Area	Laundry Room	
Suspected Material Identified	Vinyl Floor	
Condition of Material Identified	Good	
Categories: (Assessment type). 1: ACM common characteristics or 2: Presumed ACM or 3: Sample collected for analysis	Presumed ACM	
Sample No.	N/A	
Laboratory Analysis Findings	N/A	
Quantity of Material Identified	8.5m ²

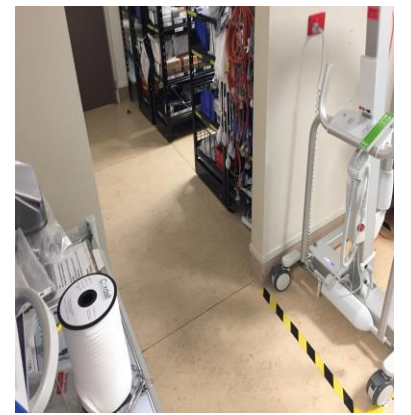
ID: CARD NO:007

Photograph No.	007
Location/Area	Supply Room
Suspected Material Identified	Vinyl Floor
Condition of Material Identified	Good
Categories: (Assessment type). 1: ACM common characteristics or 2: Presumed ACM or 3: Sample collected for analysis	Presumed ACM
Sample No.	N/A
Laboratory Analysis Findings	N/A
Quantity of Material Identified	38m ²

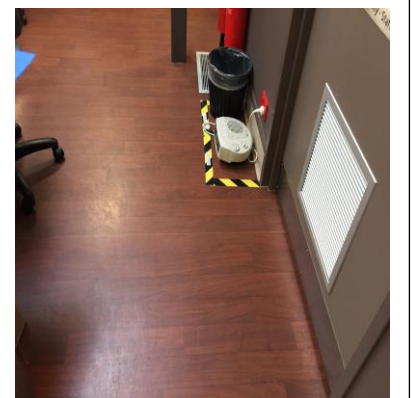
ID: CARD NO:008

Photograph No.	008
Location/Area	Reception/Office
Suspected Material Identified	Vinyl Floor
Condition of Material Identified	Good
Categories: (Assessment type). 1: ACM common characteristics or 2: Presumed ACM or 3: Sample collected for analysis	Presumed ACM
Sample No.	N/A
Laboratory Analysis Findings	N/A
Quantity of Material Identified	29m ²

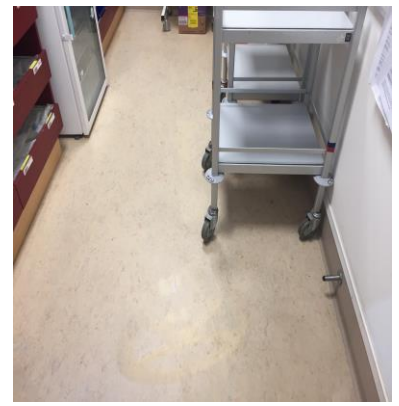
ID: CARD NO:009

Photograph No.	009
Location/Area	Preparation Room
Suspected Material Identified	Vinyl Floor
Condition of Material Identified	Good
Categories: (Assessment type). 1: ACM common characteristics or 2: Presumed ACM or 3: Sample collected for analysis	Presumed ACM
Sample No.	N/A
Laboratory Analysis Findings	N/A
Quantity of Material Identified	10.3m ²

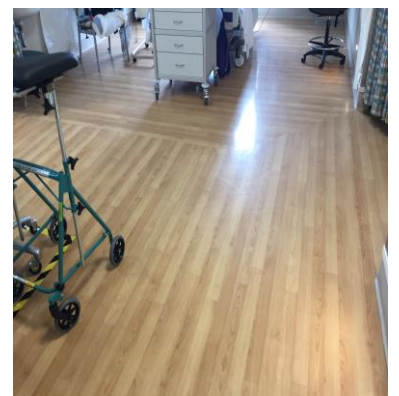
ID: CARD NO:010

Photograph No.	010
Location/Area	Observational Rooms
Suspected Material Identified	Vinyl Floor
Condition of Material Identified	Good
Categories: (Assessment type). 1: ACM common characteristics or 2: Presumed ACM or 3: Sample collected for analysis	Presumed ACM
Sample No.	N/A
Laboratory Analysis Findings	N/A
Quantity of Material Identified	146m ²

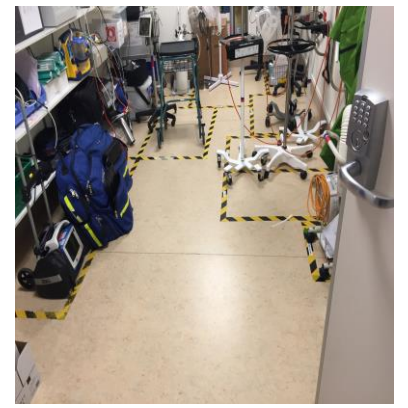
ID: CARD NO:011

Photograph No.	011
Location/Area	Store Room
Suspected Material Identified	Vinyl Floor
Condition of Material Identified	Good
Categories: (Assessment type). 1: ACM common characteristics or 2: Presumed ACM or 3: Sample collected for analysis	Presumed ACM
Sample No.	N/A
Laboratory Analysis Findings	N/A
Quantity of Material Identified	18m ²
