Asbestos Management Survey Report

***EMERGENCY DEPARTMENT
WHANGANUI HOSPITAL
ASBESTOS MANAGEMENT SURVEY***

WHANGANUI HOSPITAL – EMERGENCY DEPARTMENT

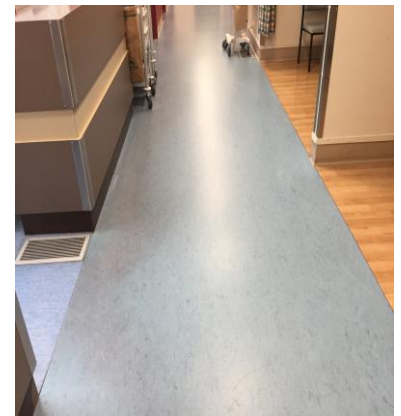
ID: CARD NO:001

Photograph No.	001
Location/Area	Corridors
Suspected Material Identified	Vinyl Floor
Condition of Material Identified	Good
Categories: (Assessment type). 1: ACM common characteristics or 2: Presumed ACM or 3: Sample collected for analysis	Presumed ACM
Sample No.	N/A
Laboratory Analysis Findings	N/A
Quantity of Material Identified	159m ²

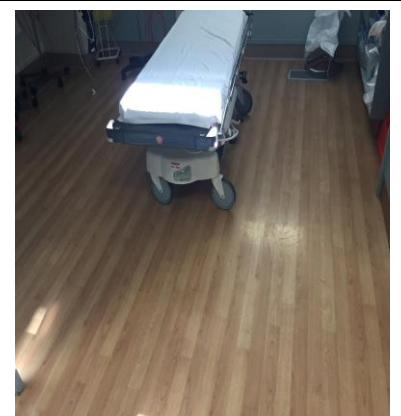
ID: CARD NO:002

Photograph No.	002
Location/Area	Resuscitation Room 1 & 2
Suspected Material Identified	Vinyl Floor
Condition of Material Identified	Good
Categories: (Assessment type). 1: ACM common characteristics or 2: Presumed ACM or 3: Sample collected for analysis	Presumed ACM
Sample No.	N/A
Laboratory Analysis Findings	N/A
Quantity of Material Identified	41m ²

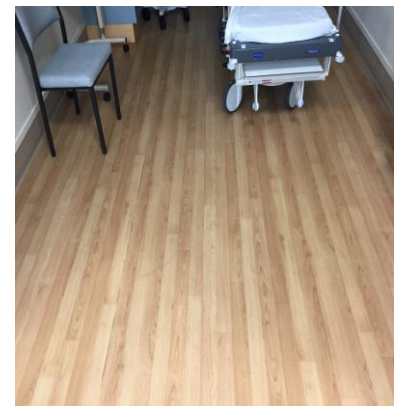
ID: CARD NO:003

Photograph No.	003
Location/Area	Patient Room 3
Suspected Material Identified	Vinyl Floor
Condition of Material Identified	Good
Categories: (Assessment type). 1: ACM common characteristics or 2: Presumed ACM or 3: Sample collected for analysis	Presumed ACM
Sample No.	N/A
Laboratory Analysis Findings	N/A
Quantity of Material Identified	12m ²

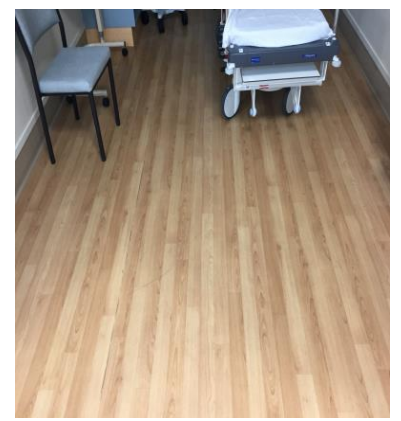
ID: CARD NO:004

Photograph No.	004
Location/Area	Patient Room 4
Suspected Material Identified	Vinyl Floor
Condition of Material Identified	Good
Categories: (Assessment type). 1: ACM common characteristics or 2: Presumed ACM or 3: Sample collected for analysis	Presumed ACM
Sample No.	N/A
Laboratory Analysis Findings	N/A
Quantity of Material Identified	12m ²

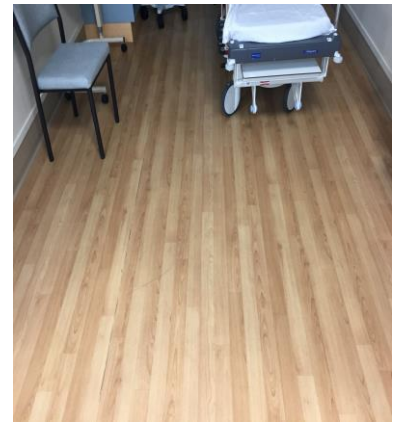
ID: CARD NO:005

Photograph No.	005
Location/Area	Patient Room 5
Suspected Material Identified	Vinyl Floor
Condition of Material Identified	Good
Categories: (Assessment type). 1: ACM common characteristics or 2: Presumed ACM or 3: Sample collected for analysis	Presumed ACM
Sample No.	N/A
Laboratory Analysis Findings	N/A
Quantity of Material Identified	12m ²

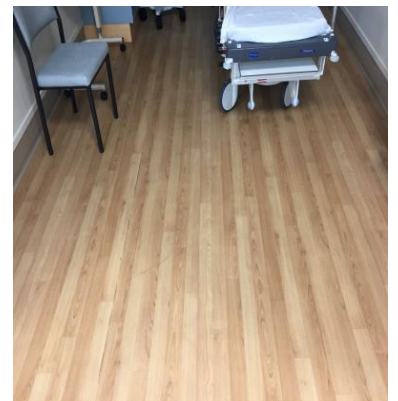
ID: CARD NO:006

Photograph No.	006
Location/Area	Patient Room 6
Suspected Material Identified	Vinyl Floor
Condition of Material Identified	Good
Categories: (Assessment type). 1: ACM common characteristics or 2: Presumed ACM or 3: Sample collected for analysis	Presumed ACM
Sample No.	N/A
Laboratory Analysis Findings	N/A
Quantity of Material Identified	12m ²

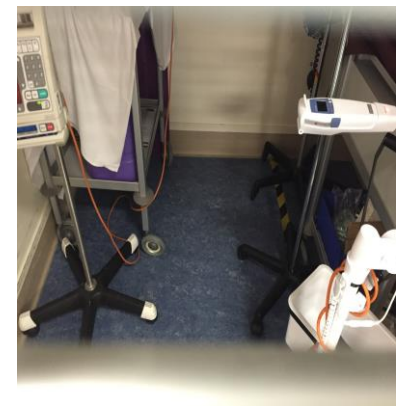
ID: CARD NO:007

Photograph No.	007
Location/Area	Monitor Room
Suspected Material Identified	Vinyl Floor
Condition of Material Identified	Good
Categories: (Assessment type). 1: ACM common characteristics or 2: Presumed ACM or 3: Sample collected for analysis	Presumed ACM
Sample No.	N/A
Laboratory Analysis Findings	N/A
Quantity of Material Identified	4m ²

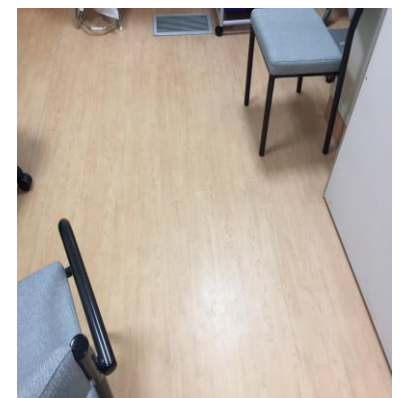
ID: CARD NO:008

Photograph No.	008
Location/Area	Triage
Suspected Material Identified	Vinyl Floor
Condition of Material Identified	Good
Categories: (Assessment type). 1: ACM common characteristics or 2: Presumed ACM or 3: Sample collected for analysis	Presumed ACM
Sample No.	N/A
Laboratory Analysis Findings	N/A
Quantity of Material Identified	12m ²

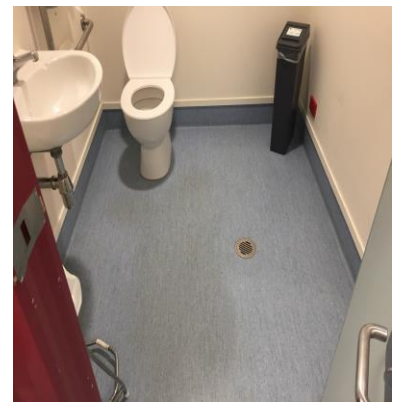
ID: CARD NO:009

Photograph No.	009
Location/Area	Unisex Toilet 1
Suspected Material Identified	Vinyl Floor
Condition of Material Identified	Good
Categories: (Assessment type). 1: ACM common characteristics or 2: Presumed ACM or 3: Sample collected for analysis	Presumed ACM
Sample No.	N/A
Laboratory Analysis Findings	N/A
Quantity of Material Identified	3.5m ²

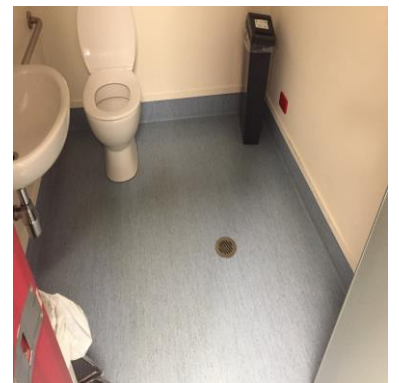
ID: CARD NO:010

Photograph No.	010
Location/Area	Unisex Toilet 2
Suspected Material Identified	Vinyl Floor
Condition of Material Identified	Good
Categories: (Assessment type). 1: ACM common characteristics or 2: Presumed ACM or 3: Sample collected for analysis	Presumed ACM
Sample No.	N/A
Laboratory Analysis Findings	N/A
Quantity of Material Identified	3.5m ²

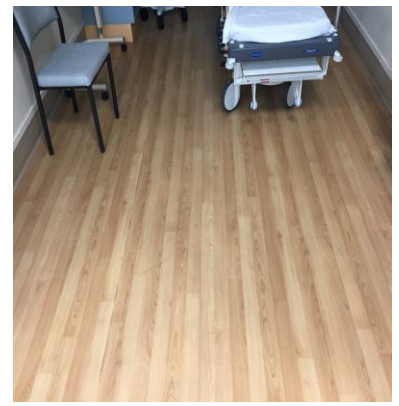
ID: CARD NO:011

Photograph No.	011
Location/Area	Patient Room 7
Suspected Material Identified	Vinyl Floor
Condition of Material Identified	Good
Categories: (Assessment type). 1: ACM common characteristics or 2: Presumed ACM or 3: Sample collected for analysis	Presumed ACM
Sample No.	N/A
Laboratory Analysis Findings	N/A
Quantity of Material Identified	12m ²

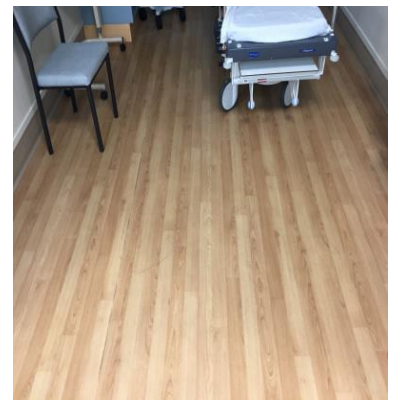
ID: CARD NO:012

Photograph No.	012
Location/Area	Patient Room 8
Suspected Material Identified	Vinyl Floor
Condition of Material Identified	Good
Categories: (Assessment type). 1: ACM common characteristics or 2: Presumed ACM or 3: Sample collected for analysis	Presumed ACM
Sample No.	N/A
Laboratory Analysis Findings	N/A
Quantity of Material Identified	12m ²

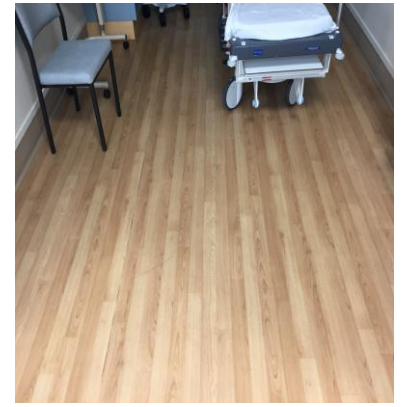
ID: CARD NO:013

Photograph No.	013
Location/Area	Patient Room 9
Suspected Material Identified	Vinyl Floor
Condition of Material Identified	Good
Categories: (Assessment type). 1: ACM common characteristics or 2: Presumed ACM or 3: Sample collected for analysis	Presumed ACM
Sample No.	N/A
Laboratory Analysis Findings	N/A
Quantity of Material Identified	12m ²

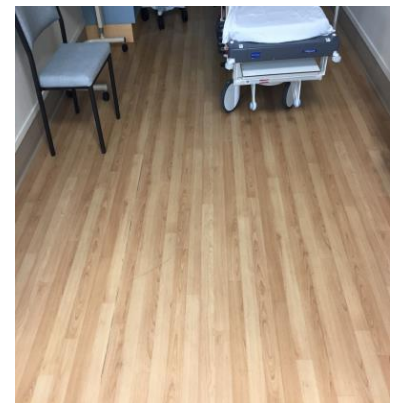
ID: CARD NO:014

Photograph No.	014
Location/Area	Patient Room 10
Suspected Material Identified	Vinyl Floor
Condition of Material Identified	Good
Categories: (Assessment type). 1: ACM common characteristics or 2: Presumed ACM or 3: Sample collected for analysis	Presumed ACM
Sample No.	N/A
Laboratory Analysis Findings	N/A
Quantity of Material Identified	12m ²

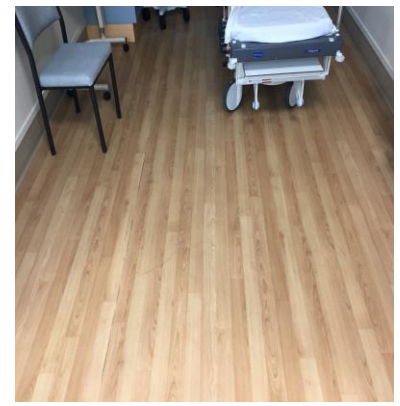
ID: CARD NO:015

Photograph No.	015
Location/Area	Patient Room 11
Suspected Material Identified	Vinyl Floor
Condition of Material Identified	Good
Categories: (Assessment type). 1: ACM common characteristics or 2: Presumed ACM or 3: Sample collected for analysis	Presumed ACM
Sample No.	N/A
Laboratory Analysis Findings	N/A
Quantity of Material Identified	12m ²

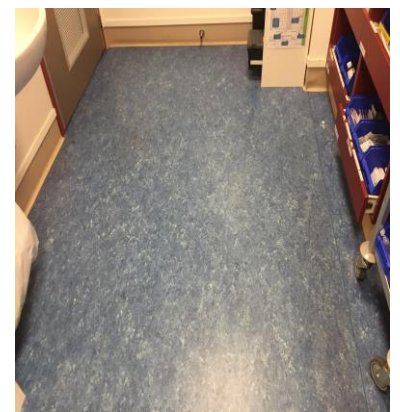
ID: CARD NO:016

Photograph No.	016
Location/Area	Medical Supplies
Suspected Material Identified	Vinyl Floor
Condition of Material Identified	Good
Categories: (Assessment type). 1: ACM common characteristics or 2: Presumed ACM or 3: Sample collected for analysis	Presumed ACM
Sample No.	N/A
Laboratory Analysis Findings	N/A
Quantity of Material Identified	9m ²

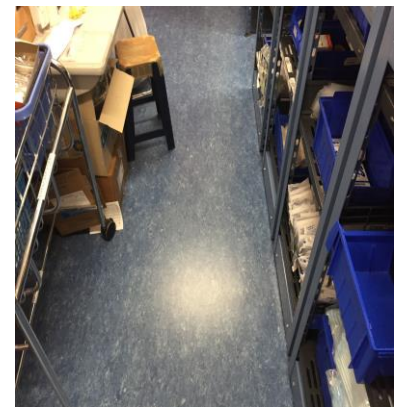
ID: CARD NO:017

Photograph No.	017
Location/Area	Store Room
Suspected Material Identified	Vinyl Floor
Condition of Material Identified	Good
Categories: (Assessment type). 1: ACM common characteristics or 2: Presumed ACM or 3: Sample collected for analysis	Presumed ACM
Sample No.	N/A
Laboratory Analysis Findings	N/A
Quantity of Material Identified	13m ²

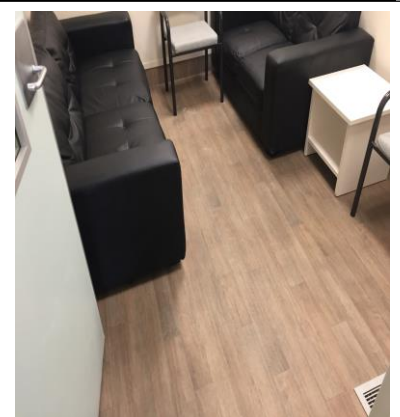
ID: CARD NO:018

Photograph No.	018
Location/Area	Interview Room
Suspected Material Identified	Vinyl Floor
Condition of Material Identified	Good
Categories: (Assessment type). 1: ACM common characteristics or 2: Presumed ACM or 3: Sample collected for analysis	Presumed ACM
Sample No.	N/A
Laboratory Analysis Findings	N/A
Quantity of Material Identified	7m ²

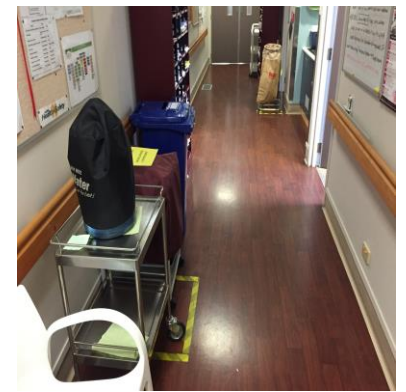
ID: CARD NO:019

Photograph No.	019
Location/Area	Ambulance Entrance
Suspected Material Identified	Vinyl Floor
Condition of Material Identified	Good
Categories: (Assessment type). 1: ACM common characteristics or 2: Presumed ACM or 3: Sample collected for analysis	Presumed ACM
Sample No.	N/A
Laboratory Analysis Findings	N/A
Quantity of Material Identified	12m ²

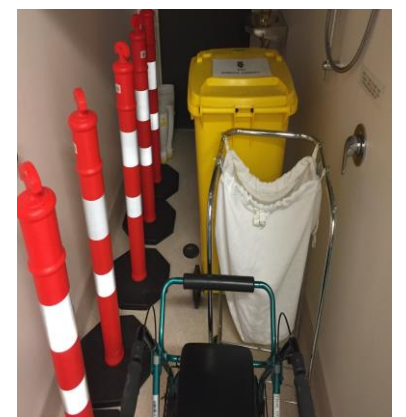
ID: CARD NO:020

Photograph No.	020
Location/Area	Ambulance Entrance Decontamination Shower
Suspected Material Identified	Vinyl Floor
Condition of Material Identified	Good
Categories: (Assessment type). 1: ACM common characteristics or 2: Presumed ACM or 3: Sample collected for analysis	Presumed ACM
Sample No.	N/A
Laboratory Analysis Findings	N/A
Quantity of Material Identified	8m ²

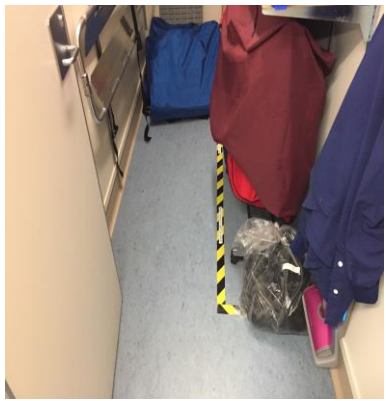
Photograph No.	021

Location/Area	Ambulance Entrance Storage Room	
Suspected Material Identified	Vinyl Floor	
Condition of Material Identified	Good	
Categories: (Assessment type). 1: ACM common characteristics or 2: Presumed ACM or 3: Sample collected for analysis	Presumed ACM	
Sample No.	N/A	
Laboratory Analysis Findings	N/A	
Quantity of Material Identified	6m ²

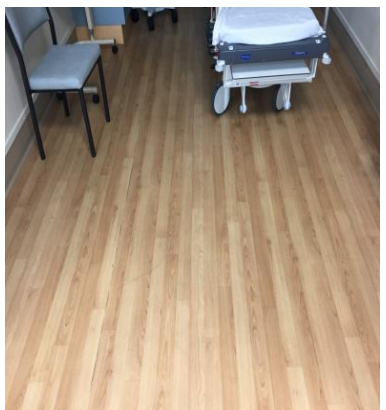
Photograph No.	022

Location/Area	Patient Room 12	
Suspected Material Identified	Vinyl Floor	
Condition of Material Identified	Good	
Categories: (Assessment type). 1: ACM common characteristics or 2: Presumed ACM or 3: Sample collected for analysis	Presumed ACM	
Sample No.	N/A	
Laboratory Analysis Findings	N/A	
Quantity of Material Identified	12m ²

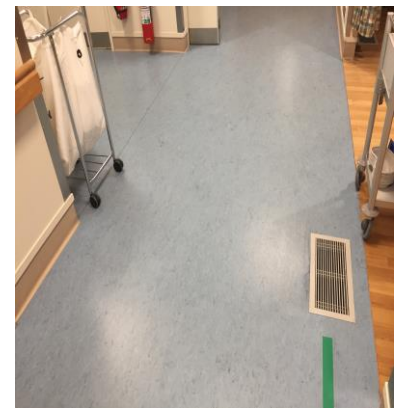
ID: CARD NO:025

Photograph No.	025
Location/Area	E.D Staff Area
Suspected Material Identified	Vinyl Floor
Condition of Material Identified	Good
Categories: (Assessment type). 1: ACM common characteristics or 2: Presumed ACM or 3: Sample collected for analysis	Presumed ACM
Sample No.	N/A
Laboratory Analysis Findings	N/A
Quantity of Material Identified	17.5m ²

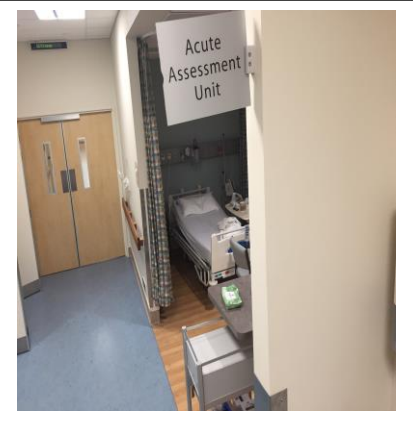
ID: CARD NO:027

Photograph No.	027
Location/Area	Acute Assessment Unit
Suspected Material Identified	Vinyl Floor
Condition of Material Identified	Good
Categories: (Assessment type). 1: ACM common characteristics or 2: Presumed ACM or 3: Sample collected for analysis	Presumed ACM
Sample No.	N/A
Laboratory Analysis Findings	N/A
Quantity of Material Identified	22m ²

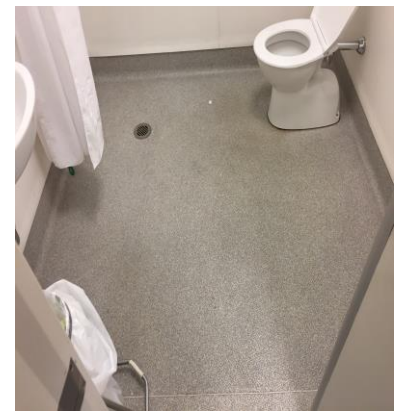
ID: CARD NO:029

Photograph No.	029
Location/Area	Toilet/Shower
Suspected Material Identified	Vinyl Floor/Walls
Condition of Material Identified	Good
Categories: (Assessment type). 1: ACM common characteristics or 2: Presumed ACM or 3: Sample collected for analysis	Presumed ACM
Sample No.	N/A
Laboratory Analysis Findings	N/A
Quantity of Material Identified	5m ² /17.6m ²
