Totara Street

Preliminary design stage safety audit

Report prepared for
Tauranga City Council
May 2020

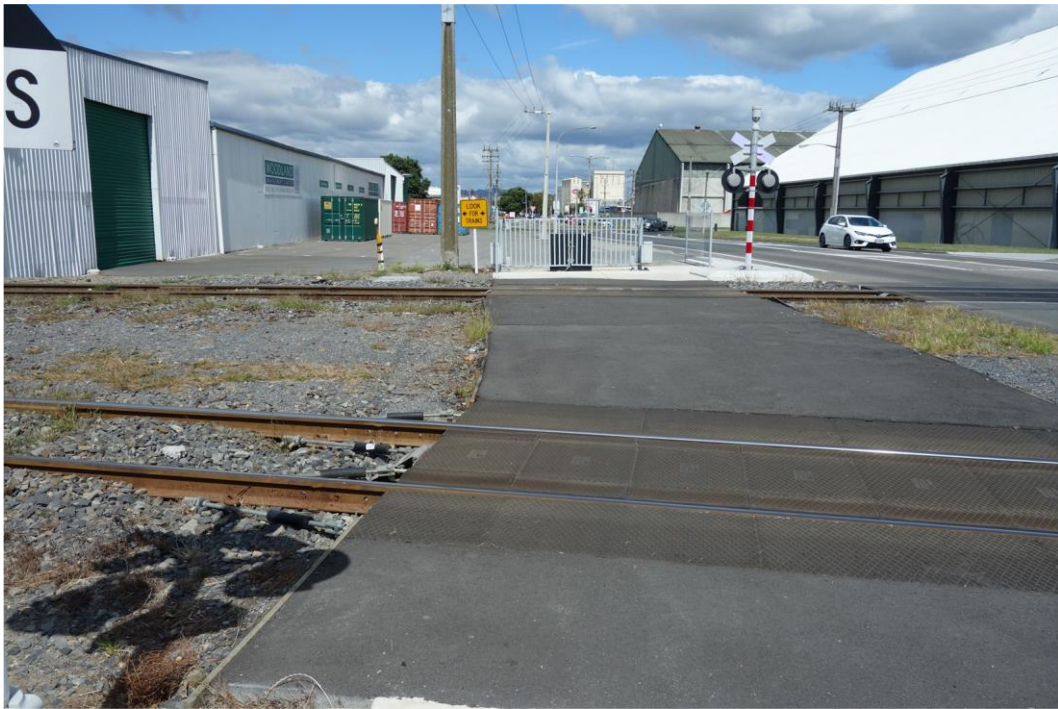
Cover photo: Automatic gates have already been installed, but are not operational yet

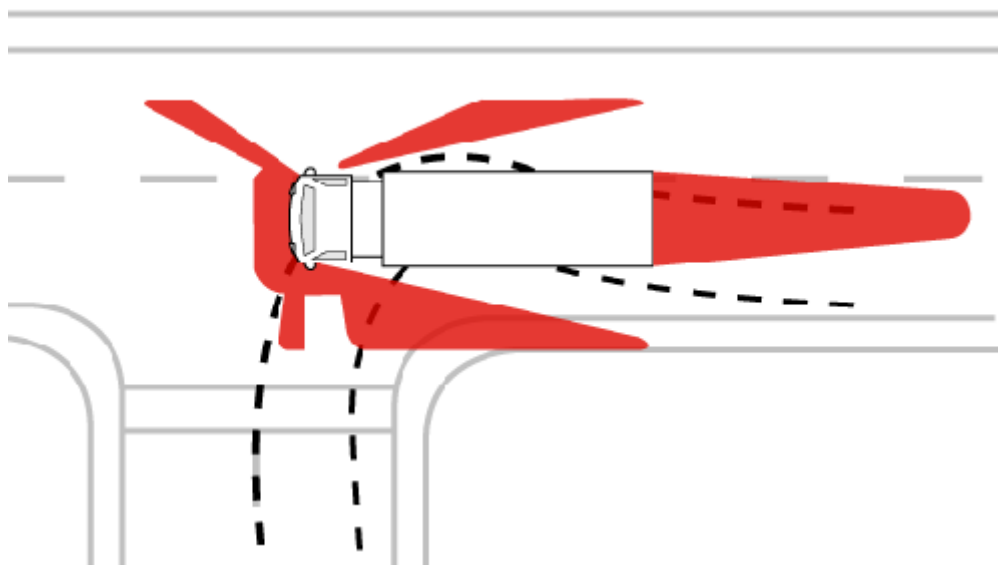
Figure 2: blind spots for truck drivers in red³

Truck drivers have very limited visibility to their left, and immediately in front of their vehicle. The graphic in Figure 2 gives an indication of this.

Truck driver visibility will cause a problem at the three proposed dual crossings. If a truck stops at a crossing to wait for path users crossing in either direction, a cyclist approaching from behind the truck and then crossing in front of that truck will be in the truck driver’s blind spot for almost the entire time. If the truck driver was not initially aware of that cyclist, or if another approaches from behind at some distance, a truck driver may start up as a cyclist is about to cross; it is conceivable that the driver will never have seen the second cyclist, and that the cyclist is unaware of not having been seen.

For this reason, path approaches to dual crossings should ideally be perpendicular to the road to be crossed (but offset from the carriageway enough so that path users are not in the side of the driver blindspot). This is not the case with either of the crossings.

One way to possibly mitigate for this risk is to set back the limit line from that approach to the dual crossing where cyclists approach the crossing from behind a truck driver. For example, instead of the standard 5 m setback, consider doubling that distance.

2.1.2.1. Mitigate the risk to cyclists who are approaching the dual crossings from behind trucks already stopped at the limit line being overlooked / in the driver’s blind spot.

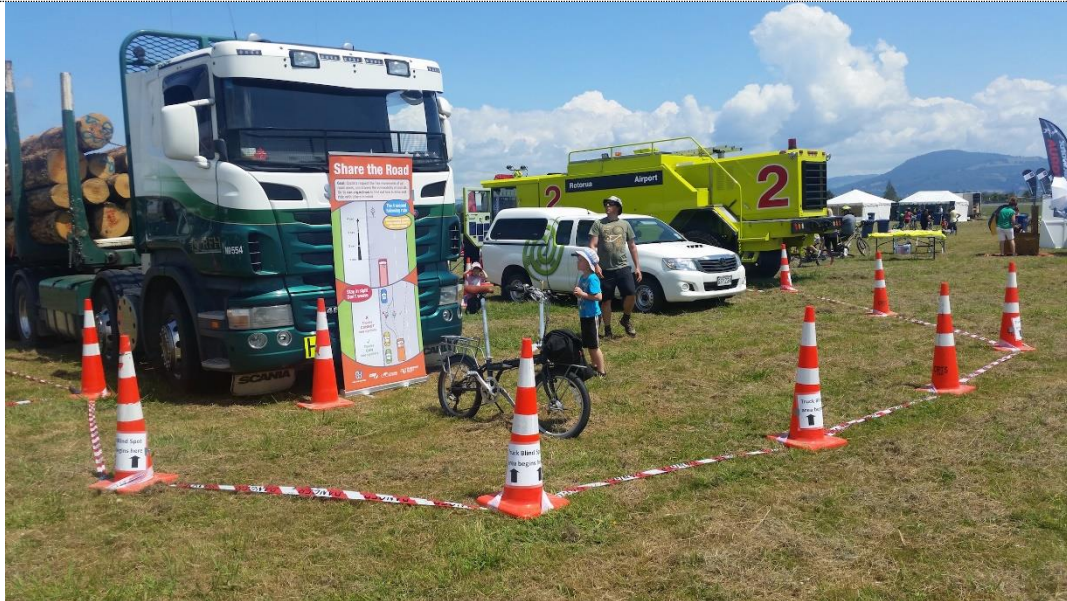
Figure 3: truck driver blind spot area is coned off

The area coned off in Figure 3 (including the bicycle) cannot be seen by the driver of the logging truck; neither can the yellow airport fire engine be seen by the driver.

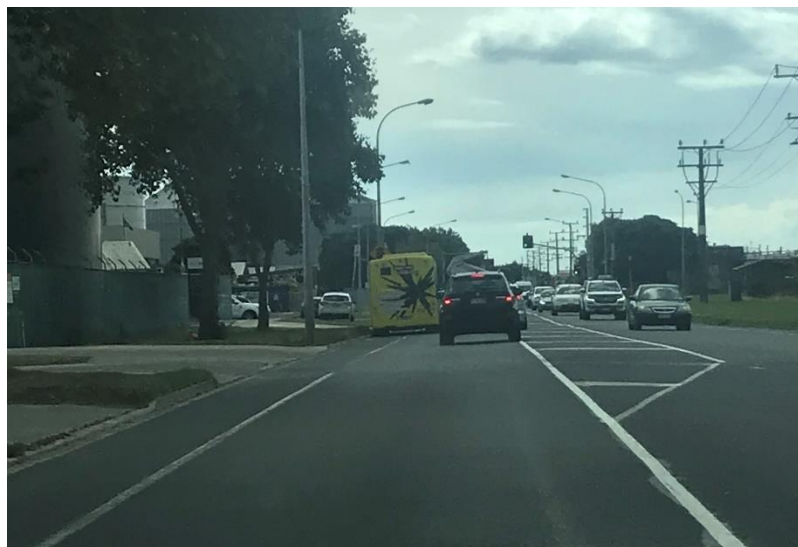
Figure 4: bus stopped at bus stop outside 198 Totara Street

Totara Street is now serviced by a bus route (see Figure 6). It is unclear whether the provision of pedestrian islands should be part of the scope of this project. Given the traffic volume on the road, pedestrian islands would certainly make it easier (and probably safer) to get to and from the bus stops from the other side of the road.

2.1.4.1. Consider pedestrian refuge islands to give better access to bus stops.

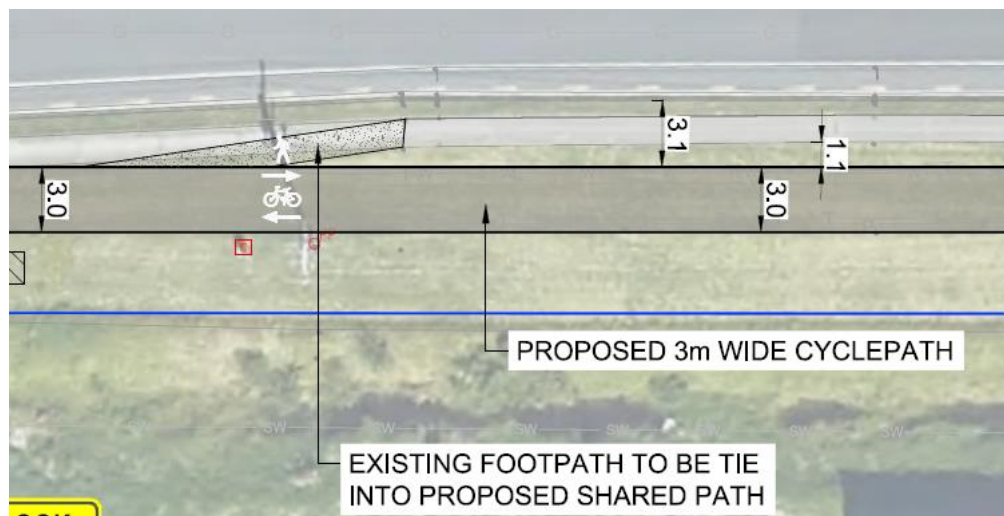
Figure 5: Incorrect alignment of path markings

The cycle and pedestrian symbols used in path markings should be aligned for view of the path users. Driveway markings, on the other hand, are aligned for view of drivers on the driveway. Figure 5 shows an example of where path markings have been used with incorrect orientation for path users.

2.1.5.1. Realign path markings.

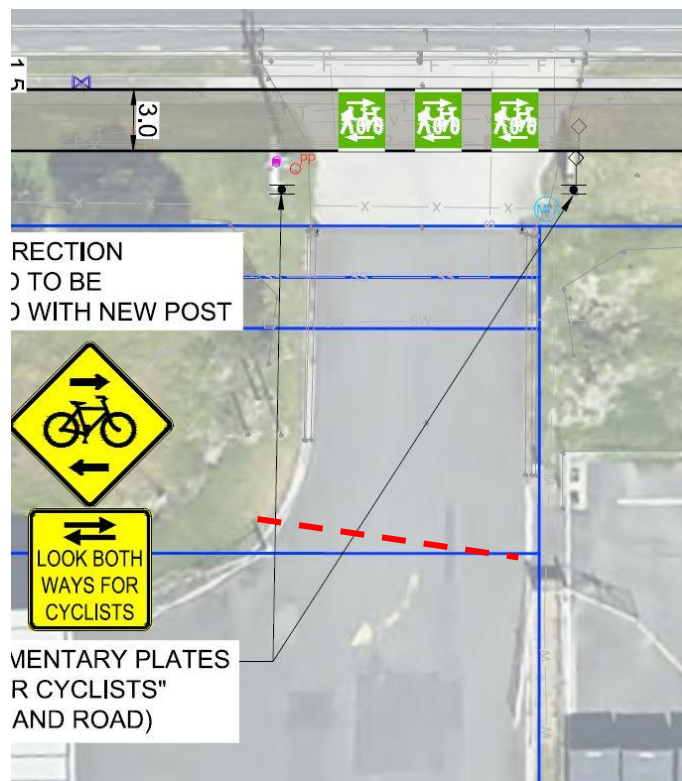
Figure 6: gate indicated in red dashed line

The SAT does not know the operational practice at 207 Totara Street (see Figure 6). There is a gate installed some 20 m beyond the edge of the proposed pathway. An HPMV is 23 m long. If these types of vehicle were to stop at a closed gate, a pathway would be completely blocked.

Recommendations:	
2.2.1.1.	Ensure that there are no operational procedures in place that require entering HPMVs to stop at a closed gate.
2.2.1.2.	Alternatively, shift the gate further into the site.
Designer Response:	<i>Agree with the SAT. TCC will require consultation with the owner/operator to ensure the gates remain open during business hours for use by large heavy vehicles to avoid stopping and encroaching over the shared path.</i>
SAT Response:	no further comment
Safety Engineer:	<i>Agree with Designer response and recommend that TCC make use of any available enforcement options to ensure that the site operator is not creating a hazard (i.e. trailer blocking the thoroughfare) due to their gate procedures.</i>
Client Decision:	<i>Agree, the team to get formal agreement from 207 Totara Street around use of gates. This will be incorporated into comms and engagement plan to ensure action is closed out</i>

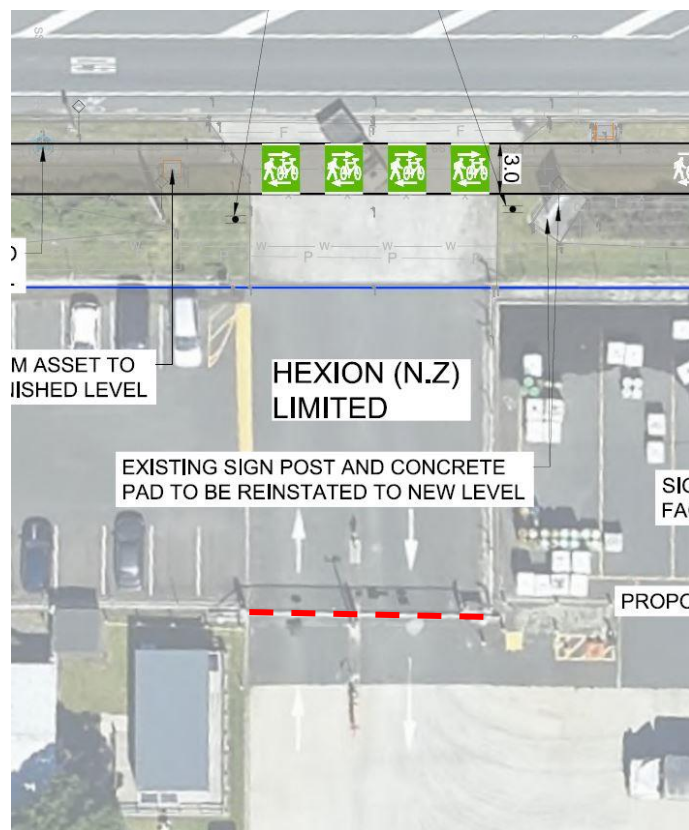
Figure 7: Hexion driveway layout, with gate indicated in red dashed line

<p>Probability of crash occurring – Infrequent</p> <p>Likelihood of serious / fatal injury – Likely</p> <p>Ranking – Moderate</p>
<p>The SAT was informed that the procedure of letting a truck onto the Hexion site at 165 Totara Street takes about 10 minutes. The driveway gate scales at some 24 m from the edge of the path (Figure 7), meaning that an HPMV that pulls up close to the gate would not block the path. The problem is, though, that trucks parked for a long time immediately adjacent to the edge of the shared path waiting to access the site will completely block visibility for drivers leaving the site at this driveway. There is no intervisibility between leaving drivers and southbound cyclists.</p>

The problem at that a cyclist hit by a vehicle leaving the driveway may be thrown into a live traffic lane or run over by the vehicle leaving the site. This may happen infrequently but can be expected to likely result in serious injury or death.

2.2.2.1. Consider options available for mitigating the risk of drivers leaving the driveway and southbound cyclists have zero intervisibility when a long truck gets processed at the entry gate.

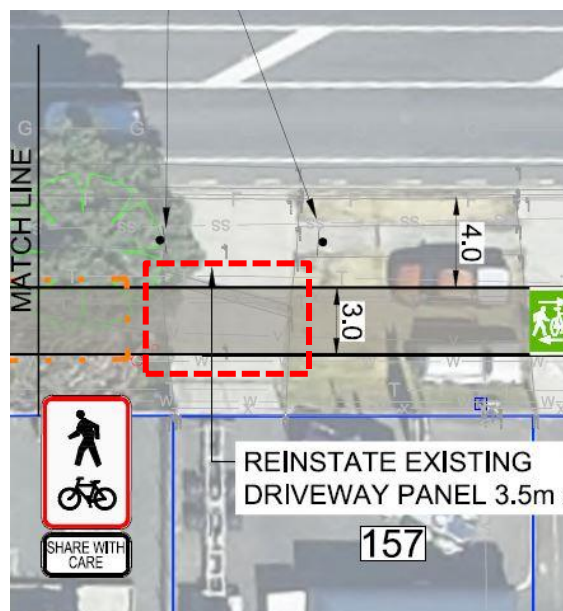
Figure 8: missing pathway markings (highlighted)

The driveway at 157 Totara Street on sheet C06 is missing the shared path markings (see Figure 8).

Recommendations:	
2.2.3.1.	Add the shared pathway markings.
Designer Response:	<i>Agree markings to be added</i>
SAT Response:	no further comment
Safety Engineer:	<i>Agree with Designer response.</i>
Client Decision:	<i>Agree with Designer response.</i>
Action Taken:	<i>Implemented as part of the design</i>

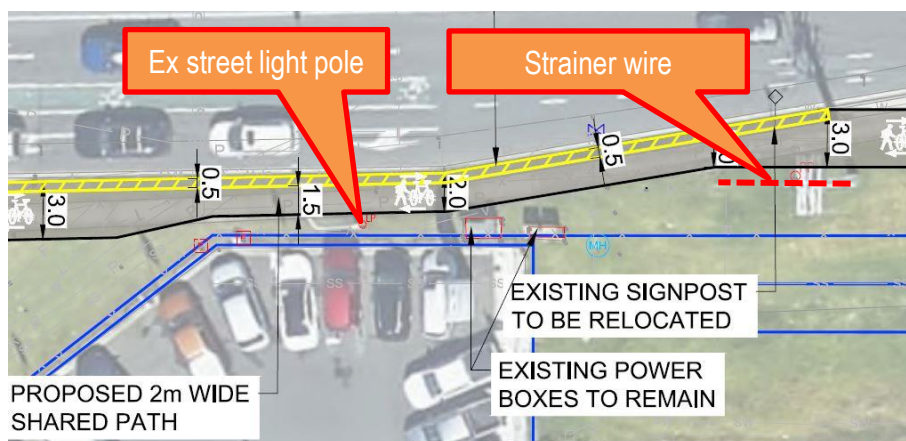
Figure 9: narrow path over 40 m

On sheet C01, the shared path narrows to just 2.0 m over a length of some 40 m (see Figure 9). This happens in an area where it is proposed to mark a 0.5 m wide yellow buffer zone, leaving a useable width of just 1.5 m for the shared path. It needs to be noted that it can be commonly observed that vehicles wanting to reach the kerbside lane mount the pathway with their left wheels. Therefore, having such a narrow path in this location is at best undesirable.

It is acknowledged that there is a large electricity box on the boundary that poses an existing constraint, and it may well be acceptable if the path momentarily narrows at that box. There is also an existing street light pole in this narrow section, but this should be easy to relocate.

2.2.4.1. Reconsider the width and alignment of the path shown in Figure 9.

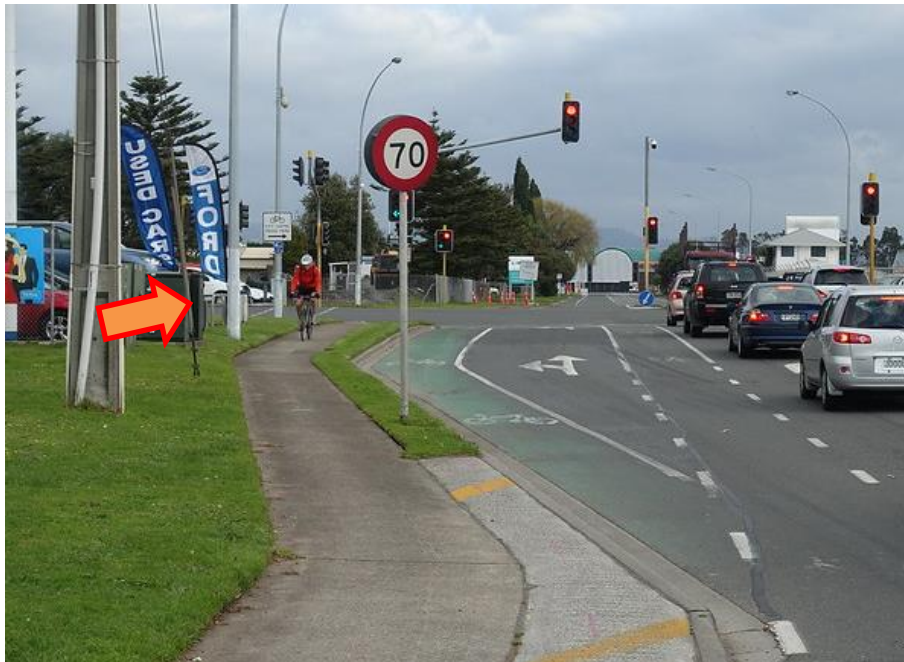
Figure 10: Strainer wire (highlighted)

There is also a strainer wire that may impact on path width if it is too complex or expensive to relocate. If that were to be the case, it may be preferable to have the path in this location behind the power pole and strainer wire. Whilst the path would not be 3.0 m

wide adjacent to the pole, this is preferable over having a narrow path hard against a busy road.

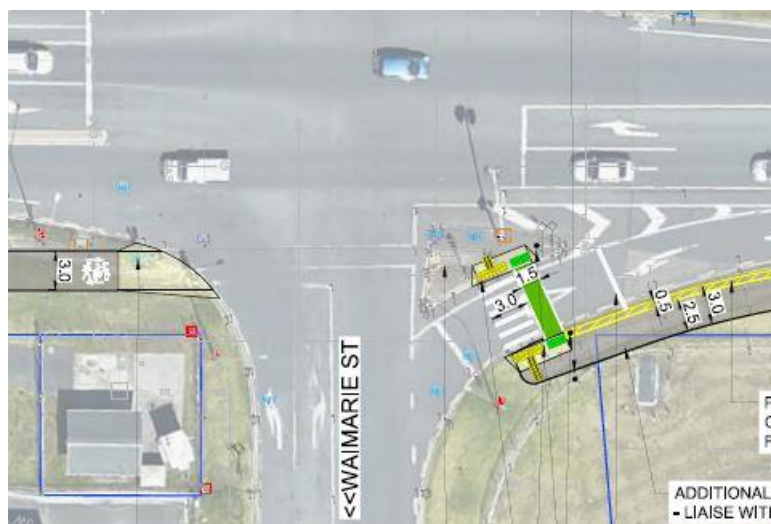
Figure 11: incomplete design at the Waimarie Street approach

The design for the crossing facilities at Waimarie Street is incomplete (see Figure 11). The dual crossing is wider than the current cut down on the splitter island. The crosswalk is much narrower than the shared path approaching it. The limit line for the Waimarie Street approach is within the extension of the shared pathway; the limit line will have to be relocated. With the design not adequately detailed, it is not possible to provide safety audit comments.

Recommendations:	
2.2.5.1.	Provide a design that can be safety audited.
Designer Response:	<i>Agree with SAT. The designer is aware of these issues which will be addressed during the next phase.</i>
SAT Response:	no further comment
Safety Engineer:	<p><i>Agree that the signals layout will need to be modified to suit the width of the shared path.</i></p> <p><i>Also, on the issue of priority on the non-signalised left-turn from Totara into Waimarie, we note the following. The volume of pedestrians and cyclists on the shared path is expected to be relatively low. The volume of vehicles using the left-turn slip is also expected to be very low. However, the majority of vehicles are expected to be heavy vehicles. Given that both parties are expected to have a very high level of service regardless of who has priority, it may be beneficial to maintain the existing vehicle priority arrangement on the slip.</i></p>

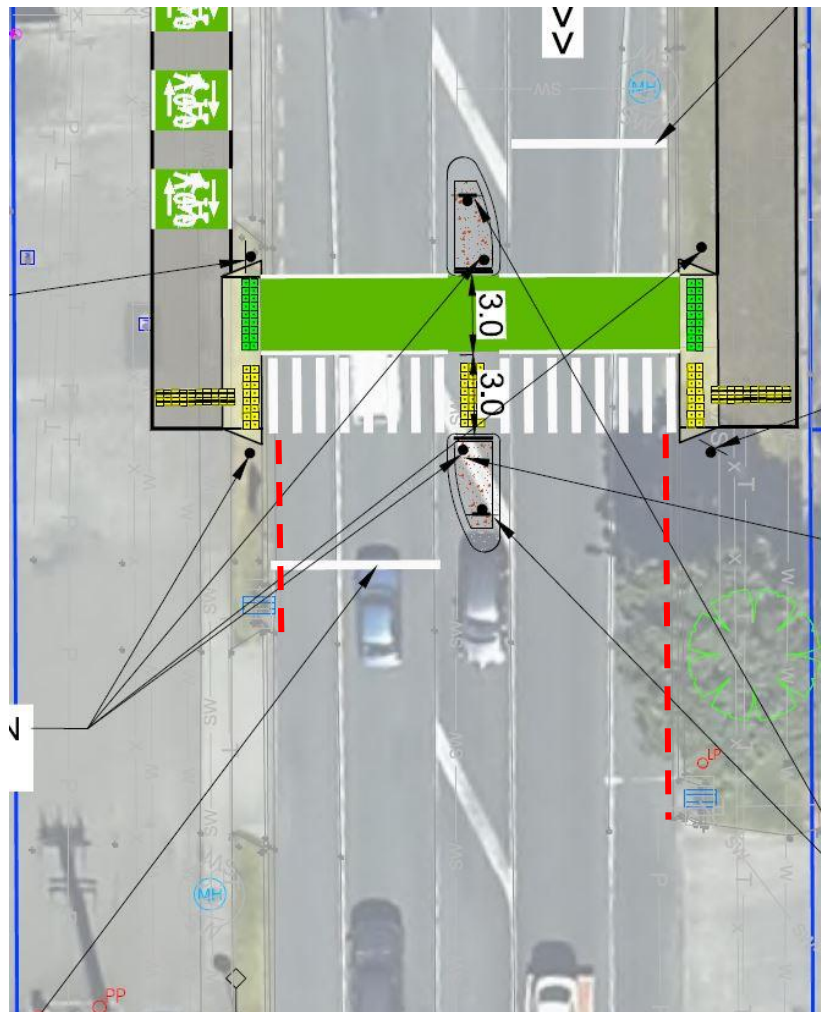
Figure 12: Missing broken yellow lines shown in red

Ranking – Comment
<p>Broken yellow lines have inadvertently been left off sheet 07 as shown in Figure 12. On the approach, broken yellow lines should be included to ensure that there is good intervisibility. On the departure side, broken yellow lines would prevent a squeeze point at the refuge island for people cycling on the carriageway.</p>

2.2.6.1. Add broken yellow lines to the design.
