# Categorisation of Open Stormwater Drains in Waihi Beach, Te Puke, and Maketu

Opus International Consultants Limited  
Tauranga Office  
405 Cameron Road  
PO Box 646  
Tauranga, New Zealand

Date: 8 February 2008  
Reference: g:\5\project\9z178.01\_drains\_phase\_2\final  
Status: FINAL  
document\main document.doc

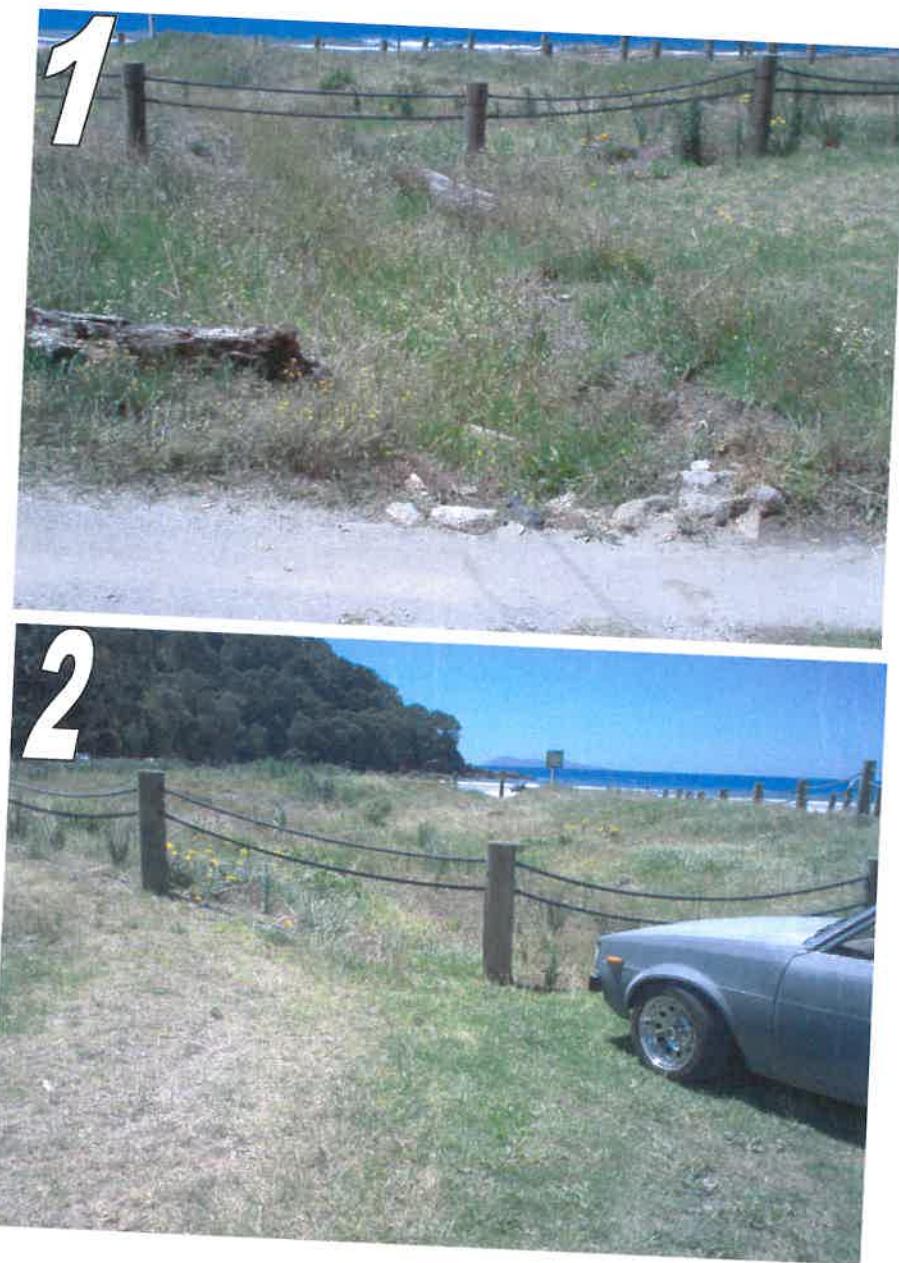
## Drain 1-The Esplanade

PARAMETER	OBSERVATION	RATING
DEPTH	< 0.5 m	0
BATTER SLOPE	< 2:1	0
DISTANCE ROAD SURFACE AND DRAIN	>4 m	0
INLET/OUTLET PROTECTION	Not Applicable	0
PROXIMITY TO SENSITIVE FACILITIES	Next to main beach	0
AESTHETIC CONSIDERATIONS	None	10
HEALTH CONSIDERATIONS	None	0
ENVIRONMENTAL CONSIDERATIONS	None	0
PROXIMITY TO DEVELOPMENT	Adjacent to development	0
SAFETY INDEX	The drain is well demarcated and doesn't constitute a safety risk	10
DRAIN INDEX		3.00
		1.50

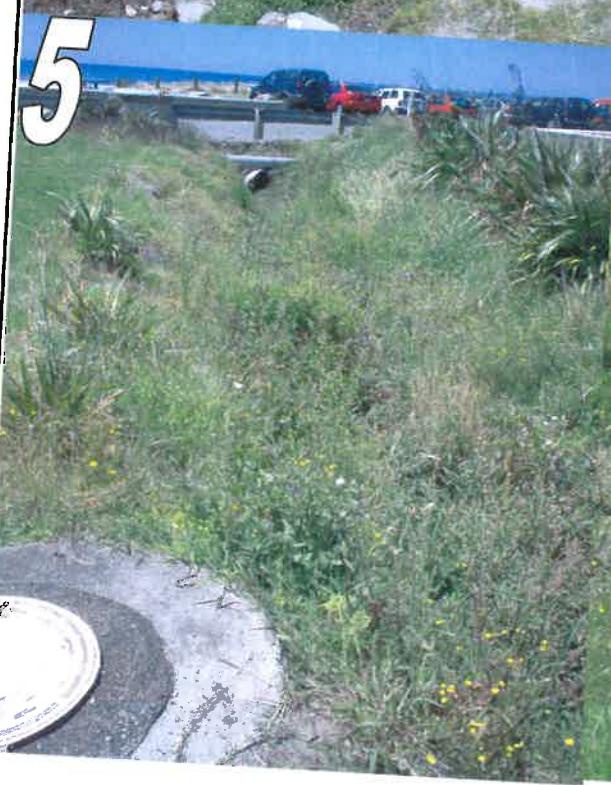
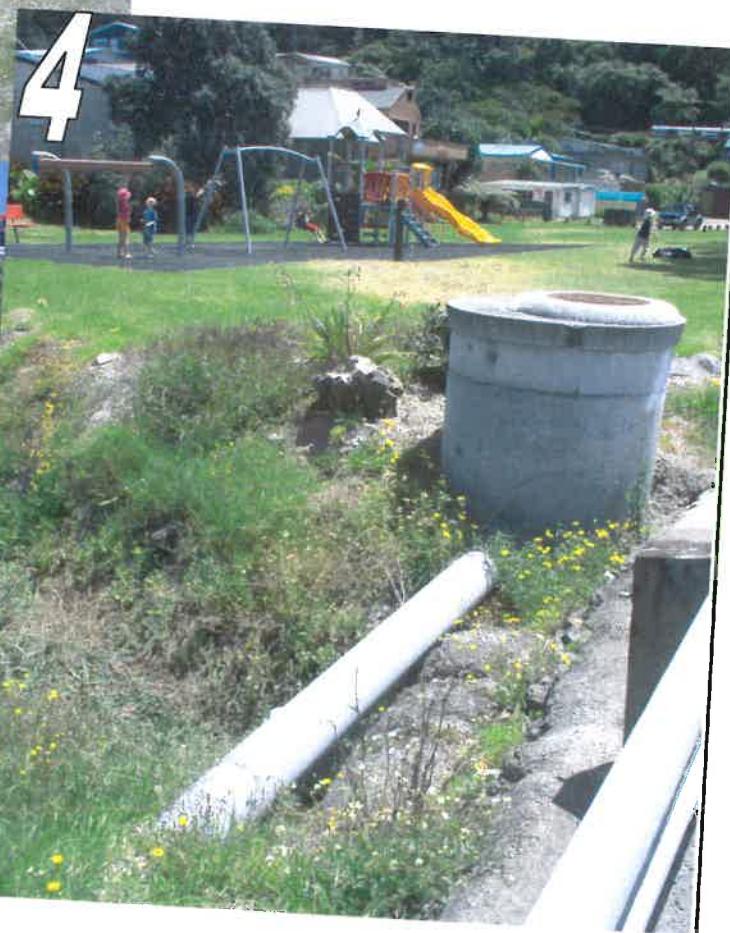
## Drain 2-The Esplanade

PARAMETER	OBSERVATION	RATING
DEPTH	> 1 m	10
BATTER SLOPE	> 1:1	10
DISTANCE ROAD SURFACE AND DRAIN	Perpendicular to road.	0
INLET/OUTLET PROTECTION	Inlet and outlet is part of a road crossing.	0
PROXIMITY TO SENSITIVE FACILITIES	Adjacent to development and beach	10
AESTHETIC CONSIDERATIONS	Excessive growth.	10
HEALTH CONSIDERATIONS	None.	10
ENVIRONMENTAL CONSIDERATIONS	None.	10
PROXIMITY TO DEVELOPMENT	Adjacent to development	0
SAFETY INDEX	The drain is adjacent to a play park and should be better protected	10
DRAIN INDEX		7.15
		7.15

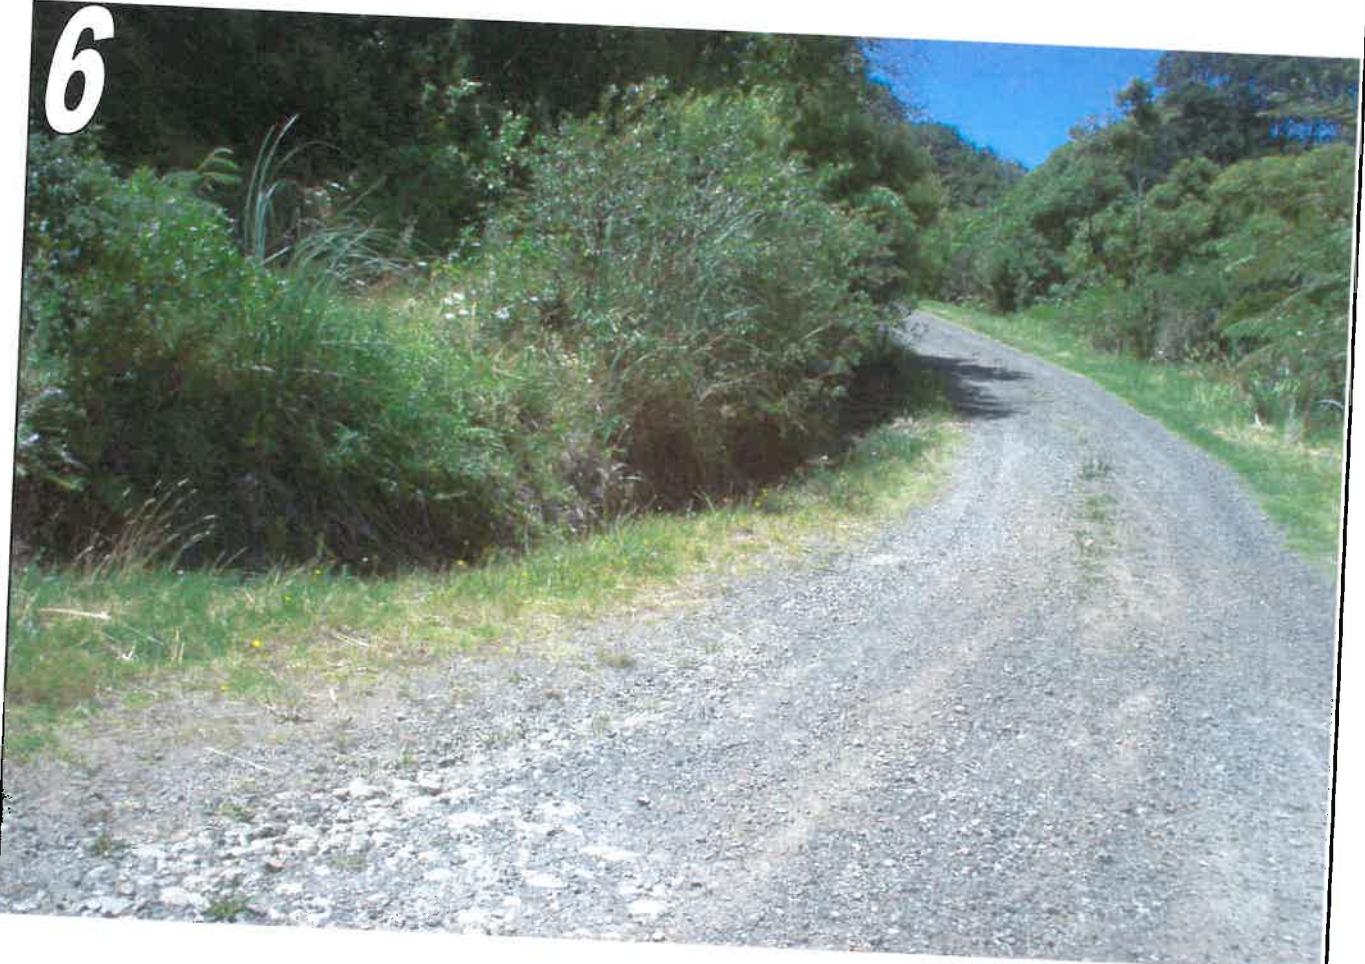
**6**

PARAMETER	OBSERVATION	RATING
DEPTH	0.5-1 m	5
BATTER SLOPE	2:1 - 1:1	5
DISTANCE ROAD SURFACE AND DRAIN	> 4 m	10
INLET/OUTLET PROTECTION	Inlet not protected but not required as per Report	0
PROXIMITY TO SENSITIVE FACILITIES	Removed from sensitive facilities	0
AESTHETIC CONSIDERATIONS	Slight growth	5
HEALTH CONSIDERATIONS	None	0
ENVIRONMENTAL CONSIDERATIONS	None	0
PROXIMITY TO DEVELOPMENT	Easily accessible	10
<b>SAFETY INDEX</b>	The drain is at the toe of an escarpment and adjacent to a gravel road. There are no real safety	3.43
<b>DRAIN INDEX</b>		2.68

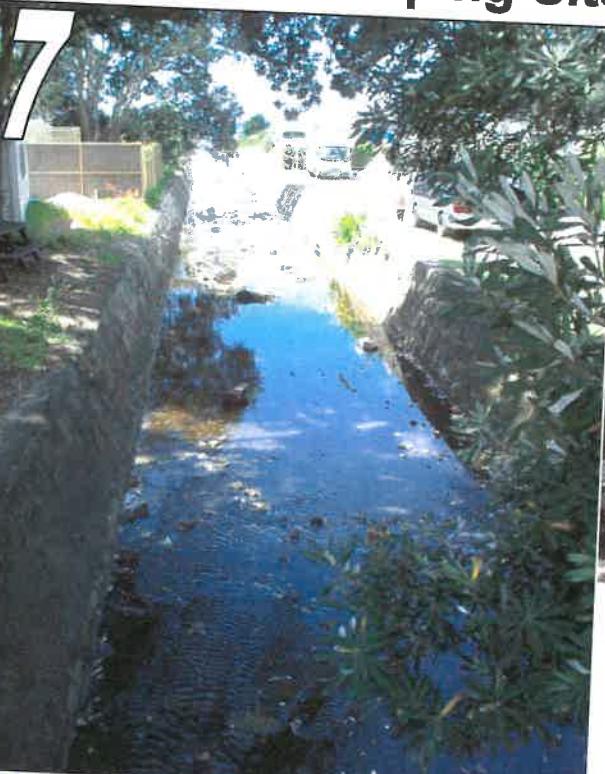
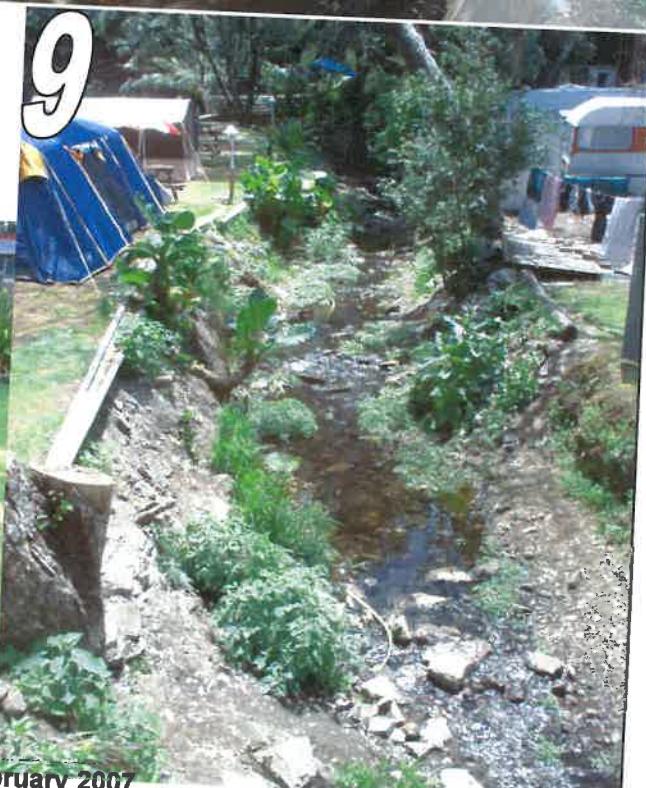
## Drain 4-Camping Site-both sides of Beach Rd

PARAMETER	OBSERVATION	RATING
DEPTH	> 1 m.	10
BATTER SLOPE	> 1:1	10
DISTANCE ROAD SURFACE AND DRAIN	Drain is perpendicular to road.	0
INLET/OUTLET PROTECTION	Inlet and outlet is part of a road crossing.	0
PROXIMITY TO SENSITIVE FACILITIES	Adjacent to development and beach	10
AESTHETIC CONSIDERATIONS	Slight growth	5
HEALTH CONSIDERATIONS	None	0
ENVIRONMENTAL CONSIDERATIONS	None	0
PROXIMITY TO DEVELOPMENT	Adjacent to development	10
SAFETY INDEX	Three children were slightly injured after falling into the open drain during the past holidays.	6.65
DRAIN INDEX		5.40

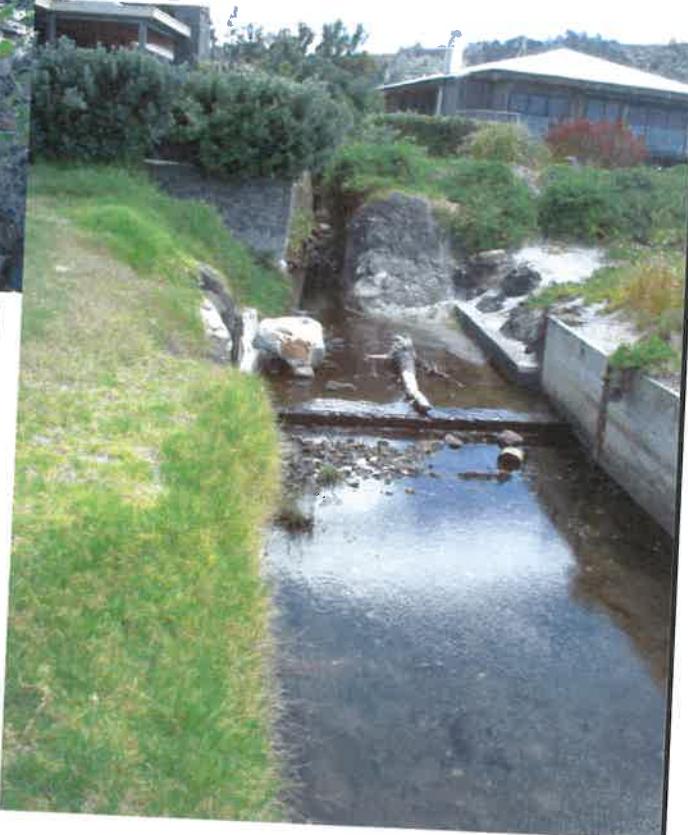
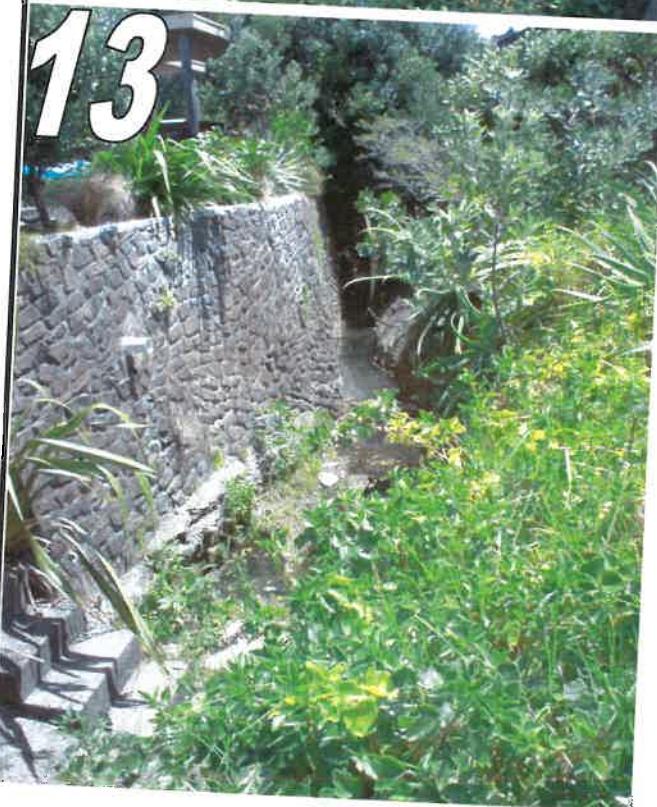
PARAMETER	OBSERVATION	RATING
DEPTH	2.2 m along sections	10
BATTER SLOPE	Vertical along sections	10
DISTANCE ROAD SURFACE AND DRAIN	> 4 m	0
INLET/OUTLET PROTECTION	Inlet not protected but has safety rails.	0
PROXIMITY TO SENSITIVE FACILITIES	Adjacent to development and beach	10
AESTHETIC CONSIDERATIONS	Slight growth	5
HEALTH CONSIDERATIONS	Standing water	10
ENVIRONMENTAL CONSIDERATIONS	None	10
PROXIMITY TO DEVELOPMENT	Adjacent to development	5
SAFETY INDEX	The drain isn't easily accessible and is mostly on private land	6.90
DRAIN INDEX		7.40

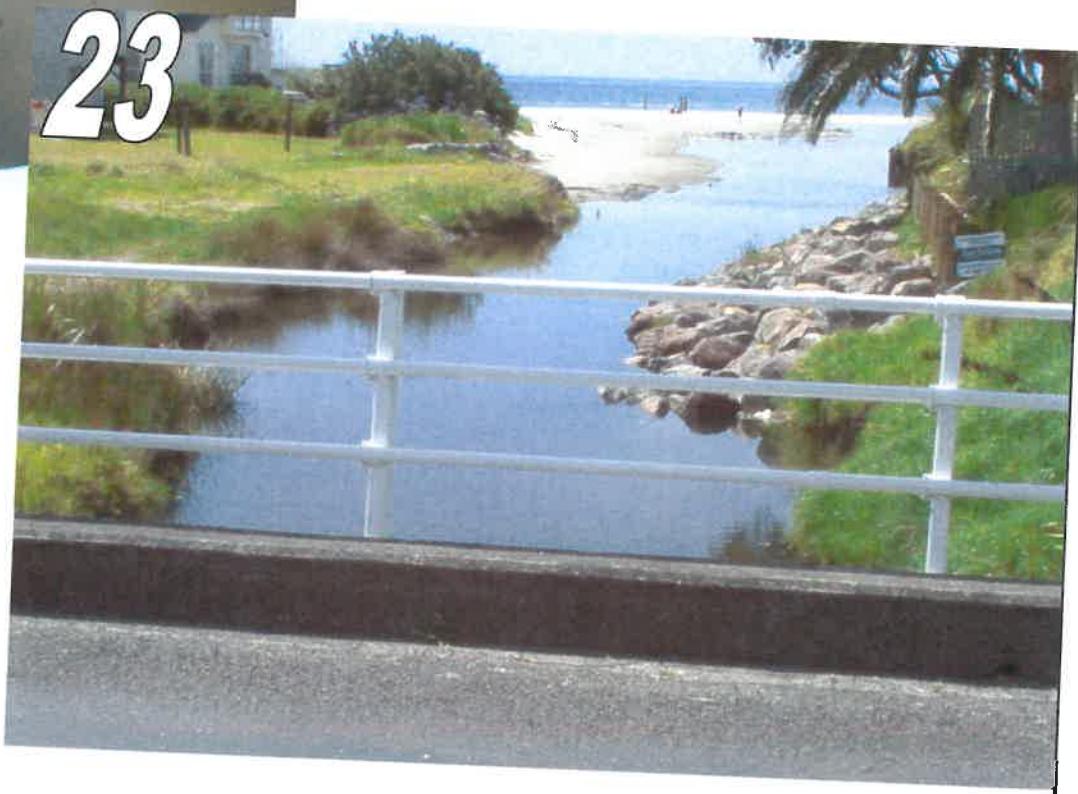
## Drain 8-Between Edinburgh St & Wilson Rd

PARAMETER	OBSERVATION	RATING
DEPTH	> 2m	10
BATTER SLOPE	Vertical along sections	10
DISTANCE ROAD SURFACE AND DRAIN	> 4 m	0
INLET/OUTLET PROTECTION	Inlet and outlet is part of a road crossing.	0
PROXIMITY TO SENSITIVE FACILITIES	Traverses beach	10
AESTHETIC CONSIDERATIONS	Slight growth	10
HEALTH CONSIDERATIONS	Standing water	5
ENVIRONMENTAL CONSIDERATIONS	None	10
PROXIMITY TO DEVELOPMENT	Adjacent to development and beach	0
SAFETY INDEX	The drain traverses private properties where no easements exist	10
DRAIN INDEX		6.40

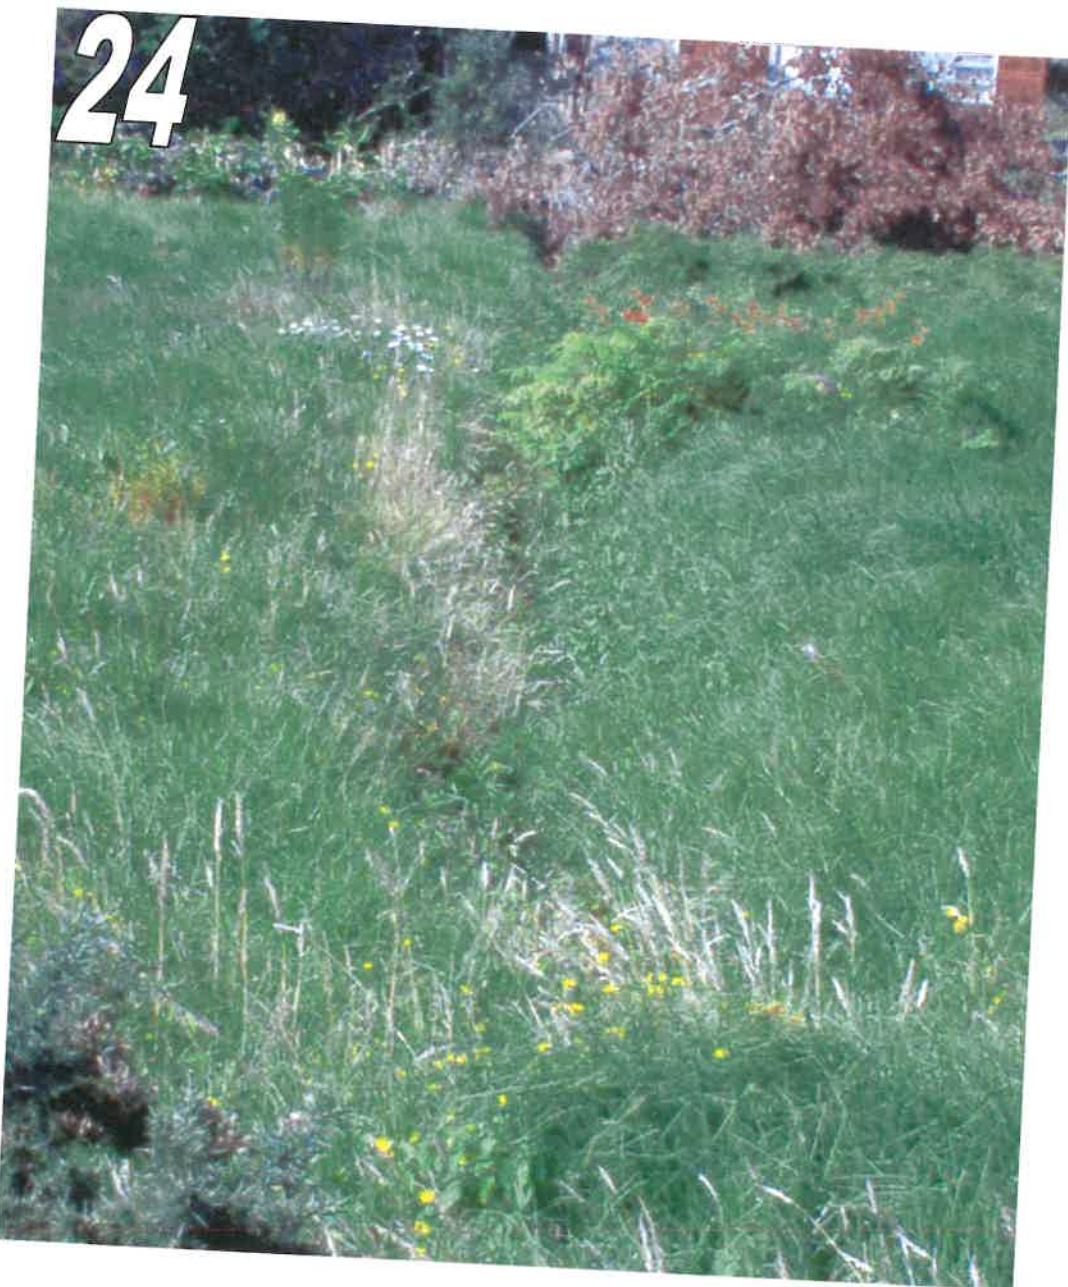
## Drain 9-Lower end of Edinburgh St

PARAMETER	OBSERVATION	RATING
DEPTH	0.5-1 m	5
BATTER SLOPE	2:1 - 1:1	5
DISTANCE ROAD SURFACE AND DRAIN	> 4 m	0
INLET/OUTLET PROTECTION	Not applicable	0
PROXIMITY TO SENSITIVE FACILITIES	Not close	0
AESTHETIC CONSIDERATIONS	Normal growth	5
HEALTH CONSIDERATIONS	None	0
ENVIRONMENTAL CONSIDERATIONS	None	0
PROXIMITY TO DEVELOPMENT	Removed from development	5
SAFETY INDEX	The drain is in a marshy area which is not easily accessible. No substantive safety issues	2.33
DRAIN INDEX		2.33

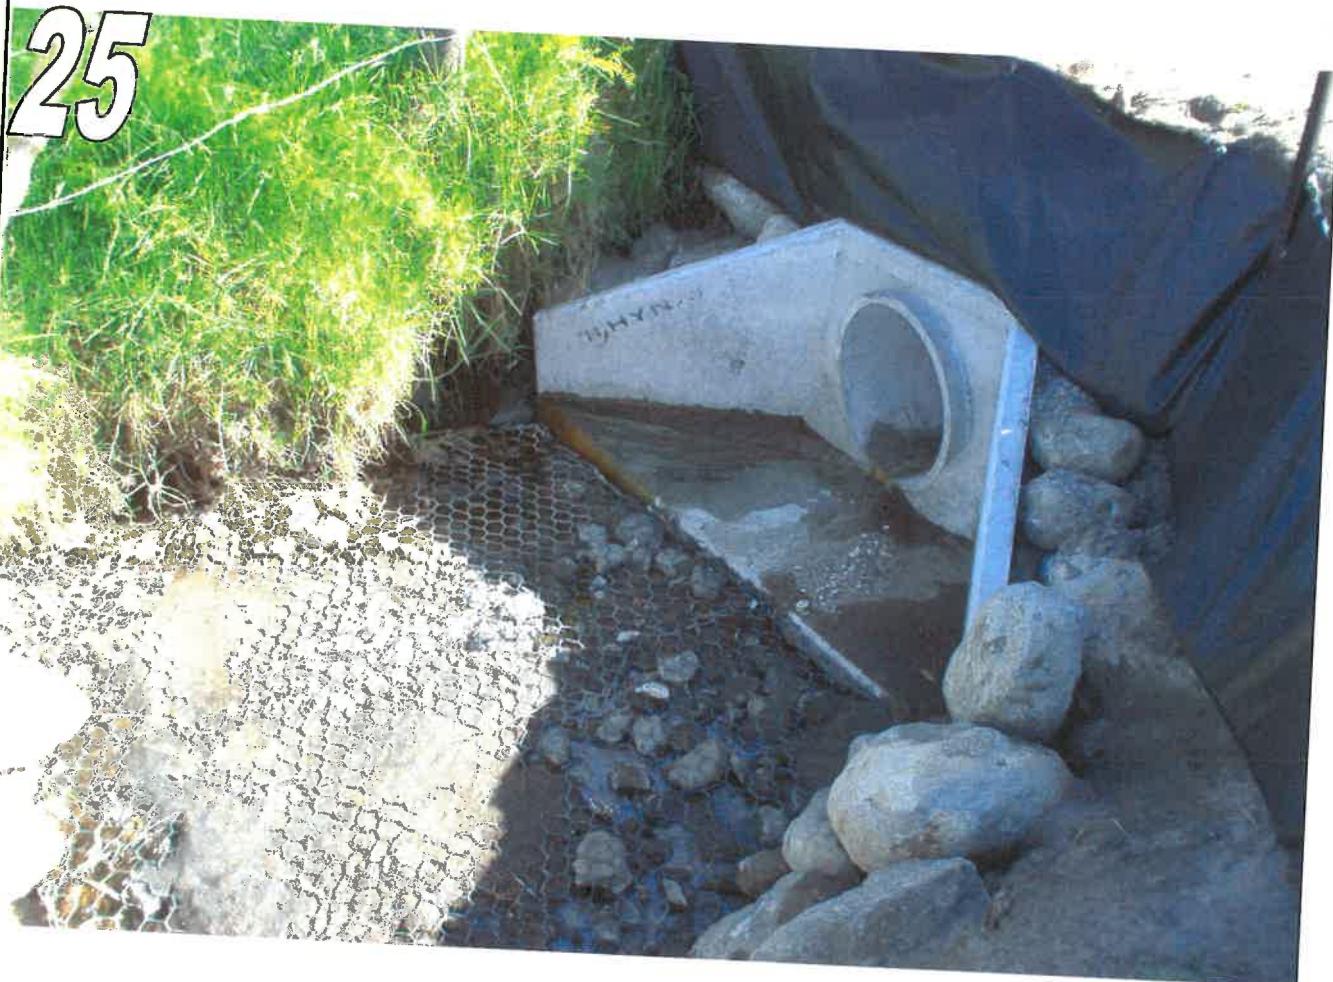
## Drain 11-Hillview Road

PARAMETER	OBSERVATION	RATING
DEPTH	1,2 - 1,5 m	9
BATTER SLOPE	2:1 - 1:1	5
DISTANCE ROAD SURFACE AND DRAIN	> 4 m	0
INLET/OUTLET PROTECTION	Inlet not protected but not required as per Report	0
PROXIMITY TO SENSITIVE FACILITIES	Removed from sensitive facilities	0
AESTHETIC CONSIDERATIONS	Slight growth	5
HEALTH CONSIDERATIONS	None	0
ENVIRONMENTAL CONSIDERATIONS	None	0
PROXIMITY TO DEVELOPMENT	Removed from development	5
SAFETY INDEX	The drain is in a marshy area which is not easily accessible. No substantive safety issues	2.96
DRAIN INDEX		2.96

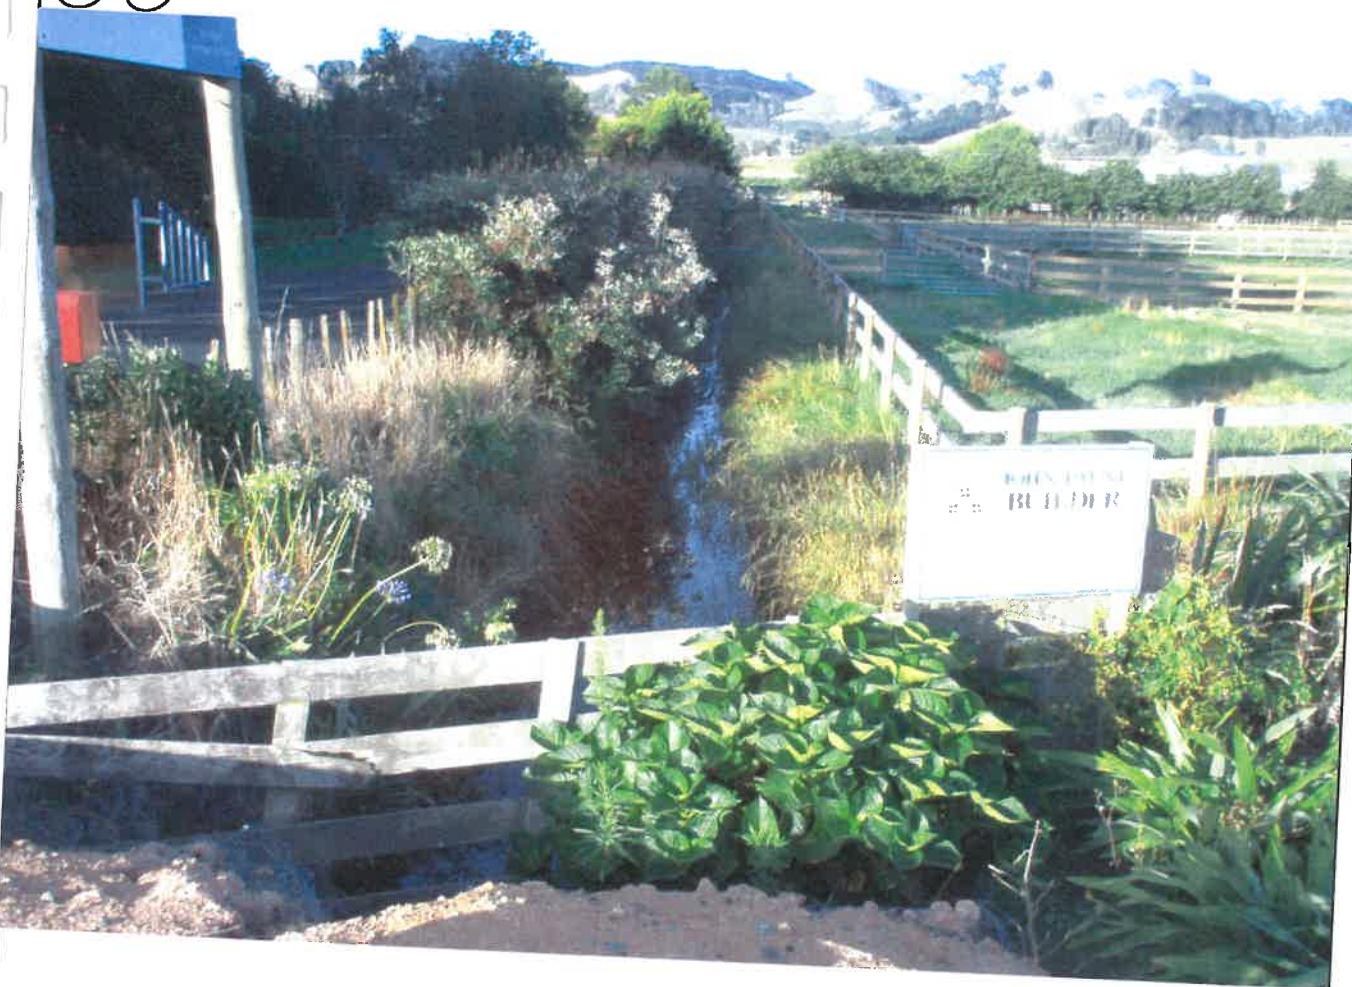
30

PARAMETER	OBSERVATION	RATING
DEPTH	1 - 2 m	9
BATTER SLOPE	Vertical along sections	10
DISTANCE ROAD SURFACE AND DRAIN	< 2 m	10
INLET/OUTLET PROTECTION	Inlet and outlet is part of a road crossing.	0
PROXIMITY TO SENSITIVE FACILITIES	Next to horse paddocks	10
AESTHETIC CONSIDERATIONS	Fair	5
HEALTH CONSIDERATIONS	Standing water	10
ENVIRONMENTAL CONSIDERATIONS	None	0
PROXIMITY TO DEVELOPMENT	New development on upstream side	0
SAFETY INDEX	The drain is protected on both sides with wooden fences	7.09
DRAIN INDEX		6.59

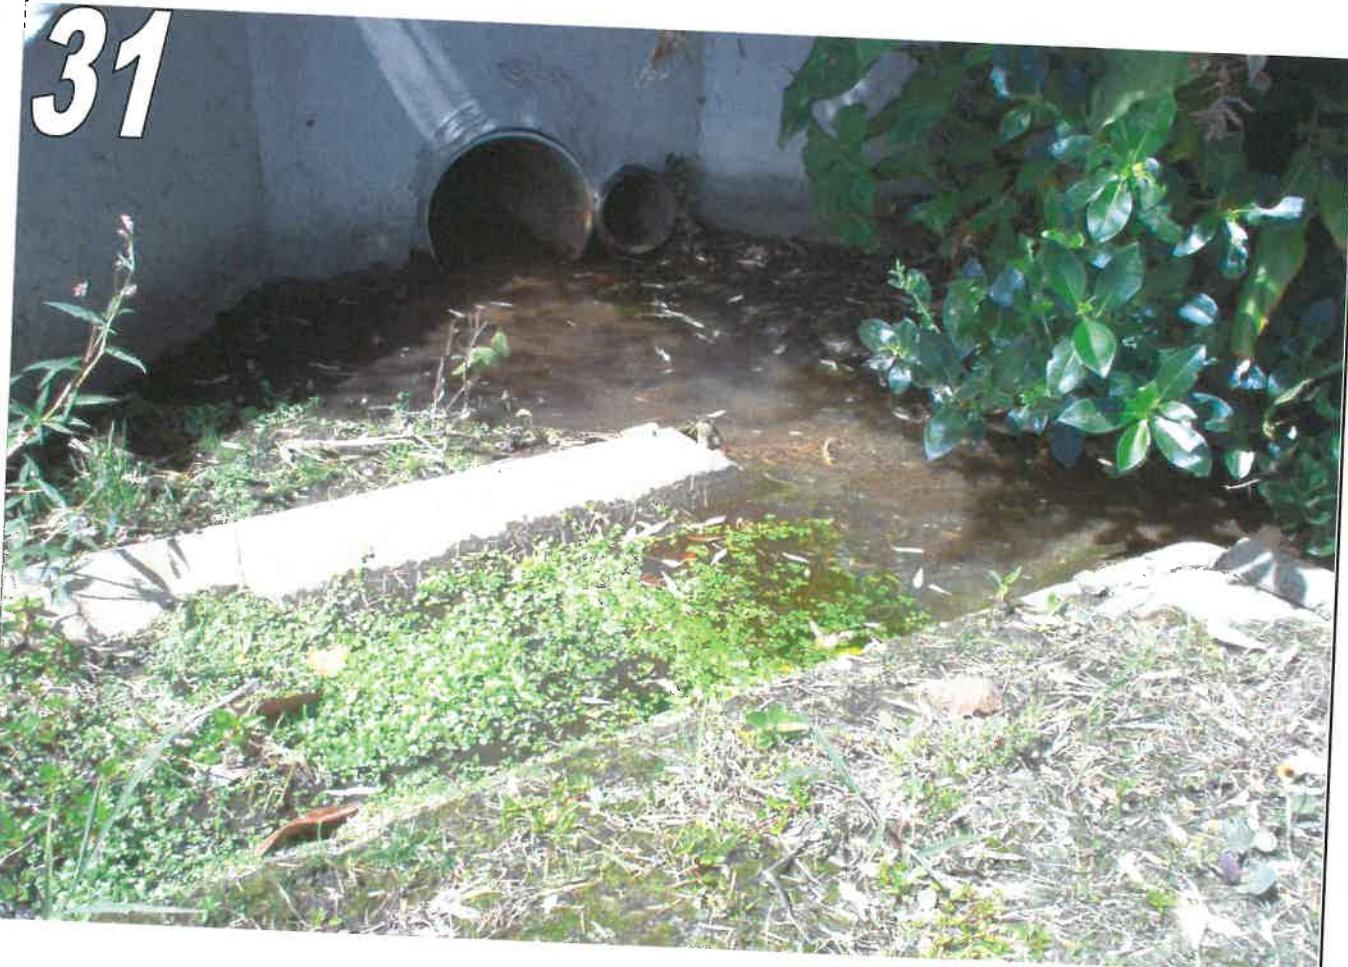
**31**

PARAMETER	OBSERVATION	RATING
DEPTH	< 0.5 m	0
BATTER SLOPE	< 2:1	0
DISTANCE ROAD SURFACE AND DRAIN	> 4 m	0
INLET/OUTLET PROTECTION	Inlet/outlet are < 300 mm	0
PROXIMITY TO SENSITIVE FACILITIES	Removed from sensitive facilities	0
AESTHETIC CONSIDERATIONS	Neat concrete channel	0
HEALTH CONSIDERATIONS	None	0
ENVIRONMENTAL CONSIDERATIONS	None	0
PROXIMITY TO DEVELOPMENT	Within developed area	10
SAFETY INDEX	This is an unobtrusive small drain with no safety concerns	1.50
DRAIN INDEX		0.00

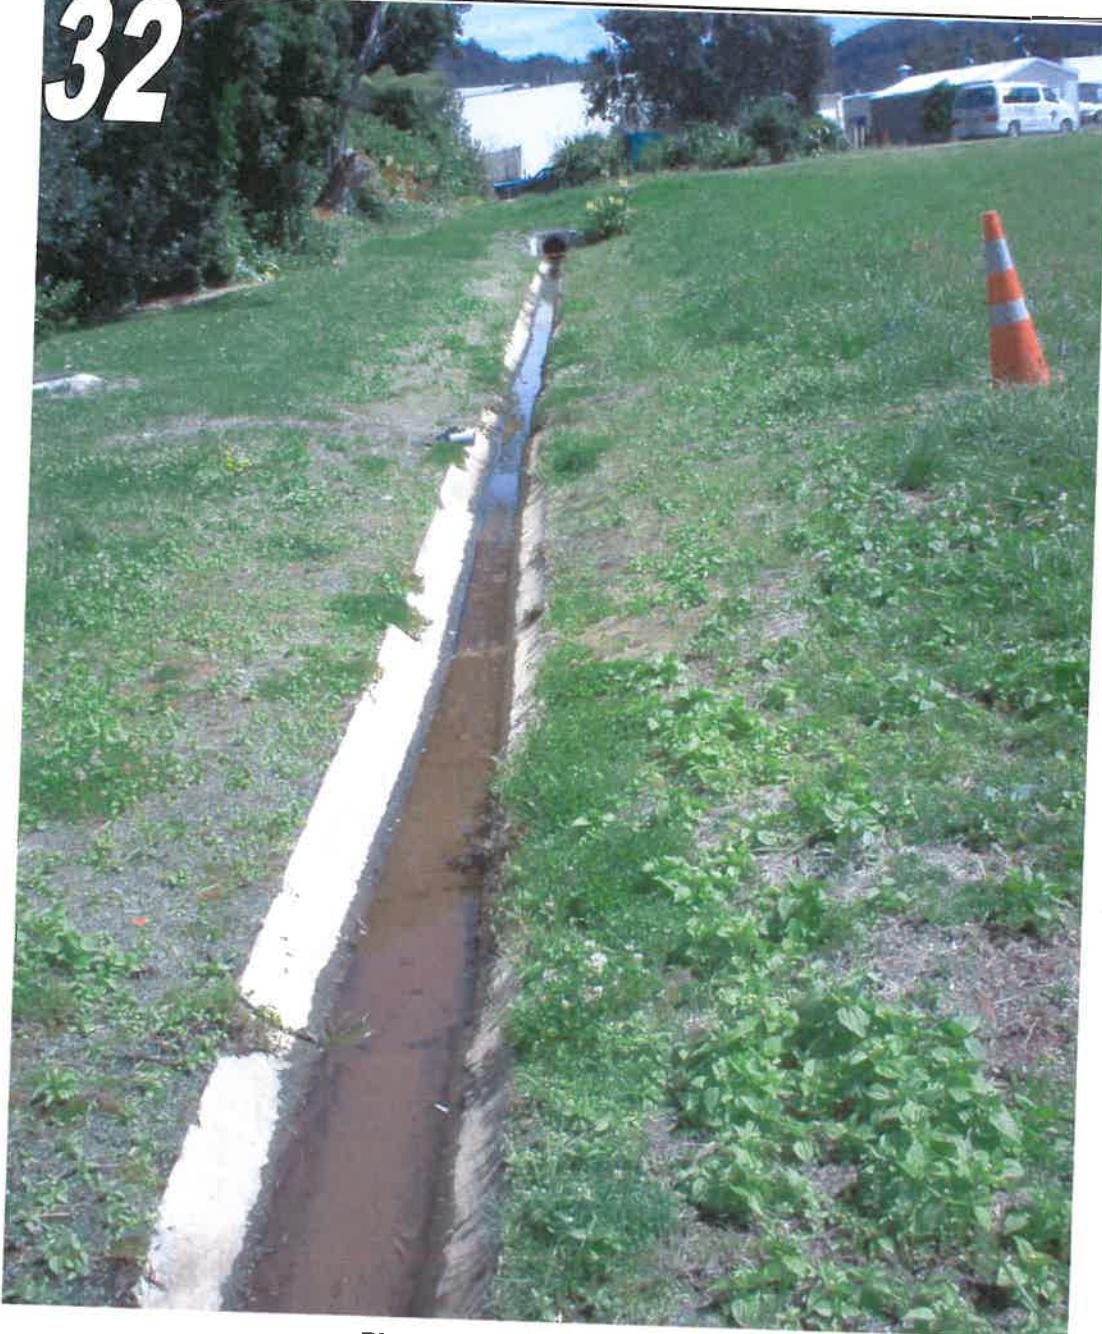
**32**

PARAMETER	OBSERVATION	RATING
DEPTH	< 0.5 m	0
BATTER SLOPE	< 2:1	0
DISTANCE ROAD SURFACE AND DRAIN	> 4 m	0
INLET/OUTLET PROTECTION	Inlet/outlet are < 300 mm	0
PROXIMITY TO SENSITIVE FACILITIES	Removed from sensitive facilities	0
AESTHETIC CONSIDERATIONS	Neat concrete channel	0
HEALTH CONSIDERATIONS	None	0
ENVIRONMENTAL CONSIDERATIONS	None	0
PROXIMITY TO DEVELOPMENT	Within developed area	10
SAFETY INDEX	This is an unobtrusive small drain with no safety concerns	1.50
DRAIN INDEX		0.00

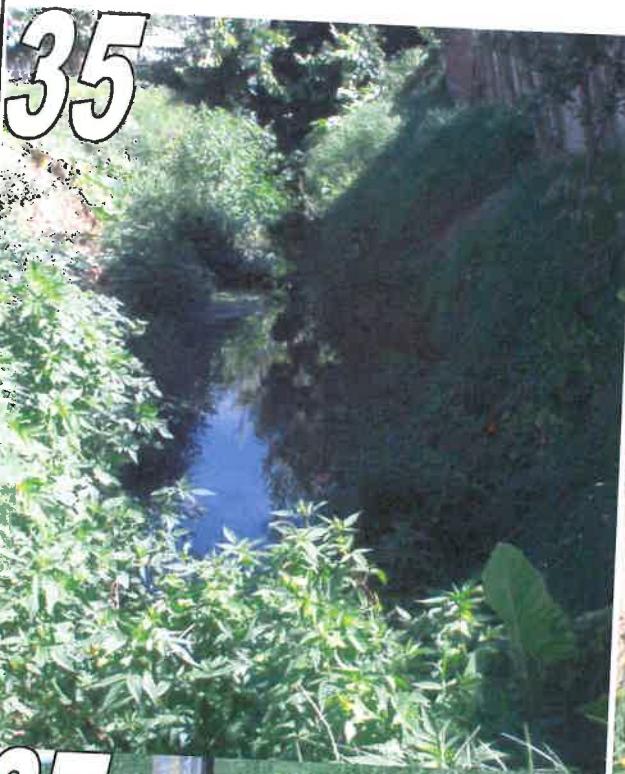
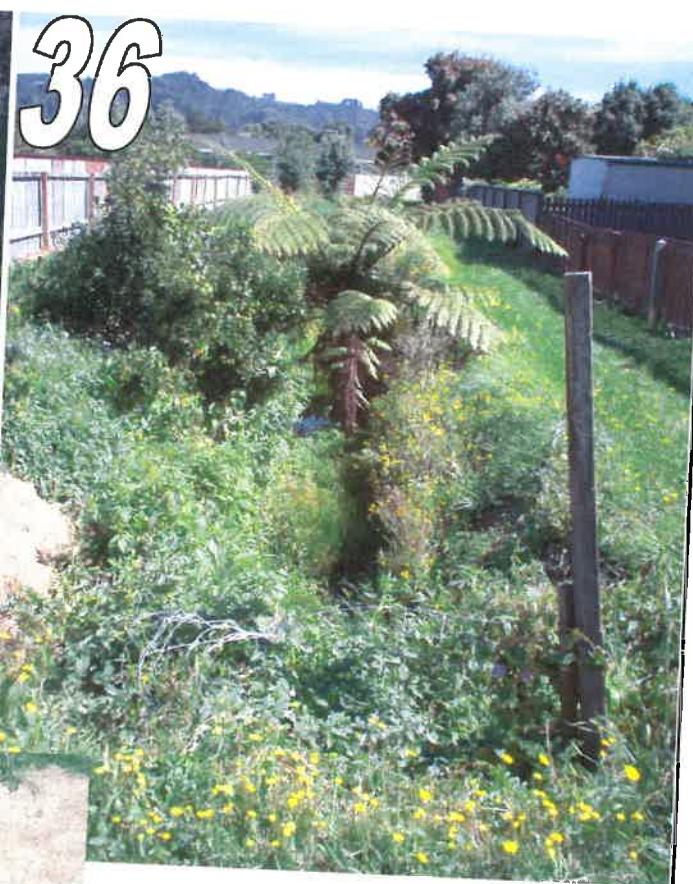
## Drain 18-Between Snell Cres & Hereford Place

PARAMETER	OBSERVATION	RATING
DEPTH	2.5 m along sections	10
BATTER SLOPE	Vertical along sections	10
DISTANCE ROAD SURFACE AND DRAIN	> 4 m	0
INLET/OUTLET PROTECTION	Outlet not protected	0
PROXIMITY TO SENSITIVE FACILITIES	Removed from sensitive facilities	0
AESTHETIC CONSIDERATIONS	Excessive growth	10
HEALTH CONSIDERATIONS	None	0
ENVIRONMENTAL CONSIDERATIONS	None	0
PROXIMITY TO DEVELOPMENT	Within development	0
SAFETY INDEX	Drain is situated within easement. Access to the easement could be restricted	10
DRAIN INDEX		6.15
		6.15

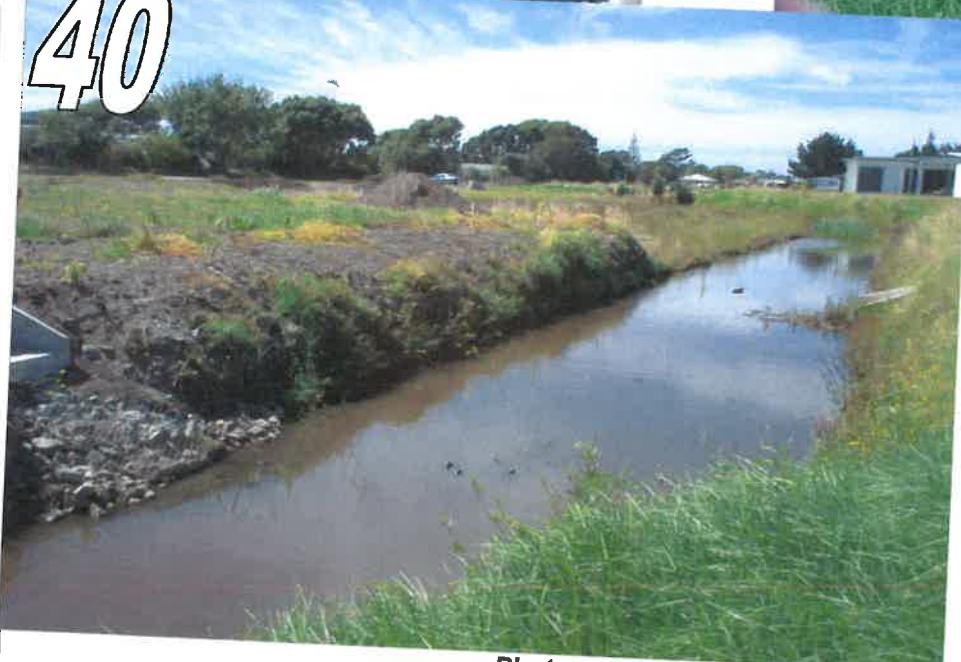
**40**

PARAMETER	OBSERVATION	RATING
DEPTH	1 - 2 m	9
BATTER SLOPE	Vertical along sections	10
DISTANCE ROAD SURFACE AND DRAIN	> 4 m	0
INLET/OUTLET PROTECTION	Inlet and outlet is part of a road crossing.	5
PROXIMITY TO SENSITIVE FACILITIES	Removed from sensitive facilities	0
AESTHETIC CONSIDERATIONS	Normal to slightly more than normal growth	5
HEALTH CONSIDERATIONS	Standing water	10
ENVIRONMENTAL CONSIDERATIONS	None	0
PROXIMITY TO DEVELOPMENT	Adjacent to new development	10
SAFETY INDEX	The batter slope of the drain varies which reduces the safety risk	6.74
DRAIN INDEX		5.49

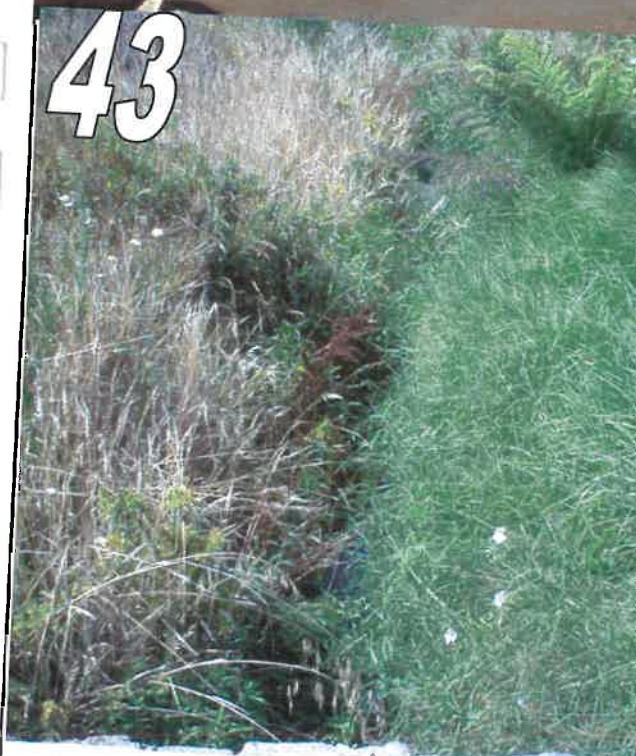
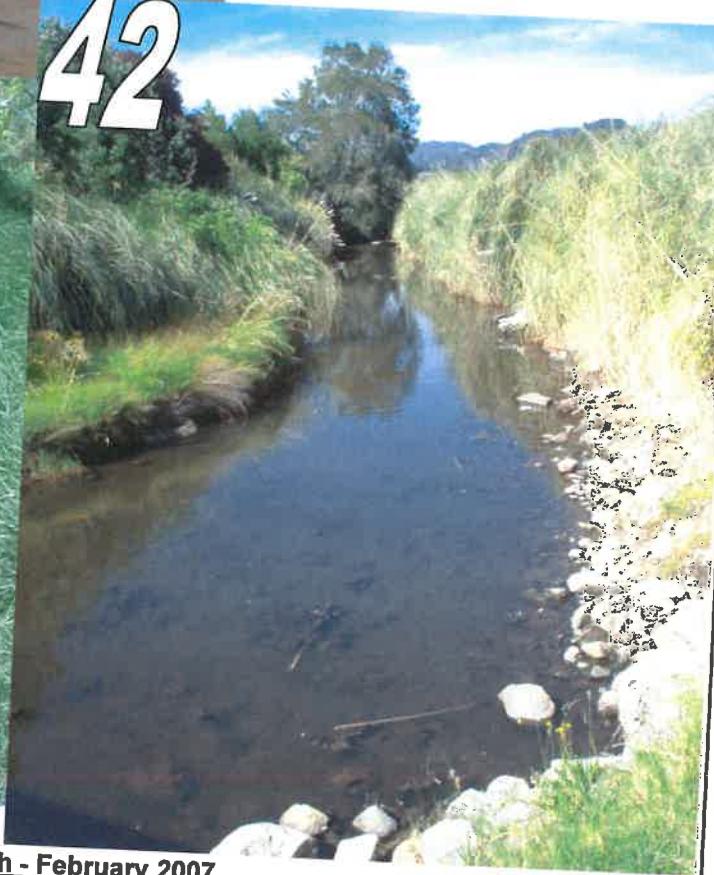
PARAMETER	OBSERVATION	RATING
DEPTH	>2 m	10
BATTER SLOPE	Vertical along sections	10
DISTANCE ROAD SURFACE AND DRAIN	> 4 m	0
INLET/OUTLET PROTECTION	Not applicable	0
PROXIMITY TO SENSITIVE FACILITIES	Crosses the beach	10
AESTHETIC CONSIDERATIONS	Standing water	5
HEALTH CONSIDERATIONS	Excessive growth along sections	10
ENVIRONMENTAL CONSIDERATIONS	No erosion	0
PROXIMITY TO DEVELOPMENT	Within development	10
SAFETY INDEX	The drain is slightly removed from development and not easily accessible	7.65
DRAIN INDEX		6.40

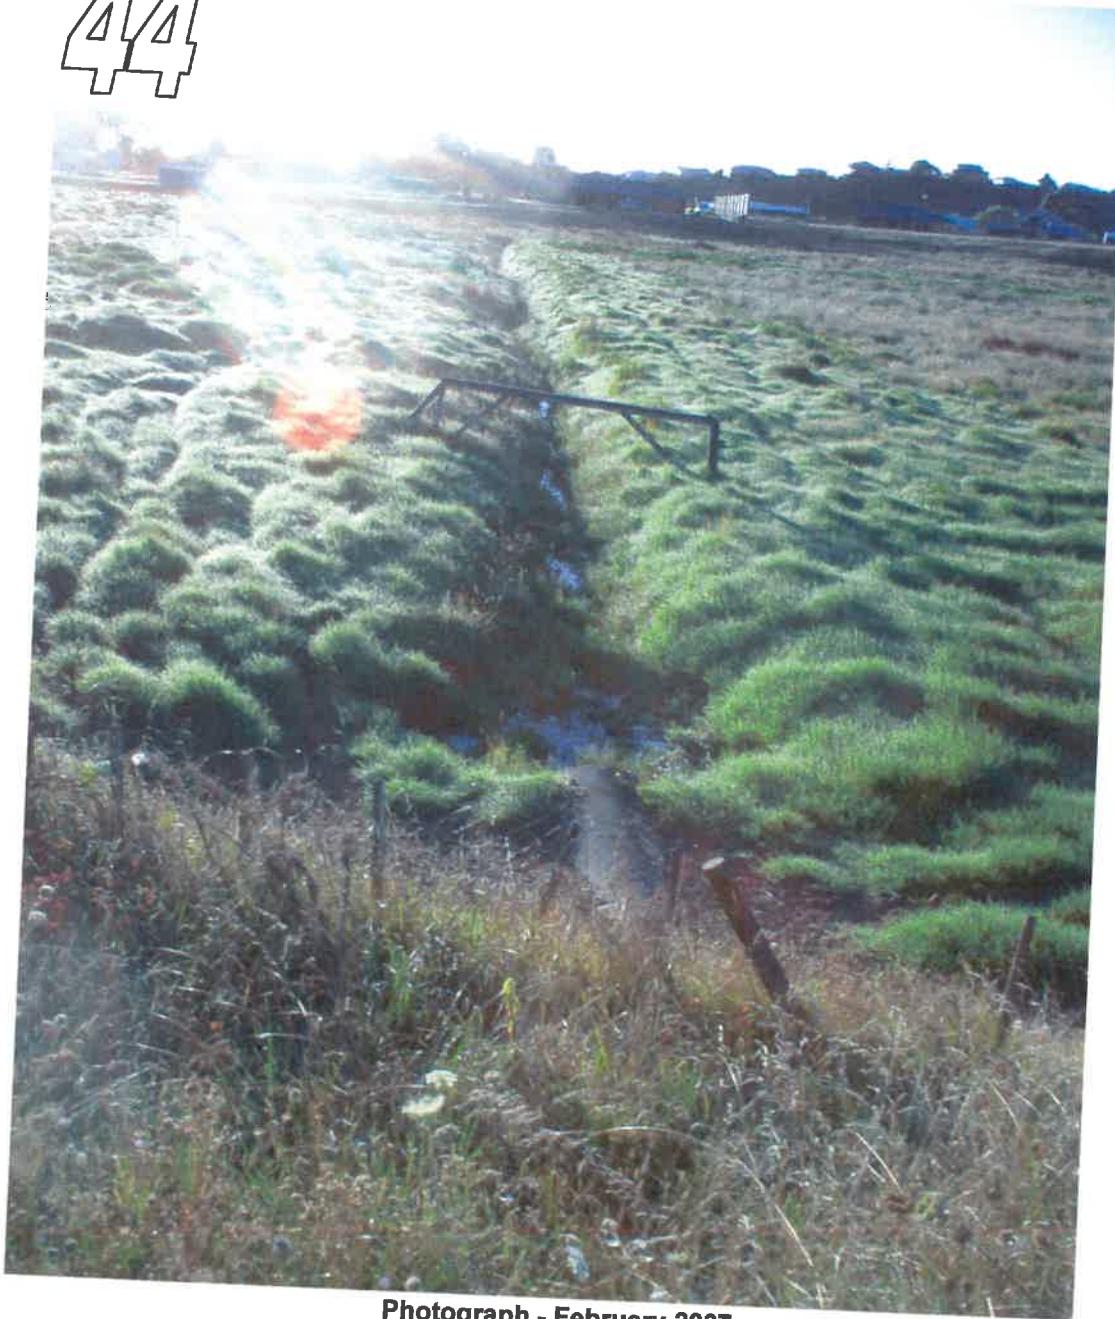
**44**

PARAMETER	OBSERVATION	RATING
DEPTH	0.5 - 1 m	5
BATTER SLOPE	2:1-1:1	5
DISTANCE ROAD SURFACE AND DRAIN	> 4 m	0
INLET/OUTLET PROTECTION	Inflet not protected but not required as per Report	0
PROXIMITY TO SENSITIVE FACILITIES	Removed from sensitive facilities	0
AESTHETIC CONSIDERATIONS	Normal growth	5
HEALTH CONSIDERATIONS	Standing water	10
ENVIRONMENTAL CONSIDERATIONS	In open veld	0
PROXIMITY TO DEVELOPMENT	Removed from development	0
SAFETY INDEX	This Drain discharges into Drain 13 and is a secondary Drain	2.58
DRAIN INDEX		3.33

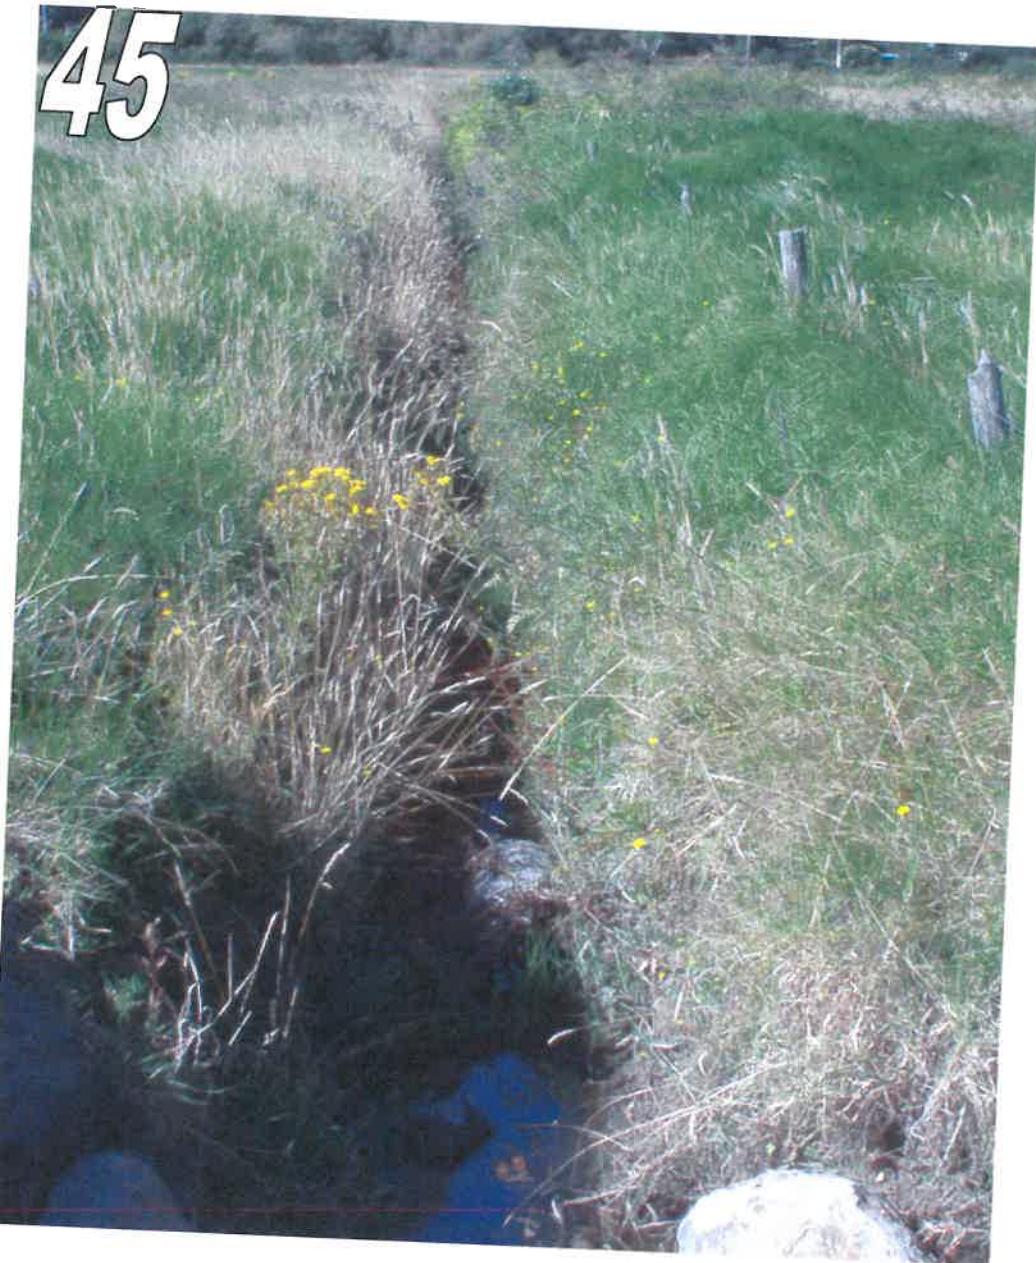
## Drain 22-Adjacent to Wilson Rd

PARAMETER	OBSERVATION	RATING
DEPTH	0.5 - 1 m	5
BATTER SLOPE	2:1-1:1	5
DISTANCE ROAD SURFACE AND DRAIN	5 m	0
INLET/OUTLET PROTECTION	Not applicable	0
PROXIMITY TO SENSITIVE FACILITIES	Removed from sensitive facilities	0
AESTHETIC CONSIDERATIONS	Normal growth	5
HEALTH CONSIDERATIONS	Standing water	5
ENVIRONMENTAL CONSIDERATIONS	None	10
PROXIMITY TO DEVELOPMENT	Opposite Waihi Beach Hotel	0
SAFETY INDEX	The drain is far enough from the road not to constitute a safety risk	5
DRAIN INDEX		3.33

APPENDIX 2A – WAIHI BEACH: DISCUSSION OF DRAIN CONDITION AND REMEDIAL ACTION REQUIRED			
Drain No	Discussion	Remedial Action Required	
22	<p><b>Position:</b> This is the only Drain that runs adjacent to a Council road.</p> <p><b>Depth/Batter:</b> The Drain is less than 1 metre deep with gentle batter slopes.</p> <p><b>Aesthetic Considerations:</b> The Drain is slightly overgrown.</p> <p><b>Safety:</b> The Drain is fenced off from the road and has a moderate depth and batter slope. The Drain does not constitute risk.</p>	<p><b>Aesthetic Considerations:</b> The full length of Drain must be cleared of excess growth.</p>	
23	<p><b>Position:</b> The Drain is situated along Citrus Avenue.</p> <p><b>Depth/Batter:</b> The Drain is less than 1 metre in depth but the batter slope exceeds 1:1.</p> <p><b>Inlet/Outlet:</b> The access road ways to the various houses are well constructed with stormwater pipes placed at each entrance with a small bridge structure constructed over the stormwater pipe. The sides of the access ways are protected with wooden barriers.</p> <p><b>Aesthetic Considerations:</b> The Drain has a pleasing appearance.</p> <p><b>Safety:</b> It would be safer to fence the Drain off but much will be lost aesthetically. The Drain is highly visible and not excessively deep. The Drain as is represents moderate risk but not to the extent that remedial action is required.</p>	<p><b>Further Suggestion:</b> One access way is not protected with wooden barriers on the sides and must be upgraded to the same standards as the other entrances.</p>
