# Categorisation of Open Stormwater Drains in Waihi Beach, Te Puke, and Maketu

Opus International Consultants Limited  
Tauranga Office  
405 Cameron Road  
PO Box 646  
Tauranga, New Zealand

Date: 8 February 2008  
Reference: g:\5\project\9z178.01\_drains\_phase\_2\final  
Status: FINAL  
document\main document.doc

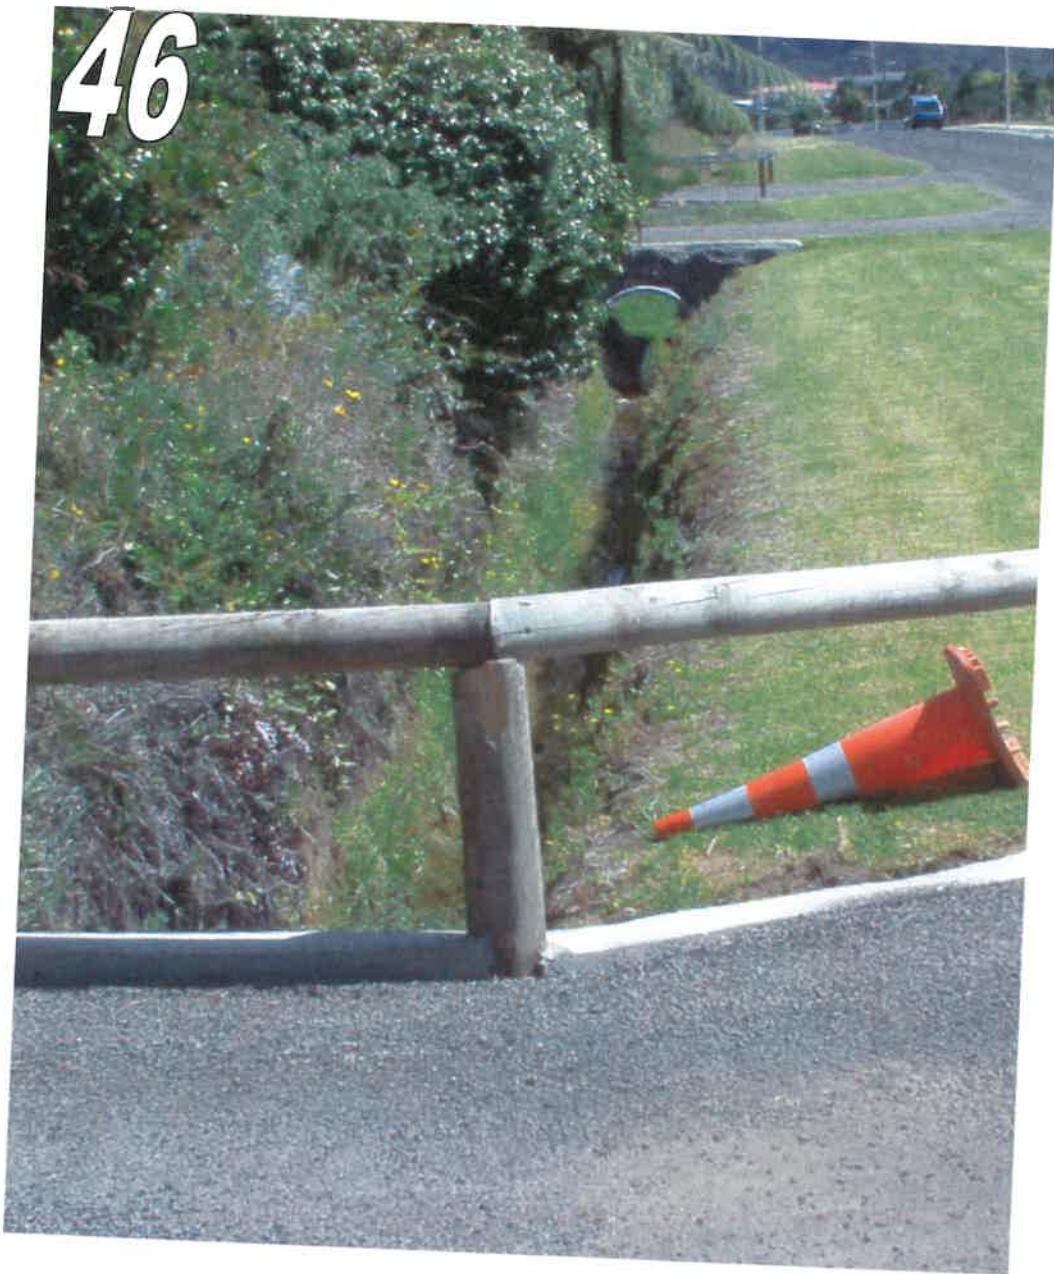
## Drain 23-Adjacent to Citrus Ave

PARAMETER	OBSERVATION	RATING
DEPTH	0.5 - 1 m	5
BATTER SLOPE	> 1:1	10
DISTANCE ROAD SURFACE AND DRAIN	> 4 m	0
INLET/OUTLET PROTECTION	Inlet/Outlets not protected/not required as per Report	0
PROXIMITY TO SENSITIVE FACILITIES	Removed from sensitive facilities	0
AESTHETIC CONSIDERATIONS	Well maintained	0
HEALTH CONSIDERATIONS	None	0
ENVIRONMENTAL CONSIDERATIONS	None	0
PROXIMITY TO DEVELOPMENT	Within development	10
SAFETY INDEX	The drain is well maintained and is at a reasonable distance from the road	3.86
DRAIN INDEX		2.36

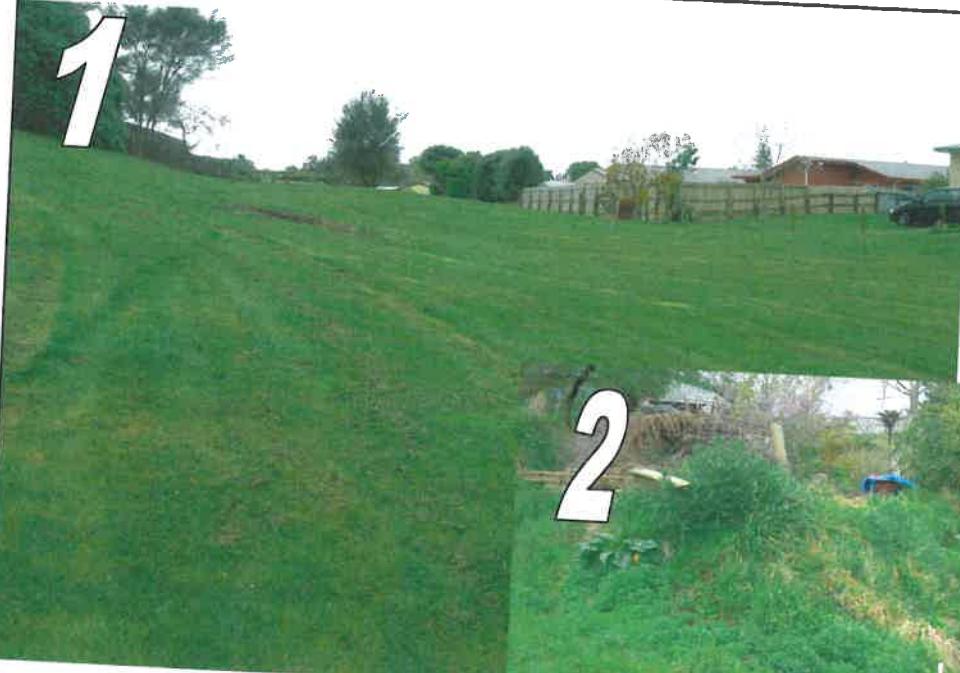
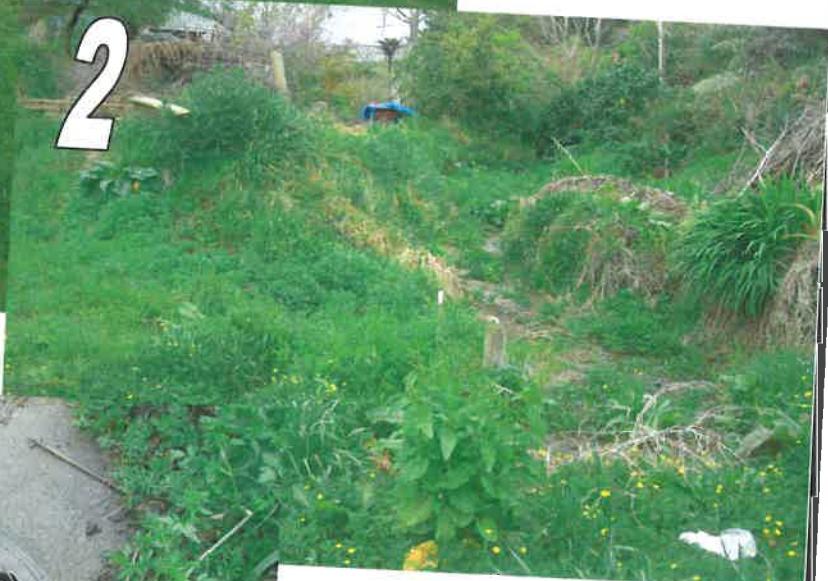
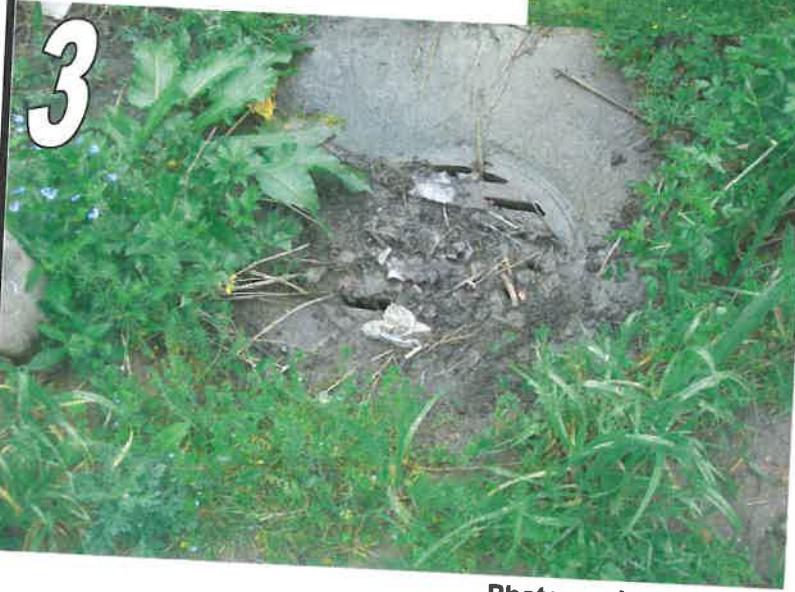
PARAMETER	OBSERVATION	RATING
DEPTH	< 0.5 m	0
BATTER SLOPE	< 2:1	0
DISTANCE ROAD SURFACE AND DRAIN INLET/OUTLET PROTECTION	>4 m Outlet of drain prone to be blocked	0
PROXIMITY TO SENSITIVE FACILITIES	None	5
AESTHETIC CONSIDERATIONS	Wild growth	0
HEALTH CONSIDERATIONS	None	10
ENVIRONMENTAL CONSIDERATIONS	None	0
PROXIMITY TO DEVELOPMENT	Adjacent to development	0
<b>SAFETY INDEX</b>	The drain is well demarcated and doesn't constitute a safety risk	10
<b>DRAIN INDEX</b>		2.75
		2.25

APPENDIX 2B – TE PUKE: DISCUSSION OF DRAIN CONDITION AND REMEDIAL ACTION REQUIRED		
Drain No	Discussion	Remedial Action Required
1	<p><b>Position:</b> The Drain is situated adjacent to residential properties</p> <p><b>Inlet/Outlet Protection:</b> The open drain discharges into a drain pipe via an inlet structure that is shown in picture 3. The grate that serves as an inlet structure is prone to blockage.</p> <p><b>Aesthetic Considerations:</b> The open drain section consists of wild growth.</p> <p><b>Safety:</b> Although the Drain is very overgrown it does not constitute risk.</p>	<p><b>Inlet/Outlet Protection:</b> It is recommended that a scruffy dome inlet structure be constructed where the open drain discharges into the piped drain. This drain could be slightly raised to keep debris at bay.</p> <p><b>Aesthetic Considerations:</b> The Drain is not in the public eye and it would be uneconomical to keep it in a tidy condition. It is recommended that the status quo be retained.</p>

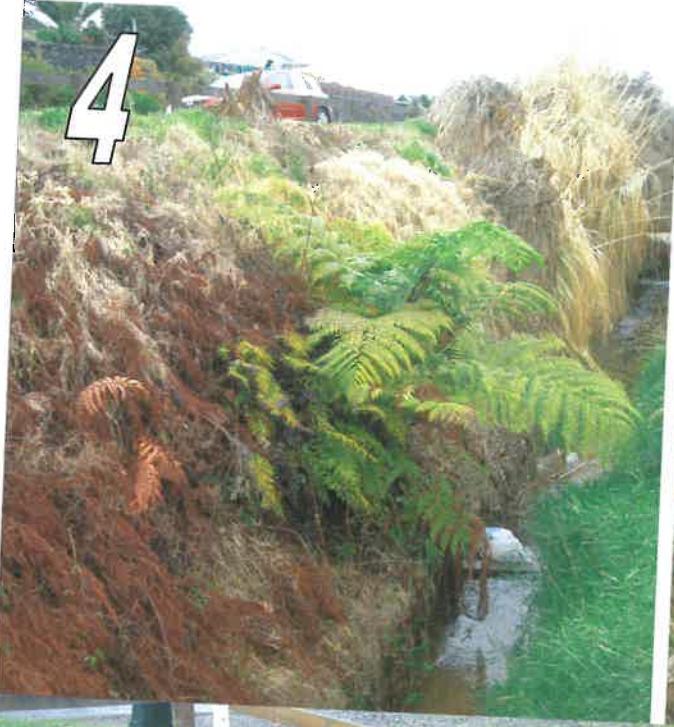
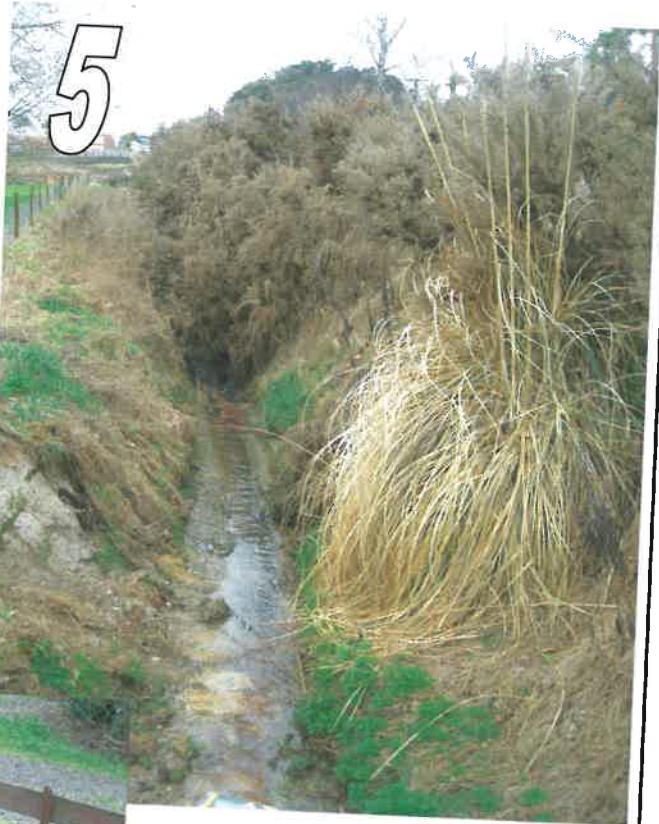
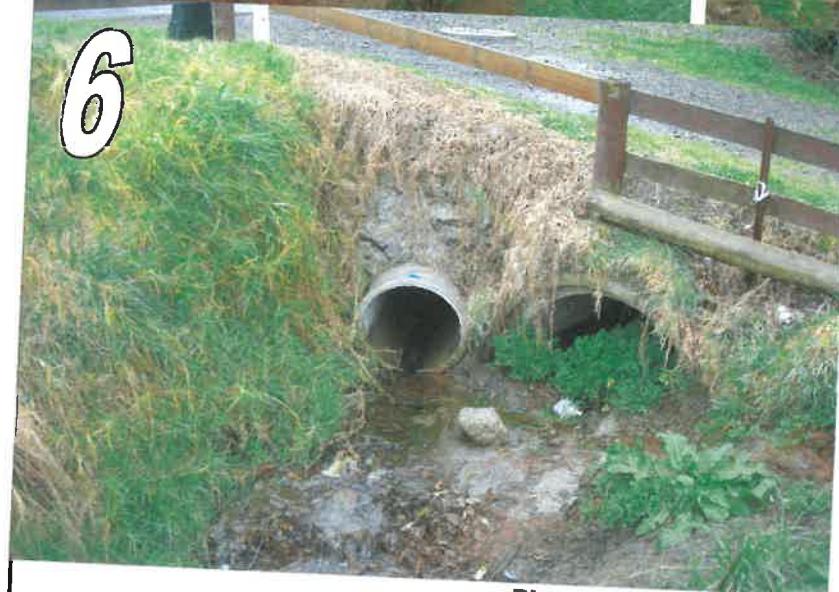
PARAMETER	OBSERVATION	RATING
DEPTH	> 1 m	10
BATTER SLOPE	> 1:1	10
DISTANCE ROAD SURFACE AND DRAIN	Close to road.	5
INLET/OUTLET PROTECTION	Excessive sediment in inlet pipes	0
PROXIMITY TO SENSITIVE FACILITIES	None.	5
AESTHETIC CONSIDERATIONS	Excessive growth.	10
HEALTH CONSIDERATIONS	None.	0
ENVIRONMENTAL CONSIDERATIONS	None.	0
PROXIMITY TO DEVELOPMENT	Adjacent to development	10
SAFETY INDEX	The drain is not adequately protected from the road.	5.58
DRAIN INDEX		5.58

2	<p><b>Position:</b> This Drain is of considerable depth and is in close proximity to the road.</p> <p><b>Depth/Batter Slope:</b> The depth, batter slope and close proximity to the road constitute a risk.</p> <p><b>Aesthetic Considerations:</b> There is excessive growth along the banks of this open drain as is evident from photos 4 and 5. The drain is adjacent to a major sport field and very much in the public eye.</p> <p><b>Safety:</b> This Drain is unsafe.</p>	<p><b>Depth/Batter Slope:</b> The open drain just downstream from this drain is in the process of being converted into a closed drain and it recommended that this drain be closed as well. A less effective alternative would be to provide a sturdy fence between the road and the open drain.</p> <p><b>Aesthetic Considerations:</b> An effort must be made to remove the excessive growth and to keep it maintained. This problem however will be solved if the drain is converted into a closed drain.</p>

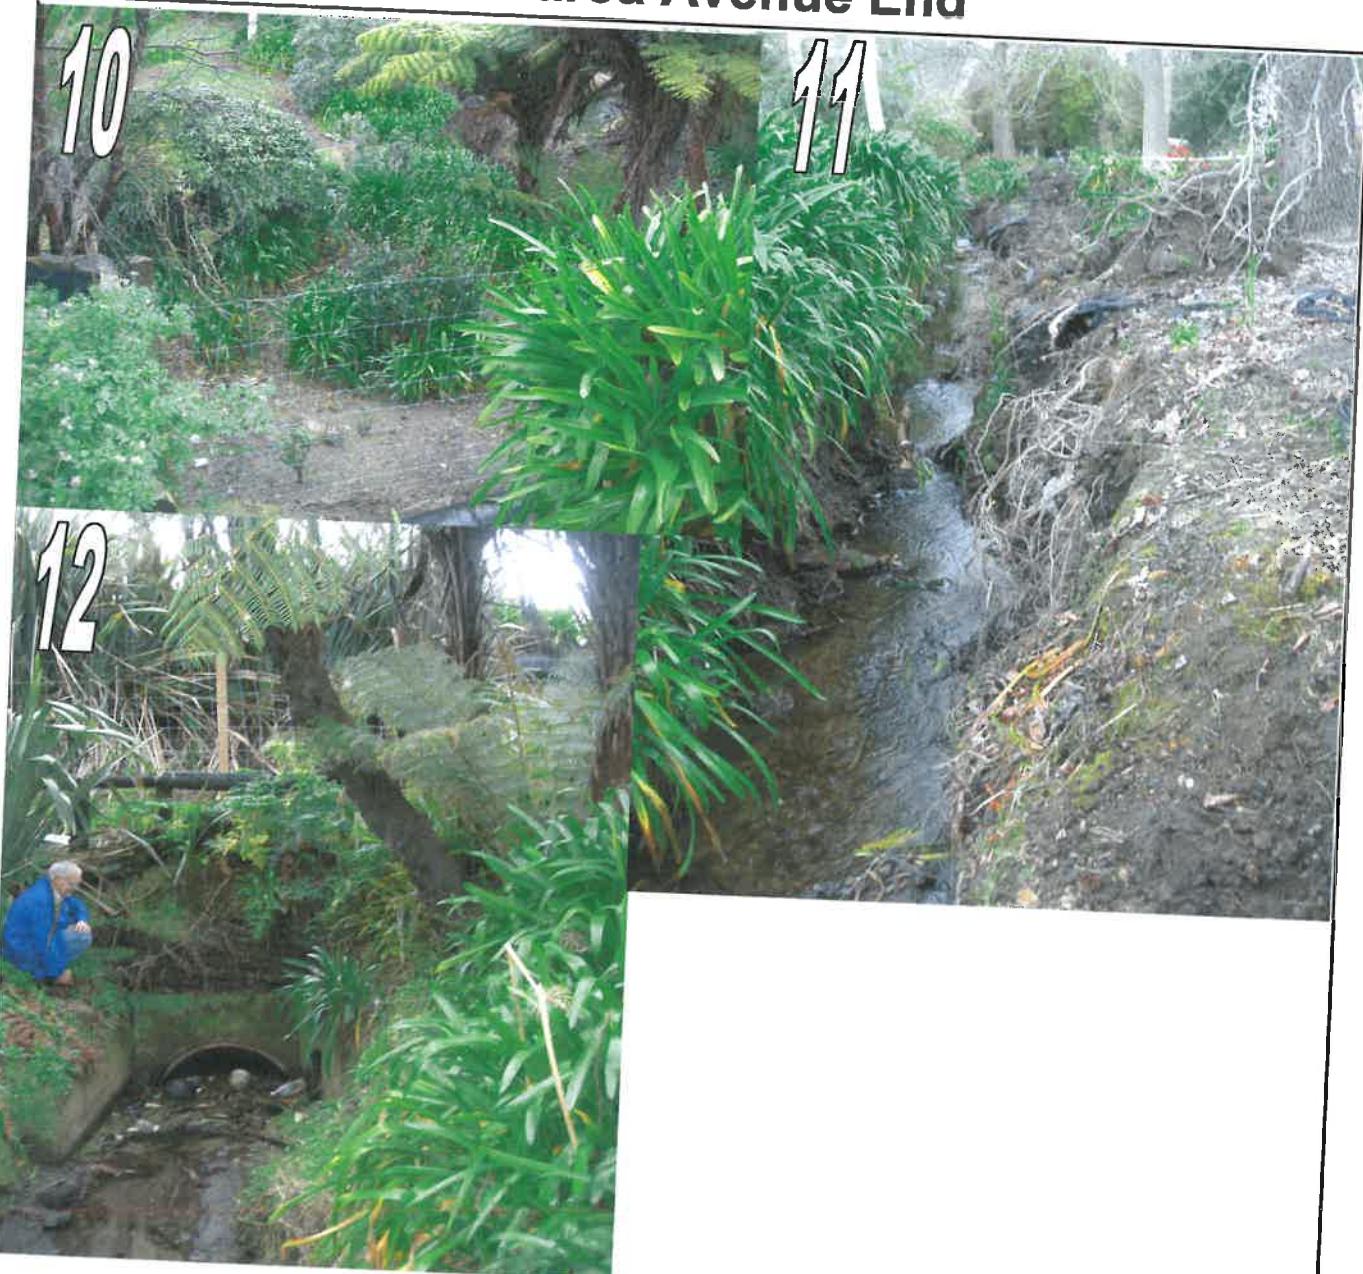
## Atuaroa Avenue End

PARAMETER	OBSERVATION	RATING
DEPTH	0.5 - 1 m	5
BATTER SLOPE	2:1 - 1:1	5
DISTANCE ROAD SURFACE AND DRAIN	Drain is perpendicular to road.	0
INLET/OUTLET PROTECTION	Inlet and outlet is part of a road crossing.	0
PROXIMITY TO SENSITIVE FACILITIES	None	0
AESTHETIC CONSIDERATIONS	Slight growth	5
HEALTH CONSIDERATIONS	None	0
ENVIRONMENTAL CONSIDERATIONS	None	0
PROXIMITY TO DEVELOPMENT	Adjacent to development	5
SAFETY INDEX	It is assumed that the drain is situated on private property. Not accessible to the general public.	2.83
DRAIN INDEX		2.33

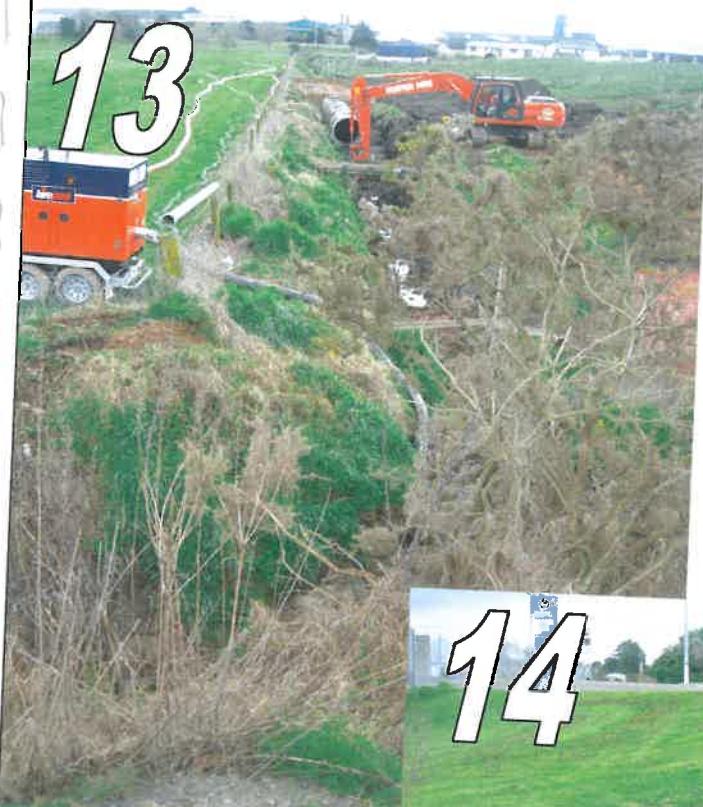
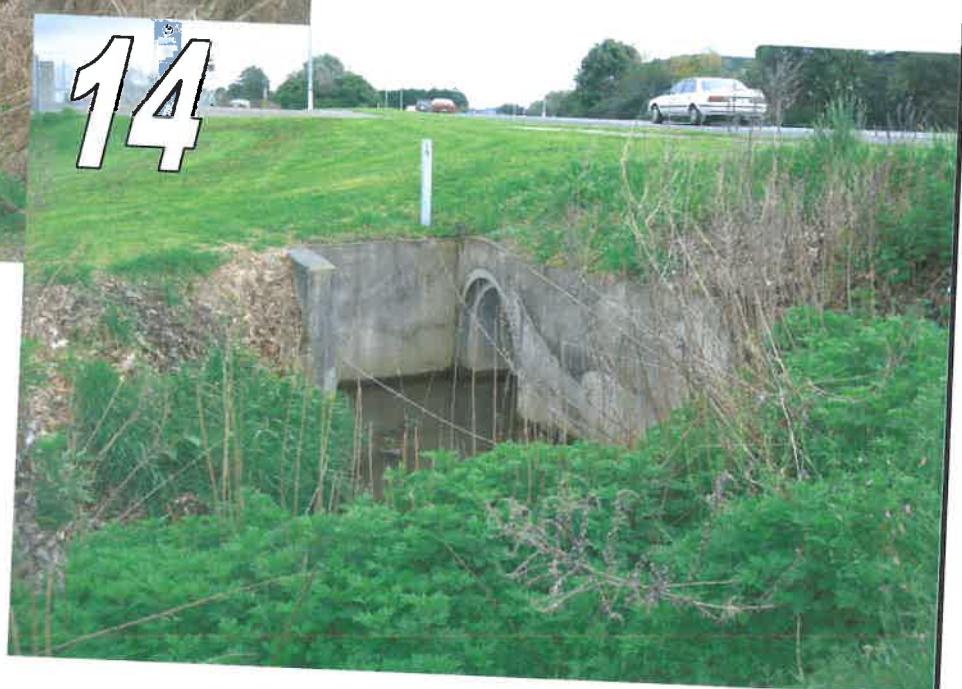
## Drain 4-Adjacent to Sportsfield at Atuaroa Ave

PARAMETER	OBSERVATION	RATING
DEPTH		
BATTER SLOPE		0
DISTANCE ROAD SURFACE AND DRAIN		0
INLET/OUTLET PROTECTION		0
PROXIMITY TO SENSITIVE FACILITIES		0
AESTHETIC CONSIDERATIONS		0
HEALTH CONSIDERATIONS		0
ENVIRONMENTAL CONSIDERATIONS		0
PROXIMITY TO DEVELOPMENT		0
SAFETY INDEX		5
DRAIN INDEX	Drain is in the process of being piped	0.75
		0.00

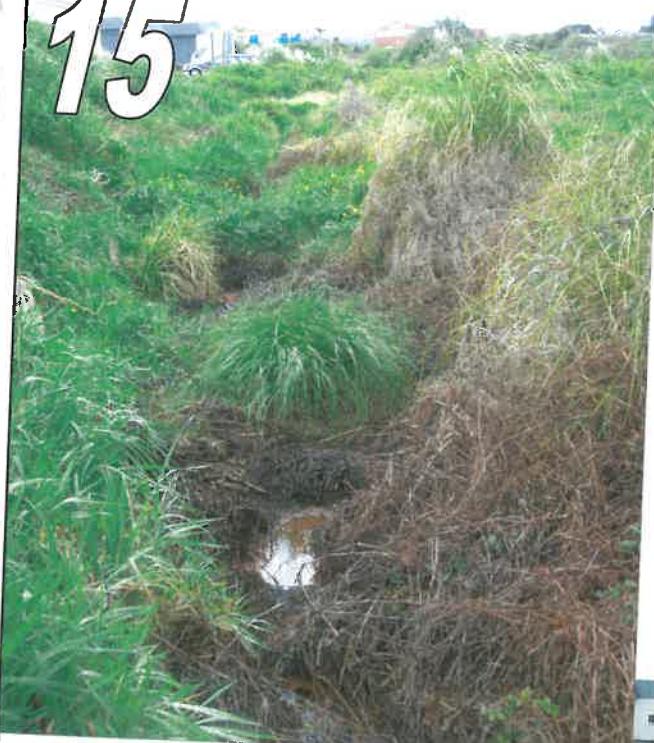
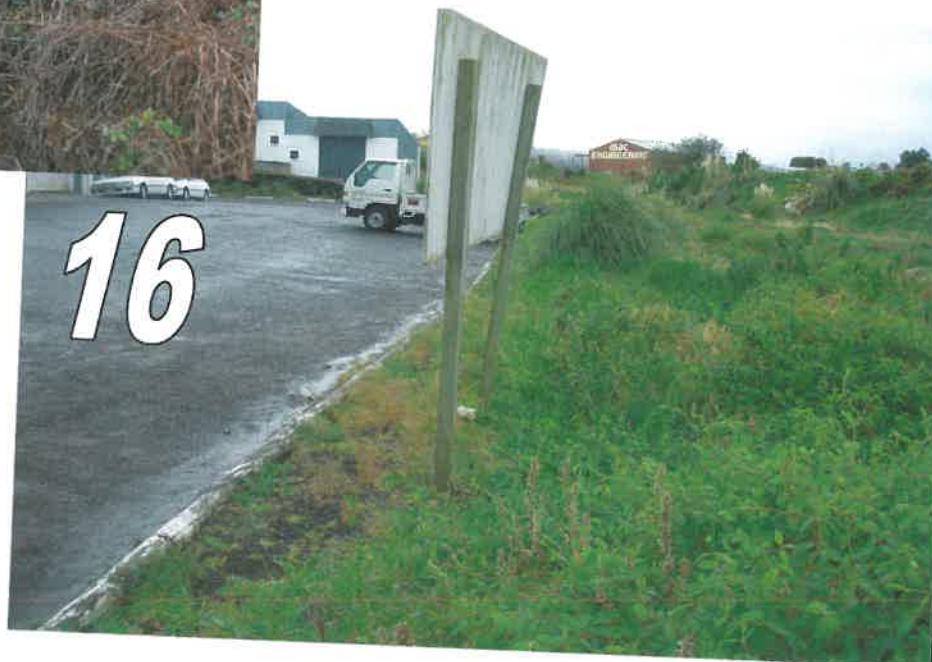
PARAMETER	OBSERVATION	RATING
DEPTH	< 0.5 m	0
BATTER SLOPE	< 2:1	0
DISTANCE ROAD SURFACE AND DRAIN	> 4 m	0
INLET/OUTLET PROTECTION	None	0
PROXIMITY TO SENSITIVE FACILITIES	Next to commercial area	0
AESTHETIC CONSIDERATIONS	Excessive growth	5
HEALTH CONSIDERATIONS	Standing water	10
ENVIRONMENTAL CONSIDERATIONS	None	10
PROXIMITY TO DEVELOPMENT	Close to development	0
SAFETY INDEX	No safety issues	2.50
DRAIN INDEX		3.25

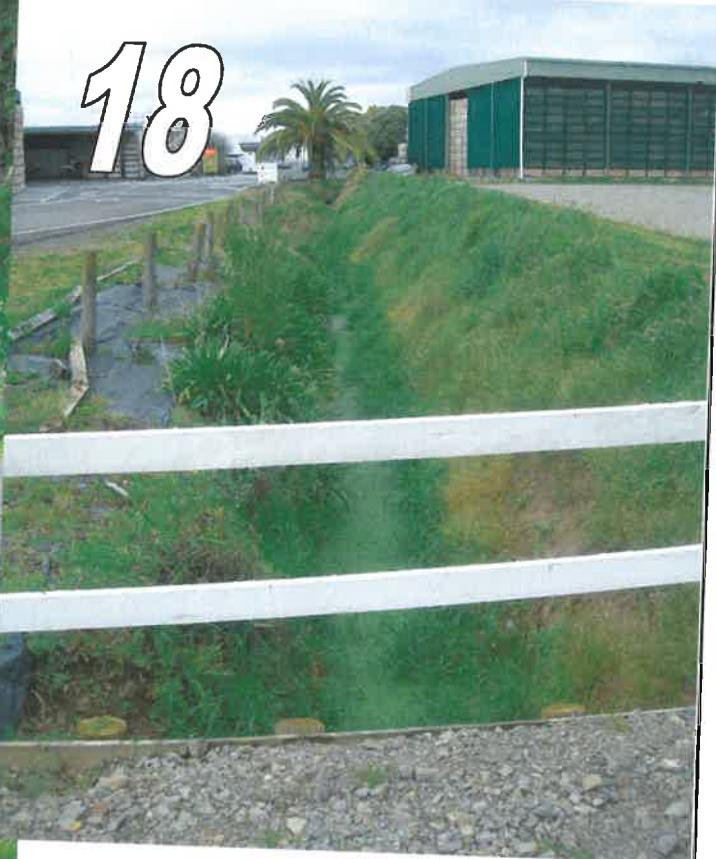
## Drain 8-End of Washer Road

PARAMETER	OBSERVATION	RATING
DEPTH	1 - 2 m	9
BATTER SLOPE	Steeper than 45 degrees	10
DISTANCE ROAD SURFACE AND DRAIN	2 - 4 m	5
INLET/OUTLET PROTECTION	Inlet and outlet is part of a road crossing.	0
PROXIMITY TO SENSITIVE FACILITIES	Situated inside an industrial area	0
AESTHETIC CONSIDERATIONS	Slight growth	5
HEALTH CONSIDERATIONS	Standing water	0
ENVIRONMENTAL CONSIDERATIONS	None	0
PROXIMITY TO DEVELOPMENT	Situated inside an industrial area	5
SAFETY INDEX	No significant safety risk	3.92
DRAIN INDEX		3.92

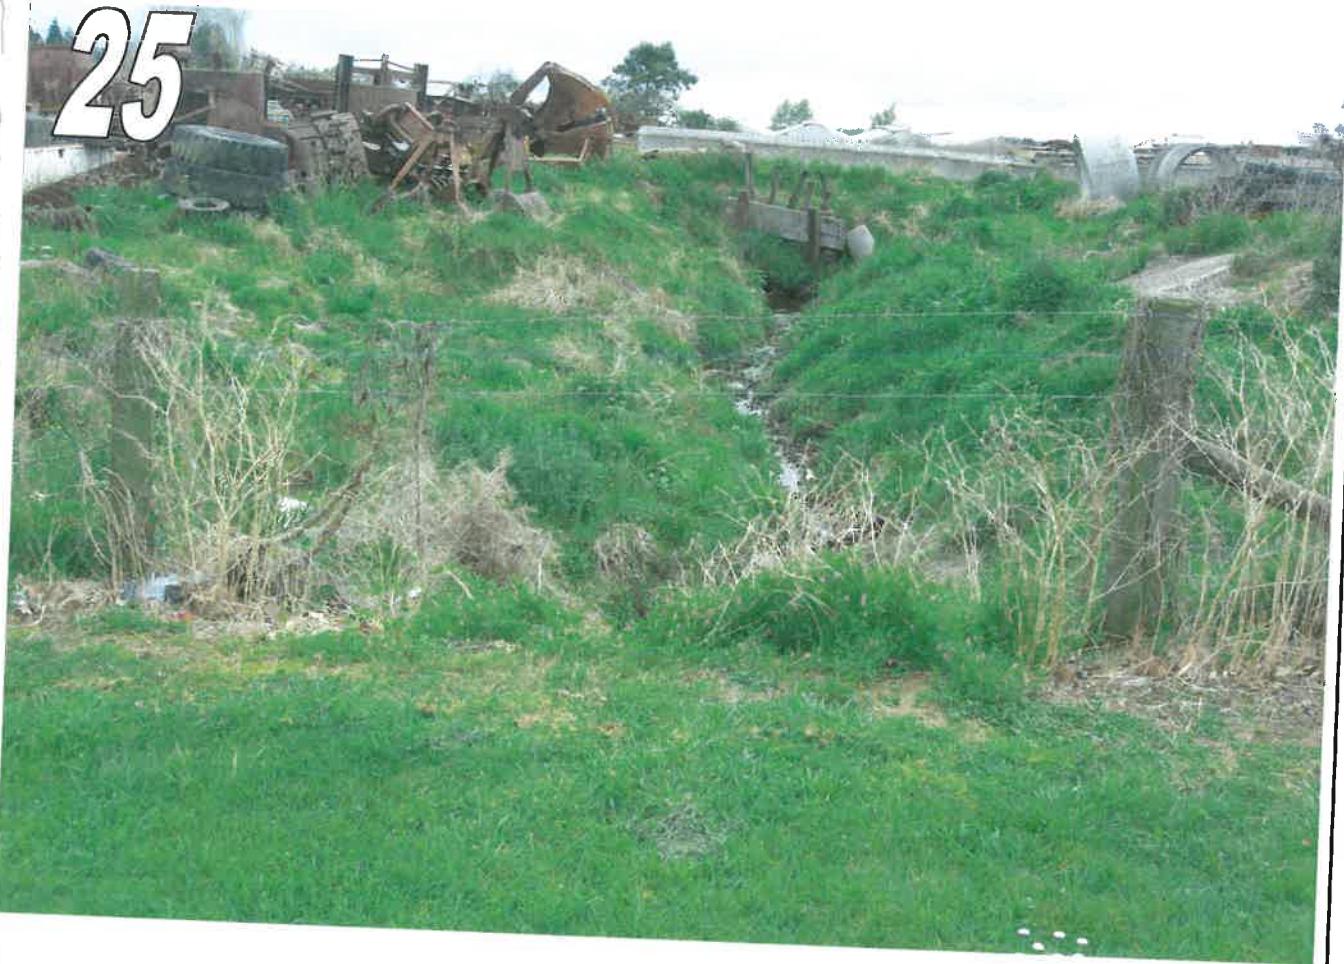
**25**

PARAMETER	OBSERVATION	RATING
DEPTH	0 -0.5 m	5
BATTER SLOPE	< 2:1	0
DISTANCE ROAD SURFACE AND DRAIN	> 4 m	0
INLET/OUTLET PROTECTION	Not applicable	0
PROXIMITY TO SENSITIVE FACILITIES	Situated in Industrial area	0
AESTHETIC CONSIDERATIONS	Overgrown	0
HEALTH CONSIDERATIONS	Pollution possible due to proximity of Industries	10
ENVIRONMENTAL CONSIDERATIONS	None	10
PROXIMITY TO DEVELOPMENT	Removed from development	0
SAFETY INDEX	The drain is removed from residential development and is fenced off	0
DRAIN INDEX		1.79
		3.29

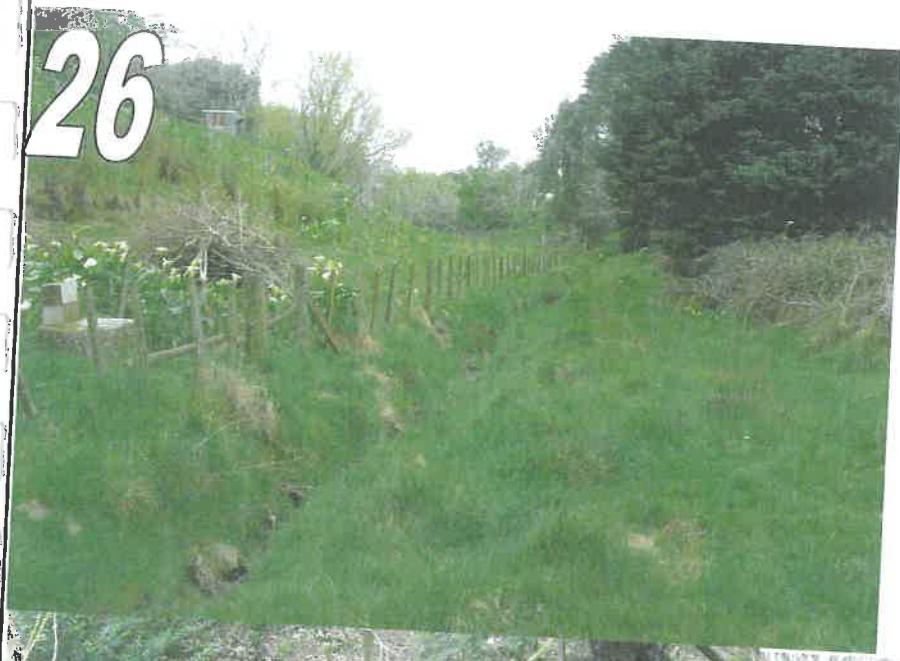
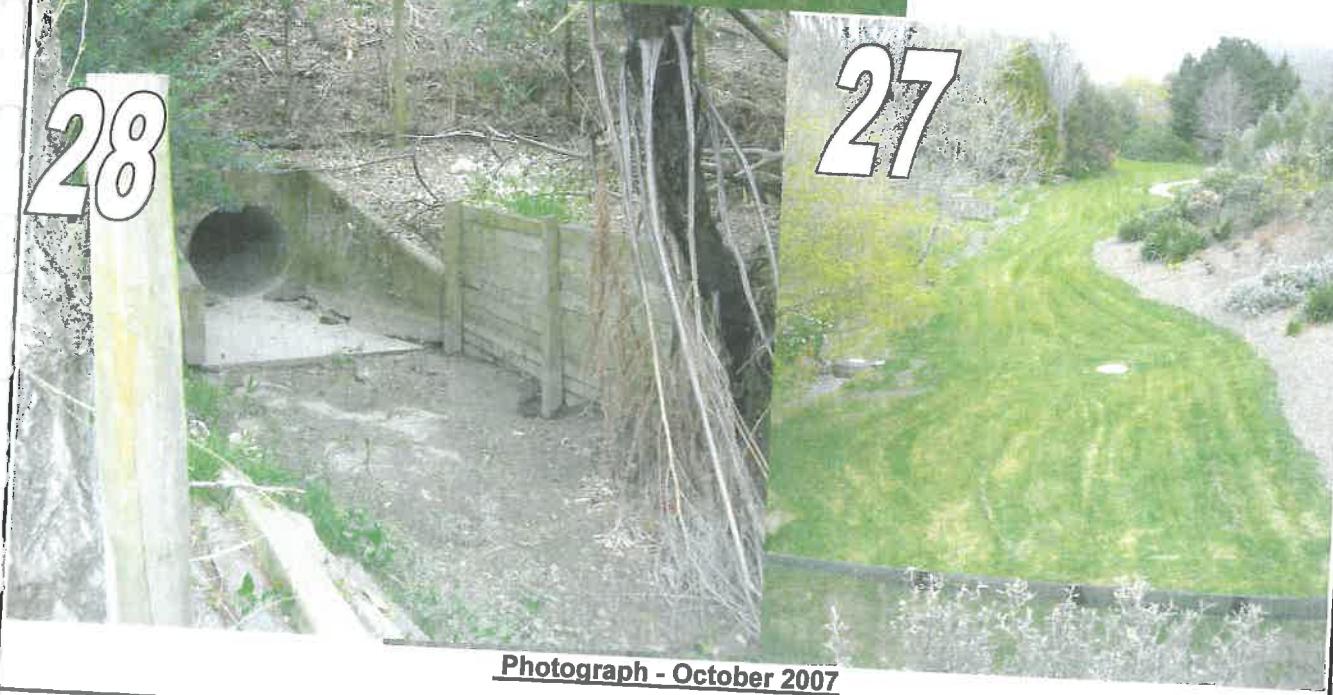
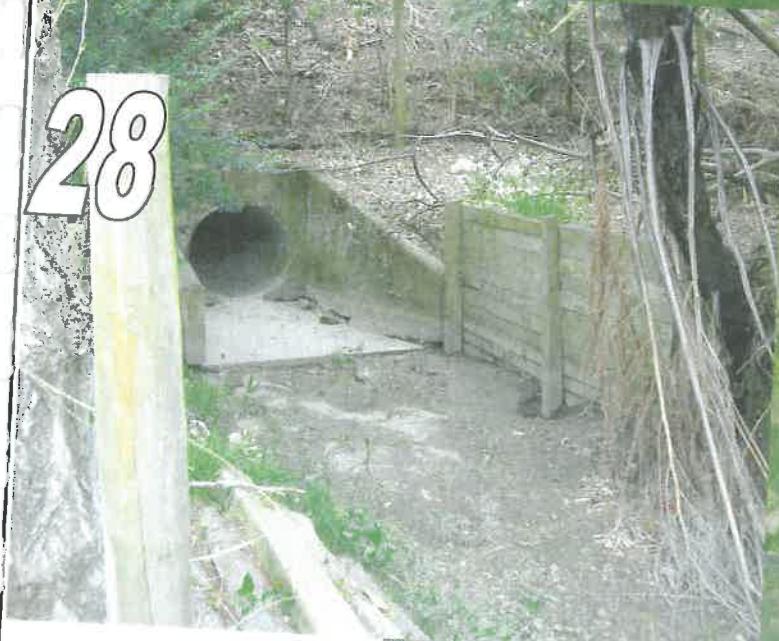
# Drain 12A-Hookey Rd Crossing

PARAMETER	OBSERVATION	RATING
DEPTH	0.5 - 1.0 m	5
BATTER SLOPE	<2:1	0
DISTANCE ROAD SURFACE AND DRAIN	Perpendicular to road	0
INLET/OUTLET PROTECTION	Inlets and outlets are part of road crossings.	0
PROXIMITY TO SENSITIVE FACILITIES	Removed from sensitive facilities	0
AESTHETIC CONSIDERATIONS	Normal growth	5
HEALTH CONSIDERATIONS	None	0
ENVIRONMENTAL CONSIDERATIONS	None	0
PROXIMITY TO DEVELOPMENT	Between residential properties	5
SAFETY INDEX	This drain is not easily accessible and does not constitute a safety risk	1.54
DRAIN INDEX		1.54

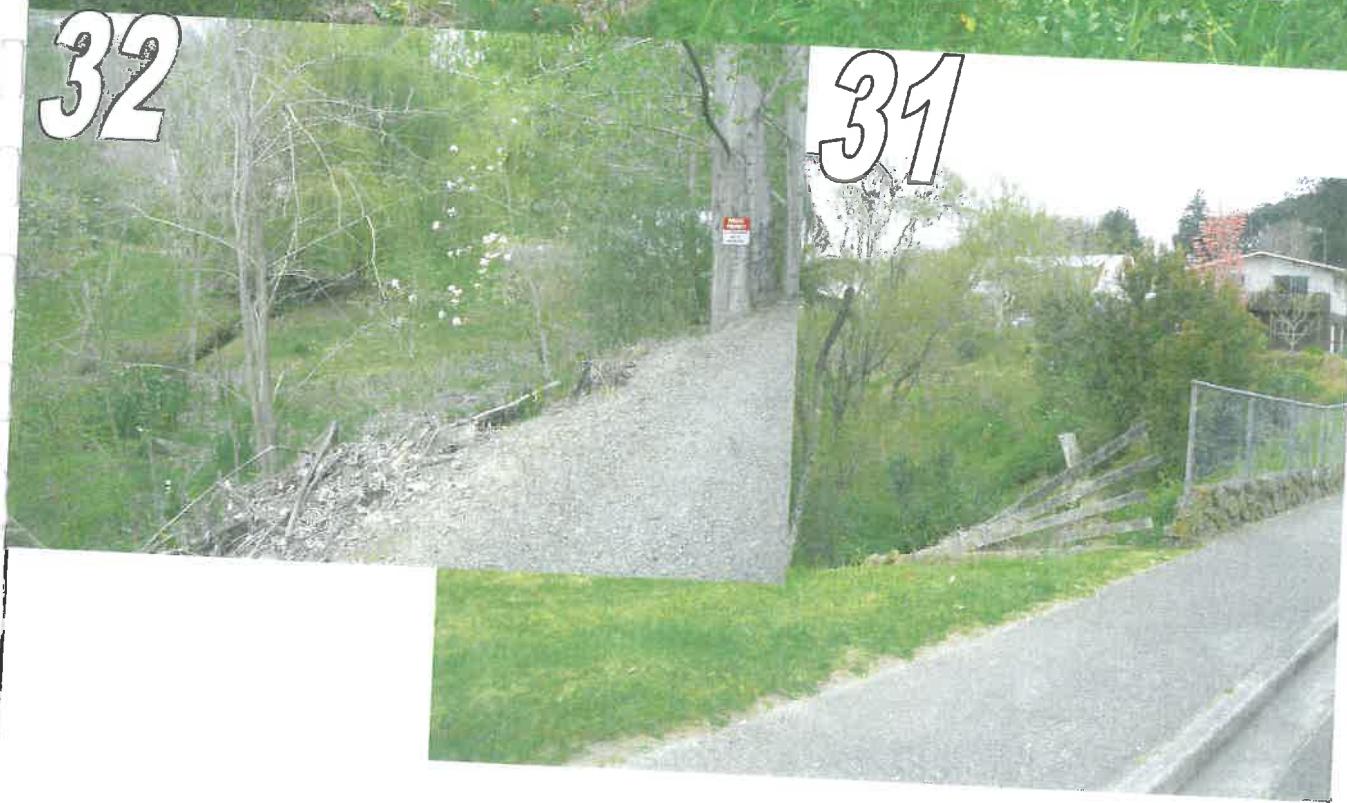
## Drain 12B-Crossing with Tui Street

PARAMETER	OBSERVATION	RATING
DEPTH	0.5 - 1.0 m	5
BATTER SLOPE	2:1 - 1:1	5
DISTANCE ROAD SURFACE AND DRAIN	Perpendicular to road	0
INLET/OUTLET PROTECTION	Inlet and outlet is part of a road crossing.	0
PROXIMITY TO SENSITIVE FACILITIES	Not close	0
AESTHETIC CONSIDERATIONS	Fair	5
HEALTH CONSIDERATIONS	None	0
ENVIRONMENTAL CONSIDERATIONS	None	0
PROXIMITY TO DEVELOPMENT	Between residential properties	0
SAFETY INDEX	The drain does require access protection where it crosses Tui Street	2.33
DRAIN INDEX		2.33

12B	<p><b>Position:</b></p> <p>The crossing of Drain 12 with Tui Street</p> <p><b>Depth/Batter Slope:</b></p> <p>The depth and batter slope of the Drain is within limits with the exception of the drain immediately to the north of Tui Street. It can be seen in photo 31 that a wooden barrier has been damaged.</p> <p><b>Safety:</b></p> <p>A wooden barrier has to be repaired.</p>	<p><b>Depth/Batter Slope:</b></p> <p>The wooden barrier as shown in photo 31 has to be reinstated. There is a steep fall from the road surface to the invert of the drain at this point.</p>
12C	<b>Position:</b>	<b>Depth/Batter Slope:</b>

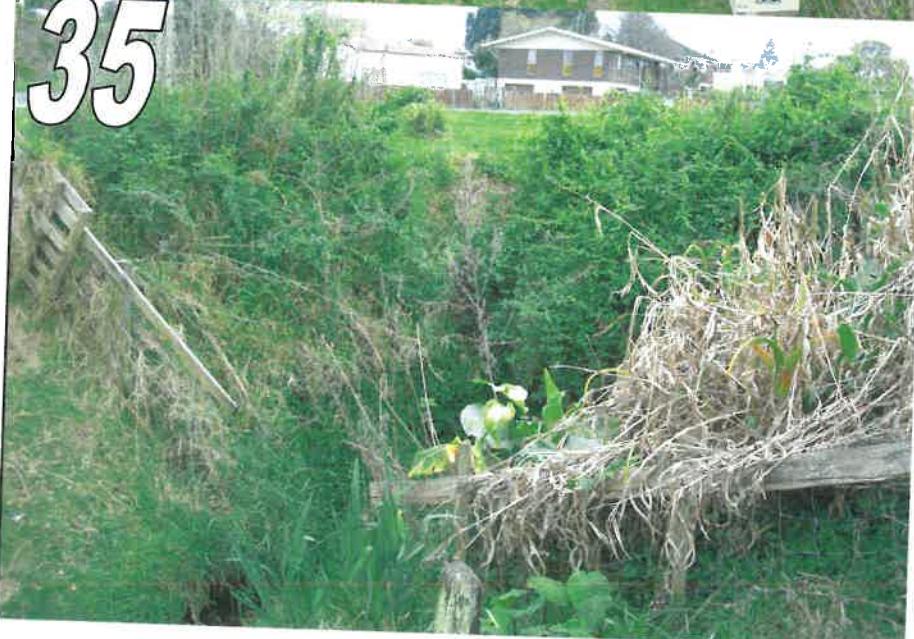
**35**

PARAMETER	OBSERVATION	RATING
DEPTH	0.5 - 1.0 m	5
BATTER SLOPE	2:1 - 1:1	5
DISTANCE ROAD SURFACE AND DRAIN	Perpendicular to road	0
INLET/OUTLET PROTECTION	Inlet and outlet is part of a road crossing.	0
PROXIMITY TO SENSITIVE FACILITIES	Not close	0
AESTHETIC CONSIDERATIONS	Fair	5
HEALTH CONSIDERATIONS	Standing water	10
ENVIRONMENTAL CONSIDERATIONS	None	
PROXIMITY TO DEVELOPMENT	Within developed area	0
SAFETY INDEX	The protection of the drain where it crosses the road should be enhanced	3.33
DRAIN INDEX		3.33

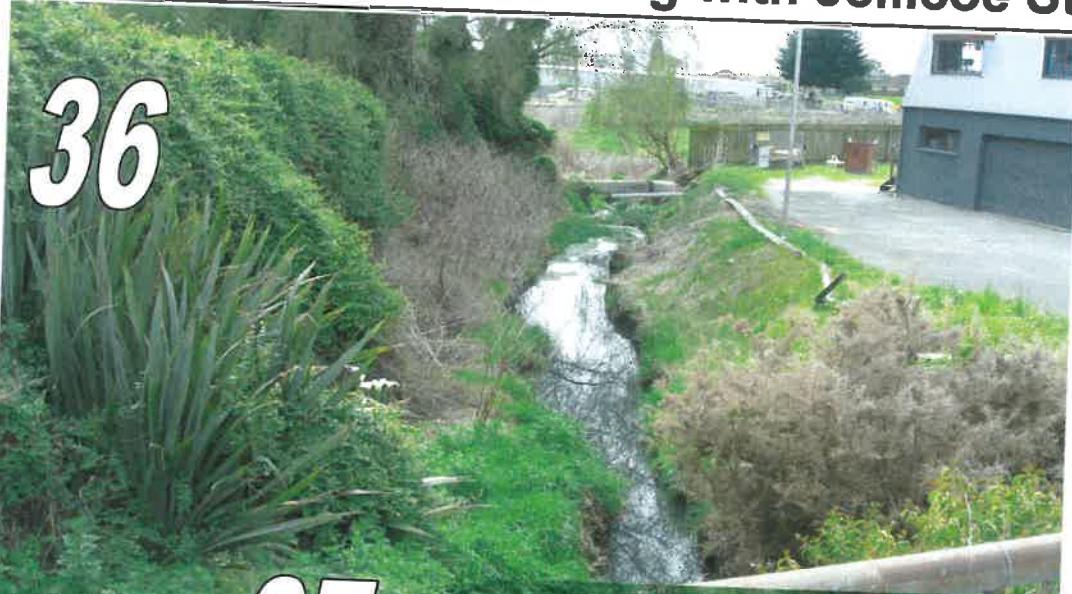
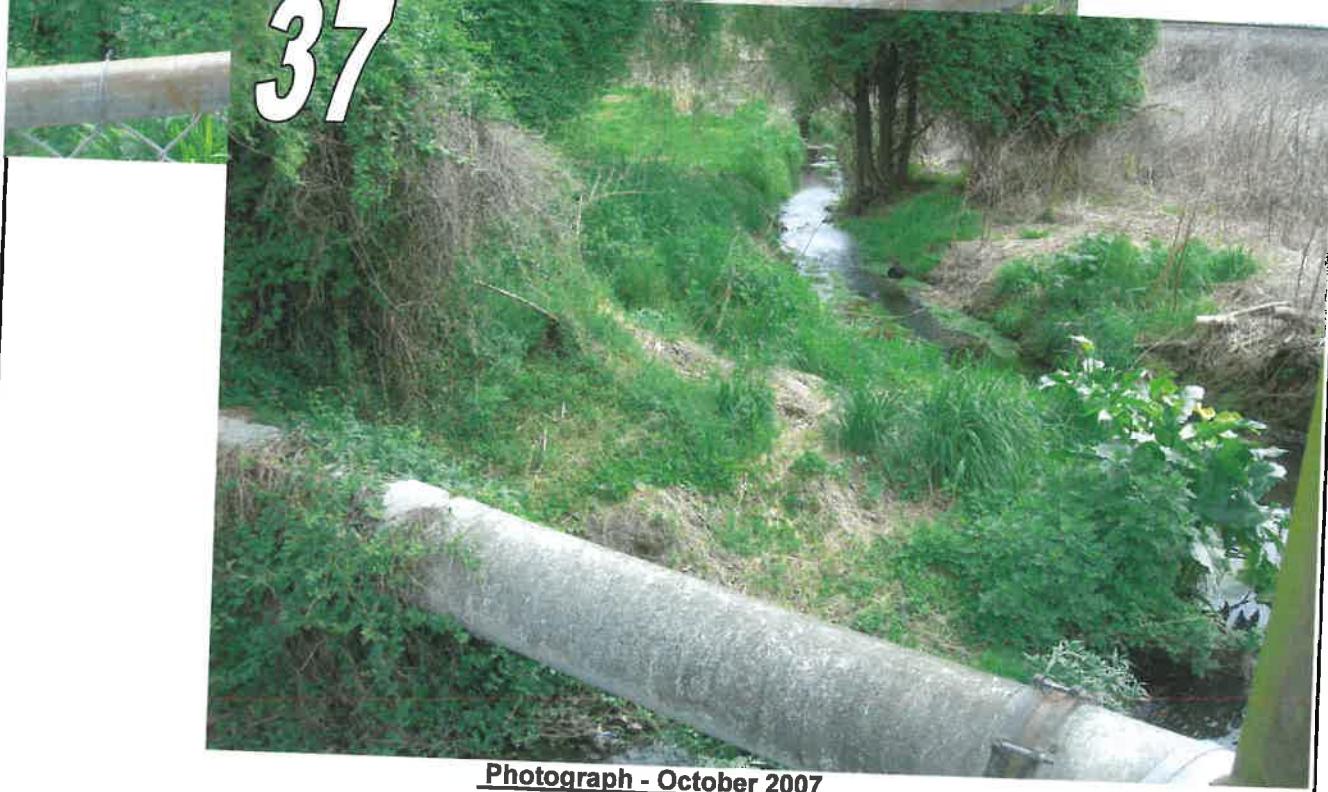
## Drain 12D-Crossing with Jellicoe Street

PARAMETER	OBSERVATION	RATING
DEPTH	1 - 2 m	9
BATTER SLOPE	> 1:1	10
DISTANCE ROAD SURFACE AND DRAIN	2 - 4 m	5
INLET/OUTLET PROTECTION	Inlet and outlet is part of a road crossing.	0
PROXIMITY TO SENSITIVE FACILITIES	Removed from sensitive facilities	0
AESTHETIC CONSIDERATIONS	Fair	5
HEALTH CONSIDERATIONS	Standing water	10
ENVIRONMENTAL CONSIDERATIONS	None	0
PROXIMITY TO DEVELOPMENT	Within developed area	10
SAFETY INDEX	A wooden barrier has been damaged and should be repaired	5.67
DRAIN INDEX		4.92

APPENDIX 2B - TE PUKE: DISCUSSION OF DRAIN CONDITION AND REMEDIAL ACTION REQUIRED		
Drain No	Discussion	Remedial Action Required
	<p>The crossing of Drain 12C with Queen Street.</p> <p><b>Depth/Batter Slope:</b> The depth and batter slope on both sides of Queen Street does not constitute risk with the exception of the area directly adjacent to the southern side of Queen Street. The distance from road surface to invert of drain is in excess of 3 meters.</p> <p><b>Safety:</b> The Drain has to be better protected from the road.</p>	<p>The section of the drain that is directly to the south of Queen Street is protected with a wooden fence as shown on photo 35. This fence is overgrown and not in a good condition. The fence is in need of replacement.</p>
12D	<p><b>Position:</b> Drain 12 crosses Jellicoe Street which is the main street that runs through Te Puke. Photos 36 and 37 are taken between Jellicoe Street and the railway line.</p> <p><b>Distance from Road/Proximity to Development:</b> The Drain is situated adjacent to a commercial development. An area that is used for parking is right adjacent to the drain.</p> <p><b>Safety:</b> The Drain has to be better protected from the road.</p>	<p><b>Distance from Road/Proximity to Development:</b> A wooden barrier existed between the parking area and the Drain. The remains of the wooden fence can be seen on photo 36. This wooden fence should be reinstated to its original state.</p>

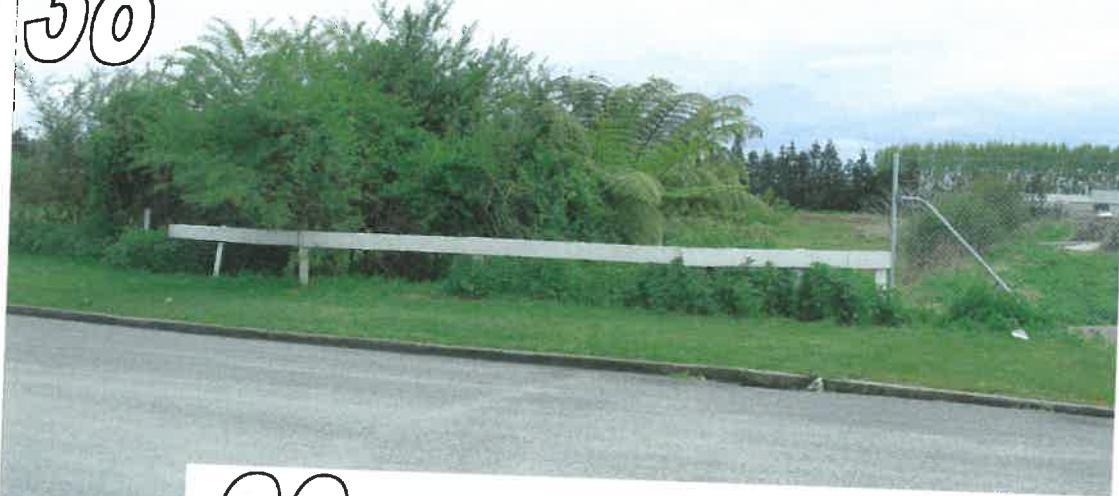
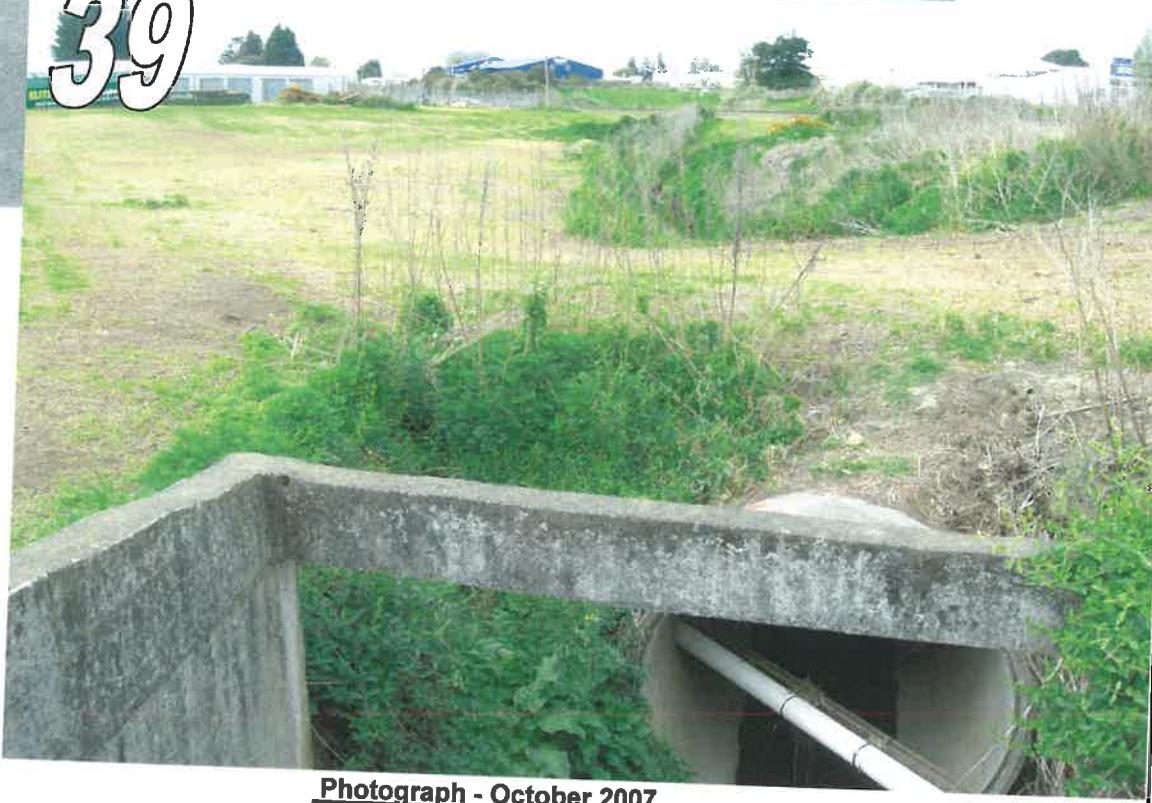
PARAMETER	OBSERVATION	RATING
DEPTH	> 1 m	10
BATTER SLOPE	> 1:1	10
DISTANCE ROAD SURFACE AND DRAIN	Perpendicular to road	0
INLET/OUTLET PROTECTION	Inlet and outlet is part of a road crossing.	0
PROXIMITY TO SENSITIVE FACILITIES	Removed from sensitive facilities	0
AESTHETIC CONSIDERATIONS	Excessive growth	10
HEALTH CONSIDERATIONS	None	0
ENVIRONMENTAL CONSIDERATIONS	None	0
PROXIMITY TO DEVELOPMENT	Removed from development	5
SAFETY INDEX	The drain is situated in the industrial area and does not constitute a risk.	3.90
DRAIN INDEX		4.65

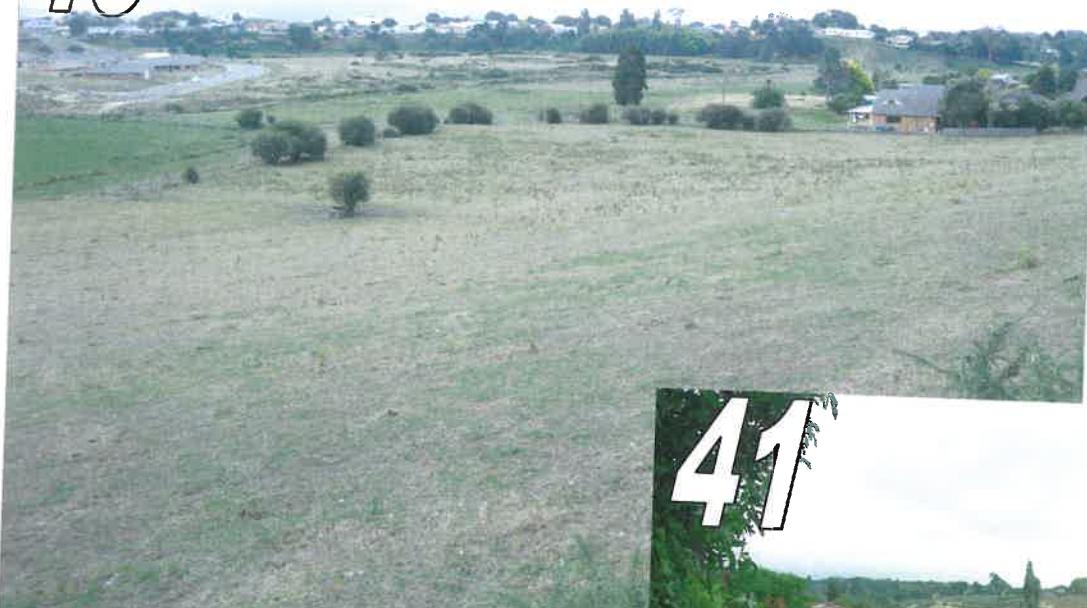
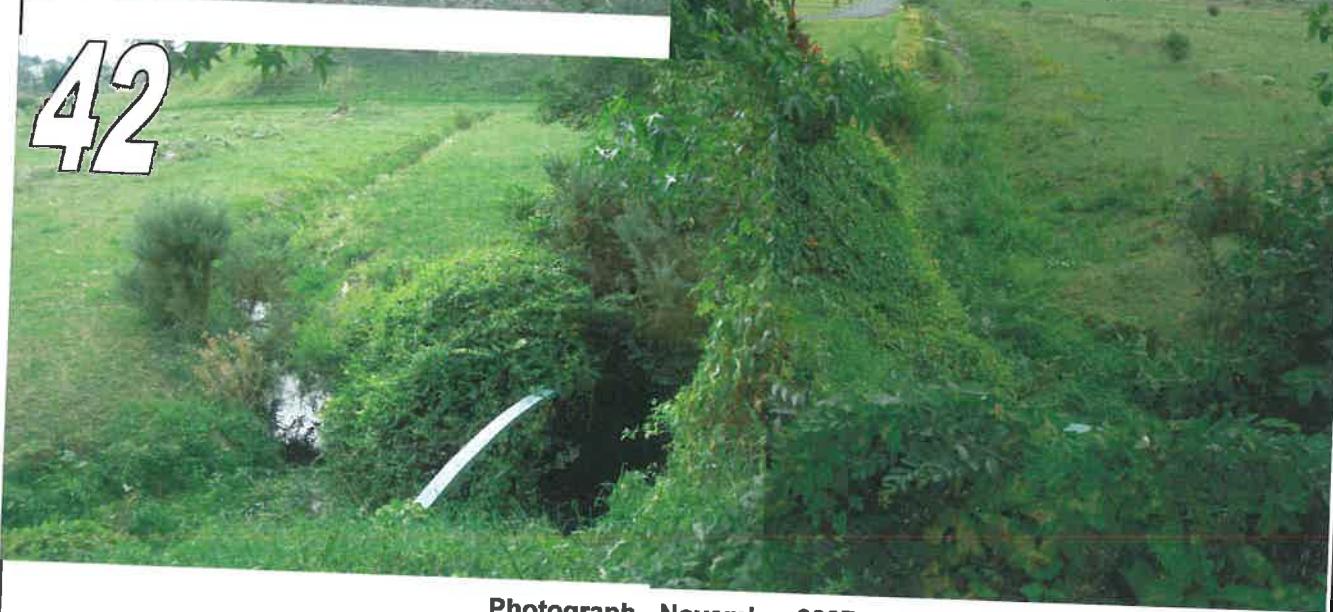
PARAMETER	OBSERVATION	RATING
DEPTH	1 - 2 m	9
BATTER SLOPE	2:1 - 1:1	5
DISTANCE ROAD SURFACE AND DRAIN	> 4 m	0
INLET/OUTLET PROTECTION	Road crossing	0
PROXIMITY TO SENSITIVE FACILITIES	Removed from sensitive facilities	0
AESTHETIC CONSIDERATIONS	Pleasing	0
HEALTH CONSIDERATIONS	None	0
ENVIRONMENTAL CONSIDERATIONS	None	0
PROXIMITY TO DEVELOPMENT	Adjacent to retirement village	0
SAFETY INDEX	The drain is deep where it enters the culvert crossing the road.	10
DRAIN INDEX		3.71
		2.21
