# Categorisation of Open Stormwater Drains in Waihi Beach, Te Puke, and Maketu

Opus International Consultants Limited  
Tauranga Office  
405 Cameron Road  
PO Box 646  
Tauranga, New Zealand

Date: 8 February 2008  
Reference: g:\5\project\9z178.01\_drains\_phase\_2\final  
Status: FINAL  
document\main document.doc

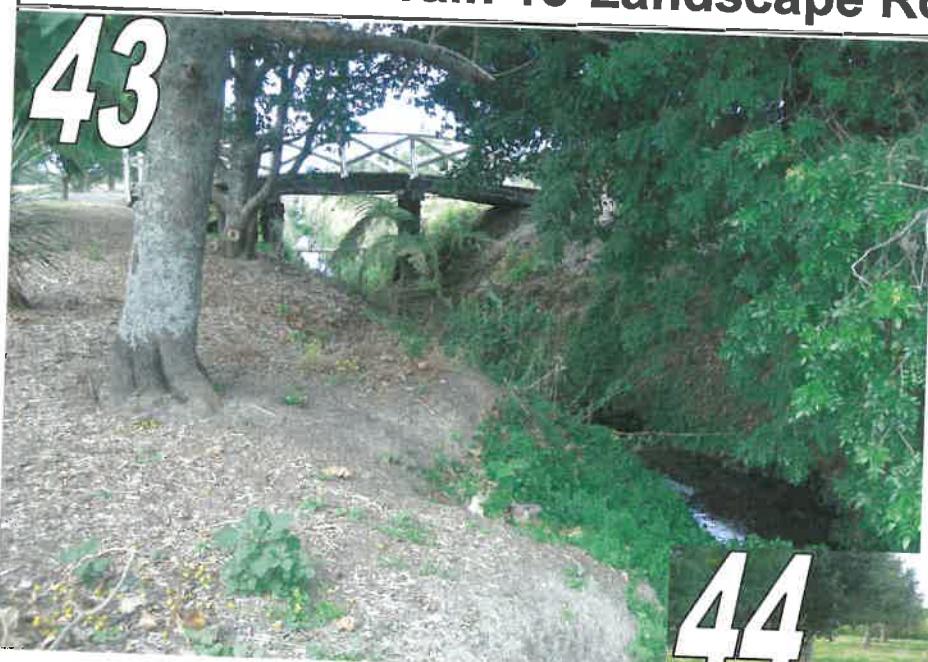
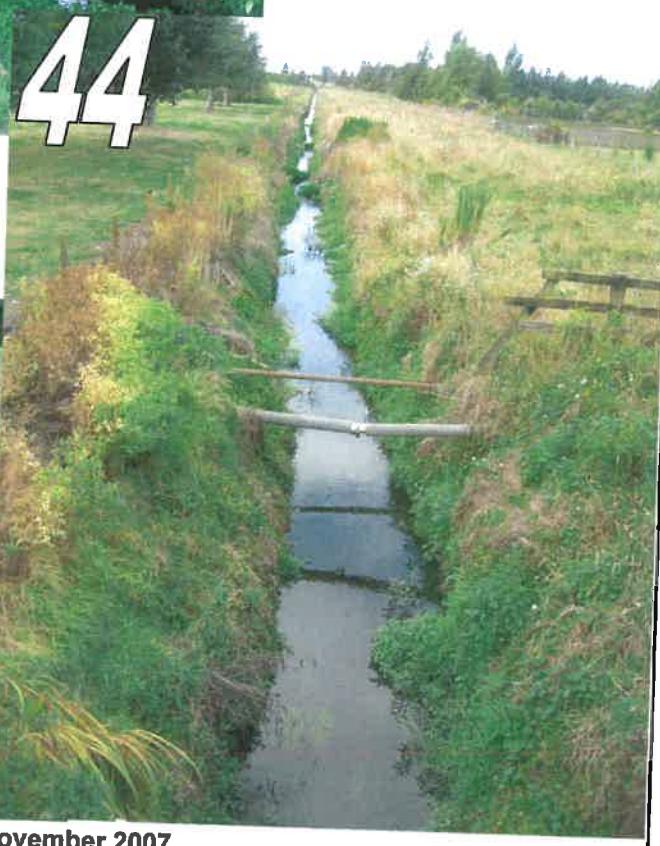
## Drain 15-Landscape Road

PARAMETER	OBSERVATION	RATING
DEPTH	1 - 2 m	9
BATTER SLOPE	>1:1	10
DISTANCE ROAD SURFACE AND DRAIN	> 4 m	0
INLET/OUTLET PROTECTION	Inlet and outlet is part of a road crossing.	0
PROXIMITY TO SENSITIVE FACILITIES	Removed from sensitive facilities	0
AESTHETIC CONSIDERATIONS	Normal to slightly more than normal growth	5
HEALTH CONSIDERATIONS	Standing water	10
ENVIRONMENTAL CONSIDERATIONS	None	0
PROXIMITY TO DEVELOPMENT	Fair distance from development	5
SAFETY INDEX	The section between the culvert and the pedestrian bridge should be protected.	4.74
DRAIN INDEX		4.74

15	<p><b>Position:</b> This Drain is the continuation of Drain 14 but just on the northern side of the main road. The Drain is reasonably sheltered from development.</p> <p><b>Depth:</b> The section of the Drain between the outlet of the culvert and the pedestrian bridge is accessible to public being adjacent to a public park. This is also the deepest section of the Drain.</p> <p><b>Safety:</b> It is recommended that a section of the Drain be fenced.</p>	<p><b>Depth:</b> The Drain is protected from the public park after it crosses the pedestrian bridge. The more accessible and deepest section of the Drain however is before the pedestrian bridge.</p> <p>This section should be provided with a similar barrier as is the case for the section beyond the pedestrian bridge.</p>

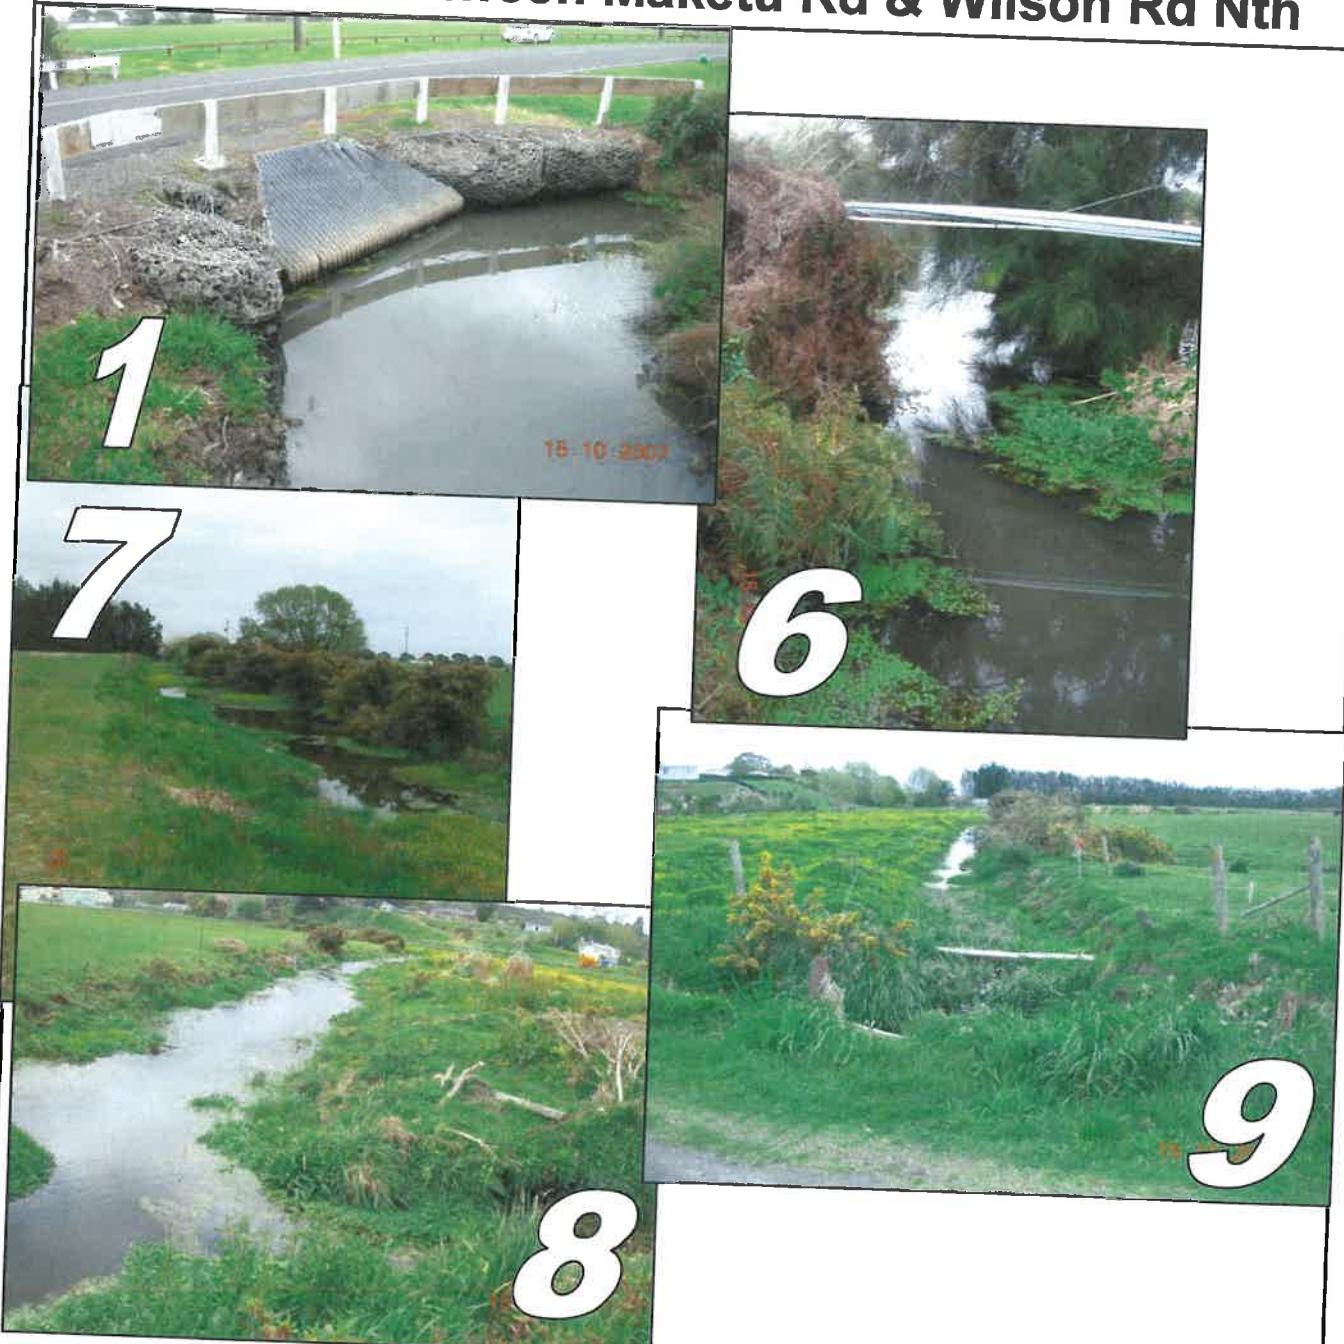
## Drain 1B - Between Maketu Rd & Wilson Rd Nth

PARAMETER	OBSERVATION	RATING
DEPTH	1-2 m	9
BATTER SLOPE	2:1 - 1:1	5
DISTANCE ROAD SURFACE AND DRAIN	Not applicable	0
INLET/OUTLET PROTECTION	No safety railing at Wilson Rd Nth crossing	10
PROXIMITY TO SENSITIVE FACILITIES	Removed from sensitive facilities	0
AESTHETIC CONSIDERATIONS	Slight growth	5
HEALTH CONSIDERATIONS	Standing water/Chance of water pollution	10
ENVIRONMENTAL CONSIDERATIONS	Erosion of gabions at outlet	5
PROXIMITY TO DEVELOPMENT	Mostly on private property	0
SAFETY INDEX	The drain is cut between two properties and connects to Drain 3 at Maketu Rd.	9.71
DRAIN INDEX		5.96

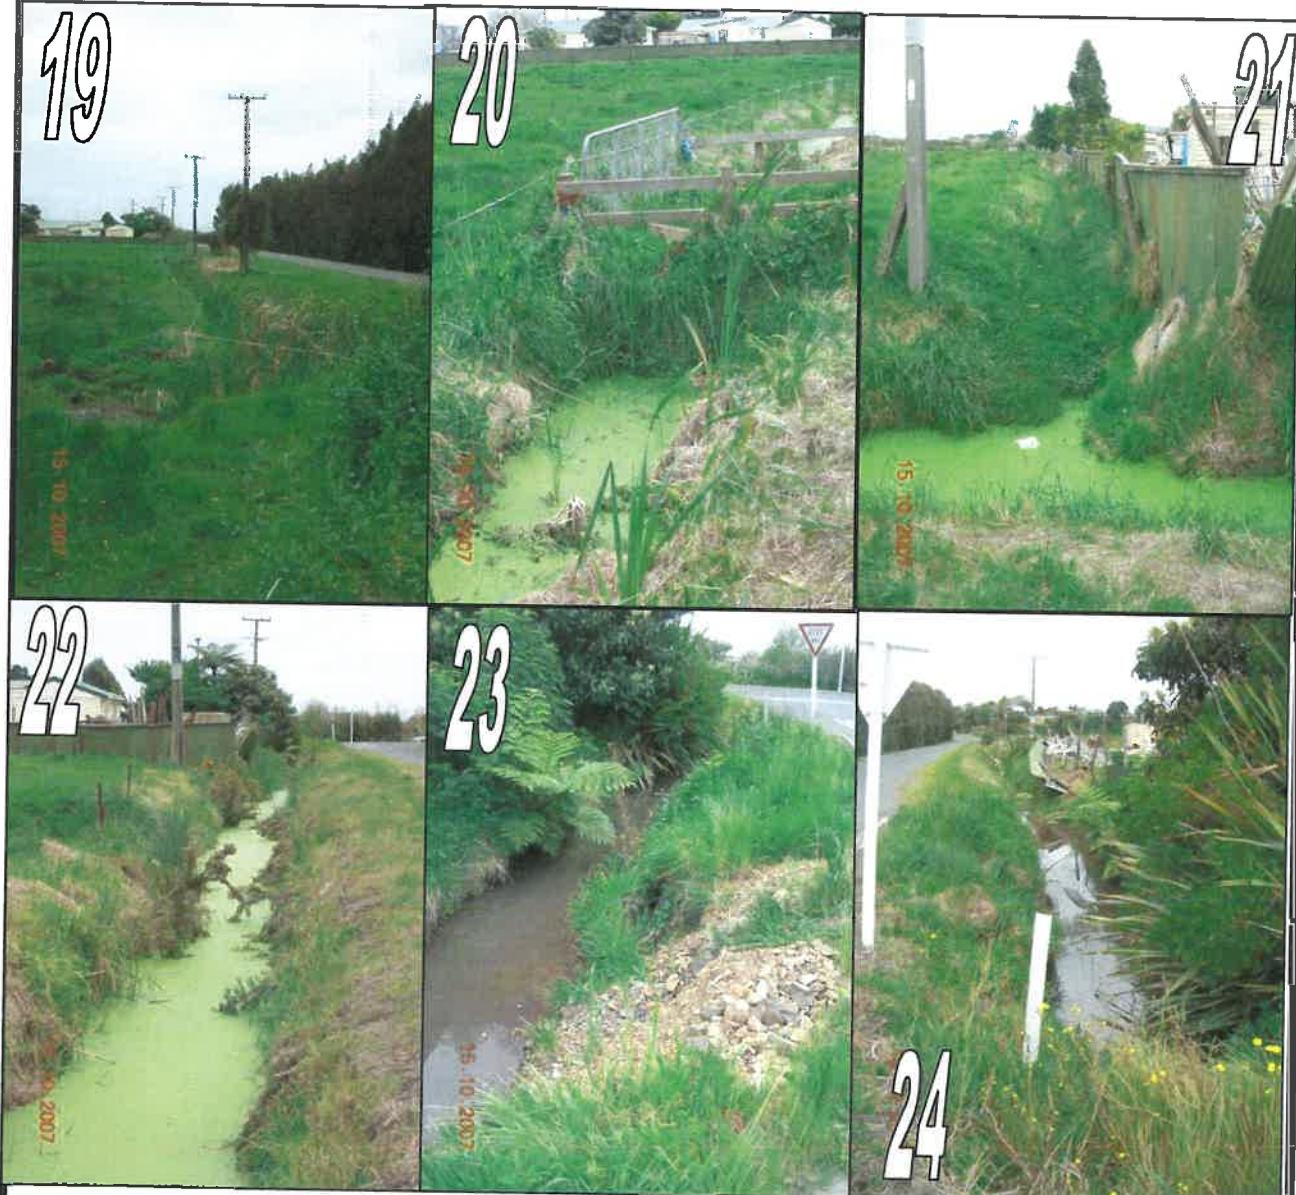
## Drain 2 - Spencer Ave South

PARAMETER	OBSERVATION	RATING
DEPTH	1-2 m	9
BATTER SLOPE	2:1 - 1:1	5
DISTANCE ROAD SURFACE AND DRAIN	2-4 m	5
INLET/OUTLET PROTECTION	Inlet/Outlet not protected/no safety rails	10
PROXIMITY TO SENSITIVE FACILITIES	Removed from sensitive facilities	0
AESTHETIC CONSIDERATIONS	Poor - algae present on surface	10
HEALTH CONSIDERATIONS	Standing water/Mosquito breeding	10
ENVIRONMENTAL CONSIDERATIONS	Mild erosion at end of kerb	5
PROXIMITY TO DEVELOPMENT	Close to a few homes. Private fence leaning over drain.	0
SAFETY INDEX	The drain is near a few houses and one is currently in danger of flooding in an extreme rain event.	5.38

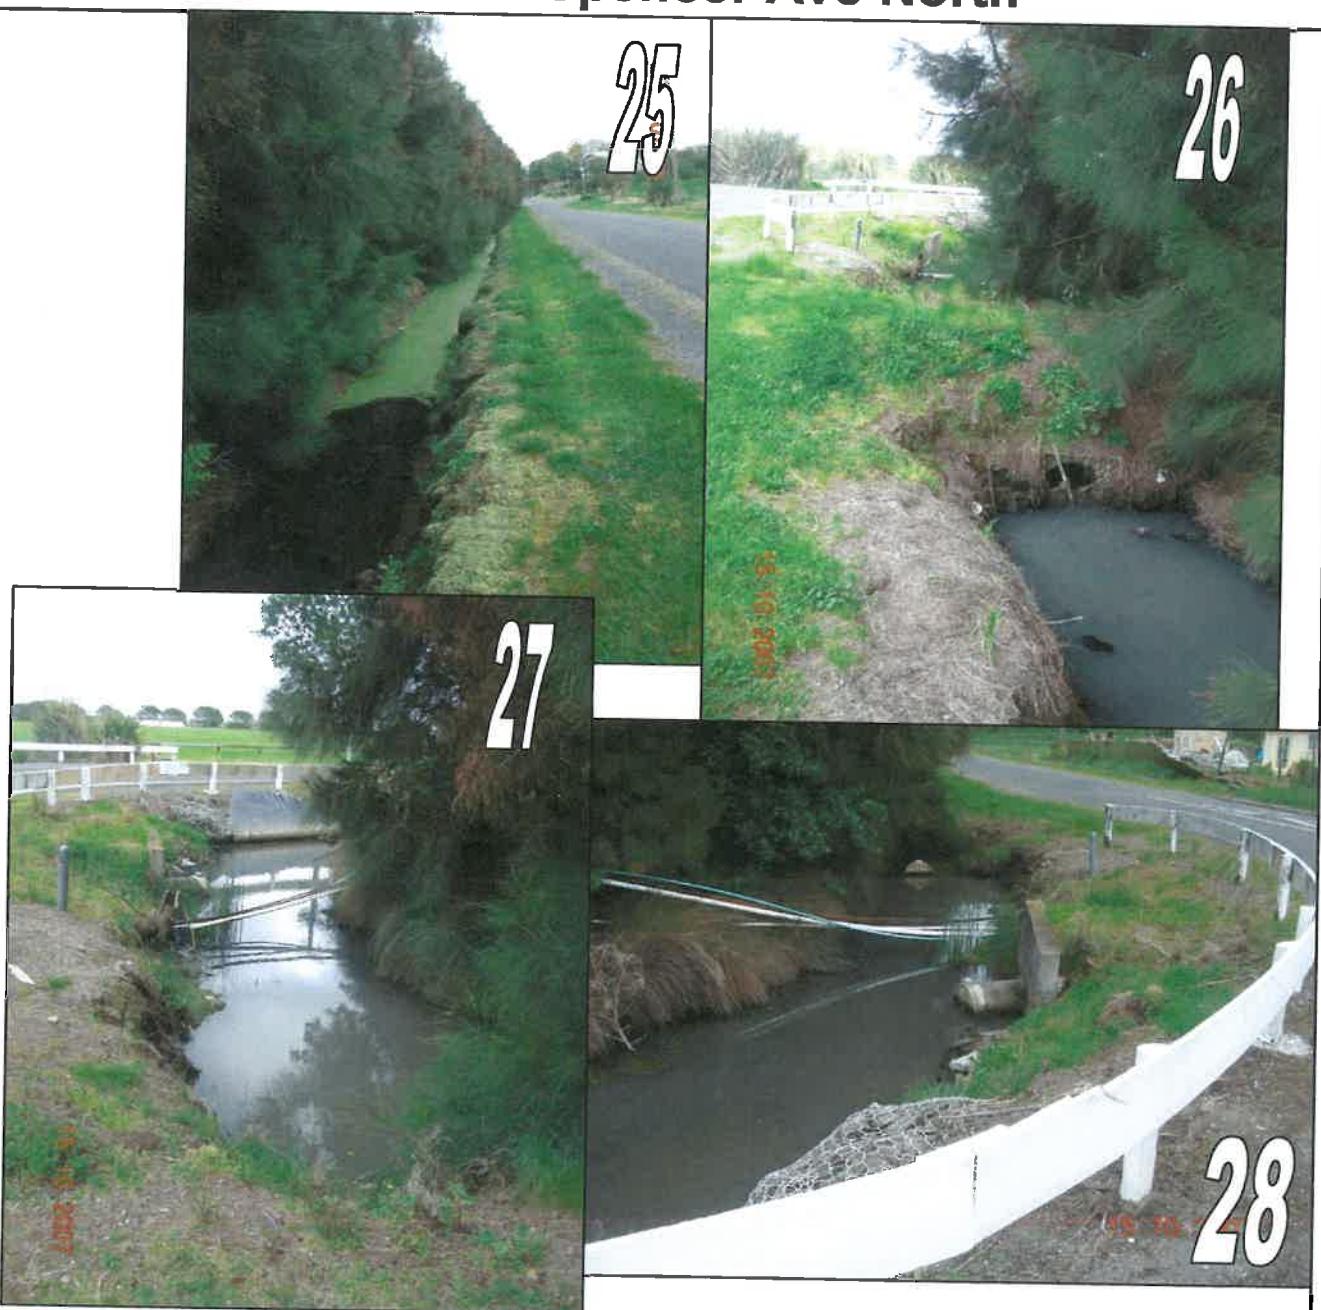
## Drain 3 - Spencer Ave North

PARAMETER	OBSERVATION	RATING
DEPTH	1-2 m	9
BATTER SLOPE	2:1 - 1:1	5
DISTANCE ROAD SURFACE AND DRAIN	2-4 m	5
INLET/OUTLET PROTECTION	Protection fair, some sight railing present	5
PROXIMITY TO SENSITIVE FACILITIES	Not applicable	10
AESTHETIC CONSIDERATIONS	Poor - algae present on surface	10
HEALTH CONSIDERATIONS	Standing water upstream/mosquito breeding	10
ENVIRONMENTAL CONSIDERATIONS	Mild erosion possible, deterioration of gabions	5
PROXIMITY TO DEVELOPMENT	Adjacent to a paddock	0
SAFETY INDEX	Drain 3 meets with Drain 1b at Maketu Rd and together they empty into Drain 1a.	6.51
DRAIN INDEX		8.01
