GEOLOGICAL INSPECTION REPORT

A1. SITE: Mintaro Hut	GRID REF: E 2097 478, N 5586 715	ALTITUDE: c. 620 m	BUILT: 1 Jan 1985
A2. LOCATION: Upper Clinton valley, Milford Track (Clinton Hut to Mackinnon Pass Section)

Geological Inspection for: Mintaro Hut

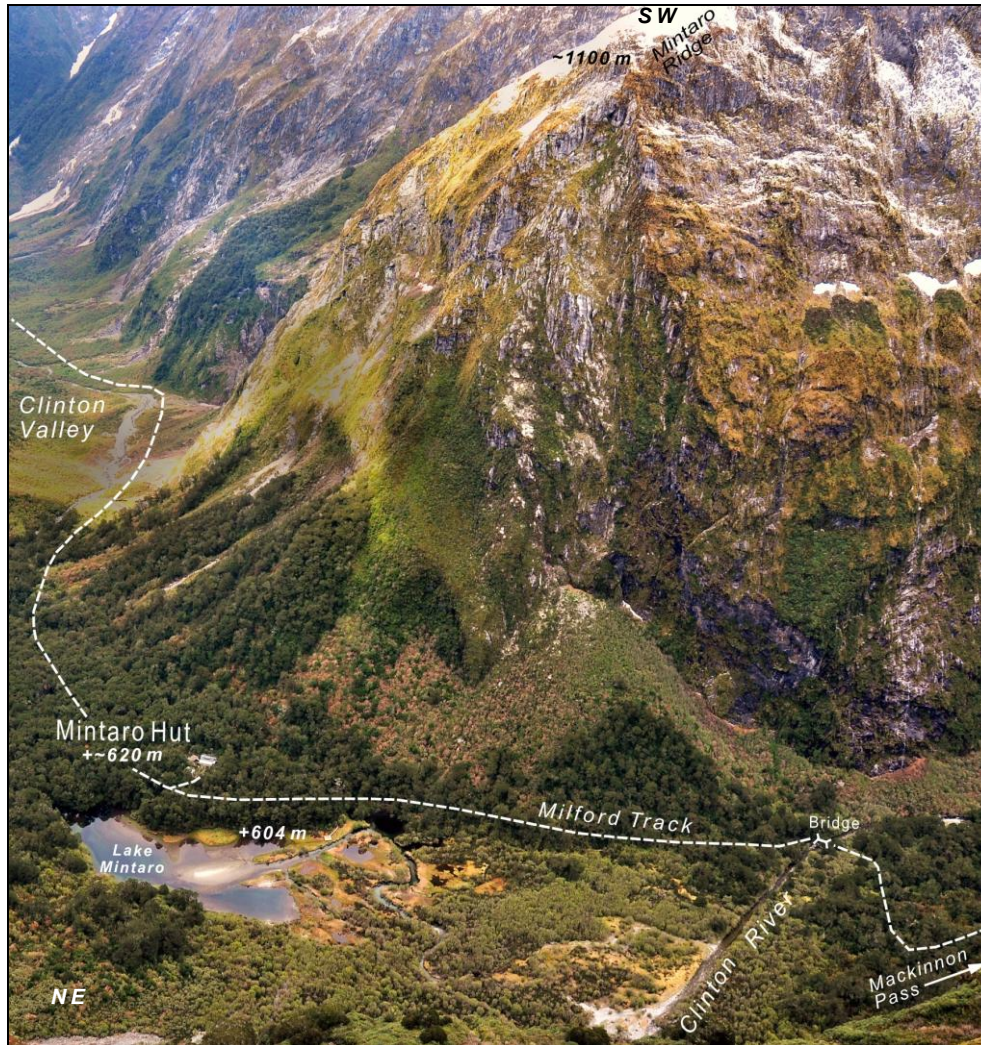
Site Photo. Aerial view of Mintaro Hut in the upper Clinton Valley. The hut is sited at the foot of Mintaro Ridge on a mound of old rock fall debris which has dammed the Clinton River to form Lake Mintaro, which is now partly infilled. The line of the site Cross Section (NE-SW, below) is also shown.

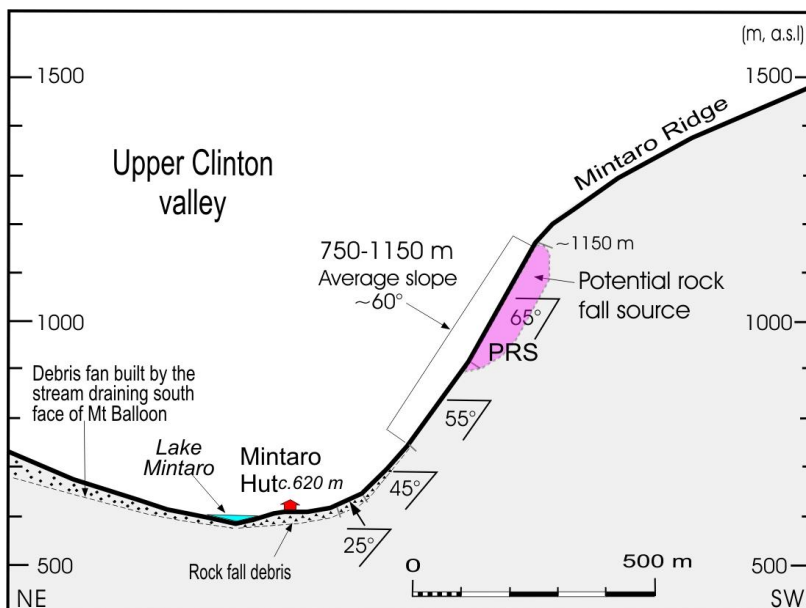
Site Cross Section. Topographic cross section of the hut site showing Mintaro Hut in relation to the slope above and across-valley from the hut site. The slope behind the hut rises steeply from elevation 750–1150 m, with an average slope of about 60°. A potential rock fall source (PRS) is located at the top of the steepest section of the slope directly above the hut.

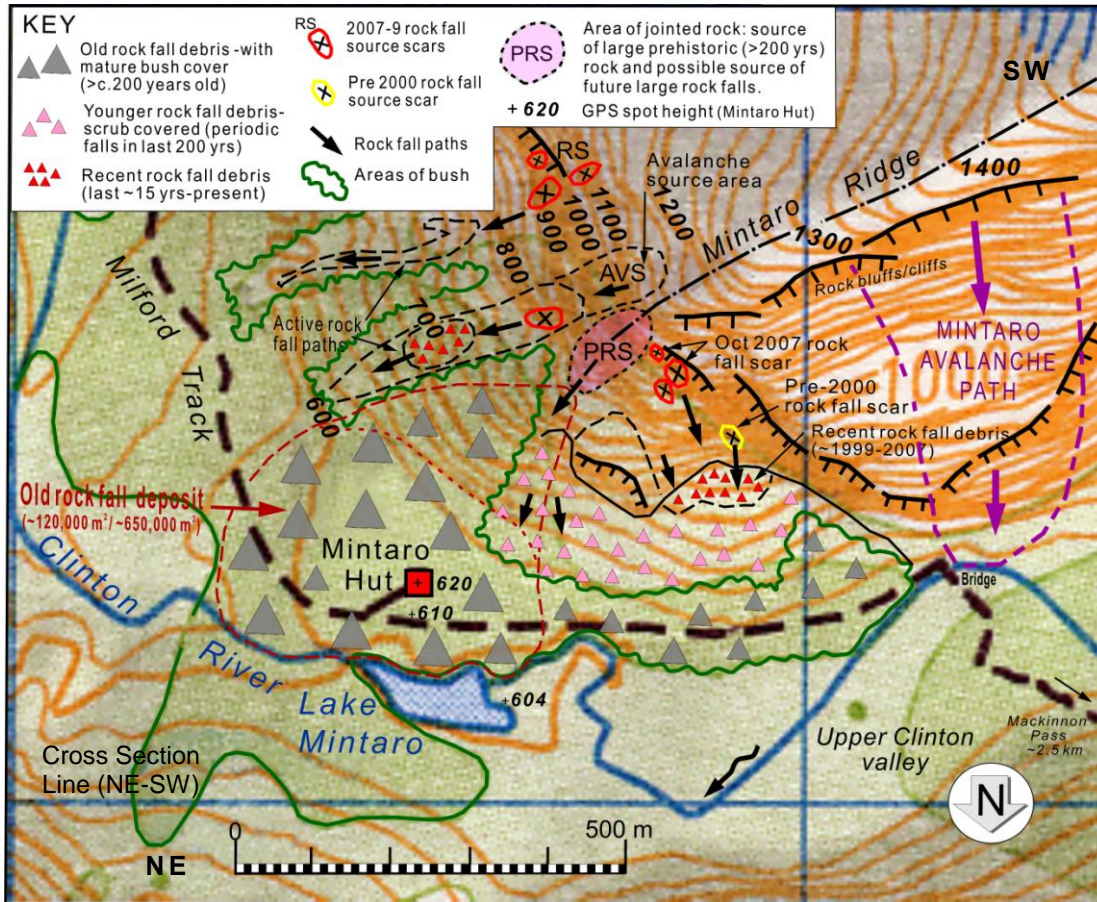
SITE MAP 1. Geomorphic map of hut site area

Site Map 1. Geomorphic map of Mintaro Hut site showing old and recent rock fall deposits, rock fall paths, October 2007 rock fall sources, and the possible source of a future large rock fall at the hut site. The volume of the older rock fall deposits on which the hut is located (inside the dashed red line) is about ~650,000 m³.

Scrub-covered rock fall debris c. 80 m southwest of the hut (*Site Map 1*) suggests there have been periodic smaller rock falls in the area which prevented establishment of beech forest, but did not reach the hut site. No rock fall trails are apparent in beech forest near the site.

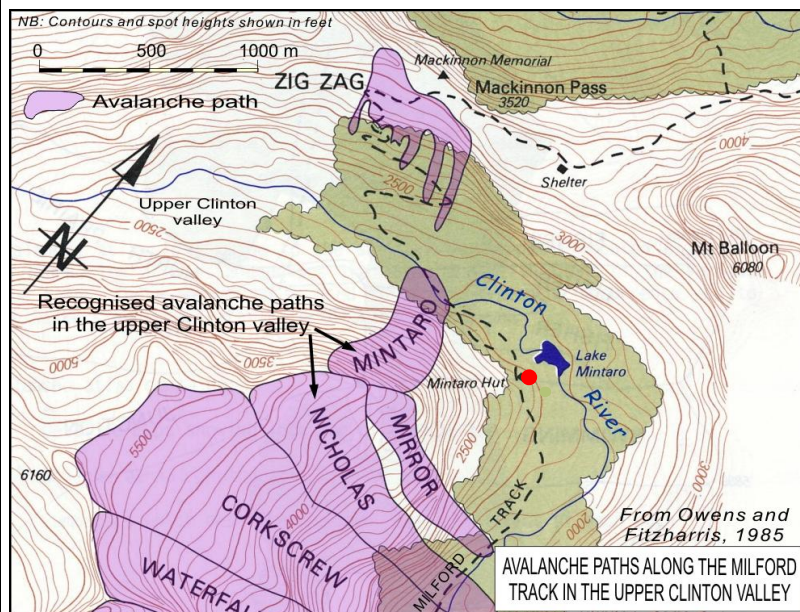
SITE MAP 2. Snow Avalanche Paths in the Mintaro Hut area

Site Map 2. Map showing snow avalanche paths along the Milford Track in the upper Clinton valley⁶. Avalanches may carry rock, soil and vegetation, and build debris fans (track location shown is incorrect – see Site Map 1).

7. Snow avalanches (associated rock and debris flows)	Unlikely RP: ~1000-5000 yrs AEP: ~0.10-0.02 %	Insignificant	Very Low	The closest known avalanche path (Mintaro - RP 20yrs) ⁶ does not affect the hut site. There is no known snow avalanche activity at the site. Risk <i>acceptable</i> .

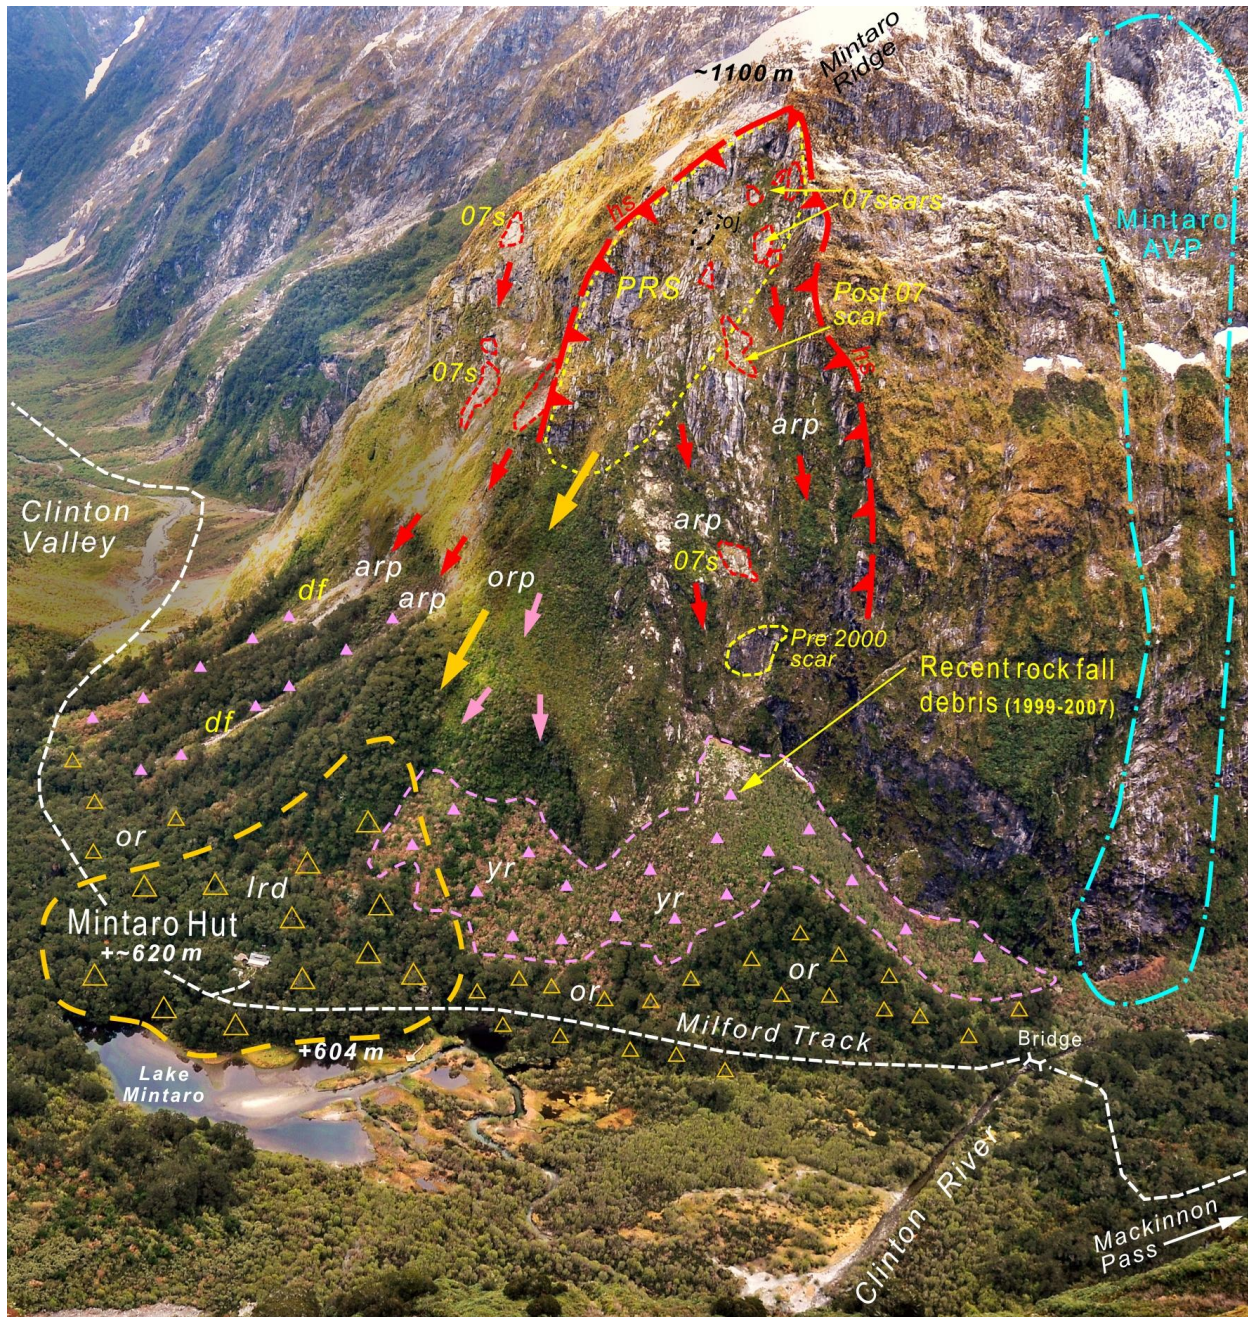
Photo 1. Aerial view of Mintaro Hut sited on old rock fall debris (yellow triangles) on the south side of the upper Clinton valley. The old rock fall deposits at the hut site include angular boulders 1–6 m across, on which ~170 year old beech trees are growing. About 100 m southwest (upstream) of the hut is an area of younger, scrub-covered rock fall debris, built up at the base of the slope by periodic rock falls down paths (YRP) on the northwest side of Mintaro Ridge. These falls did not reach the hut site. The October 2007 earthquake triggered several small rock falls near the crest the ridge (scars outlined in red). Debris from these and other recent rock falls has accumulated at the apex of the debris fan, c.400 m southwest of the hut. Rock at the top of the ridge directly above the hut is well jointed, with areas of relaxed open-jointed rock (OJ), and is a potential source of a future large rock fall at the site (PRS), particularly during a large (M7.5 or >) earthquake. The Mintaro avalanche path⁶ c.650 upstream (right) of the hut, does not affect the site.

The 16 October 2007, M_L 6.7 earthquake (locally MM 6-7) caused small rock falls (c.1-2 m³, in total possibly 5 –10 m³) in gullies 200-400 m from the hut (see *Site Map 1 and Photo 1*). No rock falls appear to have reached the hut site in the last ~180–200 years, based on tree-ring dating. However, jointed rock on the ridge above the hut is a potential source of future large rock falls (possibly c.1000 –10,000 m³ or >) that could affect the hut, given a suitable trigger, such as a nearby ~M 7.5 or > earthquake. The estimated volume (c. 650,000 m³) of old rock fall debris suggests there have been many such earthquake-induced rock falls at this site in the last 10,000 years, and they will continue to occur in the future. Rainfall induced landslides, typically shallow slides and flows, have not affected the site in the past and, mainly because of the geomorphic features at the site, are unlikely to in the future.

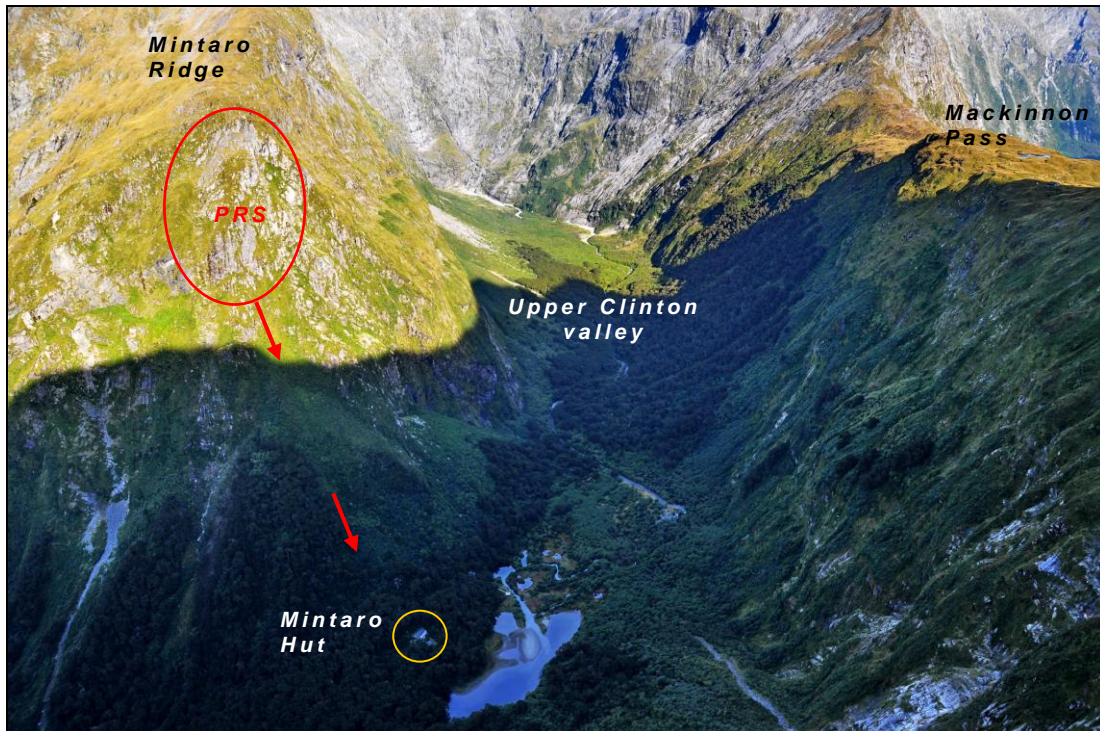
Photo 2. Aerial view of Mintaro Hut site in the head of the Clinton valley, and Mackinnon Pass 1.5 km to the northwest. An area of steep, jointed rock on the northern end of Mintaro Ridge is a potential source of a large rock falls (*PRS*) that could affect Mintaro Hut in the foreseeable future (next 50 years). The hut is founded on bush covered old rock fall debris, which last fell from that (*PRS*) part of the ridge possibly c. 200 years ago.

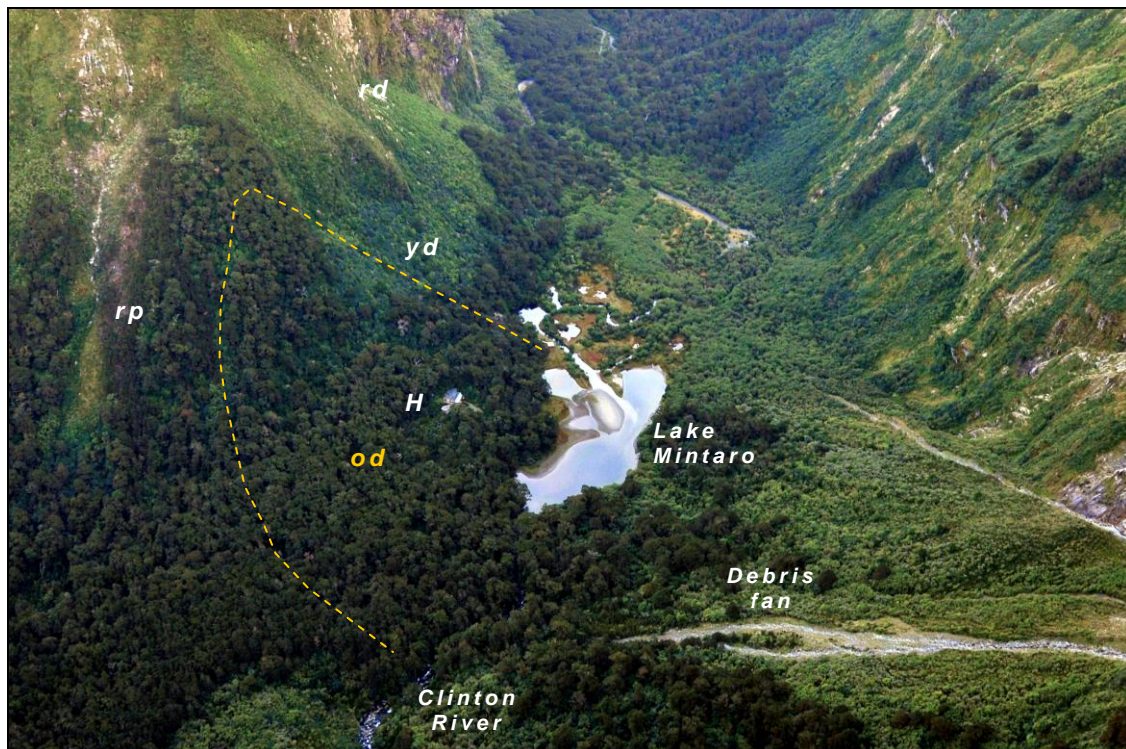
Photo 3. Closer view of Mintaro Hut (*H*). The old, bush covered rock fall debris (*od*) includes 1-6 m boulders, which are scattered around the site. Other features to note are younger, scrub-covered, rock fall deposits (*yd*); recent (c.1990-2007) rock fall debris (*rd*), and an active rock fall path (*rp*) about 250 m downstream. The partly-infilled Lake Mintaro was formed by blockage of the Clinton River by rock fall debris and a large debris fan (*lower right*).

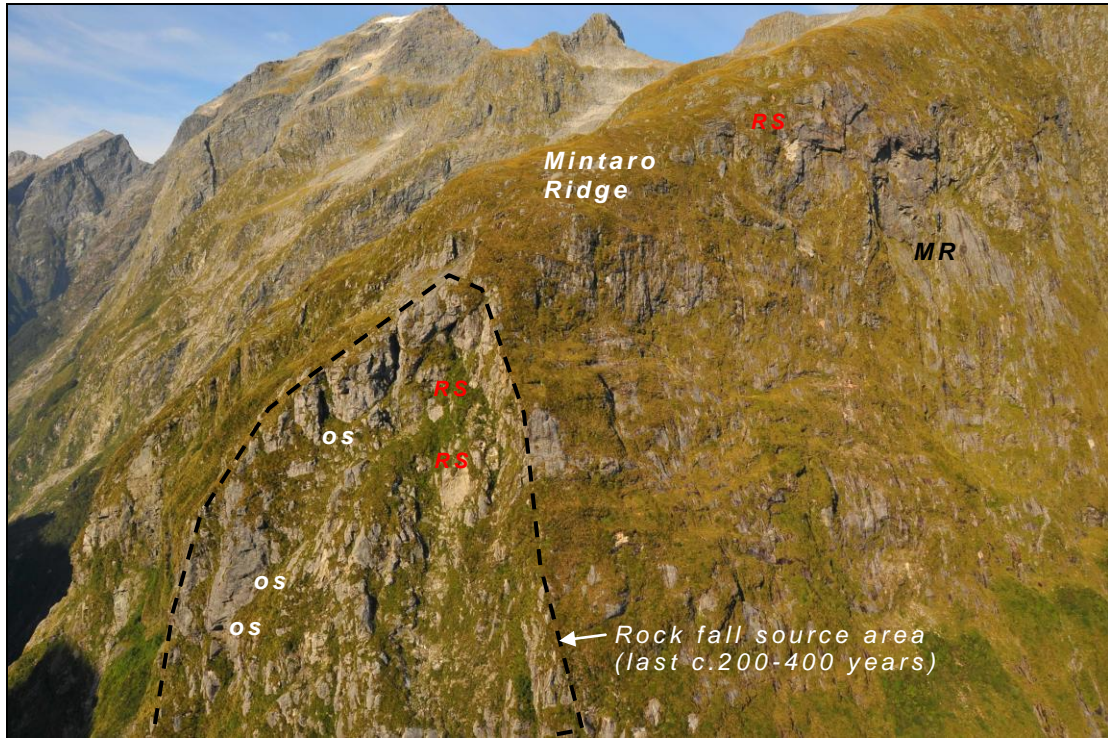
Photo 4. Aerial view of an area of well jointed rock on the ridge 400-500 m above Mintaro Hut, which was the source of rock fall debris on which the hut is built, and is the likely source of future large rock falls at the site. Scars of older wedge failures are still visible (os), as are the source-scars of the October 2007 rock falls (RS). The glaciated rock mass to the right is more massive and has few failure scars.

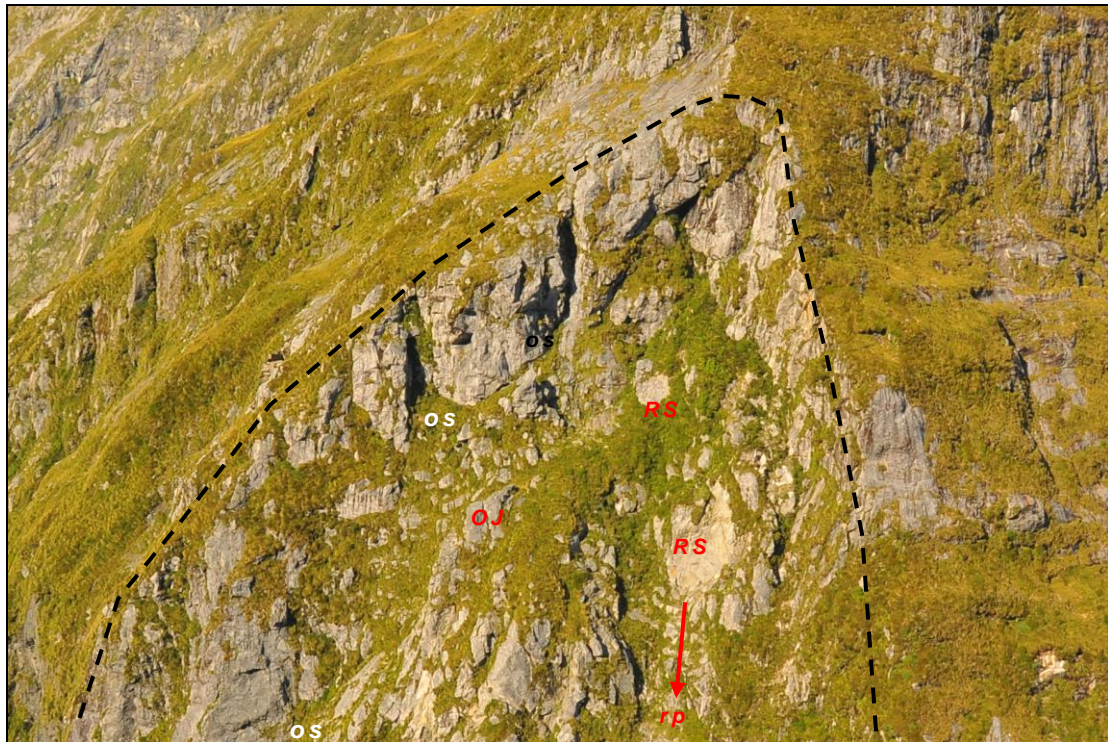
Photo 5. Closer view of the jointed rock on the ridge above Mintaro Hut showing scars of older failures (os), one large area of opened jointed rock (oj), and source-scars (RS) and paths (rp) of the October 2007 rock falls.

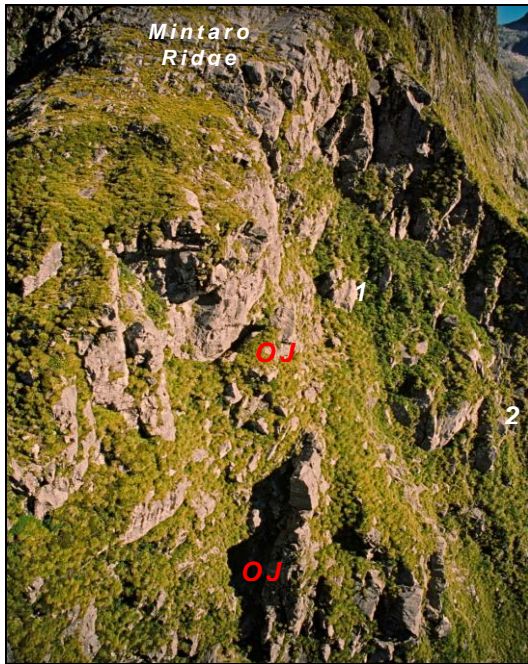
Photo 6. Aerial view of two prominent areas of open-jointed rock (OJ) on the ridge about 500 m above Mintaro Hut. This photo was taken in April 2000. Both of these sites survived the October 2007 earthquake, although one small (~1 m) block was dislodged from the upper site. The vertical extent of the lower site is estimated to be at least 15-20 m. The approximate locations of two of the 2007 rock fall source-scars are also shown (sites 1 and 2).

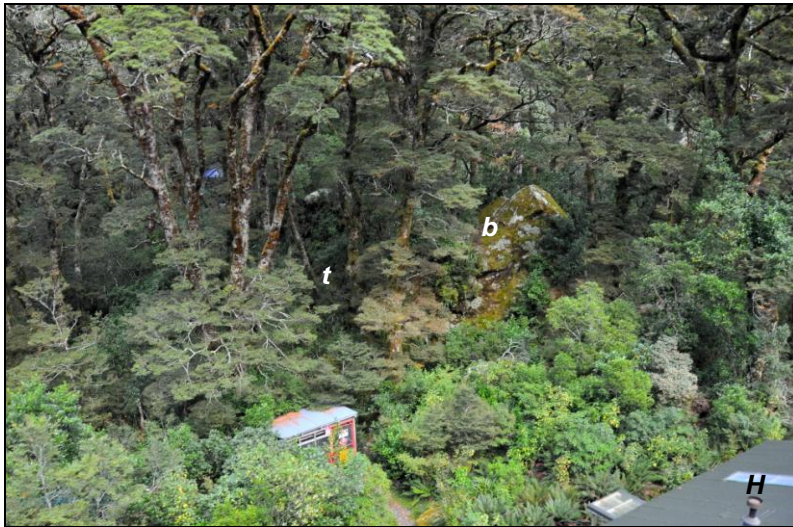
Photo 7. Close up view of the area behind Mintaro Hut (H) showing a large (6 x 4 x 3 m) boulder (b) 17 m from the hut. There are also many other 1–2 m boulders scattered around the hut site. A silver beech tree about 500 mm in diameter is growing on the boulder. Coring of a nearby beech tree 560 mm in diameter showed the tree to be c.165 years old. Assuming there was a forest regrowth time lag of c.20 years, the last large fall rock fall to reach the hut site occurred possibly 180-200 years ago.

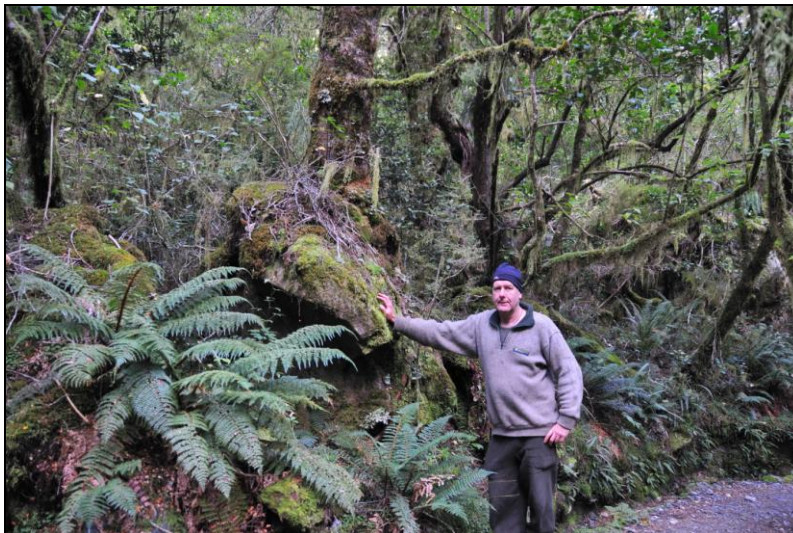
Photo 8. Silver beech tree growing on a rock fall boulder on the Milford Track, 25 m north of Mintaro Hut. This tree is slightly smaller and younger (~83 years old, see Appendix 4) than the tree which was cored (see Photo 9).

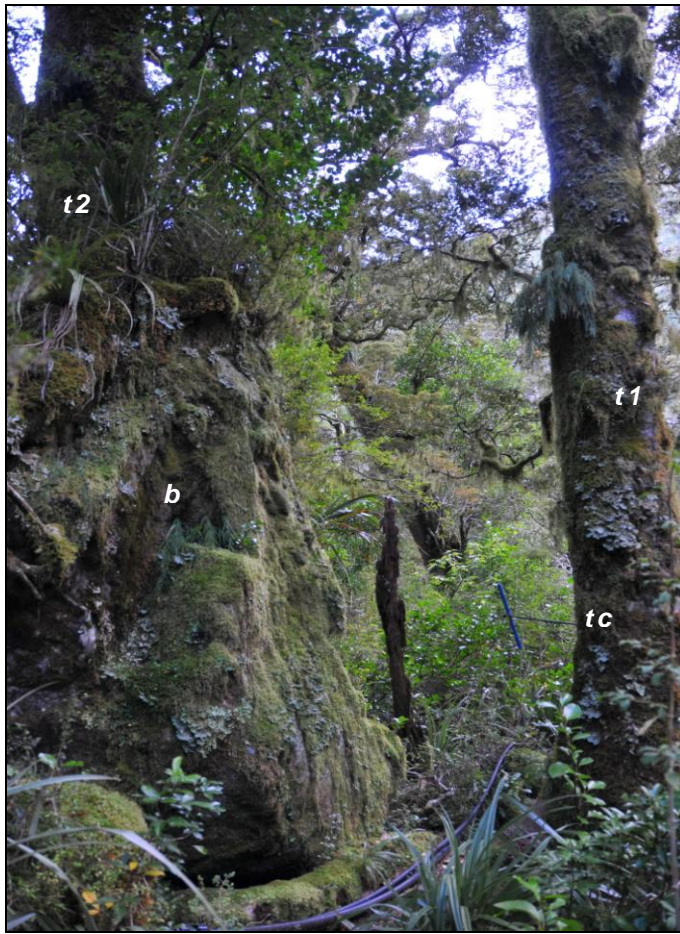
Photo 9. This photo shows the 560 mm diameter silver beech tree (*t1*) behind Mintaro Hut. Coring of this tree with an incremental tree corer (*tc*) showed that it is about 165 years old. The large rock fall boulder (*b*) to the left of the cored tree has a beech tree (*t2*) of similar size and age growing on it. This indicates that the last rock fall to reach the hut site could have occurred about 180-200 years ago.

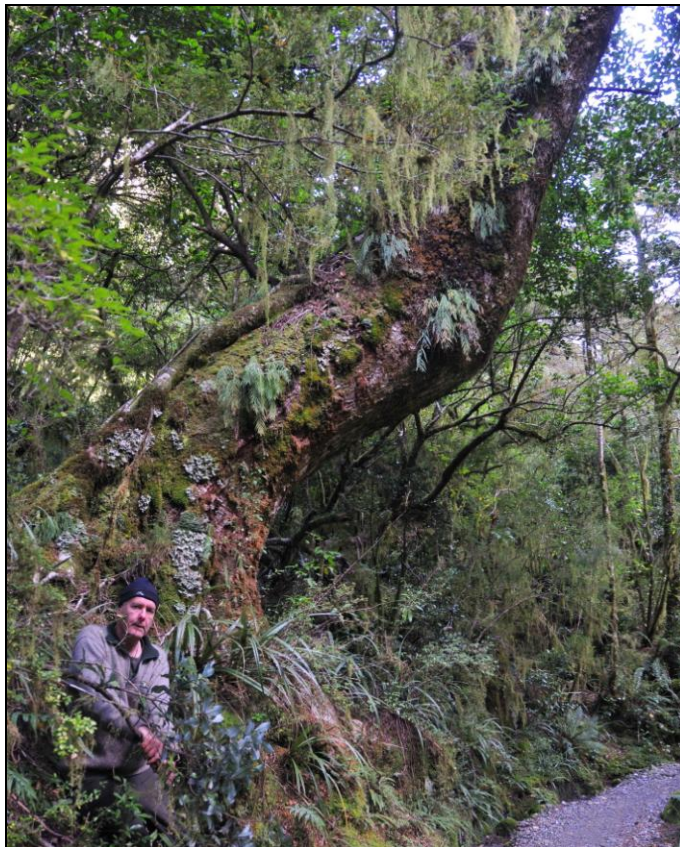
Photo 10. The tree shown here is one of a number of larger (c.1 m diameter), c.325 year old beech trees growing on older rock fall debris around the hut site. This particular tree, which is on the Milford Track about 20 from the hut, was knocked over and tilted by a 1.5 m boulder (out of picture to the left), after which it continued to grow sub-vertically. This suggests there has been a succession of large rock falls on to the Mintaro Hut site in the last few hundred years. The last large rock fall in the hut site area occurred possibly about 183 years ago, during the 1826 Fiordland earthquake (~M 8-8.5)¹.
