FIRST REPORT - INITIAL ASSESSMENT - EARTHQUAKE

Date: 28/11/2017
Claim Ref: HHH1700804
Gallagher Bassett Ref: C57813

Insured Name: Julian Dunn
Situation of Loss: 6 Langley Place
Suburb: Belfast
City: Christchurch
Date of Loss: 14/11/2016

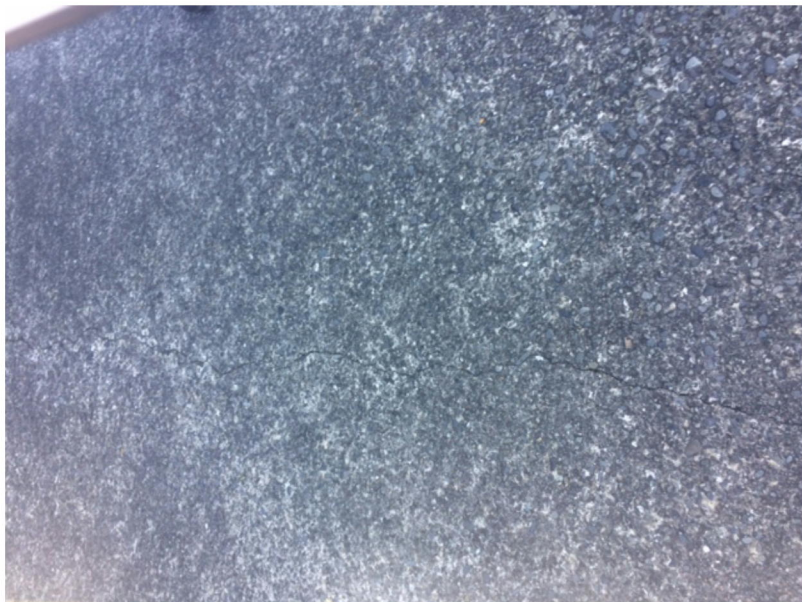
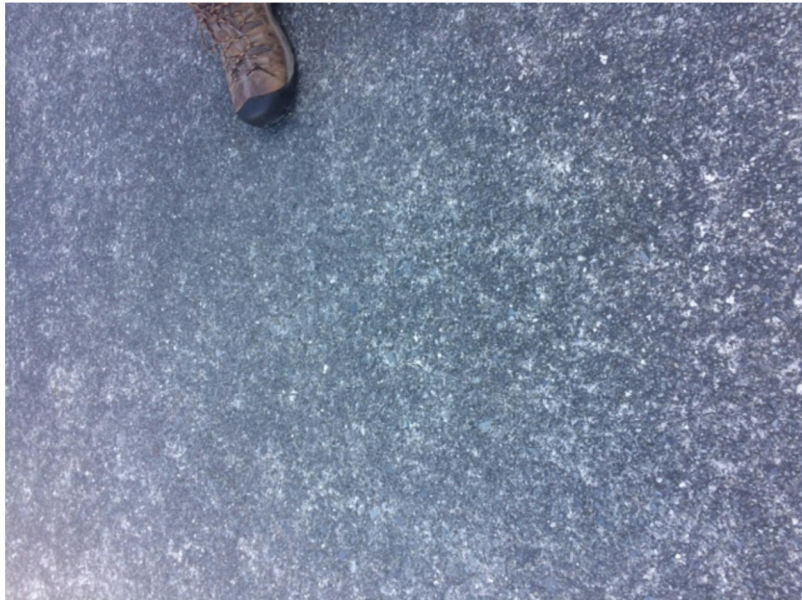
The Insured was concerned about cracking to his driveway.

We inspected the driveway and discussed this with the Insured. We believe the damage is not event related and further to this, the repair cost would not exceed the applicable \$5,000.00 excess.

Figure 1 : Driveway cracks

Figure 2 : Driveway cracks

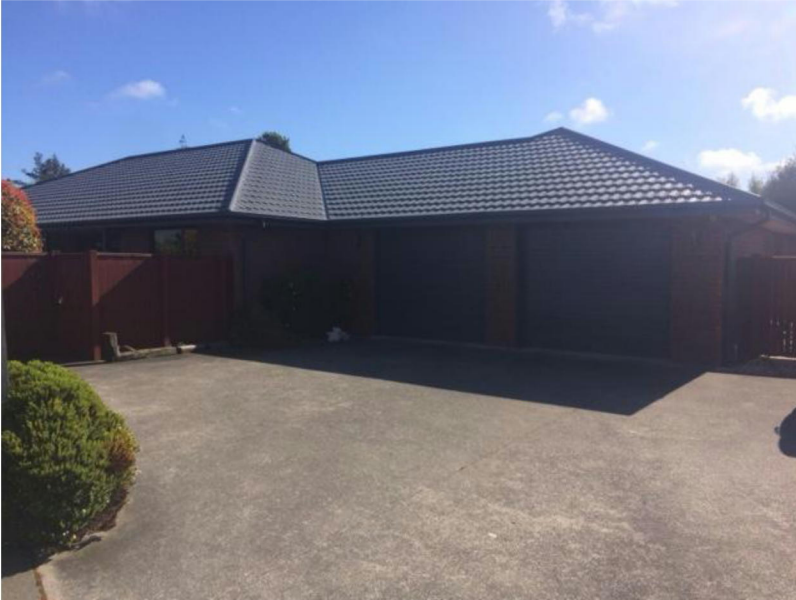
Figure 3 : Insured risk

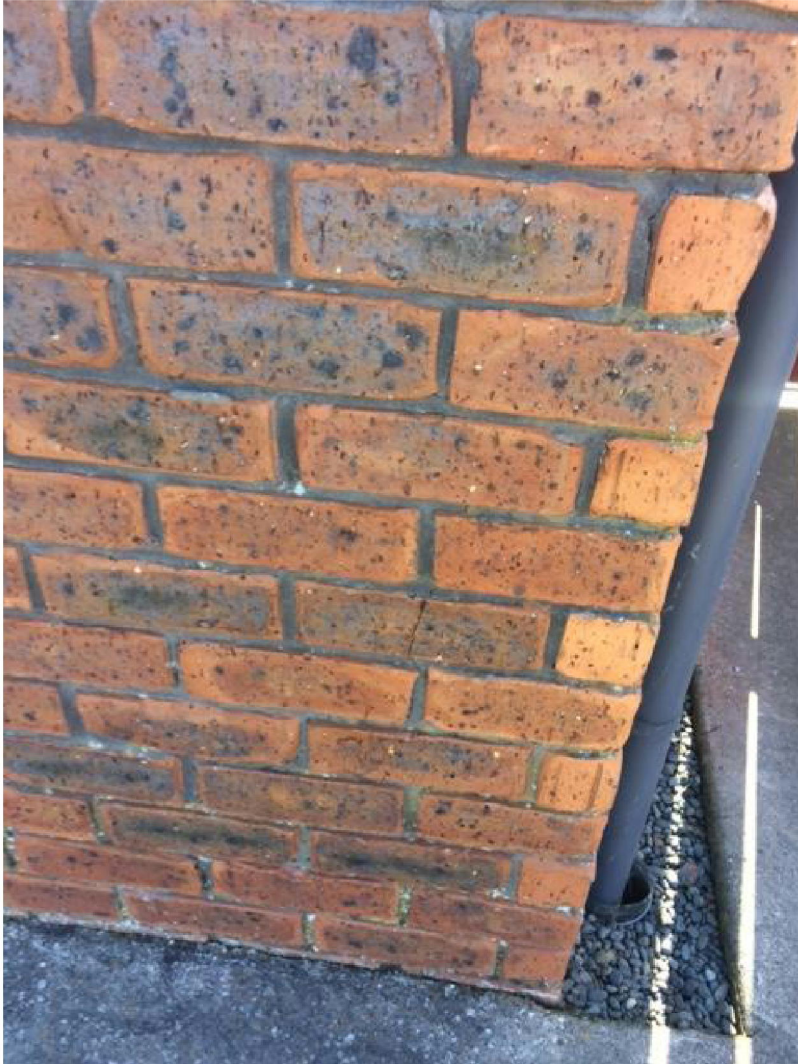
Figure 4 : South west Garage corner

The building envelope consists of a brick veneer wall cladding with a metal tile roof and displays isolated brick mortar cracking to the south west corner of the garage only.

This will respond to targeted repair options.

Category	Location	Treatment	Length	Width	Stud Height	Total Quant	Unit	Rate	Materials/ Subcontractor Rate	Labour Constant	Labour Rate	Total Rate	Total	Notes
Exterior														
	All Exterior Walls													
	Brick	CV1a - Mortar. Rake out joint, remortar and point				10	lm	\$ 50.00			\$ -	\$ 50.00	\$ 500.00

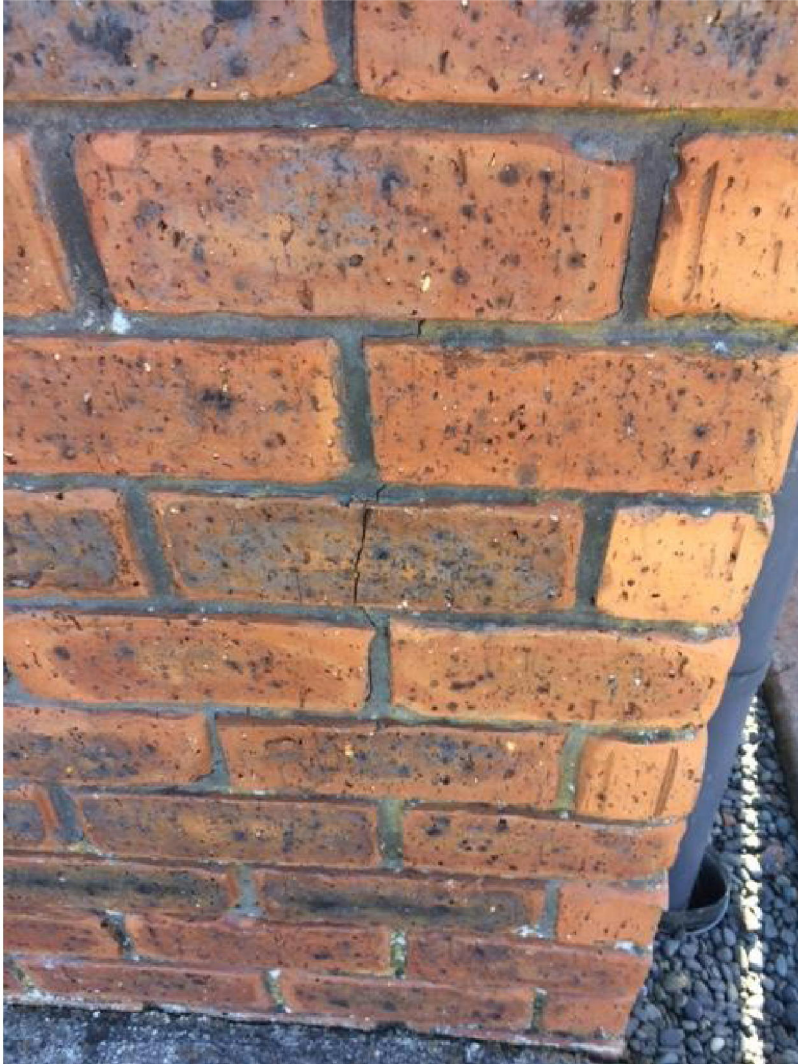
Figure 5 : South west Garage corner, step cracking and a broken brick
