South Taranaki District Council

Asbestos Survey

257 Princes Street, Hawera

Subtitle
Demolition

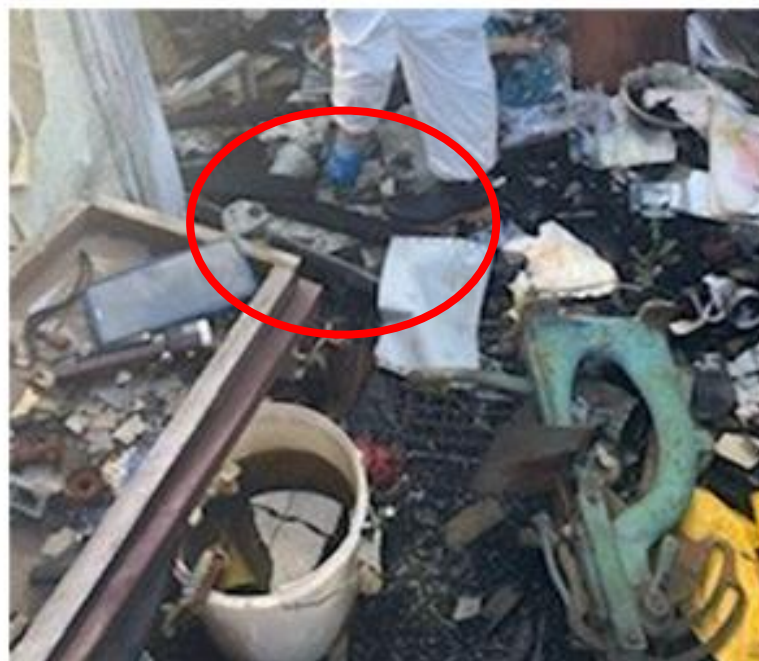
Location 1

Building / Floor	Rear of building	
Floor / Area	On top of debris	
Item / Position:	Ceiling Cladding	
Material:	Fibre Cement	
Extent:	As per photo	
Product Type:	Loose asbestos	3
Condition:	Significant breakage of non-friable materials or several areas of damage to friable material.	2
Surface Treatment:	Unsealed lagging/spray/loose asbestos.	3
Asbestos Type:	Chrysotile	-
Material Assessment:	High	8
Comments		
Photo 1

- All ACM should be removed by a licensed Class A Asbestos removal company.
- Where removal of identified ACM is likely to be in excess of 3 months from the date of sampling, a written Asbestos Management Plan should be developed for all ACM.

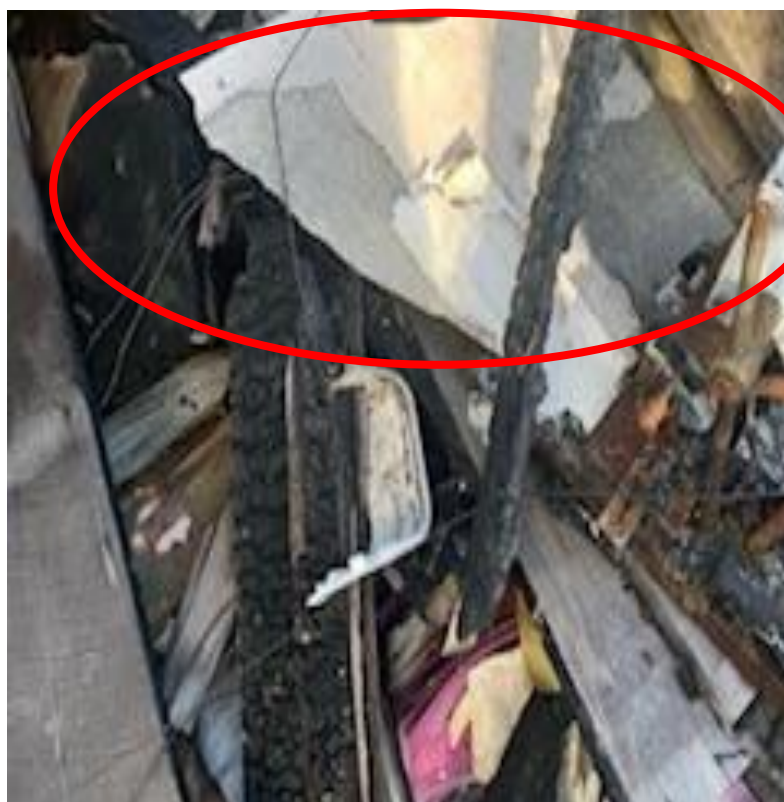
Location 2

Building / Floor:	Rear of building	
Floor / Area:	On top of debris	
Item / Position:	Ceiling Cladding	
Material:	Fibre Cement	
Extent:	As per photo	
Product Type:	Loose asbestos	3
Condition:	Significant breakage of non-friable materials or several areas of damage to friable material.	2
Surface Treatment:	Unsealed lagging/spray/loose asbestos.	3
Asbestos Type:	Chrysotile	-
Material Assessment:	High	8
Comments:		
Photo 1

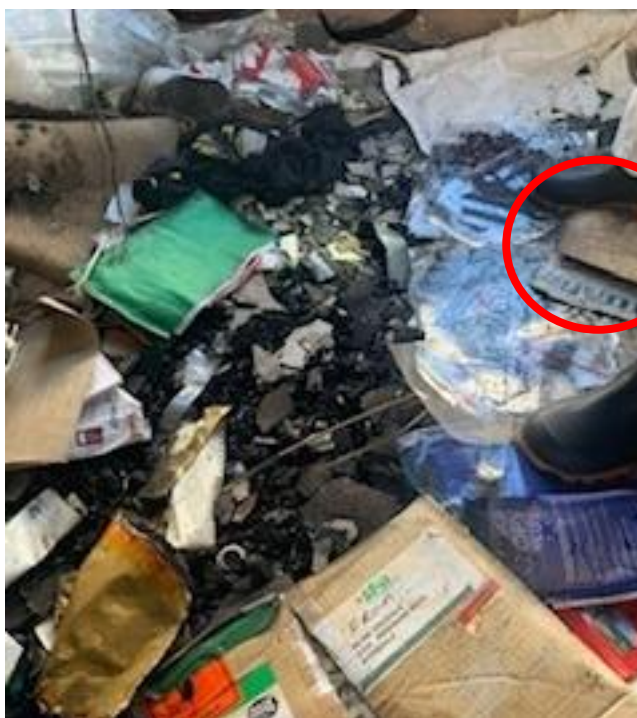
Location 3

Building / Floor:	Centre of building	
Floor / Area:	On top of debris	
Item / Position:	Wall Cladding	
Material:	Fibre Cement	
Extent:	As per photo	
Product Type:	Loose asbestos	3
Condition:	Significant breakage of non-friable materials or several areas of damage to friable material.	2
Surface Treatment:	Unsealed lagging/spray/loose asbestos.	3
Asbestos Type:	Chrysotile	-
Material Assessment:	High	8
Comments:		
Photo 1

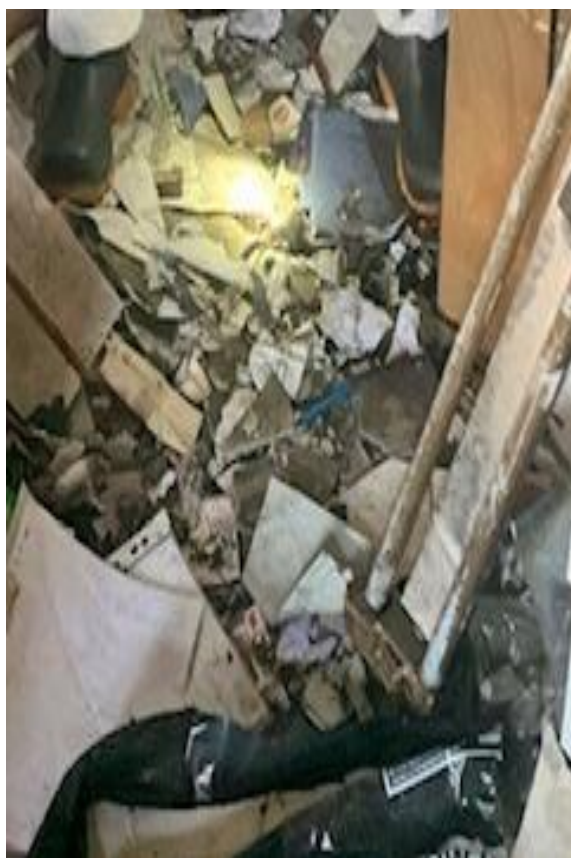
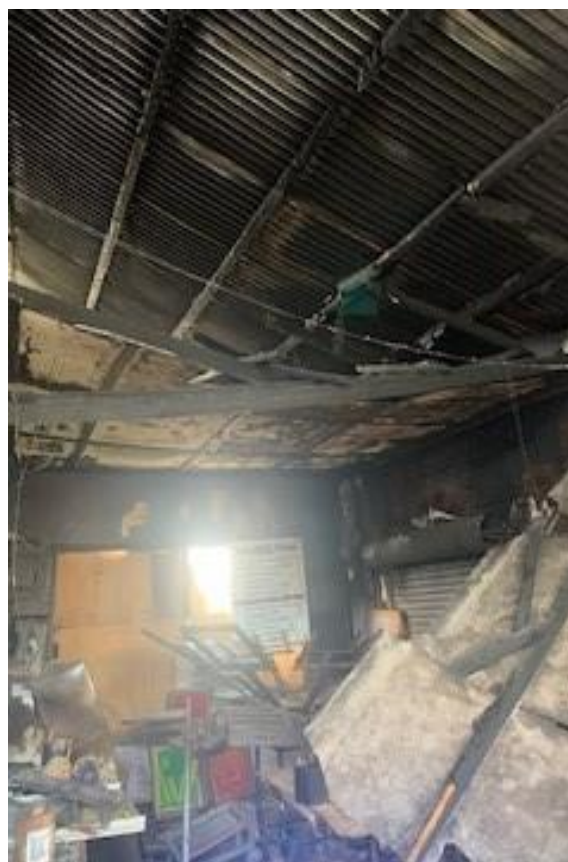
Location 4

Building / Floor:	Centre left of building	
Floor / Area:	On floor of debris	
Item / Position:	Wall Cladding	
Material:	Fibre Cement	
Extent:	As per photos	
Product Type:	Loose asbestos	3
Condition:	Significant breakage of non-friable materials or several areas of damage to friable material.	2
Surface Treatment:	Unsealed lagging/spray/loose asbestos.	3
Asbestos Type:	Chrysotile	-
Material Assessment:	High	8
Comments:		
	Photo 1	Photo 2

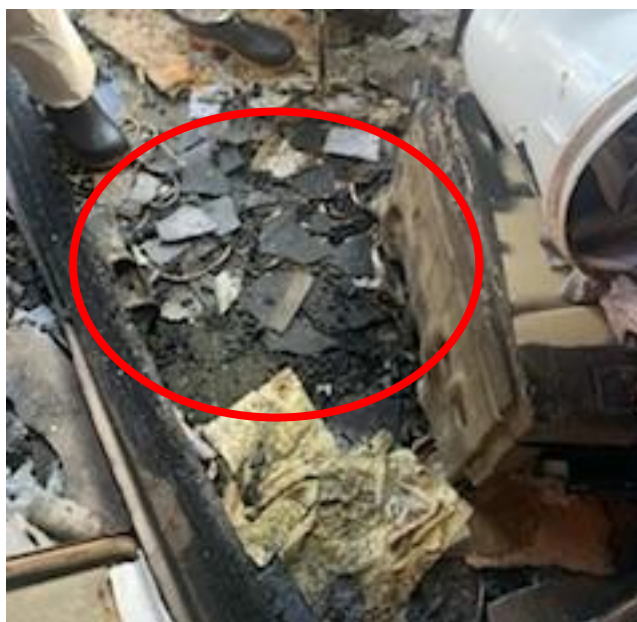
Location 5

Building / Floor:	Centre right of building	
Floor / Area:	On floor of debris	
Item / Position:	Wall Cladding	
Material:	Fibre Cement	
Extent:	As per photo	
Product Type:	Loose asbestos	3
Condition:	Significant breakage of non-friable materials or several areas of damage to friable material.	2
Surface Treatment:	Unsealed lagging/spray/loose asbestos.	3
Asbestos Type:	Chrysotile and Amosite	-
Material Assessment:	High	8
Comments:		
Photo 1

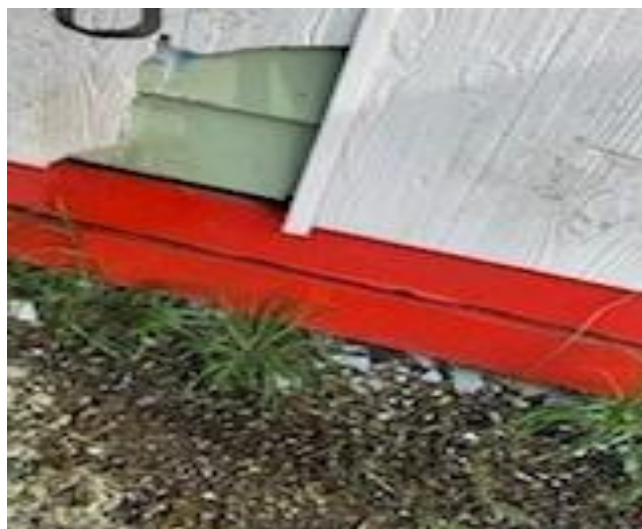
Location 6

Building / Floor:	Front exterior left of building	
Floor / Area:	On exterior wall of building	
Item / Position:	Wall Cladding	
Material:	Fibre Cement	
Extent:	As per photo	
Product Type:	Loose asbestos	3
Condition:	Significant breakage of non-friable materials or several areas of damage to friable material.	2
Surface Treatment:	Unsealed lagging/spray/loose asbestos.	3
Asbestos Type:	Chrysotile and Amosite	-
Material Assessment:	High	8
Comments:		
Photo 1

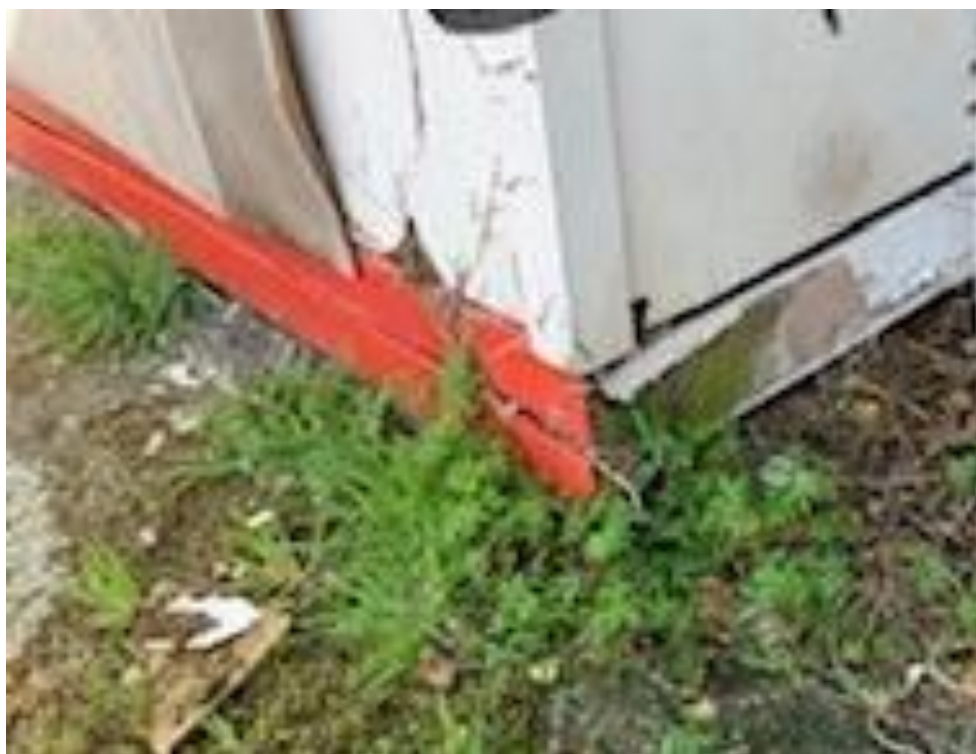
Location 7

Building / Floor:	Front exterior right of building	
Floor / Area:	On exterior wall of building	
Item / Position:	Wall Cladding	
Material:	Fibre Cement	
Extent:	As per photo	
Product Type:	Loose asbestos	3
Condition:	Significant breakage of non-friable materials or several areas of damage to friable material.	2
Surface Treatment:	Unsealed lagging/spray/loose asbestos.	3
Asbestos Type:	Chrysotile	-
Material Assessment:	High	8
Comments:		
Photo 1
