BC90898 (Radio New Zealand House)

Site Specific Asbestos Management Plan

**155 The Terrace, Wellington Central,
Wellington 6011**

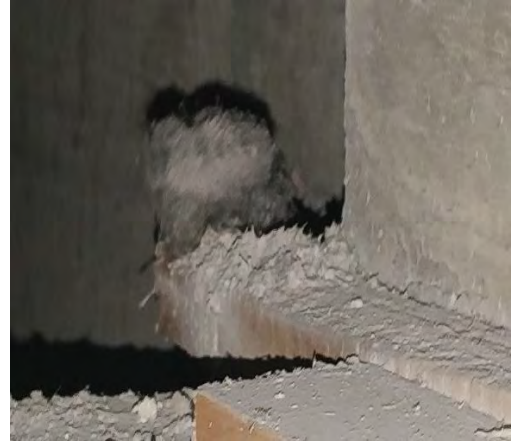
Item #	Level	Material Location	Material Description	Extent	Material Assessment					Accessibility	Labelling Status	Actual Photo
					Product	Extent of Damage	Treatment	Surface	Score			
119	General items	Internal – Inaccessible risers throughout building	Presumed Asbestos internally	Unquantifiable	3	3	3	9	D	Not possible to label

Control Measures		Presumed to contain asbestos unless proven otherwise - do not carry out any work that would cause disturbance to these materials without testing.										
Planned Removal / Remediation		To be tested or removed under appropriate control prior to any works that may cause disturbance.										
Reason for decision		High risk material type. Low risk of exposure when material is left in situ far from reach of general occupants.										
Date of Re-Assessment		July 2022	Remediation time scale		As required
