Radio NZ House - 155 The Terrace Wellington 155 The Terrace Wellington, 6011

Asbestos Management Plan

The Wellington Company Asset Management Limited

Date: 29/11/2019

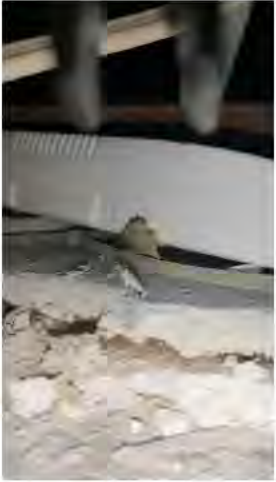
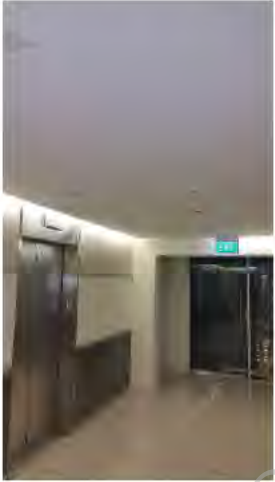
Location	Radio NZ House - 155 The Terrace Wellington, 11th Floor, 001, Entrance Foyer		Sample Number	1 (S)

Item / Position	Insulation board		
		Material:	Insulating Board		
		Extent	50m2		
		Product Type	AIB, Millboards, other low-density insulation boards, asbestos textiles, gaskets, ropes and woven textiles, asbestos paper and felt	2	
		Condition	High damage	3	
		Surface Treatment	Unsealed	3	
		Asbestos Type	Amosite / Crocidolite / Chrysotile	3	
		Material Assessment	High	11	
		Recommendation	Remove		
Comments:					
Remediation Comments:

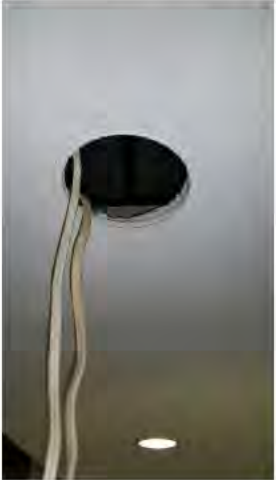
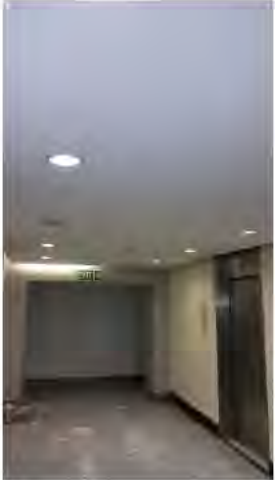
Location	Radio NZ House - 155 The Terrace Wellington, 1st Floor, 001, Entrance Foyer		Sample Number	3 (S)

Item / Position	Insulation board		
		Material:	Insulating Board		
		Extent	50m2		
		Product Type	AIB, Millboards, other low-density insulation boards, asbestos textiles, gaskets, ropes and woven textiles, asbestos paper and felt	2	
		Condition	High damage	3	
		Surface Treatment	Unsealed	3	
		Asbestos Type	Amosite / Crocidolite / Chrysotile	3	
		Material Assessment	High		11
		Recommendation	Remove		
Comments:					
Remediation Comments:

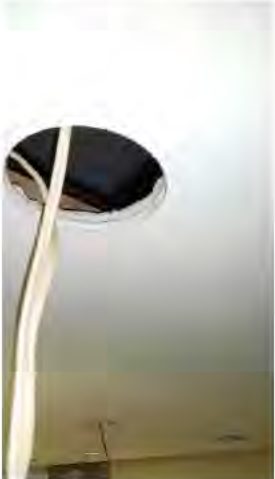
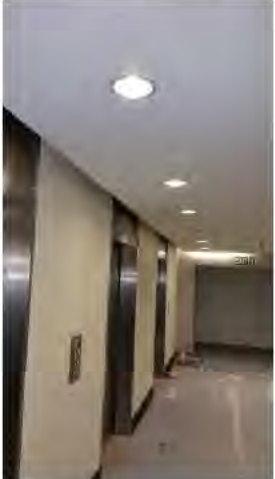
Location	Radio NZ House - 155 The Terrace Wellington, 1st Floor, 001, Entrance Foyer		Sample Number	4 (S)

Item / Position	Textured ceiling		
		Material:	Textured Coating		
		Extent	50m2		
		Product Type	Asbestos reinforced composites etc.	1	
		Condition	High damage		
		Surface Treatment	Unsealed		
		Asbestos Type	Amosite / Crocidolite / Chrysotile		
		Material Assessment	High		
		Recommendation	Remove		
Comments:					
Remediation Comments:	Tiny fragment of fibre cement found in sample

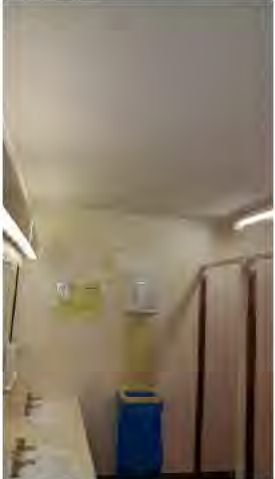
Location	Radio NZ House - 155 The Terrace Wellington, 4th Floor, 005, Toilet		Sample Number	13 (S)

Item / Position	Textured ceiling			
		Material:	Textured Coating			
		Extent	40m2			
		Product Type	Asbestos reinforced composites etc.	1		
		Condition	Low damage	1		
		Surface Treatment	Partially unsealed	2		
		Asbestos Type	Chrysotile	1		
		Material Assessment	Low	5		
		Recommendation	Manage and Label			
Comments:						
Remediation Comments:

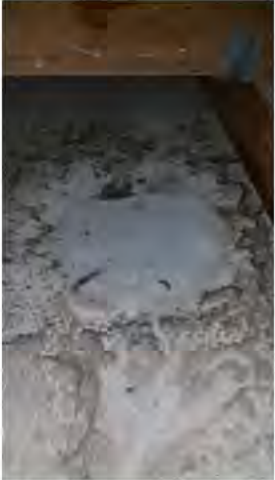
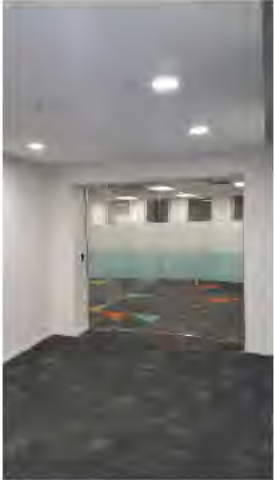
Location	Radio NZ House - 155 The Terrace Wellington, 10th Floor, 005, Entrance Foyer		Sample Number	14 (S)

Item / Position	Insulation board		
		Material:	Insulating Board		
		Extent	50m2		
		Product Type	AIB, Millboards, other low-density insulation boards, asbestos textiles, gaskets, ropes and woven textiles, asbestos paper and felt	2	
		Condition	Good condition	0	
		Surface Treatment	Surface sealed	1	
		Asbestos Type	Amosite / Crocidolite / Chrysotile	3	
		Material Assessment	Low	6	
		Recommendation	Remove		
		Comments:			
Remediation Comments:

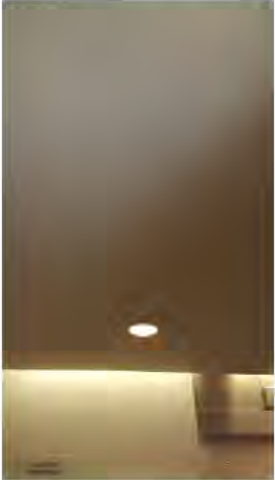
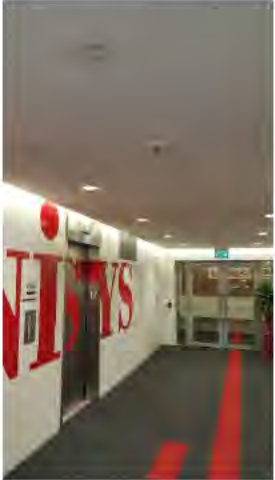
Location	Radio NZ House - 155 The Terrace Wellington, 12th Floor, 037, Entrance Foyer		Sample Number	3 (X)

Item / Position	Insulation board		
		Material:	Insulating Board		
		Extent	50m2		
		Product Type	AIB, Millboards, other low-density insulation boards, asbestos textiles, gaskets, ropes and woven textiles, asbestos paper and felt	2	
		Condition	High damage	3	
		Surface Treatment	Unsealed	3	
		Asbestos Type	Amosite / Crocidolite / Chrysotile	3	
		Material Assessment	High		11
		Recommendation	Remove		
Comments:					
Remediation Comments:

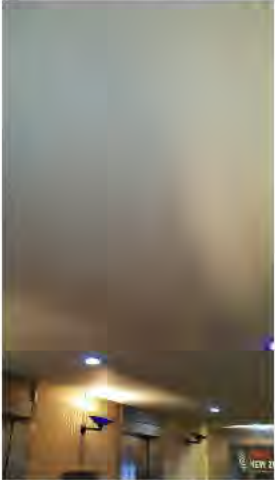
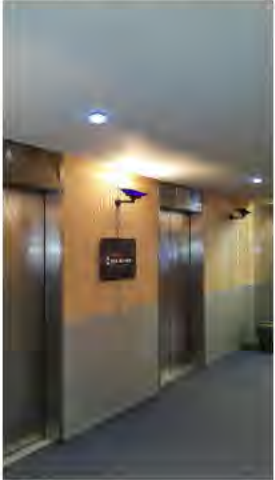
Location	Radio NZ House - 155 The Terrace Wellington, 2nd Floor, 045, Entrance Foyer		Sample Number	3 (X)

Item / Position	Insulation board			
		Material:	Insulating Board			
		Extent	50m2			
		Product Type	AIB, Millboards, other low-density insulation boards, asbestos textiles, gaskets, ropes and woven textiles, asbestos paper and felt	2		
		Condition	High damage	3		
		Surface Treatment	Unsealed	3		
		Asbestos Type	Amosite / Crocidolite / Chrysotile	3		
		Material Assessment	High		11	
		Recommendation	Remove			
Comments:						
Remediation Comments:

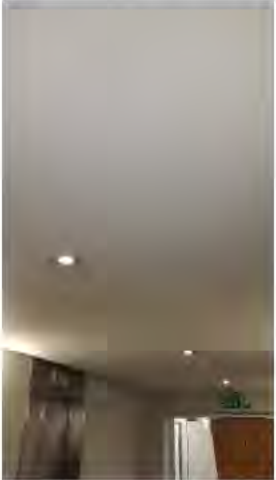
Location	Radio NZ House - 155 The Terrace Wellington, 3rd Floor, 044, Entrance Foyer		Sample Number	3 (X)

Item / Position	Insulation board			
		Material:	Insulating Board			
		Extent	50m2			
		Product Type	AIB, Millboards, other low-density insulation boards, asbestos textiles, gaskets, ropes and woven textiles, asbestos paper and felt	2		
		Condition	High damage	3		
		Surface Treatment	Unsealed	3		
		Asbestos Type	Amosite / Crocidolite / Chrysotile	3		
		Material Assessment	High		11	
		Recommendation	Remove			
Comments:						
Remediation Comments:

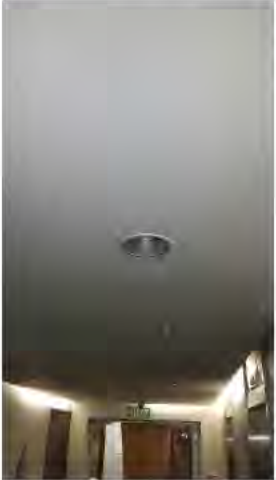
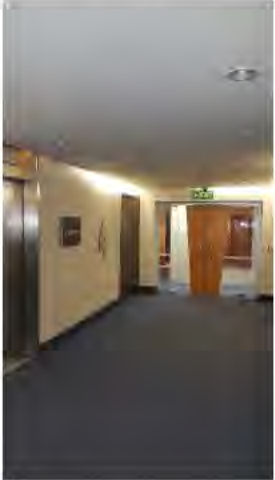
Location	Radio NZ House - 155 The Terrace Wellington, 4th Floor, 043, Entrance Foyer		Sample Number	3 (X)

Item / Position	Insulation board		
		Material:	Insulating Board		
		Extent	50m2		
		Product Type	AIB, Millboards, other low-density insulation boards, asbestos textiles, gaskets, ropes and woven textiles, asbestos paper and felt	2	
		Condition	High damage	3	
		Surface Treatment	Unsealed	3	
		Asbestos Type	Amosite / Crocidolite / Chrysotile	3	
		Material Assessment	High	11	
		Recommendation	Remove		
Comments:					
Remediation Comments:

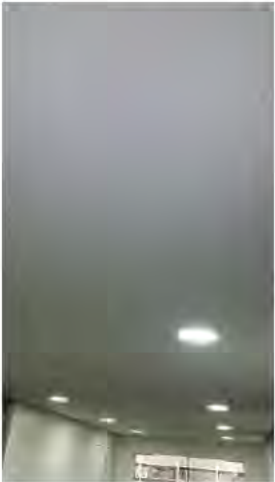
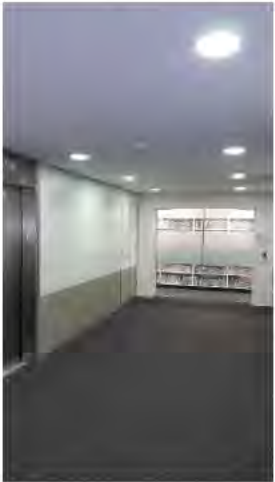
Location	Radio NZ House - 155 The Terrace Wellington, 6th Floor, 041, Entrance Foyer		Sample Number	3 (X)

Item / Position	Insulation board		
		Material:	Insulating Board		
		Extent	50m2		
		Product Type	AIB, Millboards, other low-density insulation boards, asbestos textiles, gaskets, ropes and woven textiles, asbestos paper and felt	2	
		Condition	High damage	3	
		Surface Treatment	Unsealed	3	
		Asbestos Type	Amosite / Crocidolite / Chrysotile	3	
		Material Assessment	High	11	
		Recommendation	Remove		
Comments:					
Remediation Comments:

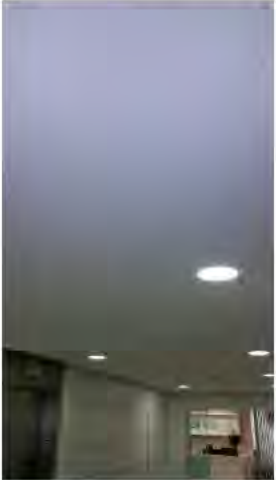
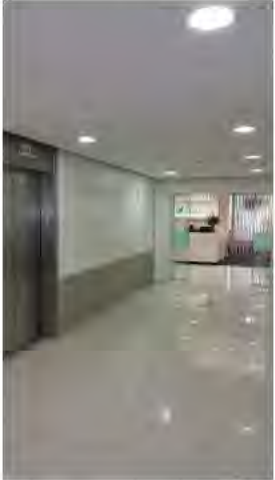
Location	Radio NZ House - 155 The Terrace Wellington, 7th Floor, 040, Entrance Foyer		Sample Number	3 (X)

Item / Position	Insulation board		
		Material:	Insulating Board		
		Extent	50m2		
		Product Type	AIB, Millboards, other low-density insulation boards, asbestos textiles, gaskets, ropes and woven textiles, asbestos paper and felt	2	
		Condition	High damage	3	
		Surface Treatment	Unsealed	3	
		Asbestos Type	Amosite / Crocidolite / Chrysotile	3	
		Material Assessment	High		11
		Recommendation	Remove		
		Comments:			
Remediation Comments:

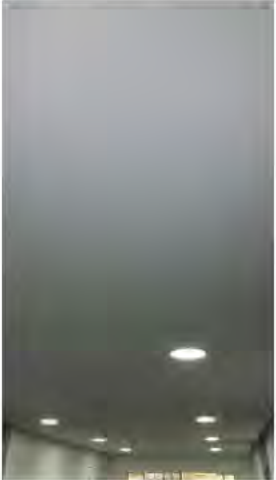
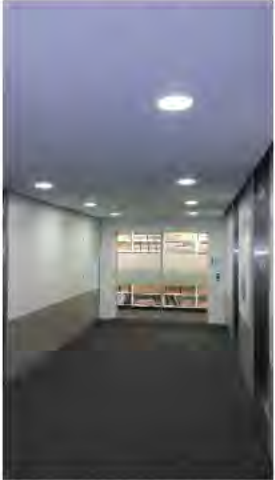
Location	Radio NZ House - 155 The Terrace Wellington, 8th Floor, 039, Entrance Foyer		Sample Number	3 (X)

Item / Position	Insulation board		
		Material:	Insulating Board		
		Extent	50m2		
		Product Type	AIB, Millboards, other low-density insulation boards, asbestos textiles, gaskets, ropes and woven textiles, asbestos paper and felt	2	
		Condition	High damage	3	
		Surface Treatment	Unsealed	3	
		Asbestos Type	Amosite / Crocidolite / Chrysotile	3	
		Material Assessment	High	11	
		Recommendation	Remove		
Comments:					
Remediation Comments:

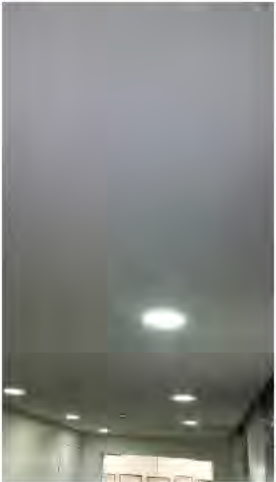
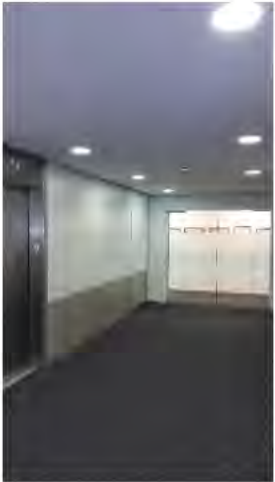
Location	Radio NZ House - 155 The Terrace Wellington, 9th Floor, 038, Entrance Foyer		Sample Number	3 (X)

Item / Position	Insulation board			
		Material:	Insulating Board			
		Extent	50m2			
		Product Type	AIB, Millboards, other low-density insulation boards, asbestos textiles, gaskets, ropes and woven textiles, asbestos paper and felt	2		
		Condition	High damage	3		
		Surface Treatment	Unsealed	3		
		Asbestos Type	Amosite / Crocidolite / Chrysotile	3		
		Material Assessment	High	11		
		Recommendation	Remove			
Comments:						
Remediation Comments:

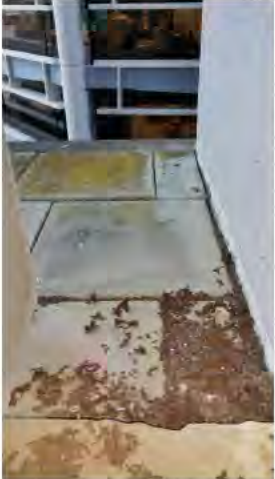
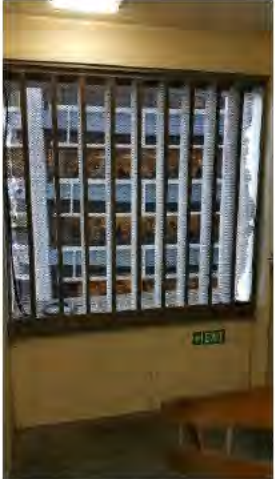
Location	Radio NZ House - 155 The Terrace Wellington, Basement, 032, Basement		Sample Number	1 (P)

Item / Position	Cement tile - based from prior tiles on level 1 balcony.		
		Material:	Cement Product		
		Extent	3m2		
		Product Type	Asbestos reinforced composites etc.	1	
		Condition	Good condition		
		Surface Treatment	Unsealed		
		Asbestos Type	Presumed Asbestos		
		Material Assessment	Medium		
		Recommendation	Remove		
		Comments:			
Remediation Comments:

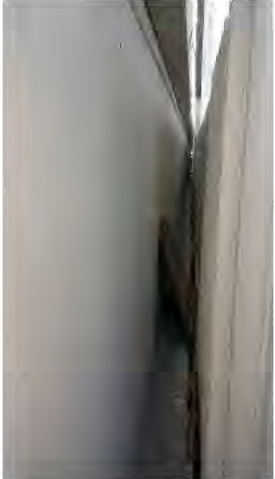
Location	Radio NZ House - 155 The Terrace Wellington, Ground Floor, 053, External South Cement Wall		Sample Number	2 (P)

Item / Position	Cement cladding		
		Material:	Cement Product		
		Extent	100m2		
		Product Type	Asbestos reinforced composites etc.	1	
		Condition	Good condition		0
		Surface Treatment	Unsealed		3
		Asbestos Type	Presumed Asbestos		3
		Material Assessment	Medium		7
		Recommendation	Manage		
Comments:					
Remediation Comments:

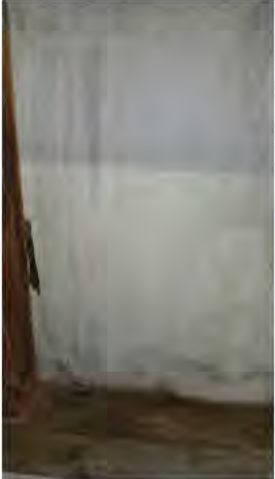
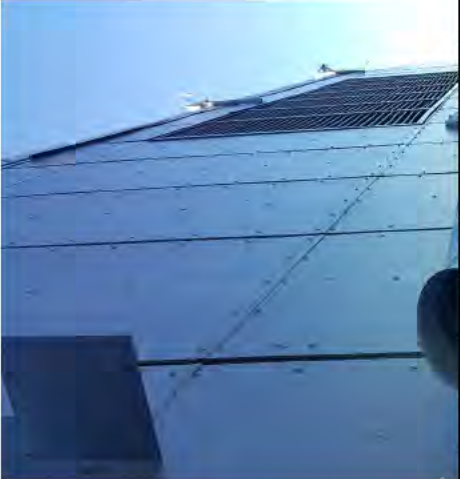
Location	Radio NZ House - 155 The Terrace Wellington, 13th Floor, 005, Plant Room		Sample Number	3 (P)

Item / Position	Cement cladding - Prior reports indicate positive for asbestos			
		Material:	Cement Product			
		Extent	1600m2			
		Product Type	Asbestos reinforced composites etc.	1		
		Condition	Low damage	1		
		Surface Treatment	Unsealed	3		
		Asbestos Type	Crocidolite	3		
		Material Assessment	Medium	8		
		Recommendation	Manage and Label			
Comments:						
Remediation Comments:

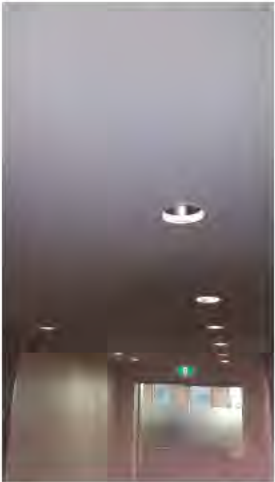
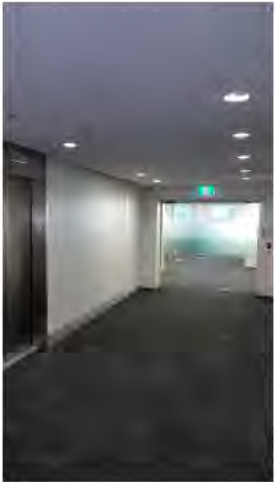
Location	Radio NZ House - 155 The Terrace Wellington, 5th Floor, 042, Entrance Foyer		Sample Number	126089 (PS)

Item / Position	Insulation board			
		Material:	Insulating Board			
		Extent	50m2			
		Product Type	AIB, Millboards, other low-density insulation boards, asbestos textiles, gaskets, ropes and woven textiles, asbestos paper and felt	2		
		Condition	High damage	3		
		Surface Treatment	Unsealed	3		
		Asbestos Type	Amosite / Crocidolite / Chrysotile	3		
		Material Assessment	High		11	
		Recommendation	Remove			
		Comments:				
Remediation Comments:

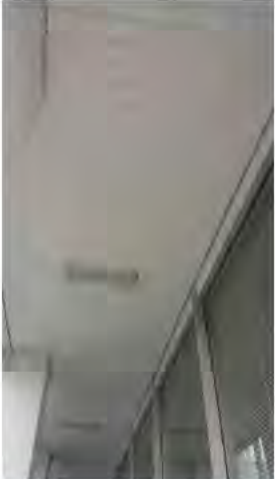
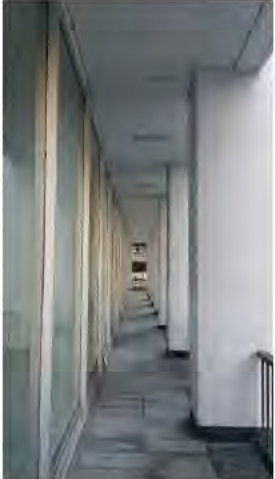
Location	Radio NZ House - 155 The Terrace Wellington, Ground Floor, 052, Balcony		Sample Number	51811 (PS)

Item / Position	Cement soffits		
		Material:	Cement Product		
		Extent	200m2		
		Product Type	Asbestos reinforced composites etc.	1	
		Condition	Good condition		
		Surface Treatment	Surface sealed		
		Asbestos Type	Amosite / Crocidolite / Chrysotile		
		Material Assessment	Low		
		Recommendation	Manage		
Comments:					
Remediation Comments:

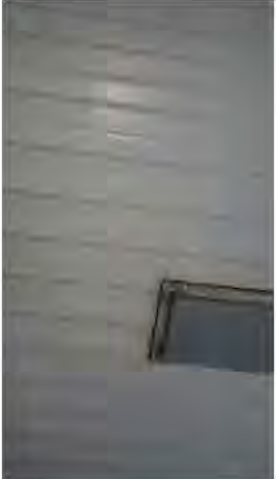
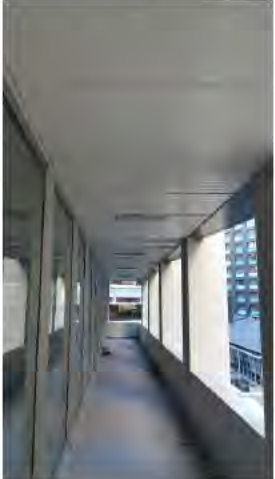
Location	Radio NZ House - 155 The Terrace Wellington, 1st Floor, 046, Balcony		Sample Number	51811 (PS)

Item / Position	Cement soffits		
		Material:	Cement Product		
		Extent	200m2		
		Product Type	Asbestos reinforced composites etc.	1	
		Condition	Good condition		
		Surface Treatment	Surface sealed		
		Asbestos Type	Amosite / Crocidolite / Chrysotile		
		Material Assessment	Low		
		Recommendation	Manage		
Comments:					
Remediation Comments:

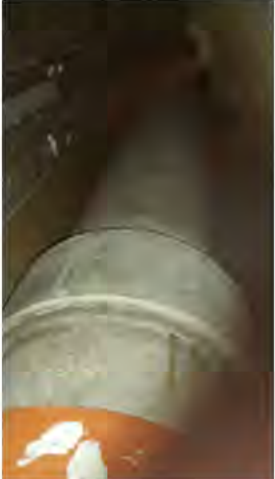
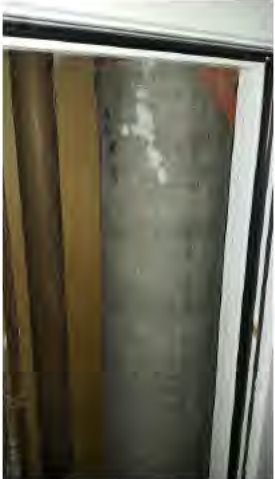
Location	Radio NZ House - 155 The Terrace Wellington, 1st Floor, 050, Riser		Sample Number	85173 (PS)

Item / Position	Cement pipe		
		Material:	Cement Product		
		Extent	60lin m		
		Product Type	Asbestos reinforced composites etc.	1	
		Condition	Good condition		
		Surface Treatment	Unsealed		
		Asbestos Type	Amosite / Chrysotile		
		Material Assessment	Low		
		Recommendation	Manage		
Comments:					
Remediation Comments:

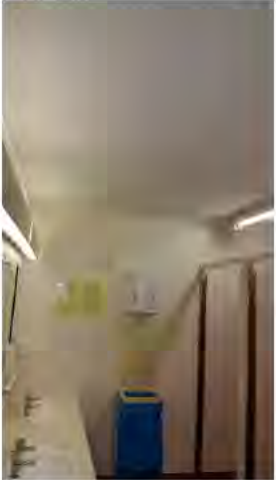
Location	Radio NZ House - 155 The Terrace Wellington, 4th Floor, 005, Toilet		Sample Number	85173 (PS)

No close-up photo available	Item / Position	Sprayed Coating		
		Material:	Sprayed Coating		
		Extent	50m2		
		Product Type	Thermal insulation (eg pipe and boiler lagging), sprayed asbestos, loose asbestos, asbestos mattresses and packing.	3	
		Condition	High damage	3	
		Surface Treatment	Unsealed	3	
		Asbestos Type	Amosite	2	
		Material Assessment	High	11	
		Recommendation	Remove		
Comments:	A previous survey indicated sprayed coating in the riser behind the toilet wall.				
Remediation Comments:	Inspect prior to maintenance or works.

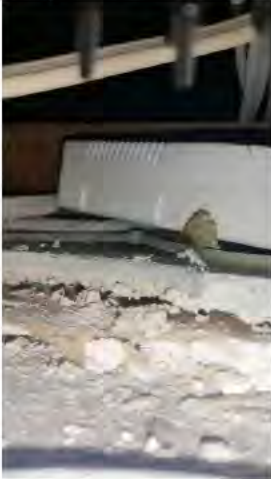
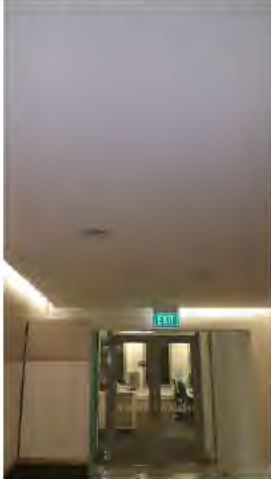
Location	Radio NZ House - 155 The Terrace Wellington, 11th Floor, 001, Entrance Foyer		Sample Number	2 (S)

Item / Position	Textured ceiling - Applied to cement board	
		Material:	Textured Coating	
		Extent	50m2	
		Product Type	N/A	N/A
		Condition	N/A	N/A
		Surface Treatment	N/A	N/A
		Asbestos Type	NAD	N/A
		Material Assessment	N/A	0
		Recommendation	No further action required	
		Comments:

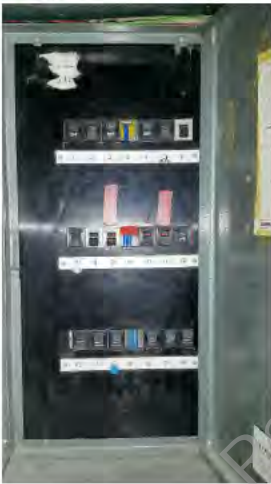
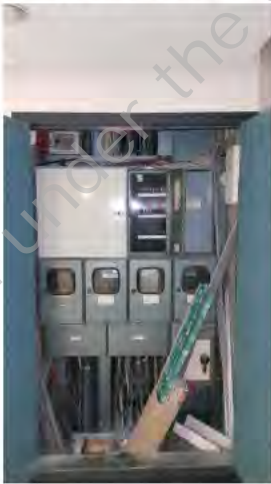
Location	Radio NZ House - 155 The Terrace Wellington, 1st Floor, 001, Entrance Foyer		Sample Number	5 (S)

Item / Position	Electrical switch board	
		Material:	PVC / Reinforced Plastics	
		Extent	1m2	
		Product Type	N/A	N/A
		Condition	N/A	N/A
		Surface Treatment	N/A	N/A
		Asbestos Type	NAD	N/A
		Material Assessment	N/A	0
		Recommendation	No further action required	
		Comments:

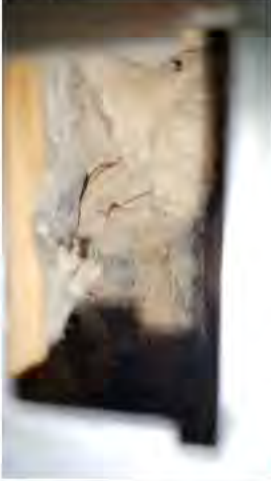
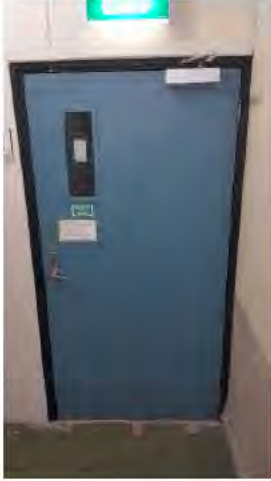
Location		Radio NZ House - 155 The Terrace Wellington, 1st Floor, 002, Stairwell North		Sample Number	6 (S)

Item / Position	Door		
		Material:	Insulation		
		Extent	3m2		
		Product Type	N/A	N/A	
		Condition	N/A	N/A	
		Surface Treatment	N/A	N/A	
		Asbestos Type	NAD	N/A	
		Material Assessment	N/A	0	
		Recommendation	No further action required		
		Comments:

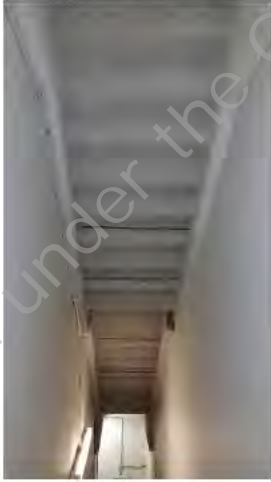
Location		Radio NZ House - 155 The Terrace Wellington, 1st Floor, 002, Stairwell North		Sample Number	7 (S)

Item / Position	Textured ceiling		
		Material:	Sprayed Coating		
		Extent	50m2		
		Product Type	N/A	N/A	
		Condition	N/A	N/A	
		Surface Treatment	N/A	N/A	
		Asbestos Type	NAD	N/A	
		Material Assessment	N/A	0	
		Recommendation	No further action required		
		Comments:

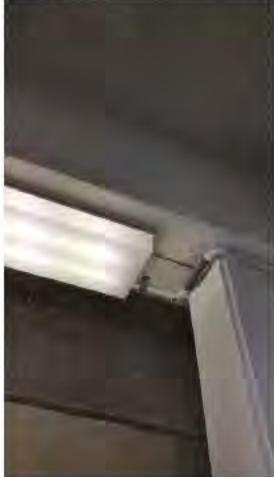
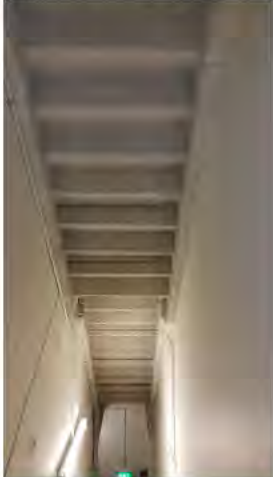
Location	Radio NZ House - 155 The Terrace Wellington, 1st Floor, 003, Stairwell South		Sample Number	8 (S)

Item / Position	Textured ceiling		
	Material:	Sprayed Coating		
	Extent	50		
	Product Type	N/A	N/A	
	Condition	N/A	N/A	
	Surface Treatment	N/A	N/A	
	Asbestos Type	NAD	N/A	
	Material Assessment	N/A	0	
	Recommendation	No further action required		
	Comments:

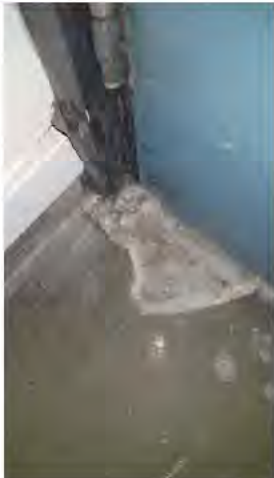
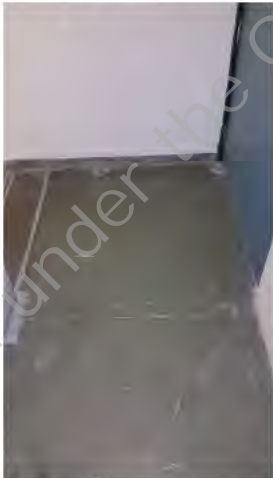
Location	Radio NZ House - 155 The Terrace Wellington, 1st Floor, 003, Stairwell South		Sample Number	9 (S)

Item / Position	Vinyl flooring		
	Material:	Vinyl Products		
	Extent	2.5m2		
	Product Type	N/A	N/A	
	Condition	N/A	N/A	
	Surface Treatment	N/A	N/A	
	Asbestos Type	NAD	N/A	
	Material Assessment	N/A	0	
	Recommendation	No further action required		
	Comments:

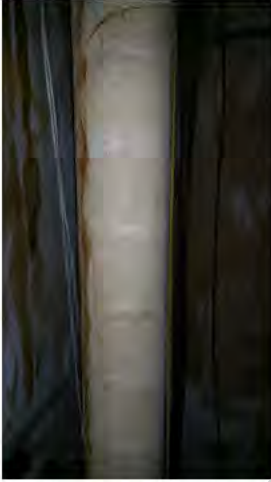
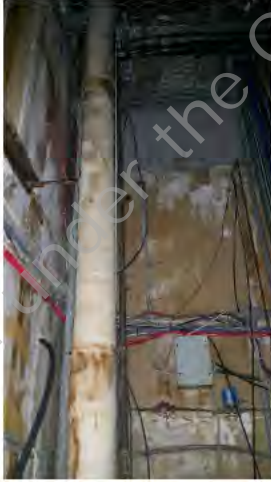
Location	Radio NZ House - 155 The Terrace Wellington, 1st Floor, 005, Duct		Sample Number	11 (S)

Item / Position	Lagging (insulation) - Small pipe		
	Material:	Insulated pipework / services		
	Extent	150lin m		
	Product Type	N/A	N/A	
	Condition	N/A	N/A	
	Surface Treatment	N/A	N/A	
	Asbestos Type	NAD	N/A	
	Material Assessment	N/A	0	
	Recommendation	No further action required		
	Comments:

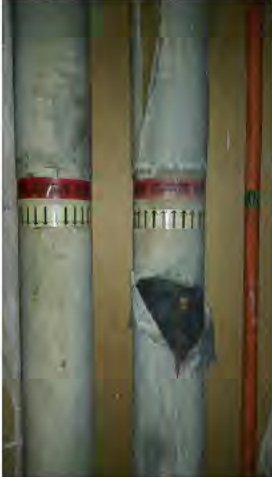
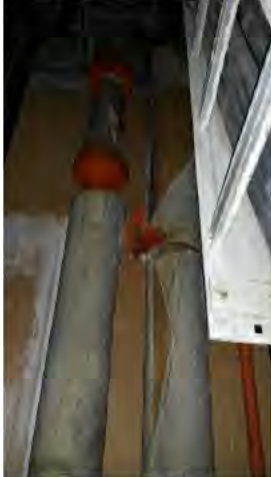
Location	Radio NZ House - 155 The Terrace Wellington, 1st Floor, 005, Duct		Sample Number	12 (S)

Item / Position	Lagging (insulation) - Large pipe x2		
	Material:	Insulated pipework / services		
	Extent	300lin m		
	Product Type	N/A	N/A	
	Condition	N/A	N/A	
	Surface Treatment	N/A	N/A	
	Asbestos Type	NAD	N/A	
	Material Assessment	N/A	0	
	Recommendation	No further action required		
	Comments:
