Napier Rainfall Event November 2020

Hazard Report

Hawkes Bay Regional Council Publication No. 5551

Jim Tetlow, Toa Consulting
Craig Goodier, Team Leader Engineering
Lisa Pearse, Team Leader Hazard Reduction

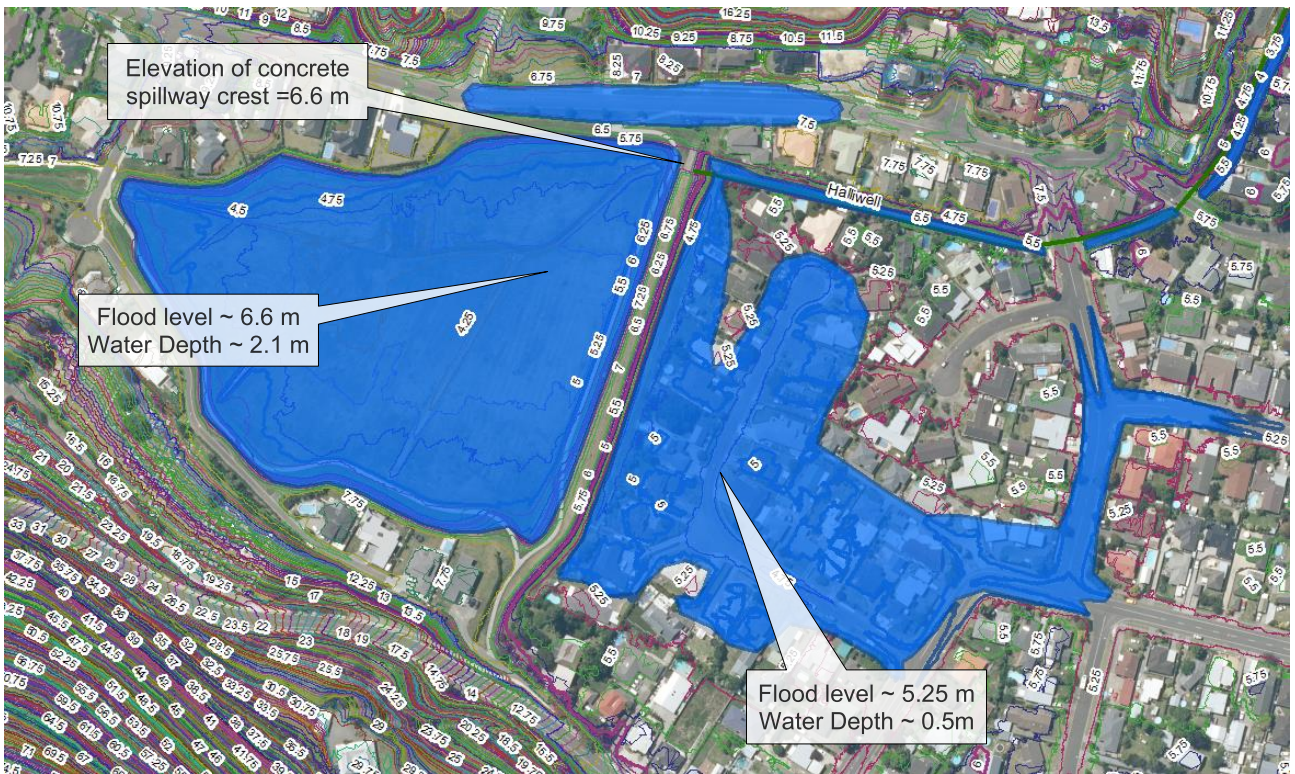
Figure 25: Halliwell Dam – flood extents within dam and downstream on Birdwood Street (contour datum NZVD16)

Immediately downstream of Halliwell Dam, a group of properties on Birdwood Street were flooded, with several houses and garages becoming inundated. The contours in Figure 25 show the ground levels in the area as low as elev. 4.75m while the surrounding land rises to around elev. 5.5m. Flood levels in this area reached approximately elev. 5.25m.

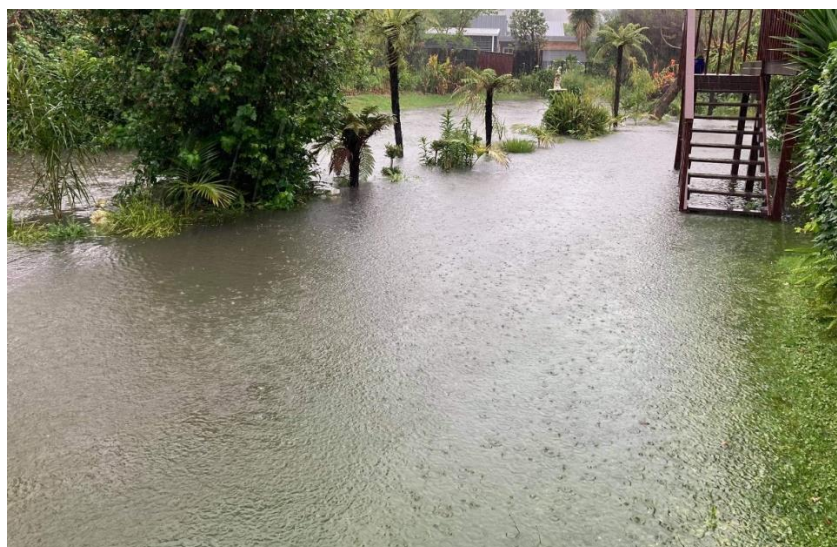
Along the Taipo Stream, water levels were high, with flood levels above the normal low flow channel, rising to cover the berm areas in most places. A comparison of observed flood levels to modelled flood levels at the lower Church Road bridge indicates the return period for the flooding along the Taipo stream is in the order of 10 years in this location. At the Ngarimu Road/Church Road crossing the observed flood level was approximately elev. 4.5m. At this location, the modelled 50-year flood level is elev. 4.85m, indicating the event likely had a return period of less than 50 years in this location. Figures 30 and 31 show the details of this location.

Figure 30: Taipo Stream u/s of Church Road, near Ngarimu Cres. Flood Level ~ 4.5 m (NZVD16)

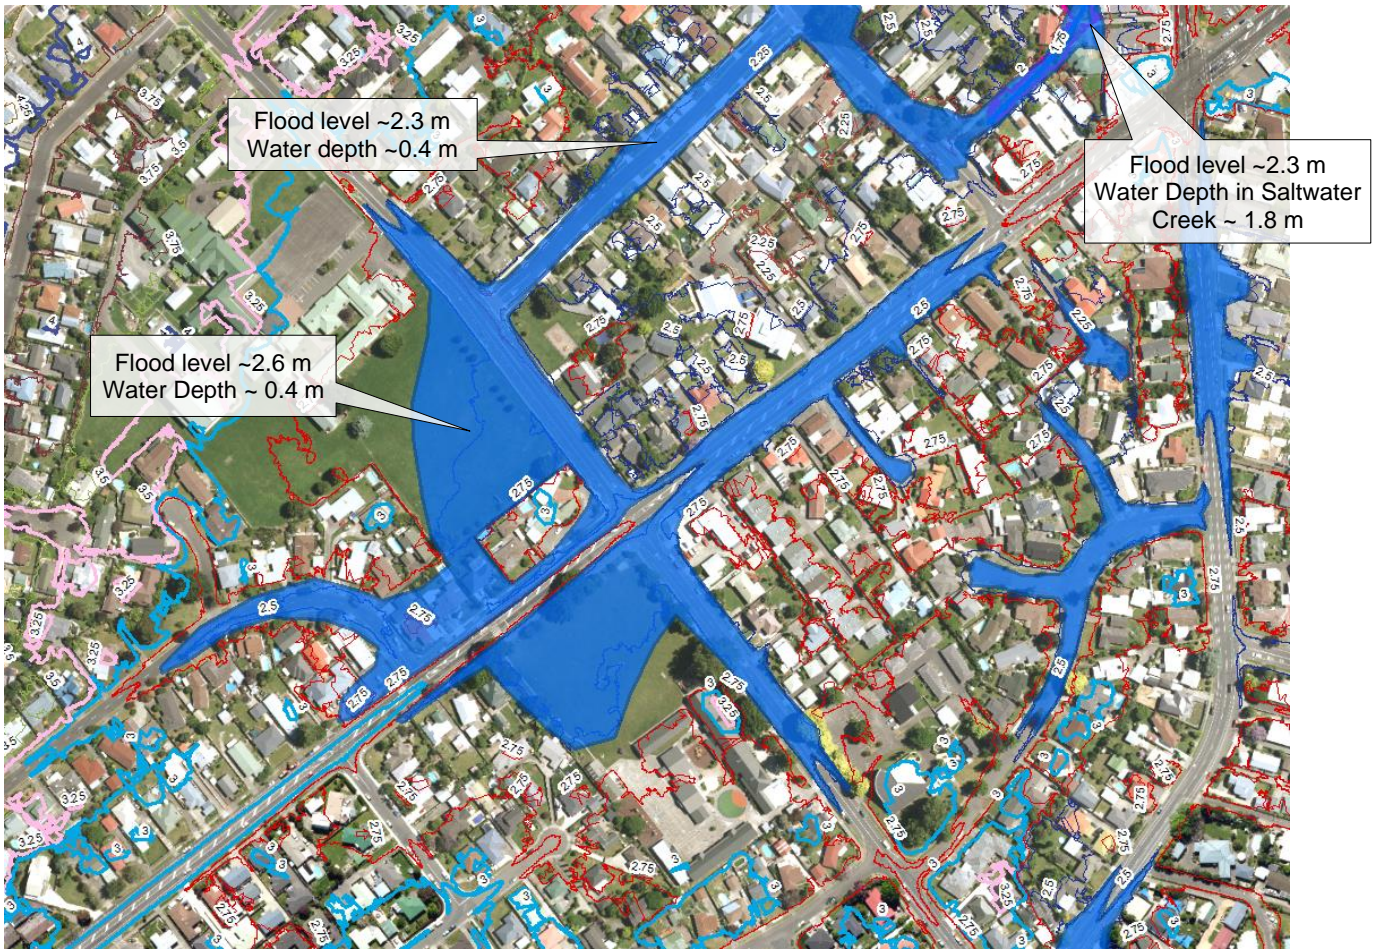
In the Taradale/Greenmeadows area, flooding occurred around the Gloucester, Osier, Avenue Road area, which as seen in Figure 41, is a relatively low area with elevations around 2.5m (NZVD16). This area flows to Saltwater Creek, which has a relatively low gradient and discharges to the Purimu Stream upstream of the Purimu pump station. Flooding in this area occurring mostly in the road reserve, however several properties and houses were also inundated.

Figure 41: Flood extents in Taradale/Greenmeadows also showing contours (datum NZVD16)

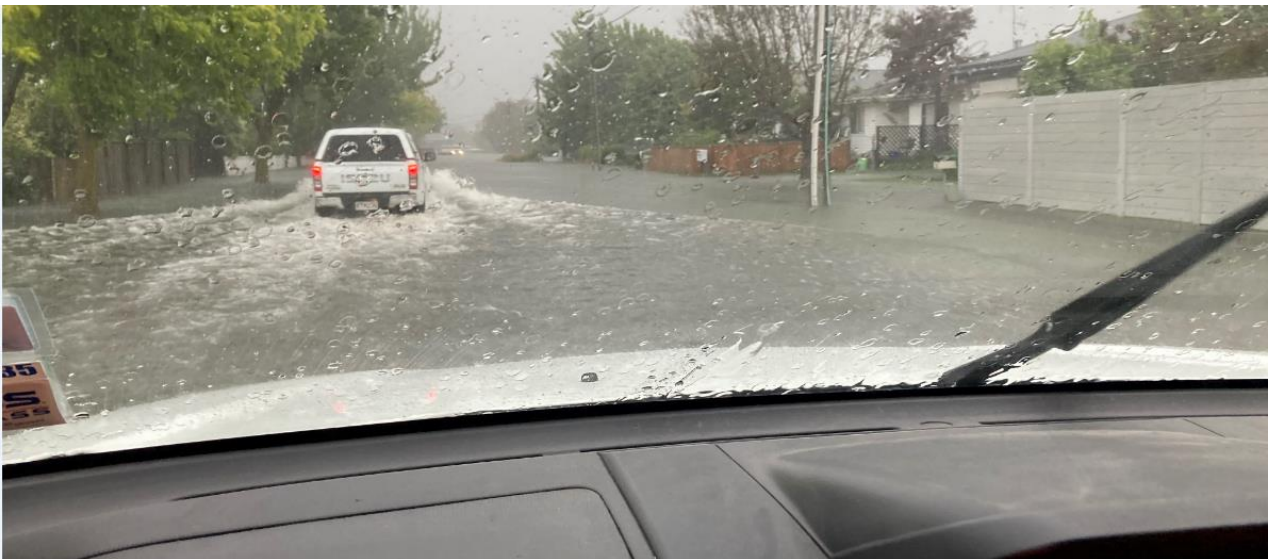
- The extent of damage to properties was potentially exacerbated by the continued use of roads by vehicles, which created bow waves that increased water heights in surrounding properties.

Figure 43: Flooding along Avenue Road

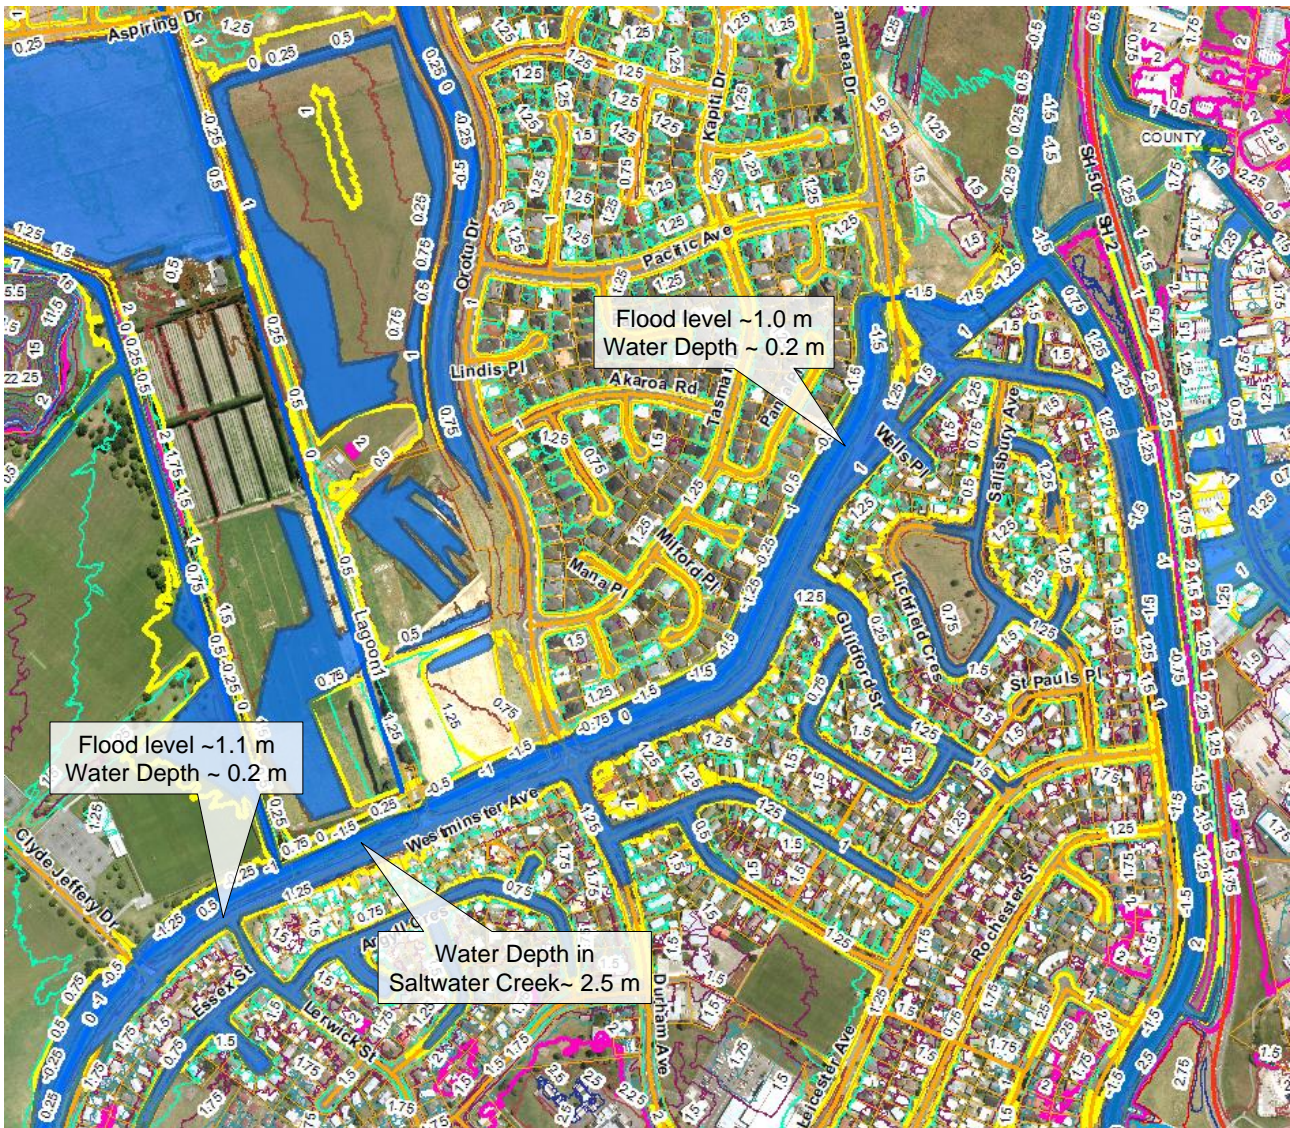
In Tamatea, where the lower reach of Saltwater Creek flows beside Westminster Avenue, the road reserve became inundated as shown in Figure 44. Flooding in this area is not uncommon, with more severe flooding occurring in this area in the October 2004 event. It should be noted this area of Tamatea has been designed with the roads relatively low to hold the flood waters flowing to the Purimu pump station. There did not appear to be any inundation of private property in this area. The 50 year modelled flood extents are greater than the flood extents which occurred during the 9th November event, indicating the return period for the event in this location is likely to be less than 50 years.

Figure 44: Flood Extents in Tamatea (datum NZVD16)

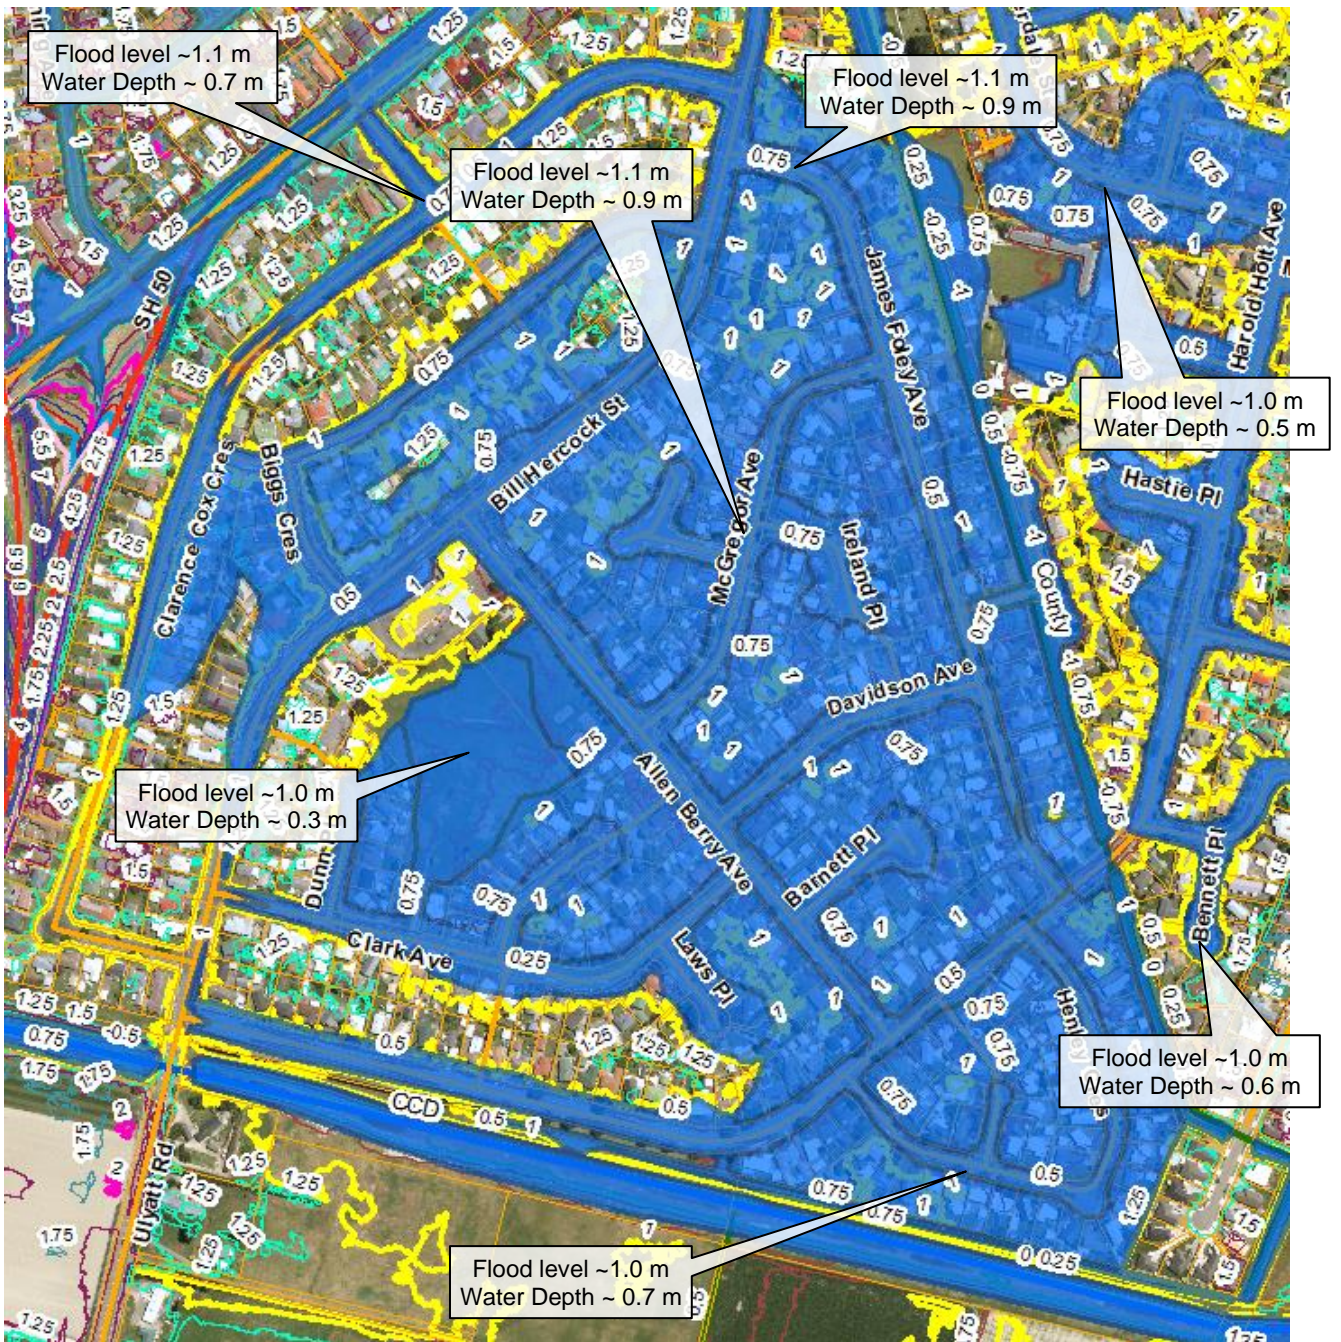
Figure 52 shows the flood extents in the Pirimai area. This area is relatively low lying, with a large portion of the streets and some properties below elevation 1m (datum NZVD16). The outlet for stormwater is the County Drain, which flows north to the County Pump station. As the drain flows to the north, it passes through ground elevations at Taradale Road which are approximately elevation 2m.

Figure 52: Flood extents in Pirimai (contour datum NZVD16)

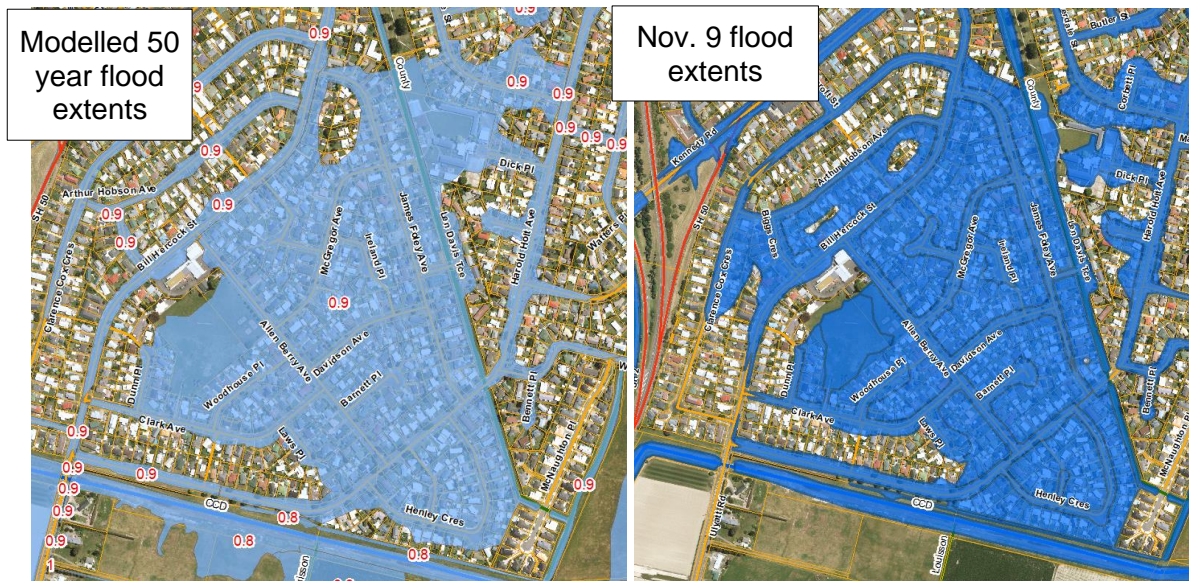
Figure 54 shows the comparison between the modelled 50-year flood extents and the 9th November observed flood extents. The extents are very similar and considering there has been at least four flood events in the past 58 years (1963 to 2021) giving credibility to assigning a return period to the 9th November event to be approximately 50 years in this area of Pirimai.

Figure 54: Comparison of Modelled 50-year return period flood extents to observed flooding in Pirimai (datum NZVD16).

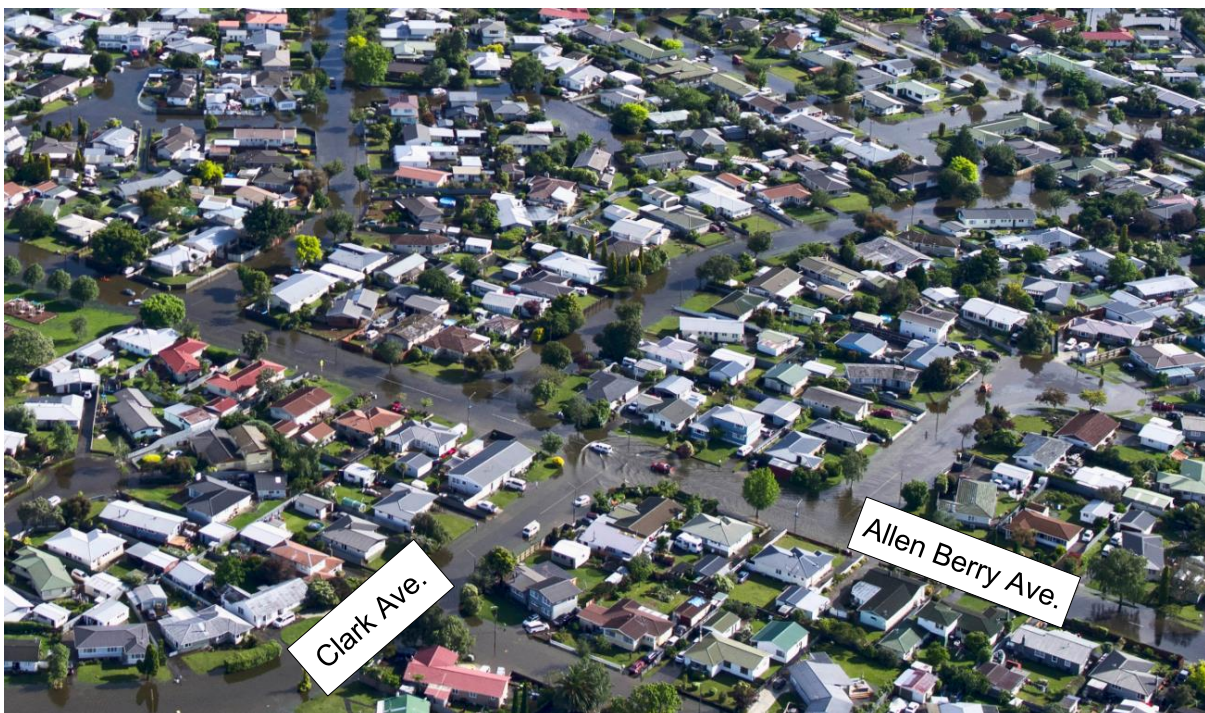
Figure 55: Flooding in Pirimai – photo taken 8am 10th November (Photo Credit – Peter Scott).

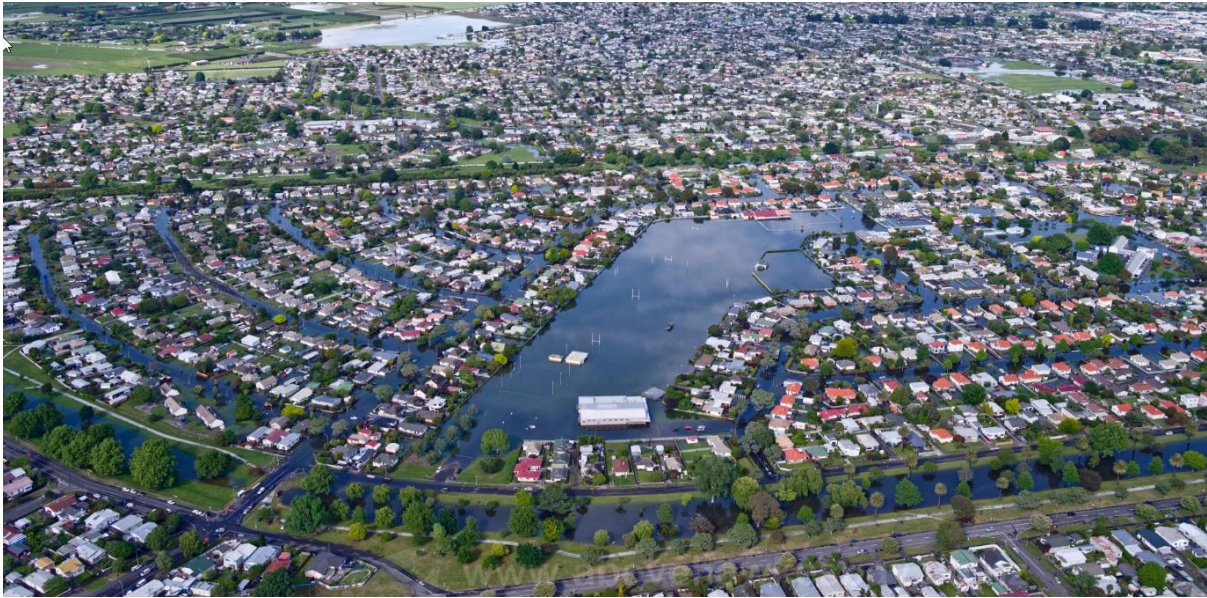
Figure 66: Photo of flooding near Whitmore Park Nov. 10, 8 am. (Photo credit – Peter Scott)

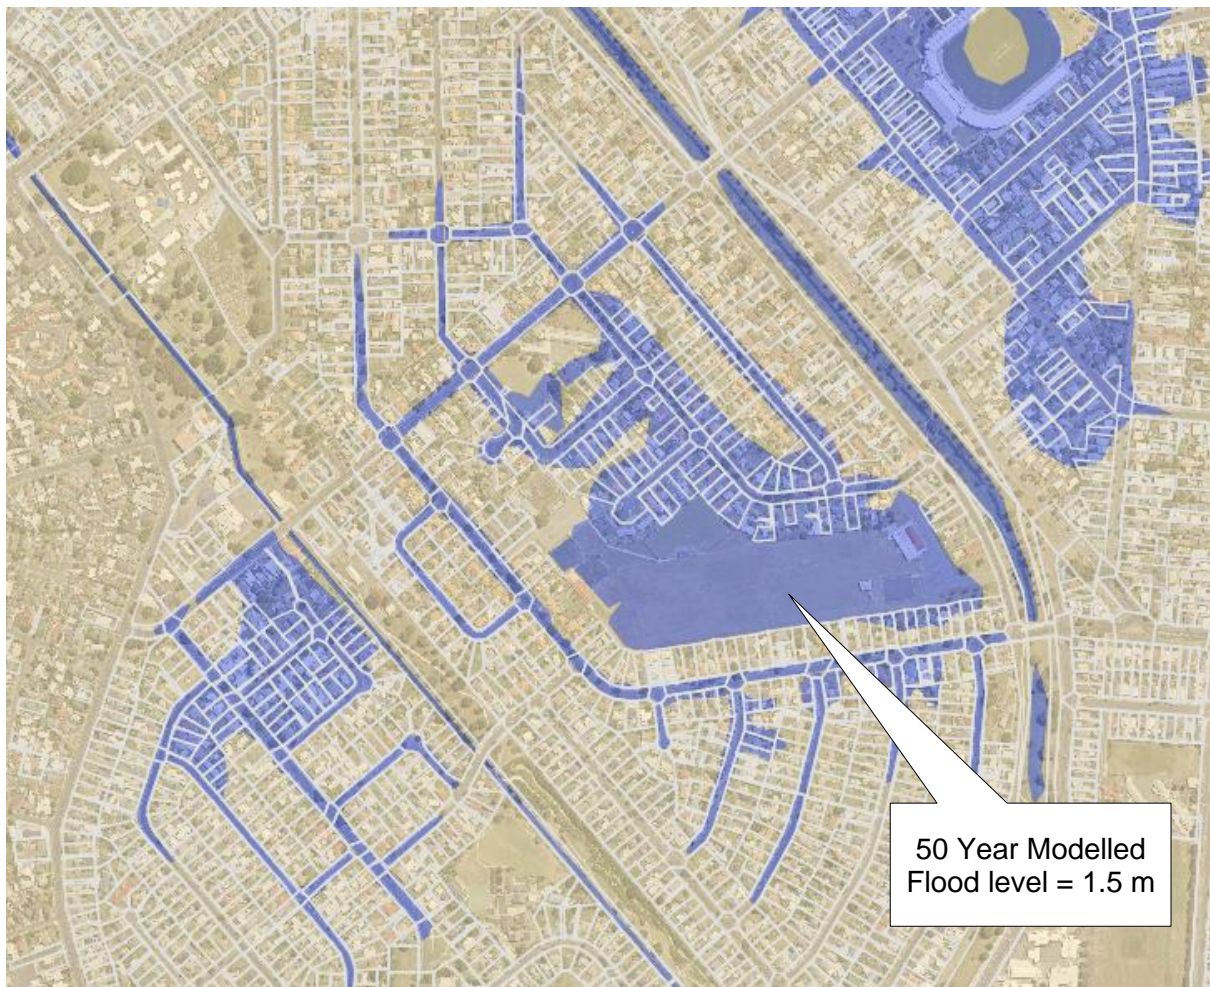
The modelled 50-year flood level in this area has a peak water surface elevation of 1.5 m (NZVD16), as shown in Figure 67. Considering this level compared to the observed peak water levels in this area (approximately elev. 1.75 m), it can be concluded that the return period for the event in this location was greater than 50 years.

Figure 67: Modelled 50-year return period Flood extents near Whitmore Park (datum NZVD16)

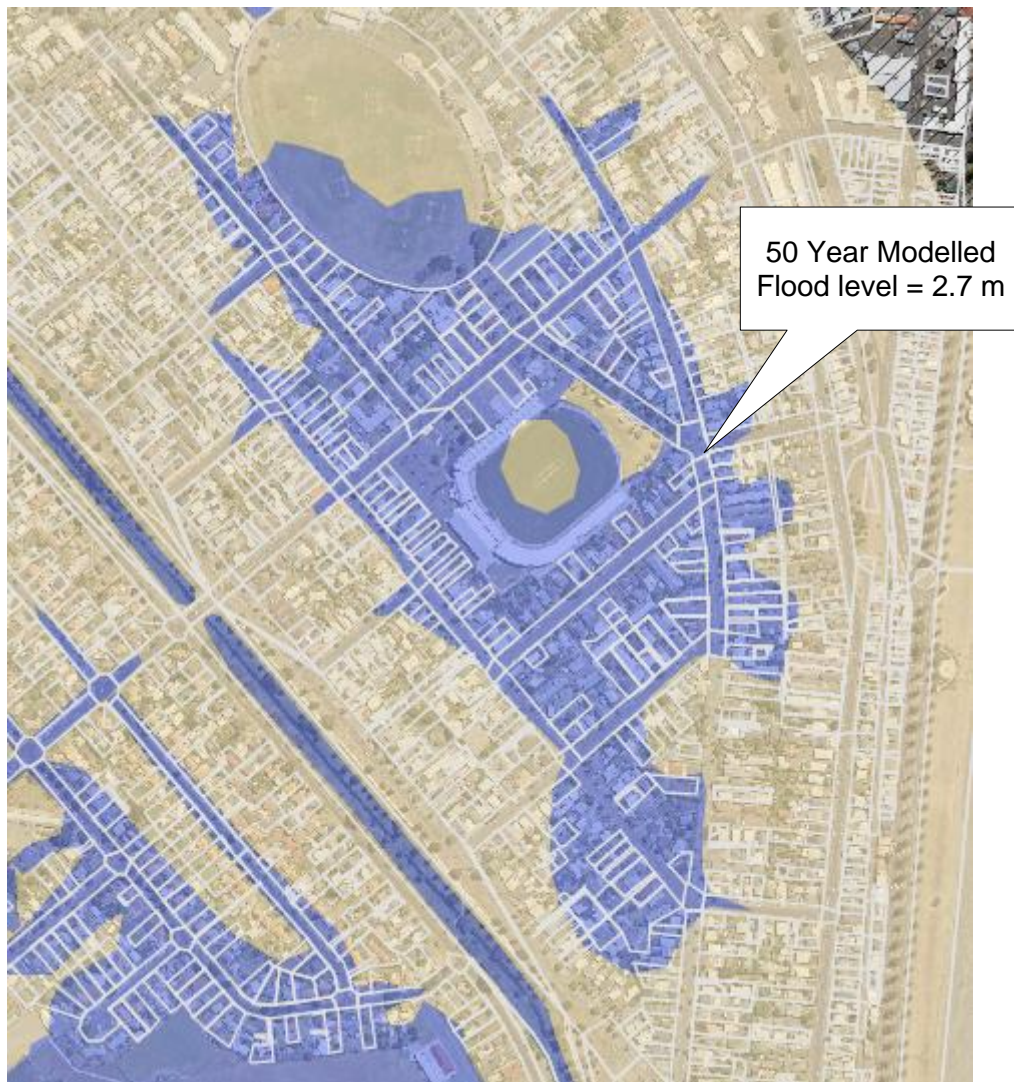
The modelled 50-year flood level in this area has a peak water surface elevation of 2.7m (NZVD16), as shown in Figure 73. Considering this level compared to the observed peak water levels in this area (approximately elev. 2.75m), it is reasonable to estimate that the return period for the event in this location was in the order of 50 years or slightly higher.

Figure 73: Modelled 50-year return period flood extents in Napier South (datum NZVD16)

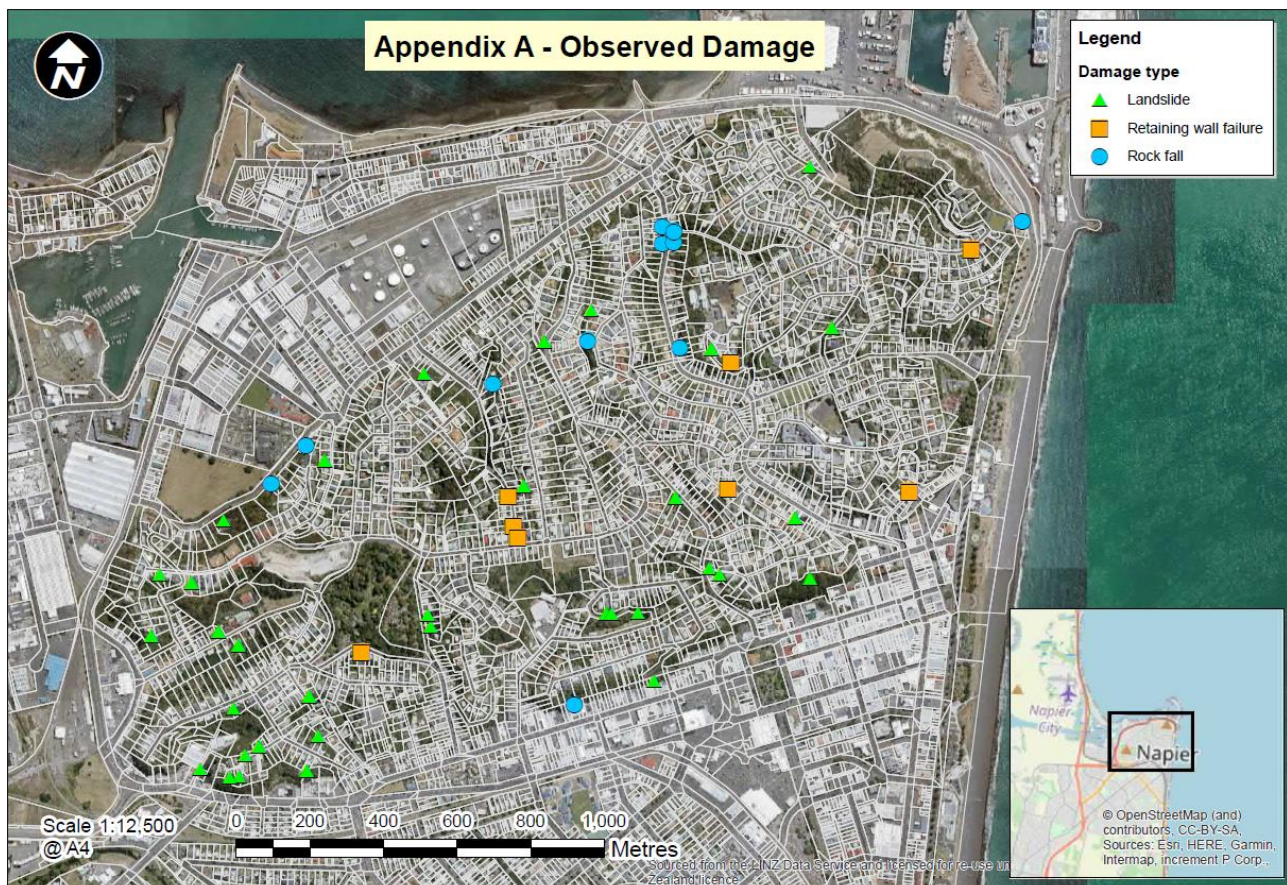
In addition to the significant flooding that occurred within Napier, the event also resulted in significant land instability issues around the Napier Hill and some in the hills surrounding the suburb of Taradale. The impacts ranged from damage to retaining walls, impacts to residential properties as a result of landslides and damage to roading and infrastructure assets. Initially this was the main focus of the event as significant life safety issues were present prior to the significant flooding that occurred in other areas.

Figure 80: Observed damage on the Napier Hill, taken from WSP Engineering Reconnaissance Report, 12th November 2020

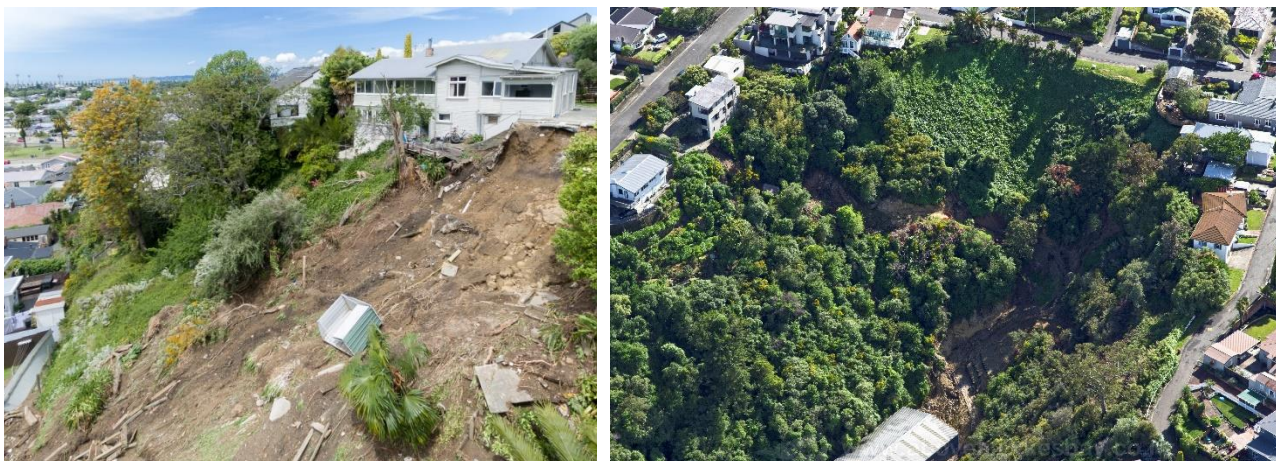
Figure 81: Damage to a property on Napier Hill from landslide, Tuesday 10th November 2020

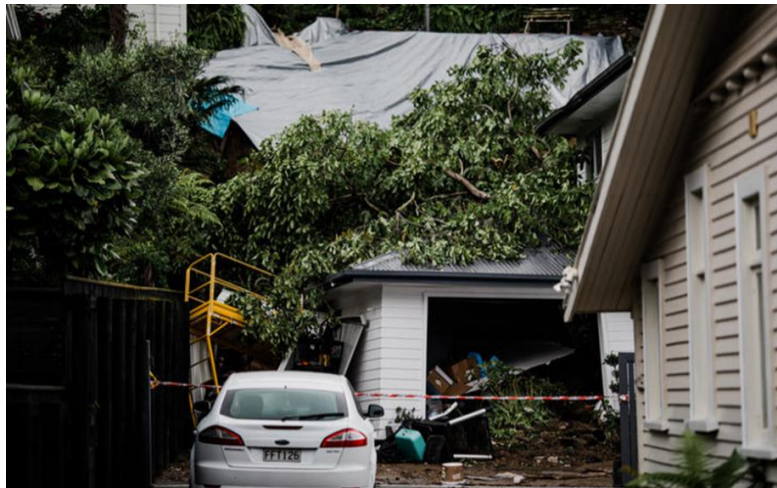
Figure 83: Damage to a property from a landslip on Napier Hill

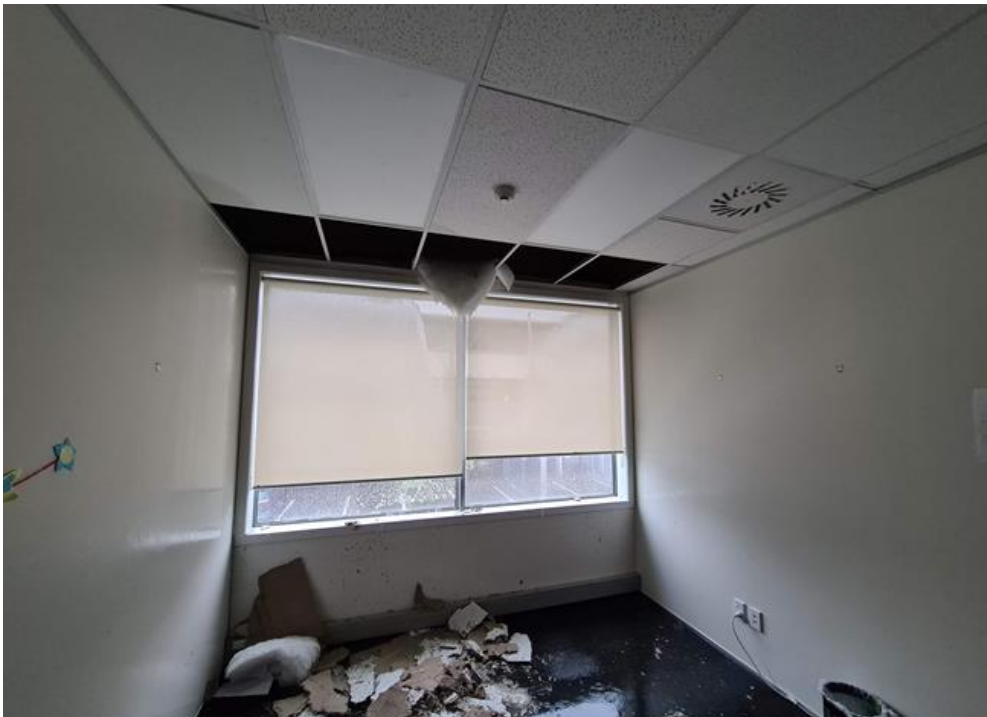
Commercial premises within the Napier CBD, Napier South, Maraenui and Onekawa were impacted by the event. The exact number of buildings impacted is not recorded, however, anecdotal evidence from NCC staff suggested most was related to flood damage from water entering properties, or as a result of guttering systems becoming overwhelmed.

Figure 85: Damage to a commercial building on Vautier Street as a result of heavy rainfall, 9th November 2020

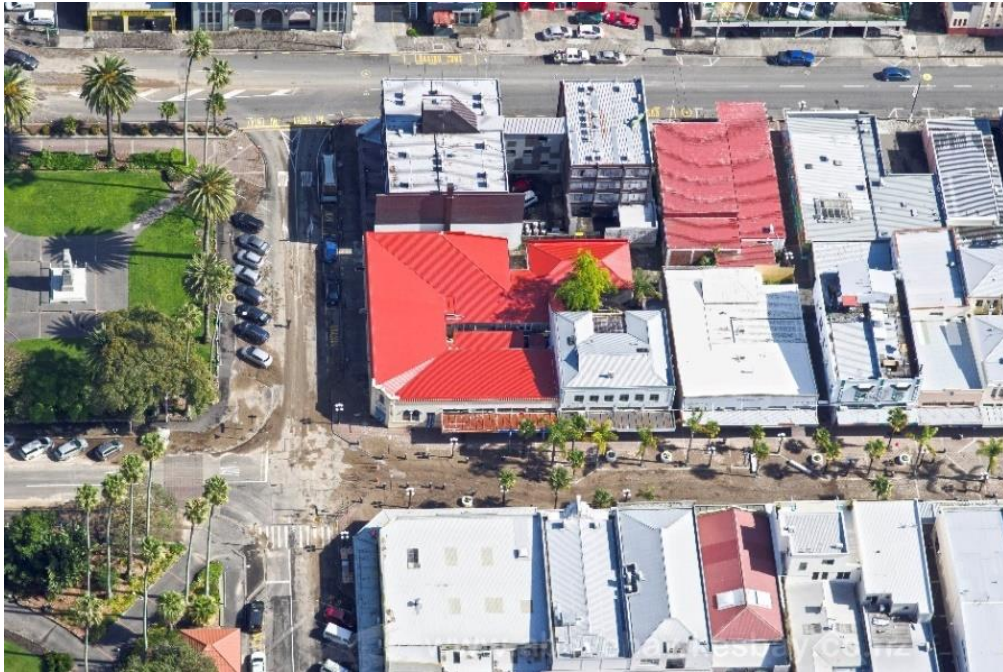
Figure 86: Silt left by flood water in lower Hastings Street, Napier CBD, Tuesday 10th November

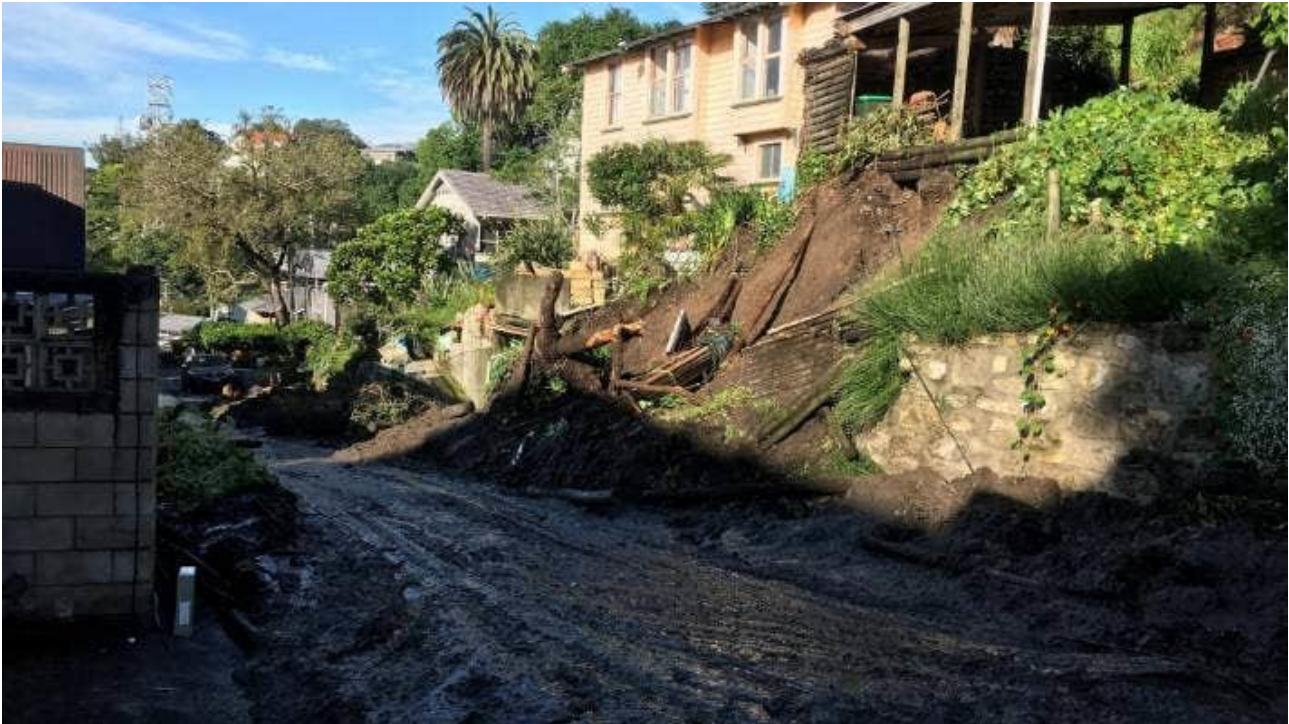
Figure 87: Roading damage on Brewster Rd, Napier Hill.

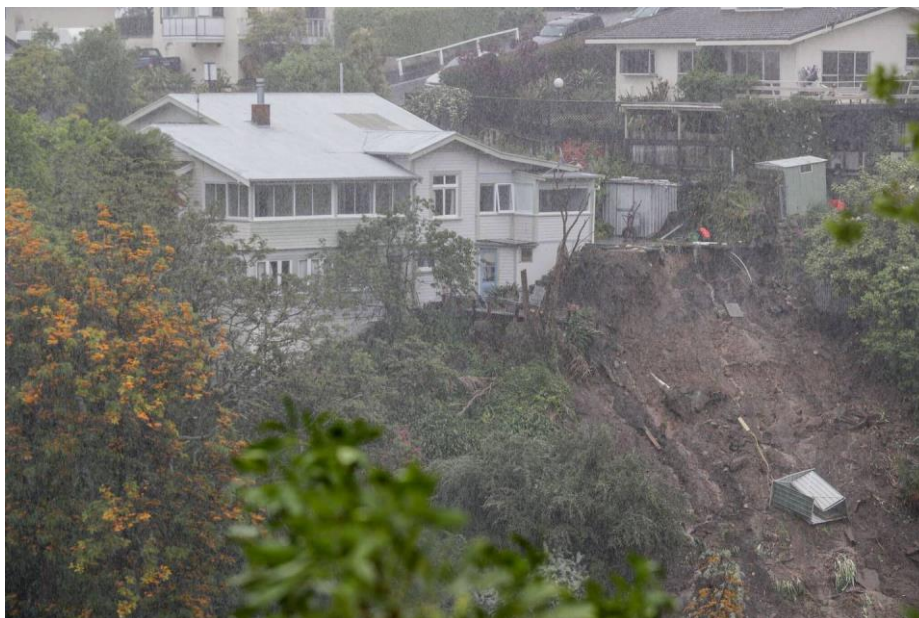
A large landslide swept away a structure on Hospital Hill, near Havelock Rd. Photo / Warren Buckland

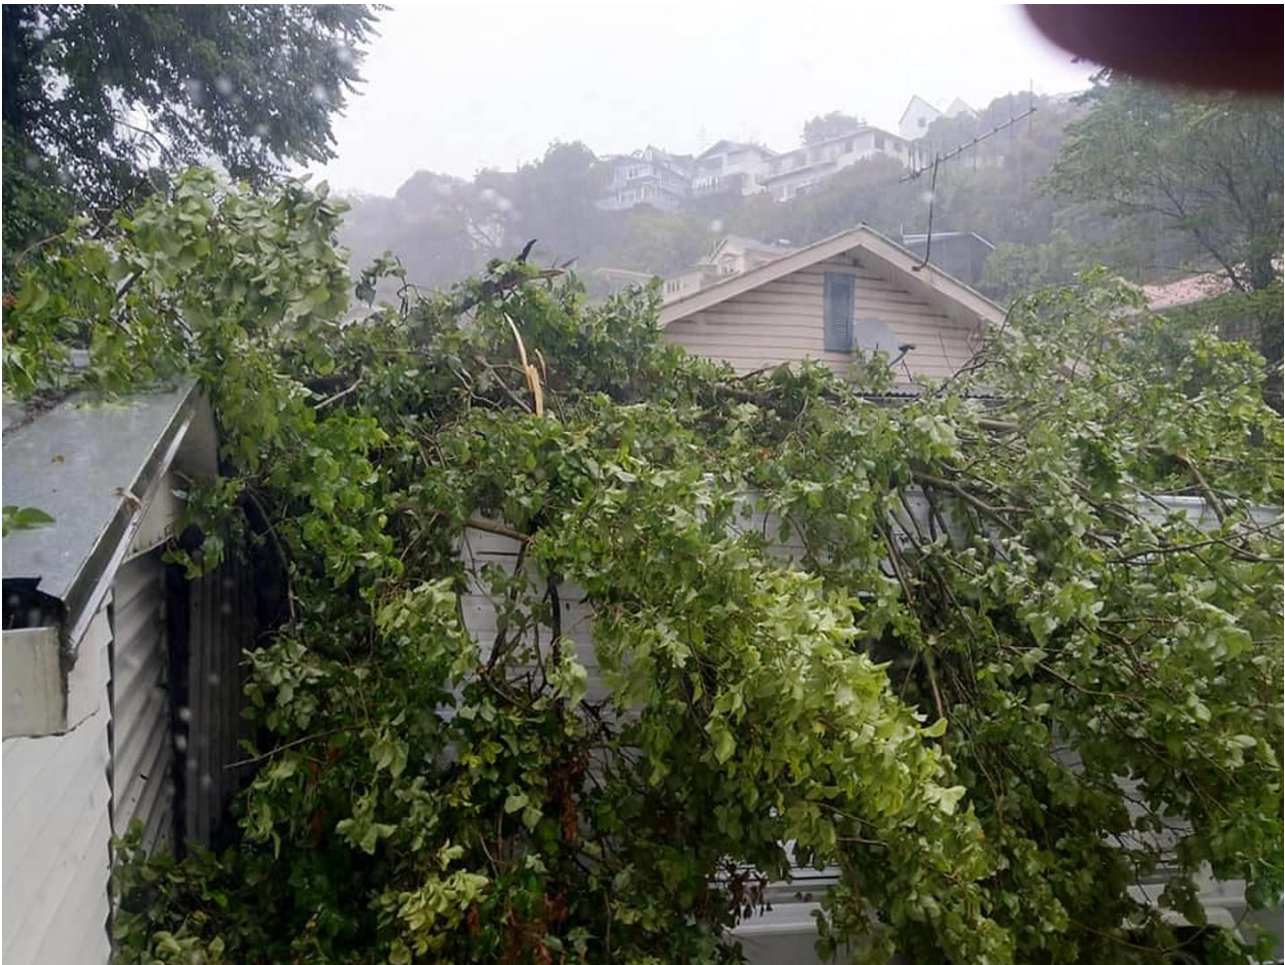
A tree had fallen onto a caravan on Shakespeare Rd in Bluff Hill, Napier, on Monday. Photo / Daniel Bryant
