## Treatment Options for Coastal Erosion at Plimmerton Fire Station

Greater Wellington

09/02/2012

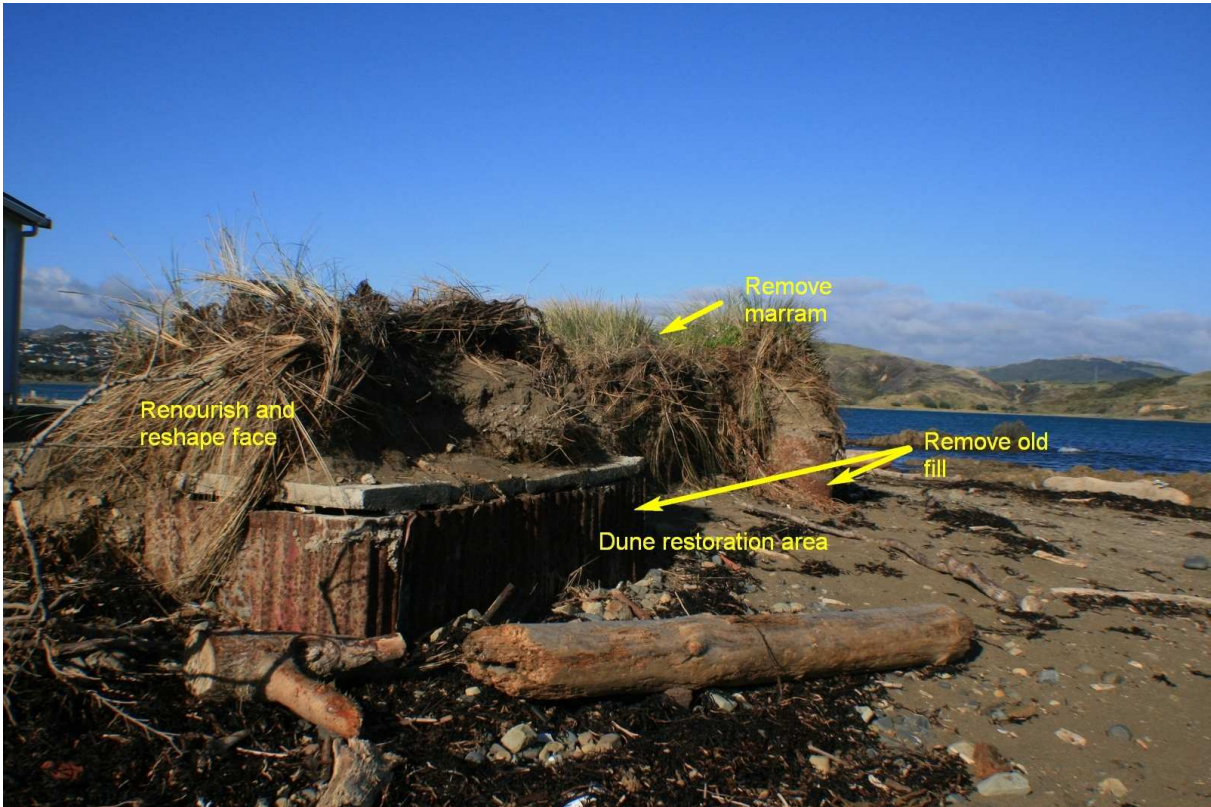
Figure 2: Western edge (front) of the site

As a rule of thumb the minimum width need to maintain a dune is 10 m. The front western edge of the site has approximately this width available. The old drums should be removed and some sand renourishment undertaken to reshape the dune to make up for the loss of volume. As discussed on site, it would be desirable to remove part of the paved area in front of the firehouse to free up a bit more width and increase the resilience the beach and dune, however, this isn't essential. In doing this, some of the vegetation will also be removed, which will require replanting. The best choice will to plant with spinifex. Any remaining marram and ice plant should be sprayed. The reason for this is that marram does not recover well from storm erosion and exacerbates sand loss from the beach as it creates a vertical scarp that is easily undermined by wave activity. This is what is partly contributing to erosion at the site. Spinifex creates a more rounded dune form with creeping runners that grow over an erosion scarp and are better able to recover the beach (figure 2).

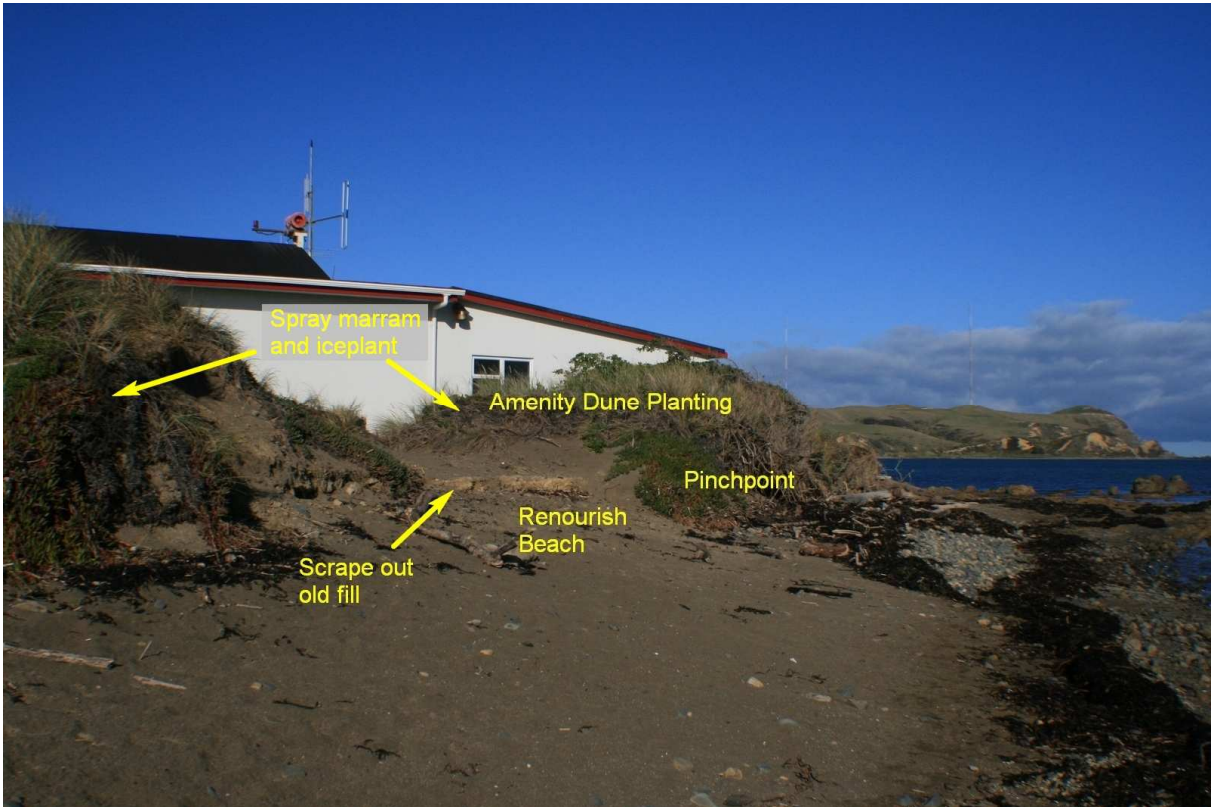
Figure 3: Northwest corner of the site

The northern and southern sides are a lot more squeezed. In particular, the northwest corner of the building has less than half the required distance for a dune restoration. It may not be possible to establish a functional dune at this pinch point. The best option is to renourish the backshore with sand to repair the blowout and rebuild the beach, and allow dunes to establish in adjacent areas. Any fill in here, such as the old clay basecourse should be removed. Clay in particular is detrimental to a beach because it filters into the pore spaces between the sand and reduces its capacity to absorb wave runup. This in turn enhances scouring of the beach during storm conditions. The backshore can then be planted to stabilize the sand and provide some amenity plantings (Figure 3).

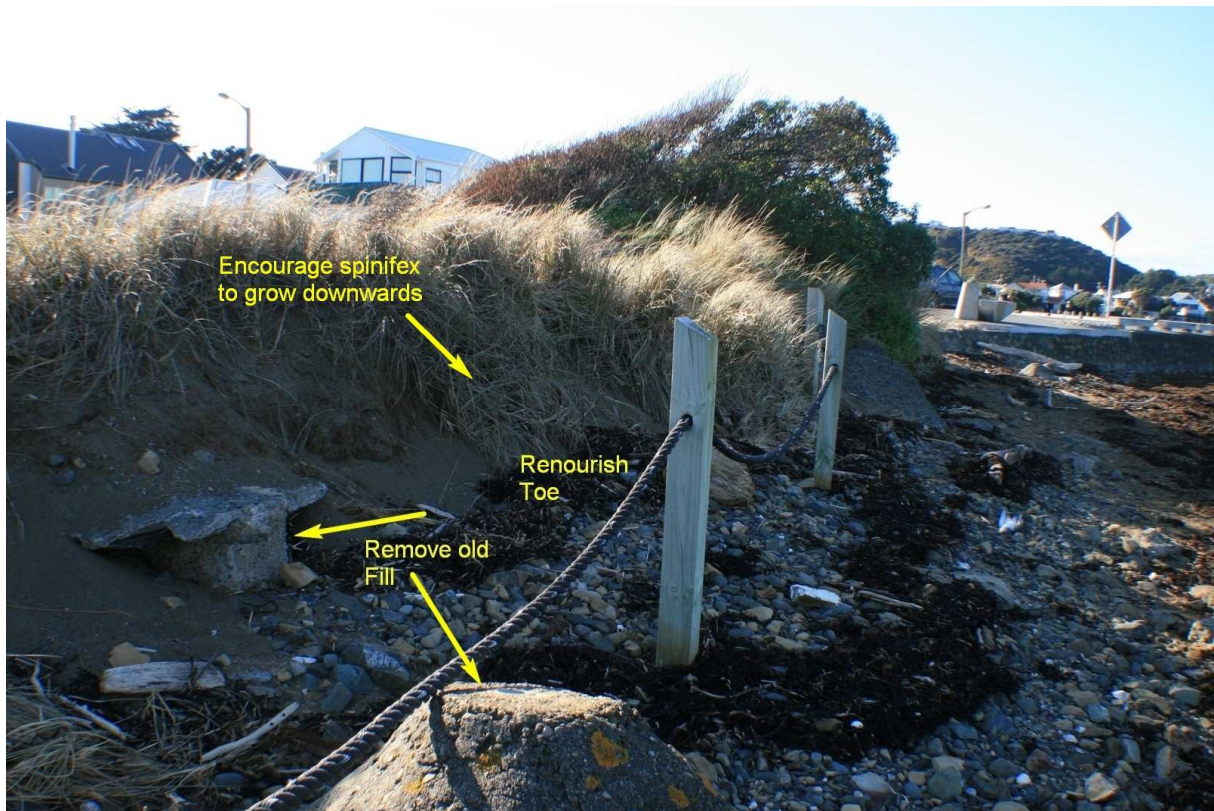
**Figure 4:** Southern edge of the site

The southern edge of the site has had some spinifex planting, but it too has become degraded by storm wave activity. In general, the spinifex has performed well and is currently holding a reasonable volume of material. The best option is to renourish the toe with sand to give a foothold for the spinifex at the crest to grow into (Figure 4).

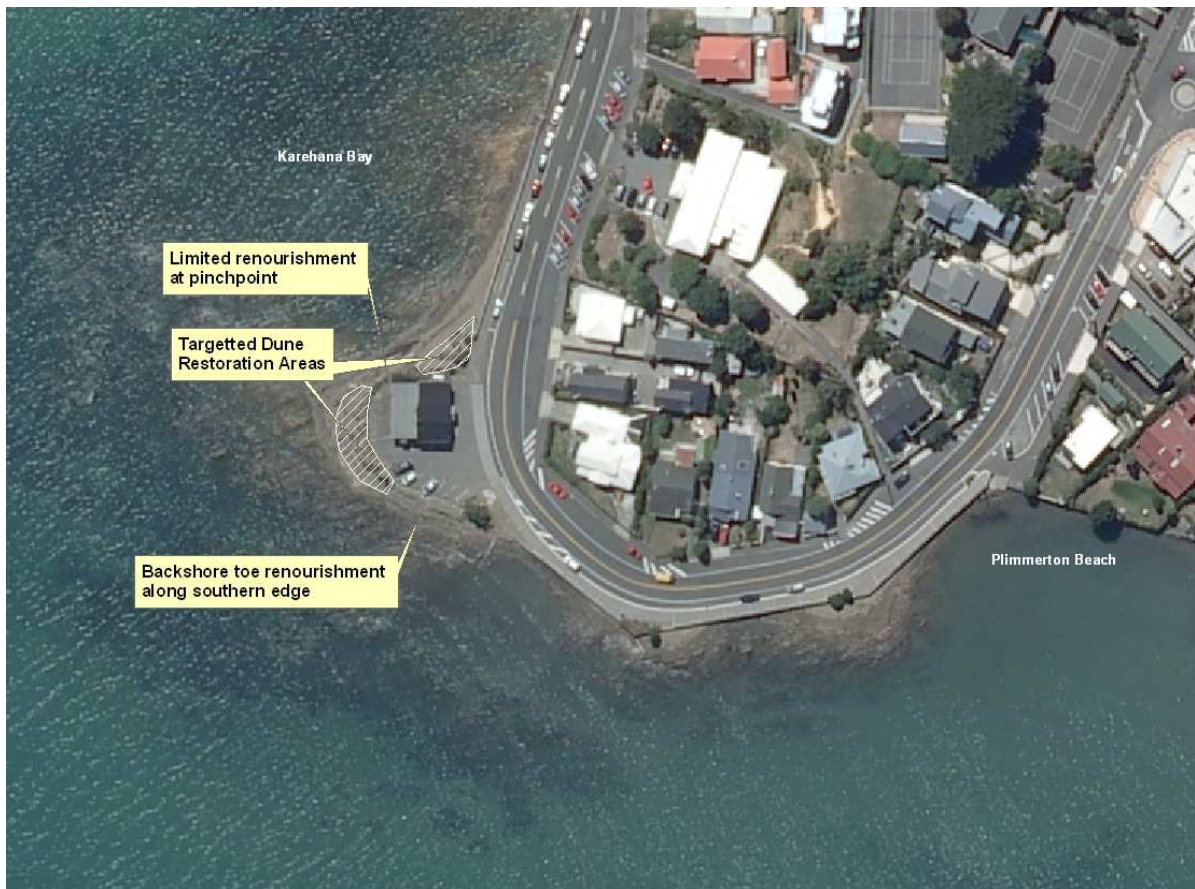
**Figure 5:** Summary of the beach and dune restoration project

In summary, it is recommended that the restoration is undertaken with the following steps (a summary is provided in Figure 5):

1. Remove old fill (particularly old concrete blocks, rusting drums and clay material) as this inhibits plant growth and provides scour points for wave and current activity during storm events.

2. Replenish the beach and dunes with sand and reshape the eroded dune scarps. (A good source for the renourishment would be sand dredged from the marina).

3. Spray out the remaining invasive exotic plants, especially the marram and ice plant that will outcompete native sand binders, but leave in place to hold the sand until native plants become established.

4. Bulk plant with spinifex above MHWS at approx. 0.75 m spacings to get a plant cover established. This is best achieved in April to May after the March equinox winds and prior to winter rainfall.

5. Could also add in some pingao (*Ficinia spiralis*) (best in clustered groups) and sand tussock (*Poa billardierei* was *Austrofestuca littoralis*) for a bit of plant variety at the crest.

6. Replenish periodically with sand to top up the beach and provide material for spinifex to help grow the dunes and provide a buffer to the station.
