Inquiry 11-003: In-flight break-up ZK-HMU, Robinson R22,
near Mount Aspiring, 27 April 2011

Final Report

Aviation inquiry 11-003
In-flight break-up ZK-HMU, Robinson R22,
near Mount Aspiring,
27 April 2011

Approved for publication: February 2014

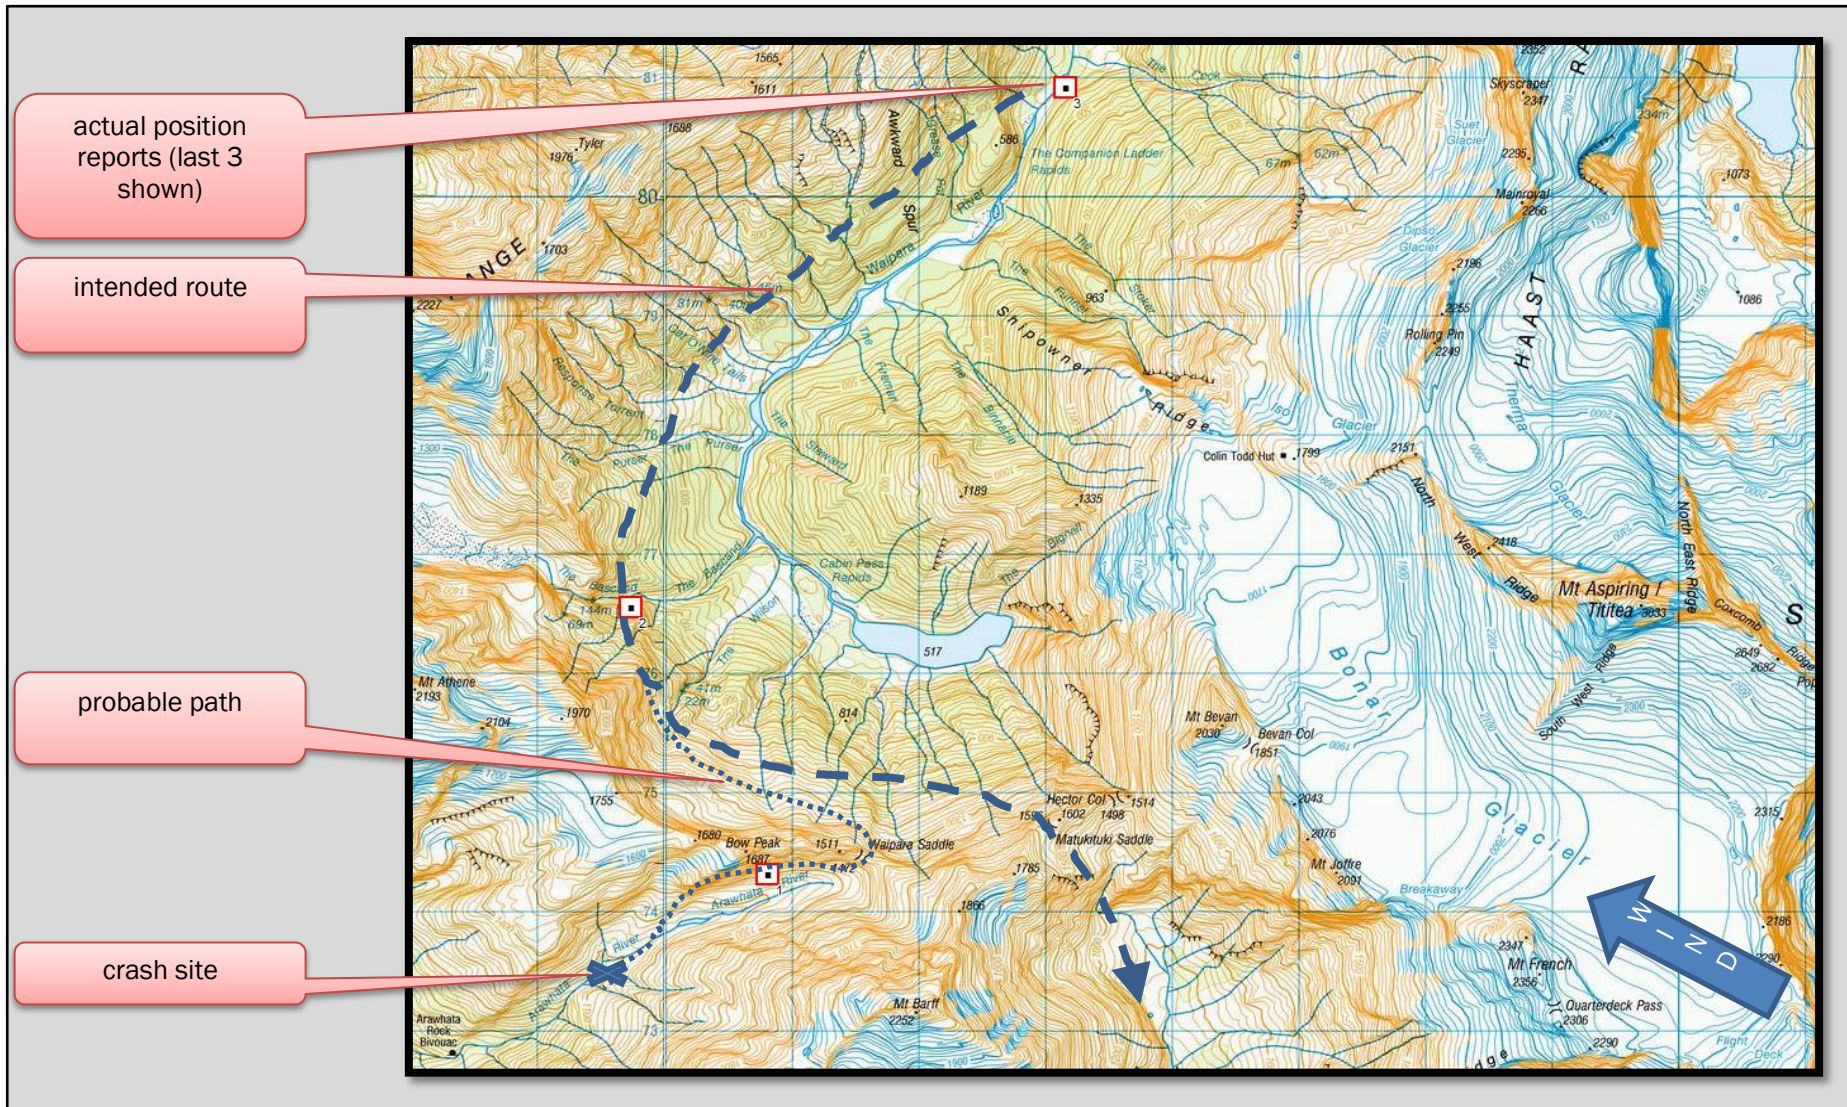
Figure 1
Flight path

- 1.4. A flight-tracking device on the helicopter showed it climbing to approach Matukituki Saddle, but instead of passing over the saddle it turned right over the nearby Waipara Saddle into the Arawhata River valley. The helicopter was reported overdue later that afternoon. The wreckage of the helicopter was found the next day in the Arawhata River valley. Both pilots had died in the crash.

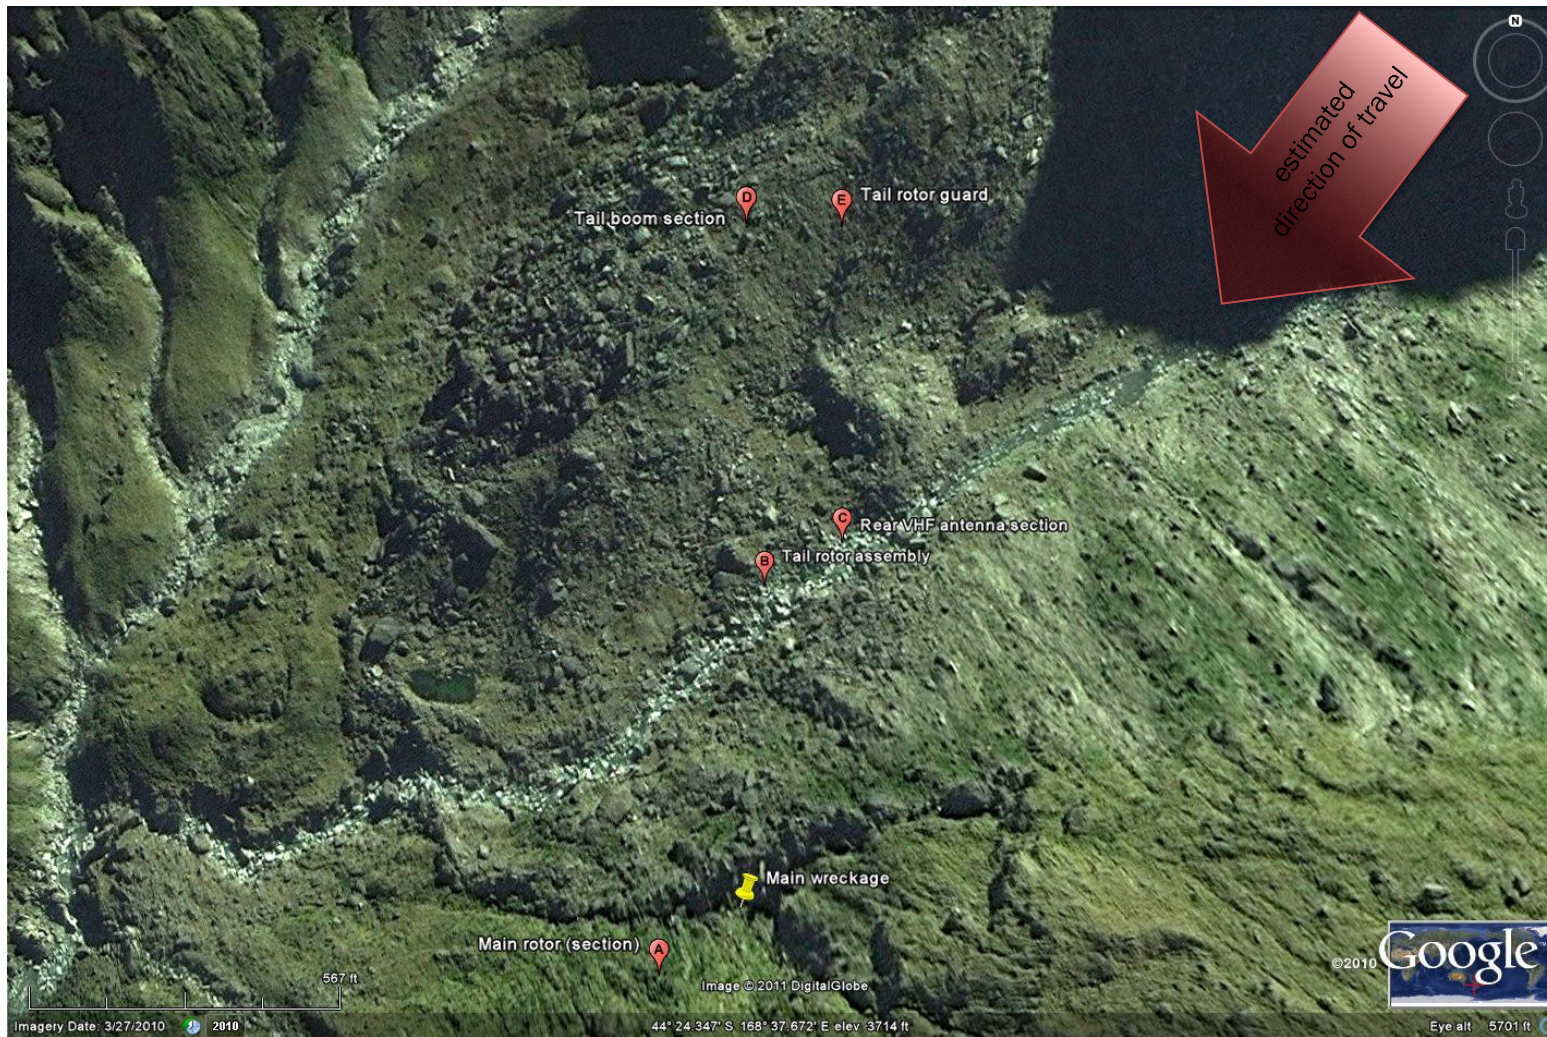
Figure 5
Wreckage spread

- 3.3.1. The main wreckage was located in a narrow, rocky stream bed, with most of the debris strewn 300 metres (m) back along the last known flight path from Waipara Saddle. The exception was the outer section of one main rotor blade, which was found about 50 m ahead of the main wreckage (see Figure 5). The impact damage indicated that the helicopter had struck a large boulder while in an upright position from a near-vertical trajectory. The fuel tanks had burst open upon impact, spilling aviation fuel around the area. There was no fire.

- 3.3.2. The wreckage trail began with the red-and-white tail rotor guard and part of the tail boom. These were found several metres apart about 300 m back from the main wreckage. The complete tail rotor assembly (including the tail fin) were found 145 m back from the main wreckage. Smaller Perspex fragments from the canopy and the red anti-collision beacon were found scattered along this first part of the wreckage trail.

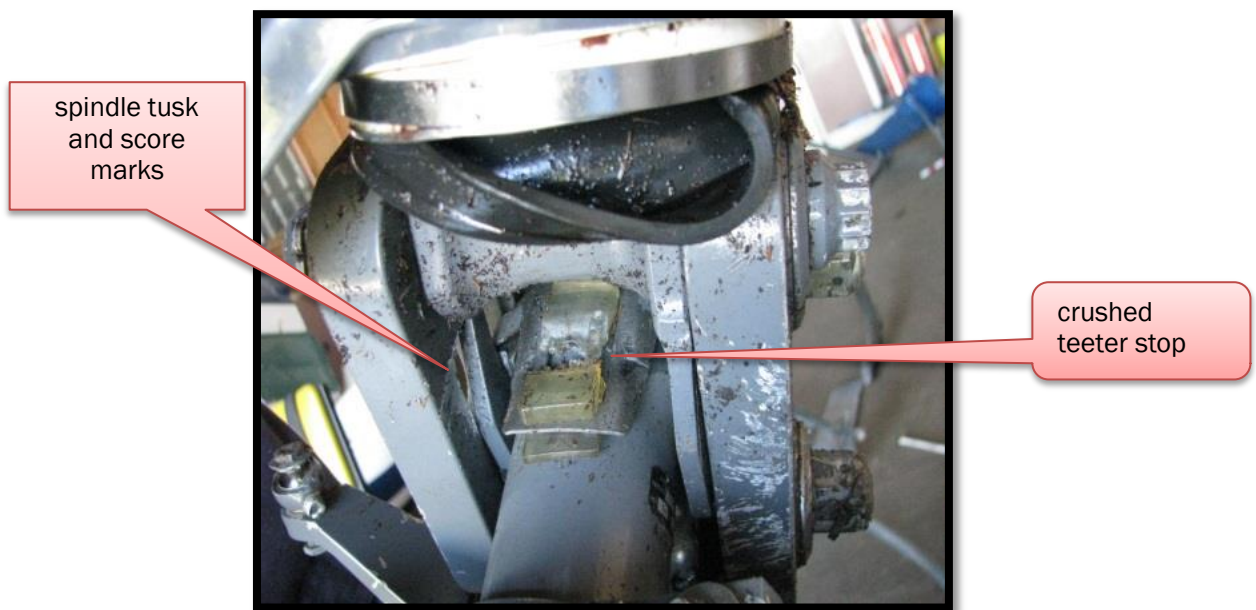
Figure 6
Rotor head and teeter stops

- 3.3.5. One of the main rotor spindle tusks had bent outwards and scored the inside surface of the rotor head (visible in Figure 6). The up-coning stop surfaces both showed evidence of crush damage. Both teeter stops had been crushed by the blade spindle compressing against the main rotor shaft. These are typical indications that excessive rotor blade flapping and mast bumping had occurred.

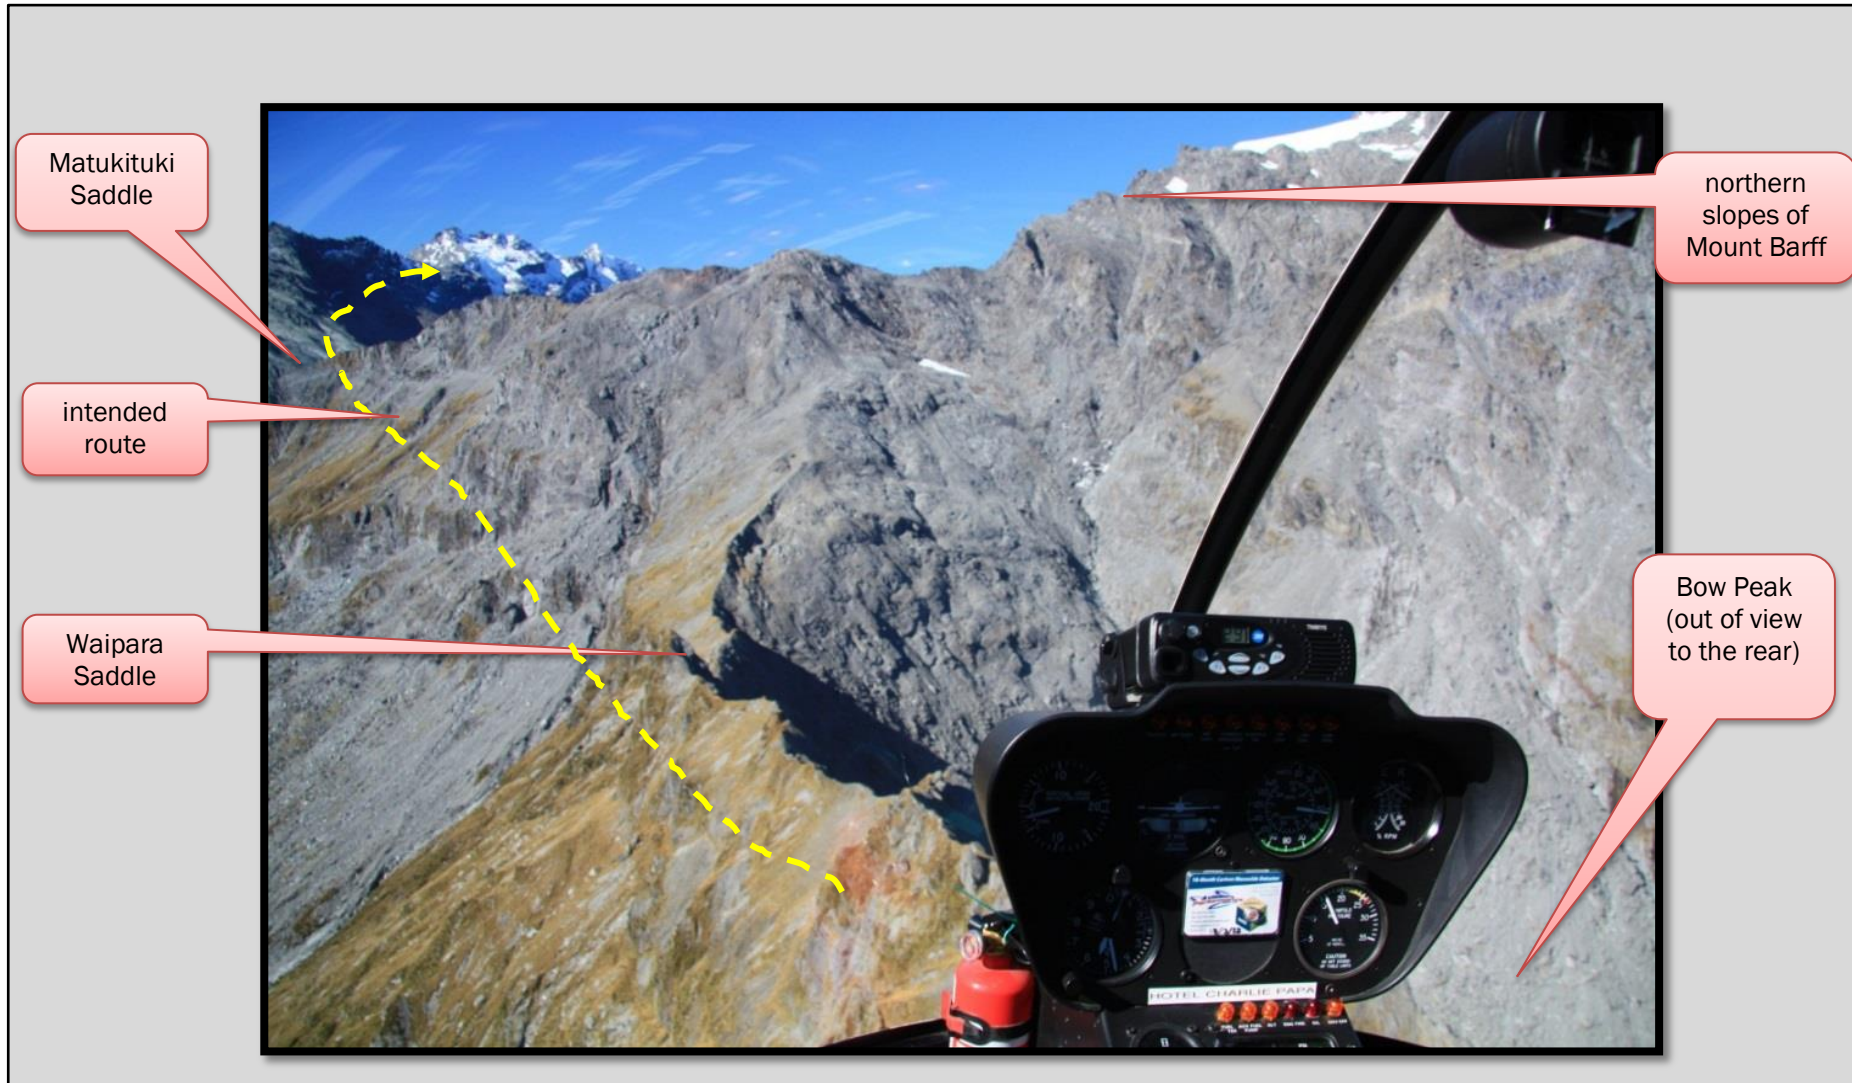
Figure 7
Approaching Matukituki Saddle towards the east
(In an R44 2 days later. Courtesy of Wanaka Helicopters Limited)

- 4.2.10. Another search pilot flew a Eurocopter EC130 over Matukituki Saddle about 3 hours after the accident. He found it too rough to remain in the area to the west of the saddle, so he flew over Waipara Saddle towards the last known position of the helicopter. He estimated the wind across Waipara Saddle into the Arawhata River basin to be 30 knots and experienced very rough turbulence as he flew past Bow Peak.

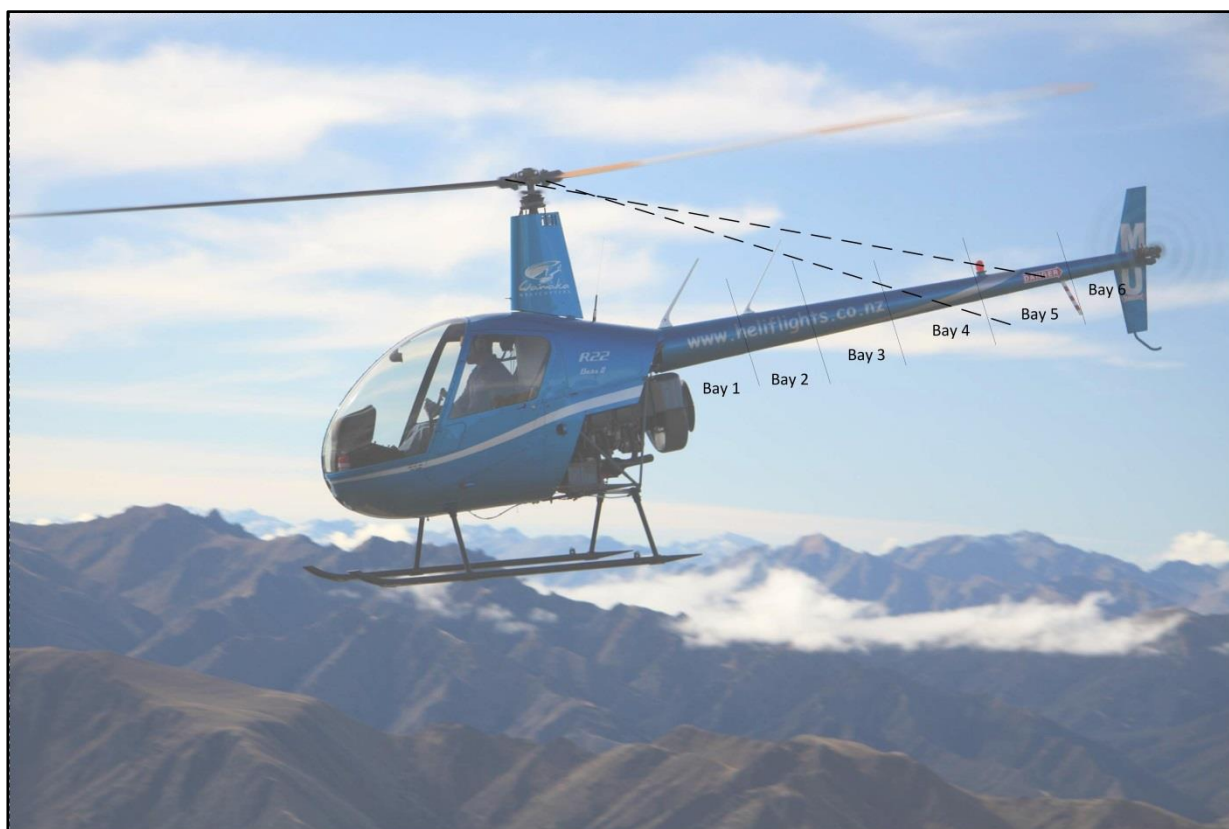
Figure 8
The tail boom impact lines

4.2.11. The tail rotor section and another section of the tail boom were found near the start of the wreckage trail. This is almost certainly a sign that the tail boom was severed by the main rotor blades and is supported by the paint transfer marks from the tail boom found on both main rotor blades, the impact impressions on the tail boom and the fact that both main rotor blades were bent backwards in the horizontal plane. This rearward bending of the main rotor blades also supports a conclusion that the main rotor blades were being driven at the time they struck the tail boom, meaning the engine was probably still delivering power when the break-up sequence began. With the loss of the tail boom and rotor, the helicopter would have become instantly uncontrollable. Figure 8 shows the angle at which the main rotor blades would have diverged from the main rotor plane in order to strike the tail boom in this way.
