**PRELIMINARY DESIGN GEOTECHNICAL ASSESSMENT REPORT  
FOR PROPOSED MANGAPAPA SCHOOL RE-DEVELOPMENT  
5 RUA STREET, MANGAPAPA, GISBORNE**

Project Reference: 15344  
26 July 2019

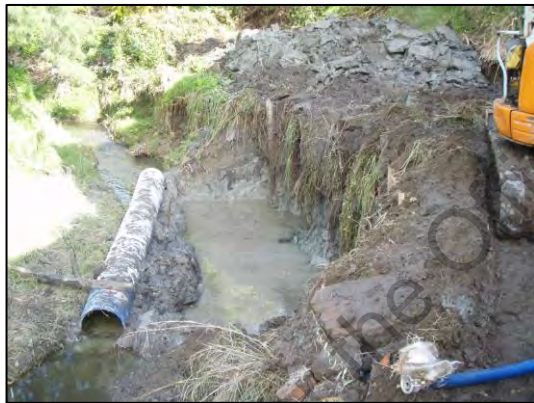
It should be noted that the wall has been in place since 2009 and gabions since 2012 with the only minor slumping in the gabions observed, likely to be due to poor packing of the rip-rap gravel within. Otherwise the wall and gabions appear in good condition with no evidence of subsidence, overturning, bulging, rotation, or other deformation of the walls.

Figure 5a: 16/05/2012 – initial undercut.

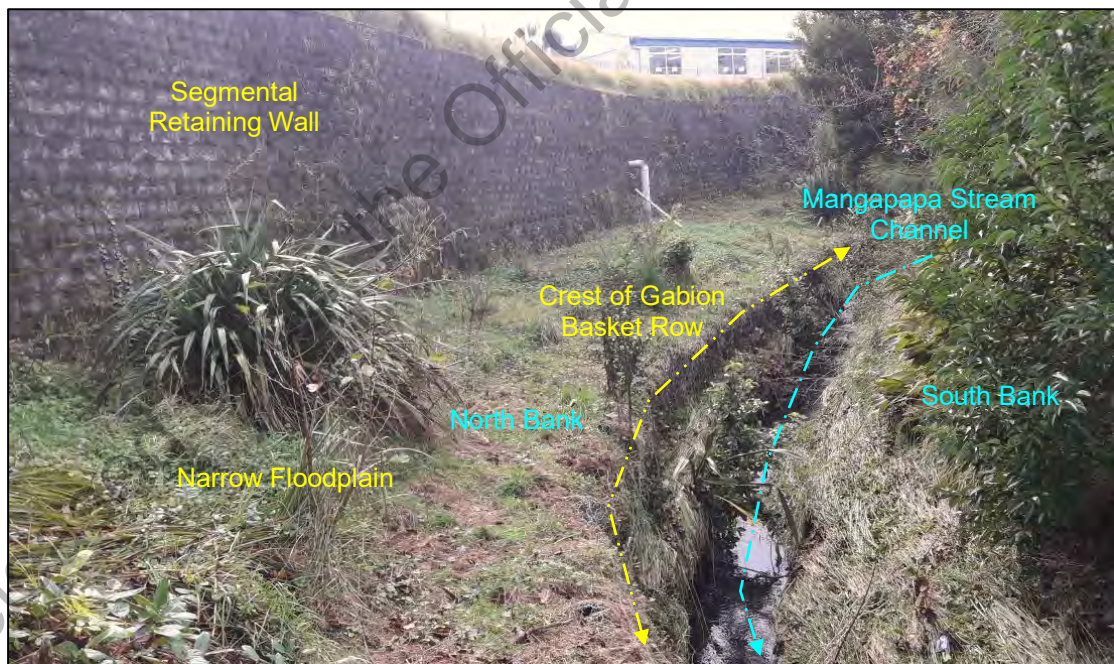
**Figure 8:** General view of the current Mangapapa Stream condition facing north. Note position of gabion baskets and 4.8m high segmental retaining wall.

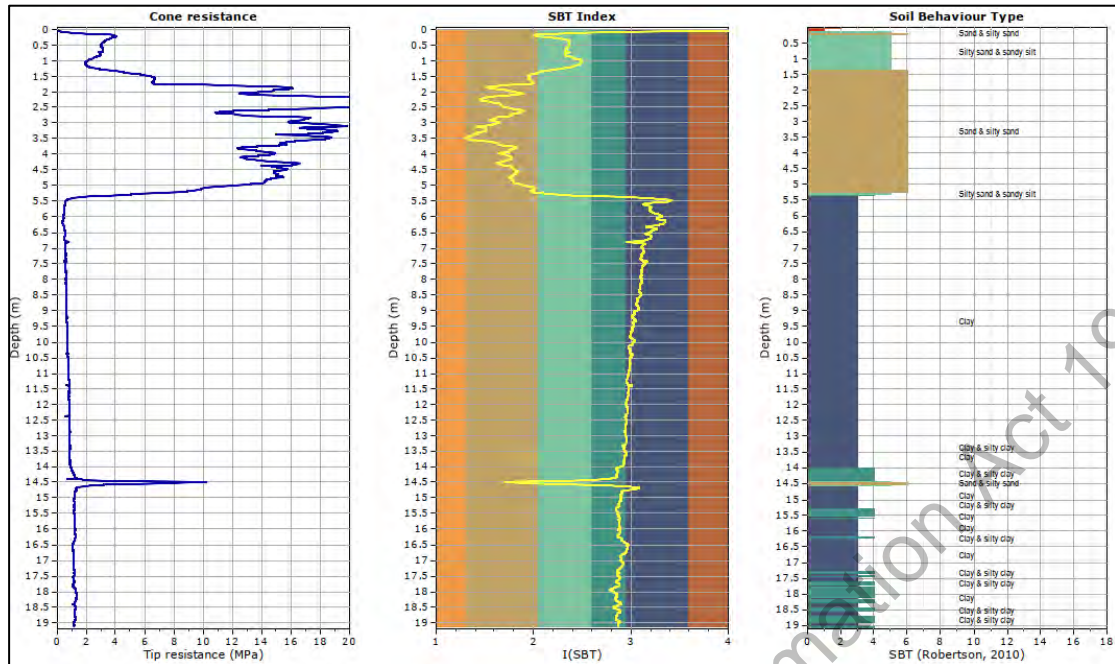
**Figure 11:** Representative soil profile of CPT-01. Note upper 5.5m of dune and beach deposits (sands) overlying deep deposit of low strength estuarine/marine deposits (silts and clays).

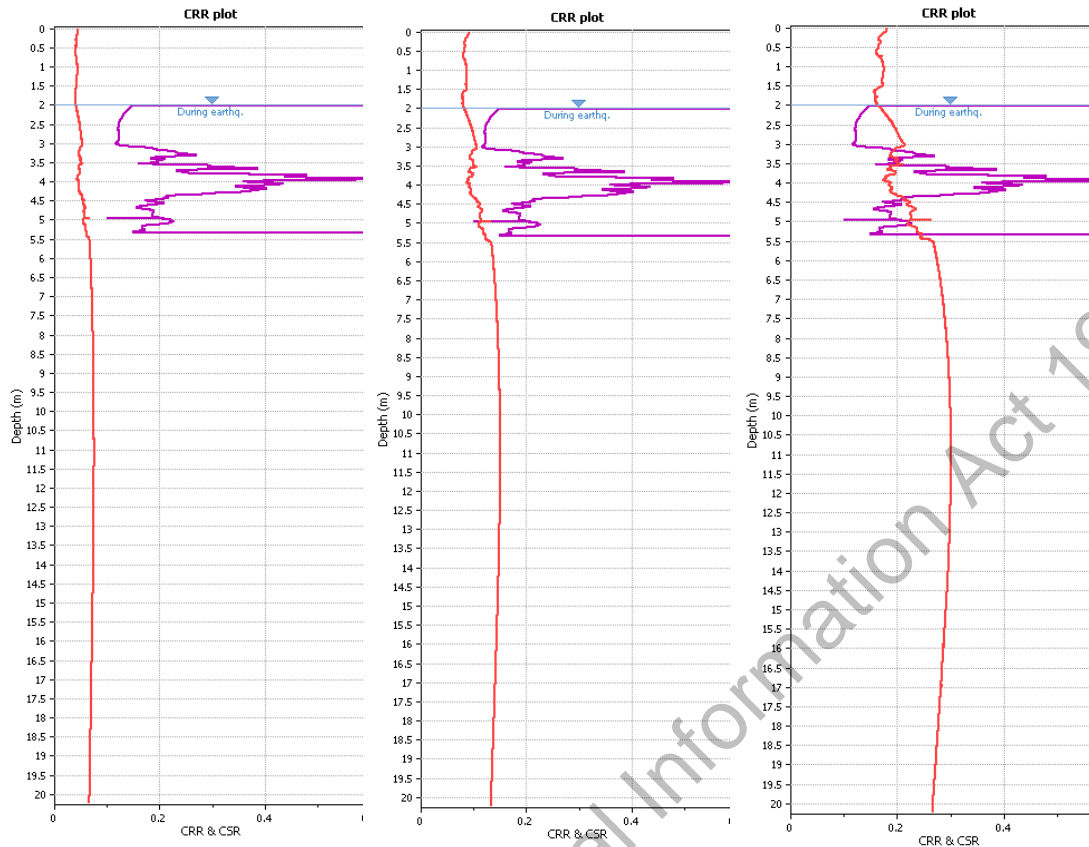
**Figure 13:** Representative profile layers from CPT105a which are susceptible to liquefaction under SLS, MLS and ULS IL2 seismic conditions (susceptible layers plot to the left of the red line).
