# OPERATIONAL REVIEW

Level 2 Vegetation Incident

F3138746

Matakana Island, Tauranga

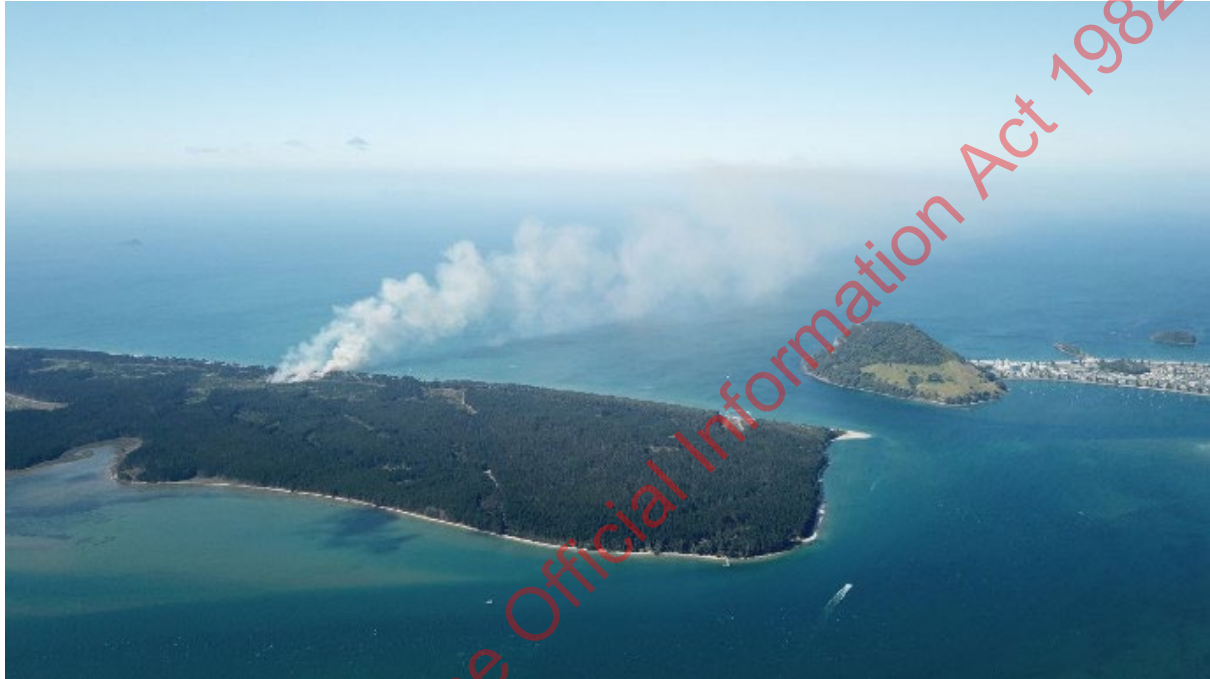
*Figure-2, Southern end of Matakana Island showing vegetation fire approximately 1 km north of Panepane point*

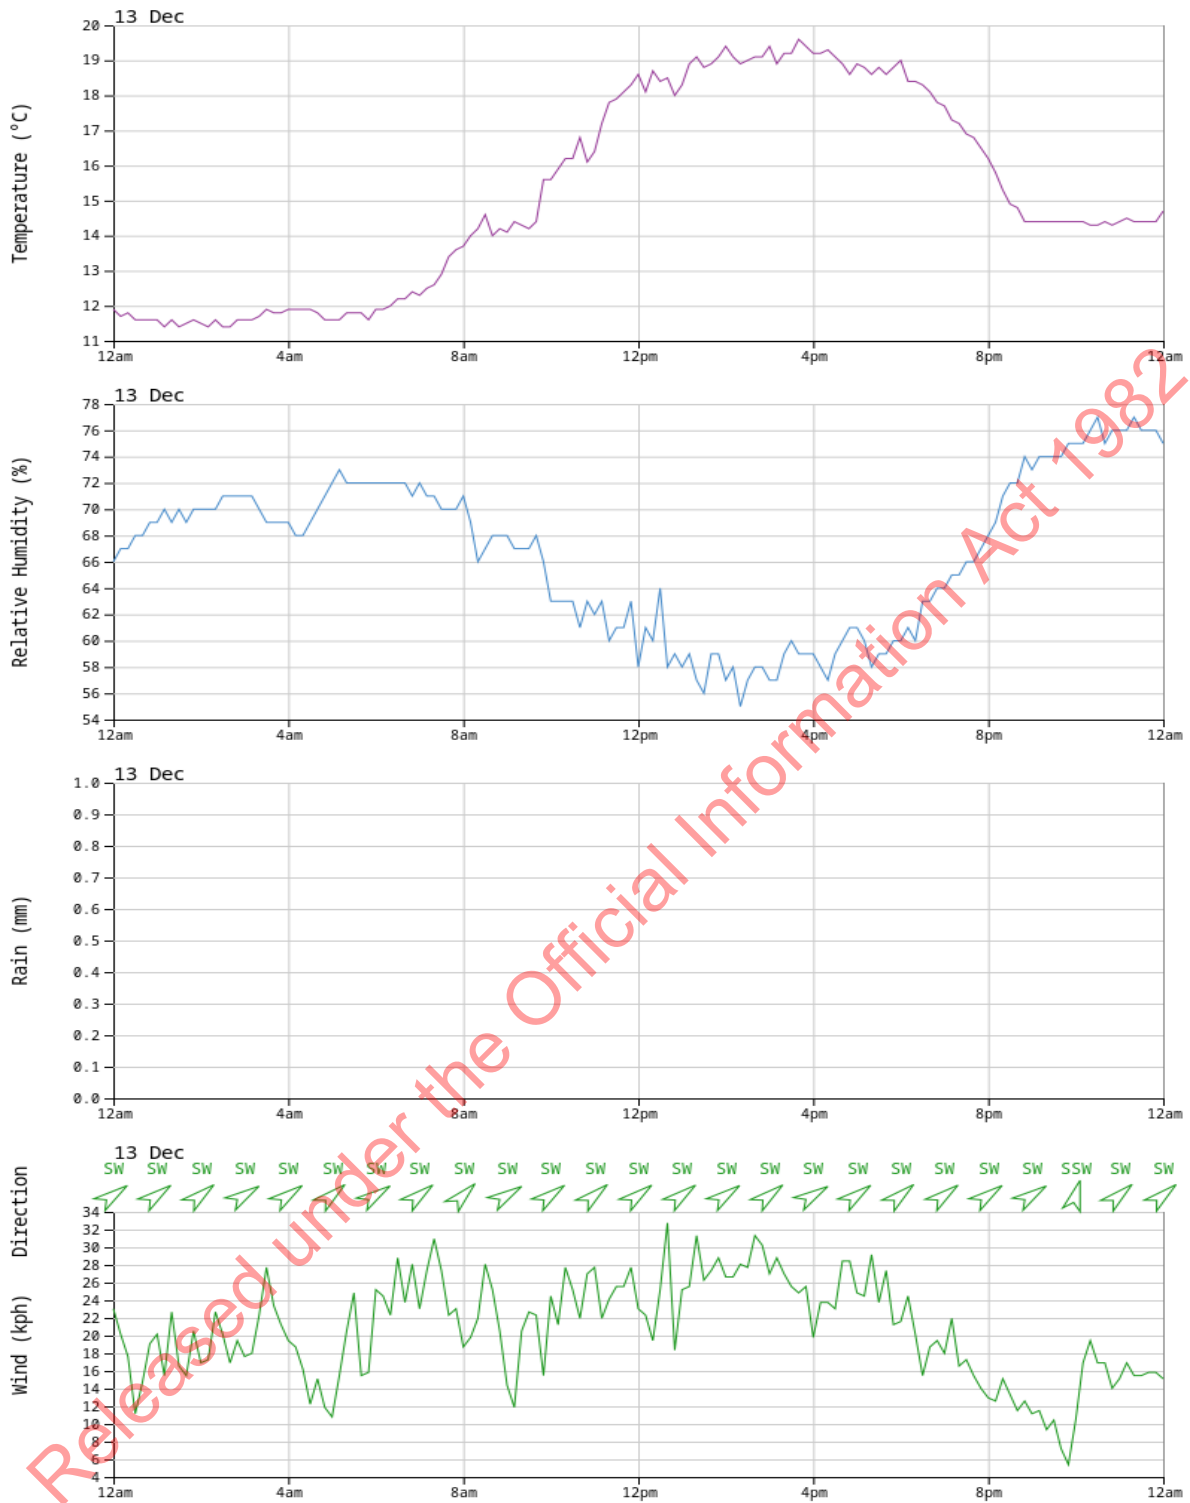
Figure-3, Fire weather data on the day of the fire, there had been no rainfall, the relative humidity was low and the temperature high. These conditions combined with light fuel and moderate breeze led to rapid fire spread and ember transfer.

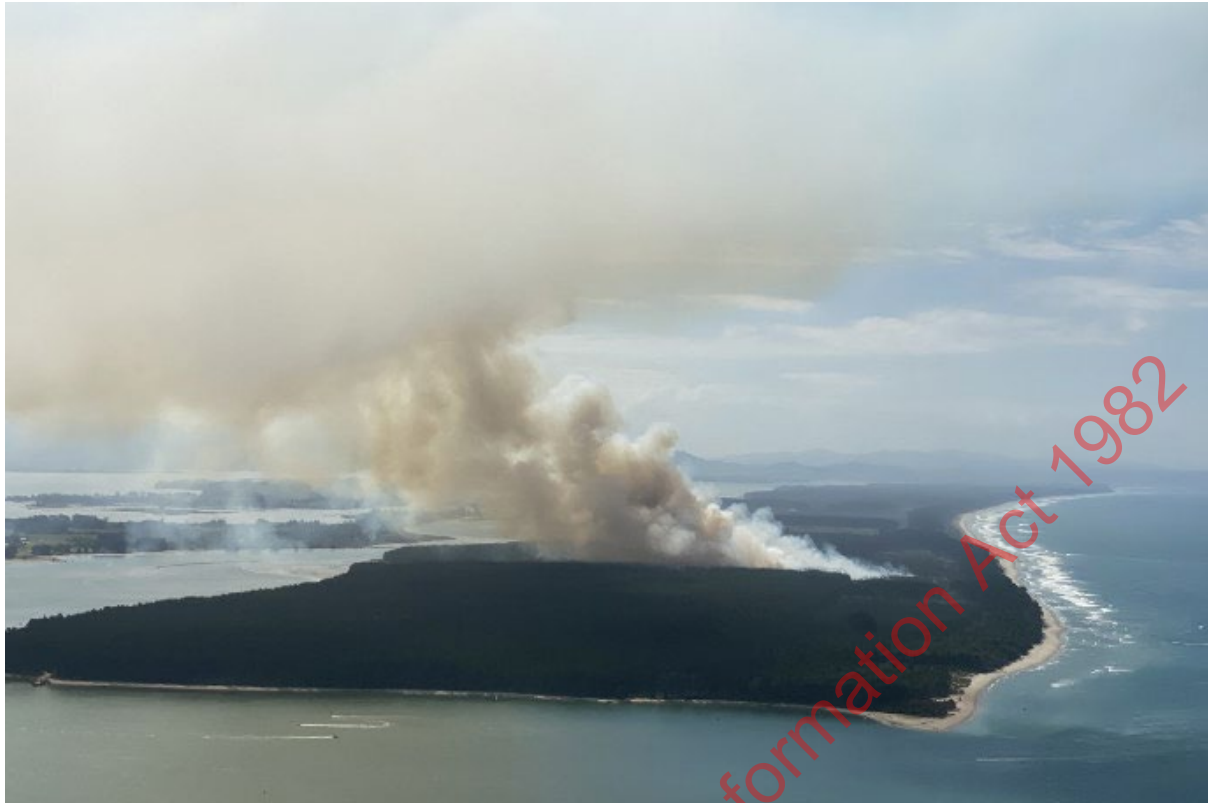
Figure-4, change to an on-shore breeze driving the fire towards the forest and ash towards the city.

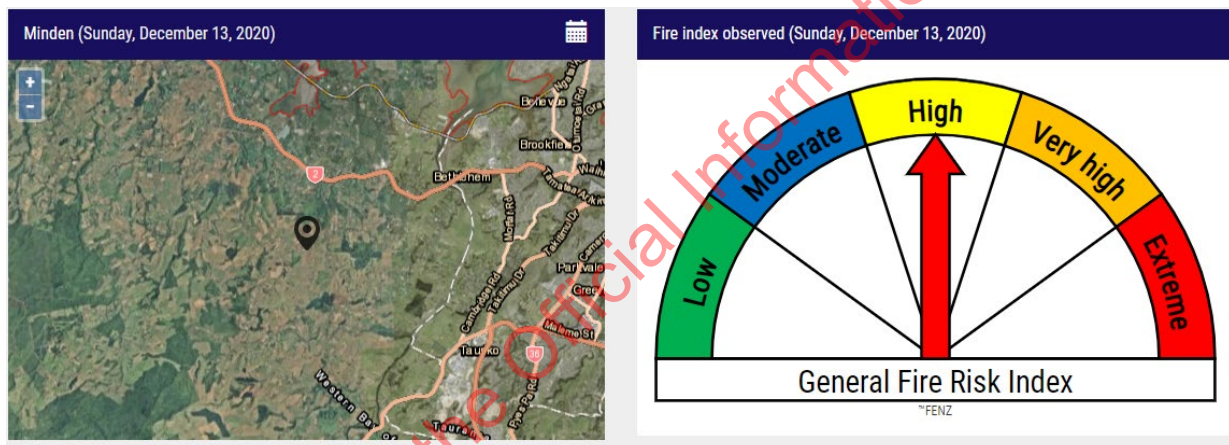
Nonetheless, it was a high fire danger and any ignition sources needed to be managed accordingly.

Figure-5. Fire conditions on the day of the fire starting
