DETAILED DESIGN ROAD SAFETY AUDIT REPORT

SH 1: Waikato Expressway Safety Improvements and Safer Speeds Classification

Prepared for Safe Road Alliance

September 2016

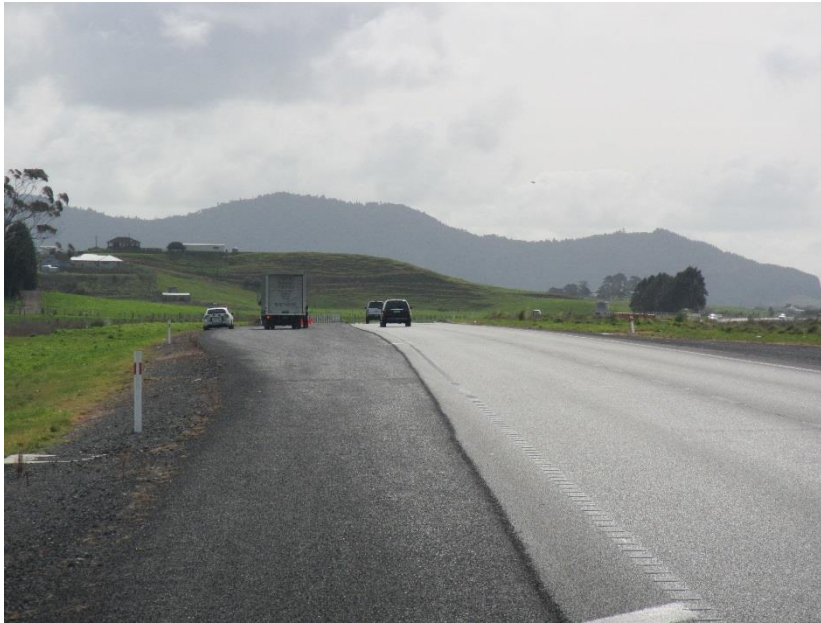
- The current wide shoulder along the northbound lane, between Station 6.1 and 0.6, is used by NZ Police for enforcement purposes. The Safety Audit Team are unsure what provision has been made along this section of the expressway. Future provision ensures that NZ Police are able to continue with enforcement including checking HCV's and their loads. The location should be relatively future proofed recognising a Hamilton Section connection at this point. Refer to Photo 1.

Photo 1: Police checking HCV's

Frequency Crashes are likely to be common	Severity Death or serious injury is unlikely	Rating The safety concern is moderate
	Section 6. The designer disagrees with these locations being used for police checks - the photo shows non-compliant police activity (the police should sit nearer to the lane than a vehicle he has stopped). The existing wide shoulder in this location is to accommodate the future Hamilton Section tie in. NZTA to confirm that HCV checks are not a recommended practice on the Expressway and provision is/will be provided elsewhere. 7. The existing safe hit posts will remain until the construction of the Hamilton Section to delineate the shoulder and discourage vehicles pulling off. The WRB is installed in this location (though it will be relocated/removed in the future in order to provide continuous edge barrier protection.	
Safety Engineer comment	1-5. Agree with designer comments relating to provision of electronic setout data and minor changes to drawings. 6 The Transport Agency should discuss appropriate enforcement locations with Police looking at the whole of the Expressway to ensure that Police can safety stop vehicles when required. 7. Agree that vehicles should be discouraged from parking on RHS shoulder through provision of safe hit posts.
