6.1 TITAHİ BAY BEACH COMMUNITY SAFETY AUDIT

Titahi Bay beach Community Safety Audit – Findings report

November 2021

TITAHI BAY BEACH LIGHTING
CPTED LIGHTING ASSESSMENT

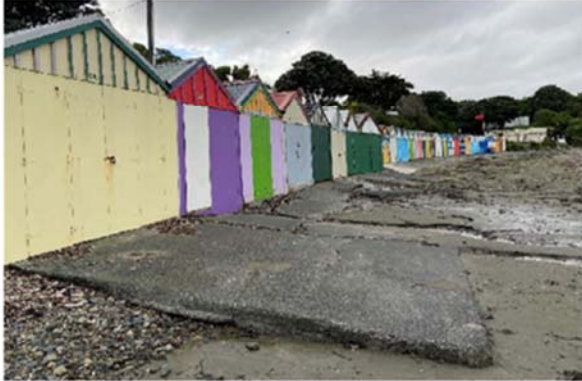
Broken concrete in front of boatsheds, looking South

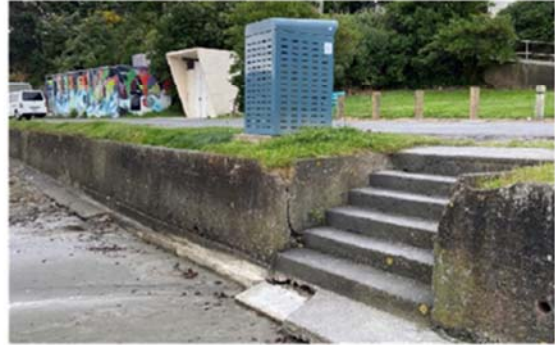
Sharp drop and broken steps - Vella Street

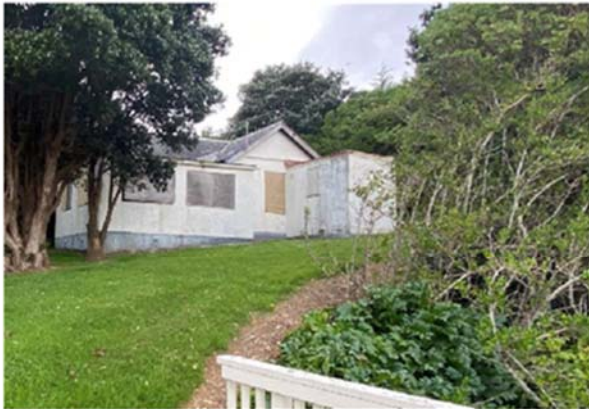
21 Bay Drive – Cable House

It is understood that the North end of the beach is a hot spot for anti-social behaviour. Specifically, the area around Cable House, with limited lighting and large trees, has been noted as a hotspot and an easy area to disappear from if Police do attend the scene.

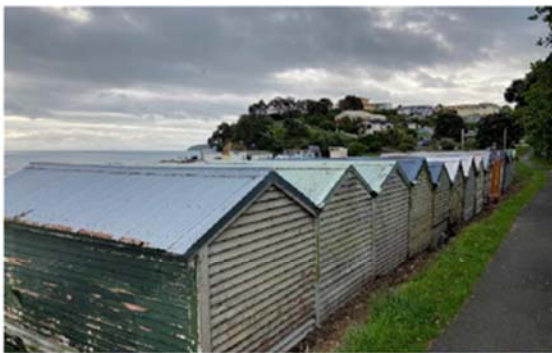
Paint peeling on boatsheds, picture taken from pathway leading to Vella Street

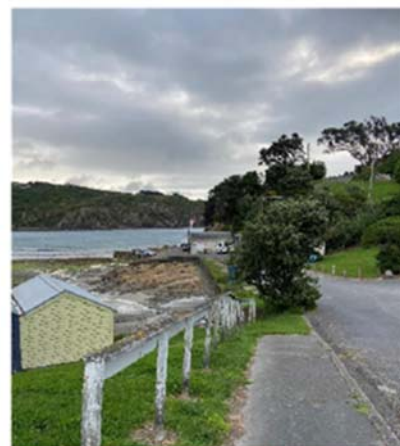
Handrail and footpath needing maintenance, taken from Vella Street looking towards the toilets

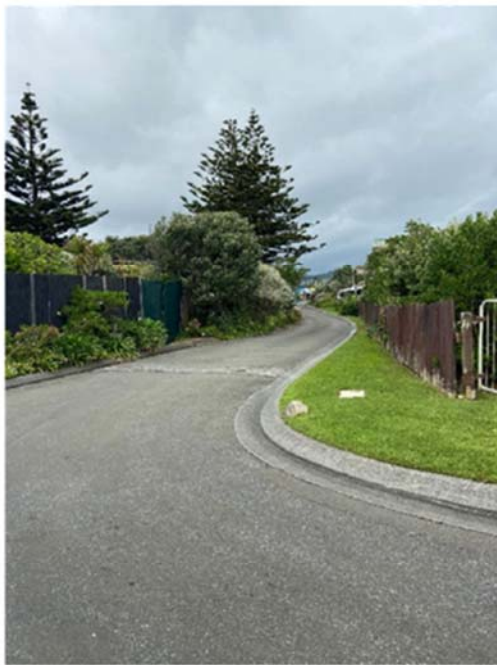
Narrow entry to carpark

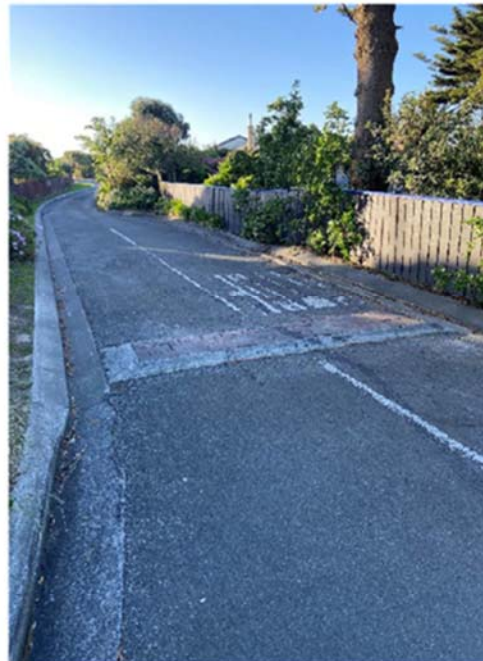
Road markings fading, maintenance required

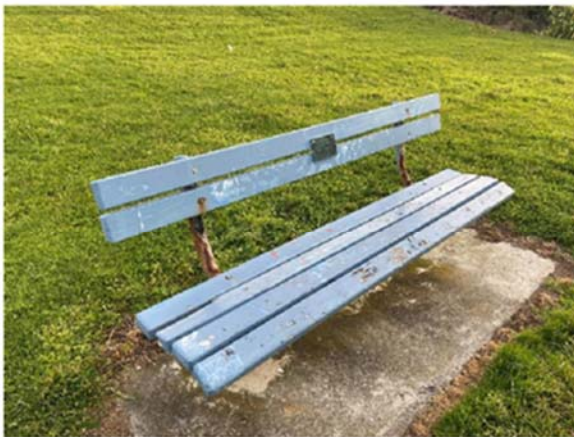
Bench needing removal and a potential new picnic area planned

- a. Remove and replace the rusty park bench
- b. Replacement of the light down the steps

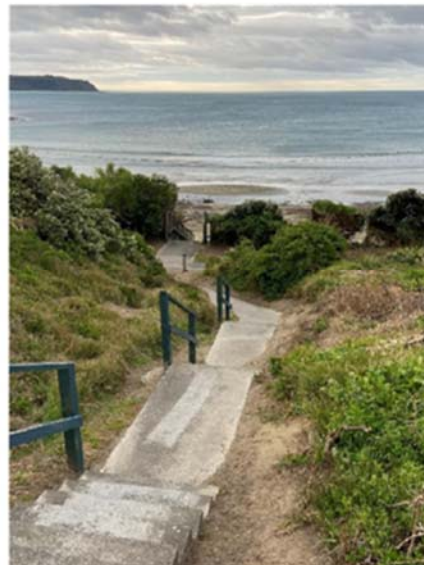
Stairs leading to beach, limited access to all mobilities and abilities

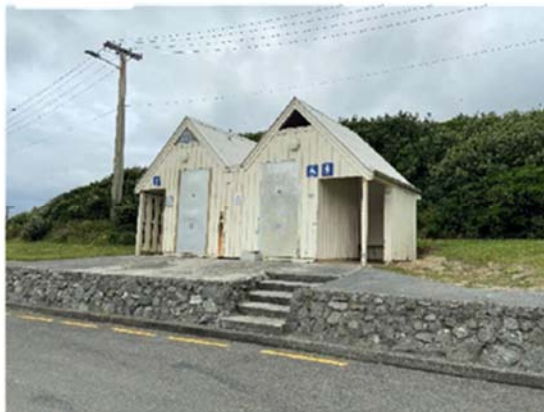
Toilets – accessibility considerations with narrow pathways and doorways

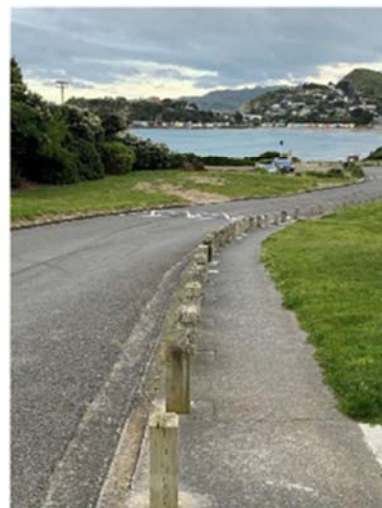
Narrow pathway leading down to carpark and beach

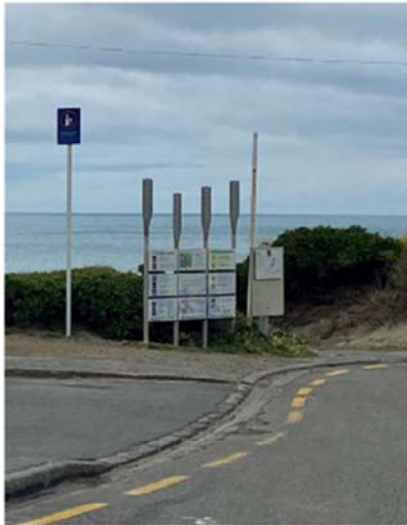
Multiple signage posts leading into the beach

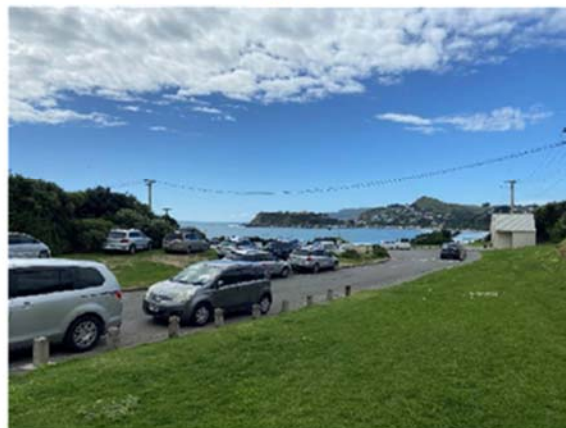
Cars parked on the side of the road, making access difficult and narrow

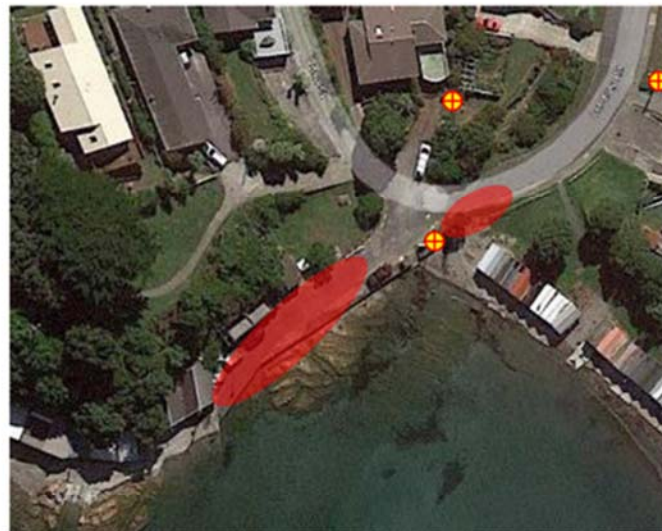
This area is lit with 3 pole mounted LED street lights. Light is blocked by vegetation creating a dark area on Lambley Road.

Locations of existing lights and dark areas (red)

- Add presence-controlled lighting to meet PR2 subcategory criteria.
- Close the public toilets at night
- Trim tree blocking light

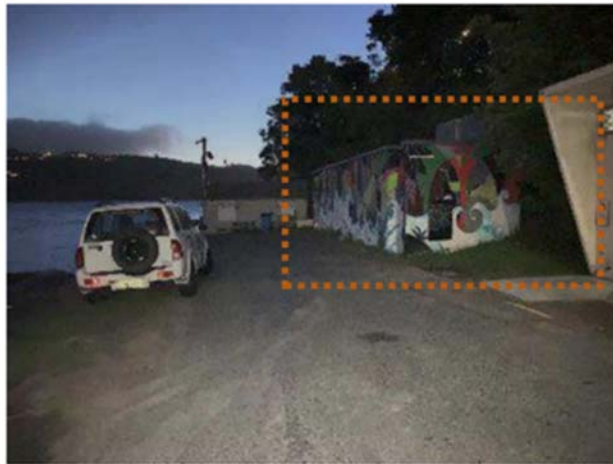
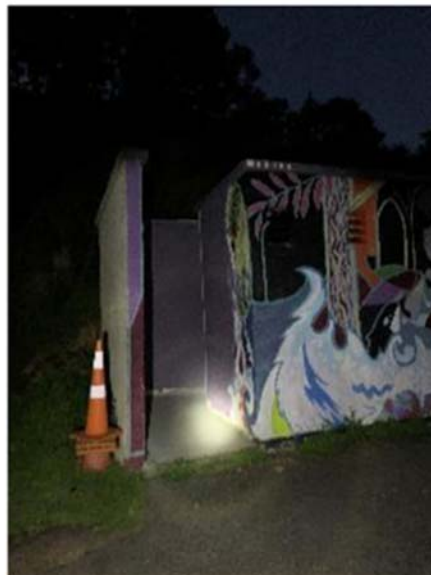
The road appears safe, however the area in front of the public toilets is not illuminated. We noticed several cars with people parked in the dark, which makes the space feel unsafe.

The public toilets are not illuminated and remain open. It creates both a risk of concealment and entrapment. There is also possible concealment opportunity between the transformer and the toilets.

We recommend closing these facilities at night and adding a presence sensor-controlled light on the driveway side wall.

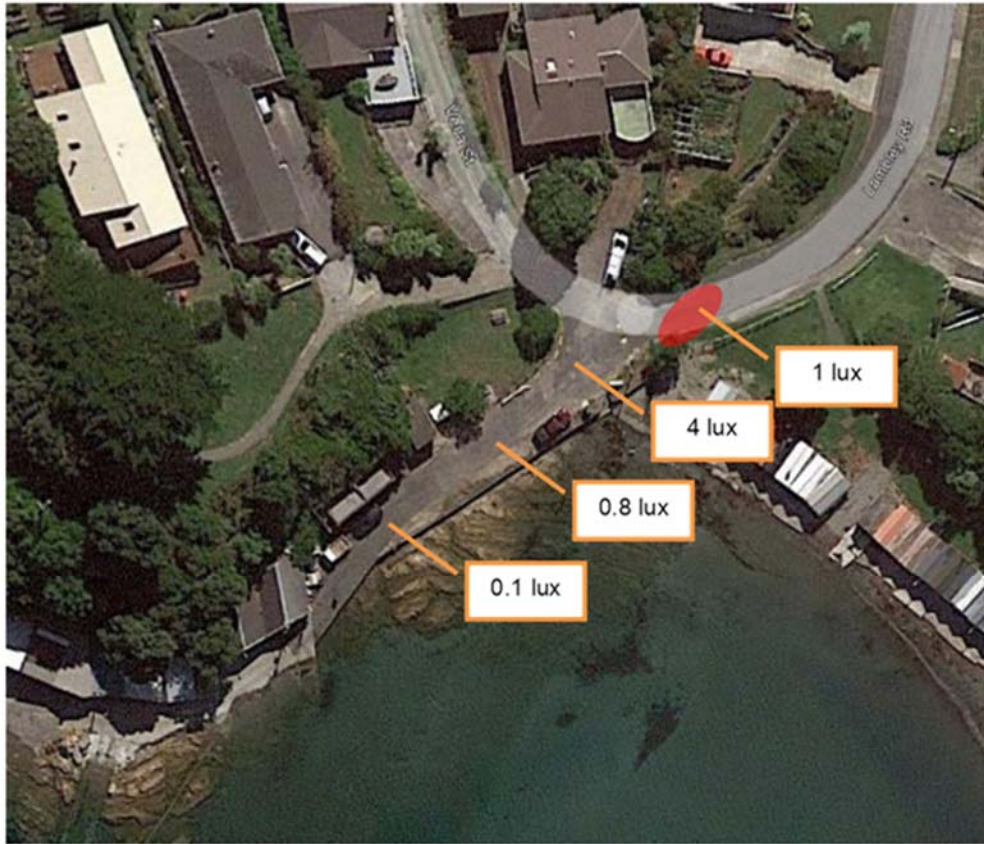
Measured Illuminance Levels

Recommendation for the dead end facing the public toilets is PR2 as "Fear of crime" criteria is medium.

New lights need to be added to meet the recommended levels on the dead-end facing the public toilets.

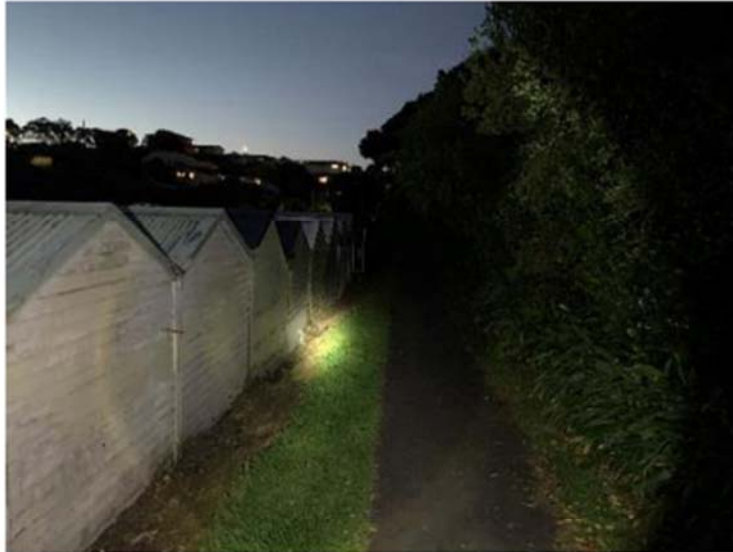
This pathway is used by several people at night as observed during the site visit. It is not illuminated. People are using their phone torches to see.

We note there is ditch on the side of the pathway which could be a fall hazard.

View of the pathway with powerful torchlight aimed at the ditch

Recommendation: Add lighting on the pathway to comply with PP3 subcategory.

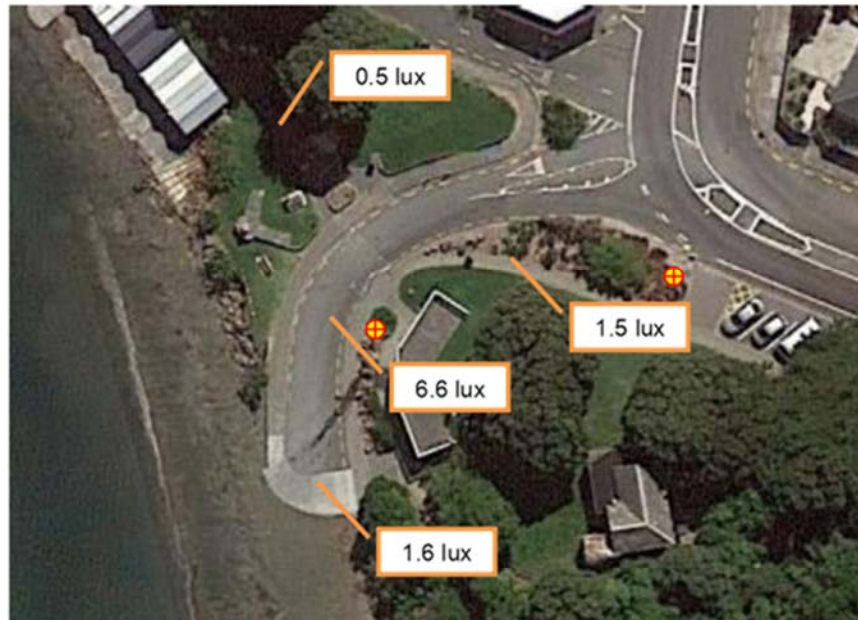
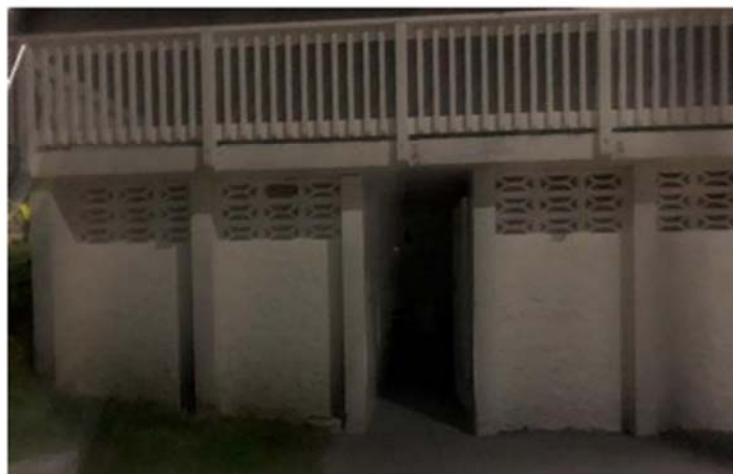
Measured Illuminance Levels

The night visibility in this area is good and feels safe. However the Public Toilets are unlit. This could lead to concealment and entrapment.

The measured lighting levels exceed the recommended lighting levels on the driveway.

Recommendation: Close public toilets at night or add presence-controlled lights.

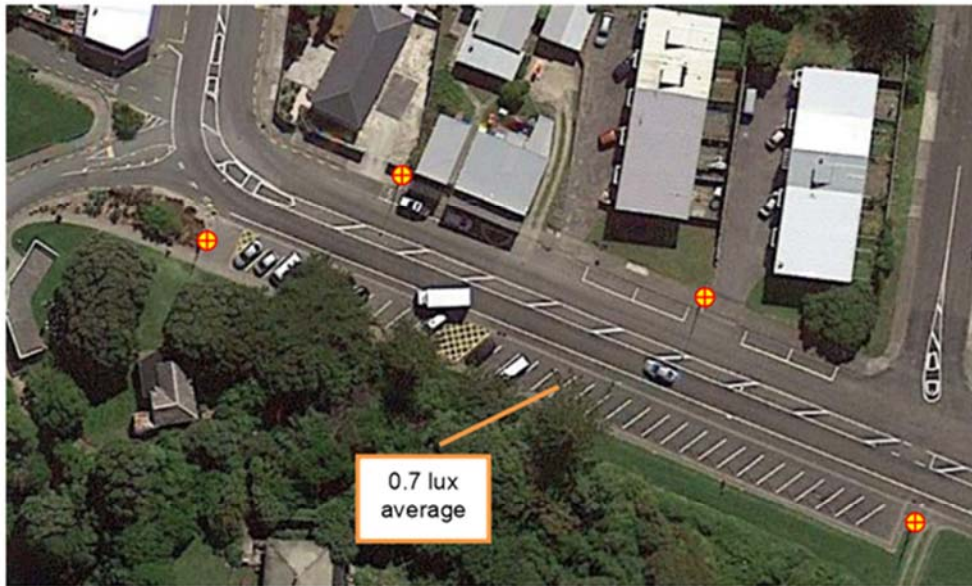
Measured Illuminance Levels

Diagonal parking bays along the roadside require vehicles to reverse, which presents higher risks for vehicles and pedestrians. Also, the standard considers that angled parked cars offer more opportunities for concealed activities. Therefore, the parking area should be considered as a separate space to the road and will require additional lighting.

The measured illuminance was 0.7 lux average. When no cars are parked the vision is not obstructed, but when cars are parked, the risk of concealment is higher. We note that some people park and stay in their cars, which results in pedestrians choosing to cross to the other side of the road.

Recommendation: Add lighting to diagonal car parking side to comply with PC2 subcategory.

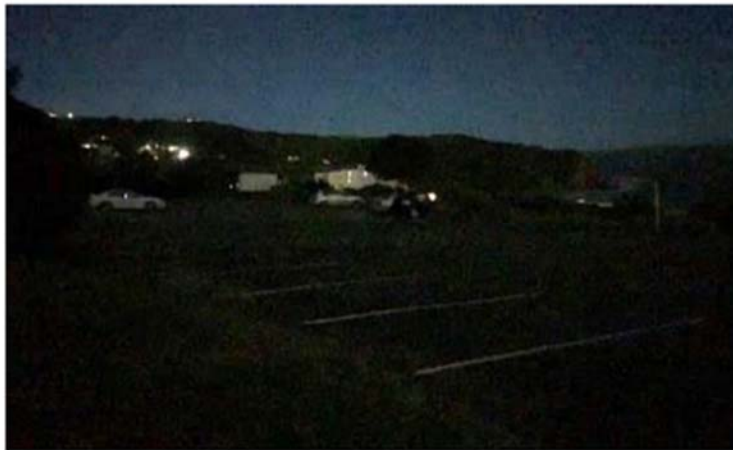
This carpark can be accessed by car via Bothamley Lane or Windley Avenue. A pathway leads to the beach. No lighting is installed on both car park and pathway to the beach.

We noticed several cars with people sitting in them. This can create a feeling of insecurity. However, no pedestrian was seen during the site visit.

Recommendation: Add lighting to the car park to comply with PC2 subcategory.

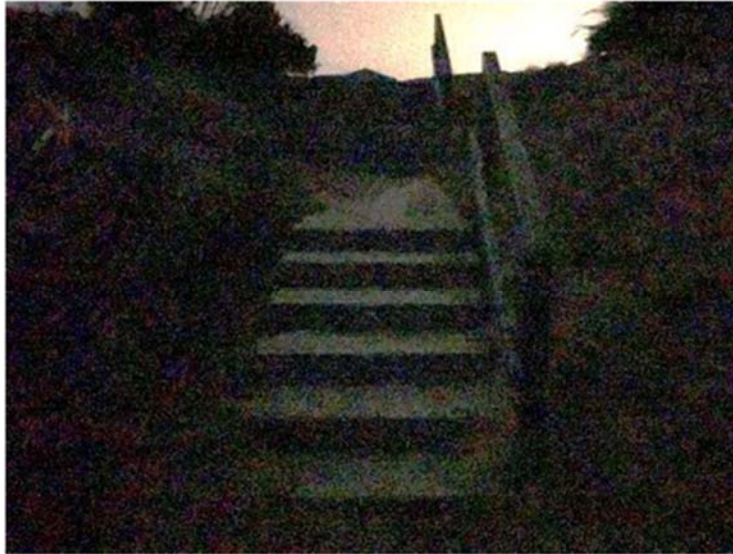
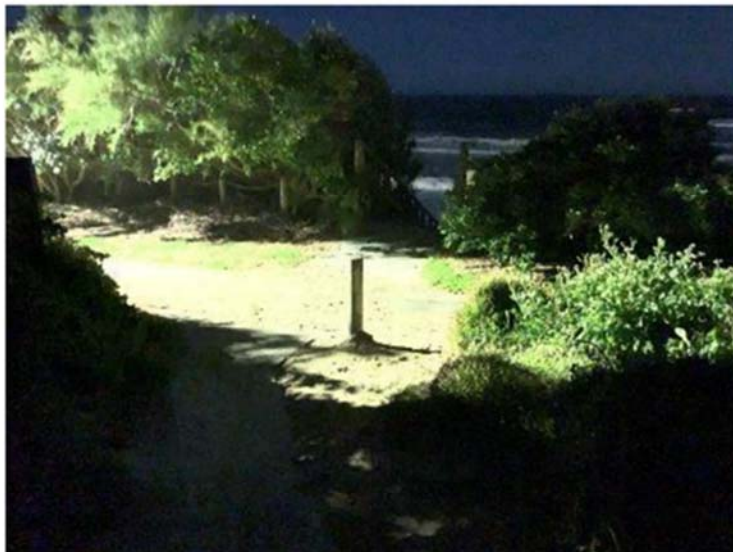
The pathway to the beach includes stairs. No lighting is installed along the pathway.

The lower end connects with another pathway (see next chapter). This end could be used as a concealment spot

The pathway looks not to be used at night and does not lead to any property.

Add lighting to comply with the PP3 subcategory except if Bothamley Car Park is not illuminated.

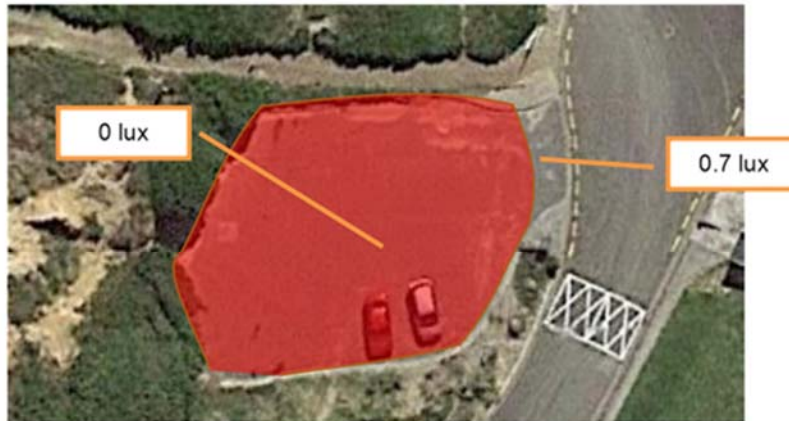
This carpark is not specifically illuminated.

We recommend installing lighting.

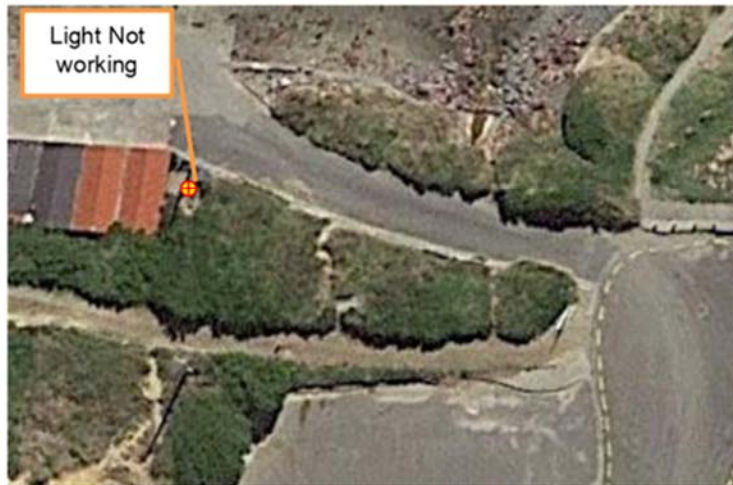
The access to the beach is closed after 9PM. Therefore, no light is needed in this area after 9PM. However, there is a streetlight installed next to the first boat shed. This streetlight is not working.

Recommendation: make existing light operational.

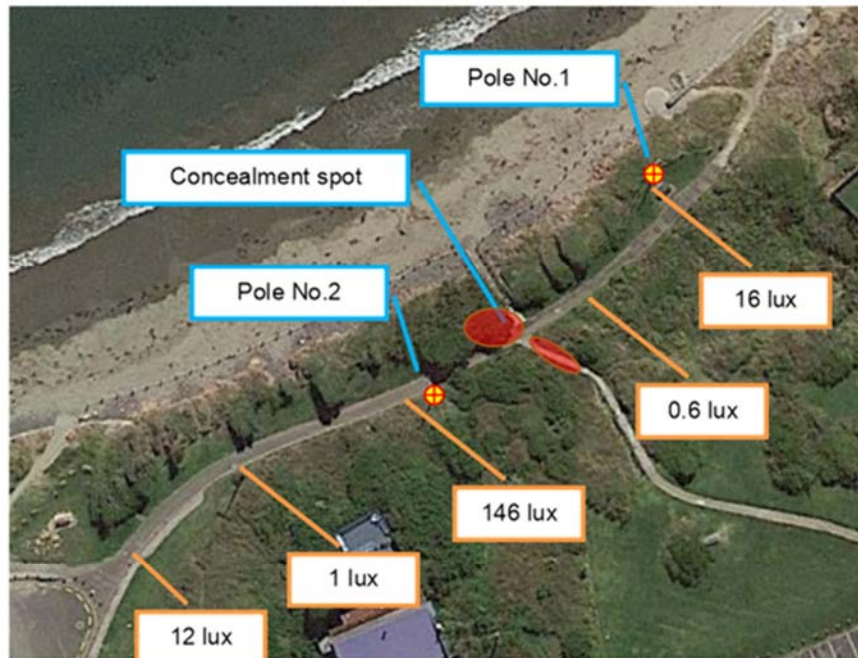
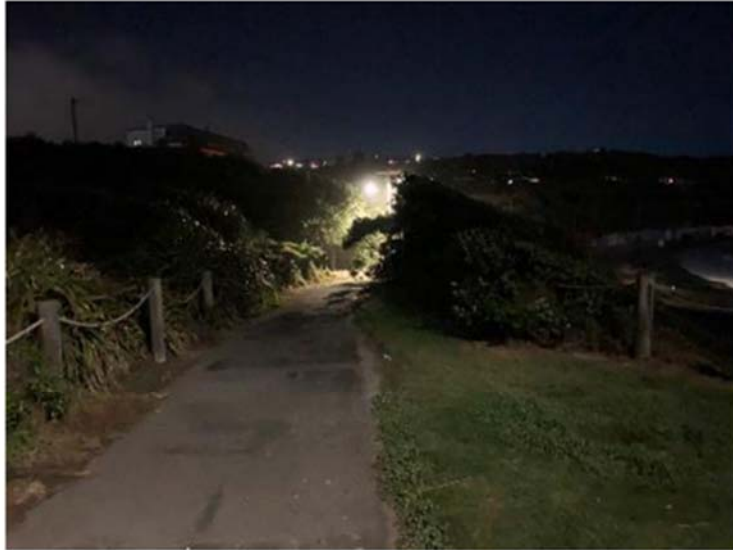
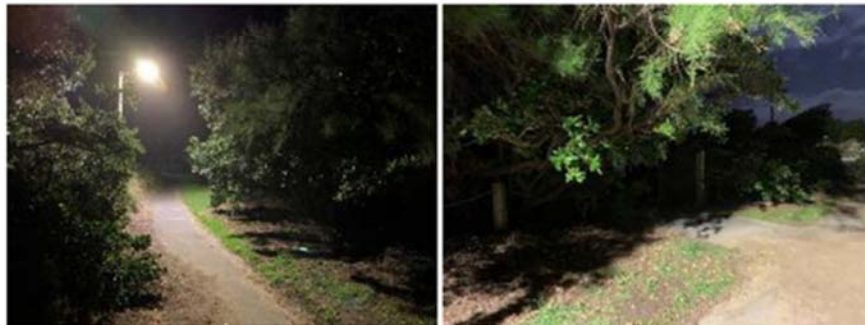
Measured Illuminance Levels

Pole No.2 is too powerful. The illuminance measured under the pole is 146 lux. This causes glare, which reduces the ability of users to see beyond this point and creating an easy concealment spots (areas circled in red above). We recommend dimming or changing this light to reduce the glare.

Vegetation is blocking light. We recommend trimming this vegetation to improve safety and allow more spread of light.

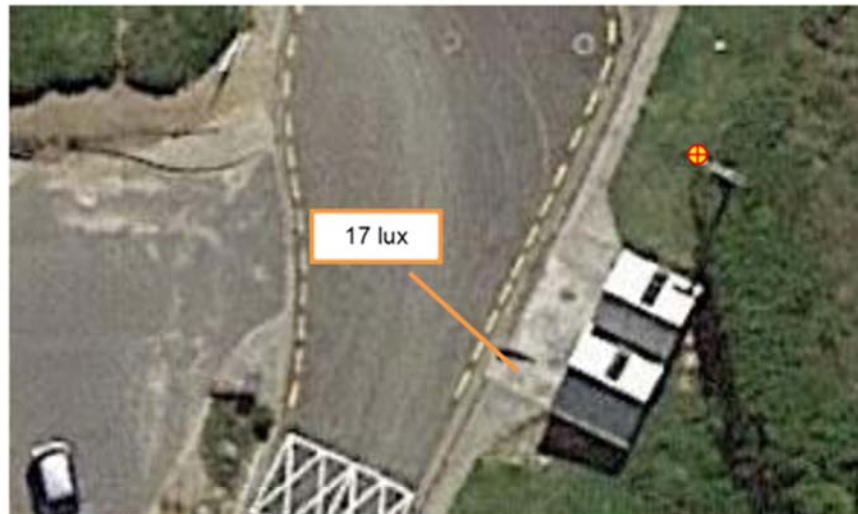
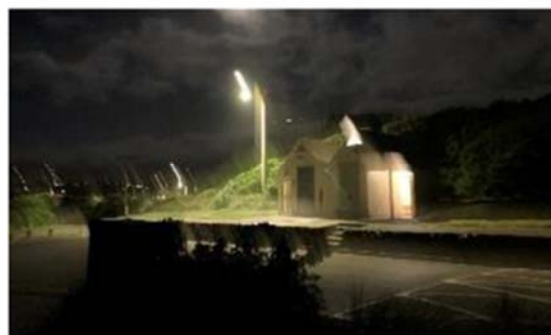
Measured Illuminance Levels

The Public Toilets area is illuminated by a street light mounted on a concrete pole. The area in front of the toilet block feels safe. We measured 17 lux on the stairs. Light inside the toilets also provides a feeling of safety.

Recommendation: We recommend retaining lighting in the toilet blocks as it is.
