INVESTIGATION DETAILS

1. MATTER UNDER INVESTIGATION

On Saturday 13 January 2018 at approximately 19:55, Mr John Sprague, a 45 year old hobby photographer, was hit by a competition stock car vehicle while he was taking photographs from a position on the infield of the racetrack at Waikaraka Family Speedway.

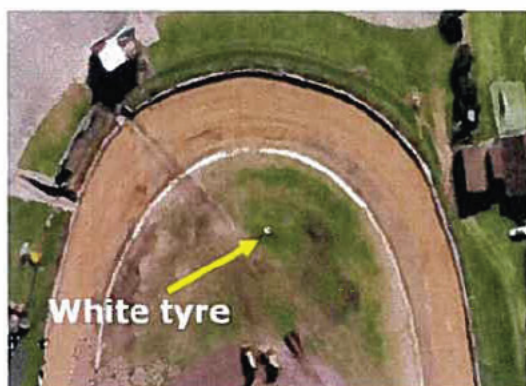
Fig. 4
Location of white tyre.
Waikaraka Family Speedway.
Image produced from Google maps

The Police investigation at the scene found that the white tyre was located approximately 17 metres from the closest edge of the track before the incident occurred.
(70007/7 P1)

Other than the tyre at each end of the track, there are no barriers to protect people standing on the infield from vehicles that leave the track for any reason.

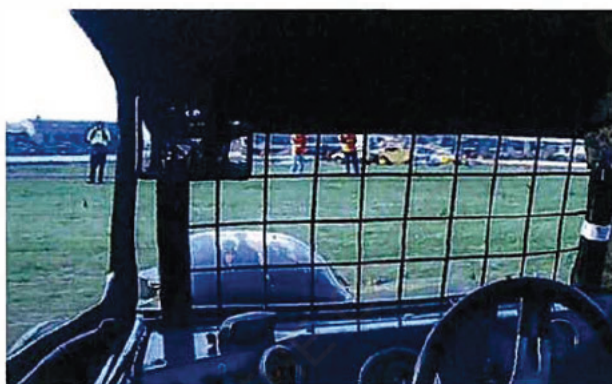
Fig. 5
Infield at Waikaraka Family
Speedway.
Image created from Police file
footage recorded by an in-vehicle
camera.

The still image above shows the infield, where various people and vehicles can be seen from inside a racing vehicle with no separation in place.

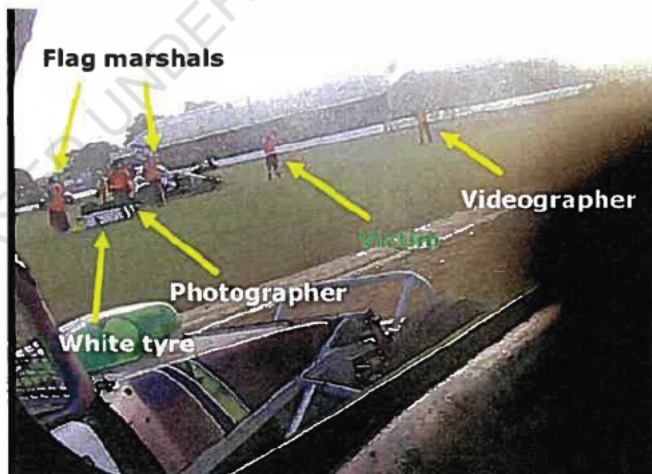
Fig. 6
Still image showing infield personnel Waikaraka Family Speedway at approx. 19:53 on 13/01/2018.
Image created from Police file footage recorded on an in-vehicle camera.

There were two other photographers and a videographer on the infield at the time the incident occurred. One of those is visible in the image above.

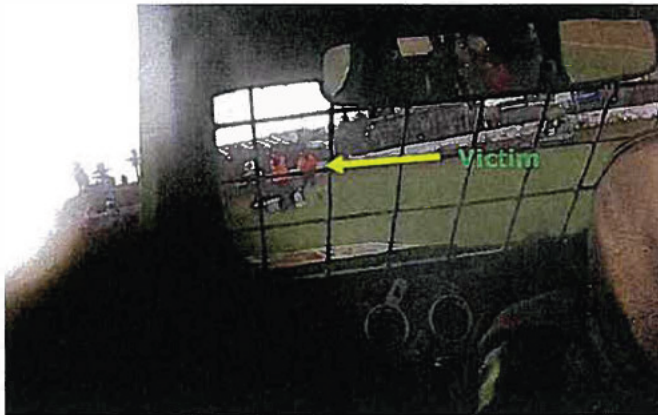
Fig. 7
Superstock 42A travelling through the infield.
Image created from Police file footage recorded on an in-vehicle camera.

Fig. 7 shows the victim and a flag marshal standing next to the white tyre. Both people appear to be facing the oncoming vehicle.

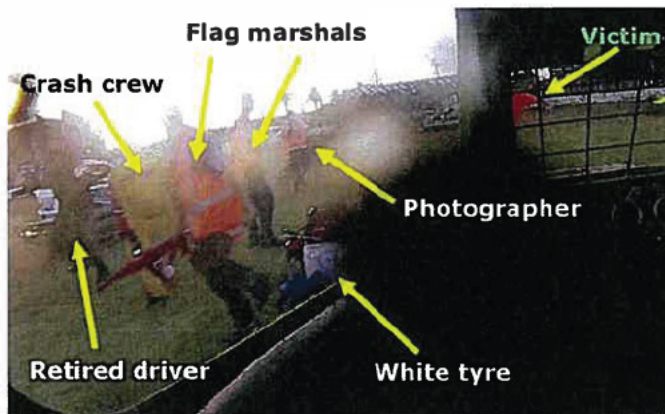
Fig. 8
Immediately prior to impact.
Image created from Police file footage recorded on an in-vehicle camera.

The image above shows the moment immediately prior to the vehicles' impact with the victim.

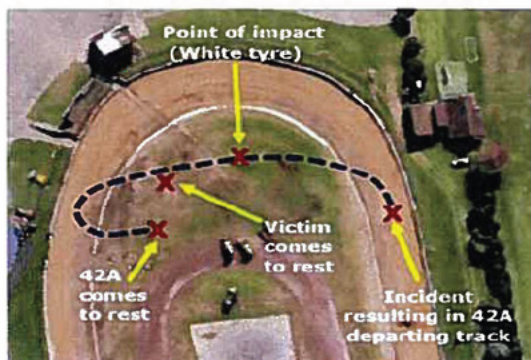
Fig. 12
Approximate map of incident. Information used to construct this image was taken from footage and scene photographs. Image created google maps.

The image above shows indicative positions only, as no formal scene mapping was undertaken as part of the scene investigation by either Police, or WorkSafe Inspectors.

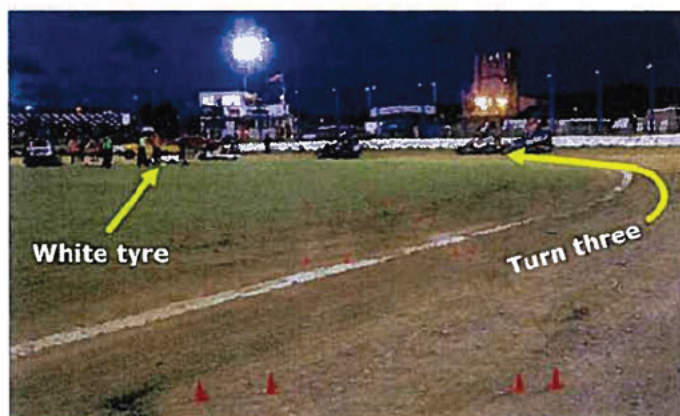
Fig. 13
Vehicle tracks leading onto the infield. Trajectory marked by cones. Scene photo from Police file.

Fig. 13 shows tyre tracks made by Superstock 42A as it left the track before turn three. These tracks were identified and marked out by Police as part of their scene investigation. (70007/7 P2)

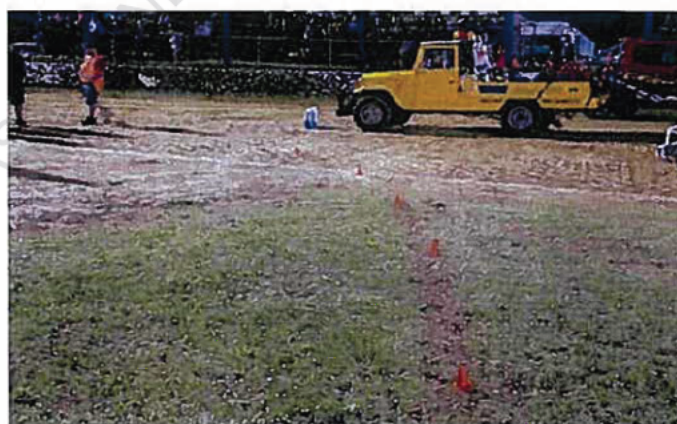
Fig. 14
Vehicle tracks leading onto the track. Trajectory marked by cones. Scene photo from Police file.

The image above shows tire tracks that Police suggest is the point at which Superstock 42A re-entered the track after turn four.

The police file notes that gouging can be seen on the track surface. Police suggest that this is consistent with what the footage show of 42A with its two front wheels turned hard to the left as it re-entered the track, but the vehicle itself not turning.
(70007/7 P3)

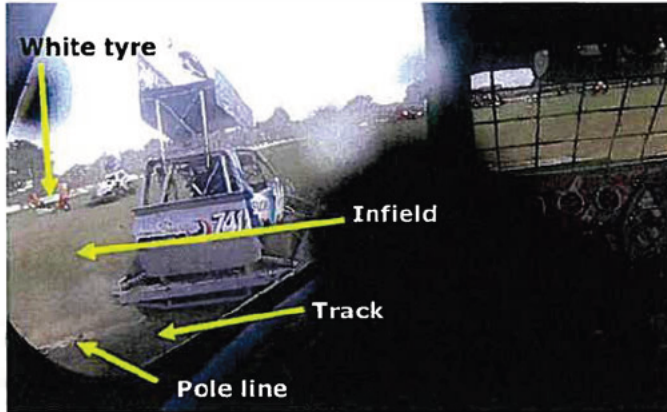
Fig. 15
View of impact between vehicles.
Image created from Police file
footage recorded on an in-vehicle
camera

The image above shows Superstock 42A impacting with Superstock 741A upon re-entering the track in turn four, after the impact with Mr Sprague.

In this image, Superstock 741A provides an example of a vehicle being forced onto the infield after contact with another vehicle on the track.

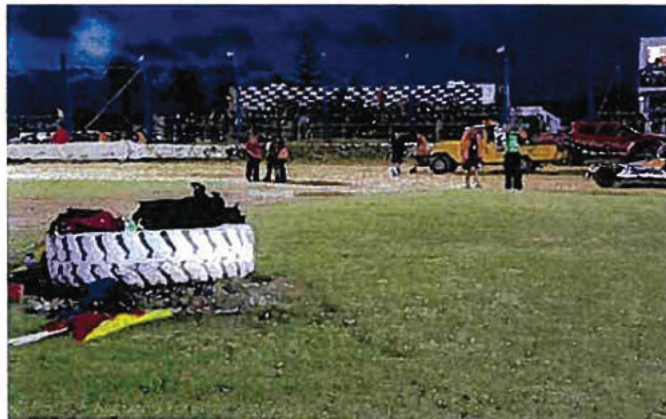
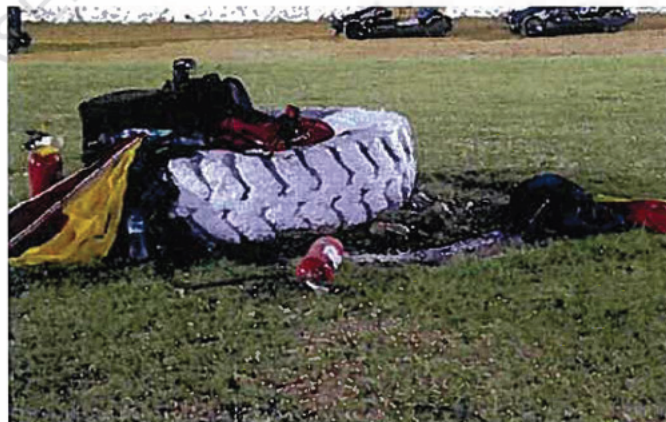
Fig. 16
White tyre following incident.
Image created from Police file
footage recorded on an in-vehicle
camera.

Fig. 17
White tyre following incident.
Image created from Police file
footage recorded on an in-vehicle
camera.

Fig. 16 and 17 both show the position of the tyre following the incident. Its original position is known by the depression in the soil, the mounded debris, and the dead grass.

In his statement for the Police file, Senior Constable Colin Nuttall of the New Zealand Police estimates that due to impact by Superstock 42A, the tyre had been moved approximately 0.8 metres.

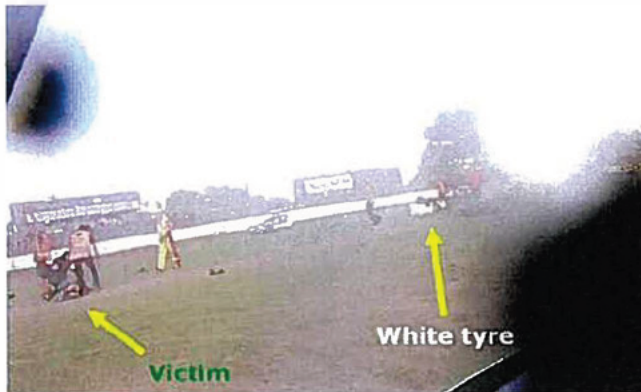
Fig. 18
View of scene immediately after the incident.
Image created from Police file footage recorded on an in-vehicle camera

The angle at which the scene is captured shows the distance between where the impact occurred at the white tyre, and where the victim came to rest.

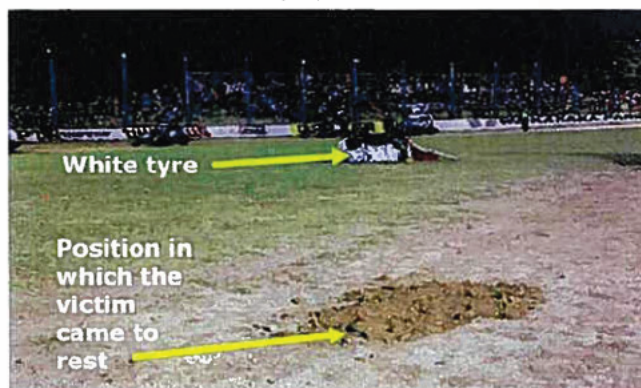
Fig. 19
Scene after removal of victim.
Image created from Police file footage recorded on an in-vehicle camera.

The image above shows the position in which the victim came to rest. Dirt had been piled by Promoter volunteers to cover the victim's blood which had pooled.

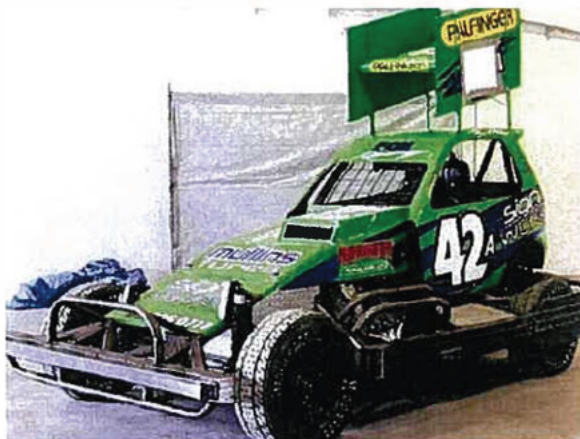
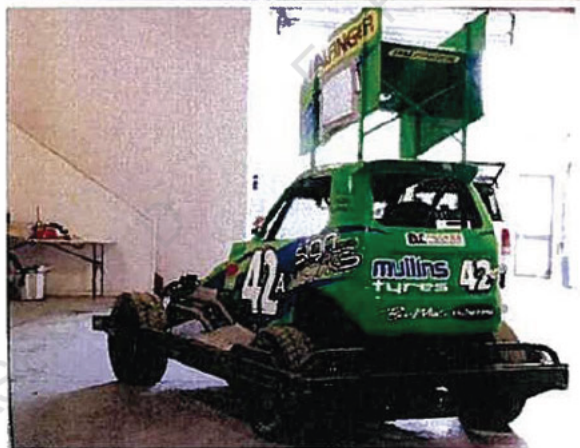
Fig. 20
Superstock 42A.
Front-left view.
Image provided from Police file.

Fig. 21
Superstock 42A.
Rear-left view.
Image provided from Police file.

The inspection found that the drive shaft had shattered during the race. A possible cause of this was not identified in the examination report, and no conclusion was offered as to the cause.

Debris from the driveshaft assembly had broken a nipple on the rear left brake calliper, which caused the vehicles hydraulic brake system to bleed rapidly and become completely ineffective.

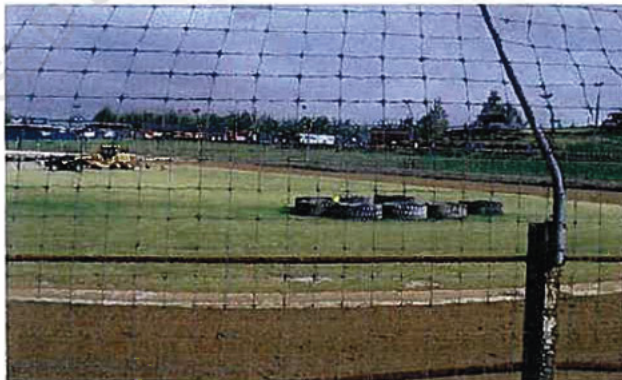
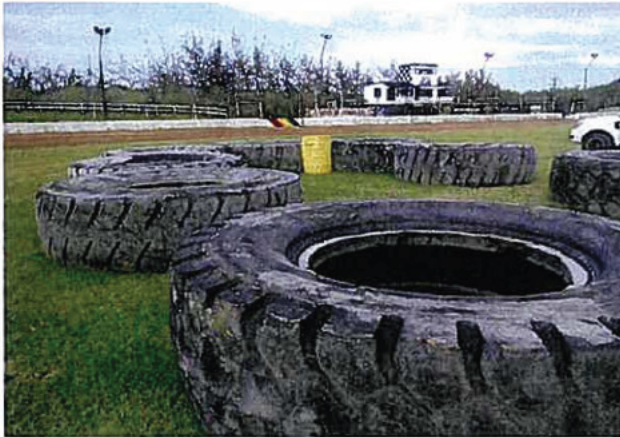
Fig. 5
Barrier system on the infield at Huntly Speedway, viewed from outside safety fence.
Photograph taken for this investigation.

Fig. 6
Close up of barrier system in place on the infield at Huntly Speedway. Photograph taken for this investigation.

As is evident from the photograph above, Huntly Speedway has installed an enclosed area at each end of the circuit which is constructed of 8 tyres, placed in an interlocked pattern.

The president of Waikato Stock and Saloon Car Club which operates Huntly Speedway, says that these tyres weigh approximately 2 ton each (44 gallon drum for scale).
(20001 P37)

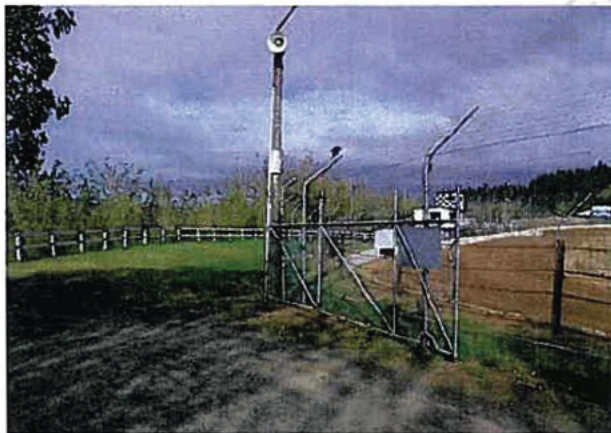
Huntly Speedway also uses cherry pickers for photographic purposes at certain events which are placed outside the circuit in the spectator area.

Fig. 8
Grassed area where cherry picker is located at Huntly Speedway. Photograph taken for this investigation.

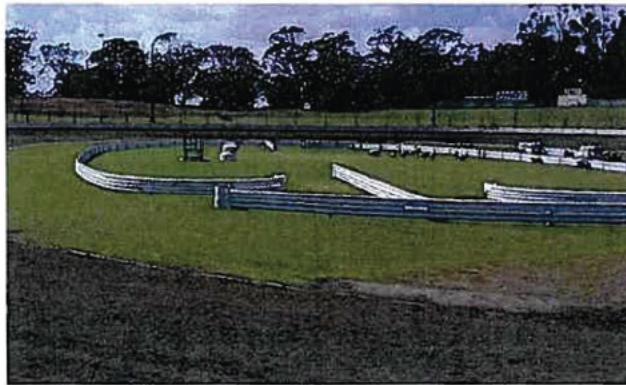
Fig. 6
View of barrier system in place on the infield at Borderline Speedway. Image taken from original provided by Tim Savell, CEO Speedway Australia.

This system was required by SafeWork South Australia, in order for a prohibition notice on all speedway racing to be lifted.

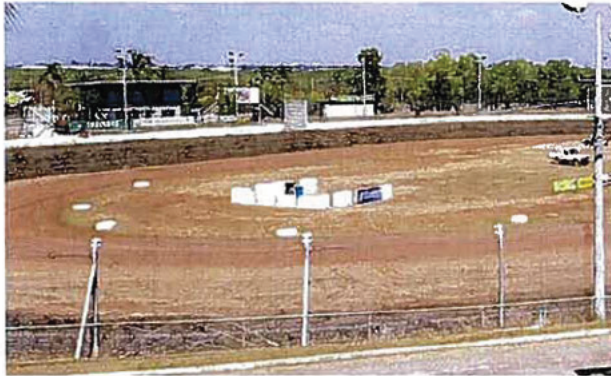
Fig. 7
View of barrier system in place on the infield at Northline Speedway. Image provided by Tim Savell, CEO Speedway Australia.

Northline Speedway implemented this system on their own initiative. Mr Savell acknowledged this proactive approach, but also discussed some issues with this system of protection.
