Detailed Seismic Assessment

Waitomo District Council –Administrative Building (for IL2)

Waitomo District Council

18 April 2023

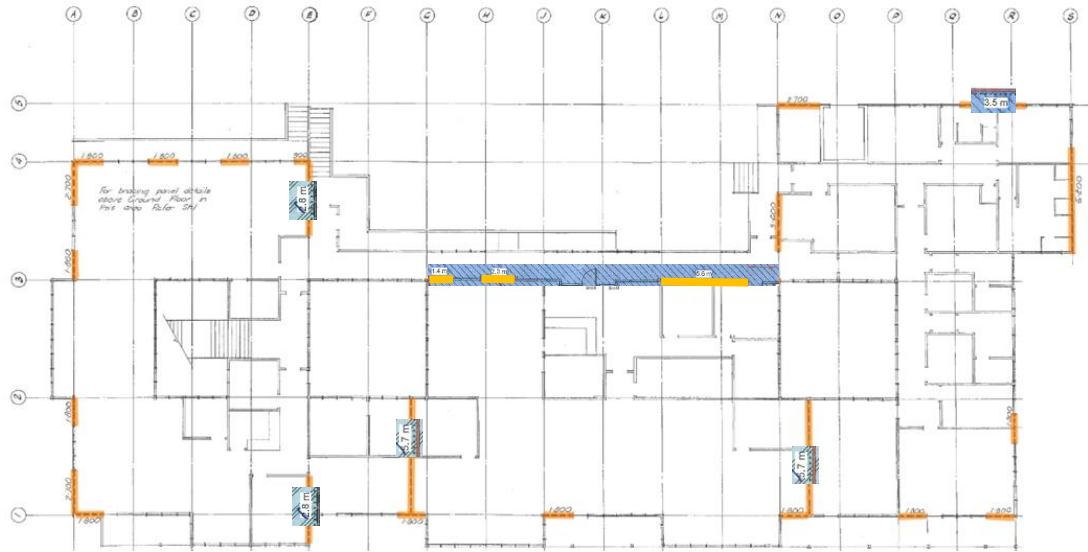
(a) Existing bracing timber walls on the First Floor

The Critical Structural Weaknesses (CSWs) controlling the building's score are the timber braced walls in the Ground floor, closely followed by the timber braced walls in the First floor. Also, in line with Part C2G of the MBIE Assessment Guidelines, the timber walls and diaphragm are identified as Severe Structural Weaknesses (SSW) because their failure could lead to the collapse of the building.

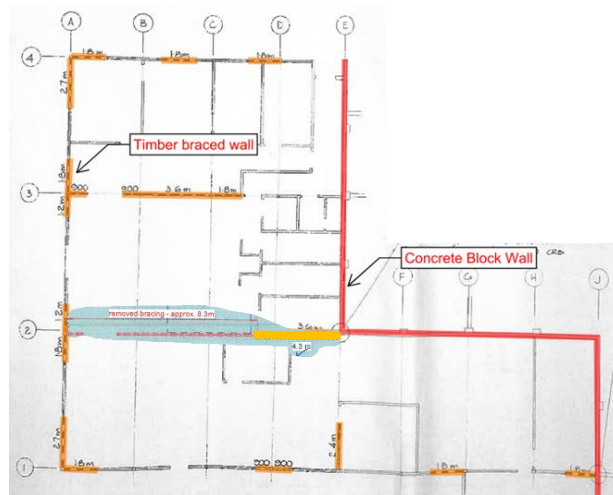
(b) Existing bracing timber walls and blockwall (retaining) on the Ground Floor

ID	Element	%NBS(IL4)	Location, mode of failure and engineering statement of structural weaknesses
1	Timber braced walls (Ground Floor)	15%	Critical Structural Weakness (CSW) – Very high risk to life-safety should a large earthquake occur Location: Timber walls on ground floor Mode of failure: Shear failure of the wall which is a combination of over-turning of the panels; bending of the studs; connection failure; and pull-out of the studs
2	Timber braced walls (First Floor)	15%	Critical Structural Weakness (CSW) – Very high risk to life-safety should a large earthquake occur Location: Timber walls on first floor Mode of failure: Shear failure of the wall which is a combination of over-turning of the panels; bending of the studs; connection failure; and pull-out of the studs
3	Floor Diaphragm	40%	Structural Weakness (SW) – Medium risk to life-safety should a large earthquake occur Location: First Floor Mode of failure: tension failure of the floor chord, open-up the floor leading to local collapse.

Based on the findings and assessed %NBS score, in conjunction with the requirements of the building Act 2004, this building must be retrofitted to at least 34%NBS. However, and in line with WDC request, it is recommended that the building is strengthened to 67%NBS(IL2), so it does not fall below the threshold for acceptable seismic risk, as recommended by NZSEE.

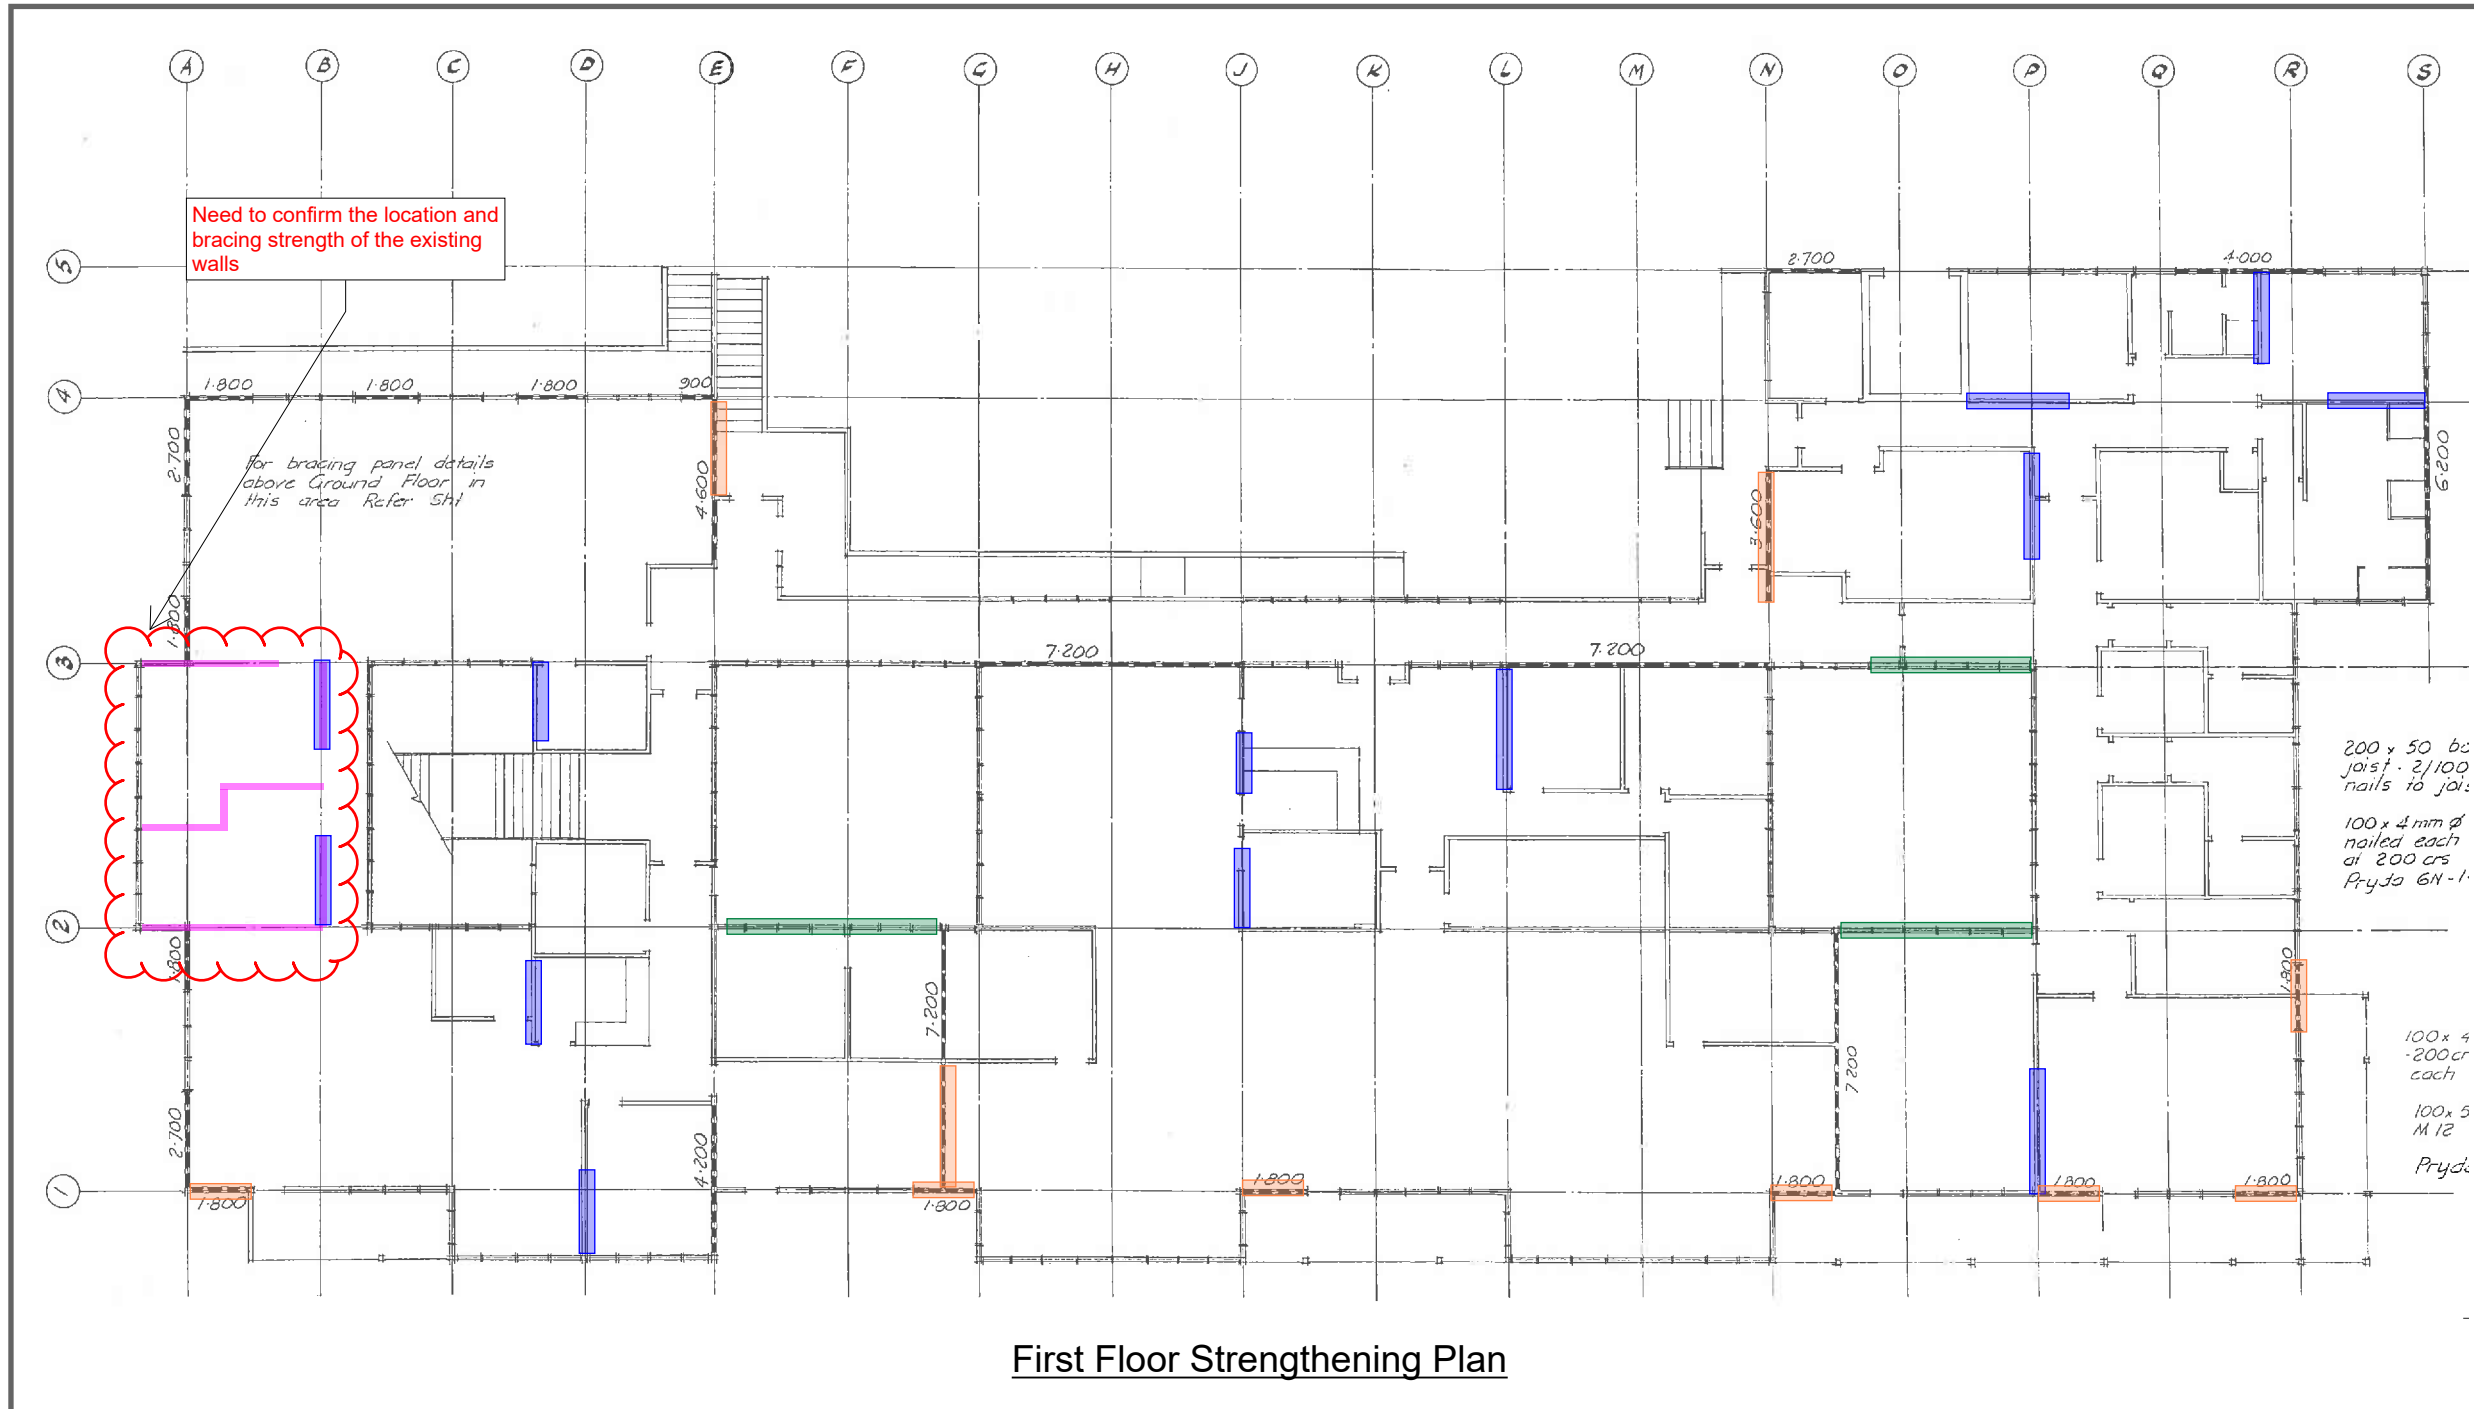
-As the connection details for the existing particle board with the timber walls/ concrete block walls at first floor are missing in the existing drawings, the extent and detail for the strengthening of the diaphragm can only be determined following inspection of the existing connections.

- Strengthening of Existing bracing Elements by replacing the current lining with new GIB lining
- Strengthening of Existing walls by new GIB lining (Tentative locations)

- New GIB braced walls
