# Detailed Seismic Assessment

**Waitomo District Council –Administrative Building**

Waitomo District Council

03 March 2023

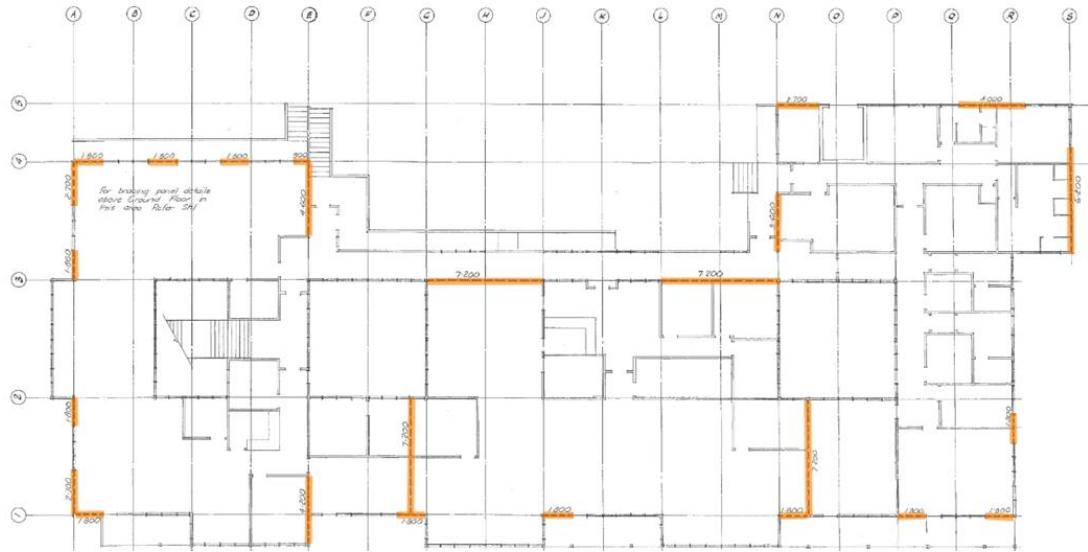
(a) Existing bracing timber walls on the First Floor

The Critical Structural Weaknesses (CSWs) controlling the building's score are the timber braced walls in the Ground floor, closely followed by the timber braced walls in the First floor and the First floor timber diaphragm. Also, in line with Part C2G of the MBIE Assessment Guidelines, the timber walls and diaphragm are identified as Severe Structural Weaknesses (SSW) because their failure could lead to the collapse of the building.

Based on the findings and assessed %NBS score, in conjunction with the requirements of the building Act 2004, this building must be retrofitted to at least 34%NBS. However, and in line with WDC request, it is recommended that the building is strengthened to 100%NBS(IL4) so it can comply with the intended post-disaster use.

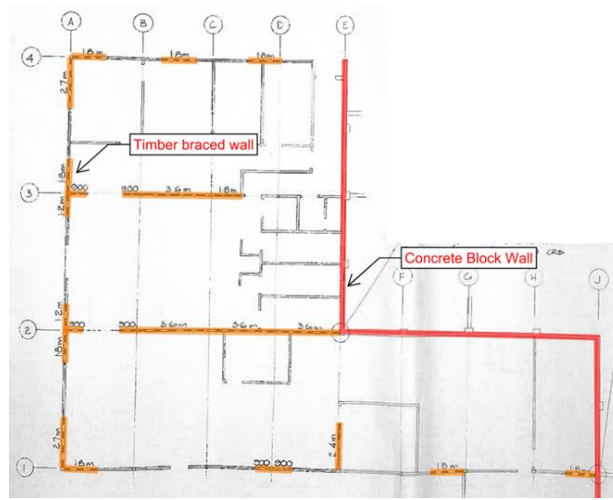
(b) Existing bracing timber walls and blockwall (retaining) on the Ground Floor

4	Concrete block walls	40%	<b>Structural Weakness (SW) – Medium risk to life-safety</b> Location: ground level along gridlines E, 2 and J Mode of failure: Flexural failure of the walls

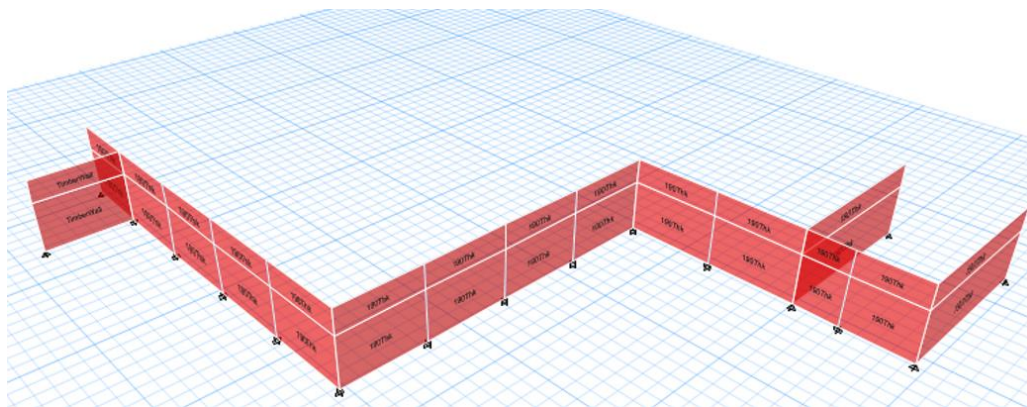
*Figure 3.2 Etabs block wall model*

Action: Due to the expected displacements the retaining wall will push against the floor diaphragm. So, the load from wall top will be transferred to the structure. This changes the support condition to fixed base - pinned top.
