Certificate of Compliance

Building name: Boulcott Hall
Street address: 47 Boulcott Street, Wellington
Legal description: Lot 1 DP 344738
Location of building, site/block No:
Level/unit: 14 Floors plus Ground

Fire Sprinkler System Survey Report

Date: 25 January 2023
Survey No: 25549
Site Ref: A3966
Issue: A

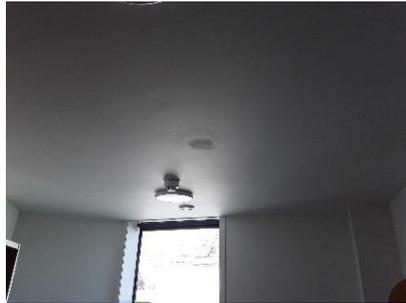
1. *Diesel Pump: The diesel pump failed to start before the sprinkler system reached a static pressure of 720kPa.*
2. *Room 1210: Concealed sprinkler head plastered over. No sprinkler protection within. Refer photo below.*

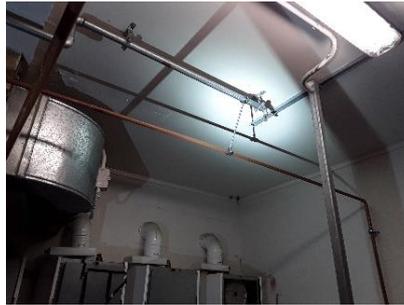
3. *It was noted concealed sprinkler plates were missing in the following locations:*
 - a. Room 906.
 - b. Room 806.
 - c. Room 615.
 - d. Room 507.
 - e. Room 405.
 - f. Room 310.
 - g. Room 306.
 - h. Room 1015.
 - i. Room 1215.
 - j. Room 1217.
 - k. Room 1303.
4. *Level 15, Plant Room: Copper water pipe attached to sprinkler pipework. Refer photo below.*

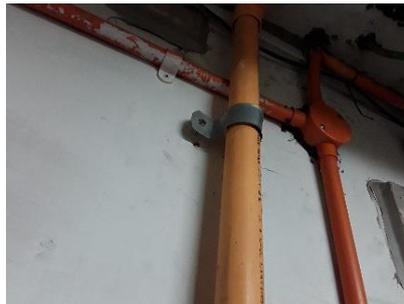
5. *Level 16, Plant Room: Pipework support not securely attached to the wall. Refer photo below.*

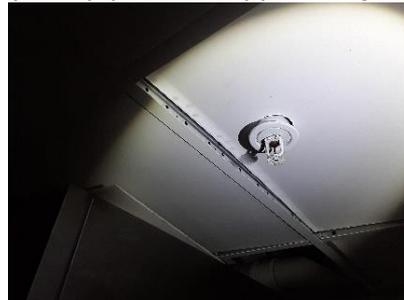
6. *Level 1, kitchen serving area: Sprinkler head dropped from ceiling and ceiling tile lifted. Contractor to confirm adequate pipework support. Refer photo below.*

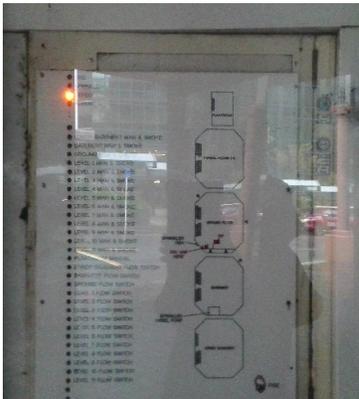
Street front panel (defect at the time, however contractor was on site)

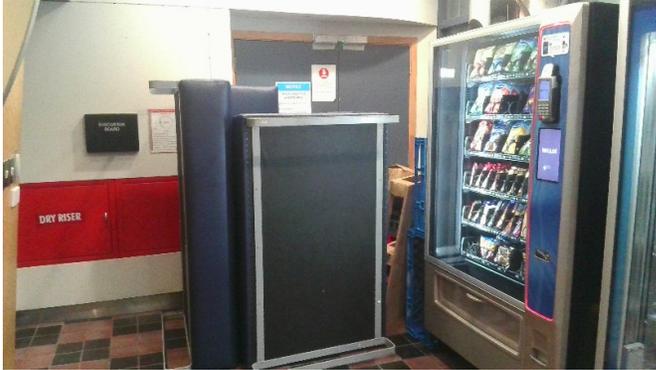
The fire exit doors from the kitchen through the lobby were blocked by furniture. This must not occur at any stage. These doors were blocked and not able to be used. Council will undertake spot visits to ensure that this does not occur again, if it is found to be happening again council can issue an infringement.

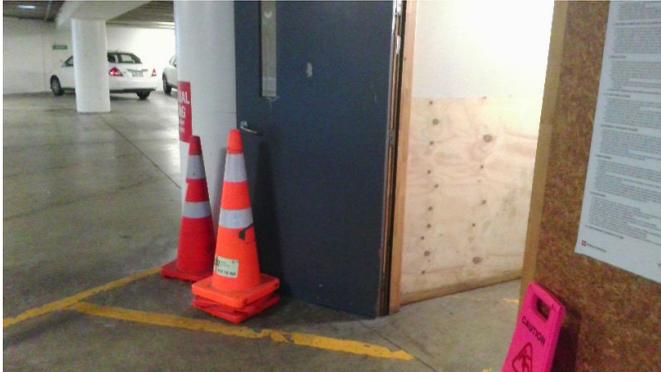
A basement door was wedged open by cones. The sign on the door reminds people to keep the door closed, and no one was around to explain why this happened.

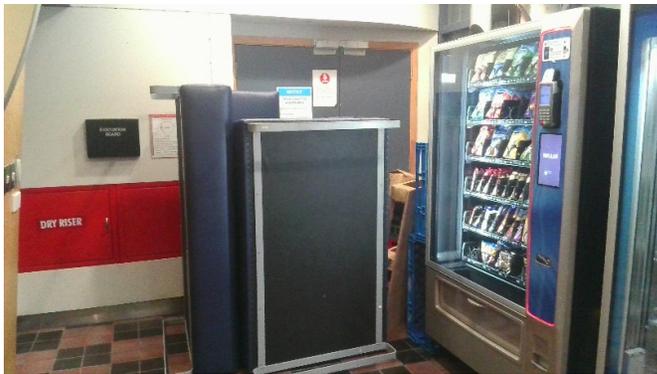
The fire exit doors from the kitchen through the lobby were blocked by furniture. This must not occur at any stage. These doors are a requirement to enable escape which was not possible at the day of audit.

This building has specific safety systems installed to protect the young persons residing there and these systems are not able to undertake their job if blocked or wedged open. Council requests that more education is provided to those who work on site.

These non-compliances have been discussed with the IQP and council would not expect to see a Form 12A for Final Exits if these non-compliances continue which will affect your BWoF.

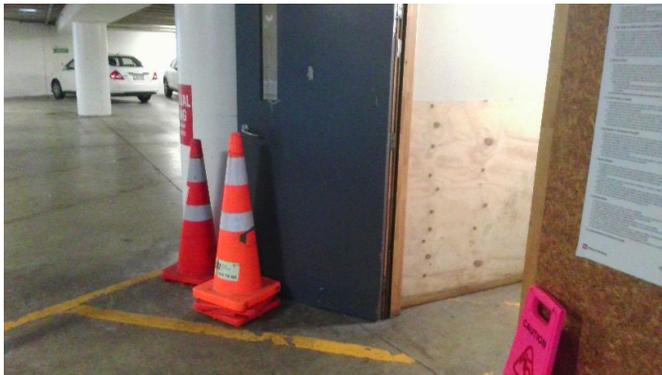
A basement door was wedged open by cones. Please ensure that this does not happen.

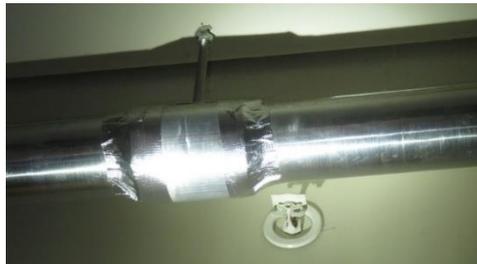
2. *Terrace Building, Level 7: The understairs sprinkler head is plugged off.*
3. *Terrace Building, Level 10: Room 1011 sidewall sprinkler head is baffled by pipework and pipework lagging upon entry. Refer to photo below.*

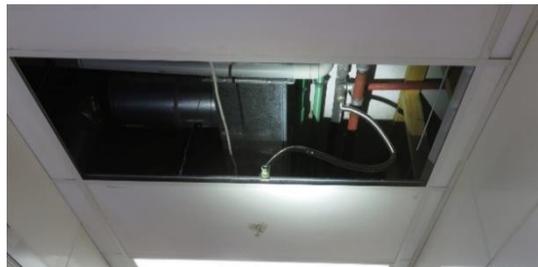
6. *Tower Building, Level 13: A sprinkler head is off vertical in the corridor between toilets. Contractor to confirm adequate pipework support.*
7. *Tower Building, Level 7 main kitchen: Missing ceiling tile above bench wash-up bench beside gas grill needs reinstating.*

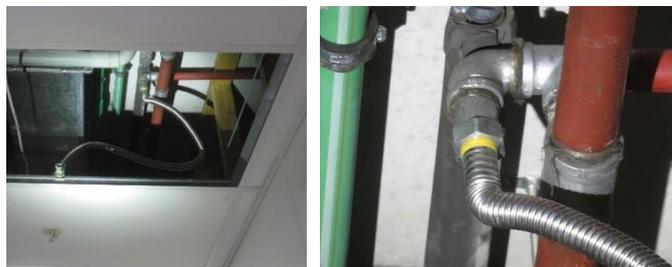
8. *Tower Building, Level 7 main kitchen: Flexible dropper visible through the missing ceiling tile above the wash-up bench beside gas grill has too tight bend radiuses. Refer two photos below.*

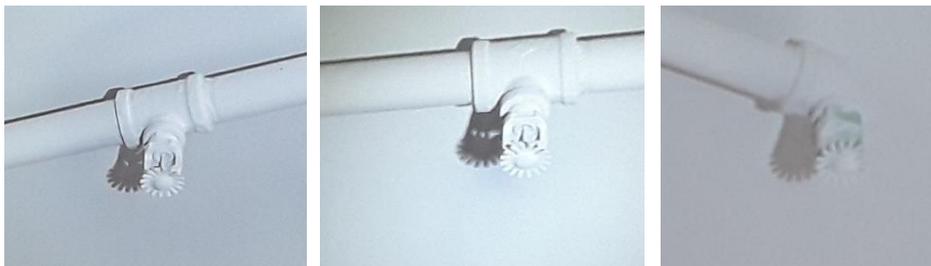
Representation of painted sprinkler heads

3. *Sprinkler bulbs were noted to be painted in the following areas:*
 - a. *Ground Floor: Room A10.*
 - b. *Ground Floor: Room A11 (x2).*
 - c. *Ground Floor: Room A7.*
 - d. *Ground Floor: Corridor outside room A13.*
 - e. *Ground Floor: Room A15.*
 - f. *Ground Floor: Corridor outside room A16.*
 - g. *Basement: Room CK1.*
 - h. *Level 1: Corridor between Rooms B13 and B12.*
 - i. *Level 2. Room C8.*

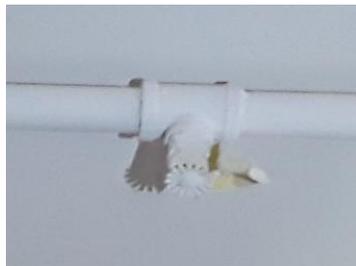
Representation of taped sprinkler heads

4. *Sprinkler heads were noted to be covered in tape in the following areas:*

1. *Ground Floor: Room A13 (x2).*
2. *Ground Floor: Memorial Common Room.*
3. *Ground Floor: Room A22 (x2).*
4. *Ground Floor: Room A15.*
5. *Ground Floor: Room A16 (x2).*
6. *Ground Floor: Room A21.*
7. *Ground Floor: Room A17.*
8. *Ground Floor: Room A20.*
9. *Ground Floor: Room A18 (x3).*
10. *Ground Floor: Room A19.*
11. *Basement: Music room.*
12. *Basement: Laundry (x3).*
13. *Basement: Drying room (x2).*
14. *Basement: Room CK2.*
15. *Basement: Room CK3.*
16. *Level 2: Room C8.*

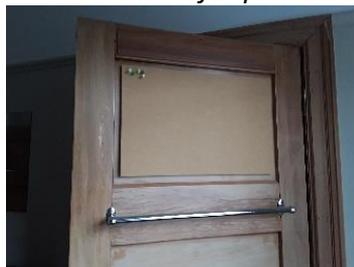
5. *The accommodation rooms cupboards/wardrobes throughout Levels 1 and 2 of the main building have recently had pinboards installed over the ventilation holes of the cupboards/wardrobe doors. These cupboards require sprinkler protection or vented into a sprinkler protected area. Refer photo below.*

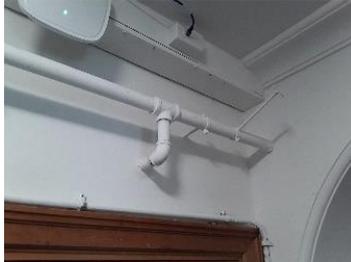
6. *Level 2, corridor outside Room B12: Pipework support not attached to wall. Refer photo below.*
